Overview of rock slope

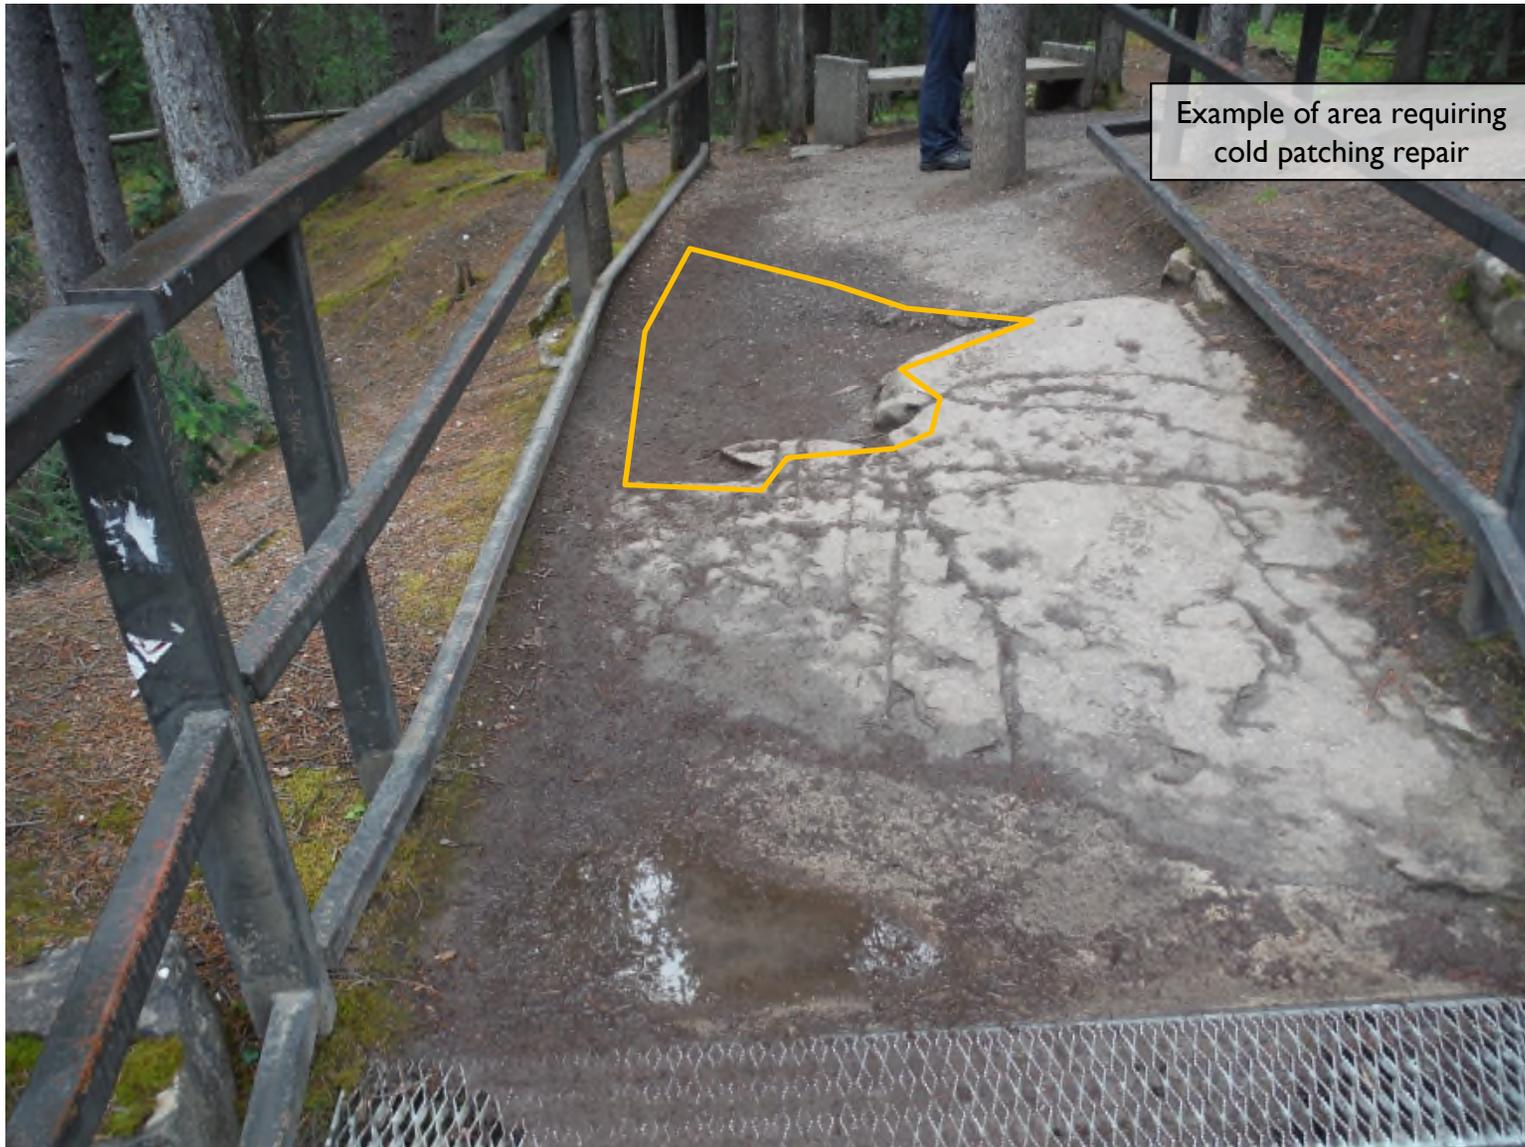
Example of area requiring cold patching repair

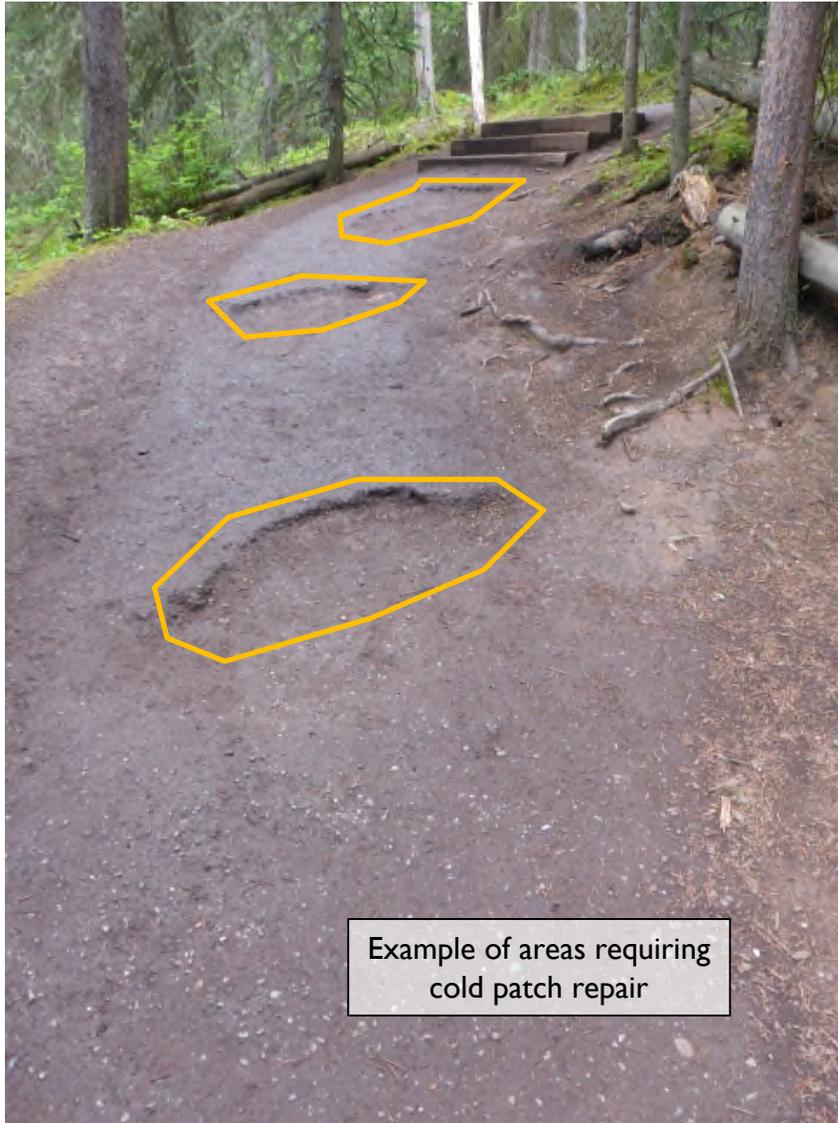
Example of areas requiring cold patch repair
