**HAZARDOUS MATERIALS
REMOVAL SPECIFICATIONS
BEAVERLODGE RESEARCH CENTRE
PROJECT NO.: R.078150.002
BEAVERLODGE, ALBERTA**

Public Works and Government Services Canada

26 JULY 2016

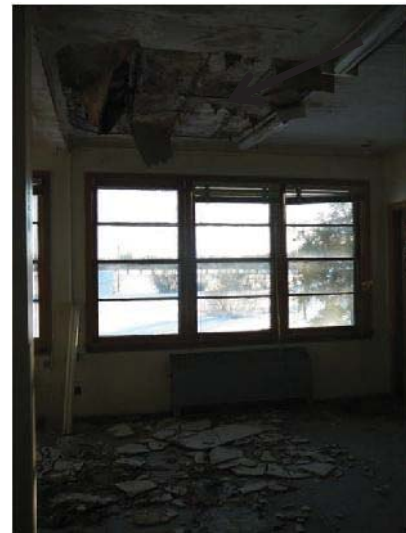
#2 Administration Office – Main Floor
Water damage and failure of the main floor ceiling

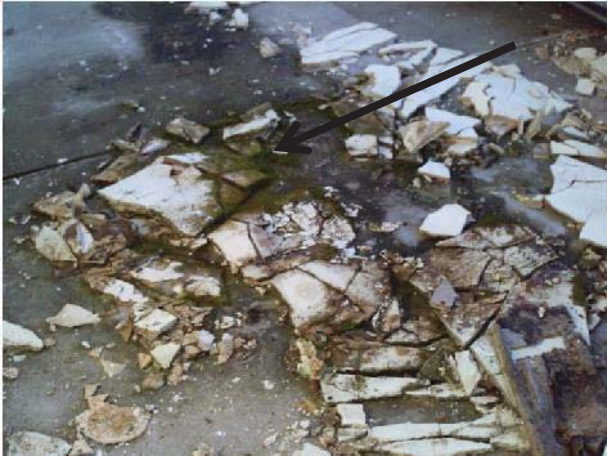
#2 Administration Office – 2nd Floor
Water Damage and debris from failure of the 2nd floor ceiling

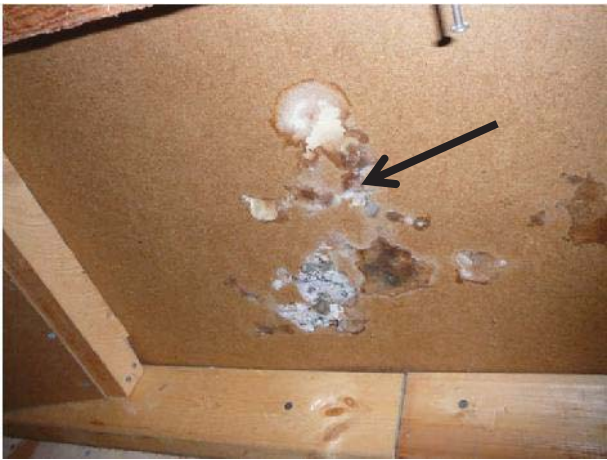
#14 Drying and Threshing Shed
Water damaged ceiling

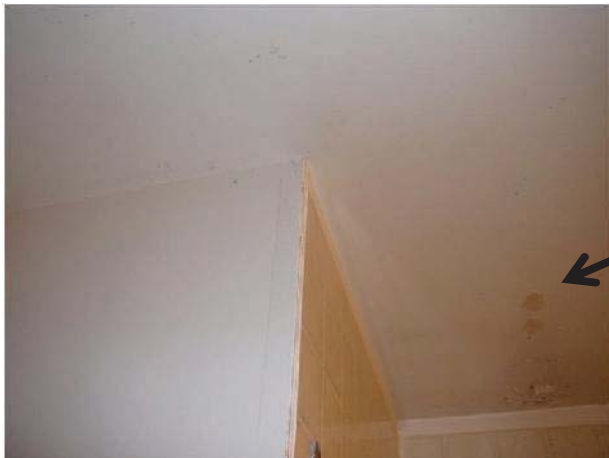
#60 Duplex House – North Unit
Water damage in the conference room closet
