OPTIONS ANALYSIS REV 02 JERICHO DIAMOND MINE, NUNAVUT

Aboriginal Affairs and Northern Development Canada

APRIL 2015
ISSUED FOR USE
FILE: E14103202-01

EXECUTIVE SUMMARY

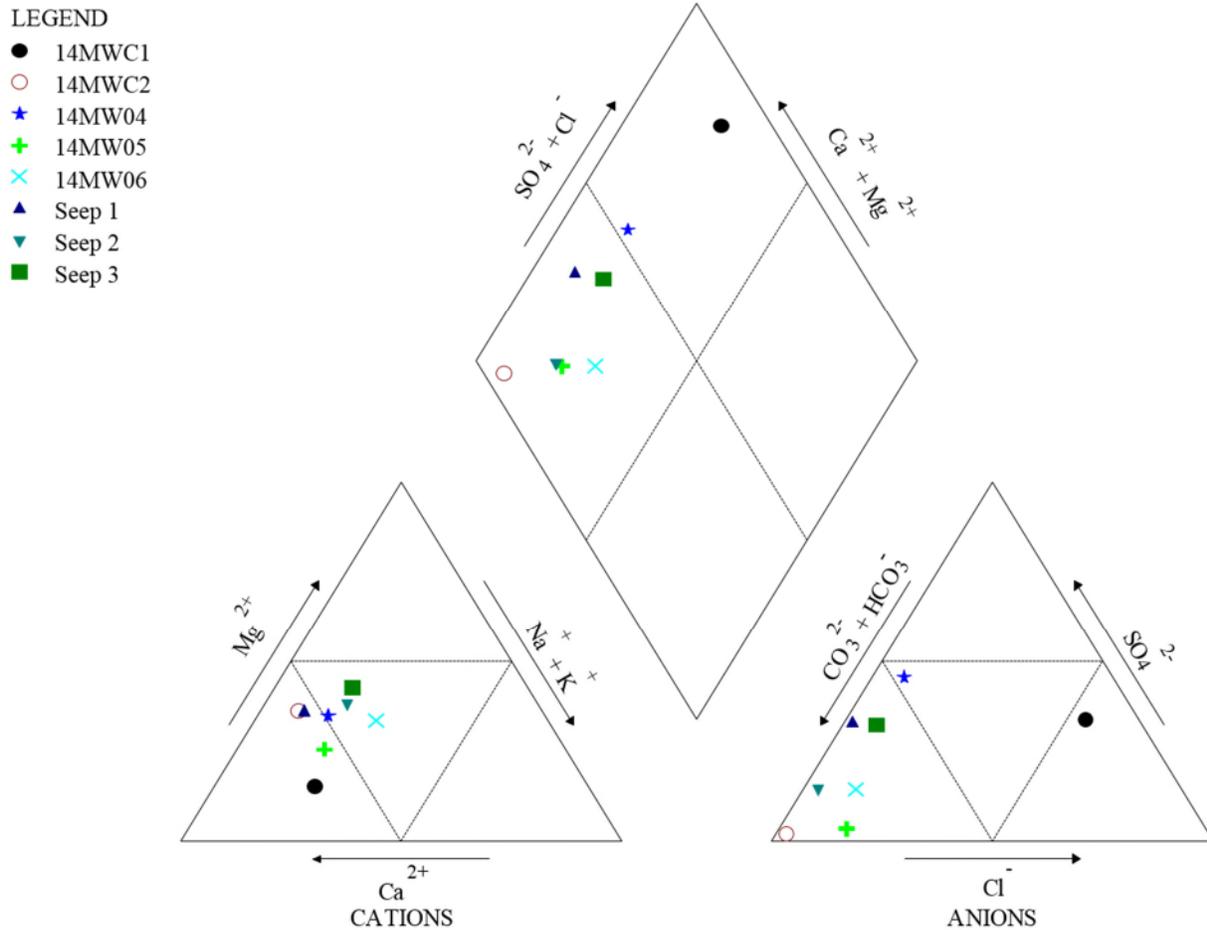
From this it appears that the waste rock may be influencing Seep 1, Seep 3, and well 14MW04, whereas Seep 2, well 14MW05, and 14MW06 may not be influenced as much by the waste rock since the chemistry composition is similar to background well 14MWC2. A further discussion on the groundwater and seep water quality is include in the conclusions and recommendation sections.

Figure 4.1: Piper plot comparing water chemistry of the background wells, down-gradient wells and seeps from the Waste Rock Pile Area at the Jericho Mine.

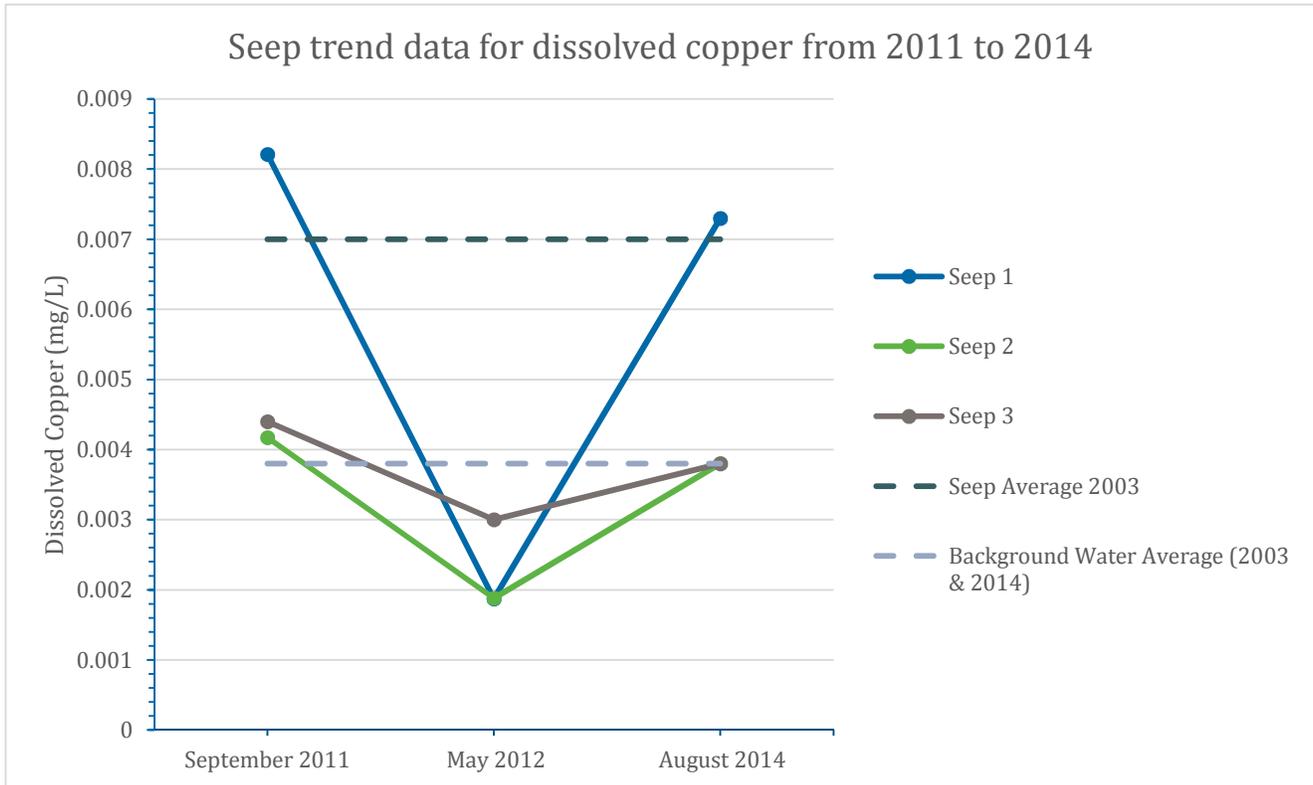
Total and dissolved copper exceeded CCME PFAL guidelines at Seep 1, Seep 2, and Seep 3. Total and dissolved copper from Seep 2 and Seep 3 are within background values. The total and dissolved copper values at Seep 1 are greater than Seep 2 and 3. The dissolved copper value at Seep 1 is within the natural variation observed at background conditions, while total copper is elevated. The total copper at Seep 1 has increased with time, while the dissolved copper has decreased. Total and dissolved copper values observed in this study are similar to background concentrations, except total copper at Seep 1. Figure 4.2 illustrates the trend of Seep 1, Seep 2, and Seep 3 from 2011 to 2014 compared to the average seep value obtained in 2003 from the waste rock pile. Seep 2 and Seep 3 have decreased since 2003, while Seep 1 is slightly greater than the 2003 data in 2011 and 2014. Generally, the concentration of dissolved copper from the waste rock has decreased with time and Seep 2 and Seep 3 are at the average background water quality conditions (average of surface water collected in 2003 and the groundwater wells in 2014).

Figure 4.2: Seep trend data for dissolved copper collected from 2011 to 2014, compared to the average seep concentration collected in 2003 from the waste rock pile and the average background dissolved copper concentrations.

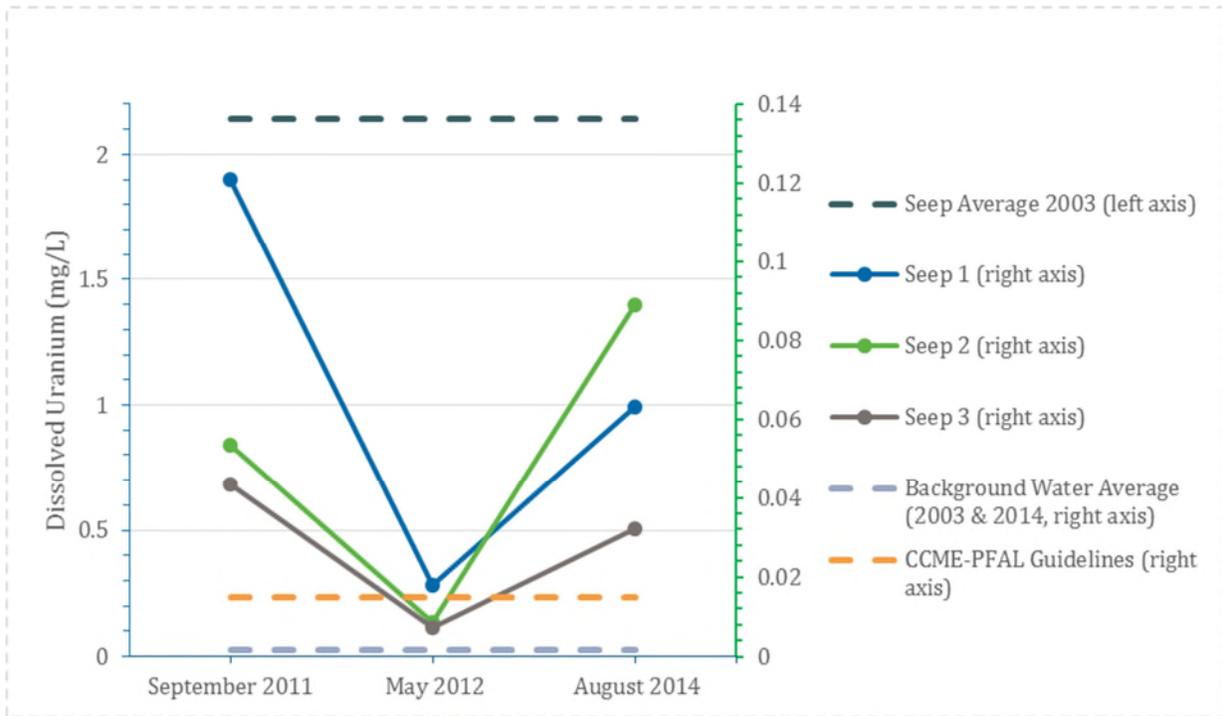
Total and dissolved uranium concentrations for Seep 1, Seep 2, and Seep 3 exceeded the CCME PFAL guidelines. Dissolved uranium values are similar to the total uranium values. The average dissolved uranium value from Seep 1 to Seep 3 from 2011 to 2014 is 0.048 mg/L, while the total uranium value is 0.053 mg/L. This suggests that the majority of the uranium measured is in the dissolved form. Total and dissolved uranium values are above the background concentrations as measured by SRK in 2003. The concentration of total and dissolved uranium from Seep 1, Seep 2, and Seep 3 have had little changes since 2011 (Figure 4.3). Uranium concentrations during freshet (May 2012) are below the CCME-PFAL guidelines except Seep 1, which is slightly above. Overall, seep samples from the waste rock have significantly decreased when compared to the seeps sampled down-gradient of the development waste rock pile in 2003. Although the seep samples are below the 2003 concentrations, dissolved uranium values are still greater than the average background concentrations collected from 2003 and 2014 (Figure 4.3). Uranium in the groundwater monitoring wells down-gradient of the waste rock pile are below the CCME-PFAL guidelines, thus uranium may not be impacting the groundwater at the sampled monitoring wells.

Figure 4.3: Seep trend data for dissolved uranium collected from 2011 to 2014, compared to the average seep concentration collected in 2003 from the waste rock pile, the average background dissolved uranium concentrations and the CCME-PFAL guideline.

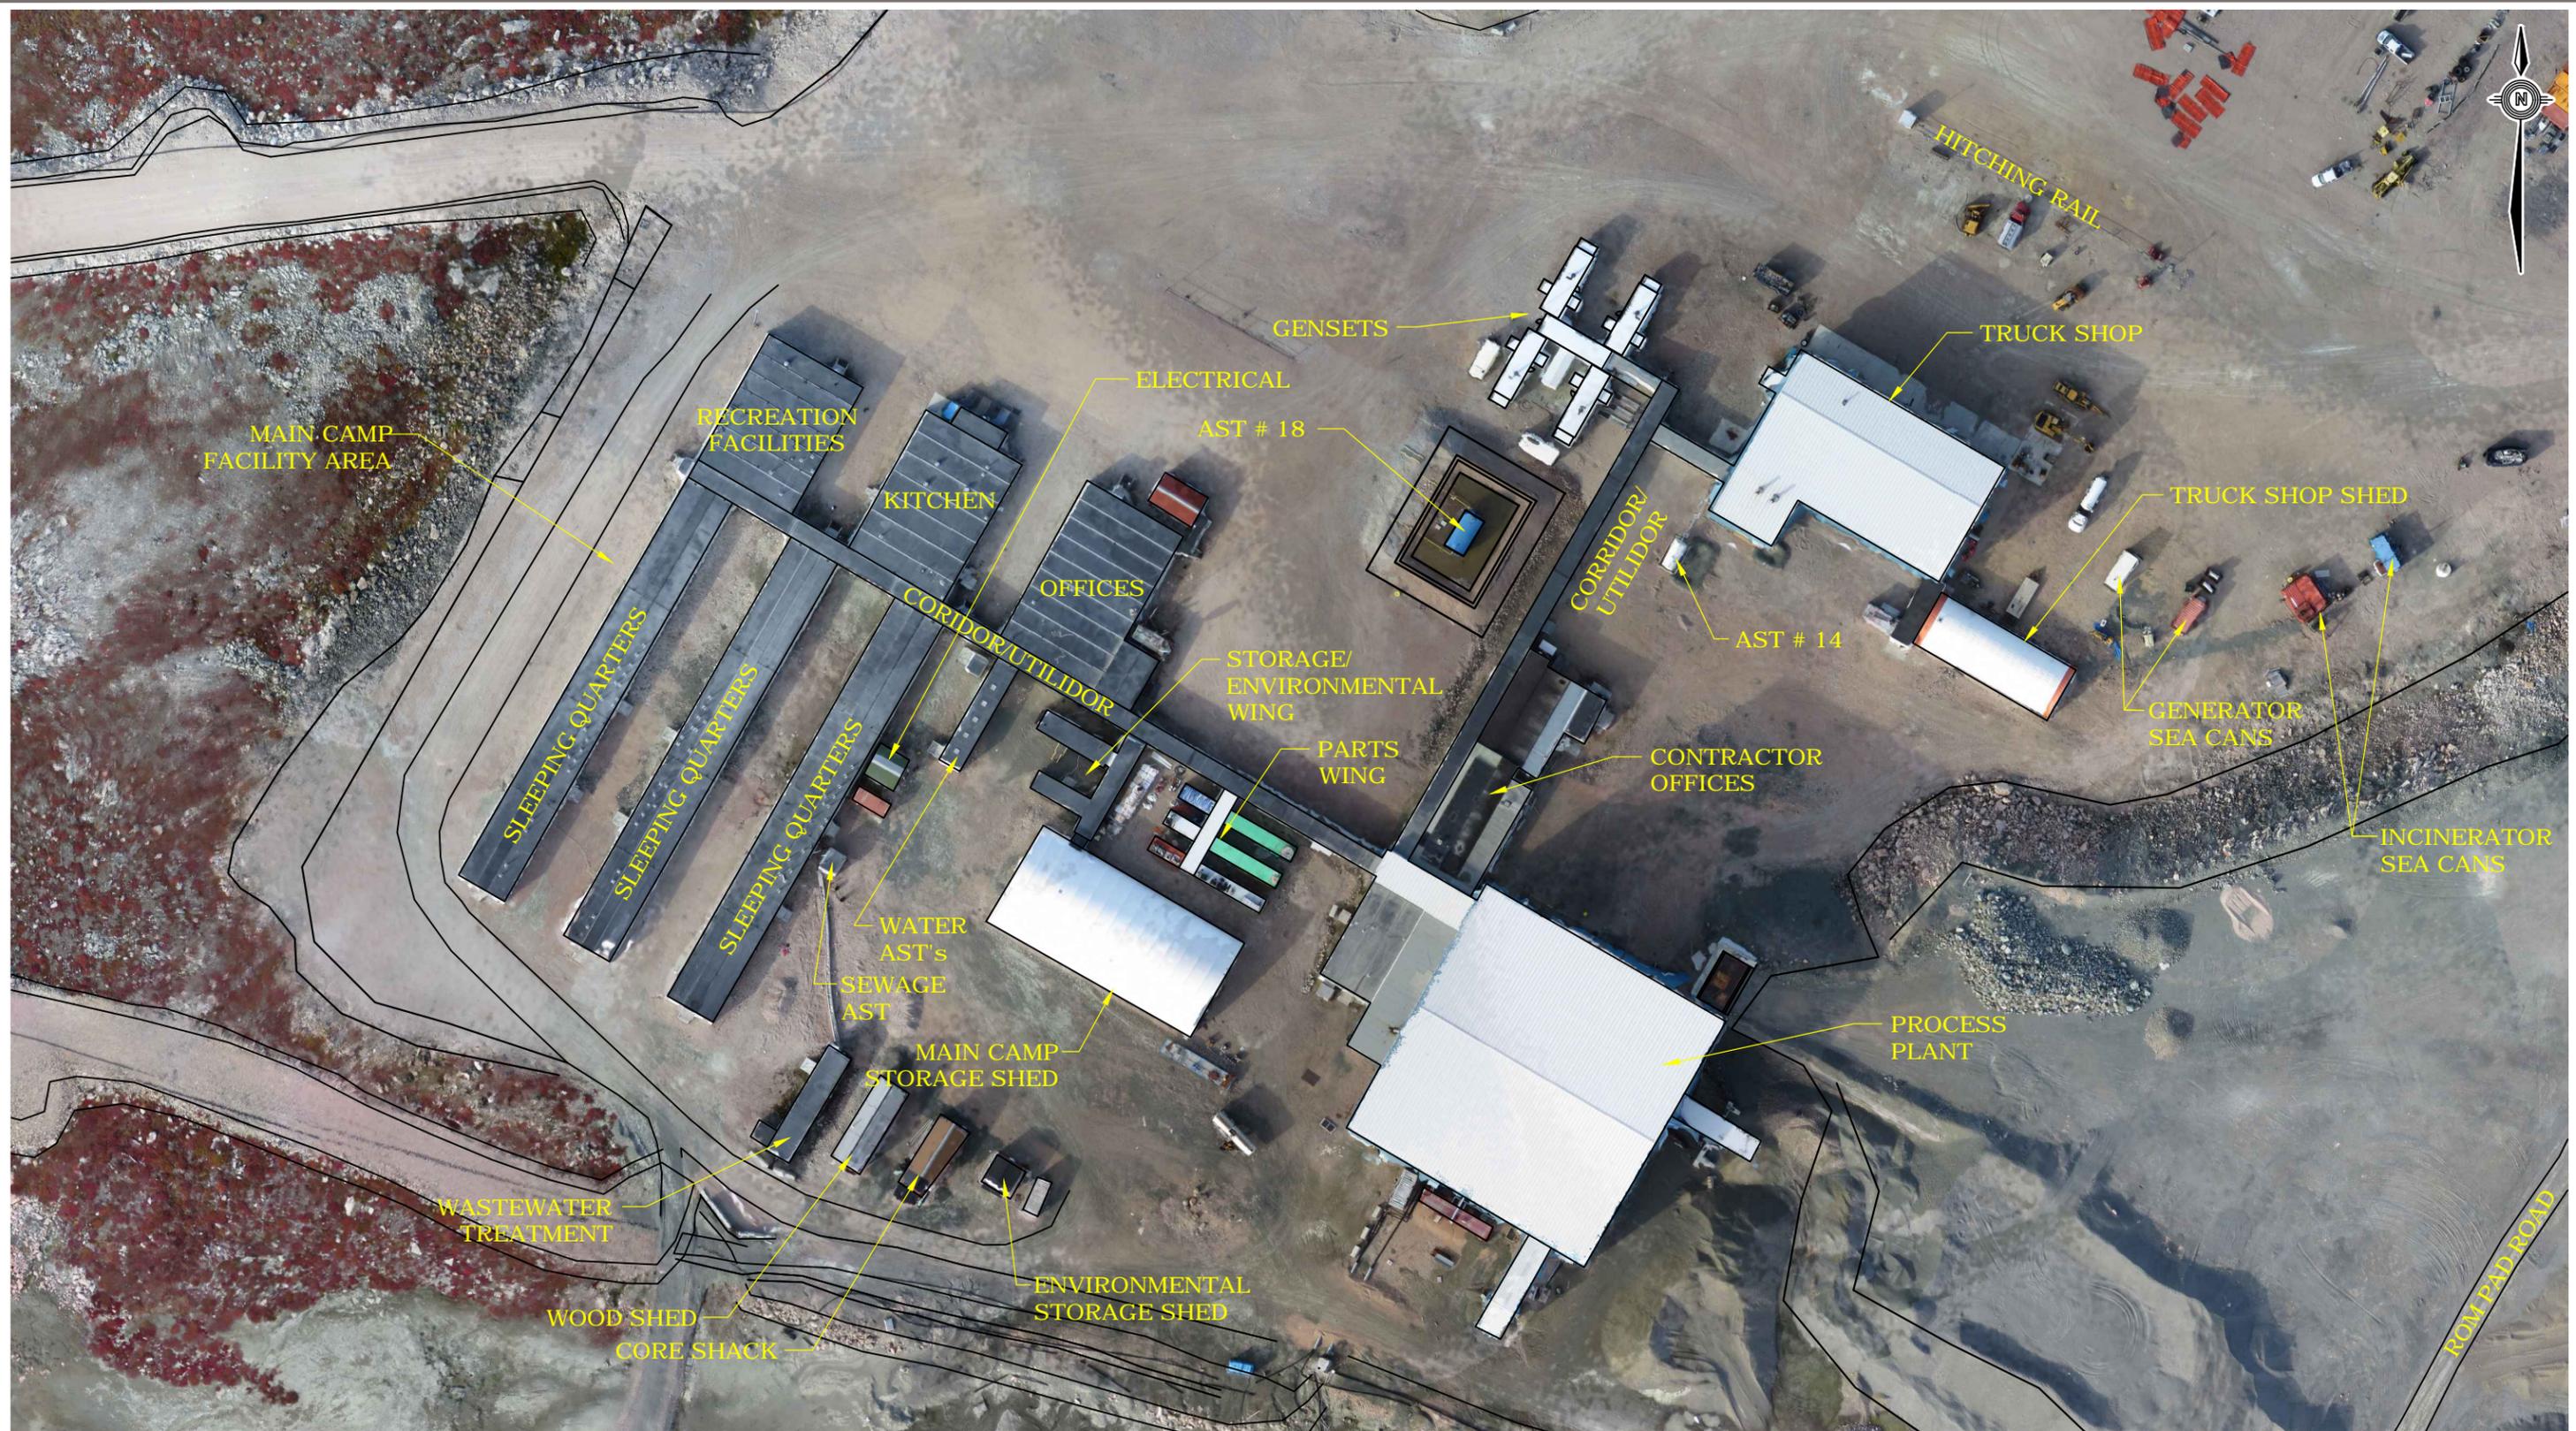
One 64,000 L fuel tank (AST #18) is located adjacent to the generator area at the plant site, as shown in Figure 3.2. The tank is contained by a lined berm containment area covered with a layer of crushed gravel. The perimeter berms are generally in good condition with no signs of instability or distress. Similarly, the tank appears to be in good condition and functioning adequately.

A low spot in the berm was observed, consistent with previous inspections. The depression in the berm could reduce the secondary containment volume of the berm.

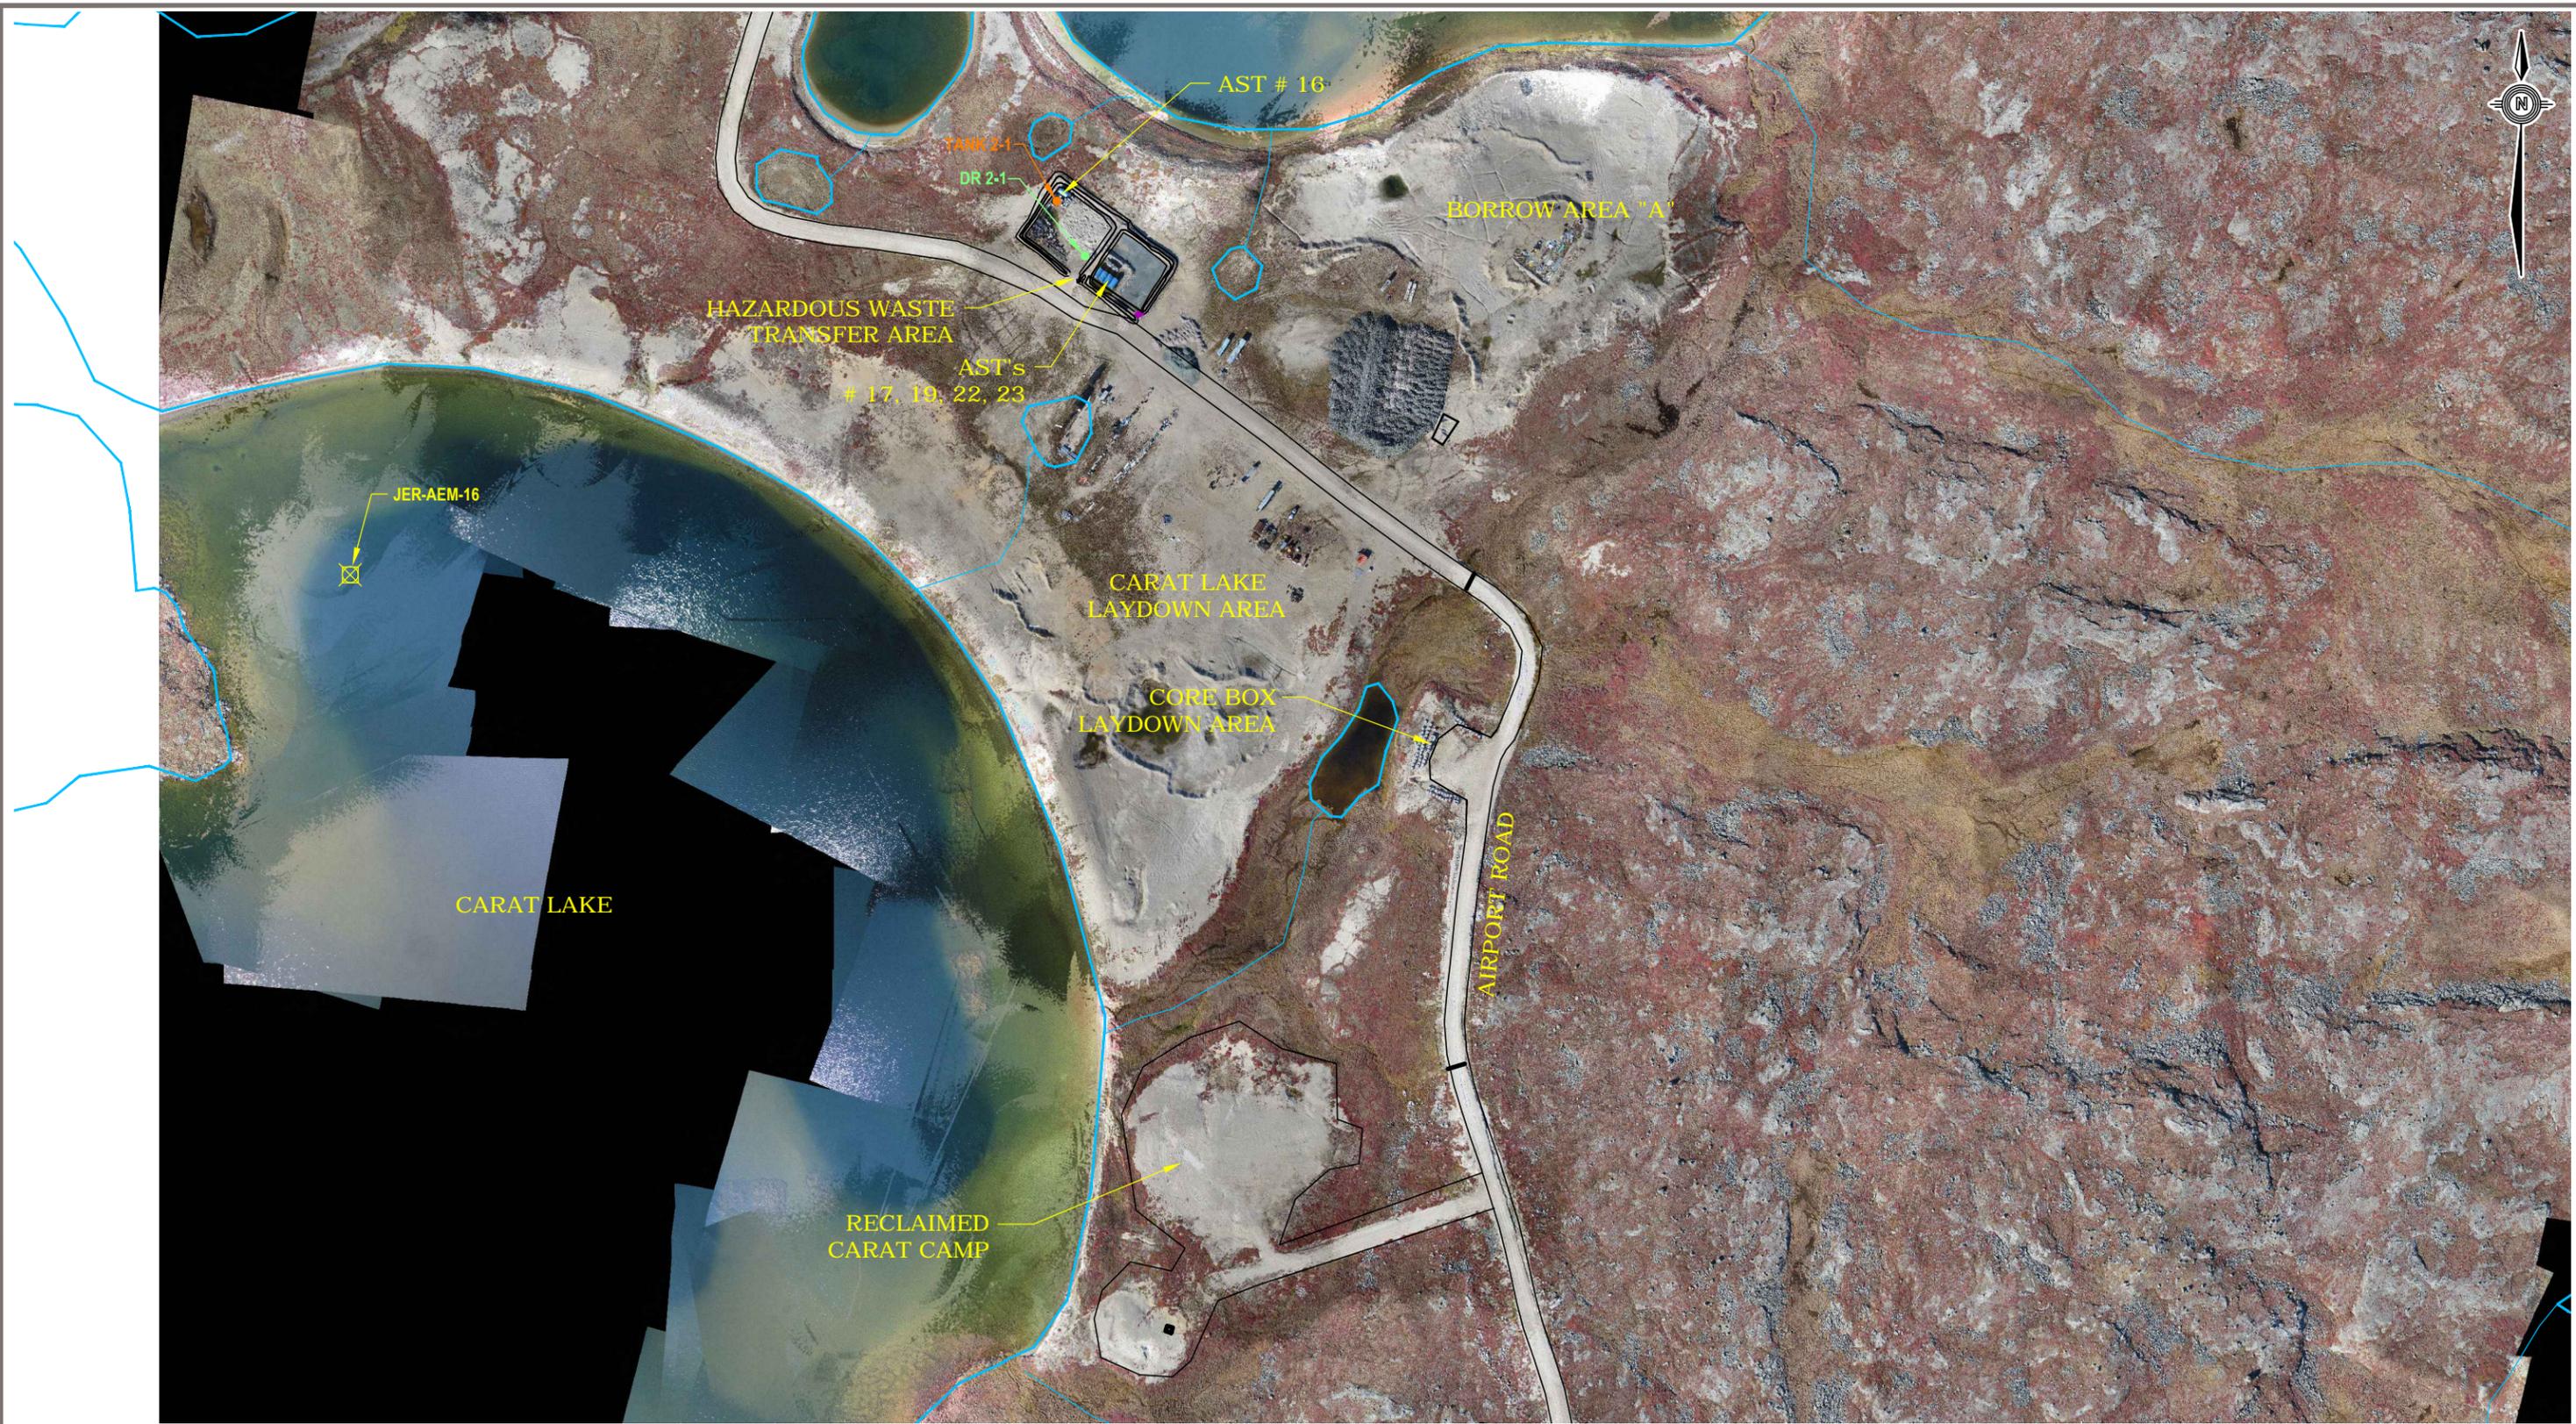
The HWTA is a HDPE-lined facility used for the temporary storage of hazardous waste prior to disposal or transfer off site. The facility was constructed by Tahera; however, details pertaining to the facility construction are limited. The HWTA is shown in Figure 6.

The HWTA berms are in good condition with no signs of instability; however, the liner system has been compromised in several locations. The perforations appear to be located some distance above the cell floor as ponding water has been observed in both cells.
