**Inspection Report for:**  
**D Jetty Fender System**  
**CFB Esquimalt**

**96272**  
**October 1996**

Reference: Inspection Report for D Jetty Fender System

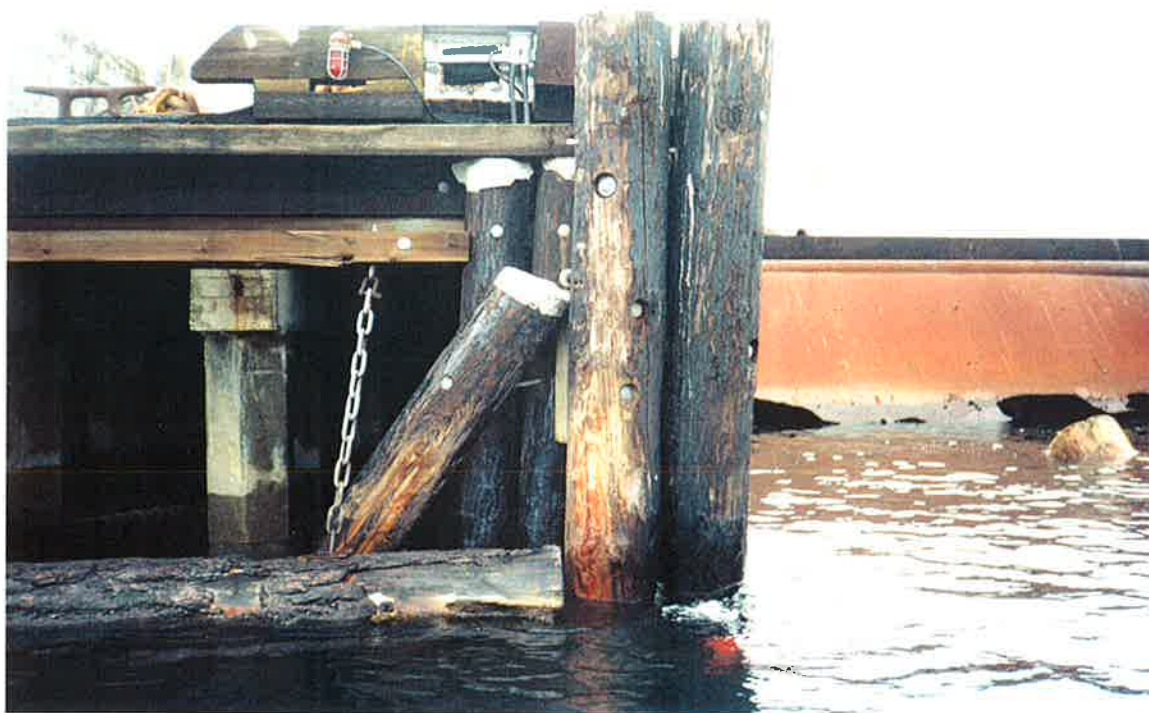
Bent	Observation	Recommendation
1A	Pile is missing.	Replace pile
5A	Lower connection bolt is missing.	Install lower connection bolts.
9A	Top 1.2 m of pile is crushed.	Replace pile
19A	Lower connection bolts are missing and pile is loose (Photograph No.1).	Replace upper and lower connection bolts.
25A	10% marine borer cavity (MBC) at lower bolt connection; bolt is missing and pile is loose.	Plug existing bolt holes and install replacement lower connection bolts at different elevation.
39A	25% MBC at lower bolt connection; pile is loose.	Remove existing bolts and plug hole; install replacement bolts at different elevation.
43A	Lower connection bolt is missing, and pile is loose causing abrasion damage in the intertidal zone.	Install lower connection bolts.
A	Rubbing Pole No.5 has 50% cross-section loss (CSL) at lower bolt connection; bolt is missing and pile is loose.	Replace pile
B	One bolt is loose due to an elongated bolt hole, and the other bolt is missing at lower connection.	Install new connection bolts at different elevation.

**Photograph No. 1:** Bent 19A, Rubbing Pole - Lower connection bolts are missing and Pile is loose.

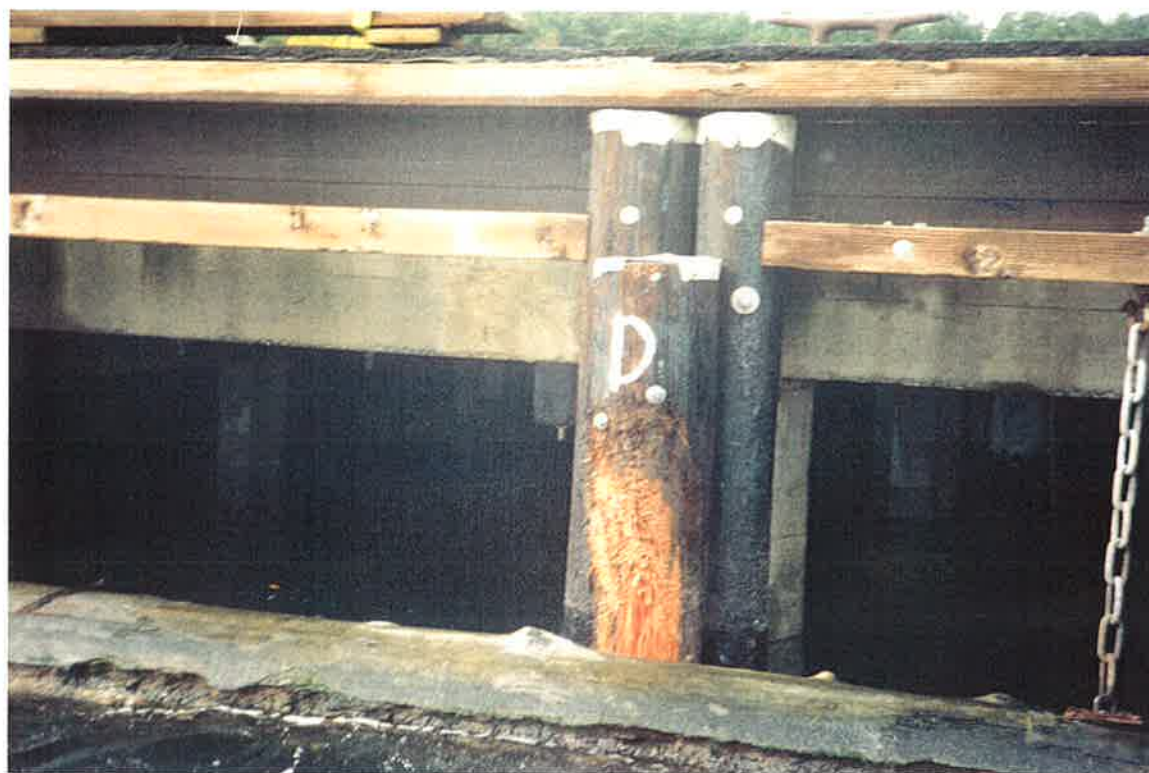
D	50% CSL in intertidal zone due to abrasion (Photograph No.2).	Replace pile

**Photograph No. 2:** Bent D, Rubbing Pole - 50% CSL in intertidal zone due to abrasion.

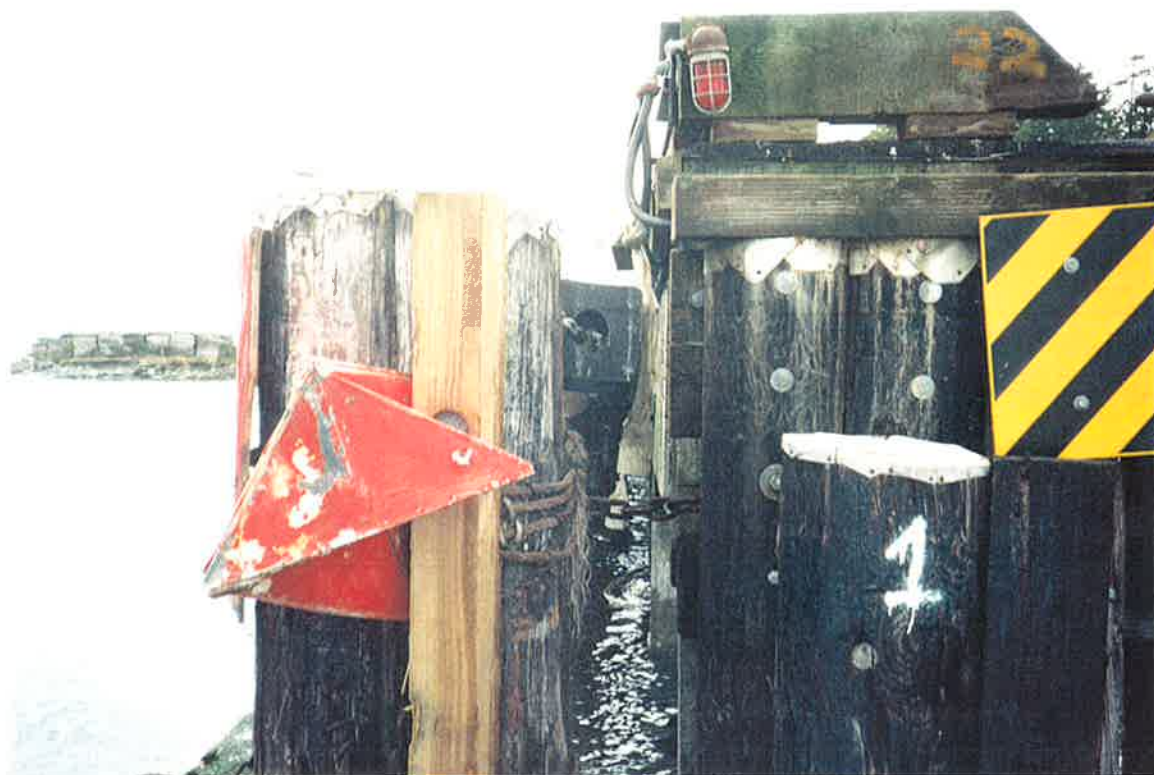
**Photograph No. 3:** Four Pile Cluster - Piles do not appear to be connected to the jetty.

Bent	Pile No.	Observation
47A - 55A	-	Fender log is missing.
A	-	Chain connection between concrete pilecap and timber fender Piles is too loose.
	-	4 Pile cluster on corner, adjacent to Bent A, does not appear to be connected to the jetty.
	5	50% CSL at lower bolt connection; bolt is missing and Pile is loose. 50% of hat is missing.
B	-	Chain connection between concrete pilecap and timber fender Piles is broken.
	2	Bolt hole is elongated at lower connection.
	3	One bolt is loose due to an elongated bolt hole and the other bolt is missing, at the lower connection.
D	3	50% CSL in intertidal zone due to abrasion.
F	3	20% CSL in intertidal zone due to abrasion. Pile is loose at bottom due to elongated lower connection bolt hole.
2	3	Lower connection is loose.
4	3	10% CSL in intertidal zone due to abrasion.
5	3	50% MBC at lower bolt connection; bolt is loose. 25% CSL in intertidal zone due to abrasion.
7	3	Lower bolt connections are loose. 30% CSL in intertidal zone due to abrasion.

\* INSTALL ADDITIONAL EYEBOLTS AND RESTRAINT CHAINS TO SECURE THE 4 PILE CLUSTER AT THE CORNER OF THE JETTY
