**DEFENCE CONSTRUCTION  
CANADA**

**Report for:**  
**Department of National Defence**  
**D Jetty Inspection**

**03133**  
**December 2003**

Reference: D Jetty Inspection  
Project No. ES 557 56  
Contract No. 22895

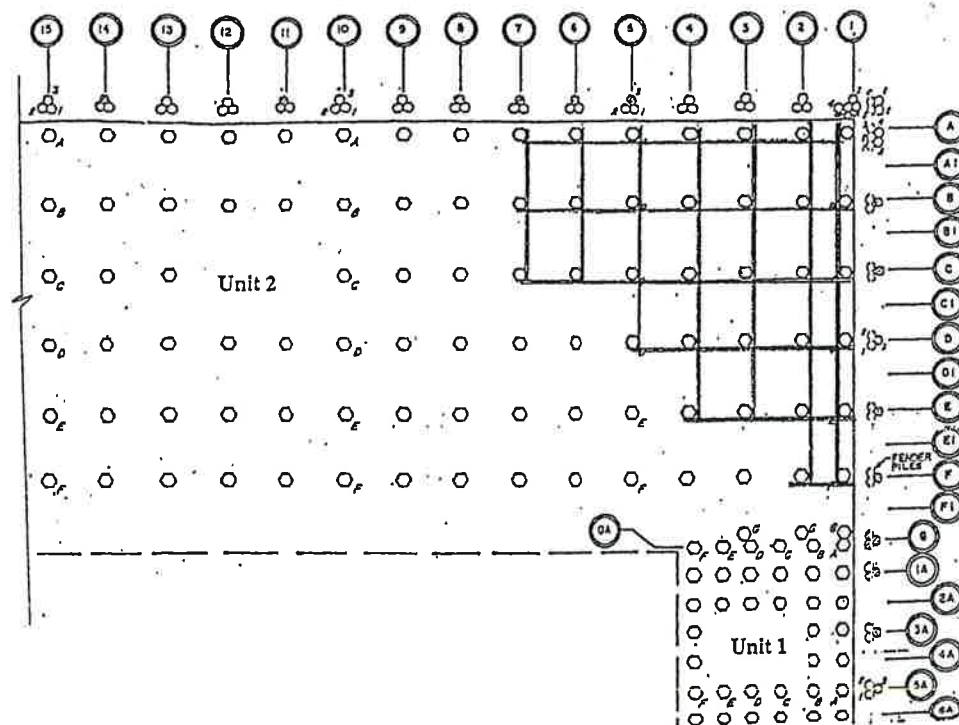
FIGURE 1: D-Jetty - Bracing Arrangement

The bracing is generally in a serviceable condition, although there has been an increase in the observed deterioration due to marine borer attack. Specific areas of bracing damage are summarized in *Table 3.4* below:

Brace No.	Description	Recommendation
1B - 7B	Brace has a 10% MBC at Pile No. 1B.	Monitor.
1C - 7C	Brace has a 10% MBC at Pile No. 1C.	Monitor.
1D - 5D	Brace has a 75% MBC at Pile No. 1D.	Replace brace.
1E - 4E	Brace has a 75% MBC at Pile No. 1E.	Replace brace.
1A - 1F	Brace has multiple 10% MBC's between Pile Nos. 1B and 1F.	Monitor.
1F - 2F	Brace has a 100% MBC at Pile No. 2F.	Replace brace.
1E - 4E	Brace has a 25% MBC at Pile No. 2E.	Monitor.
1D - 5D	Brace has a 50% MBC at Pile No. 2D.	Replace brace.
2A - 2F	Brace has multiple 10% MBC's between Pile Nos. 2D and 2F and a 100% MBC at Pile No. 2F.	Replace brace.
1C - 7C	Brace has a 25% MBC at Pile No. 2C.	Monitor.
2A - 2F	Brace has a 25% MBC between Pile Nos. 2A and 2D.	Replace brace.
1E - 3E	Brace has a 25% MBC at Pile No. 3E.	Monitor.
3A - 3E	Brace has a 50% MBC at Pile No. 3E.	Replace brace.
1E - 4E	Brace has a 100% MBC between Pile Nos. 3E and 4E.	Replace brace.

4A - 4E	Brace has a 75% MBC at Pile No. 4E.	Replace brace.
1C - 7C	Brace has a 90% MBC at Pile No. 4C.	Replace brace.
1A - 7A	Brace has a 25% MBC at Pile No. 2A, and a 10% MBC at Pile No. 4A.	Monitor.
1B - 7B	Brace has a 25% MBC at Pile No. 7B.	Monitor.
6A - 6C	Brace has 50-75% CSL due to MBC along the entire length.	Replace brace.
7A - 7C	Brace has 25-50% CSL due to MBC along the entire length.	Replace brace.

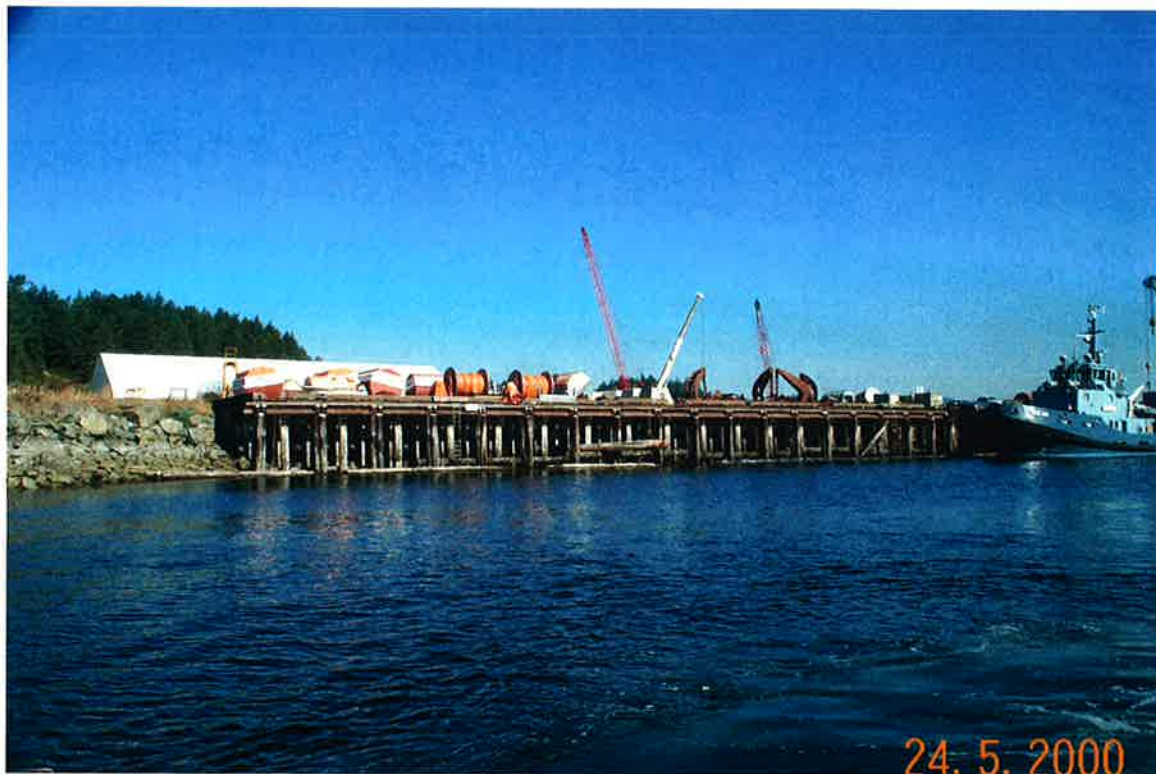
**Photograph No. 1:** General view of the east berth.

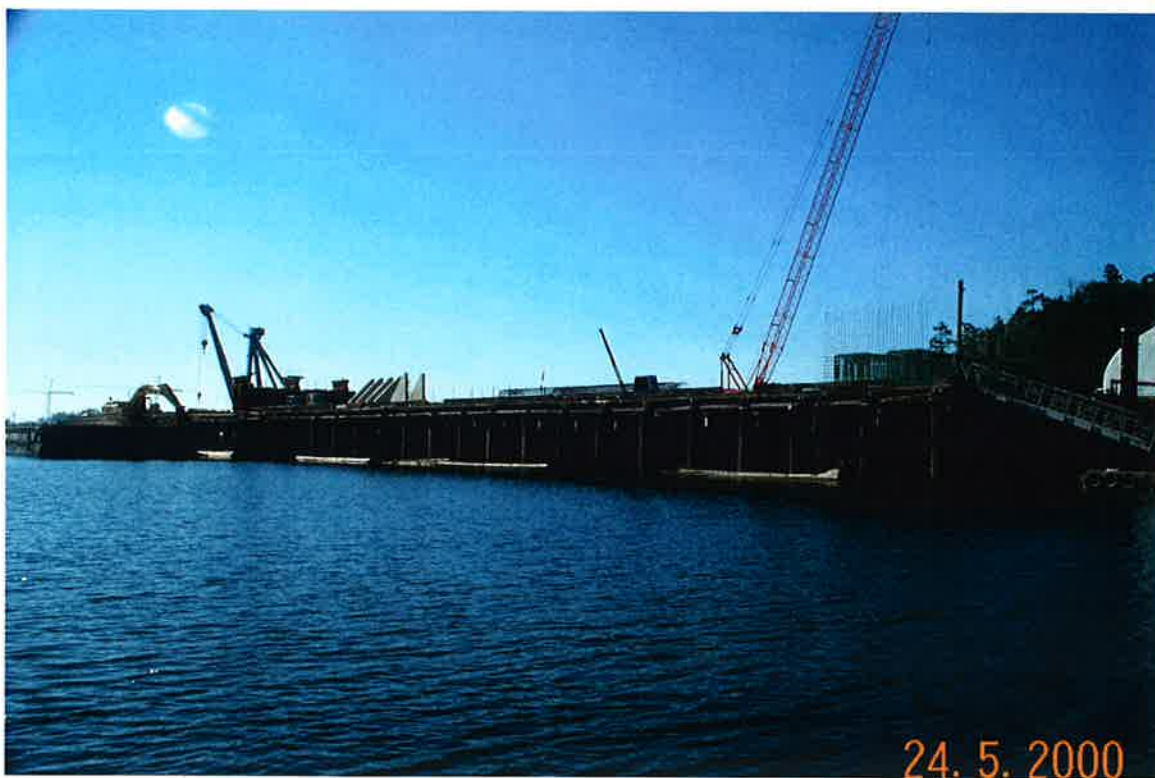
**Photograph No. 2:** General view of the north berth.

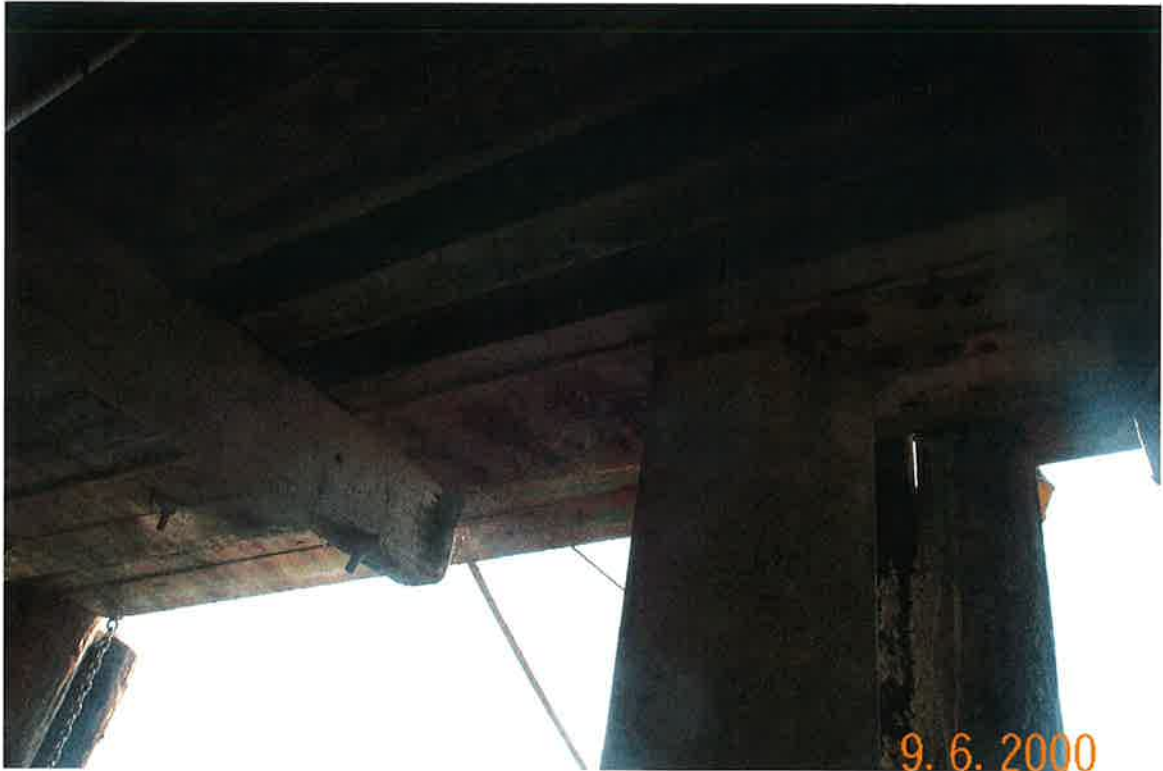
The severe deterioration of the pile cap soffit at Bent No. 3 (adjacent to Bayline G) and at Bent No. 1 (adjacent to Bayline B) has resulted in the bottom leg of the shear reinforcement (stirrups) being exposed. The extent of the deterioration does not appear to have increased since the 1997 inspection program.

Bent No.	Pile	Description of Damage
1	A-B	Concrete spalling on soffit of cap with exposed reinforcement in a 1.3 m long x 0.4 m wide x 50 mm deep section between Piles A and B ( <i>Photograph No. 3</i> ).
2	A	Minor surface spalling of concrete with exposed reinforcement steel.
3	A	Minor surface spalling of concrete with exposed reinforcement steel.
	C	Minor surface spalling of concrete with exposed reinforcement steel.
	G	Concrete spalling on soffit of pile cap with exposed reinforcement in a 300 mm x 150 mm x 50 mm deep section ( <i>Photograph No. 4</i> ).
22	A	Spalling on outside corner with exposed reinforcement steel (impact at berth face).
24	C-B	Minor surface spalling of concrete with exposed reinforcement steel (four bars visible) ( <i>Photograph No. 5</i> ).
	E	Minor surface spalling of concrete with exposed reinforcement steel.
	F	Minor surface spalling of concrete with exposed reinforcement steel (three bars visible).

Of immediate concern are the pile caps that exhibit severe spalling and exposed reinforcement. Located on the soffit of the members the damage is attributed to insufficient concrete cover resulting in the corrosion of the shear reinforcement. Section loss in the steel is in the order of 10 to 15% of the original bar diameter. Since the pile caps in shear is one of the governing factors with respect to jetty loading, remedial work consisting of the removal of delaminating concrete, cleaning of the steel and resealing the pile cap using a concrete patching system is recommended. In the event that there is severe section loss of the reinforcement steel, additional bars may be required to be drilled into the cap.

**Photograph No. 3:** Exposed, rusted reinforcing steel along Bent No. 1, between Piles A and B.

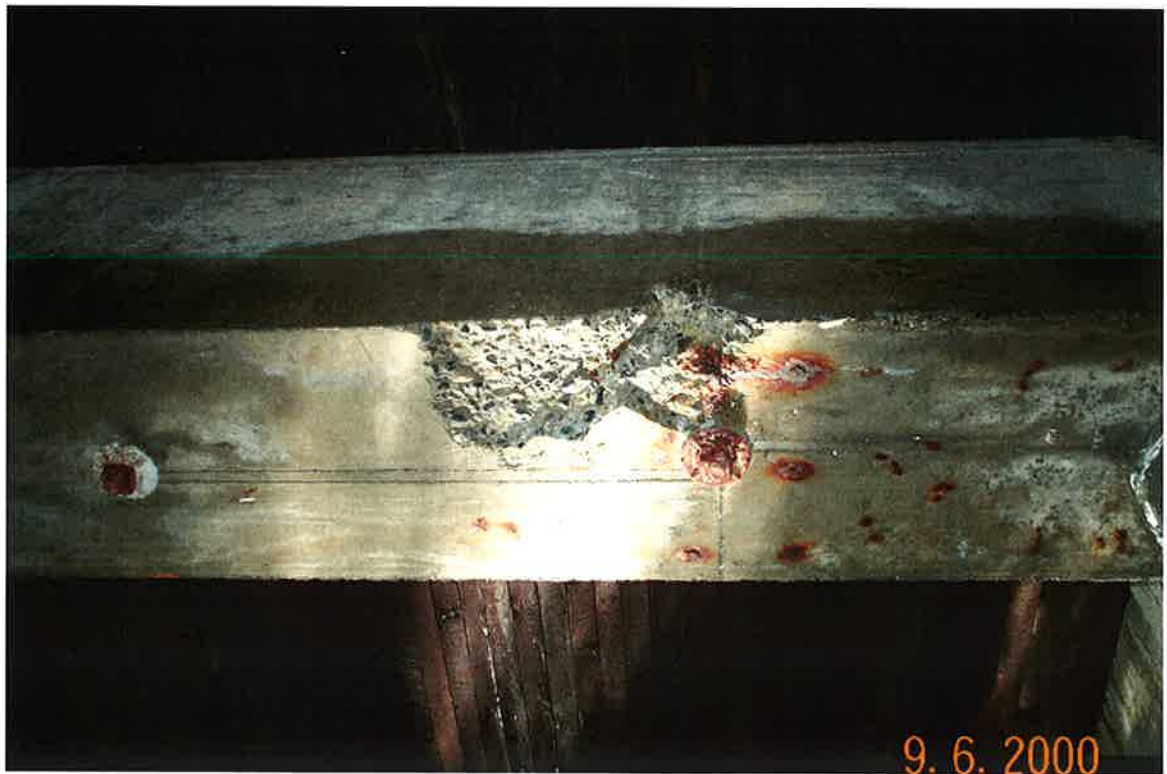
**Photograph No. 4:** Spalling on pile cap corner at Pile No. 3G.

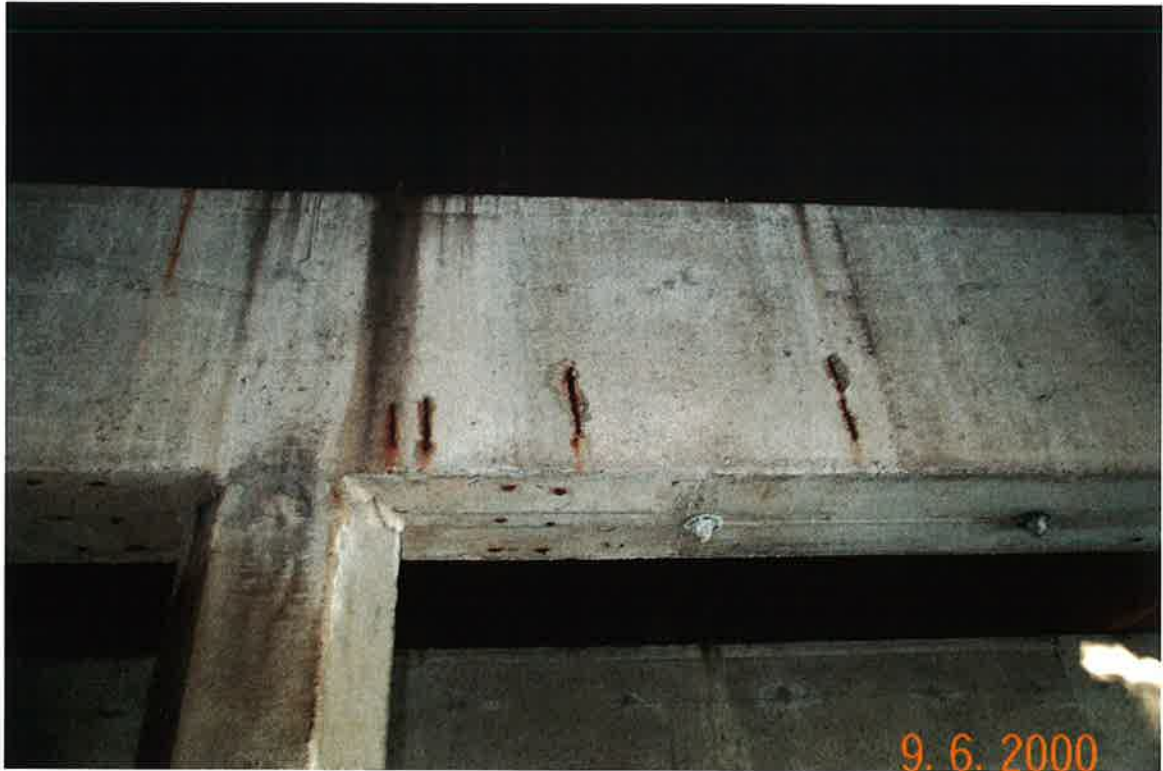
**Photograph No. 5:** Exposed, rusted reinforcement at Pile No. 24C.

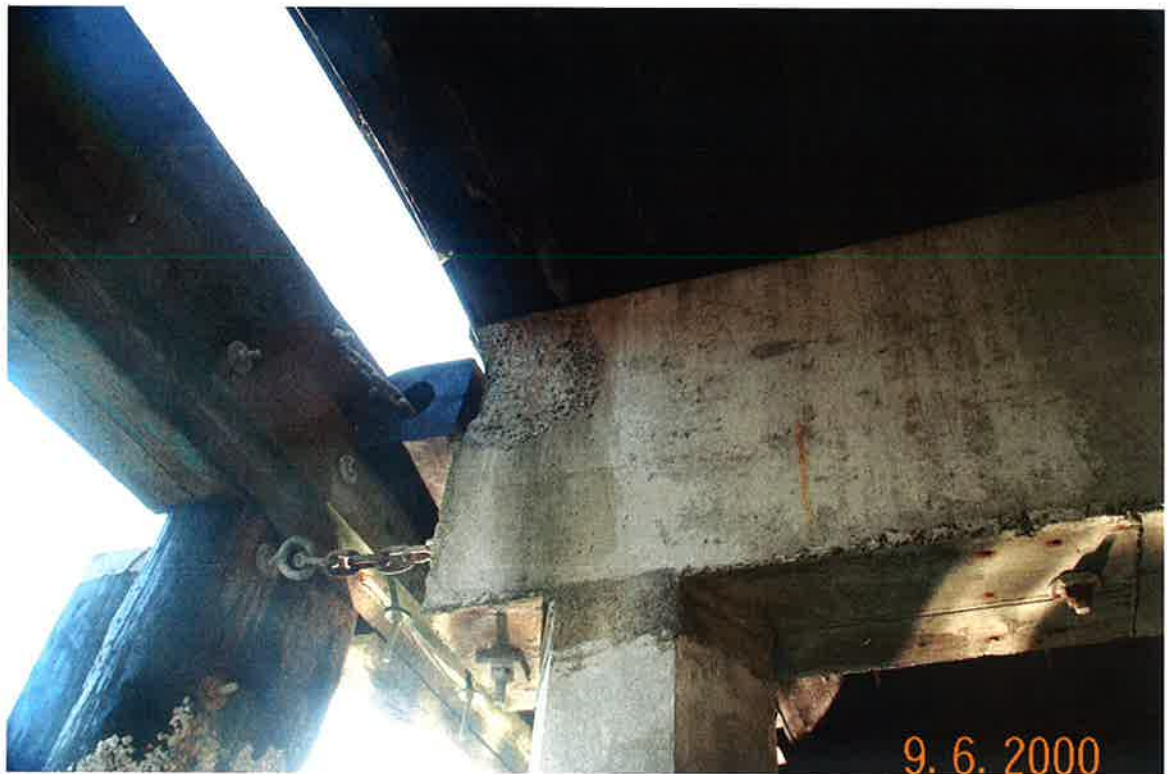
**Photograph No. 6:** Spalling resulting from impact at Pile No. 35A.

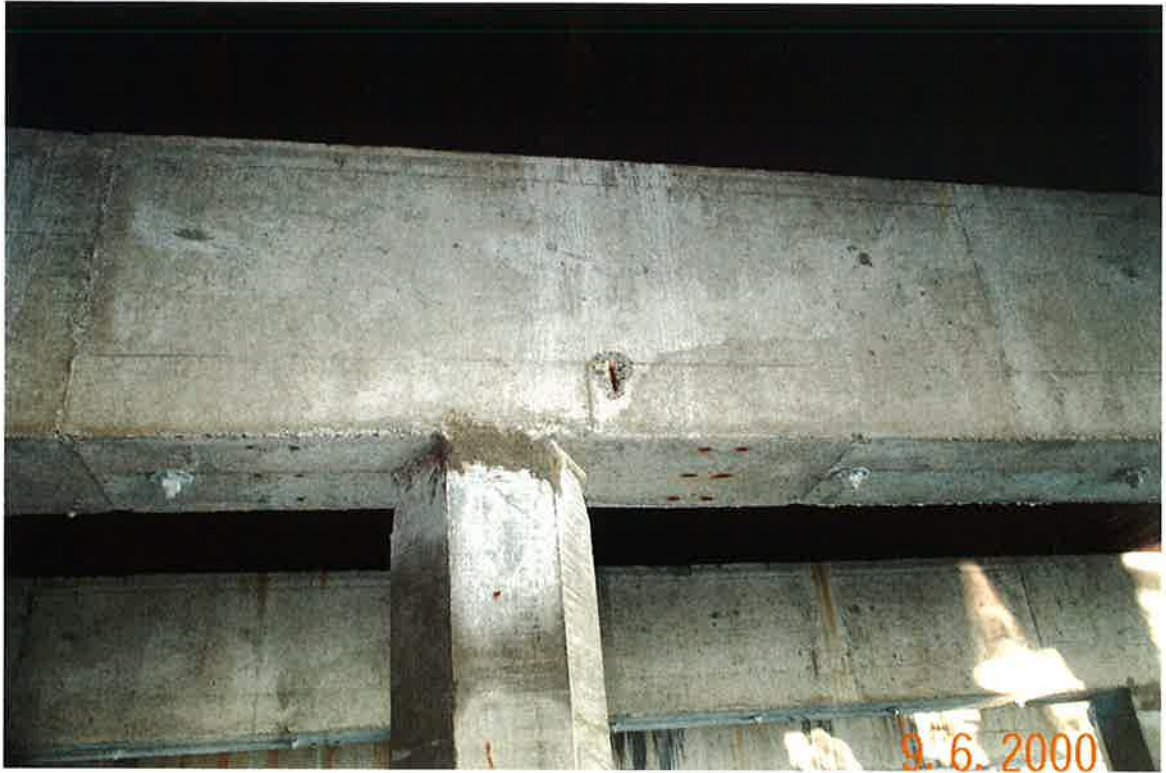
**Photograph No. 7:** Exposed, rusted reinforcement at Pile No. 36C.

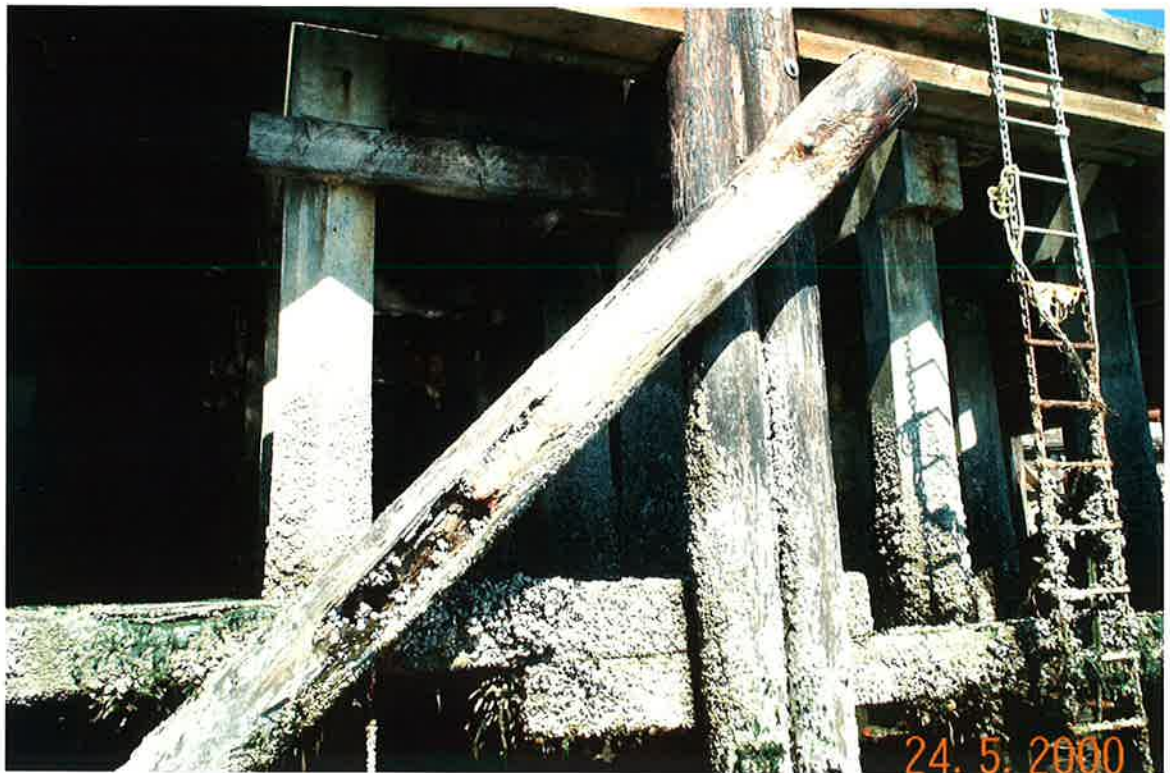
**Photograph No. 8:** Rub pile has severe marine borer infestation, and as a result the lower connection has failed.

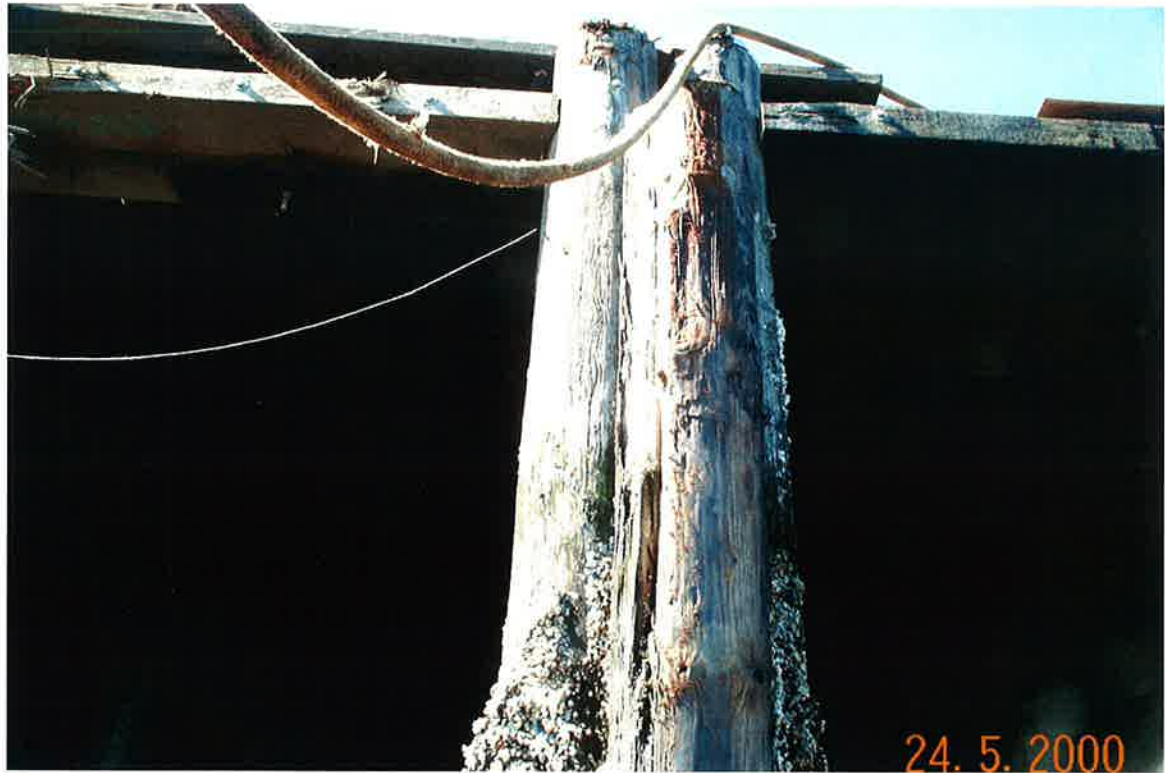
**Photograph No. 9:** Fungal decay and mechanical damage at the top of the rub pile.

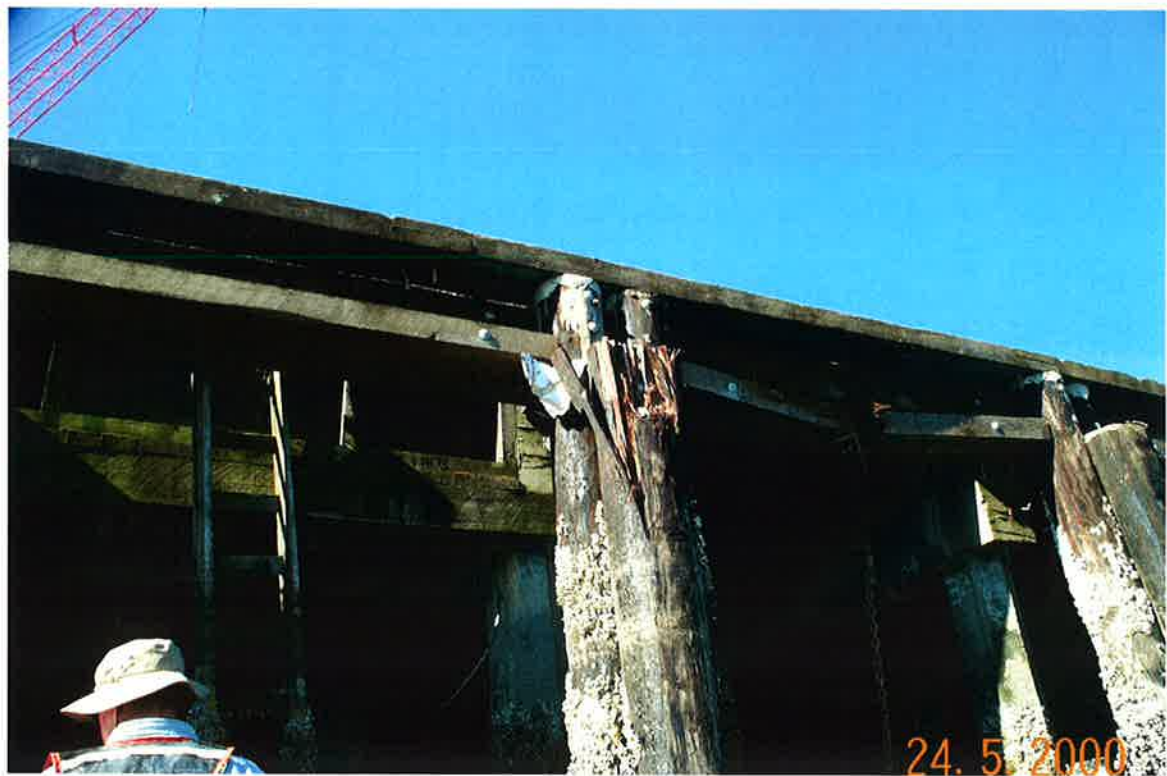
25	5% MBC in the upper ITZ.	Monitor.
28	5% MBC in the upper ITZ.	Monitor.
29	5% MBC at lower bolt connection.	Monitor.
30	Upper connection bolt is loose.	Replace upper connection bolts.
33	25% CSL at the upper bolted connection due to fungal decay ( <i>Photograph No. 10</i> ).	Replace pile.

**Photograph No. 10:** Fungal decay in the top of the rub pile at Bent No. 33.

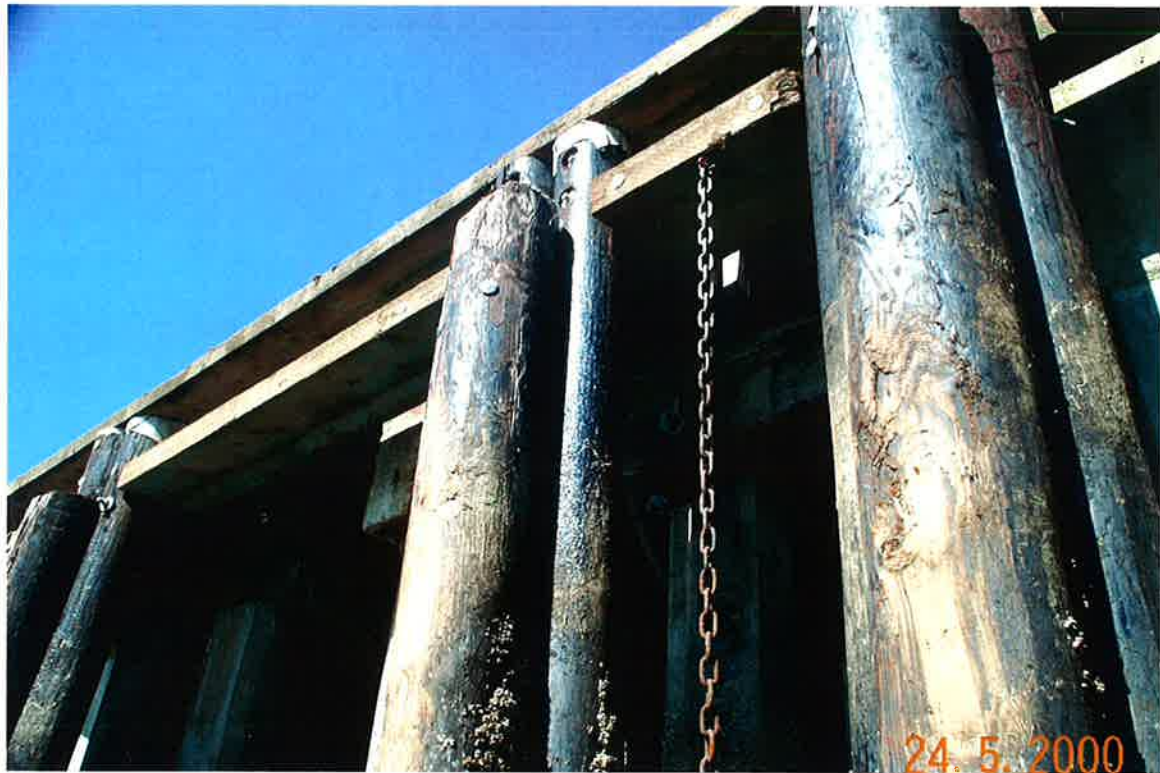
Bent	Pile No.	Observation	Recommendation
1A	2	Connection/restraint chain between concrete pile cap and timber fender piles is loose ( <i>Photograph No. 11</i> ).	Resecure restraint chain.
5A	2	Fender pile has an OBH in the ITZ.	Install resin plug.
7A	1	Upper connection has failed.	Replace upper connection bolts.
9A	1	Connection/restraint chain between concrete pile cap and timber fender piles and the eyebolt in the pile cap are missing; pile has two OBH's in the ITZ.	Install additional eyebolts and restraint chains. Install two resin plugs.
	2	Connection/restraint chain between concrete pile cap and timber fender piles and the eyebolt in the pile cap are missing.	Install additional eyebolts and restraint chains.
17A	-	Eyebolt in pile cap is missing.	Replace eyebolt.
18A	2	Upper connection is loose.	Replace upper connection bolts.
19A	-	Fendering is fractured.	Replace two piles.
21A	2	100% MBC in the upper ITZ ( <i>Photograph No. 12</i> ).	Replace pile.

**Photograph No. 11:** Eyebolt is missing at Bent No. 1A.

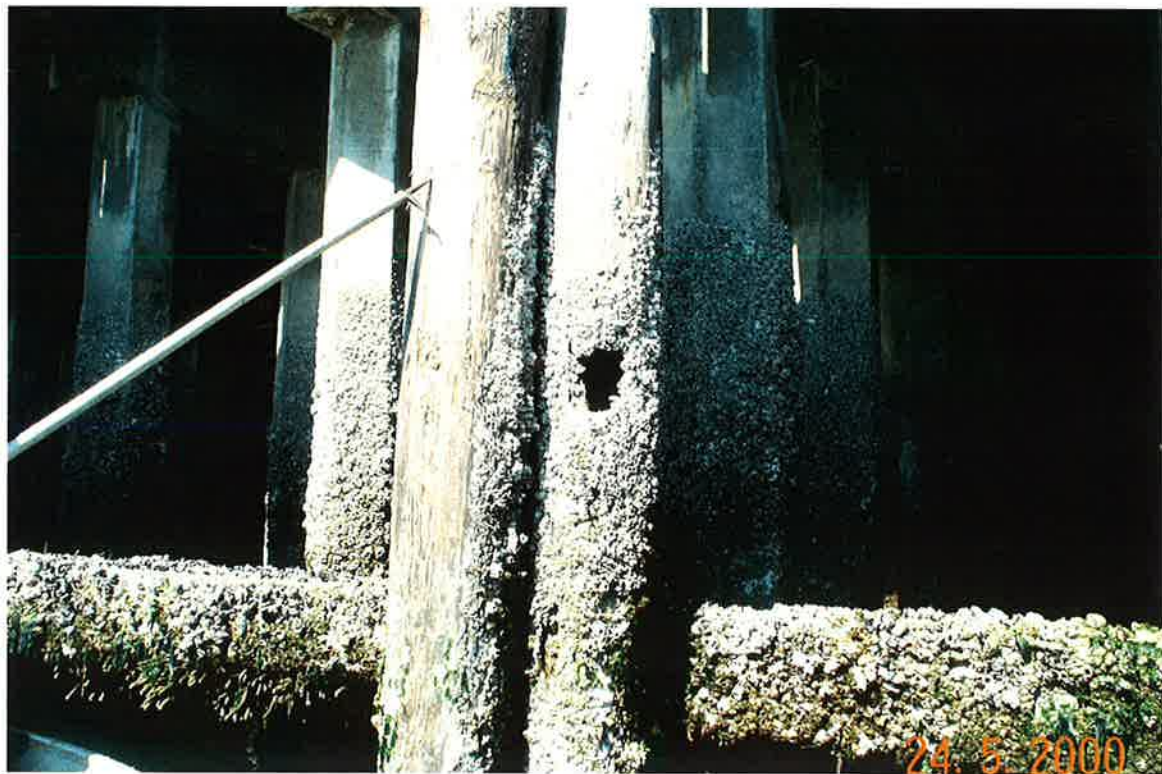
**Photograph No. 12:** Severe marine borer damage to Fender Pile No. 21A-2.

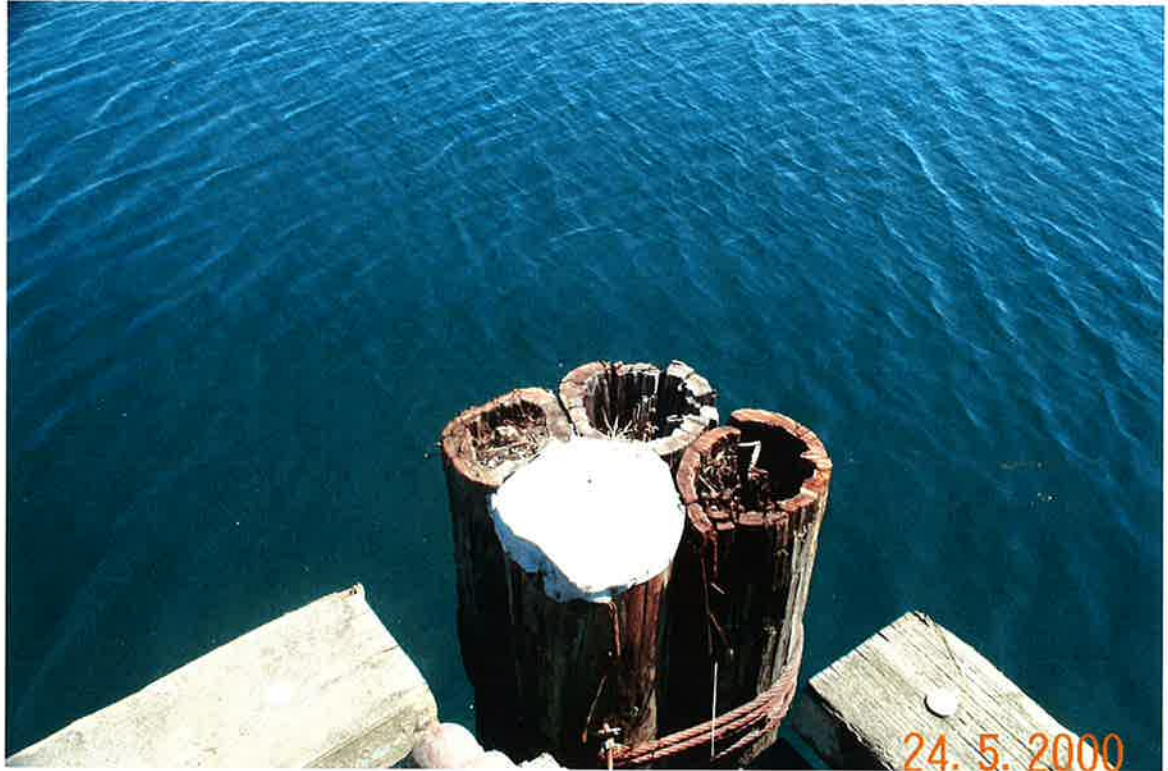
**Photograph No. 13:** Fungal decay in the tops of the 4-pile mooring dolphin at the northeast corner of the facility.

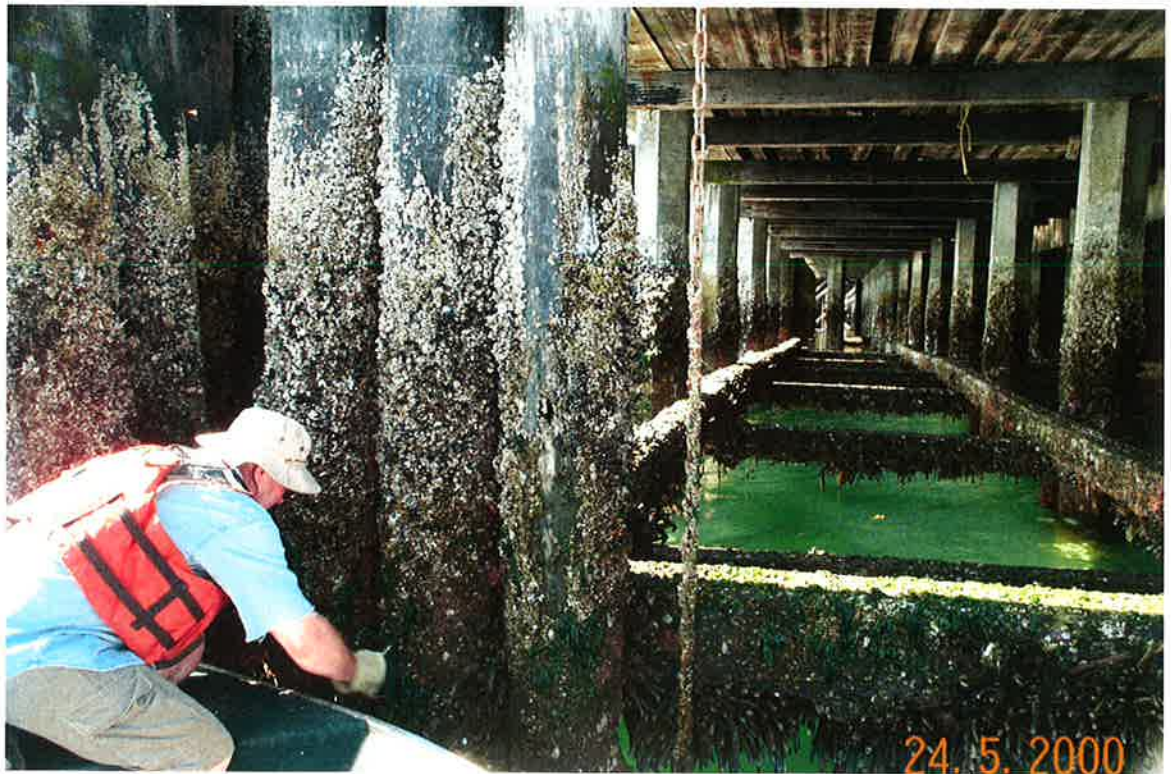
**Photograph No. 14:** Severe marine borer damage to Fender Pile No. 1-3.

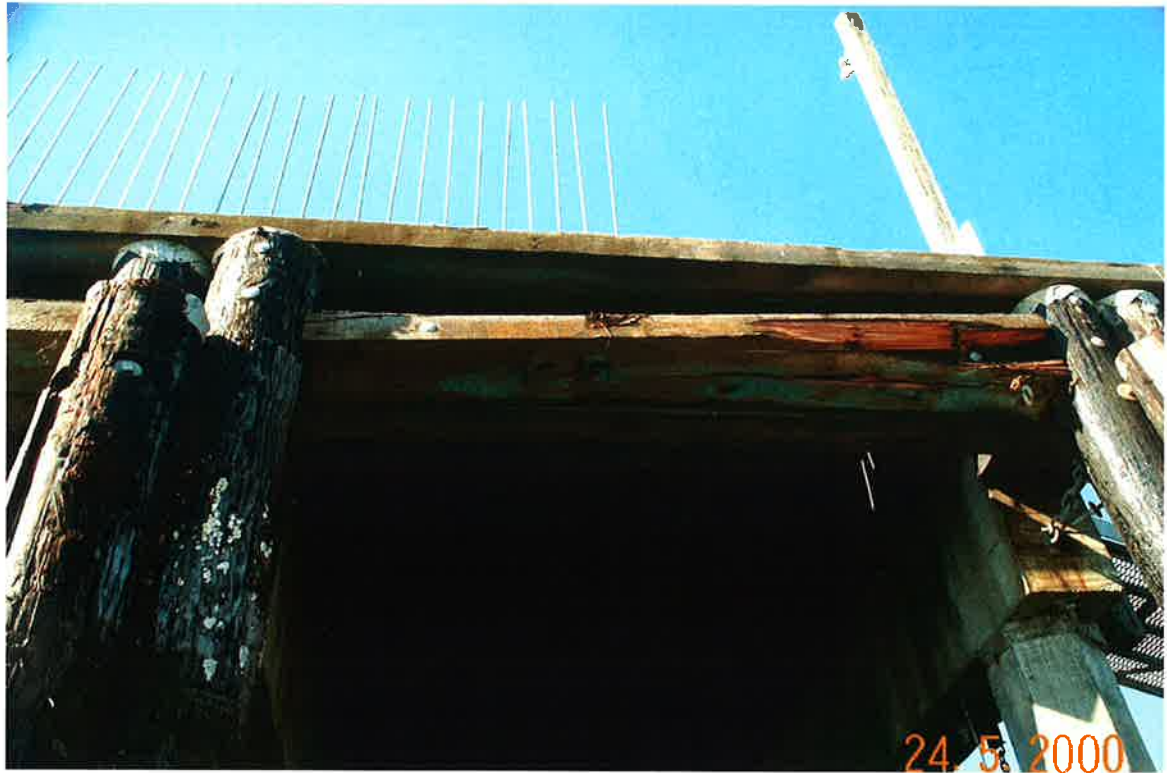
**Photograph No. 15:** Chock No. 37-38 is fractured.

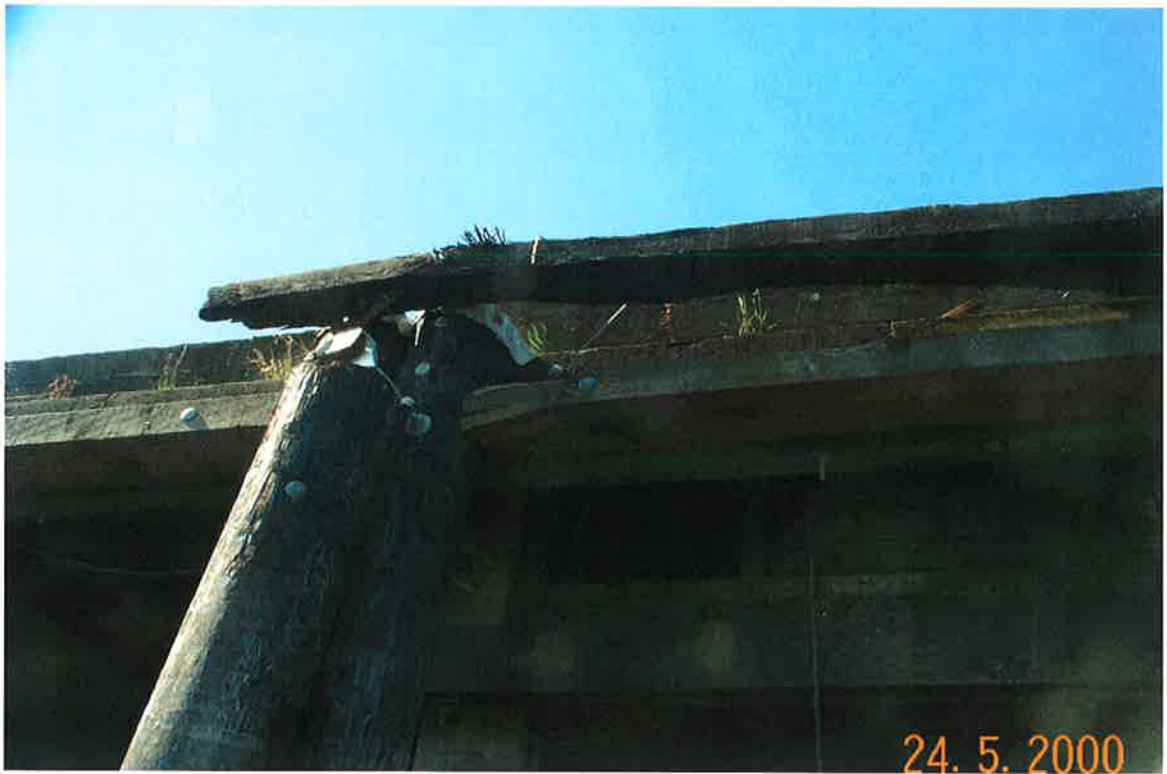
Bent	Description	Recommendation
14 - 15	Fender chock is fractured.	Replace fender chock.
19 - 20	Fender chock is split ( <i>Photograph No. 16</i> ).	Replace fender chock.
24 - 25	Fender chock is fractured.	Replace fender chock.
33 - 34	Fender chock is fractured.	Replace fender chock.
37 - 38	Fender chock is fractured ( <i>Photograph No. 15</i> ).	Replace fender chock.
F - G	Fender chock is split.	Replace fender chock.
19A - 21A	Fender chock is missing.	Replace fender chock.

**Photograph No. 16:** Chock No. 19-20 is split.
