Repairs to Mooring Base Facility Jetty

C.F.B. Esquimalt (Colwood) B.C.

ENGINEERING REPORT

September 17, 1970.

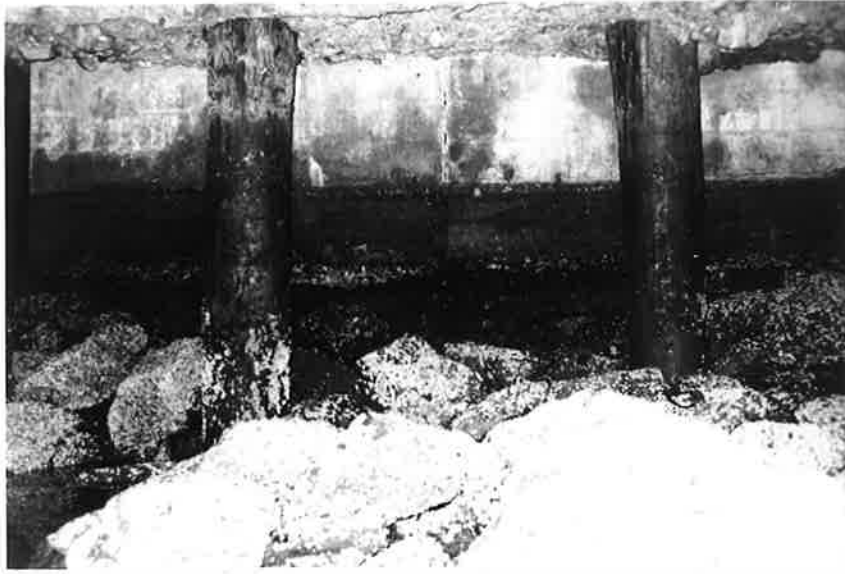
TC 70/1/3

The results of the survey indicate that the riprap has dropped down along a significant length of the coping wall under Unit 2 and has assumed a flatter slope. The amount that it has been lowered varies considerably. It is greatest under the east end of Unit 2 and is least at the west end of Unit 2 and under Unit 1. At the most critical location the riprap has dropped about  $4\frac{1}{2}$  ft. from the original elevation leaving the cavity under the

service tunnel. The crushed rock behind the riprap facing is exposed and is now subject to erosion at high tides.

View facing service tunnel and bents 4/5 showing how riprap  
has fallen about  $4\frac{1}{2}$  ft. exposing piles and service tunnel.

The immediate remedial measures now in hand by the Dept. of National Defence will involve filling the cavities under the service tunnel with concrete, and finishing with a vertical concrete face from the coping wall down to the top of the riprap. The sink holes will also be filled and paved. This will provide the required support to the service tunnel. The question arises whether further slope movements are likely which could dislodge this new concrete or leave it suspended.

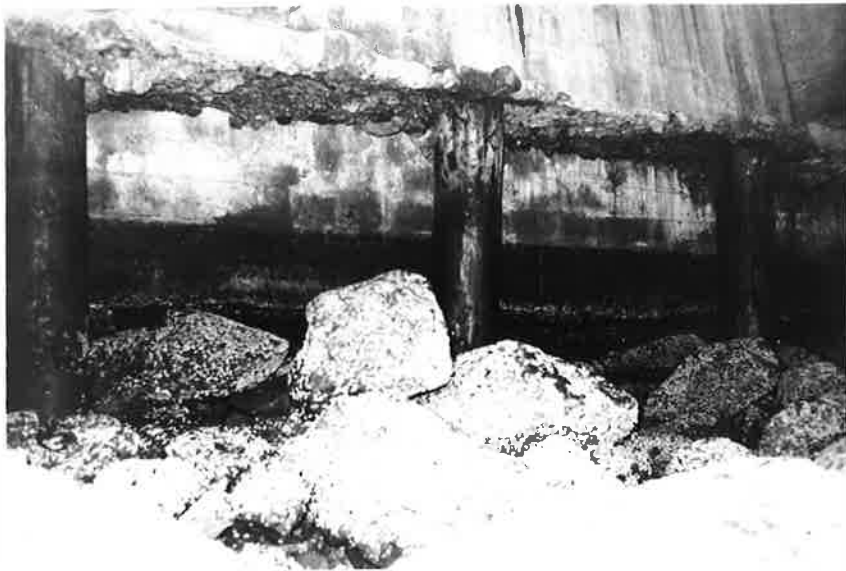
TC 70/1/4

Similar view facing bents 5/6

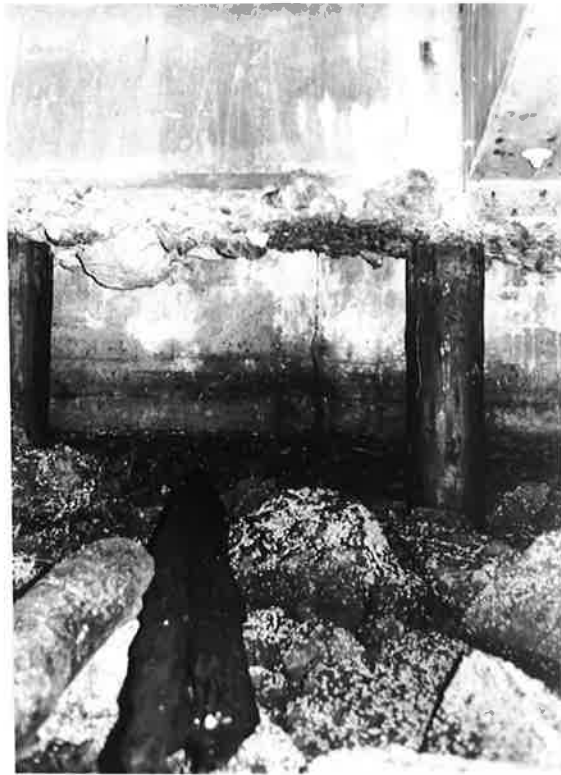
TC 70/1/6

View facing service tunnel at bents 8/9 showing exposed piles and tunnel and crack in tunnel at construction joint.

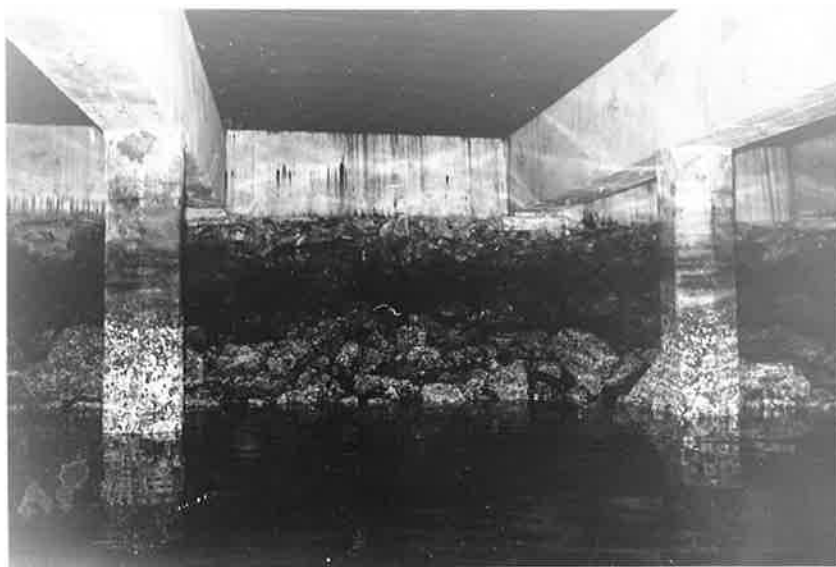
TC 70/1/12

View facing service tunnel at bents 24/25 showing satisfactory conditions and no exposure of service tunnel and timber piles

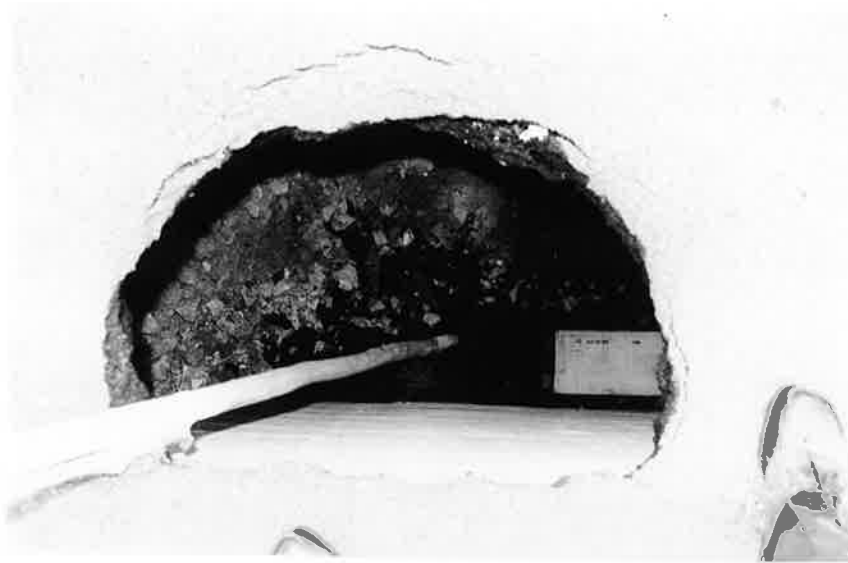
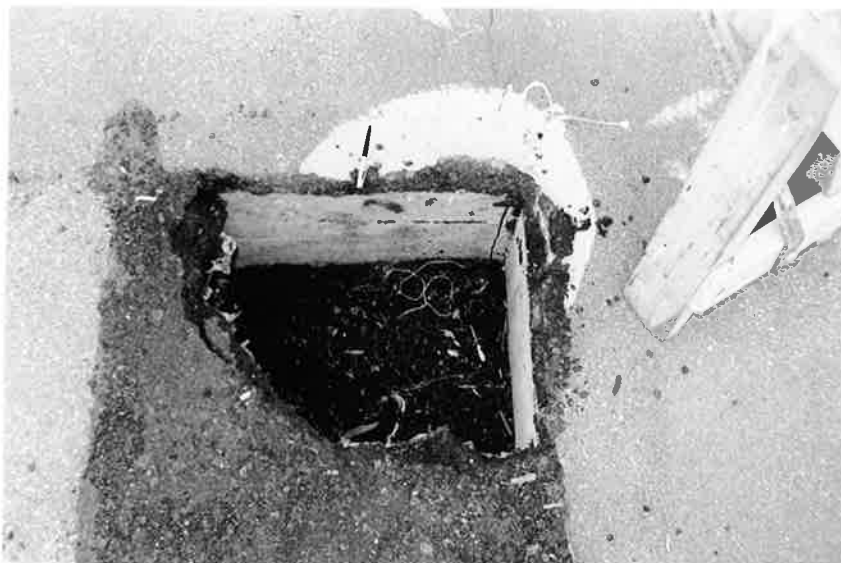
Views showing 2 sink holes in pavement on shore side of service tunnel beside unit 2.

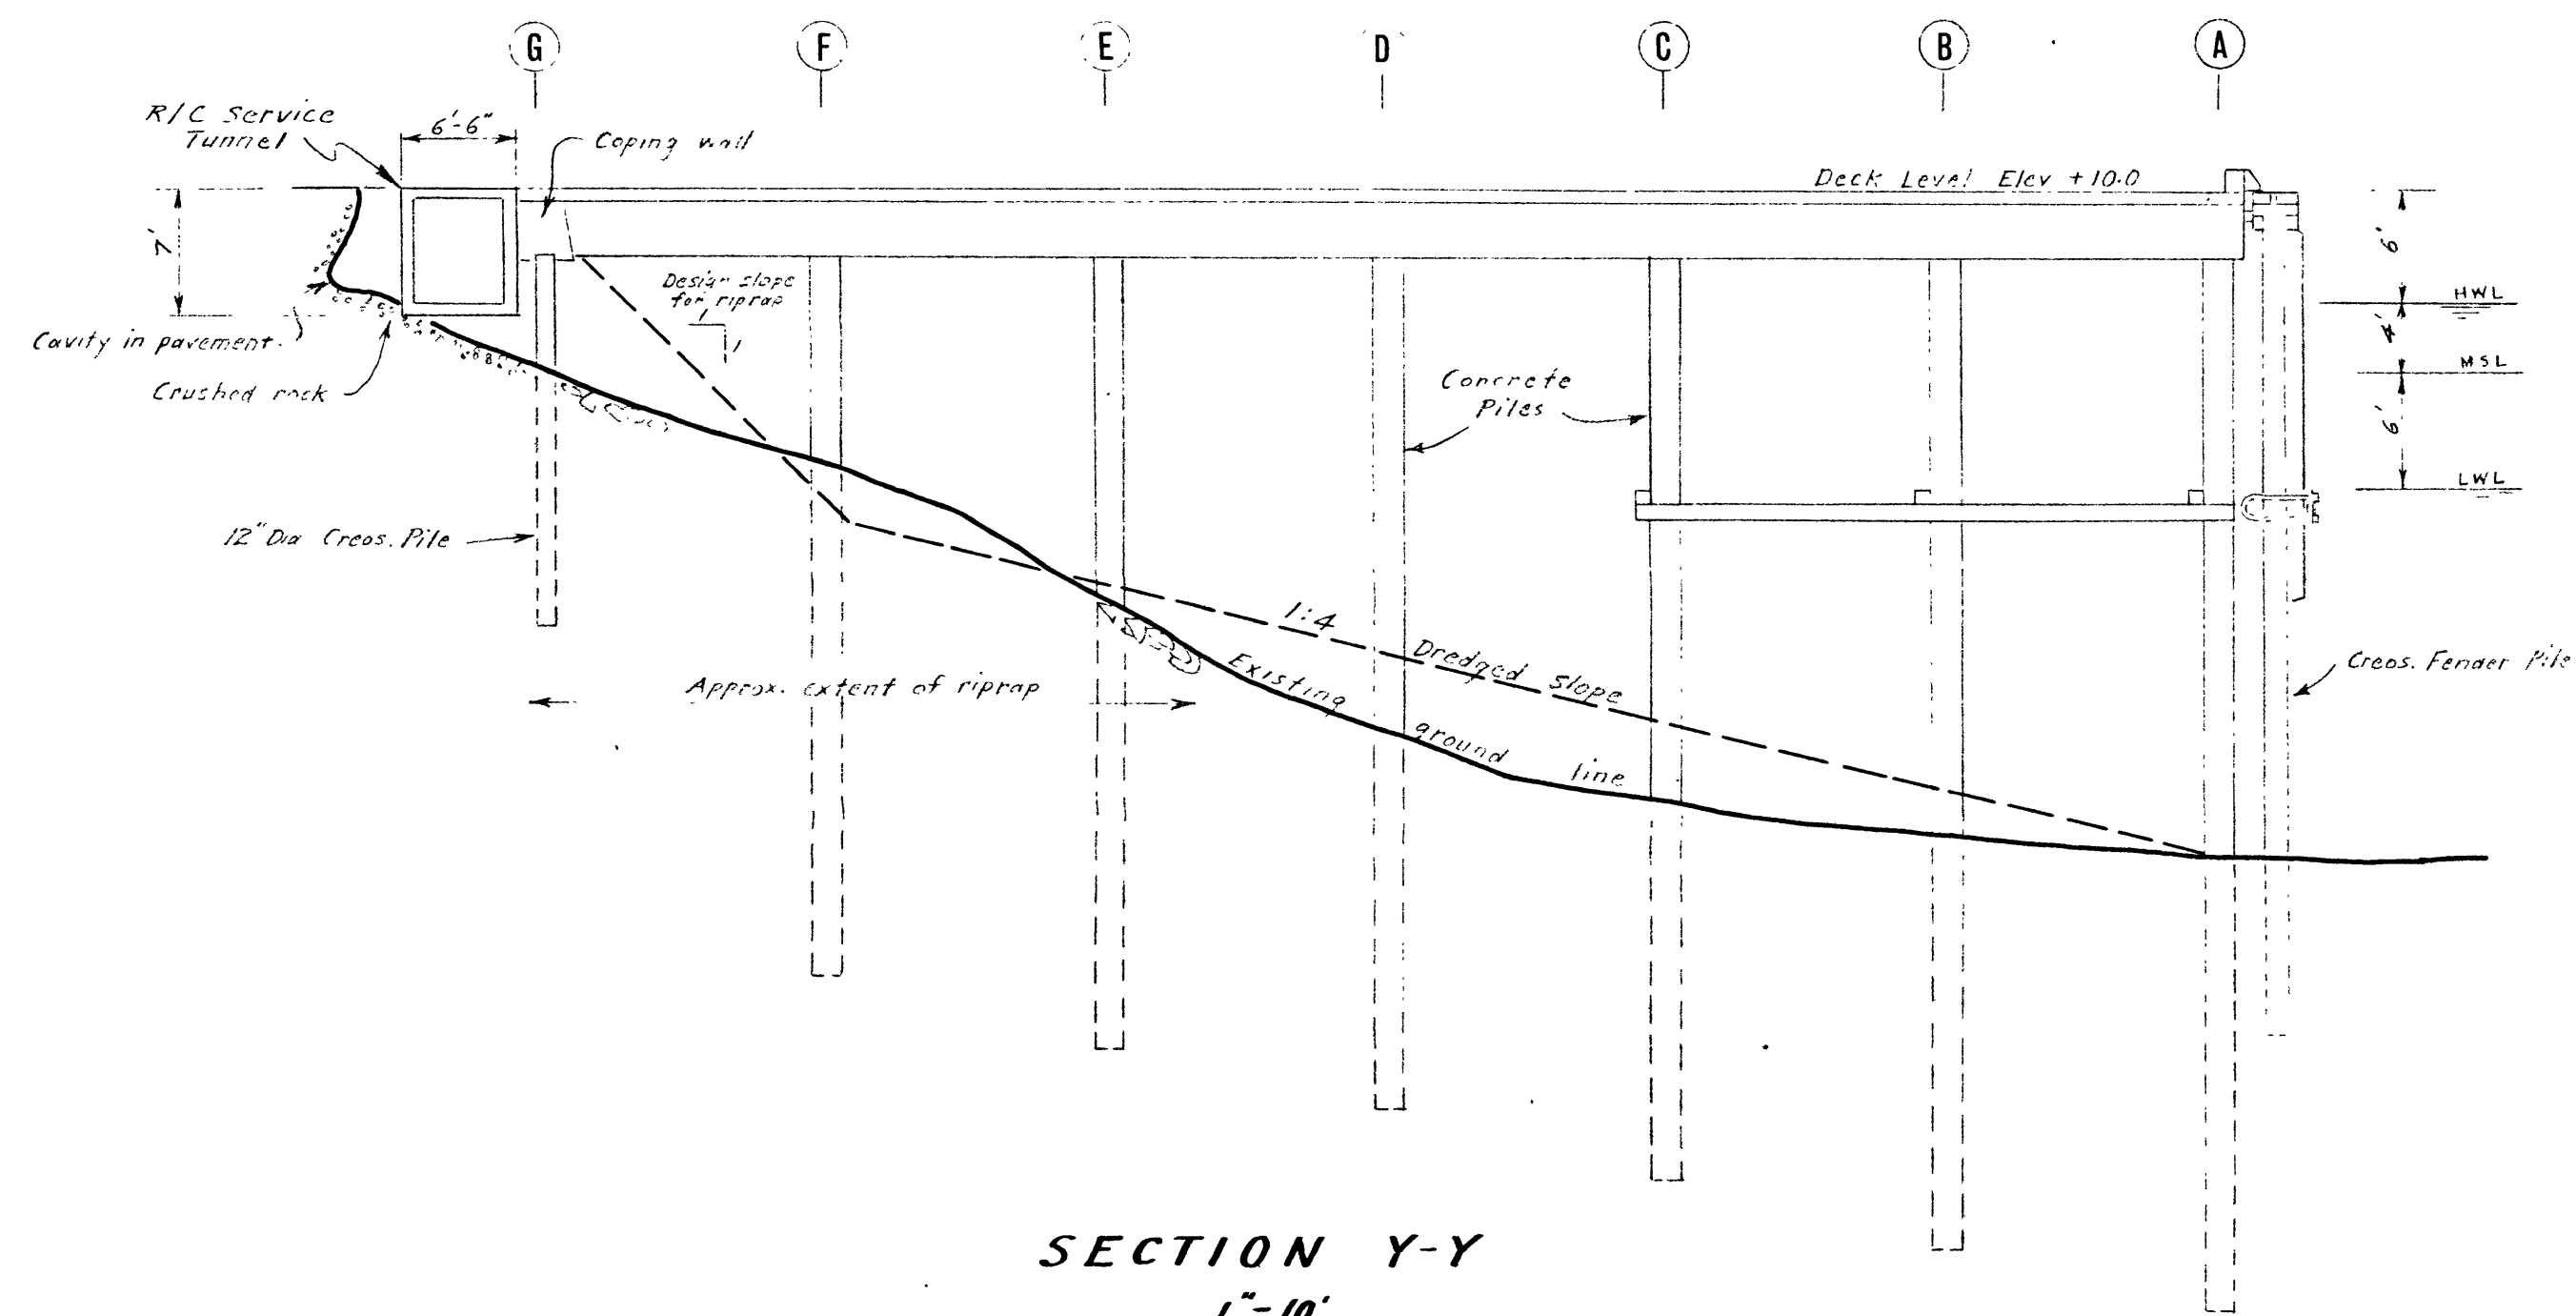
SECTION Y-Y  
1'-10'

On August 17 and 18, 1970, following authorization of the work, cross sections under the northeast corner of the jetty were made using underwater soundings and conventional survey measurements. These were made midway between successive bents of piles and perpendicular to the shore. Representative cross sections of the most critical area between bents 4 and 5 and of a satisfactory area. are shown in drawings 16-5-7-1 in Appendix B of this report.

The average gradient of the riprap rock slope where it has moved is about 2-1/4 horizontal to 1 vertical. For the remainder of its length under Unit 2 the rock slope is nearly 2:1. At no location examined is it now at the design grade of 1:1, and although this initial slope may have been constructed at a slope flatter than 1:1, the evidence shows the slope has moved down since construction to the present position.

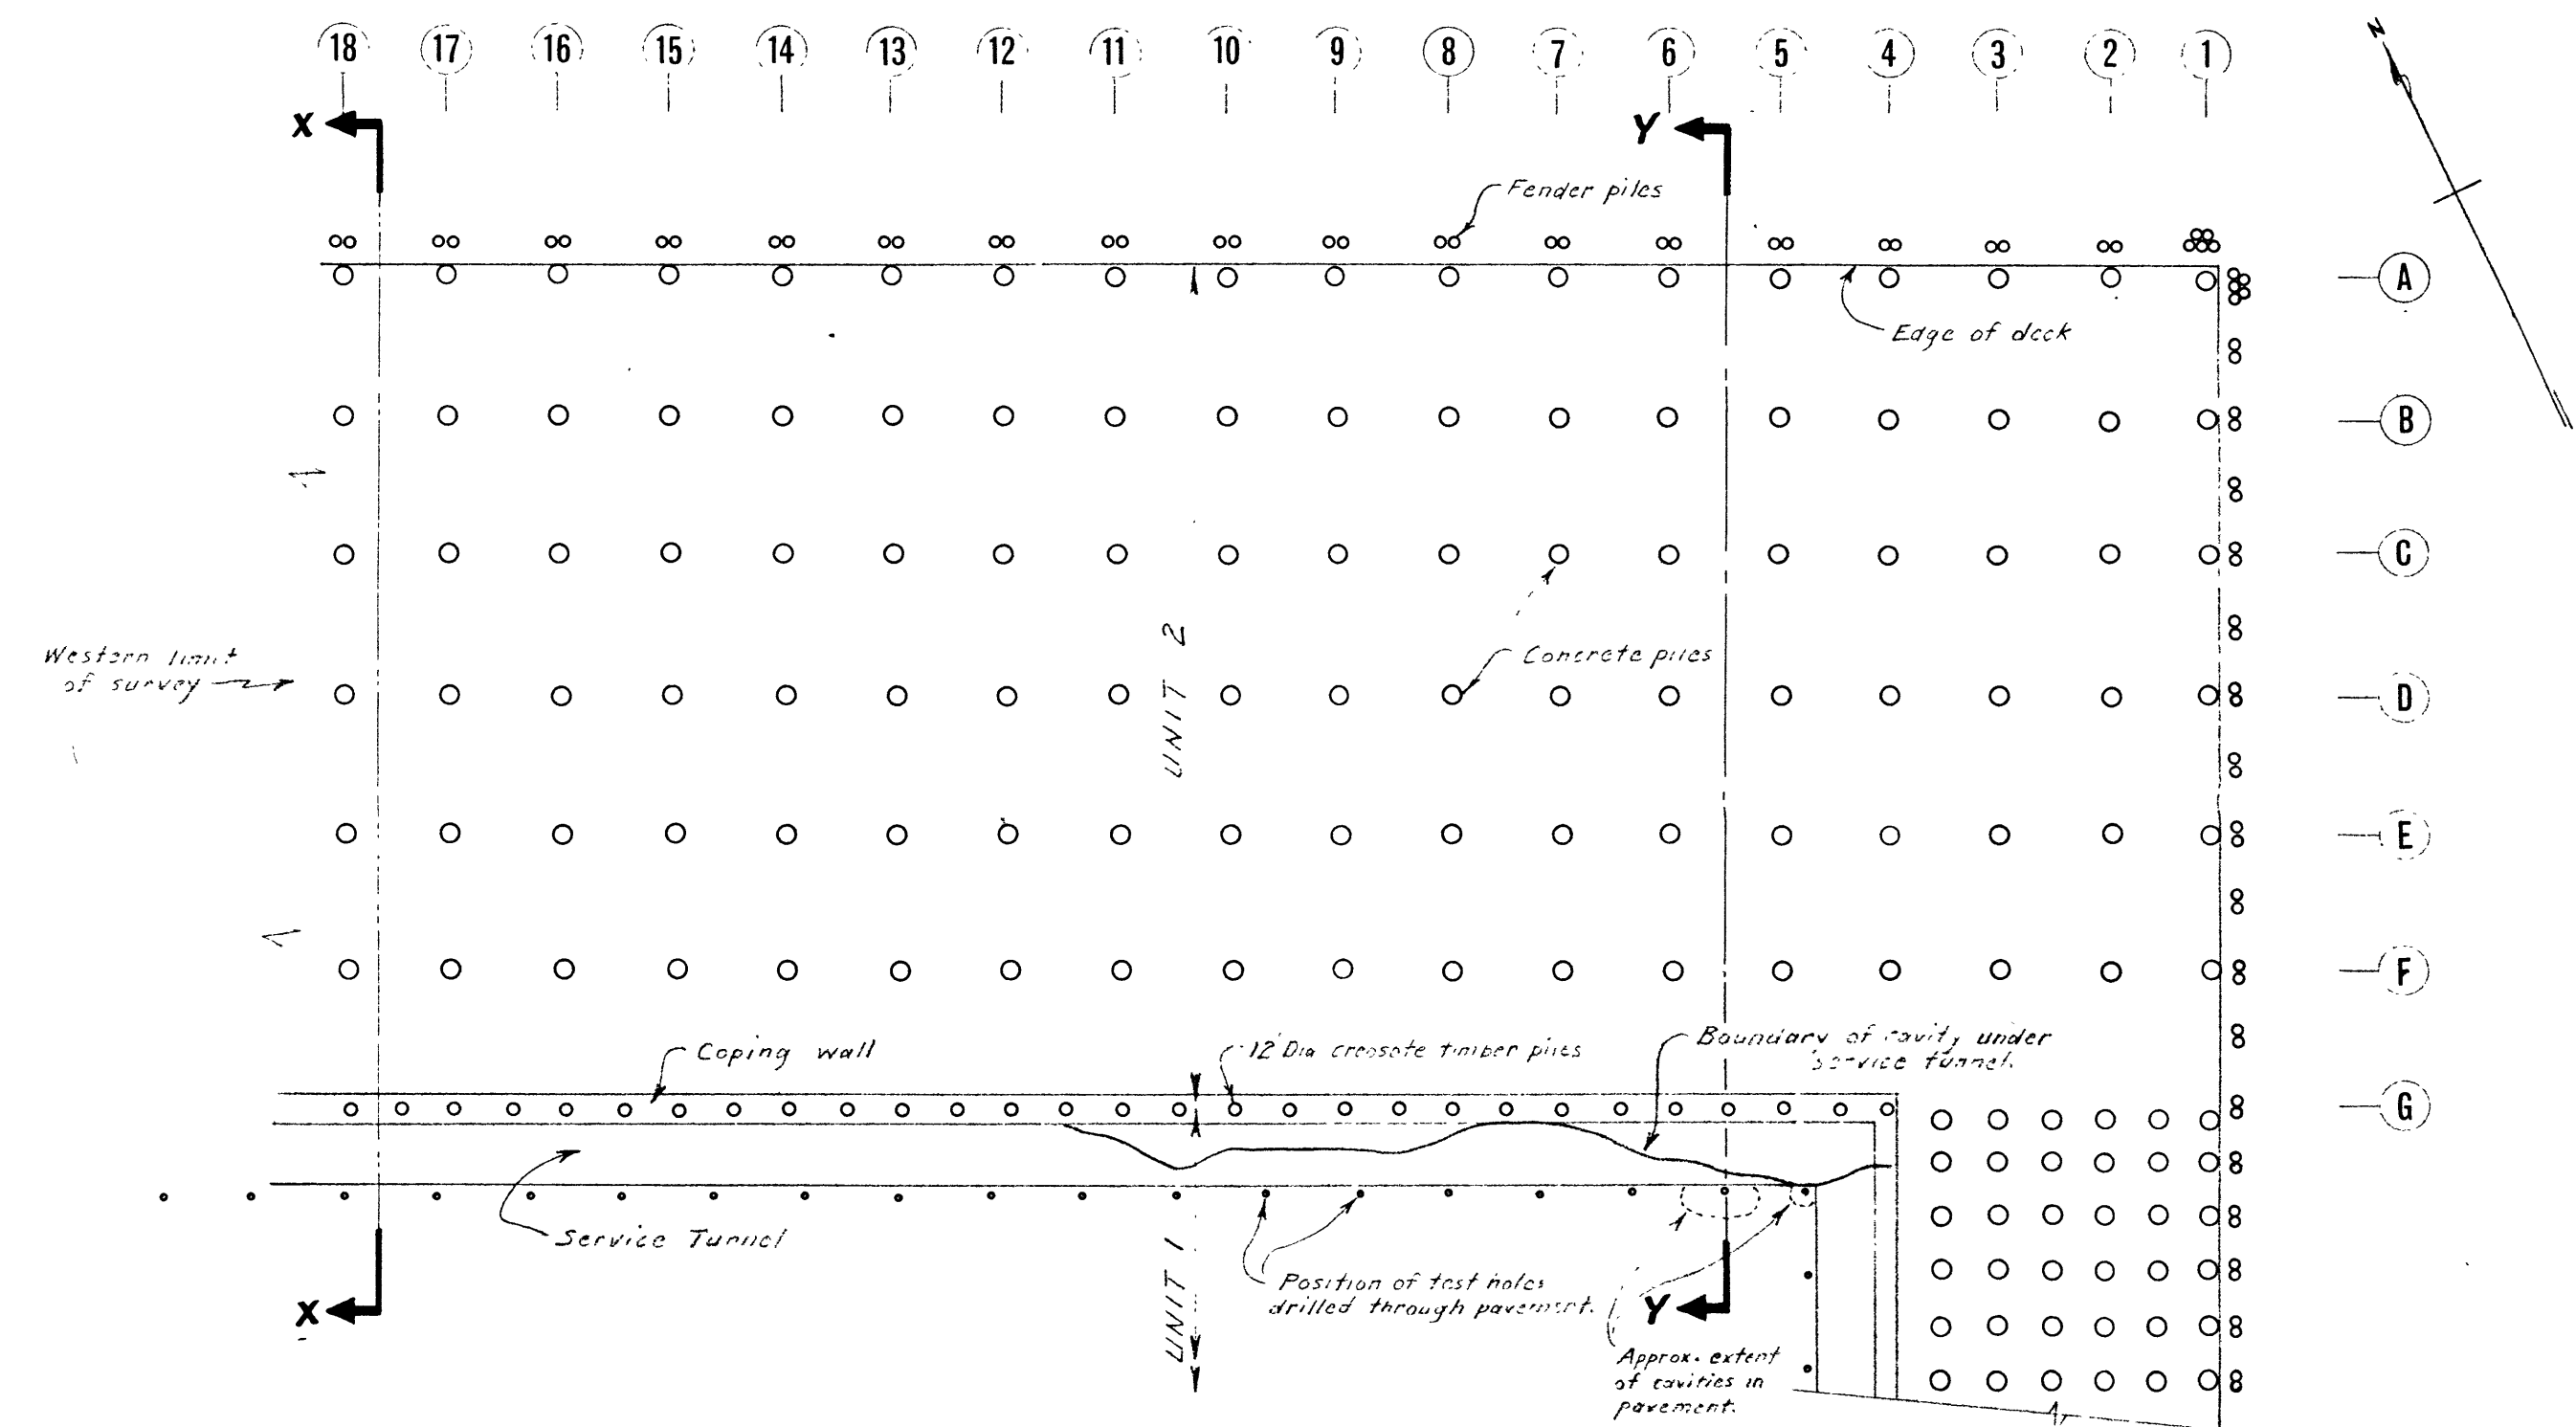
PLAN  
1'-20'

The extent of the area where the service tunnel has lost rockfill support was also determined in the survey. Drawing 16-5-7-1 in Appendix B is a plan of the site showing the limits of this area and the extent of the cavities behind the service tunnel.

A drilling program was carried out on August 31, 1970, to determine if any cavities existed under the pavement on the shoreward side of the service tunnel, but which had not yet been detected. This operation was performed by using a hand held pneumatic drill to bore through the pavement to a depth of about 10 ft. By this method, the driller could detect a cavity and determine approximately the density of the underlying material. A series of 20 such holes were drilled, at 10 ft. centres, on the south side of the service tunnel beside Unit 2. The locations of these holes are shown in Drawing 16-5-7-1.
