**Client: DEPARTMENT OF NATIONAL DEFENCE****Date: November 9, 2005****Project: INSPECTION AND REPAIRS OF D JETTY****Project No.: 05673****Subject: INSPECTION SUMMARY****Page 1 of 6**

PROJECT MEMORANDUM  
INSPECTION AND REPAIRS OF D JETTY  
Inspection Summary

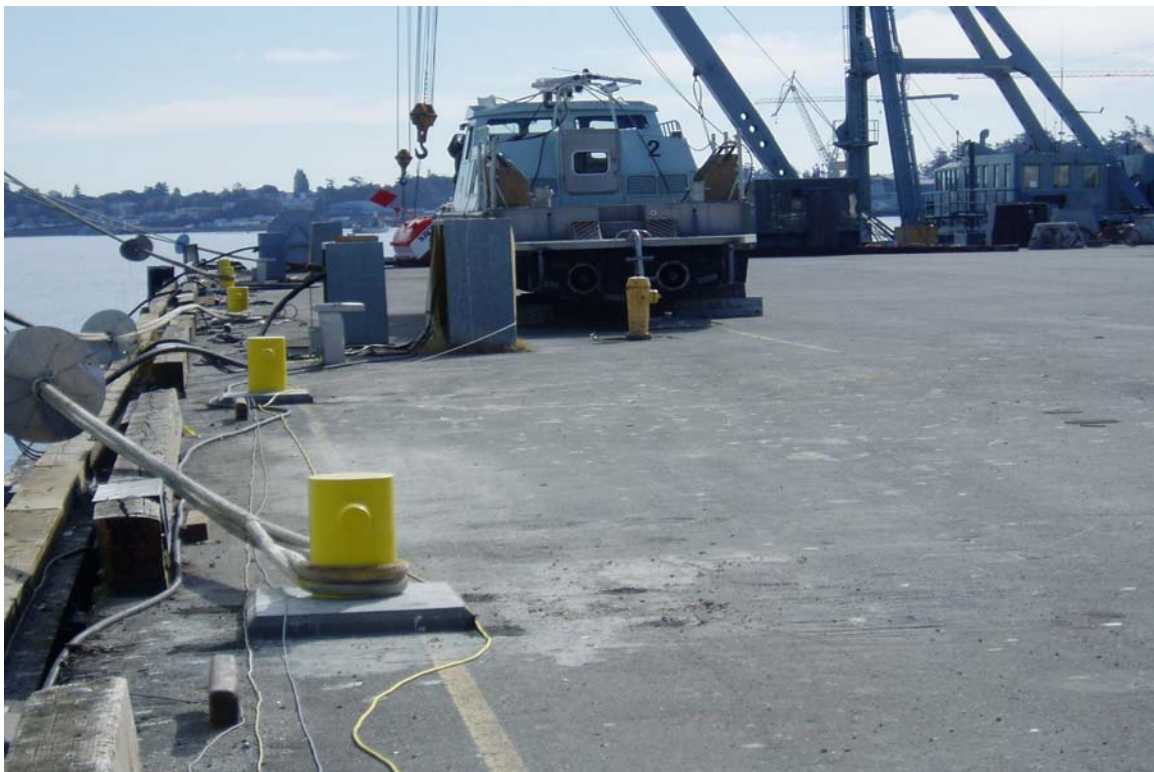
**Photograph No. 1:**      Topside view of D Jetty.

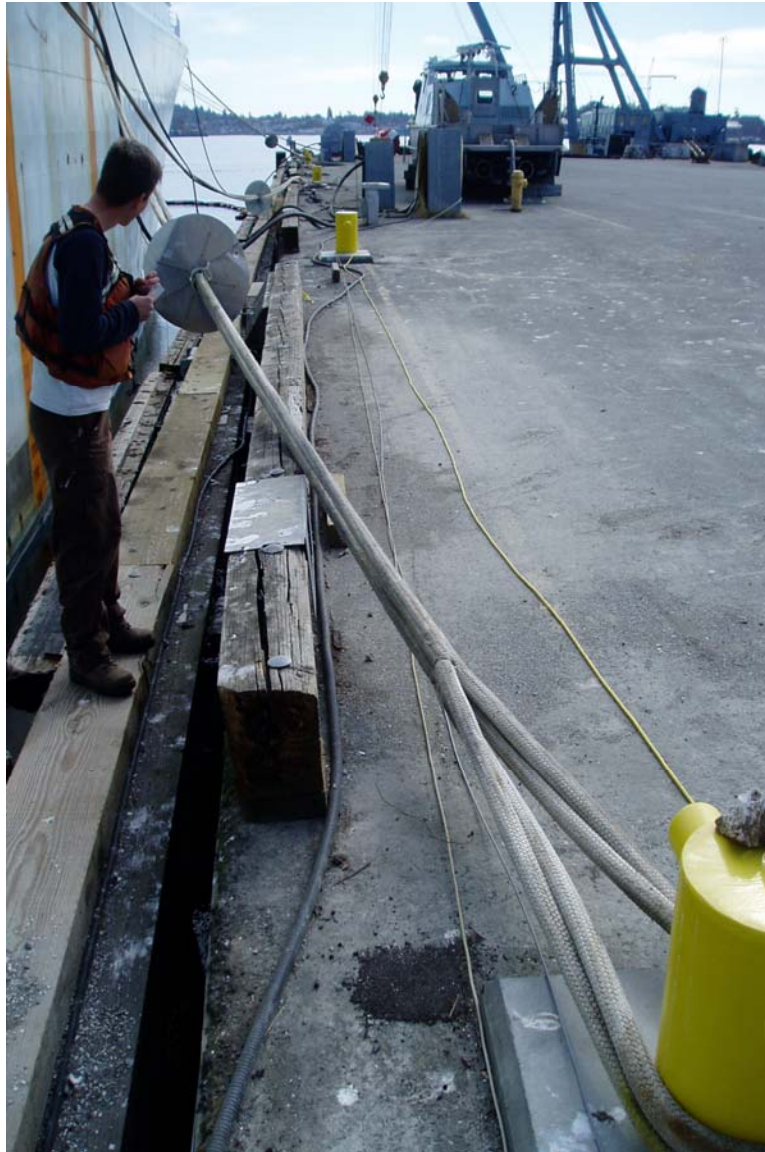
**Photograph No. 2:**      Topside view of D Jetty.

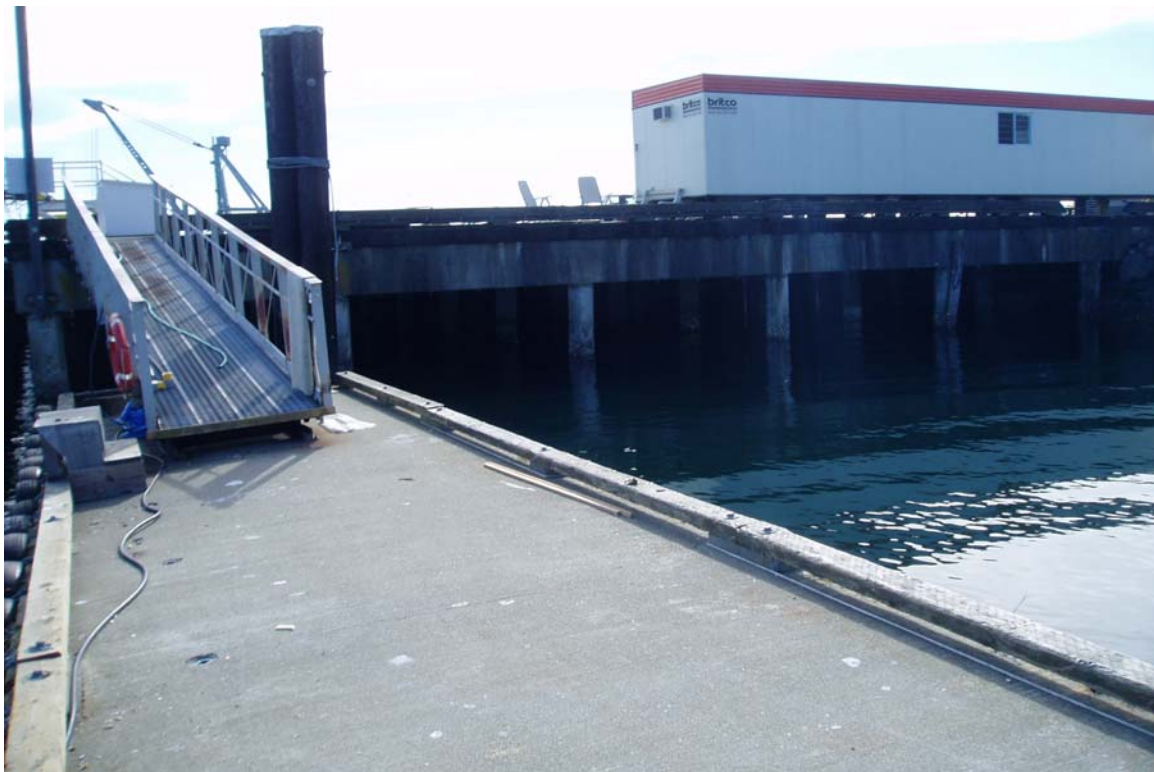
**Photograph No. 3:** General arrangement of piles.

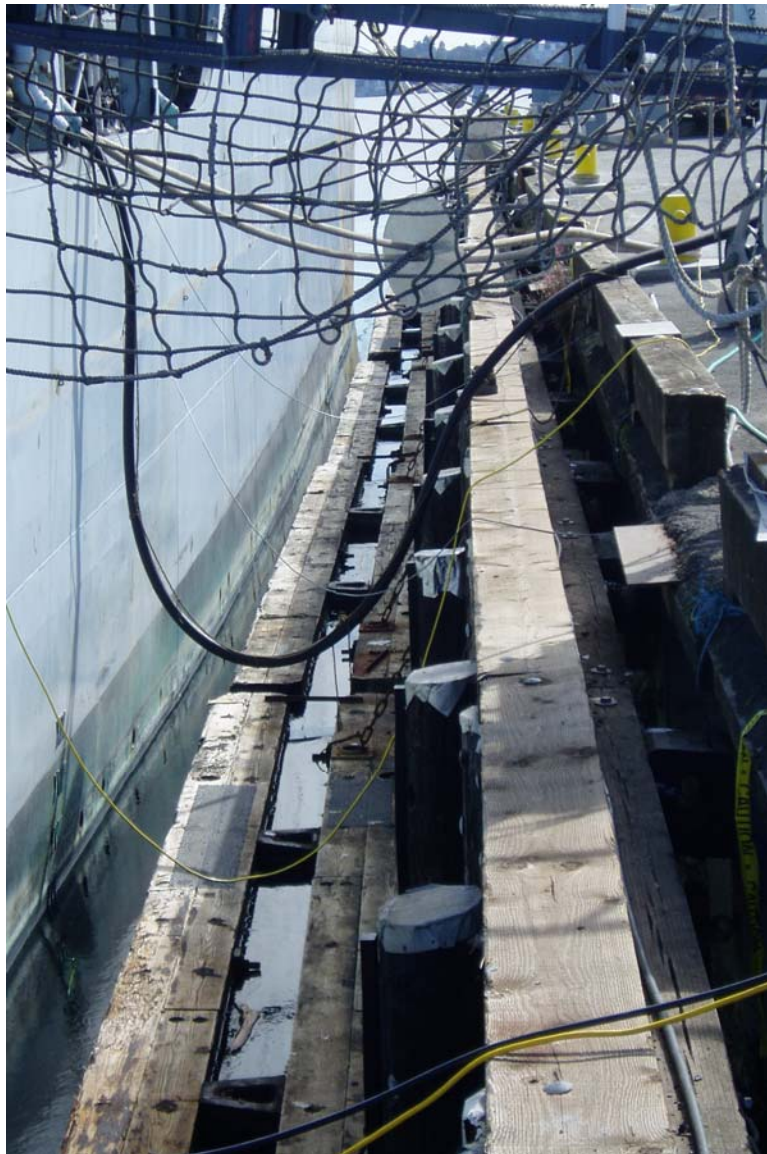
**Photograph No. 4:** Fendering on west berth face.

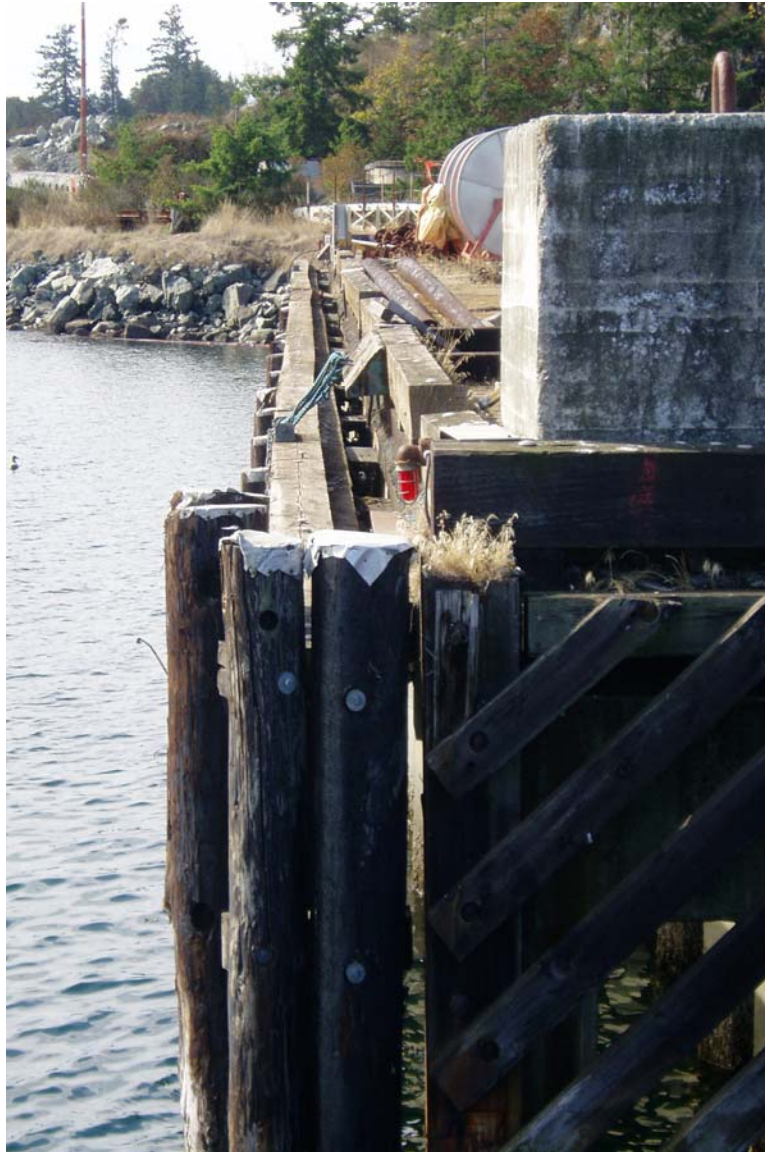
**Photograph No. 5:** Fender piles on north berth face.

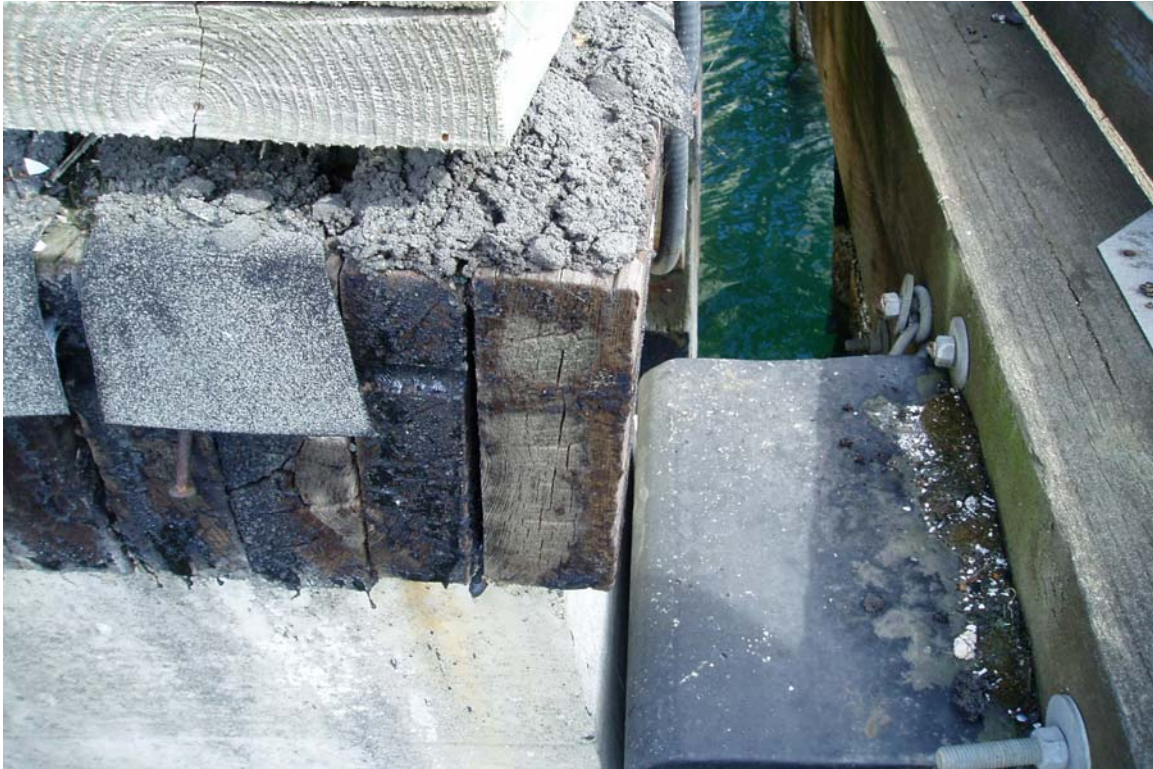
The laminated decking is damaged in the north-east corner of the facility. Based upon the current usage of this facility, it is recommended to cordon off this area and continue to monitor the decking in this area (*Photograph No. 6*).

**Photograph No. 6:** Laminated deck damage in north-east corner.

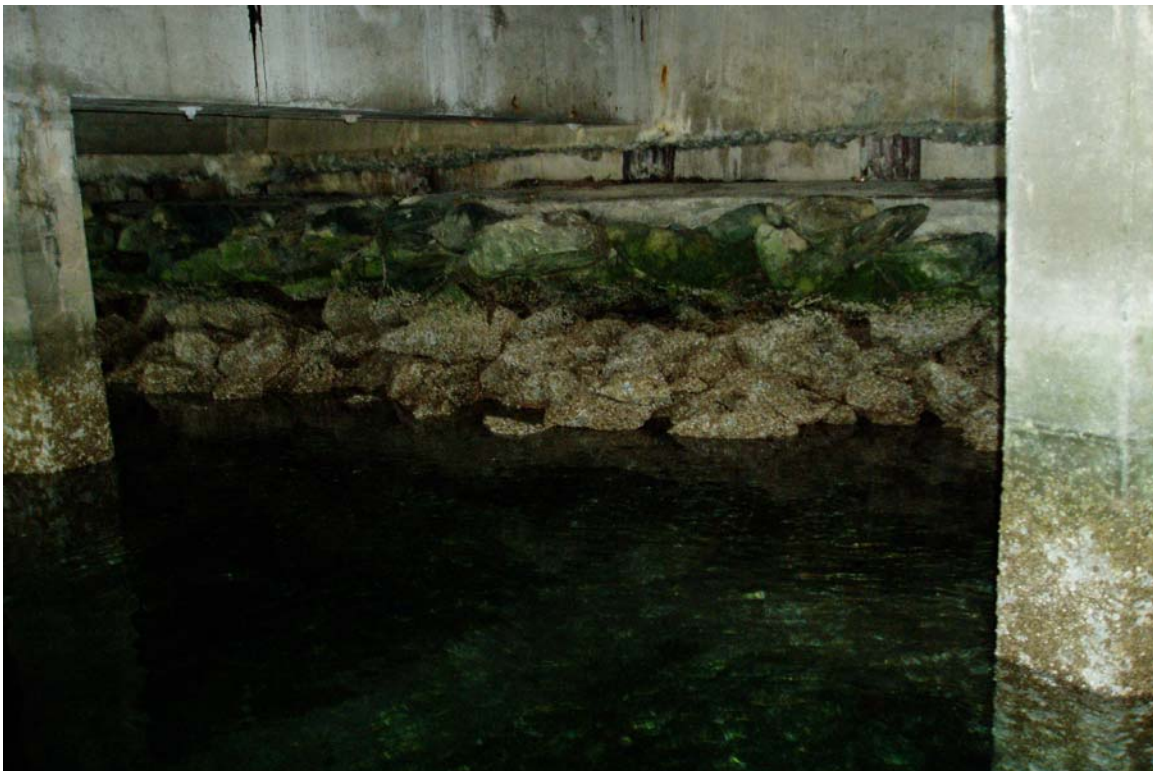
The abutment is undermined in several areas where the riprap slope protection has sloughed away from the underside of the abutment. This should continue to be monitored and rehabilitation considered within the next three years (*Photograph No. 5*).

**Photograph No. 7:** Abutment undermining.

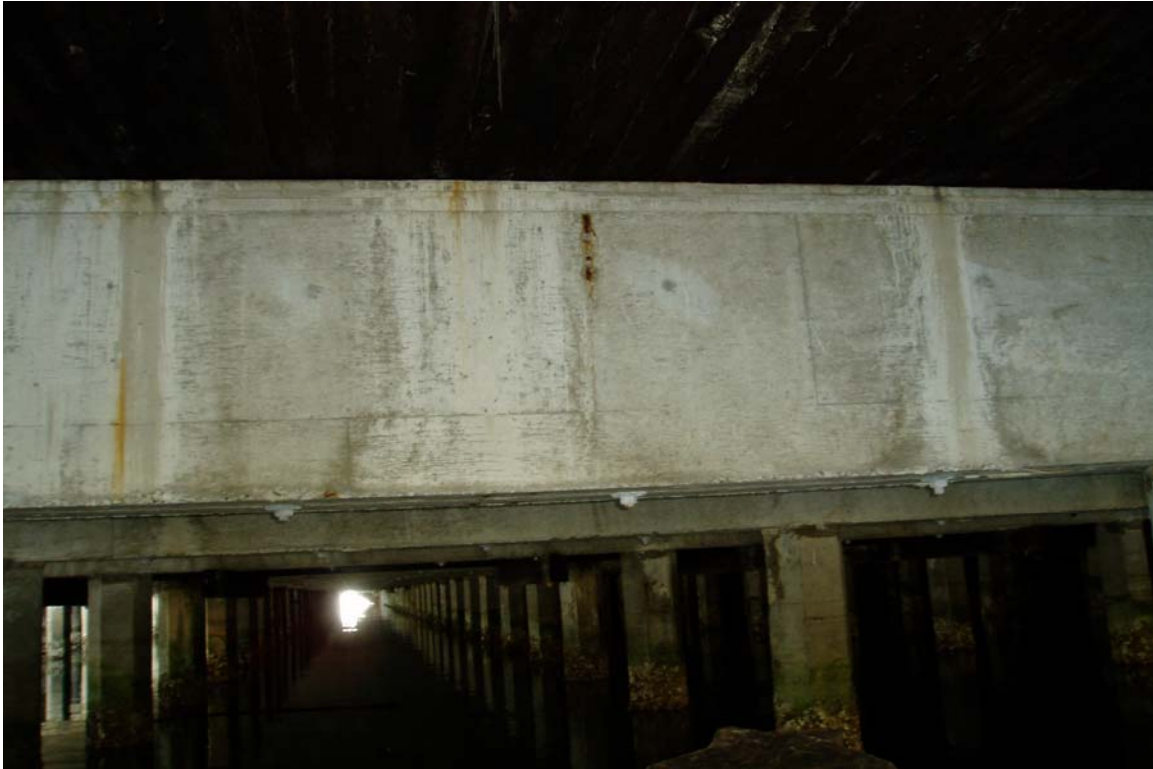
*Photograph No. 8* presents a typical view of corrosion staining on the pilecaps.

**Photograph No. 8:** Typical corrosion staining on pilecaps.

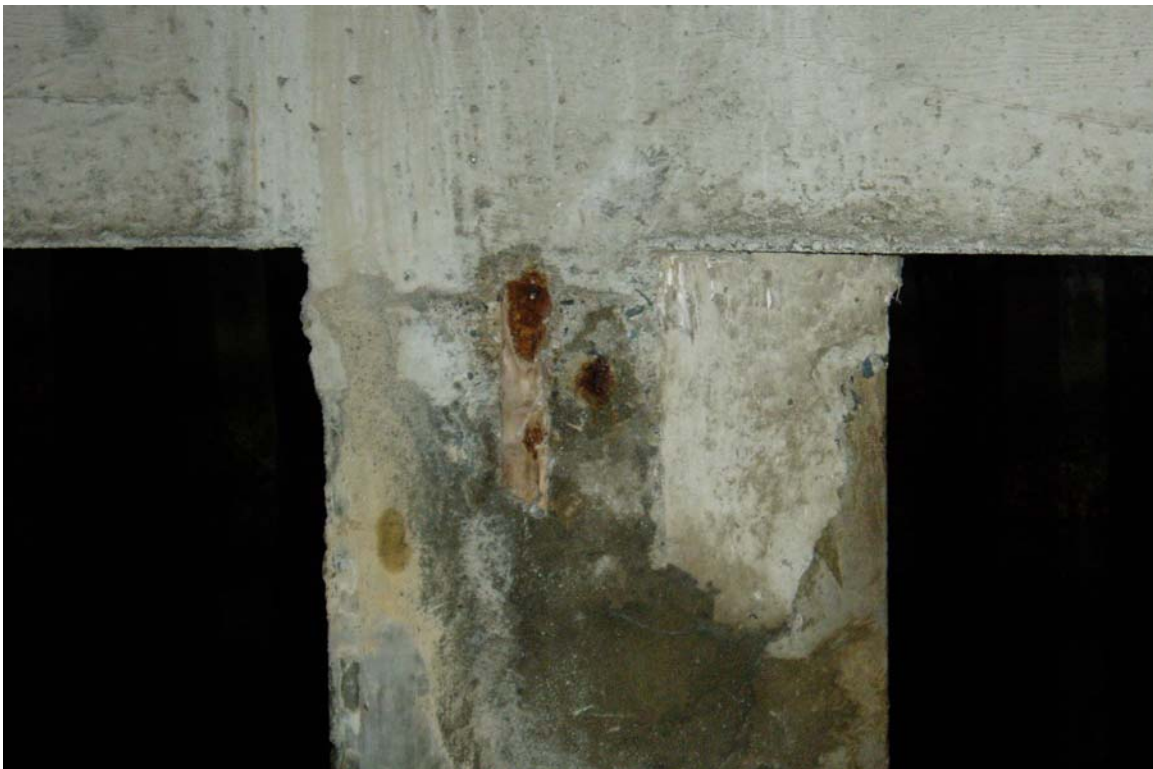
*Photograph No. 9* presents a typical view of spalling at the top of the piles.

**Photograph No. 9:** Typical pile spall.

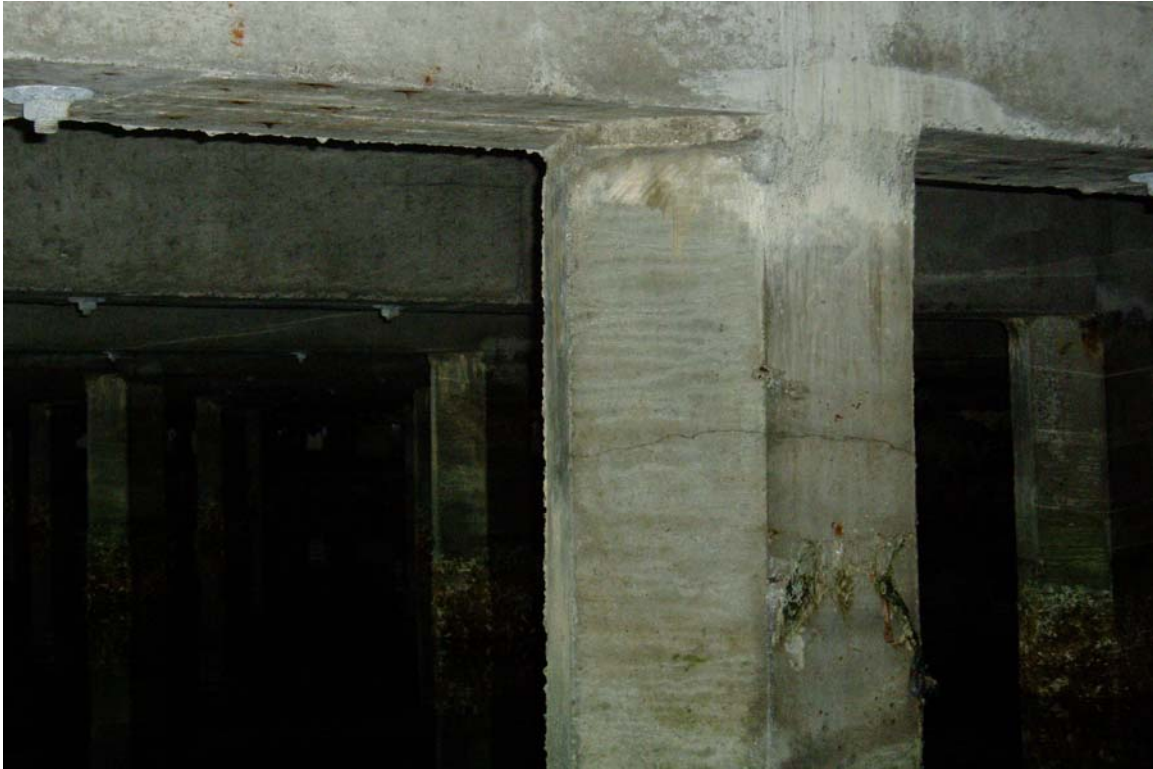
*Photograph No. 10* presents a view of typical previous pile/pilecap interface spill repairs.

**Photograph No. 10:** Typical previous repairs to pile/pilecap interface.

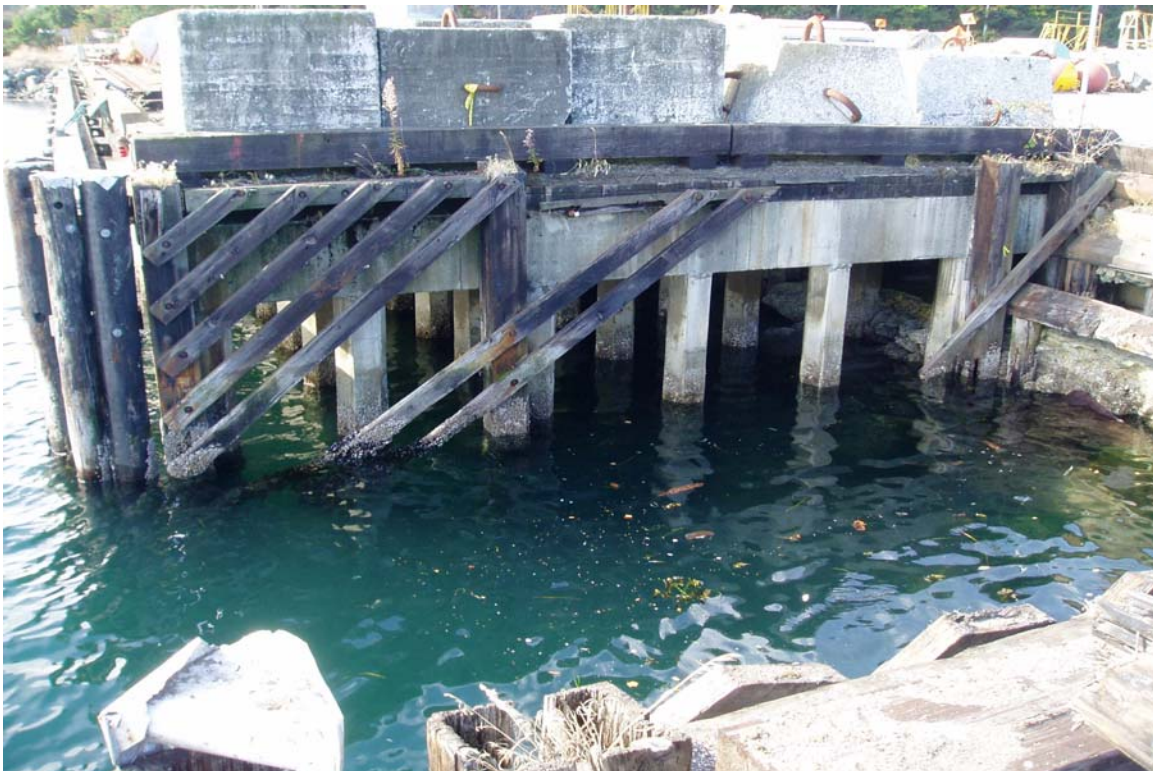
At the disused ramp areas, several of the debris guards are missing (*Photograph No. 11*). Due to the modified use of this facility, this is not considered to be of significance at this time.

**Photograph No. 11:** Disused ramp area with missing debris guards.
