# **SOUTH COAST DIVING LTD.**

SNC Lavalin Inc., Environment Division (SLE)  
**D-Jetty Perimeter and Old Fuel Float Reconnaissance**  
In-Water Field Survey Report  
February 10, 2016

## **RE: DIVE RECONNAISSANCE INSPECTION, MARINE RAILWAY**

Date(s): January 21, 2016  
Time(s): 08:00/13:00 hrs  
Location: CFB Colwood, D-Jetty/Old Fuel Float  
Item(s): Perimeter substrate, structure and rock outcropping coordinates  
Methodology: Visual recording c/w DVD-R video and digital still  
photographs of general conditions.  
Dive Supervisor: Ian Swan  
Dive Tech(s): Grsydon Tait  
Dave Dalzell  
David Littlejohn

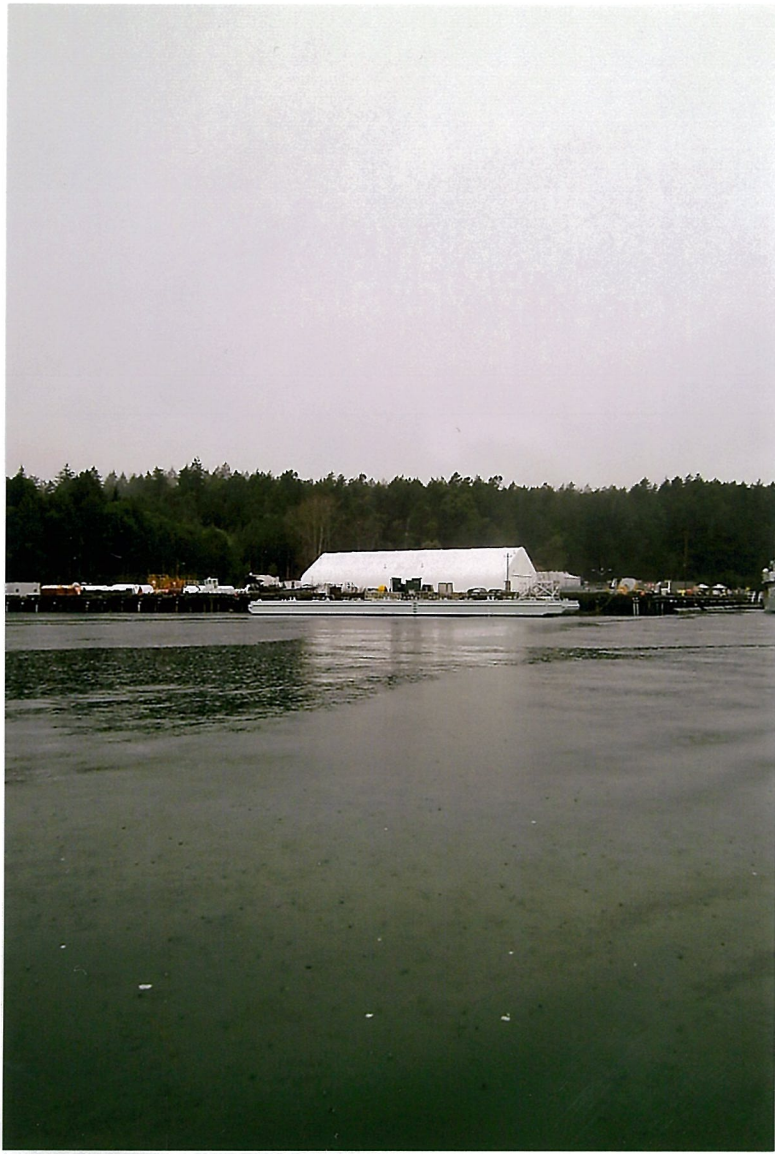
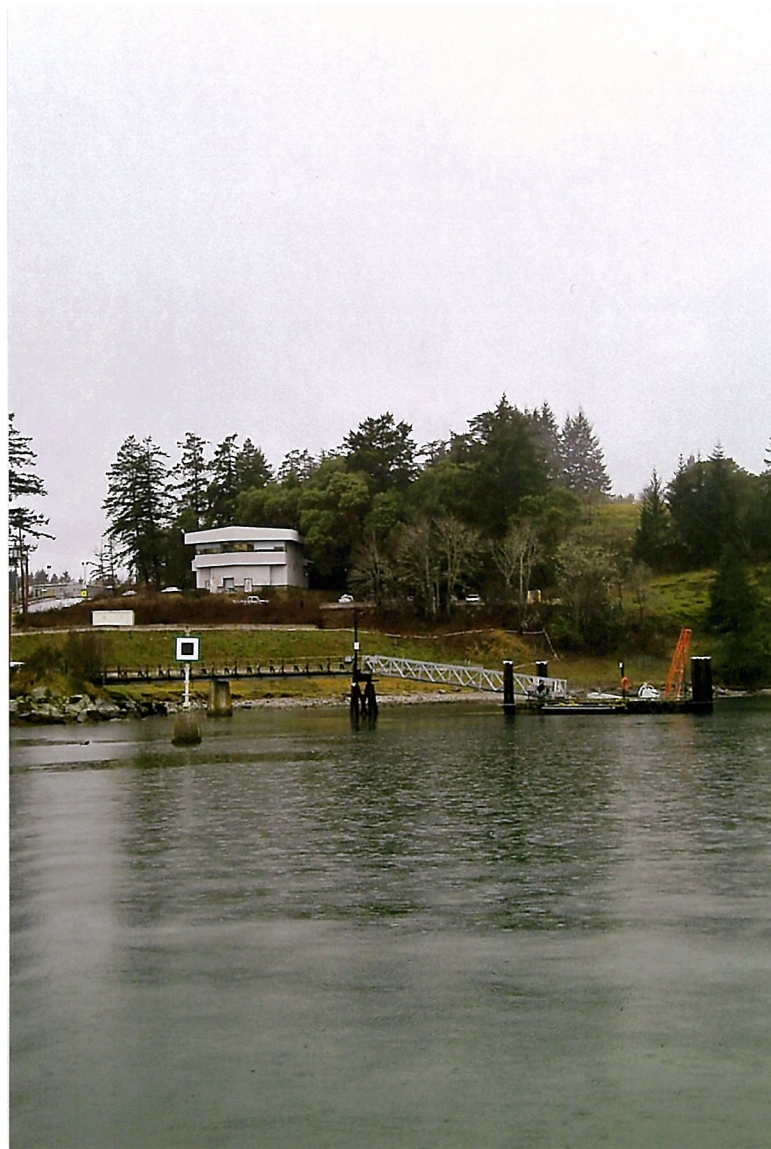
D-JETTY IN COLWOOD

OLD FUEL FLOAT IN COLWOOD

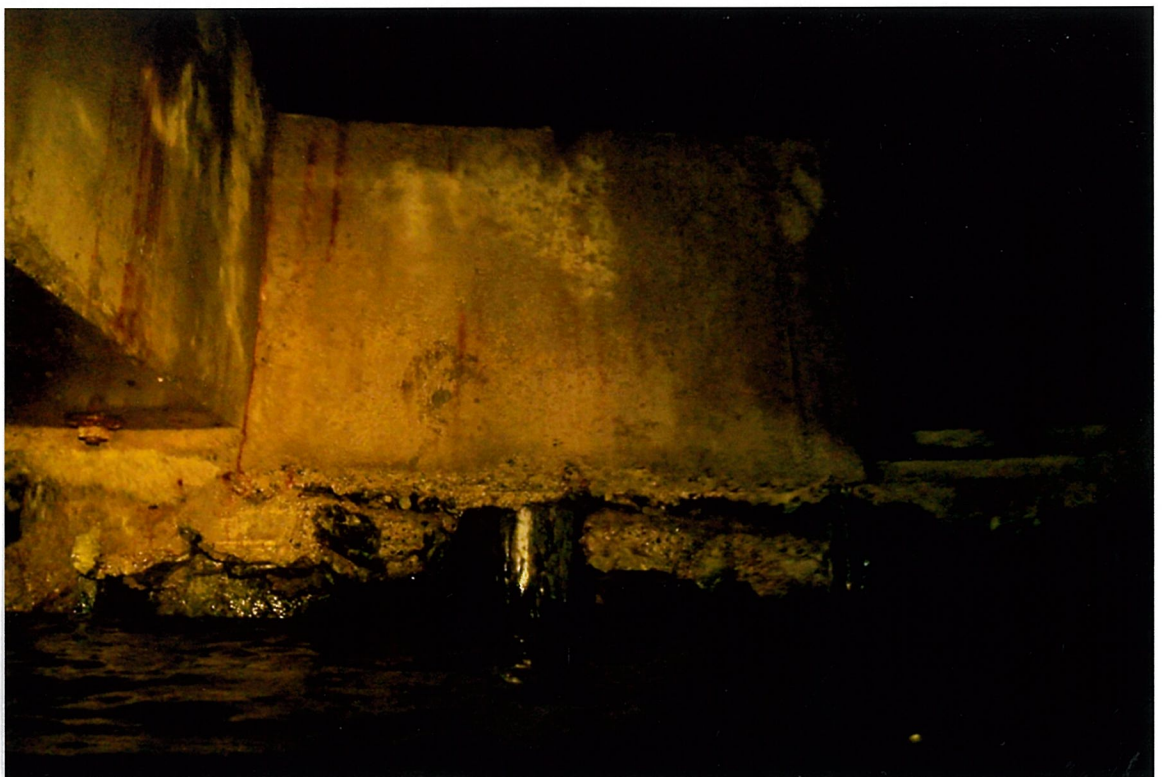
The back wall and concrete pile cap construction observed under the jetty did show some signs of lower concrete erosion due to weather and wave action. However, there does appear to be enough armouring in order to mitigate and slow this process down on the easterly or prevailing side.

VIEWS BETWEEN OCTAGONAL CONCRETE PILE BENTS UP UNDERNEATH  
THE EXISTING JETTY ALONG WITH BACK WALL AND CONCRETE CAP  
CONDITIONS

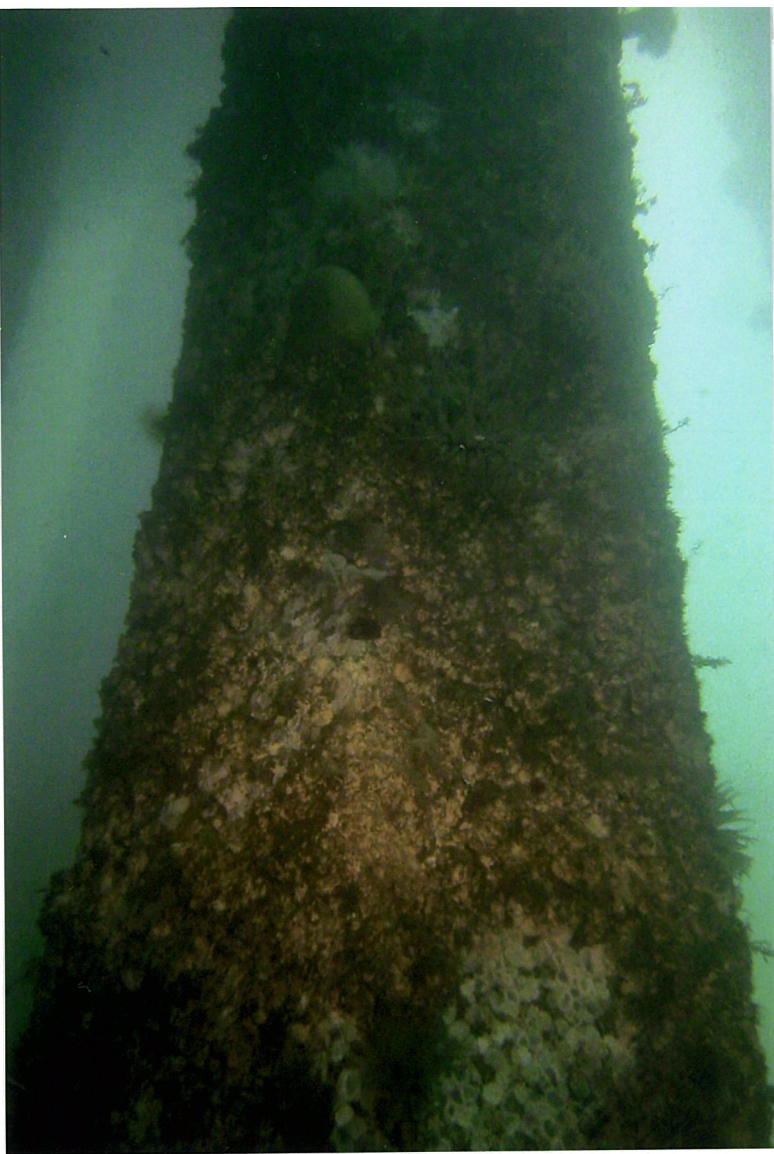
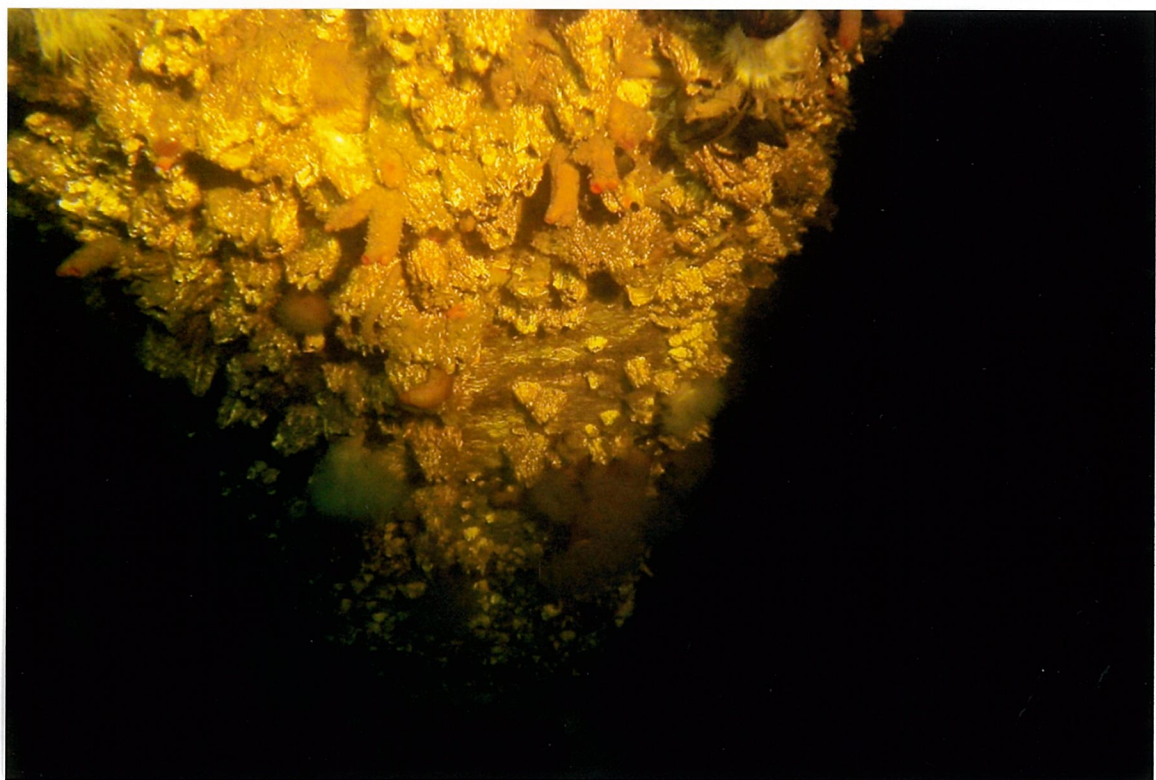
GENERAL EXTENT OF MARINE  
GROWTH AND CONDITION VIEW  
OF CONCRETE OCTAGONAL  
PILES

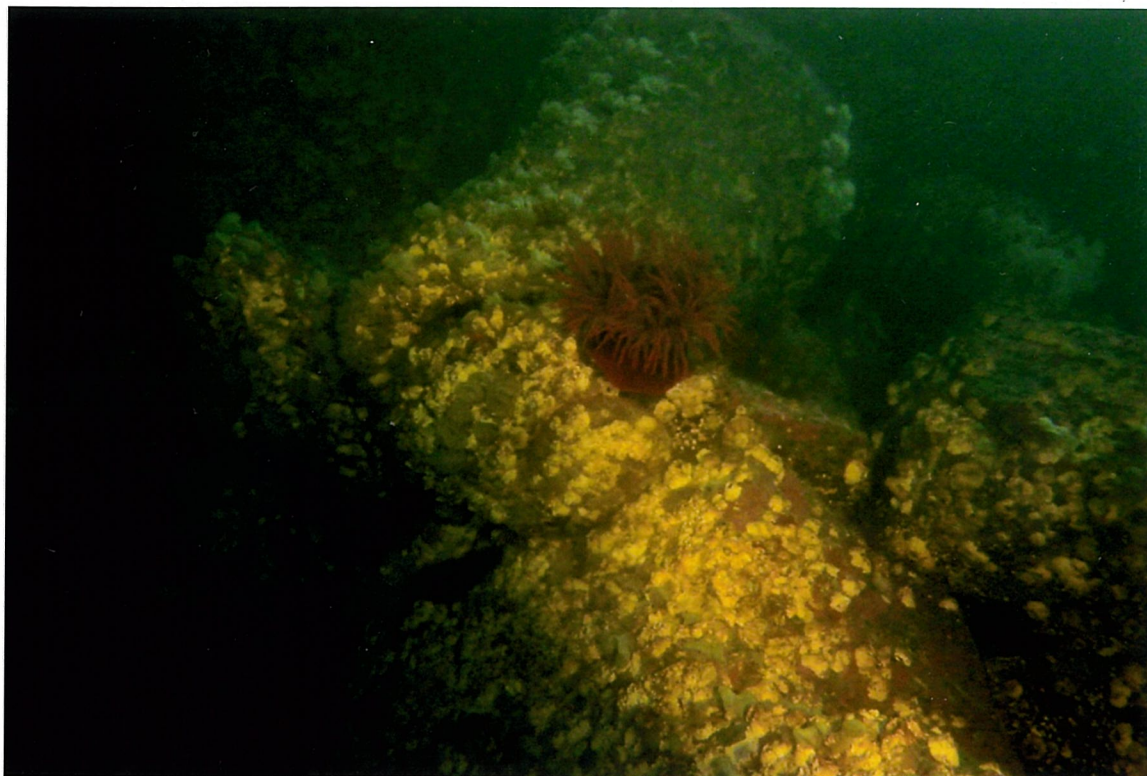
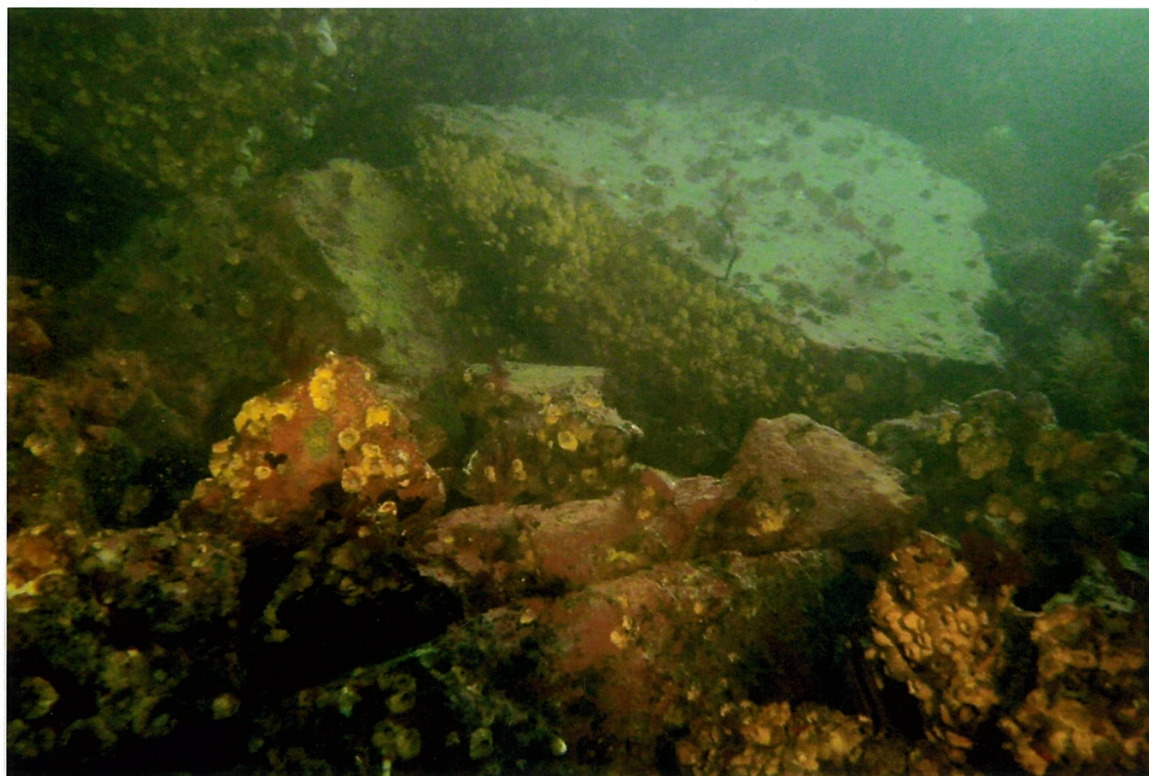
The overall perimeter composition of the seabed consisted of primarily riprap rock, cobblestone rock, shell hash and sediments commencing at the toe of the riprap moving out from underneath the jetty along the outer perimeter.

RIPRAP ARMOURING OBSERVED IMMEDIATELY COMMENCING ALONG THE  
OUTER ROW (BENT LINE) OF OCTAGONAL CONCRETE PILES

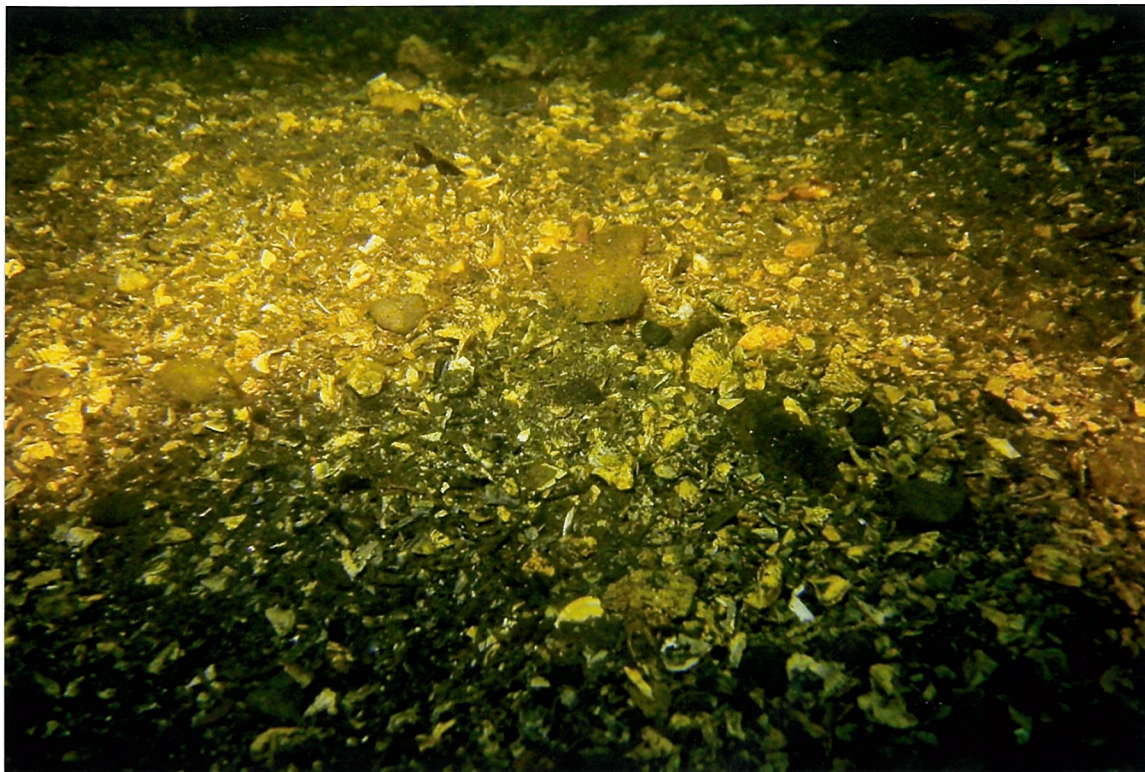
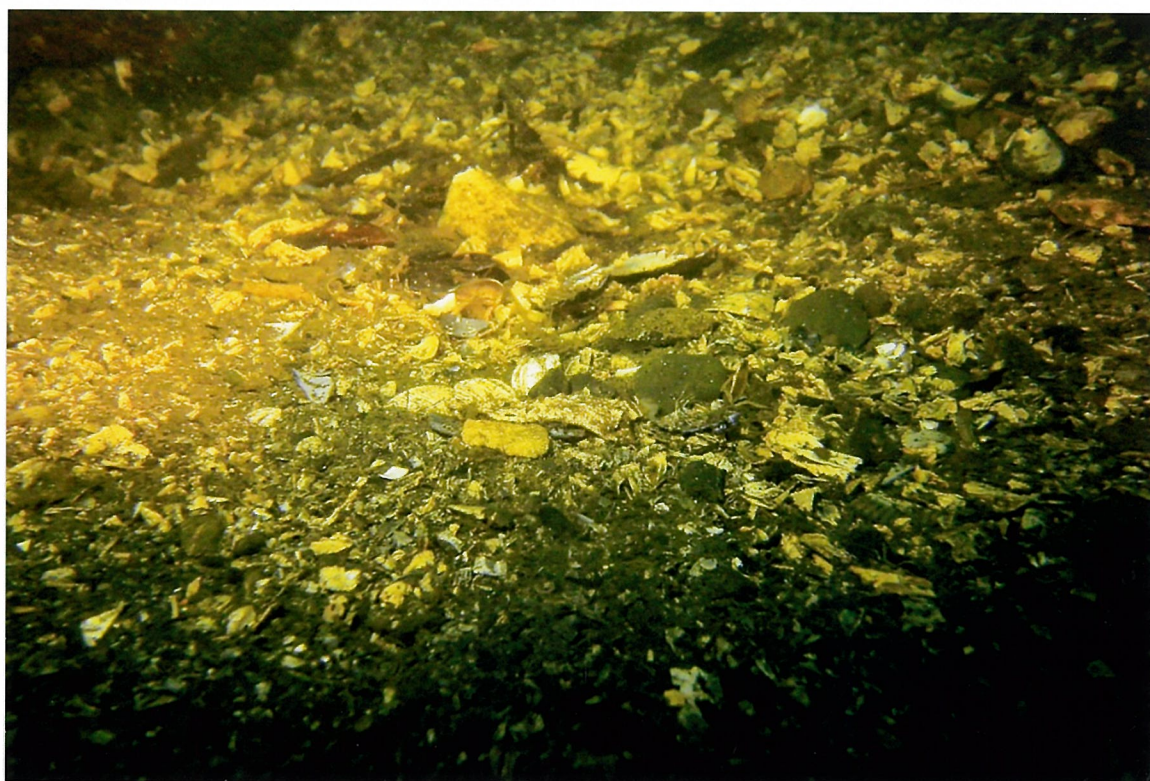
COBBLESTONE, SEDIMENTS AND SHELL HASH OBSERVED ALONG THE  
TOE OF THE RIRAP ALONG THE ENTIRE PERIMETER OF THE JETTY

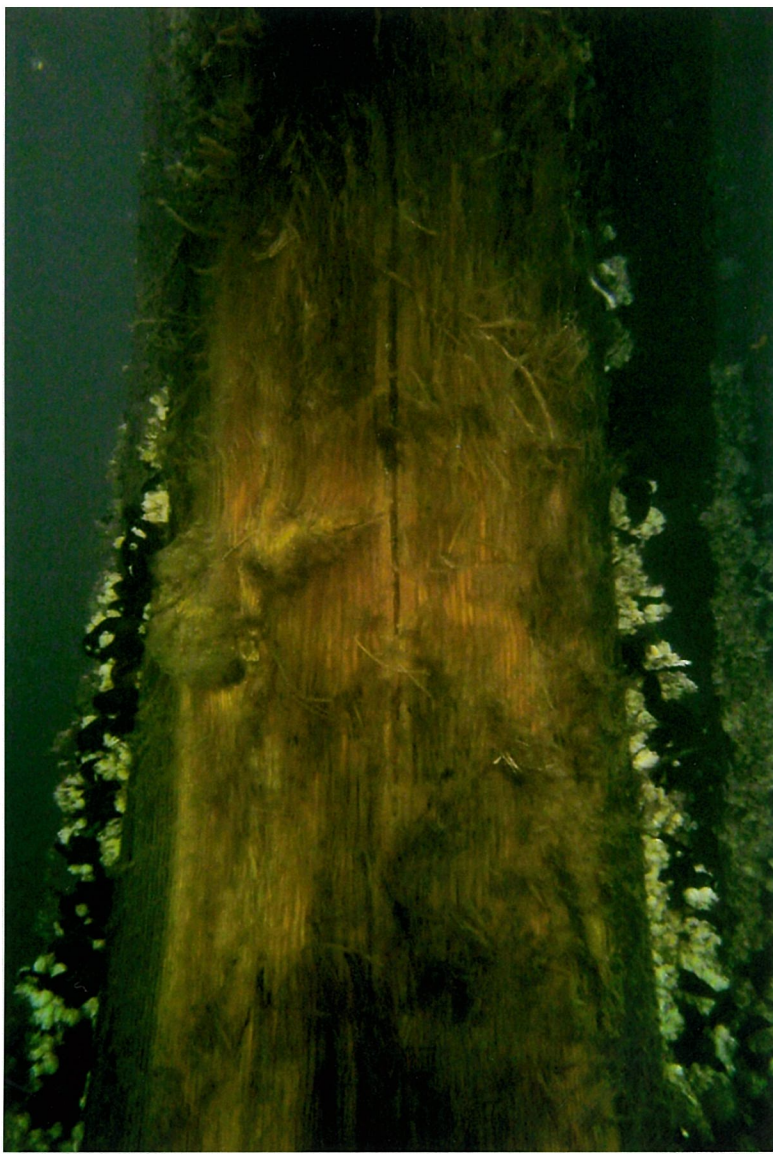
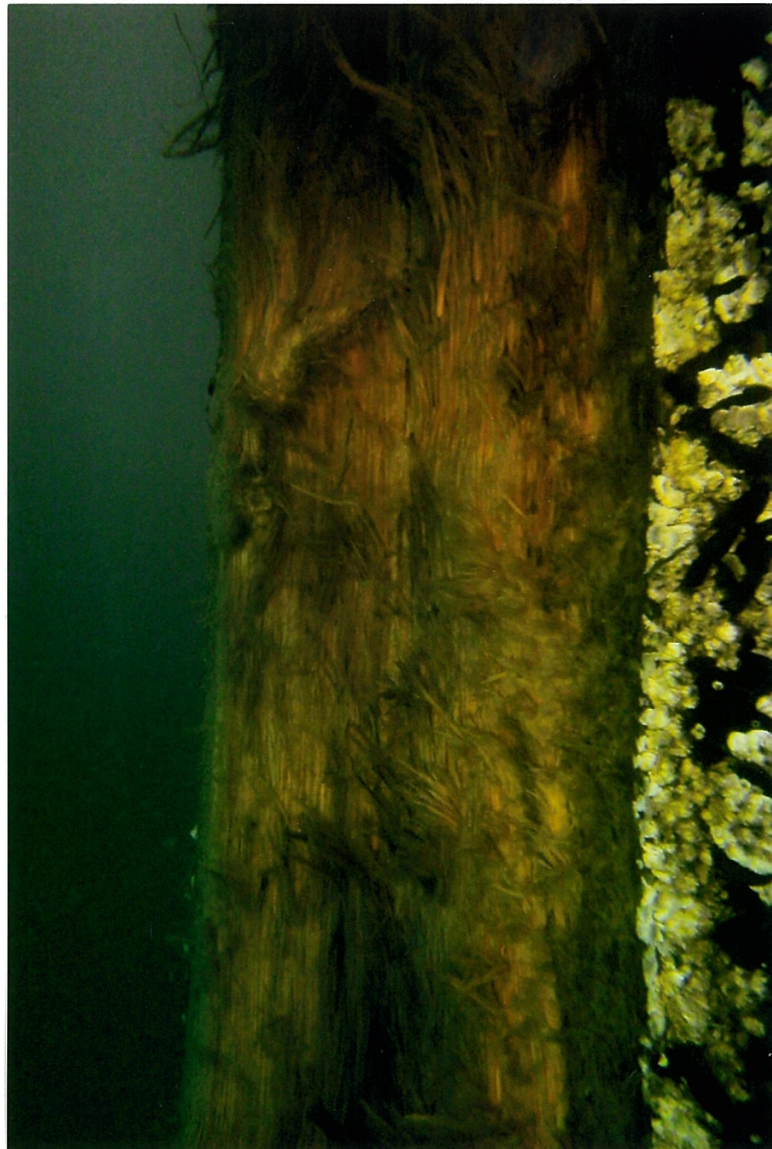
The jetty is also protected by way of timber fender piles that have seen a fair share of wear from active berthing and prevailing weather from the mouth of the harbour. The fender pile system acts as a sacrificial barrier. Replaced and damaged timbers and cross bracing was evident throughout the jetty and on the seabed.

EXTENSIVE RUB WEAR OBSERVED  
ON THE OUTER TIMBER PILE  
FENDERS FOR THE JETTY

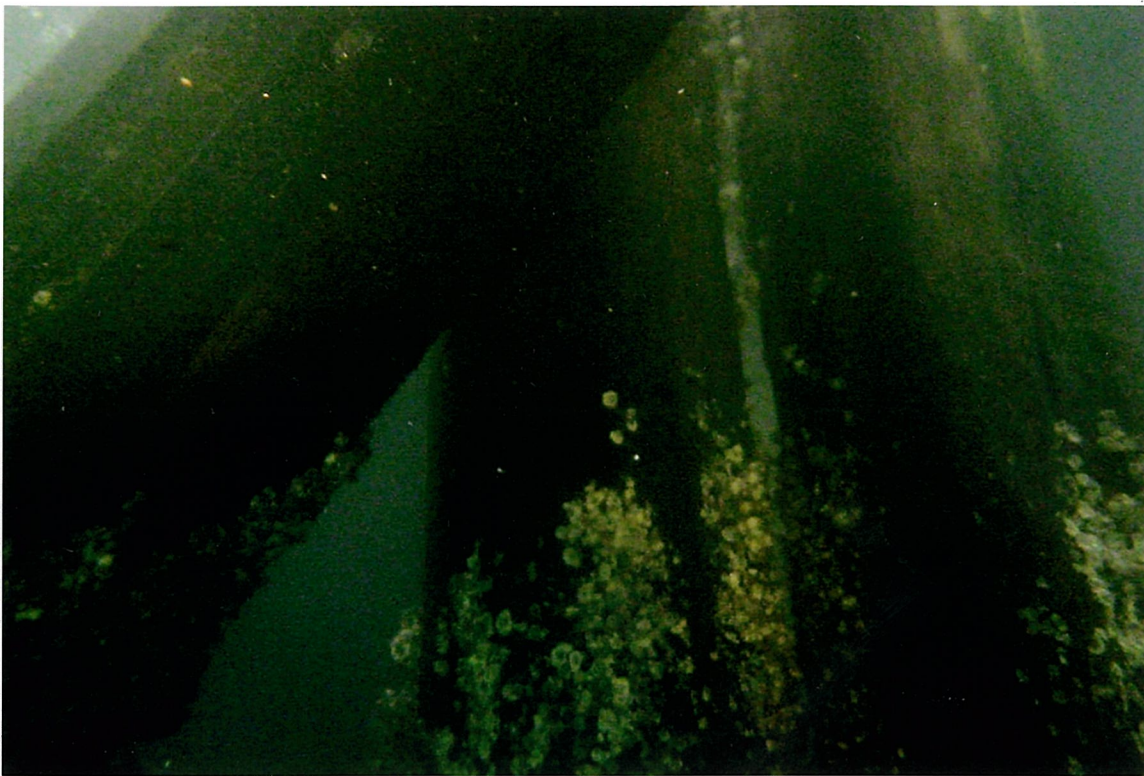
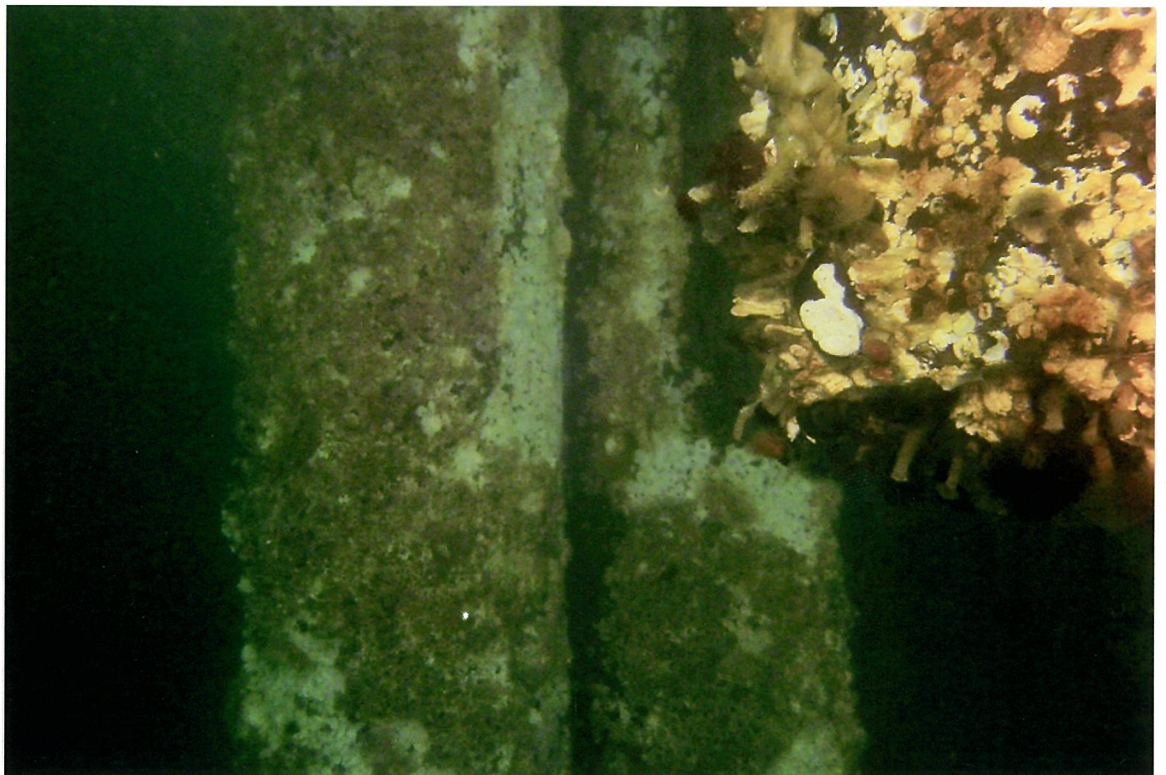
GENERAL CONDITION VIEWS OF FENDER PILES

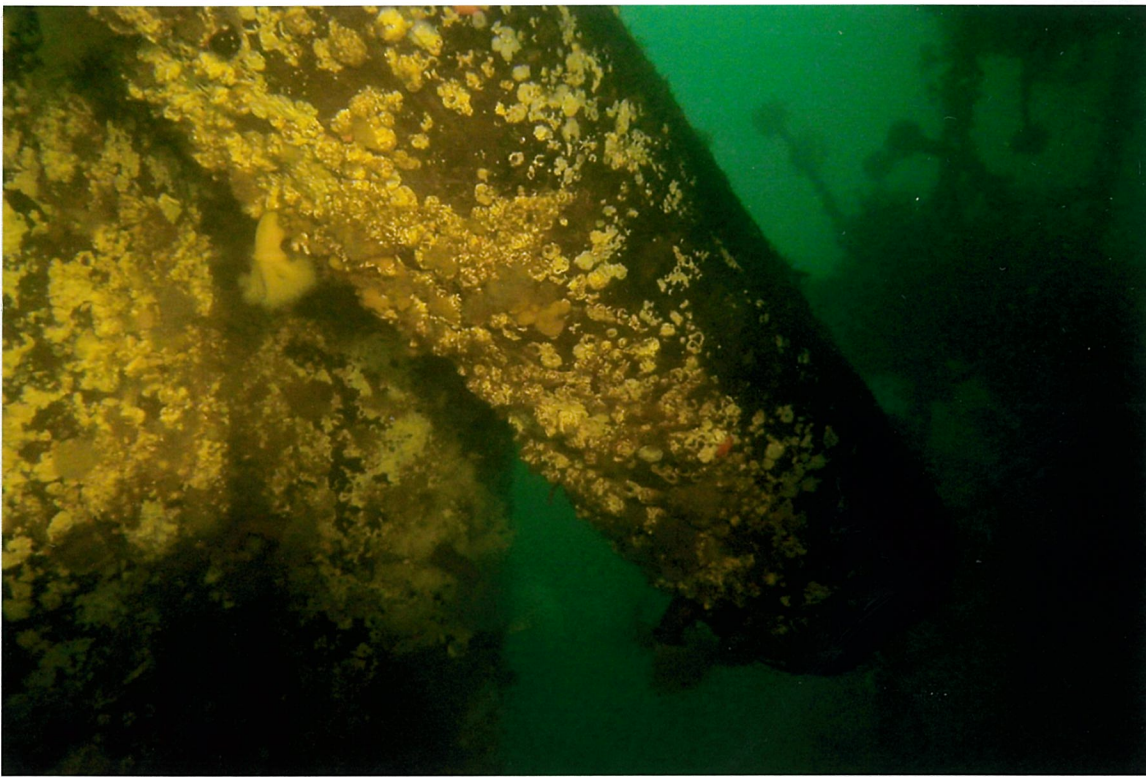
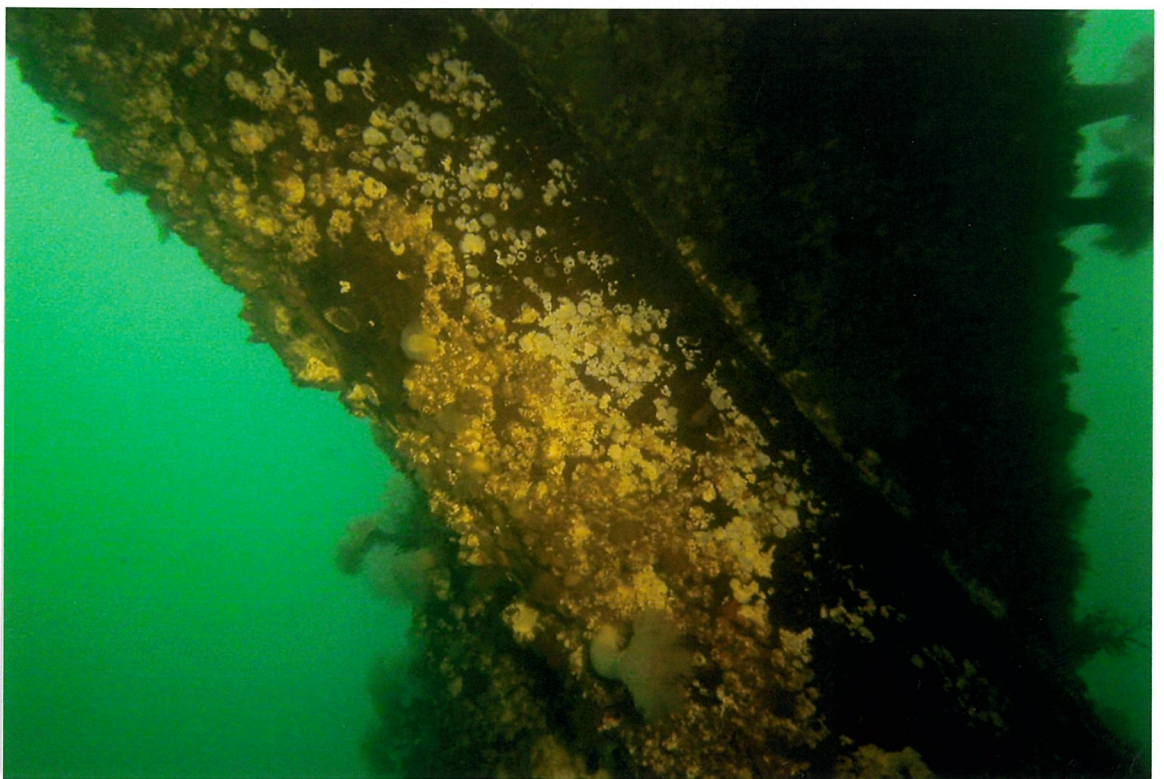
OVERALL CONDITION VIEWS OF PILE CROSS BRACING

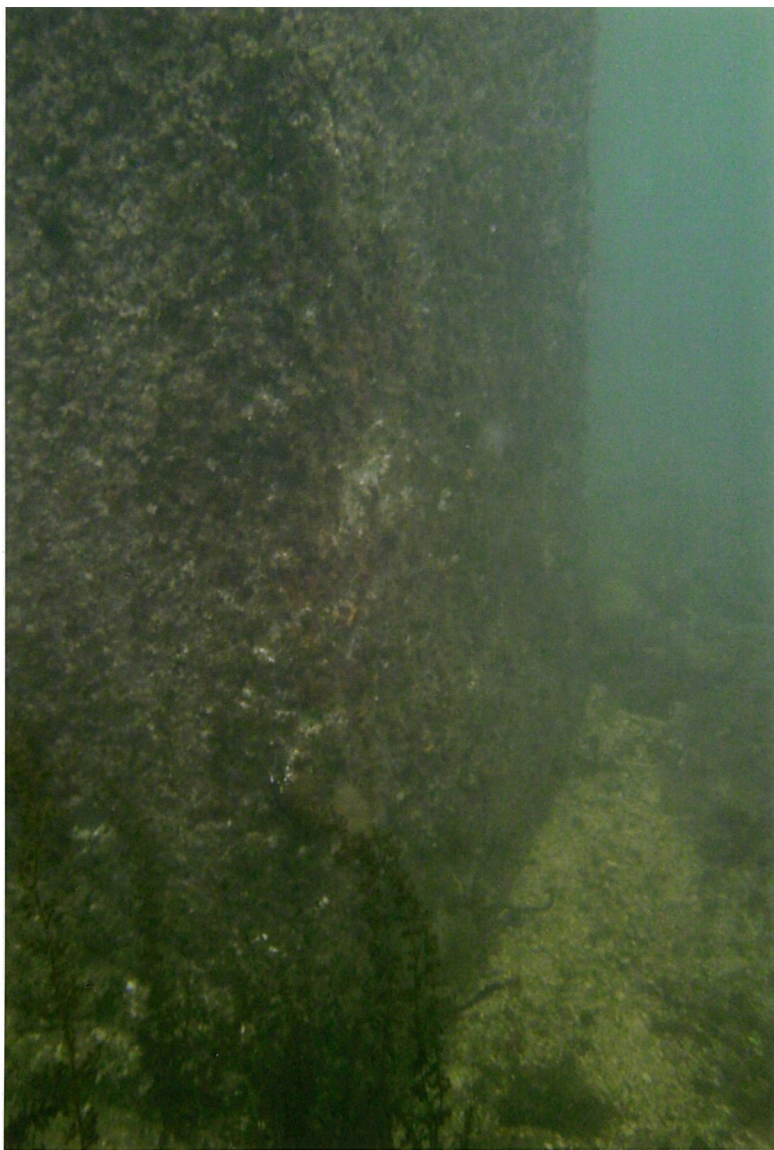
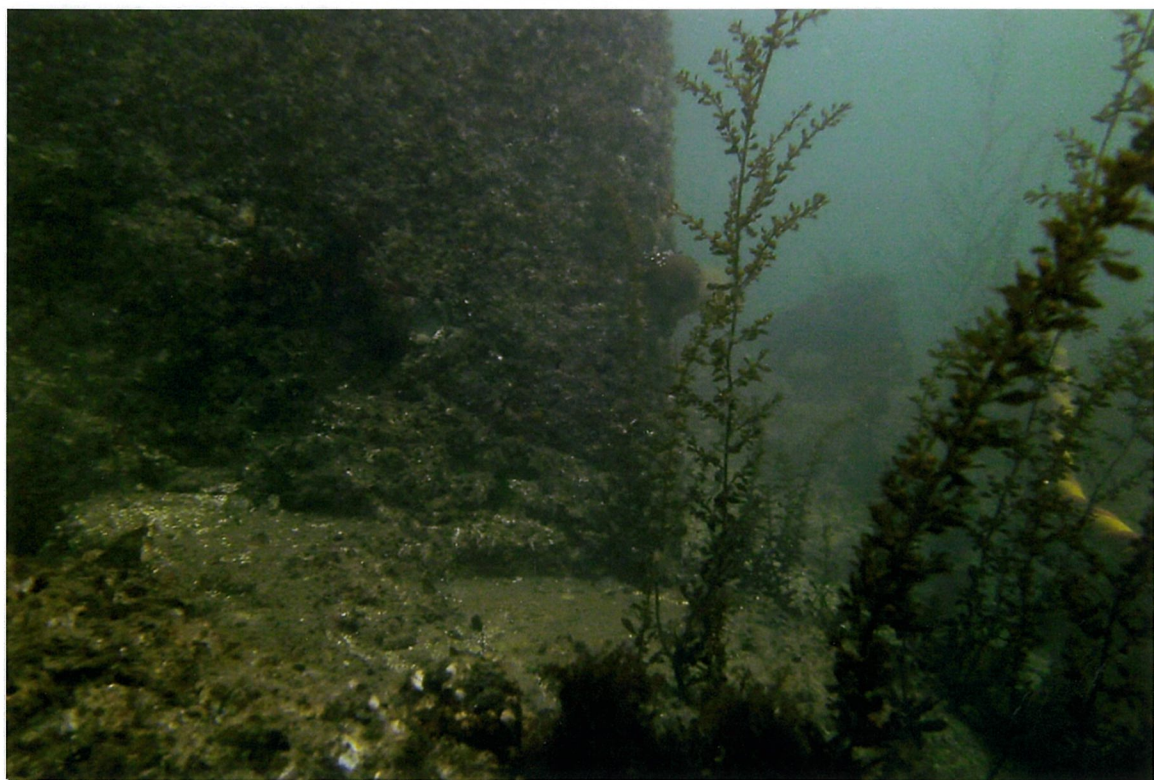
VIEWS OF INITIAL CONCRETE  
FOOTING POURED ONTO ROCK  
OUTCROPPING FOR THE  
APPROACH OF THE OLD FUEL  
FLOAT

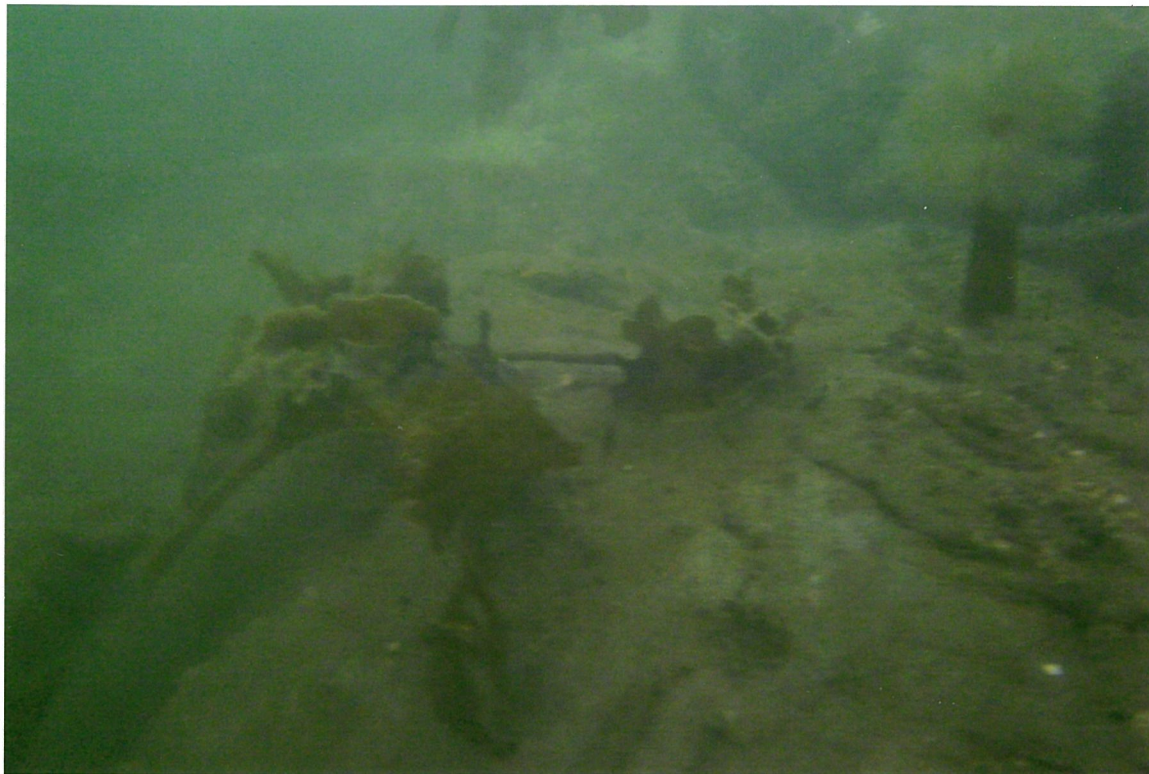
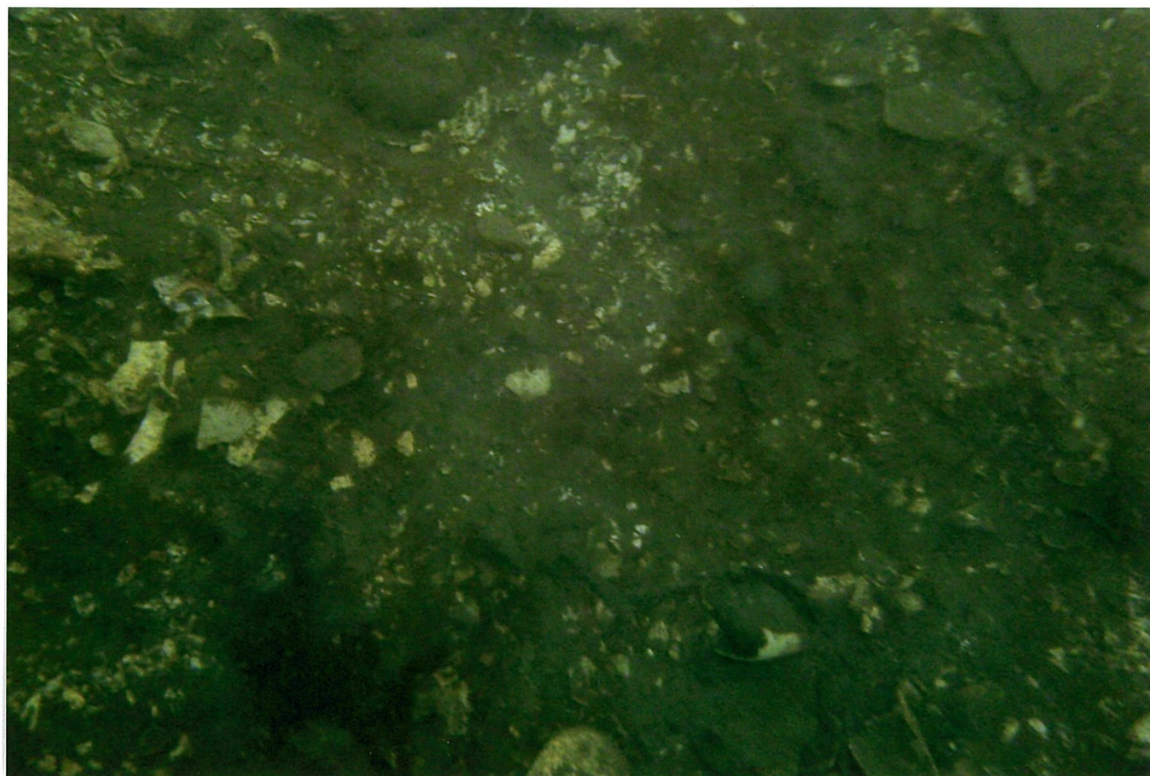
These coordinates depict the offshore end or toe section of the surrounding rock outcropping at the abutment of the old fuel float.

ROCK OUTCROPPING OBSERVED ON SHORE AT THE APPROACH FOR  
THE OLD FUEL FLOAT AND BOTTOM COMPOSITION AT THE TOE  
OF THE ROCK OUTCROPPING

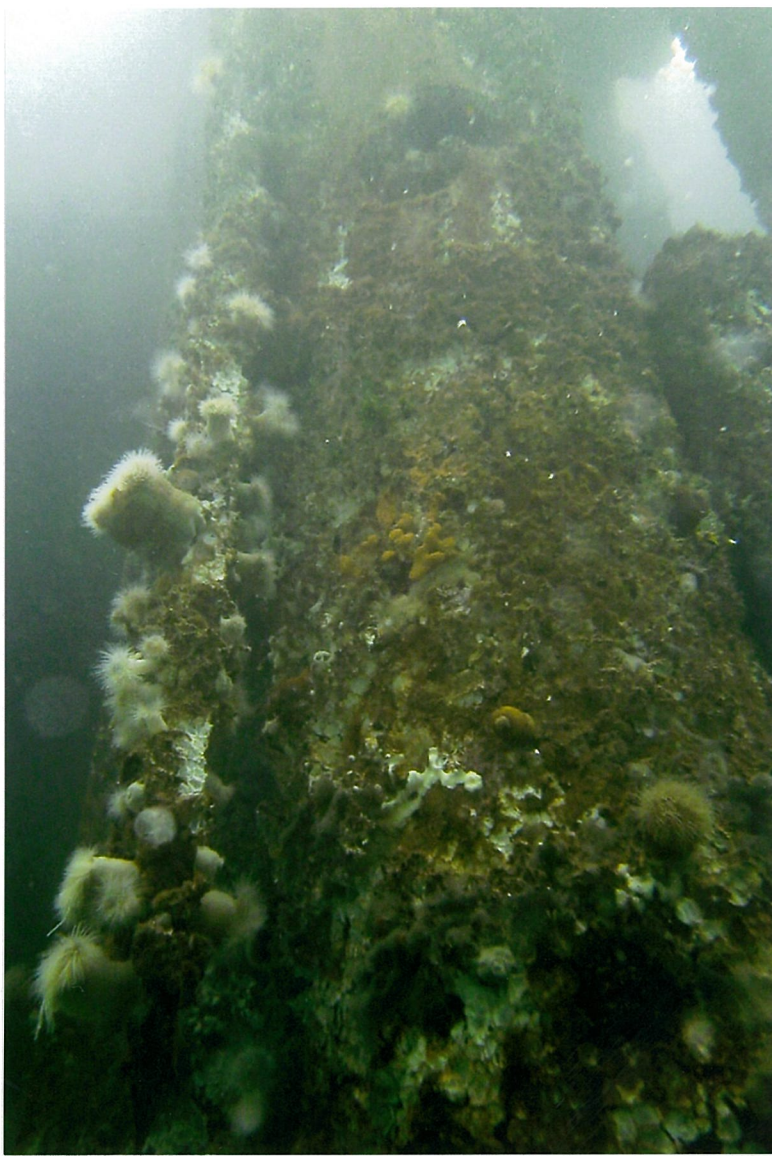
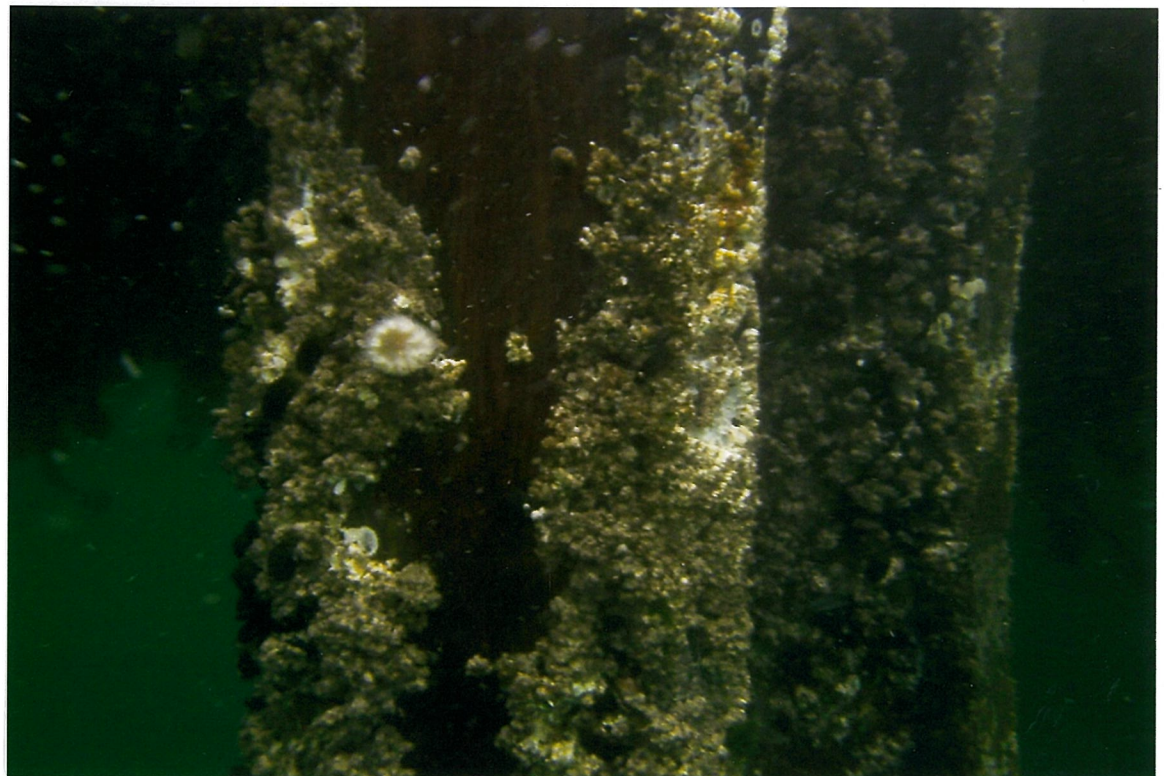
GENERAL VIEWS OF THE TIMBER  
PILE CONDITIONS OBSERVED FOR  
THE LOCATOR PILES FOR THE  
OLD FUEL FLOAT

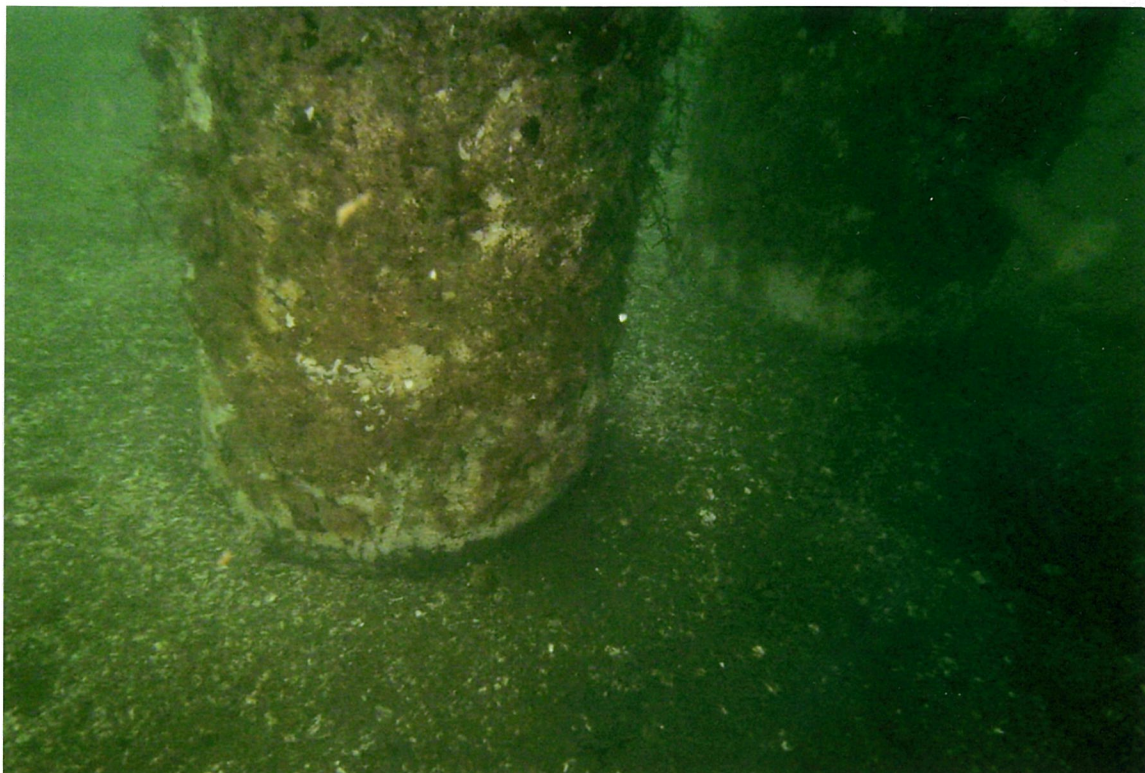
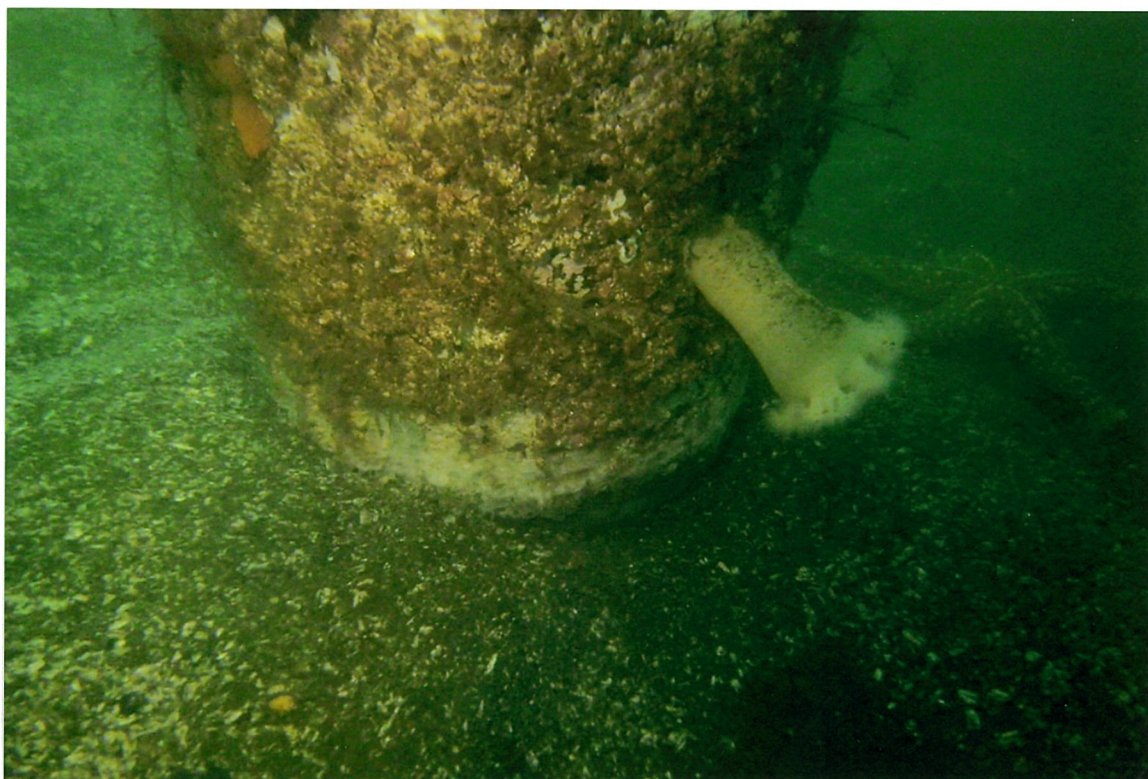
The bottom composition from the rock outcropping under the approach was primarily soft silt, gravel and shell hash as you move offshore under the float. Evidence of construction debris and creosote cross bracing from previous repairs or normal rot over the years was observed scattered on the bottom. The locator dolphin piles and related footings into the seabed appeared in fair condition with proper embedment overall. The concrete footing at the start of the approach showed some erosion around the lower footing. This damage is localized to the offshore or prevailing side.

OBSERVATIONS OF THE OVERALL CONDITION OF THE TIMBER PILE  
FOOTINGS AT THE SEABED AND GENERAL COMPOSITION OF THE  
SEABED UNDER THE OLD FUEL FLOAT
