# **SOUTH COAST DIVING LTD.**

SNC Lavalin Inc., Environment Division (SLE)  
**D-Jetty Perimeter and Old Fuel Float Reconnaissance**  
In-Water Field Survey Report  
February 10, 2016

## **RE: DIVE RECONNAISSANCE INSPECTION, MARINE RAILWAY**

Date(s): January 21, 2016  
Time(s): 08:00/13:00 hrs  
Location: CFB Colwood, D-Jetty/Old Fuel Float  
Item(s): Perimeter substrate, structure and rock outcropping coordinates  
Methodology: Visual recording c/w DVD-R video and digital still  
photographs of general conditions.  
Dive Supervisor: Ian Swan  
Dive Tech(s): Grsydon Tait  
Dave Dalzell  
David Littlejohn

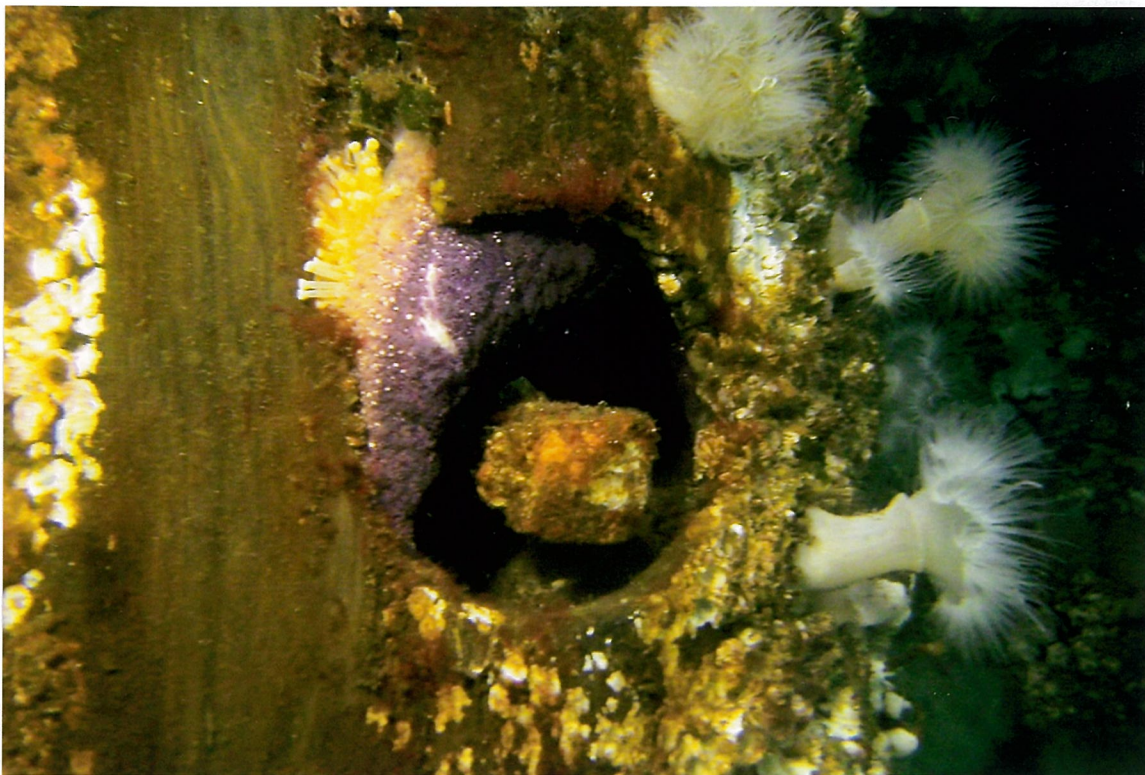
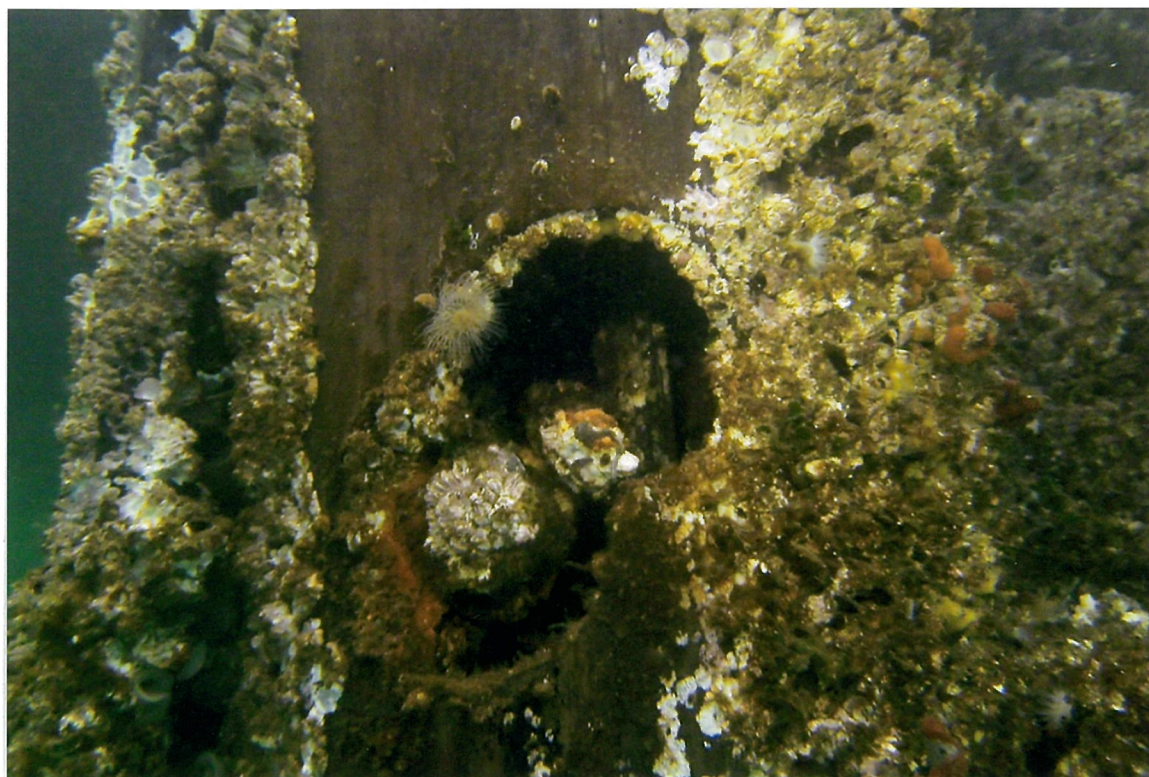
Upon completion of the perimeter survey on D-Jetty, the crew proceeded to complete a further evaluation of what is now considered the old fuel float located between F-Jetty and G-Jetty. The old fuel float consisted of an approach/gangway with a concrete footing poured over a rock outcropping inshore, an additional timber pile footing at the head of the gangway, then onto a float secured by driven timber round piles in place as locator piles on either side of the inshore end of the float and a locator dolphin at the offshore end of the float. The float is primarily used for very light duty and the overall integrity of the piles and cross bracing are showing evidence of decay and pile rot. There was very good example photographs demonstrating how a purposely installed drift pin or lag bolt creates a hole in the main pile that allows for infestation and rot to commence and work throughout the life span of the pile.

PILE ROT AND DECAY FORMED FROM PURPOSELY INSTALLED STEEL  
DRIFT PINS OR LAG BOLTS IN ORDER TO SECURE TIMBER BRACING  
THAT HAS SINCE FALLEN OFF THE MAIN PILES AT THE OLD  
FUEL FLOAT

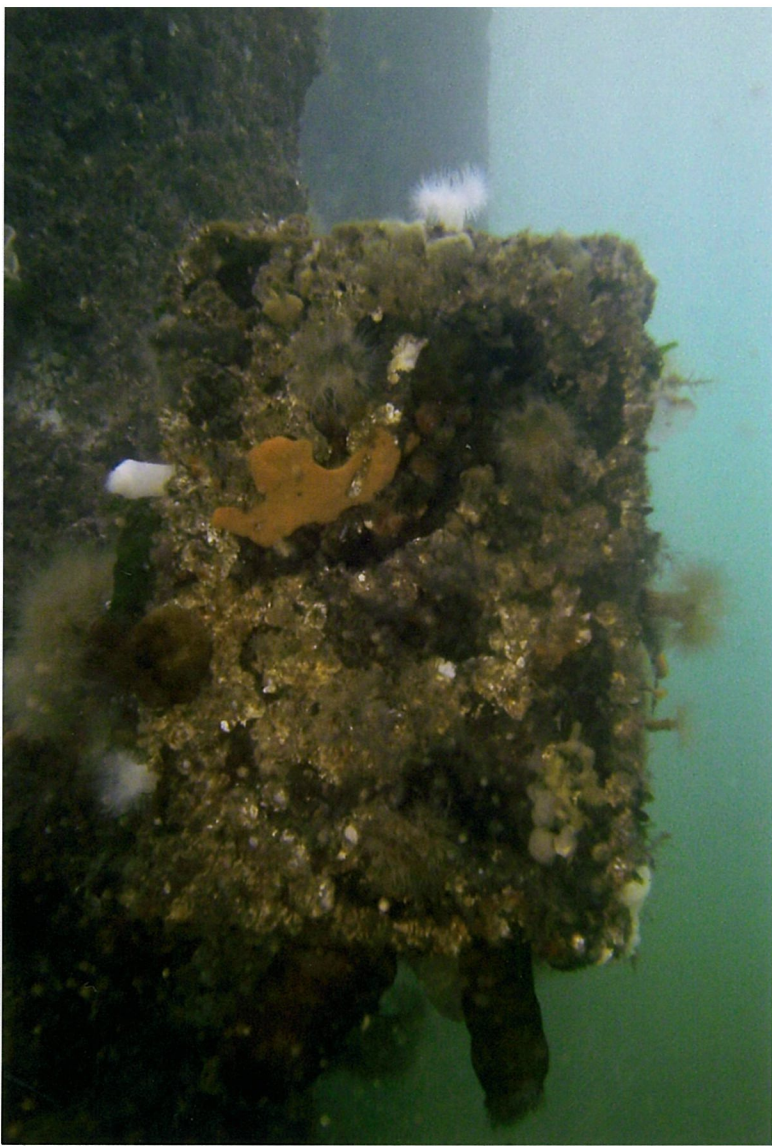
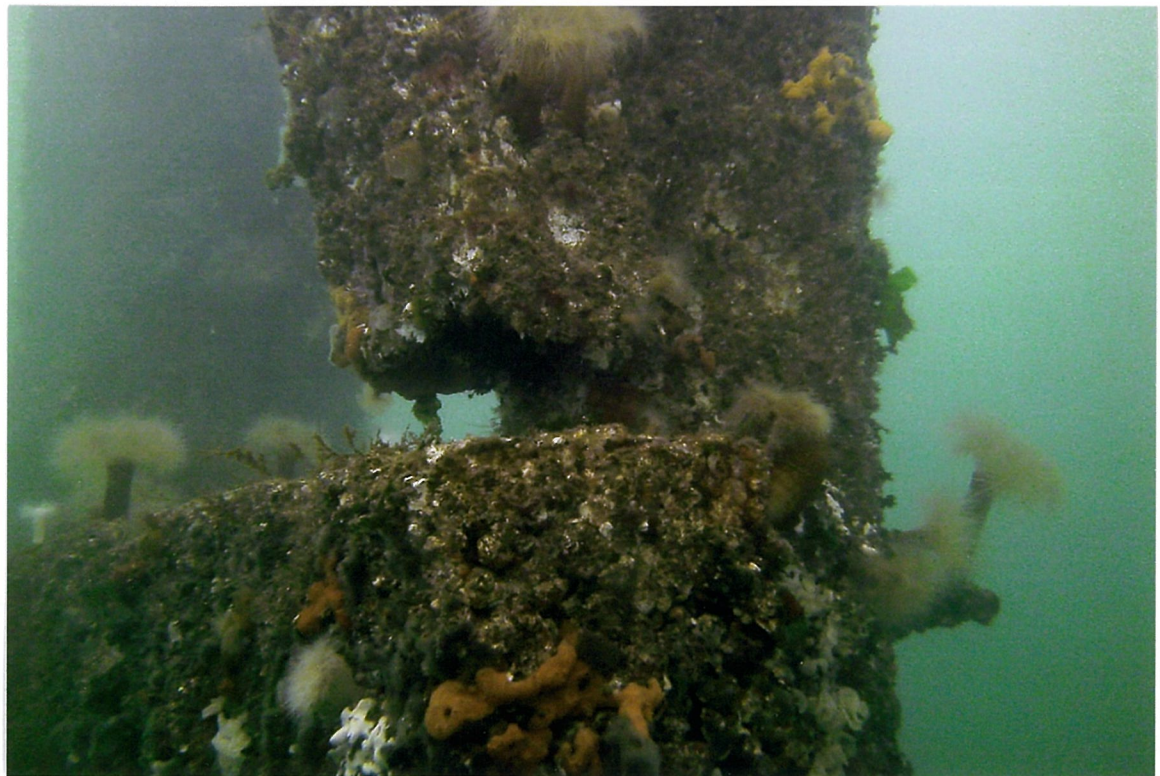
TIMBER CROSS BRACING DECAY  
AND ROT OBSERVED AT THE OLD  
FUEL FLOAT

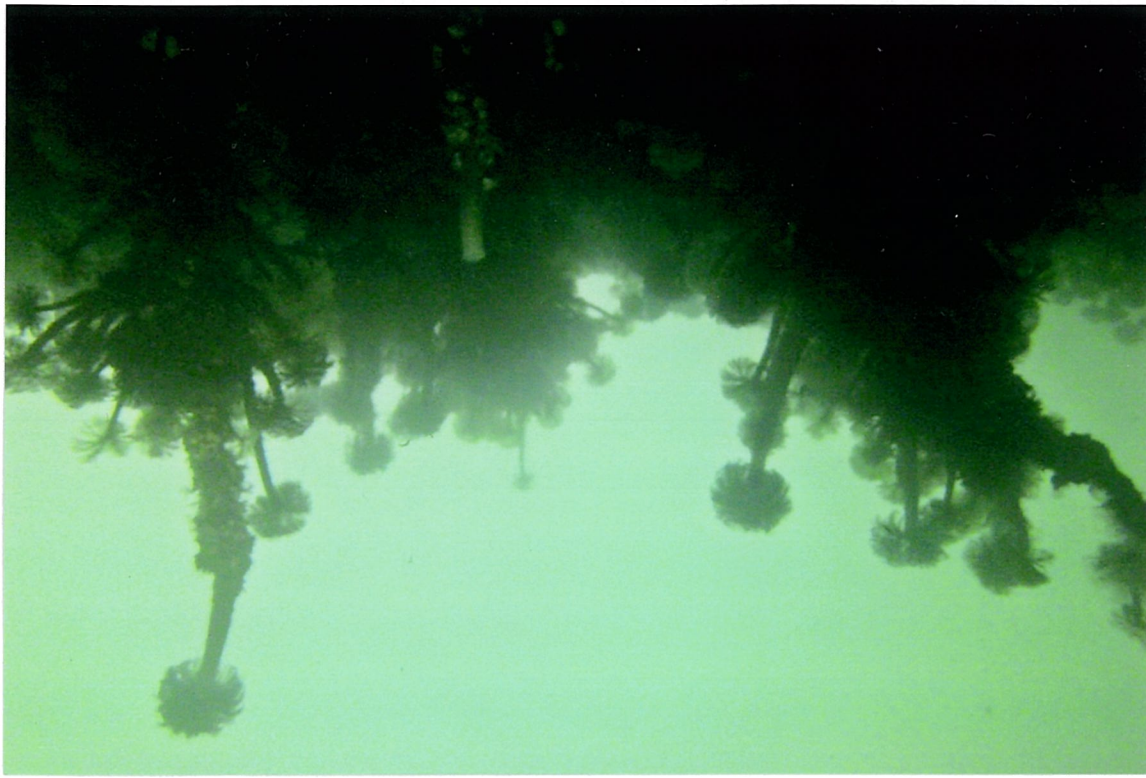
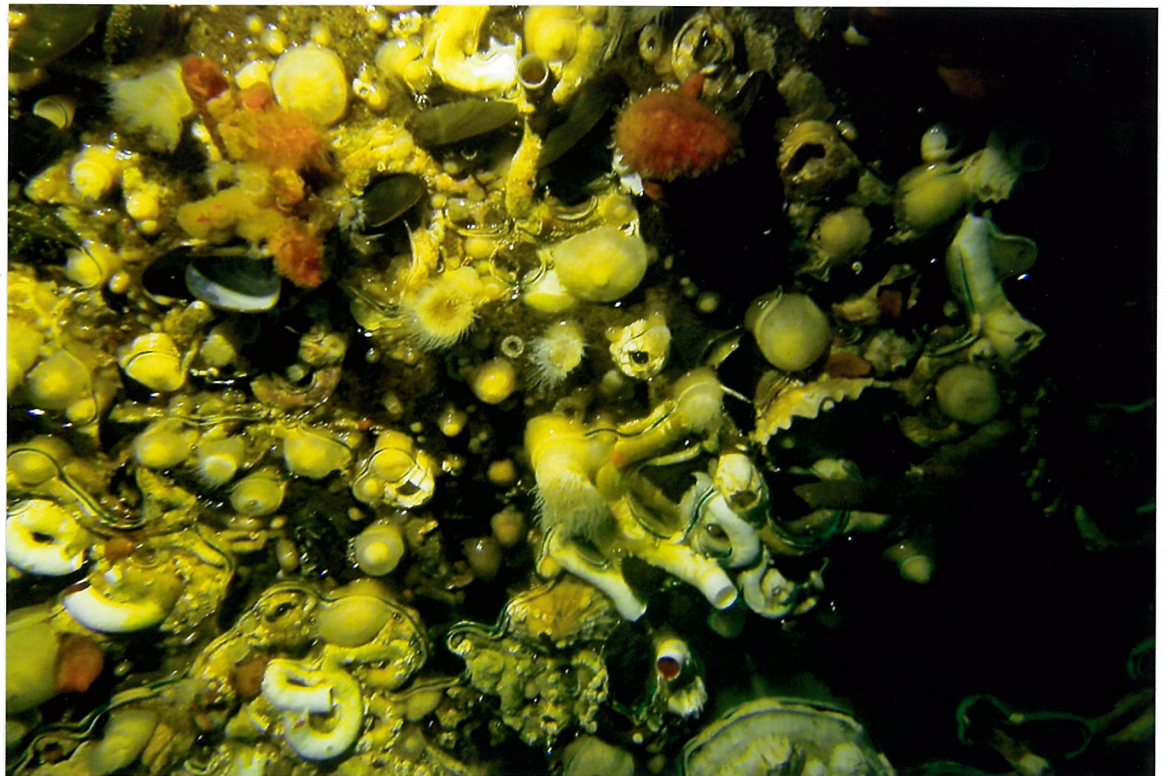
EXTENT OF MARINE GROWTH OBSERVED ON THE UNDERSIDE OF THE  
OLD FUEL FLOAT
