APPENDIX C

Structural Investigation

Re: Condition and Relocation Suitability Assessment, and Temporary Shoring Advice
for an Existing Maintenance Garage at Toad River Maintenance Camp
at Km 649 on the Alaska Highway

TOAD RIVER, BC
HIGHWAY MAINTENANCE
BUILDING ASSESSMENT

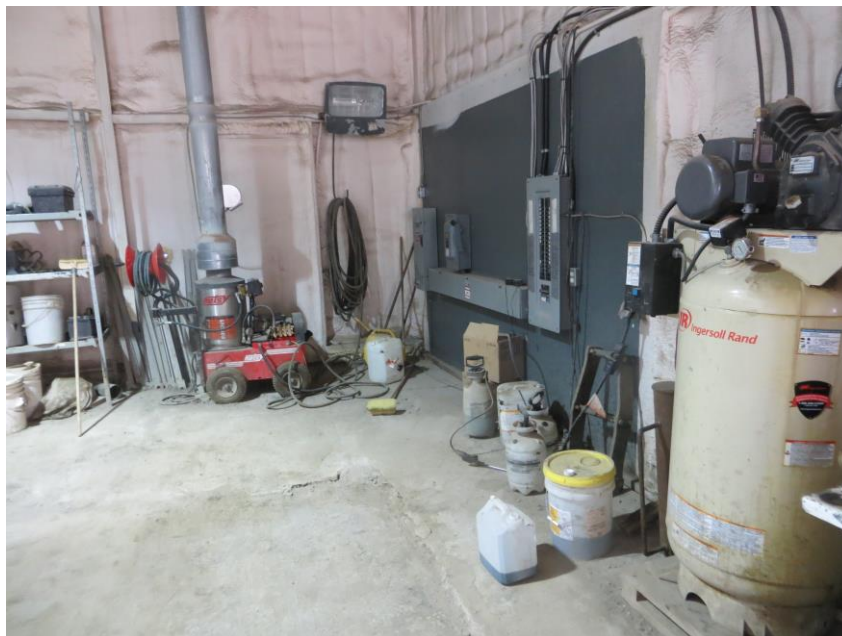
The building foundations and floor slab are in a poor condition. The timber plates below the perimeter of the building are substantially rotten, resulting in the settlement of some of the steel columns. This settlement is visible in Photo 17. The concrete floor slab surface is uneven, possibly as a result of being formed at different times, and possibly to allow for some type of floor drainage in the past. See Photos 10 and 18.

Photo 10: View of electrical panel, air compressor and pressure washer.

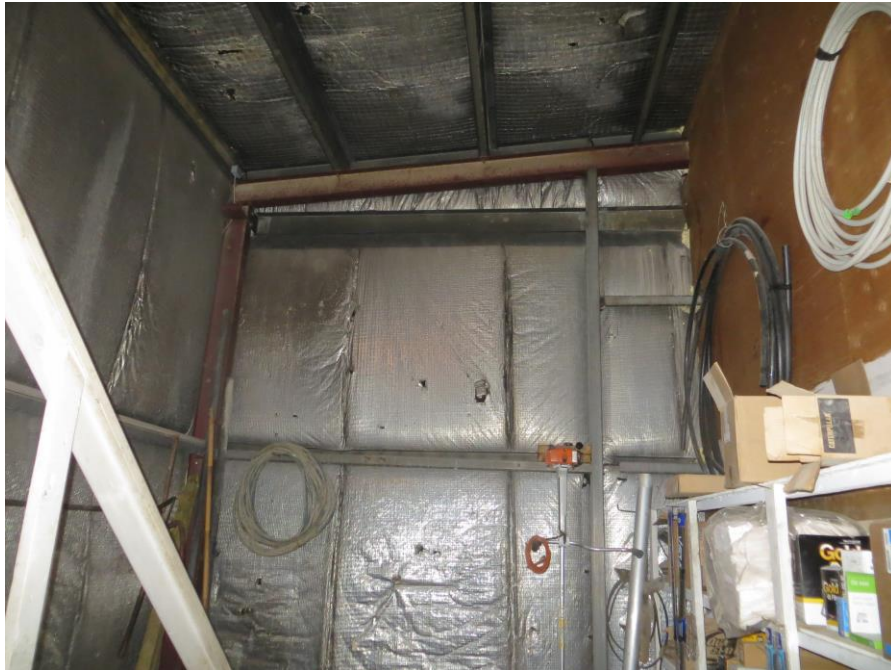
- The framing of the north wall suggests it used to accommodate a large door opening. This door opening no longer exists and is now infilled with the same corrugated metal cladding and spray foam insulation as the rest of the building.
- The framing of the south wall suggests it may have accommodated a larger door in the past.
- The profile of the wall cladding at each end of the building steps out at high level. The building may well have had large sliding doors at each end. The rails from which the slid doors where hung may have been housed within the step in the cladding. The maintenance building now has one overhead door as described previously.

Photo 13: View of secondary framing on north wall (upper).

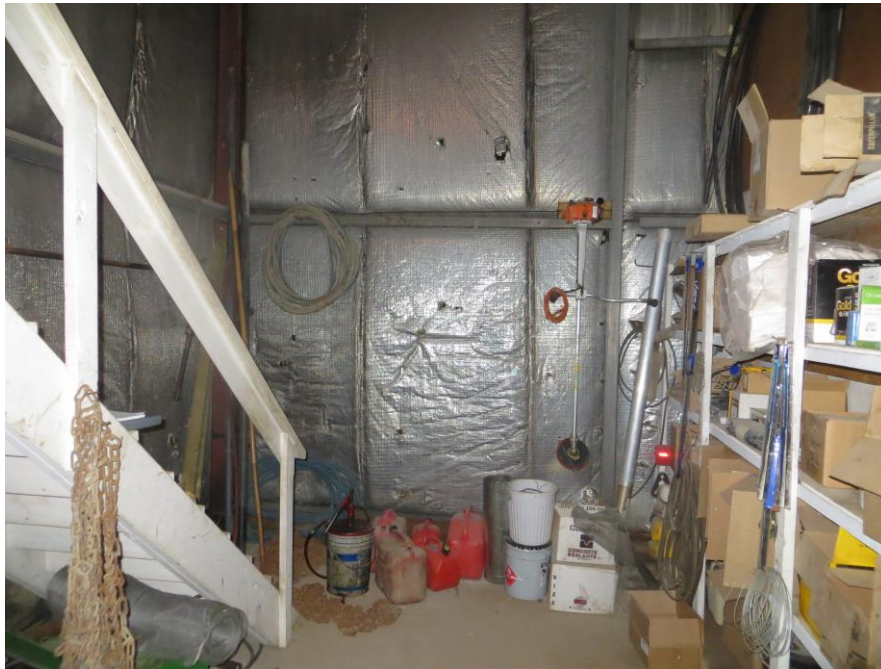
Photo 14: View of secondary framing on north wall (lower).

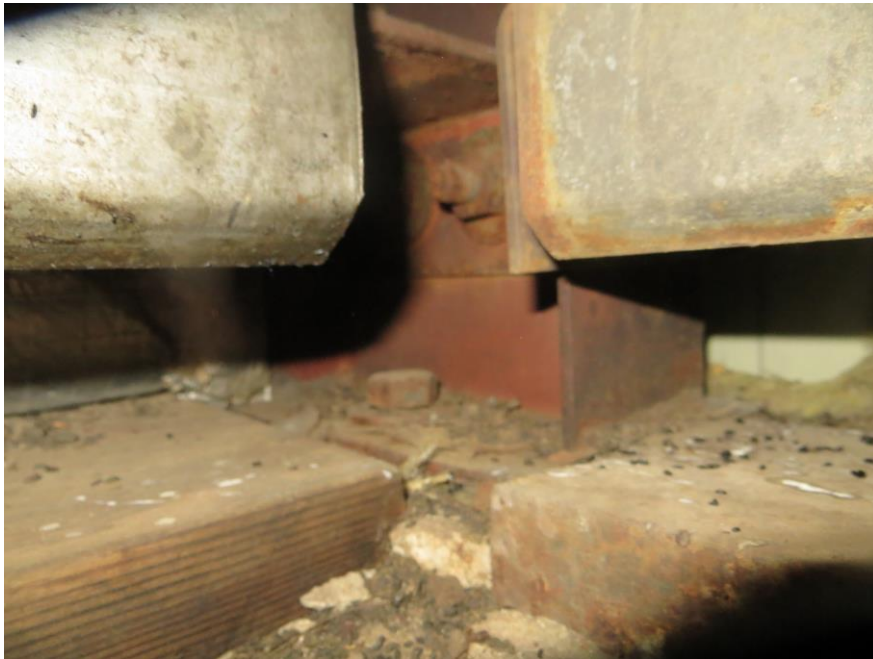
Photo 15: Typical baseplate at corner column.

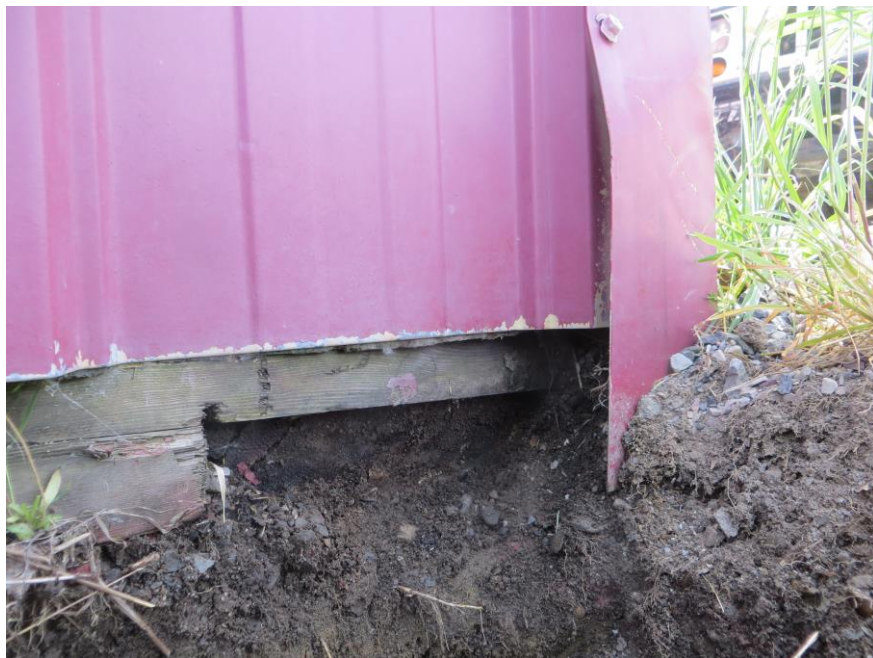
Photo 16: View of existing timber sill plate.

However, given the poor condition of the building foundations we would recommend that the building Owner consider replacing these foundations with new in the near future.

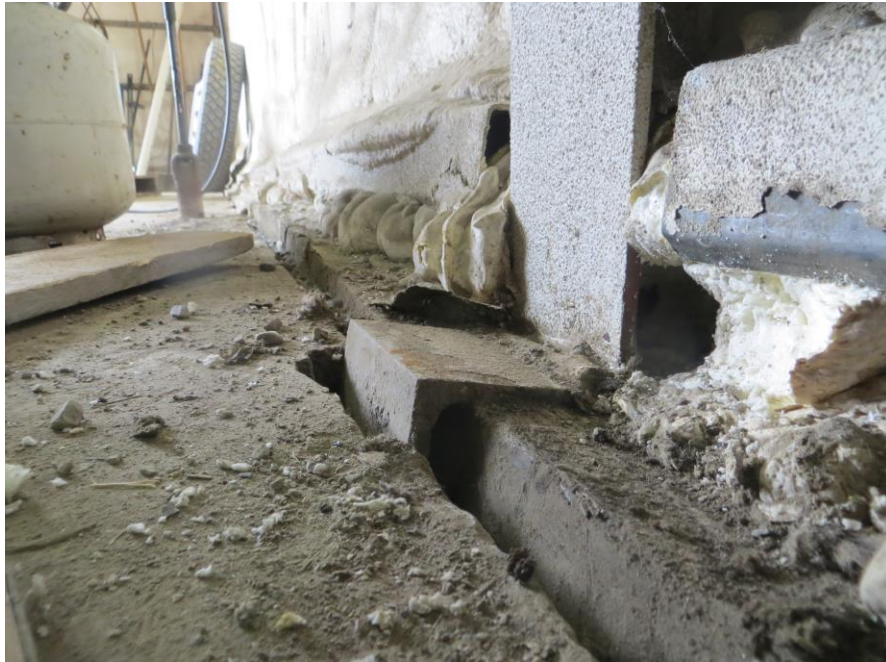
Photo 17: View of existing base plate of portal frame.

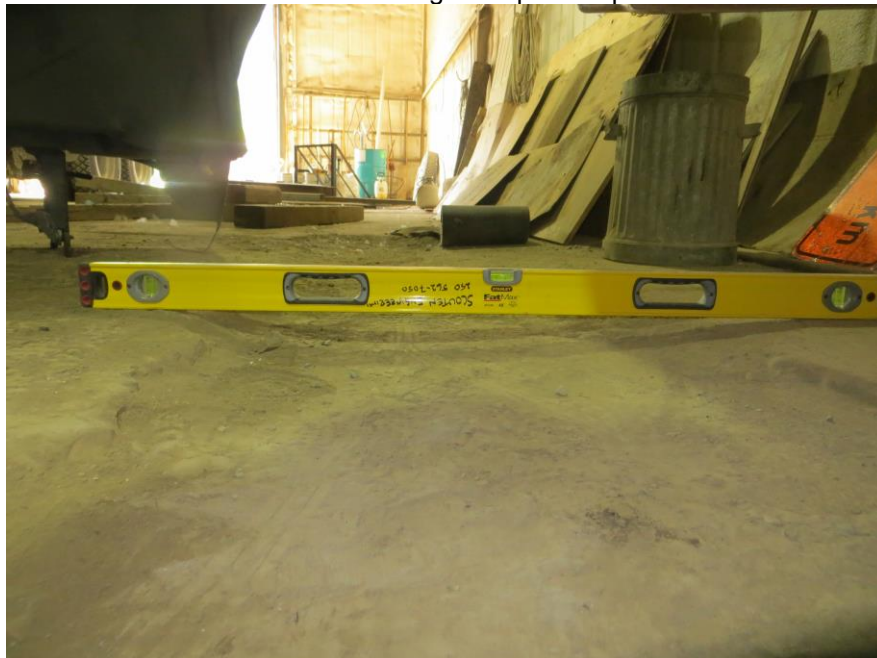
Photo 18: View of existing floor slab showing uneven nature of slab surface.
