Appendix B

Photos

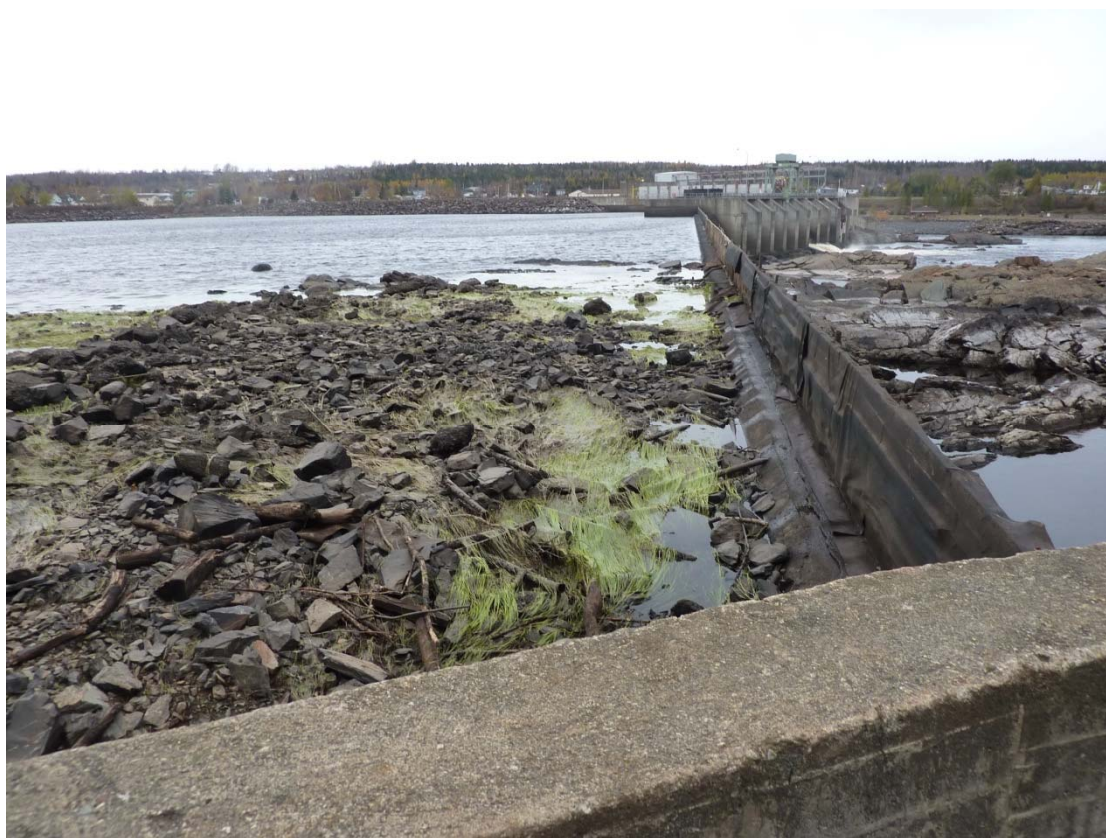
2009 – Upstream riverbed during low water conditions

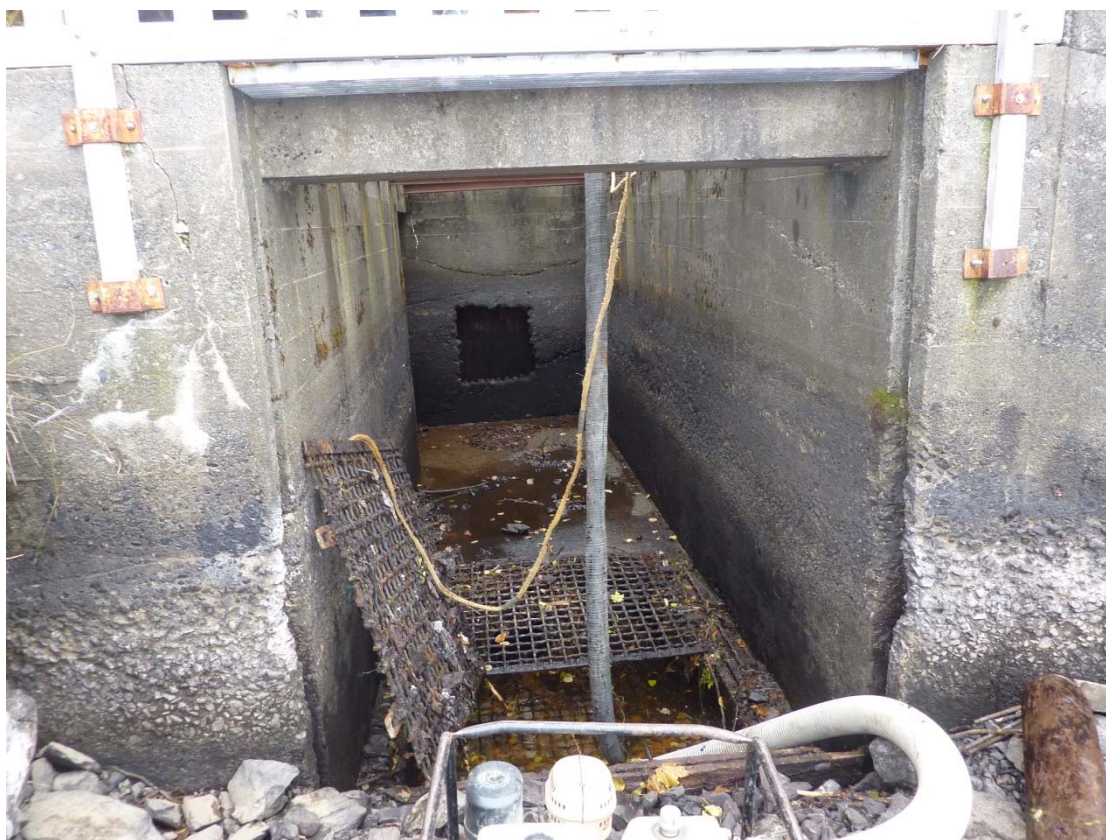
2009 – Pool No. 1 with attraction flow grating

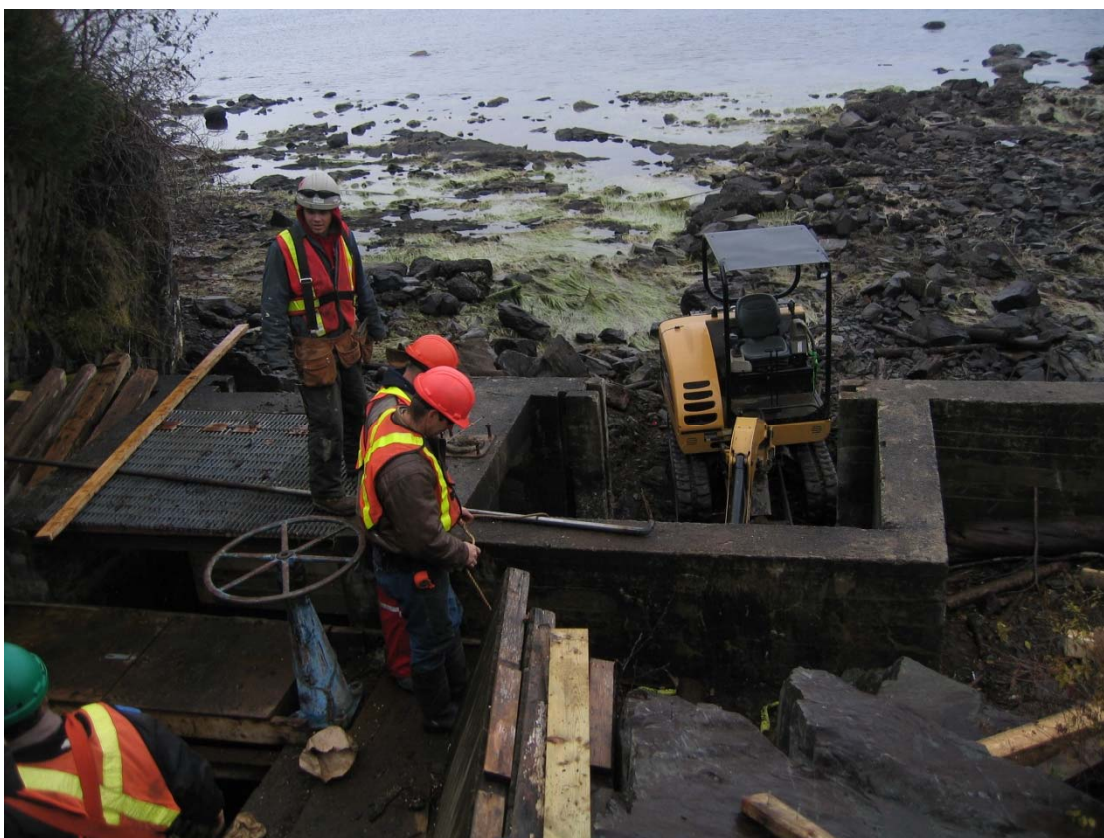
2009 – Repair work at Pool No. 6

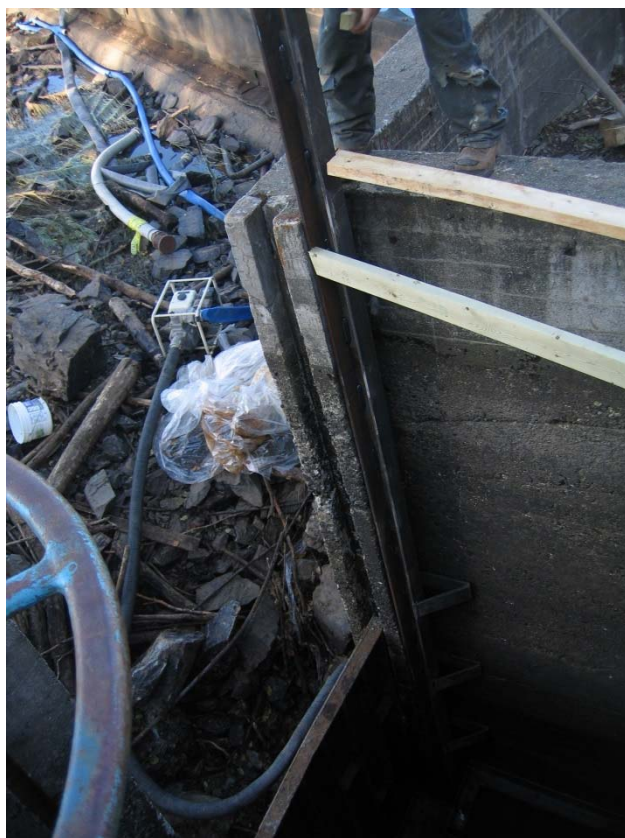
2009 – Inlet at Pool No. 6

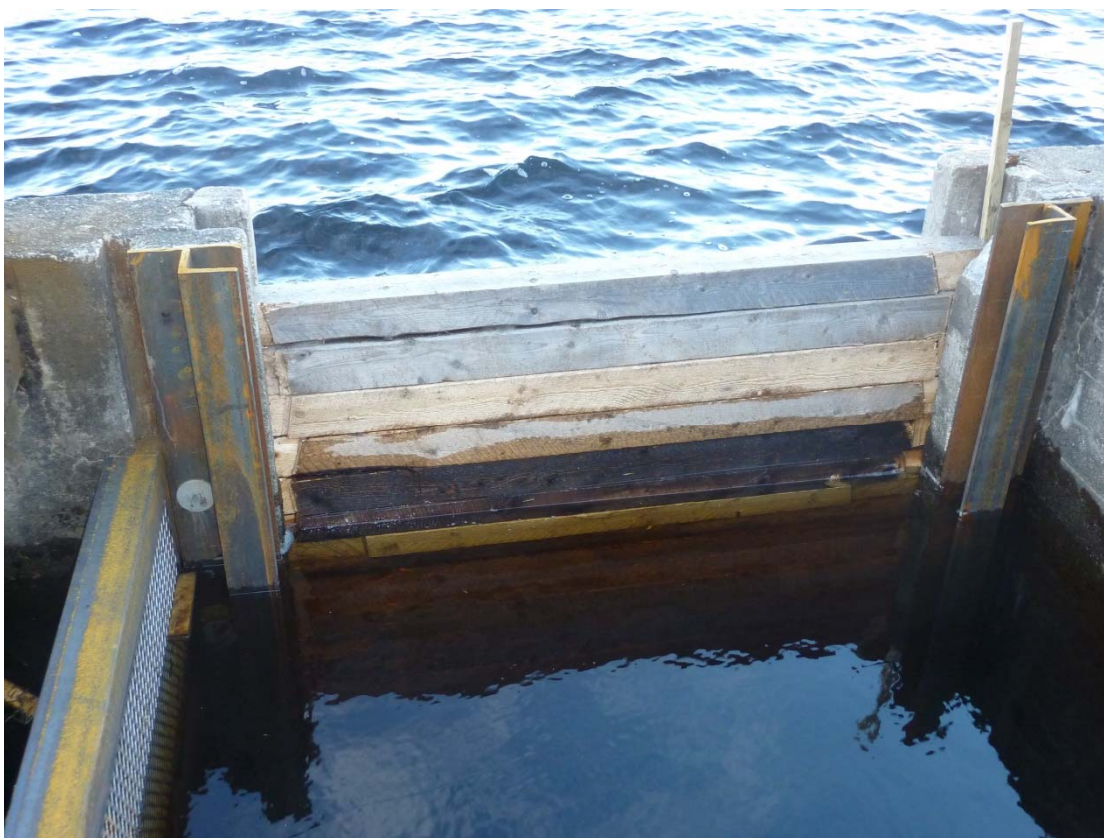
2009 – Stop logs and screen (on left) in Pool No. 6

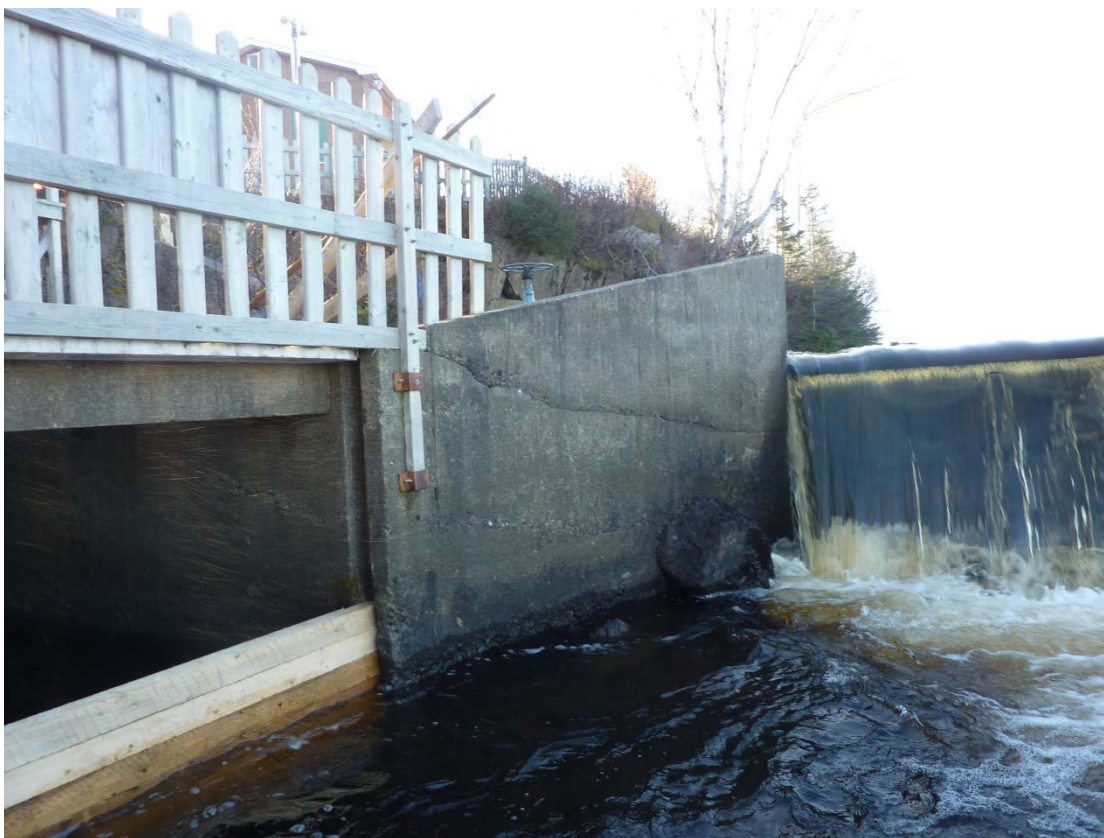
2009 – Retaining wall and inlet to Pool No. 1

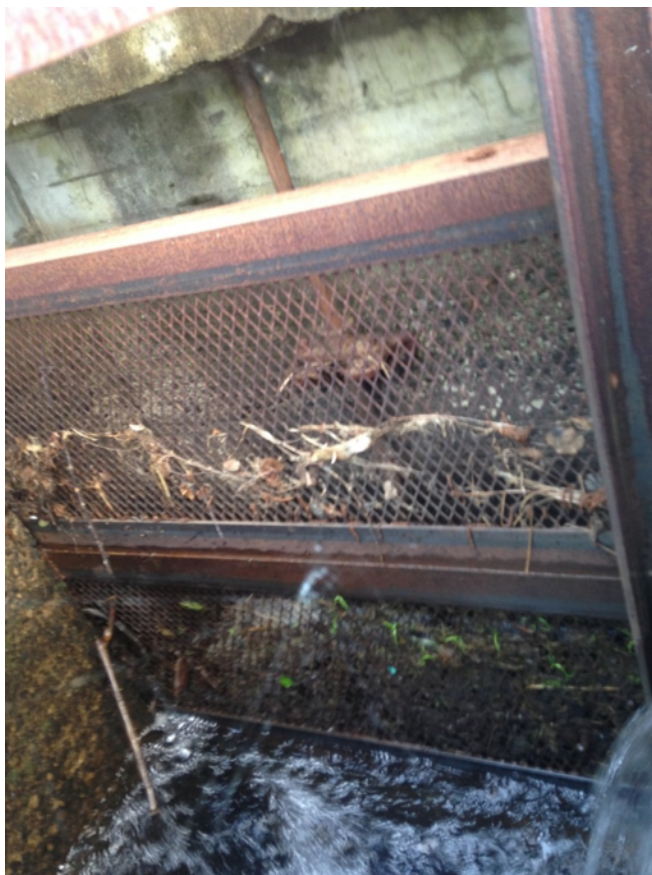
2015 – Debris on screen in Pool No. 6

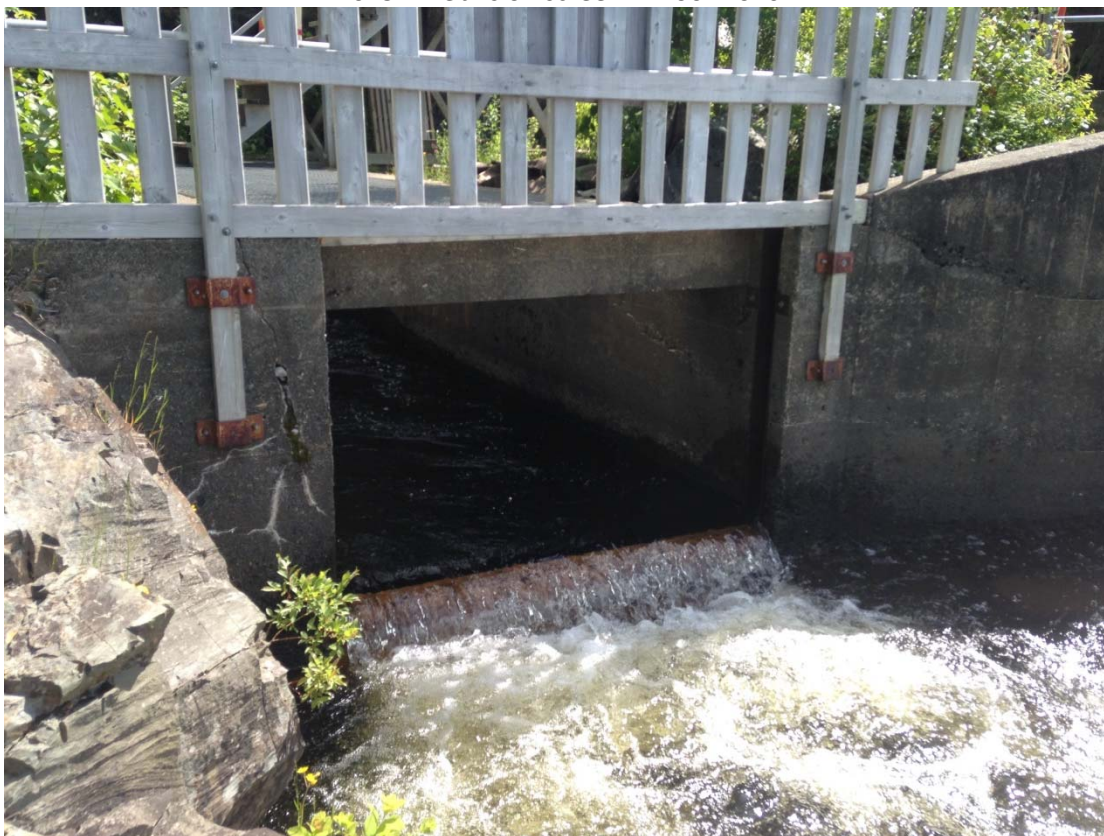
2015 – Inlet at Pool No. 1

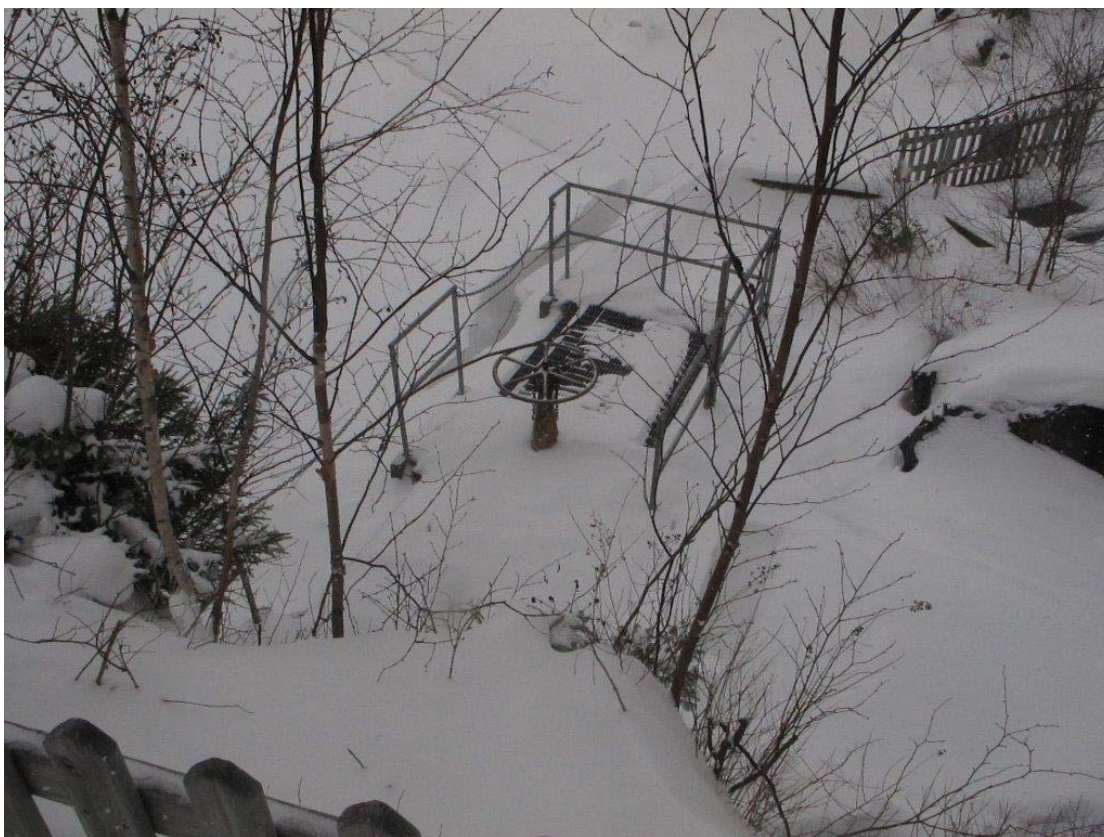
2015 – Fishway during winter, Pool No. 5 & 6

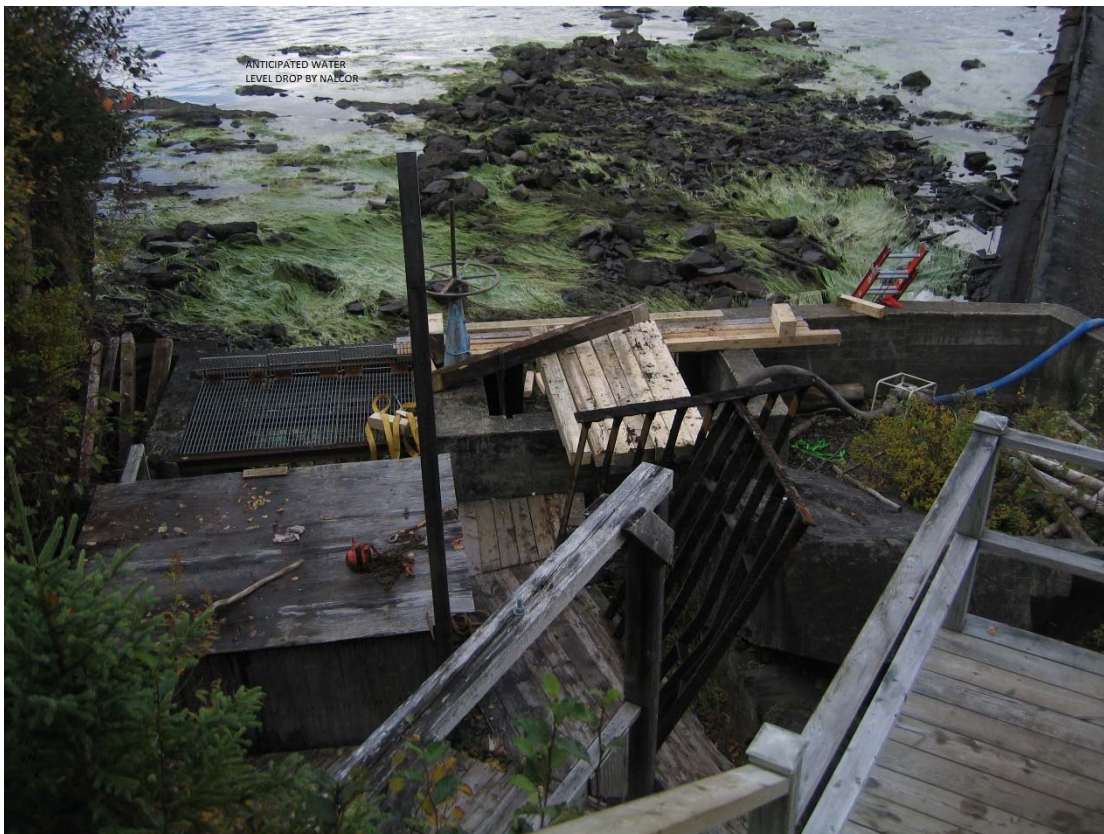
Water level dropped at entrance (Pool #5 & #6)

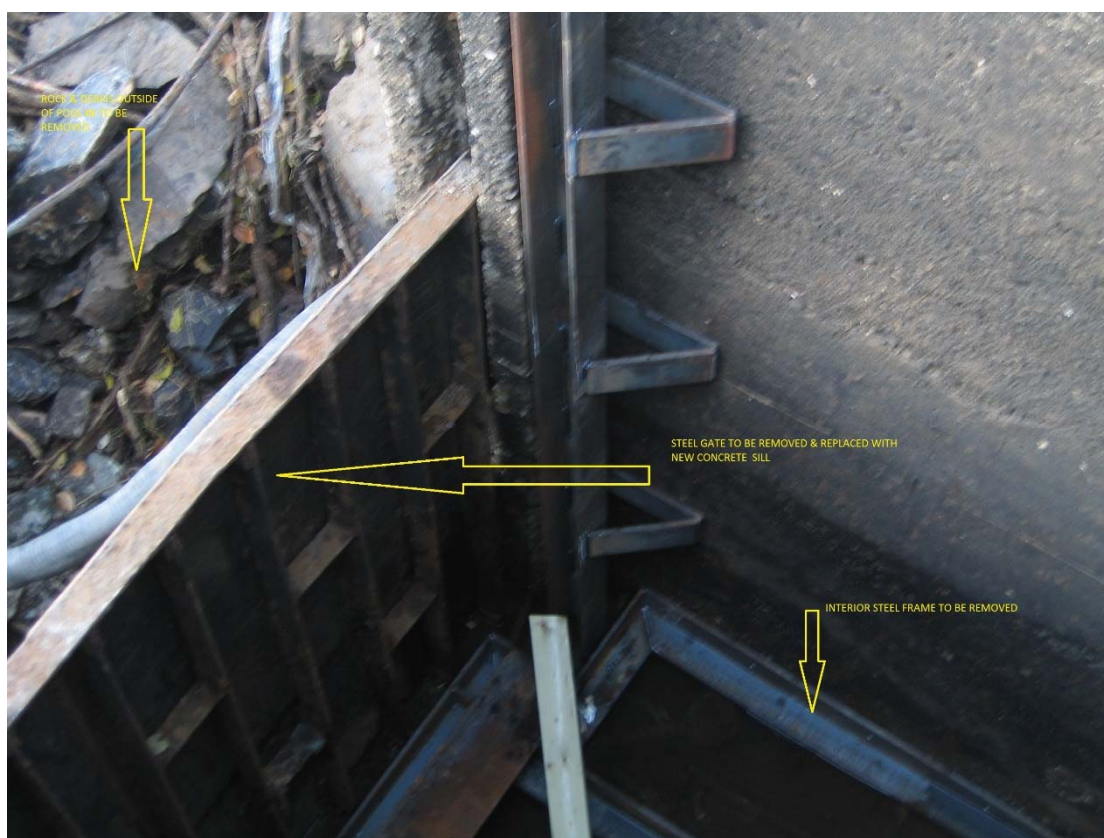
Steel sill wall, interior steel frame and rock & debris at entrance to Pool #6

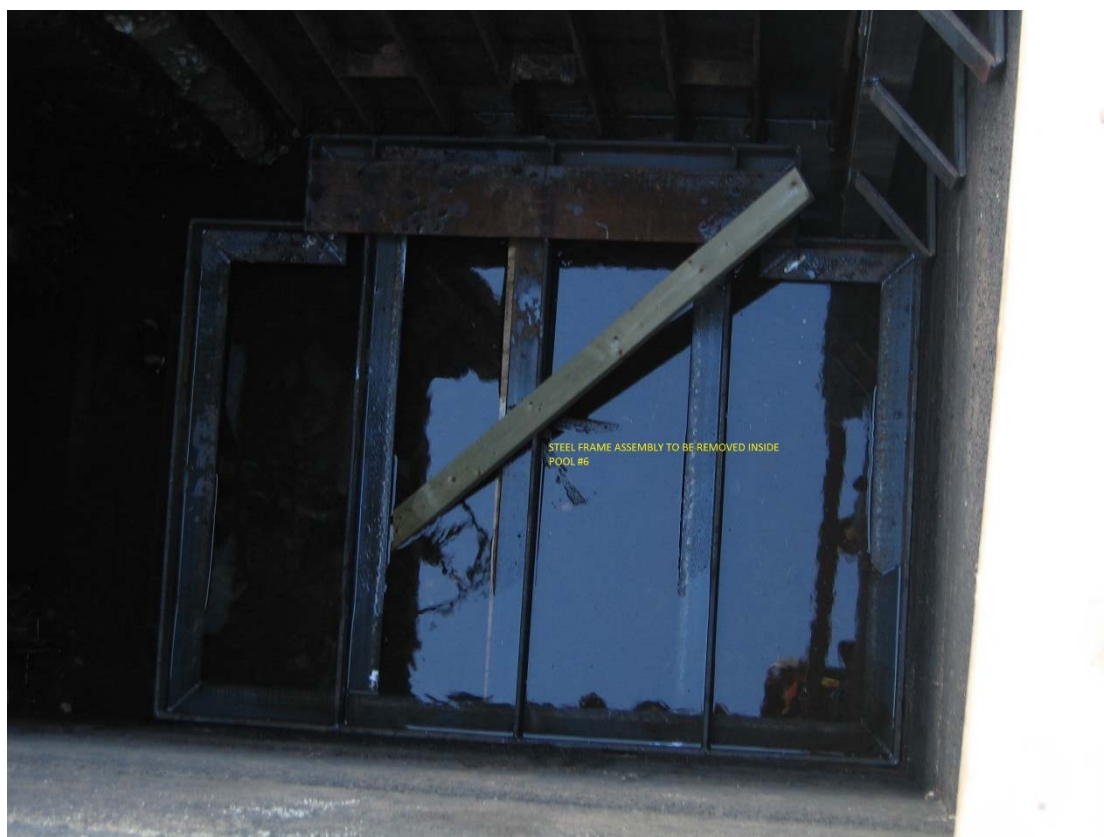
Steel frame assembly inside Pool #6

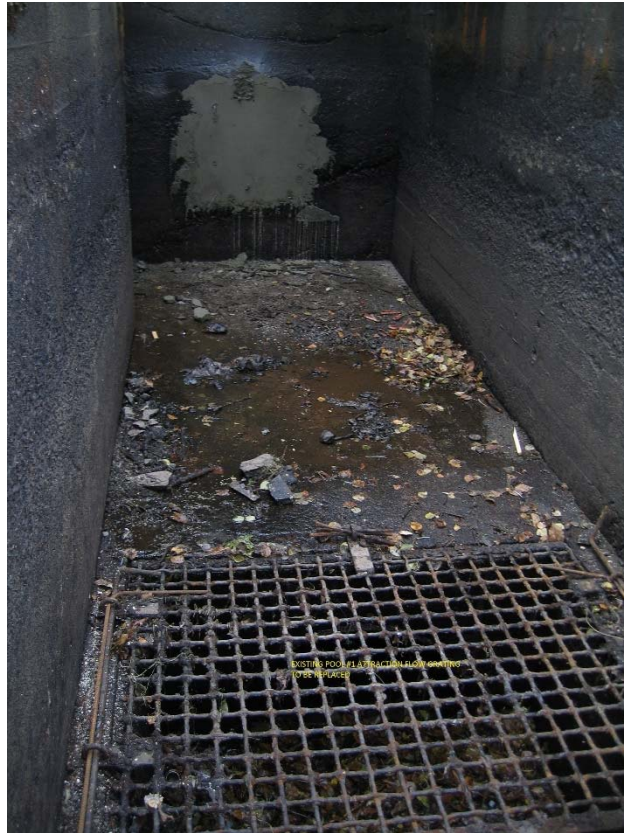
Attraction flow floor grating in Pool #1

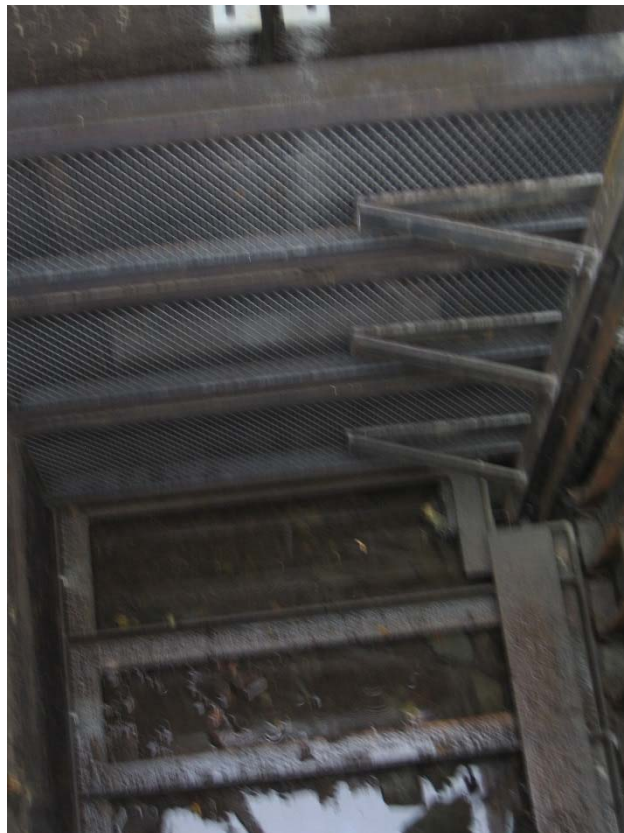
Screen replacement in Pool #6

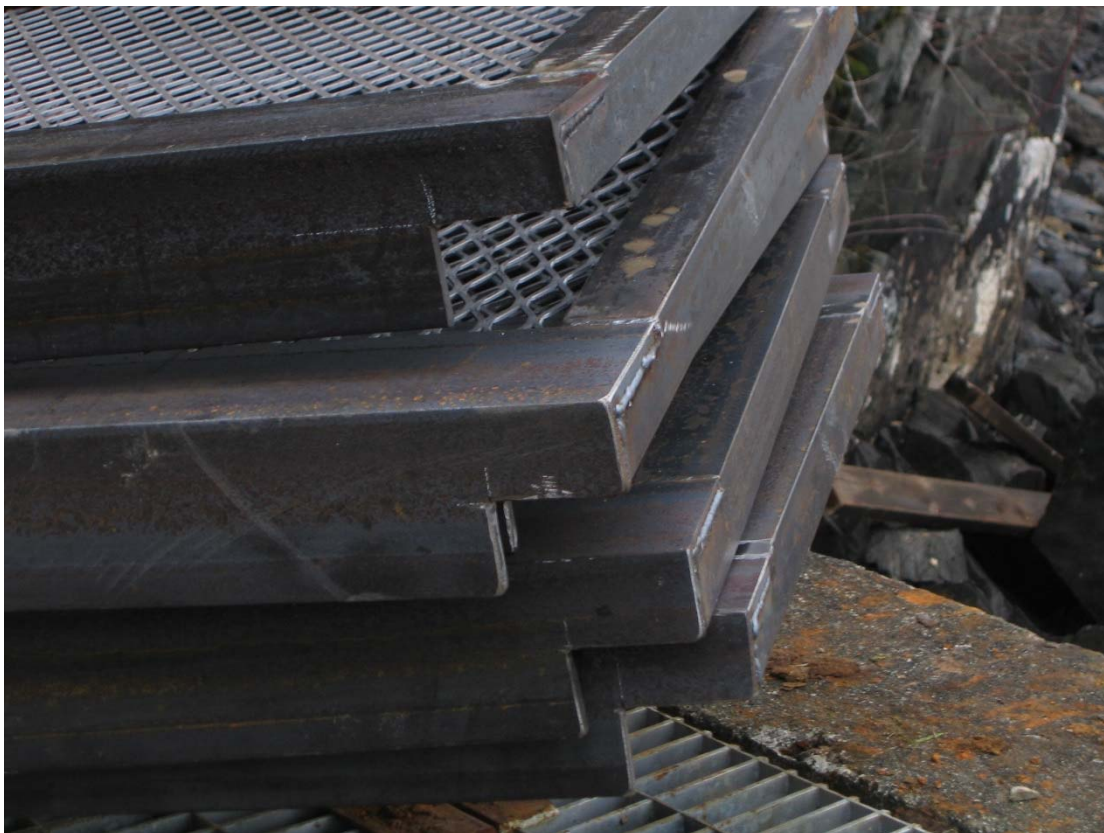
Existing screens for Pool #6
