**INTRUSIVE DESIGNATED SUBSTANCES AND
HAZARDOUS MATERIALS SURVEY OF CELL
BLOCK No.1**

**CORRECTIONAL SERVICE OF CANADA,
COLLINS BAY INSTITUTION,
KINGSTON, ONTARIO**

FINAL REPORT

February 4, 2008

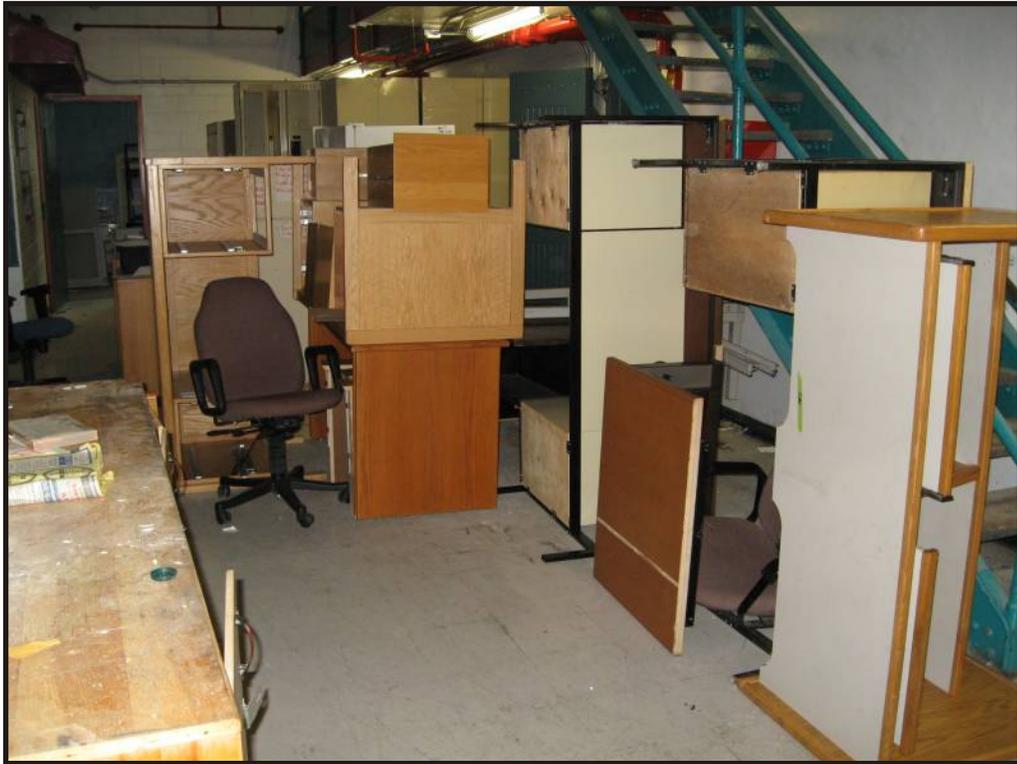
PHOTO 1: USED OFFICE FURNITURE IN ROOM 101 (img_2407.jpg)

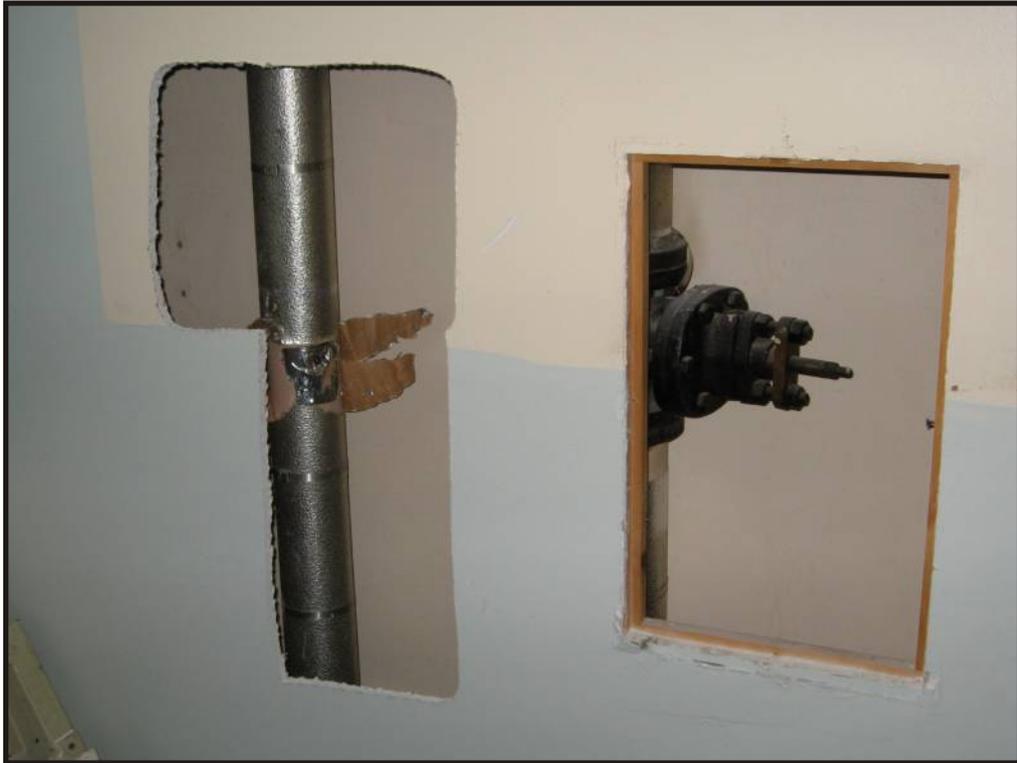
PHOTO 4: PIPE CHASE (INTERIOR) IN ROOM 104 (img_2339.jpg)

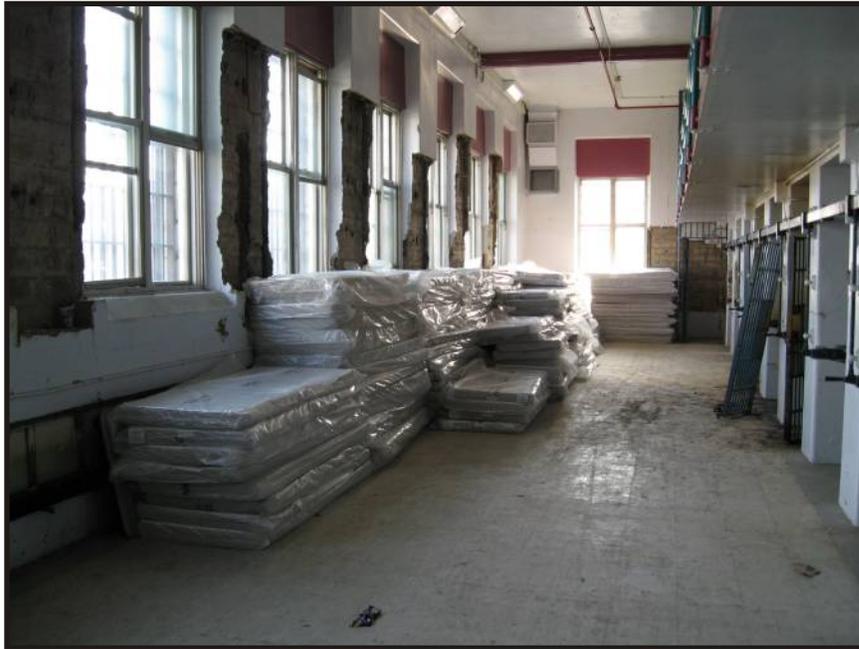
PHOTO 5: NEW MATTRESSES IN ROOM 107 (img_2404.jpg)

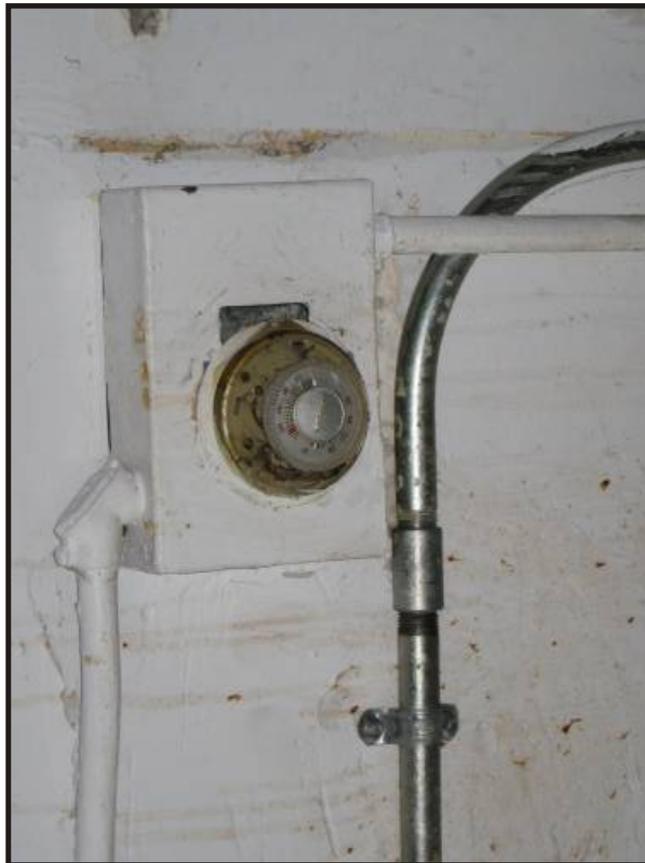
Mercury is present in Cell Block No. 1 in the form of fluorescent light tubes and a thermostat. There are approximately 387 fluorescent light tubes present in this building. In addition, one mercury-containing thermostat was observed in room 107. There are no regulatory requirements for the removal of mercury, however O. Reg. 347 regulates the disposal of mercury. All mercury-containing equipment should be recycled.

PHOTO 6: MERCURY THERMOSTAT IN ROOM 107 (img_2403.jpg)

Prior to demolition, the mercury-containing thermostat should be placed in a non-breakable container and then in a tightly sealed plastic bag (polyethylene), and contents labelled “mercury- containing thermostat”. If possible, the thermostat should be recycled through a thermostat recovery program (e.g. Honeywell's Take-Back Program) or disposed as a hazardous waste by a licensed hazardous waste disposal contractor. Common mercury waste (such as fluorescent lamps and thermostats) is not considered a subject waste under O. Reg. 347 as long it is destined for a mercury recovery facility. An MOE waste generator number and manifest would therefore not be required.

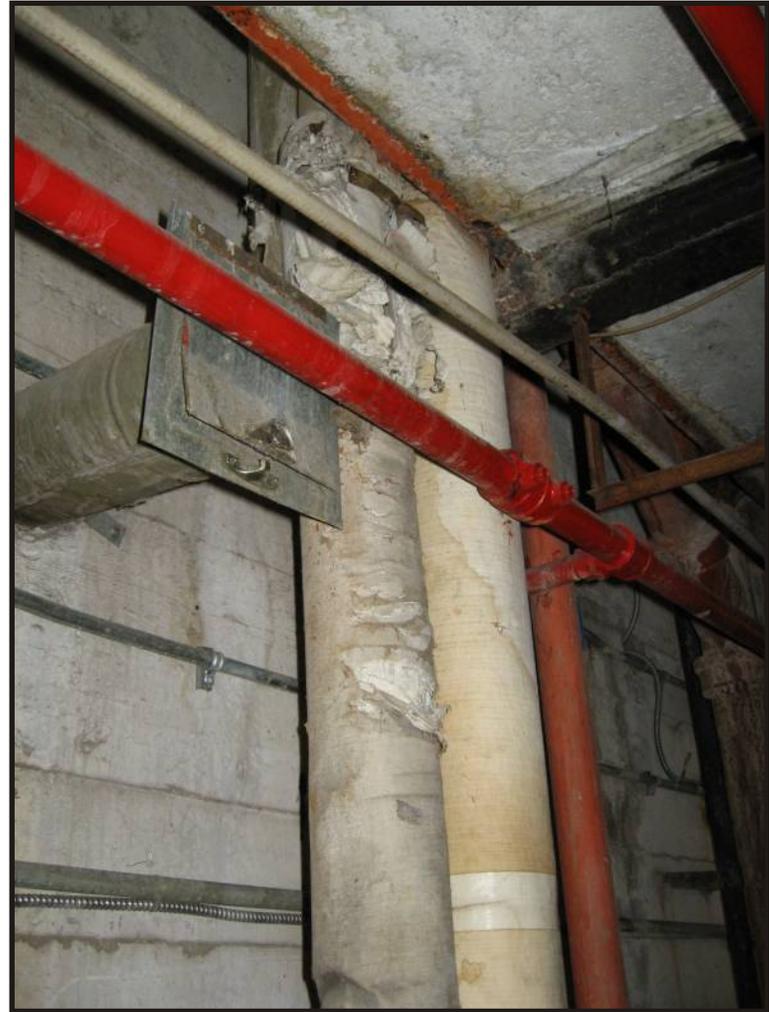
PHOTO 8: AIRCELL PIPE INSULATION (70% CHRYSOTILE) IN POOR CONDITION ROOM 108 (img_2416.jpg)

Asbestos in the form of pipe insulation (straight lengths, elbows), and vinyl floor tiles was identified in CBB1. Since CBB1 is scheduled for demolition, Action 3 removal is recommended regardless of accessibility/condition for all types of ACM. Estimated costs to remove all ACM in CBB1 is approximately \$95,000.

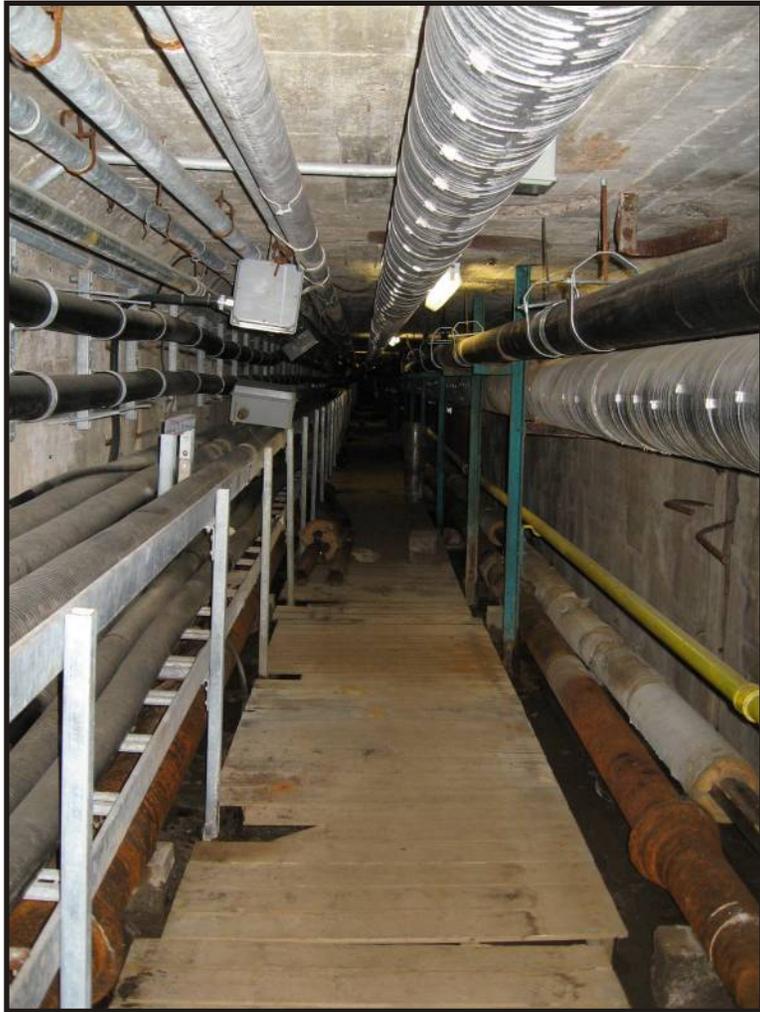
PHOTO 9: BASEMENT SERVICE TUNNEL TO CBC 3 ROOM B01 (img_1207.jpg)

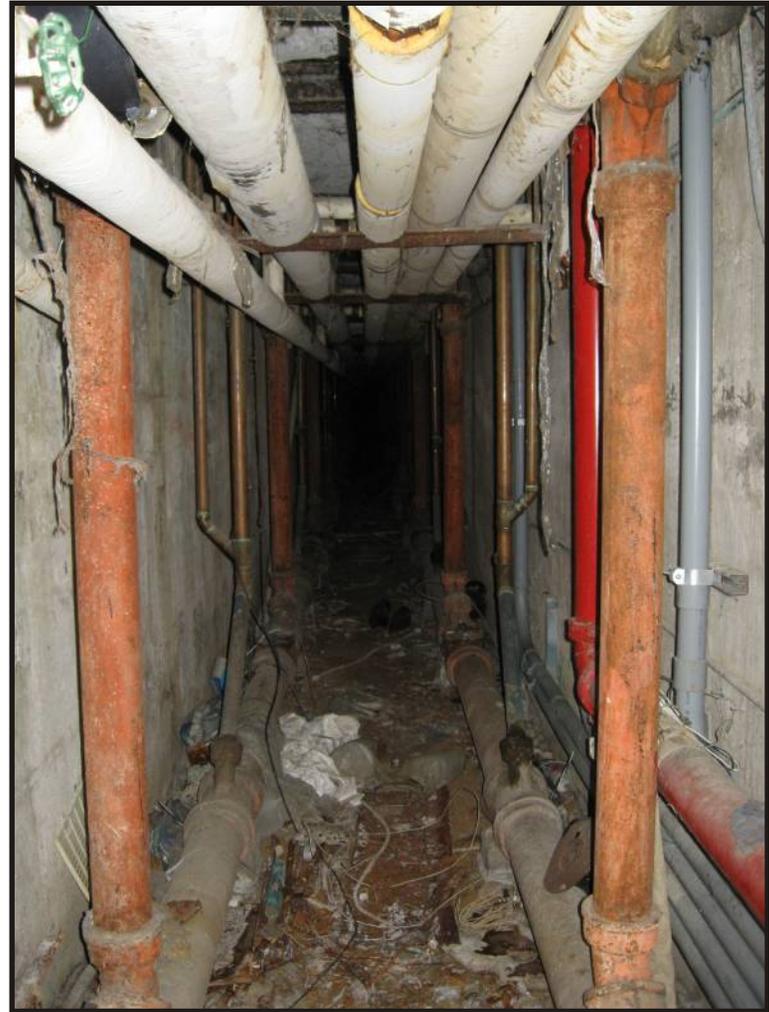
PHOTO 10: BASEMENT SERVICE TUNNEL (img_2423.jpg)
