TECHNICAL MEMORANDUM

SUBJECT: Structural Condition Assessment of the D Jetty Timber Fender System

This Technical Memorandum summarizes Klohn Crippen Berger's (KCB's) structural condition assessment of the D Jetty Fender System, completed in support of the Department of National Defence (DND) Colwood Jetties Remediation Project (CJRP), specifically addressing;

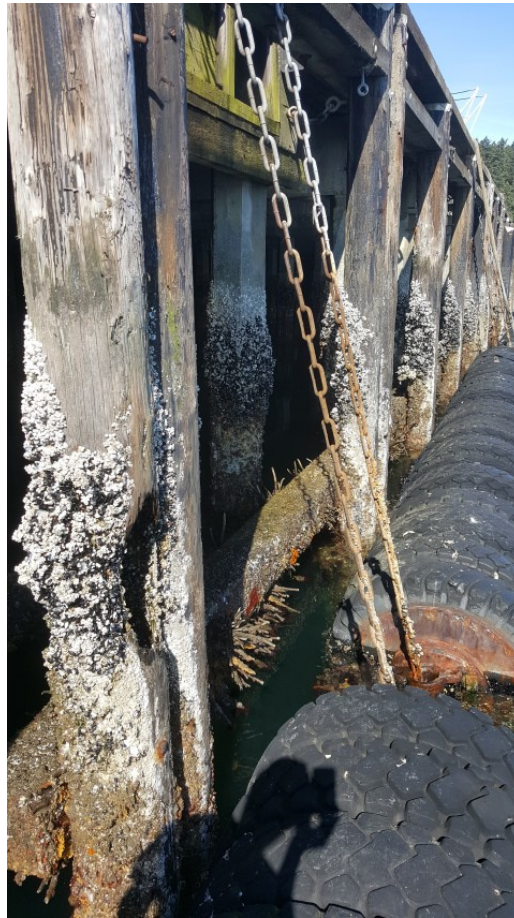
Photo 1: Rubbing pile missing, major section loss of fender pile

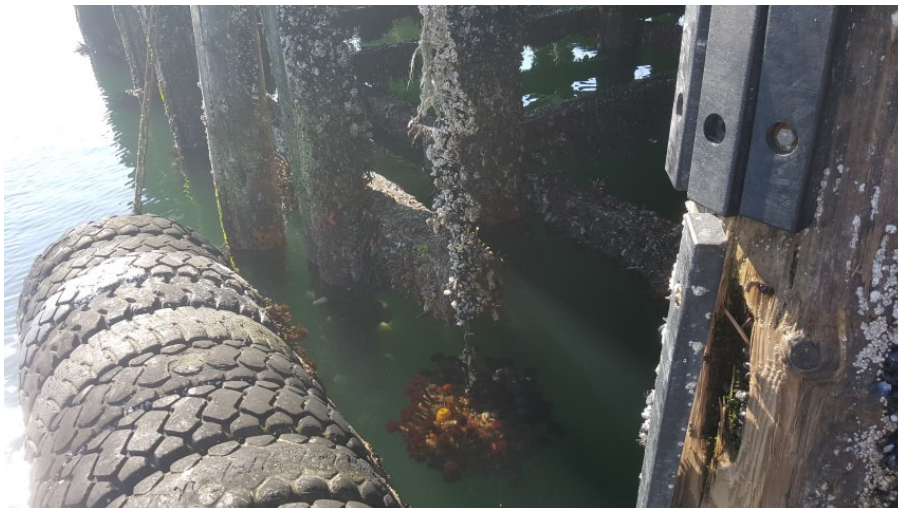
4. Pile groups along the western half of the North Berth were generally in good condition and appeared suitable for re-use.
5. The North Berth lower water beam was noted as missing between pile groups 4-6.

Photo 2: Lower waler missing at North Berth – Pile Group 3, abrasion damage, rubbing strip partially dislodged

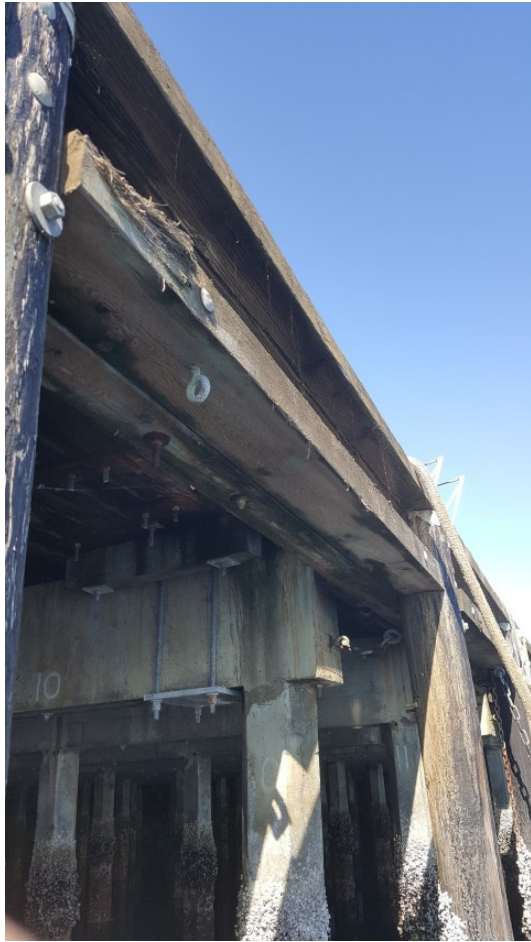
Photo 3: Minor damage to chock beam

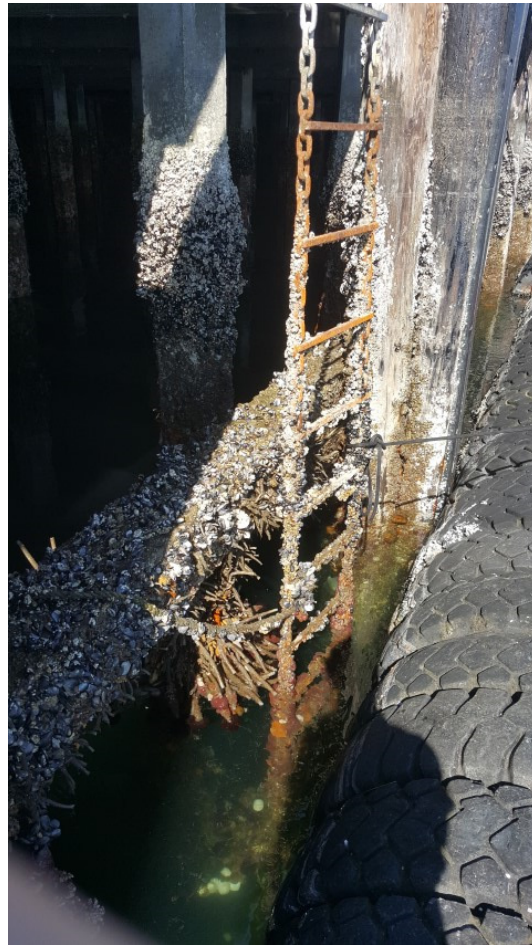
Photo 4: Heavy marine growth

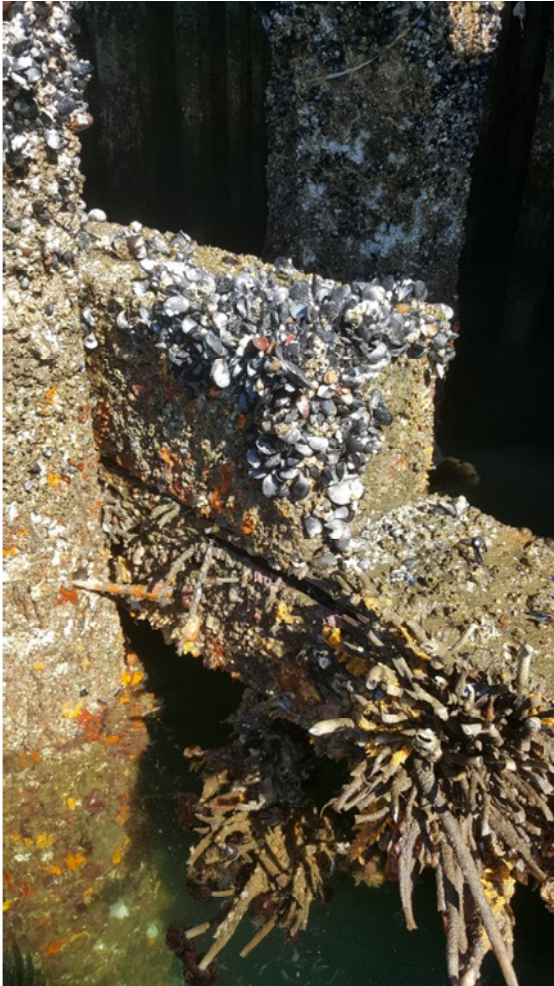
Photo 5: Longitudinal cracking in lower water

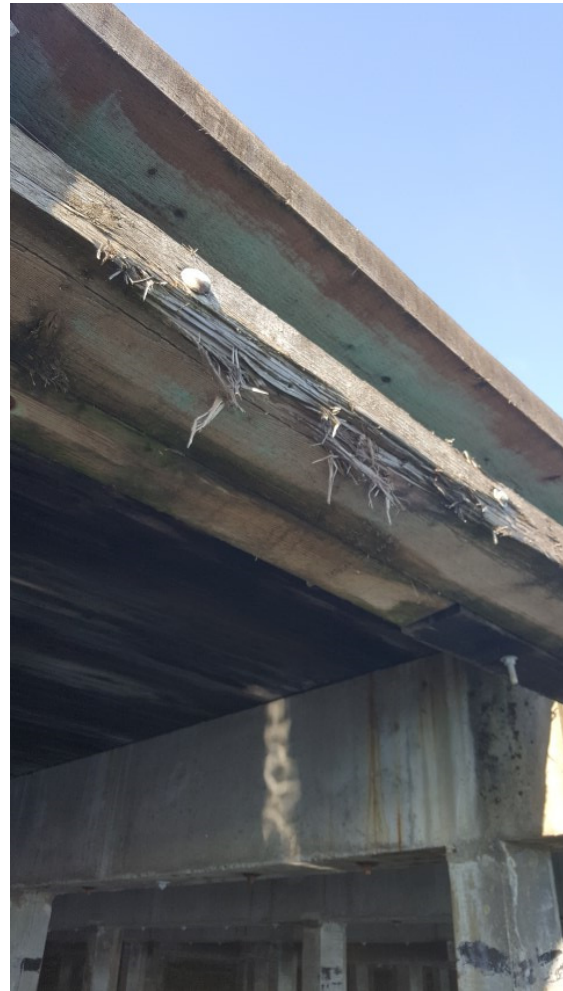
Photo 6: Abrasion damage on timber chock beam

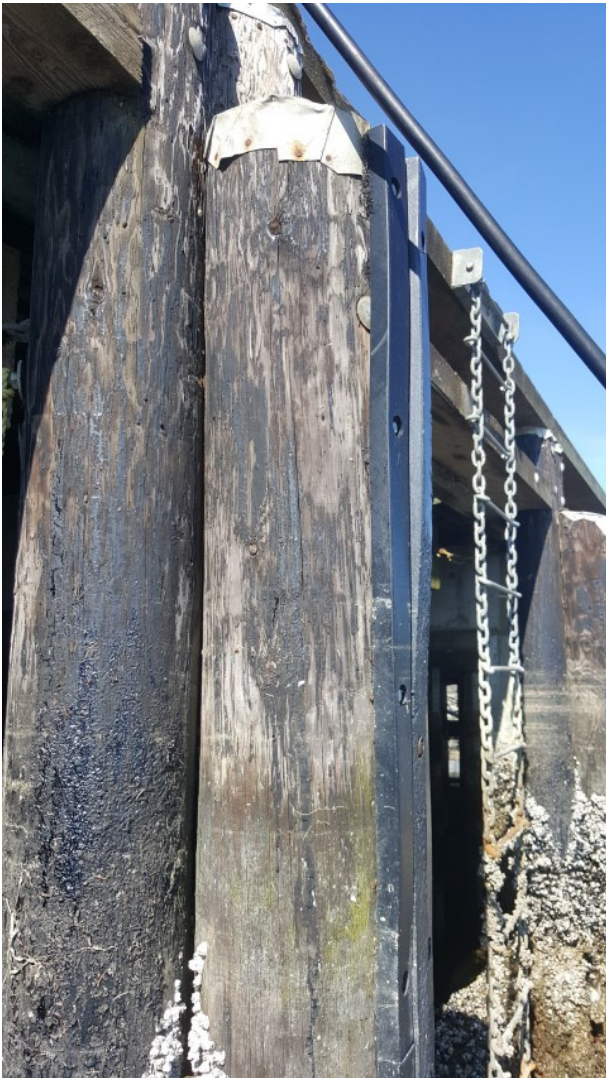
Photo 3: Fender pile in excellent condition

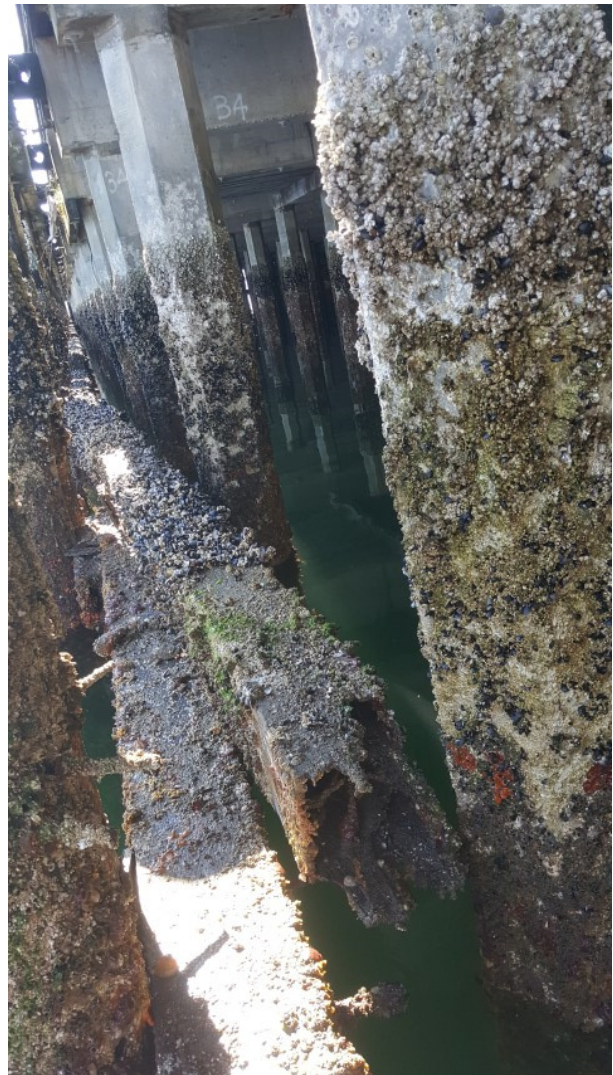
Photo 4: Broken lower waler at North Berth

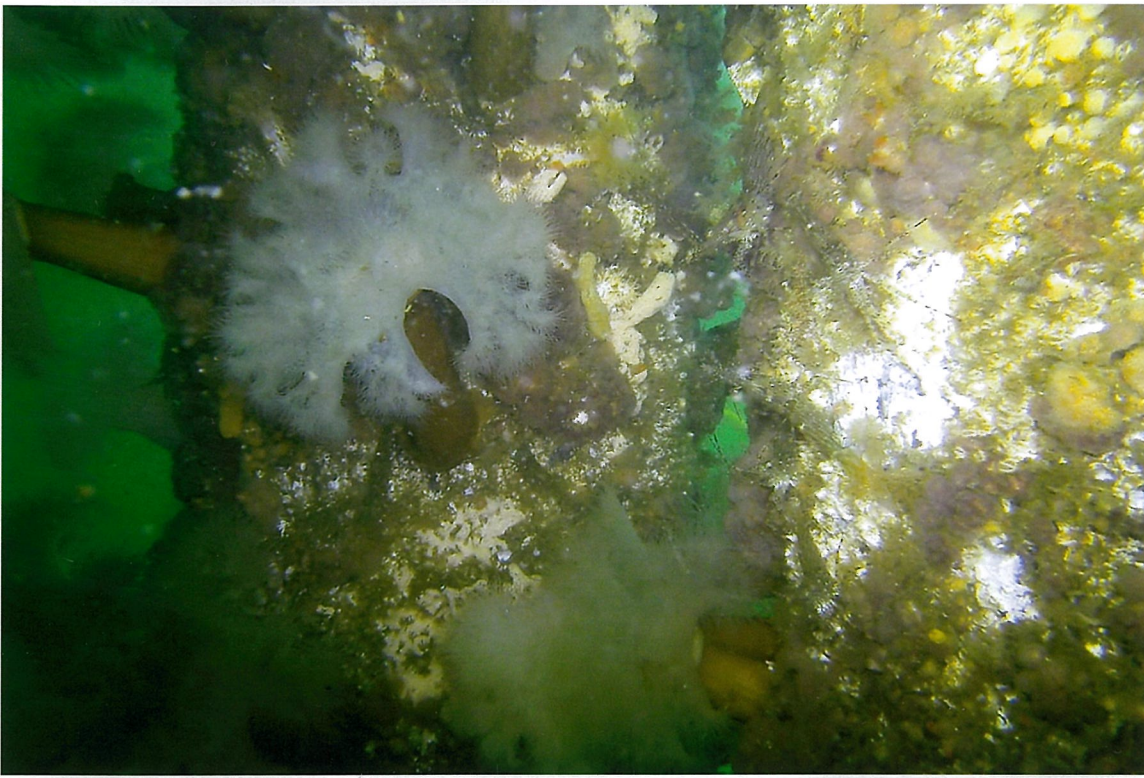
GENERAL CONDITION VIEWS OF EXTENT OF MARINE GROWTH ON PILES

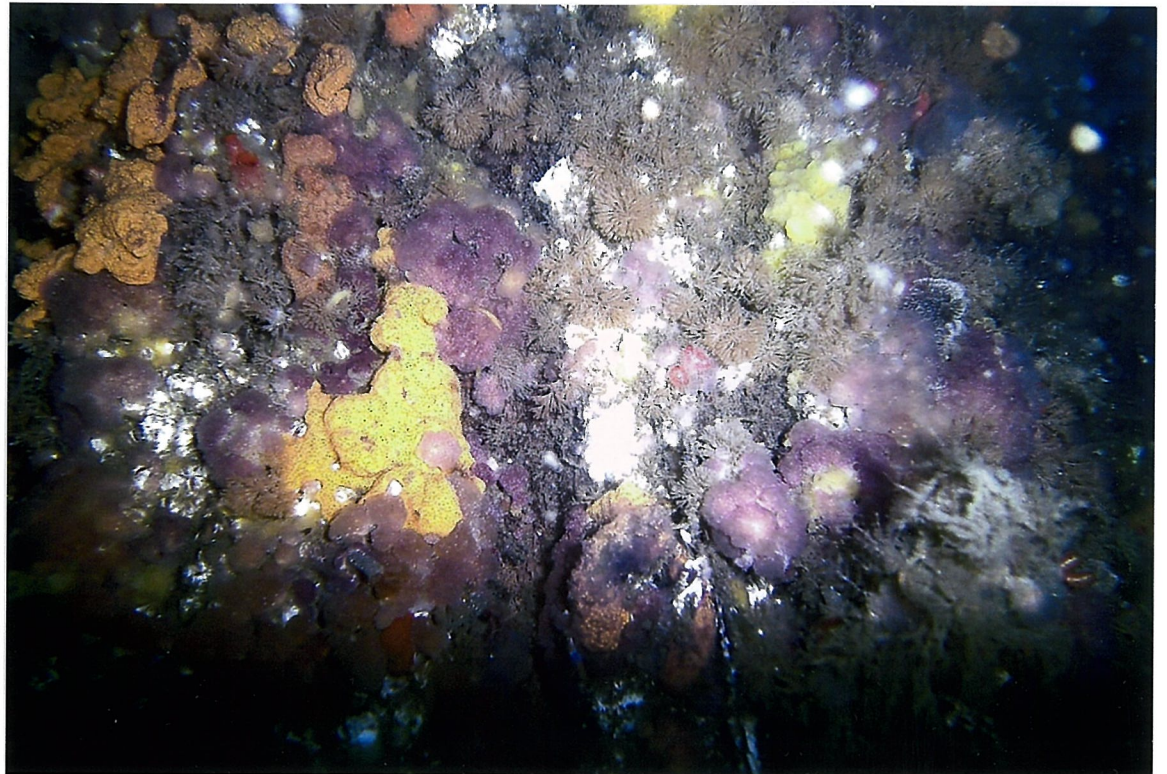
PILE GROUP 15 PILE #1 DAMAGE

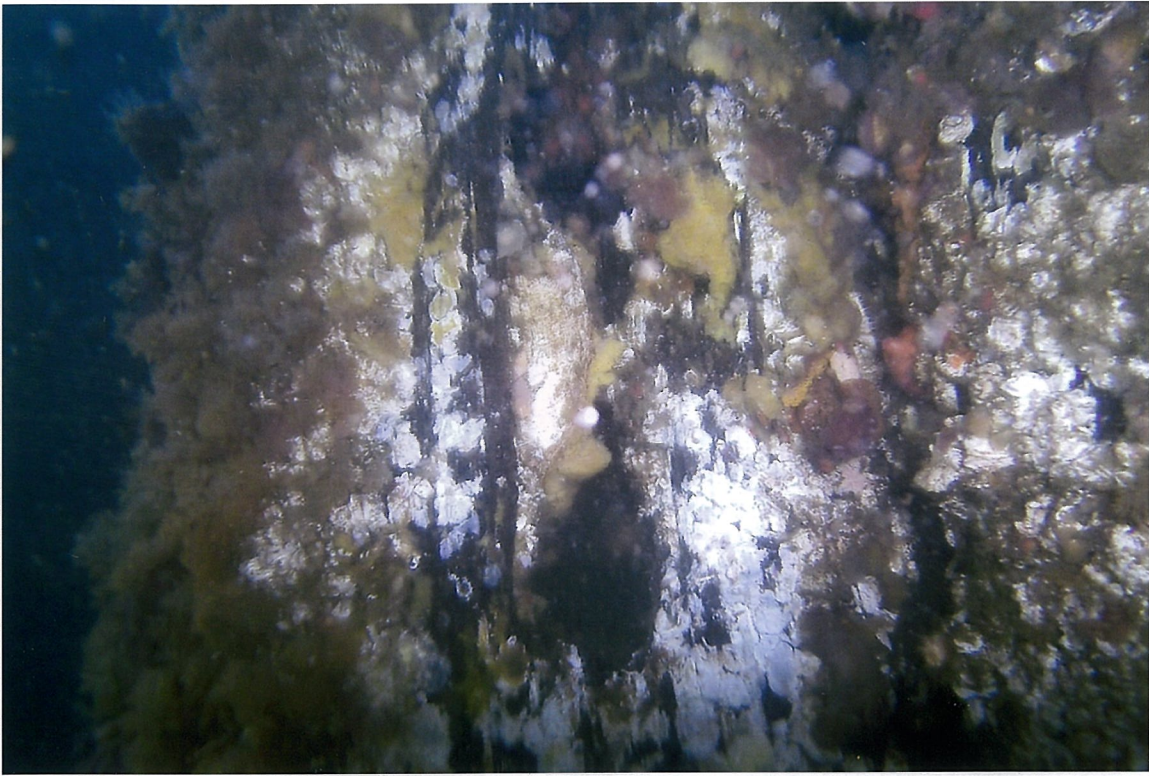
PILE GROUP 16 RUBBING POLE DAMAGE

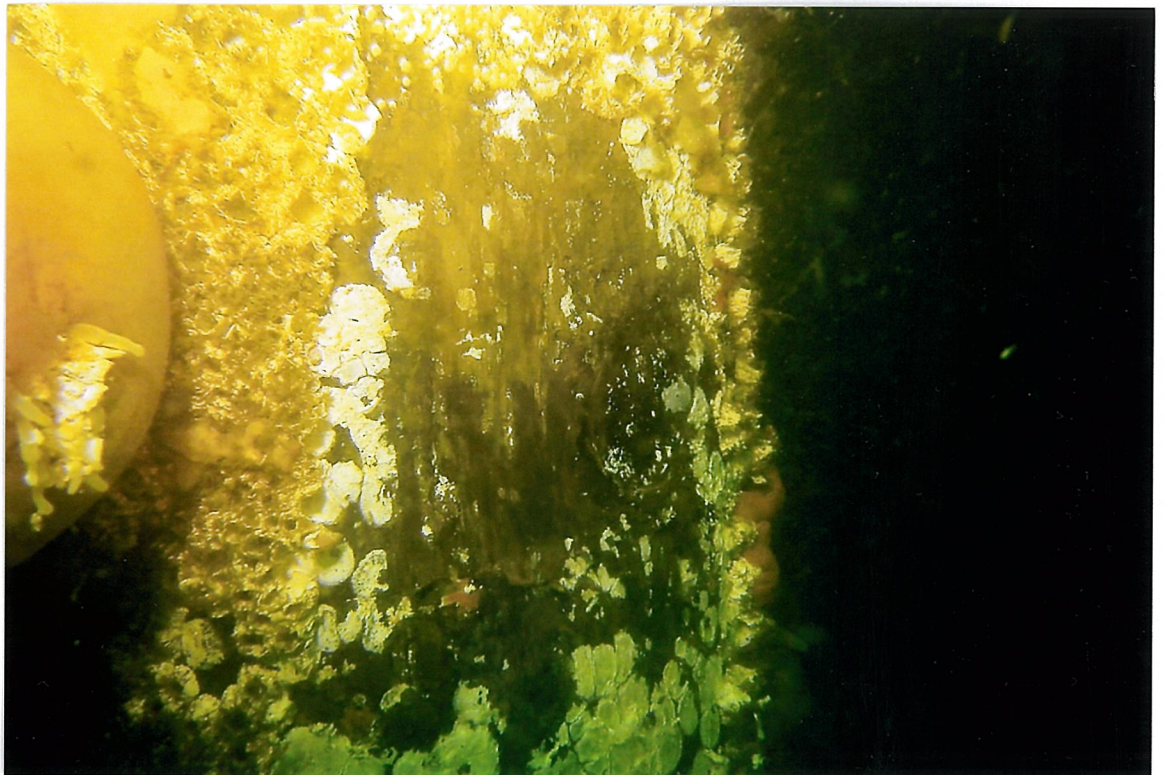
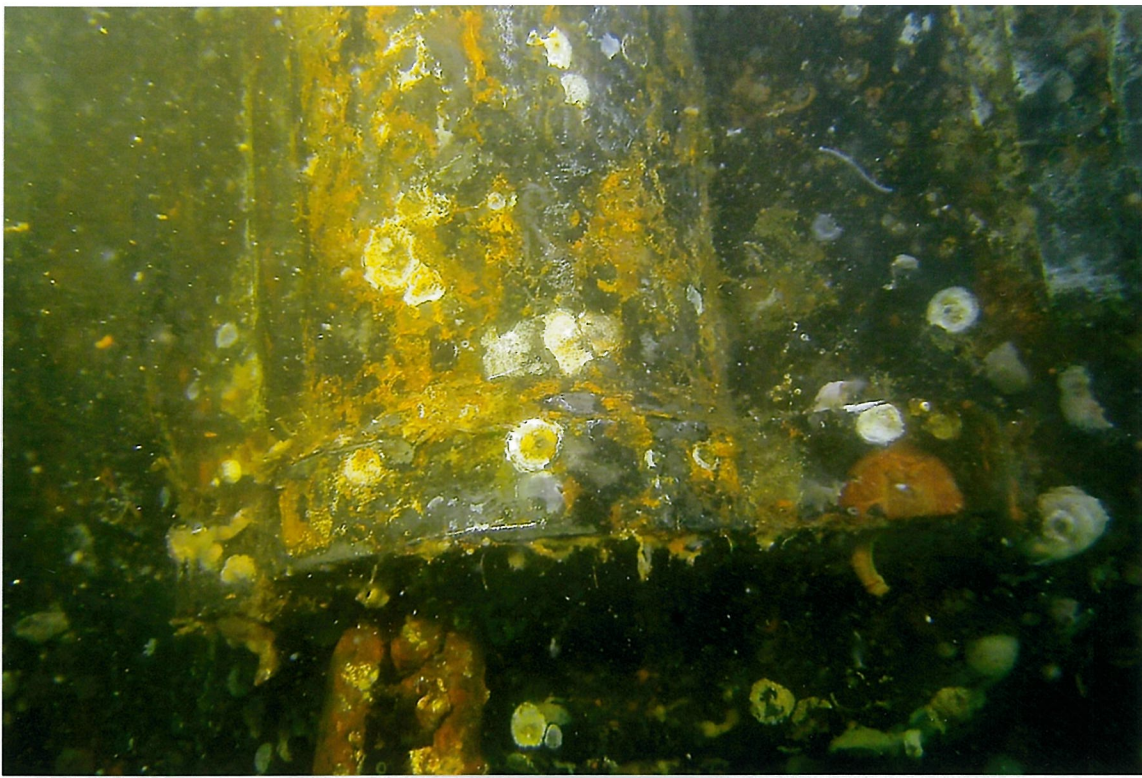
TREE SAVER STEEL CHAIN GUIDE CONDITION AFTER CLEANING
AND VIEW OF DEPLETED BAR ANODE

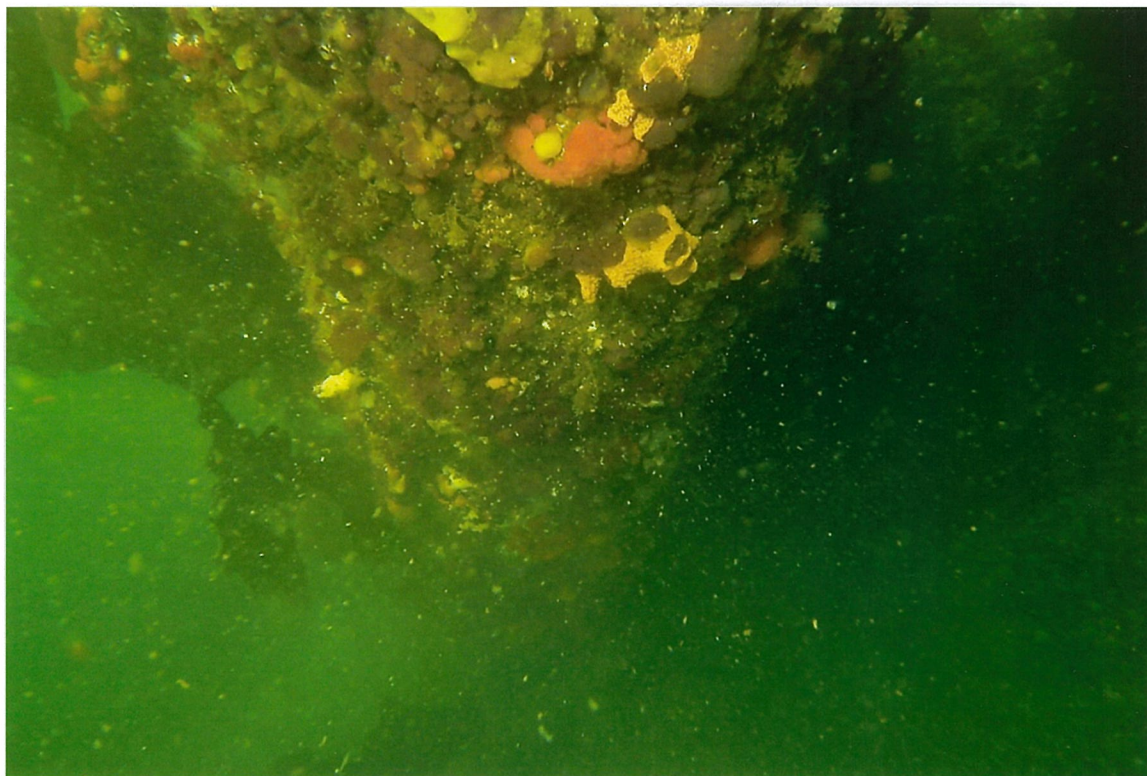
PILE GROUP 17A PILE #1 SEVERED PILE

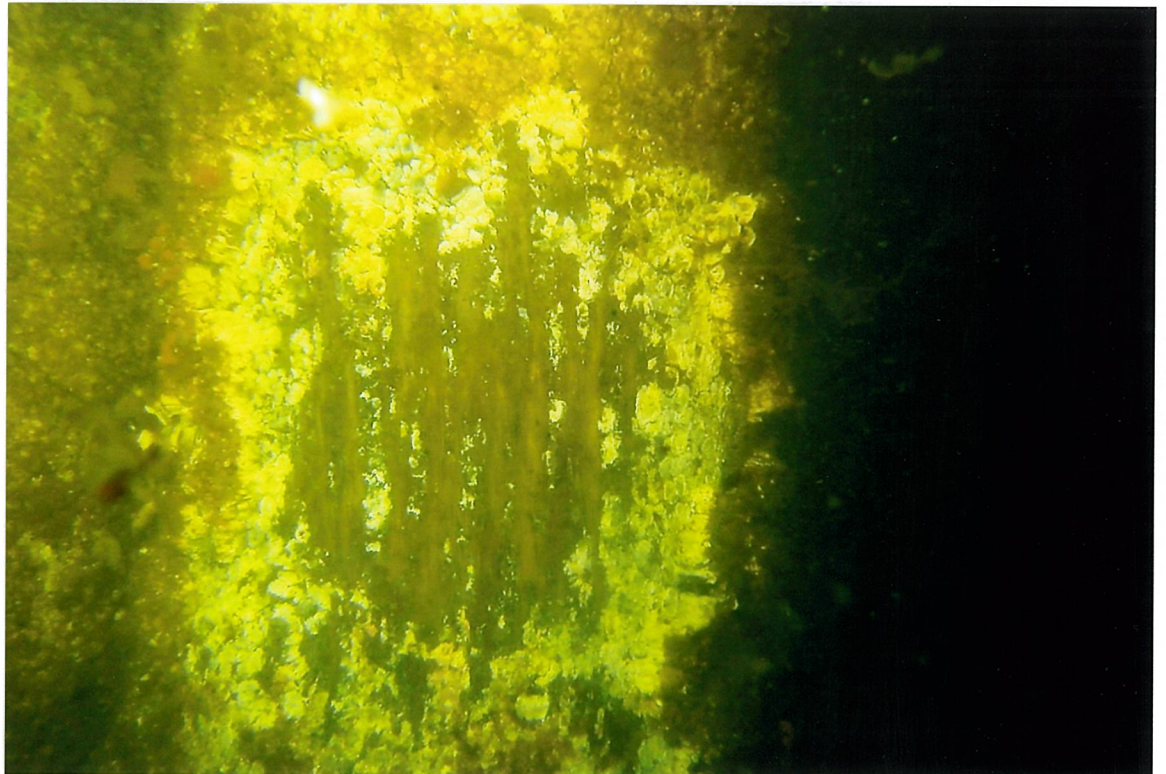
PILE GROUP 21A PILE #2 HOLE

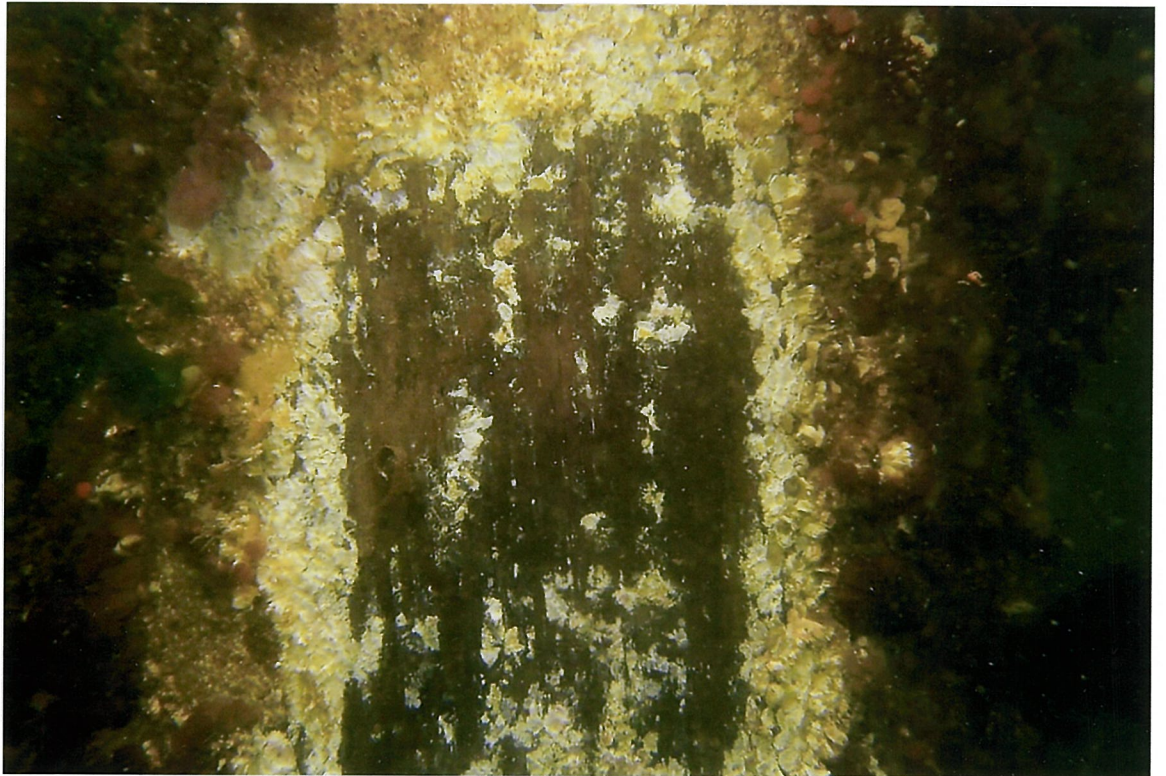
PILE GROUP 55A PILE 25 HOLLOWED AT GROUND LEVEL

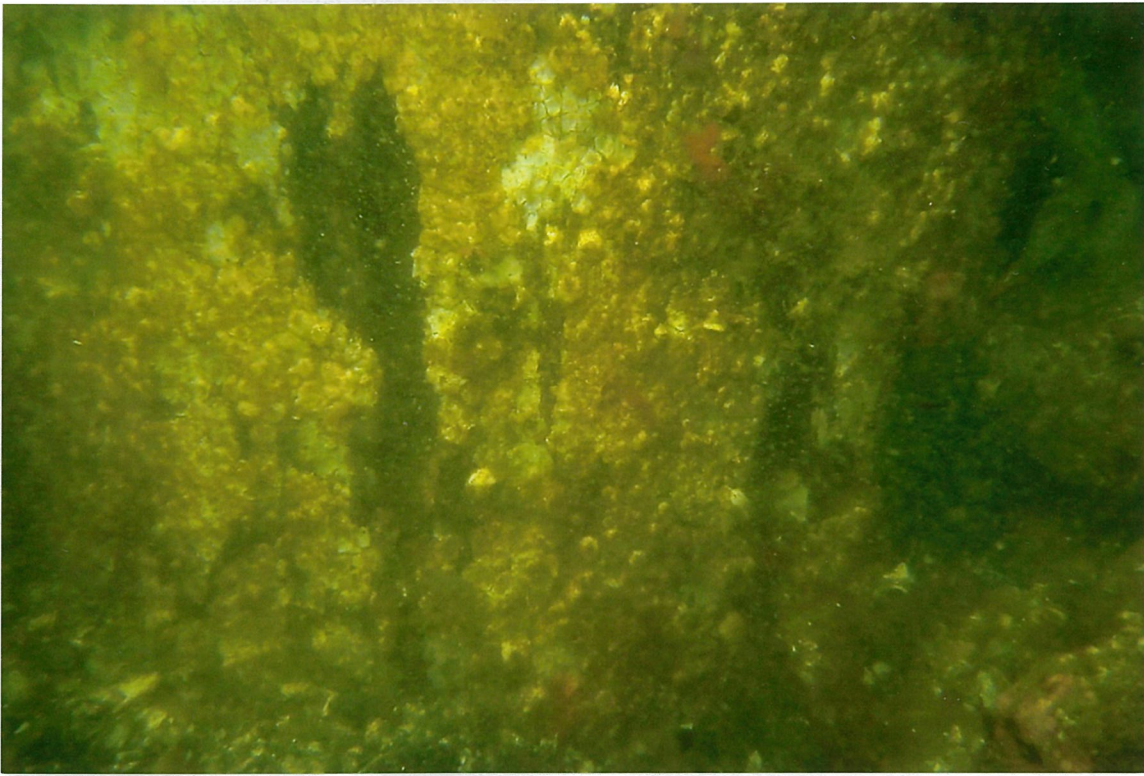
PILE GROUP 55A RUBBING POLE HOLLOWED OUT HOLE

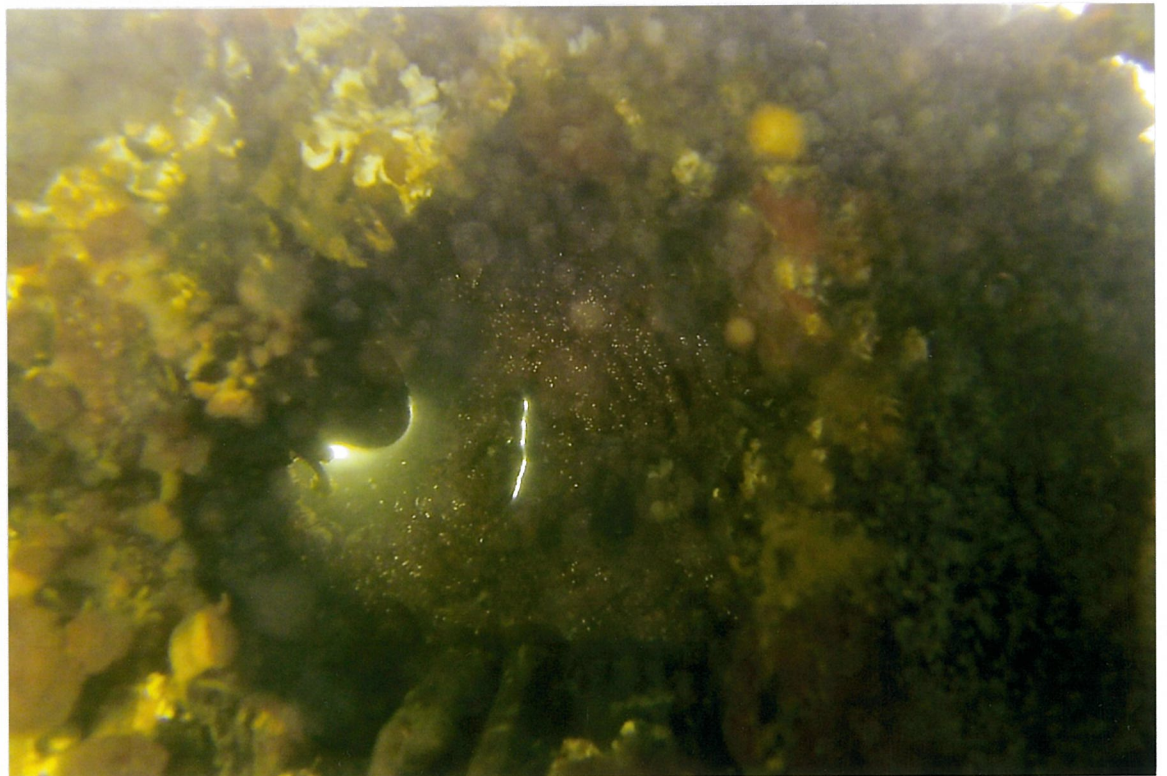
EXTENT OF MARINE GROWTH ON CAMEL FENDERS
