Preliminary Building Envelope, Structural and Space Optimization Study
Canadian Chancery,
Nairobi, Kenya

Final Submission
June 25th, 2013

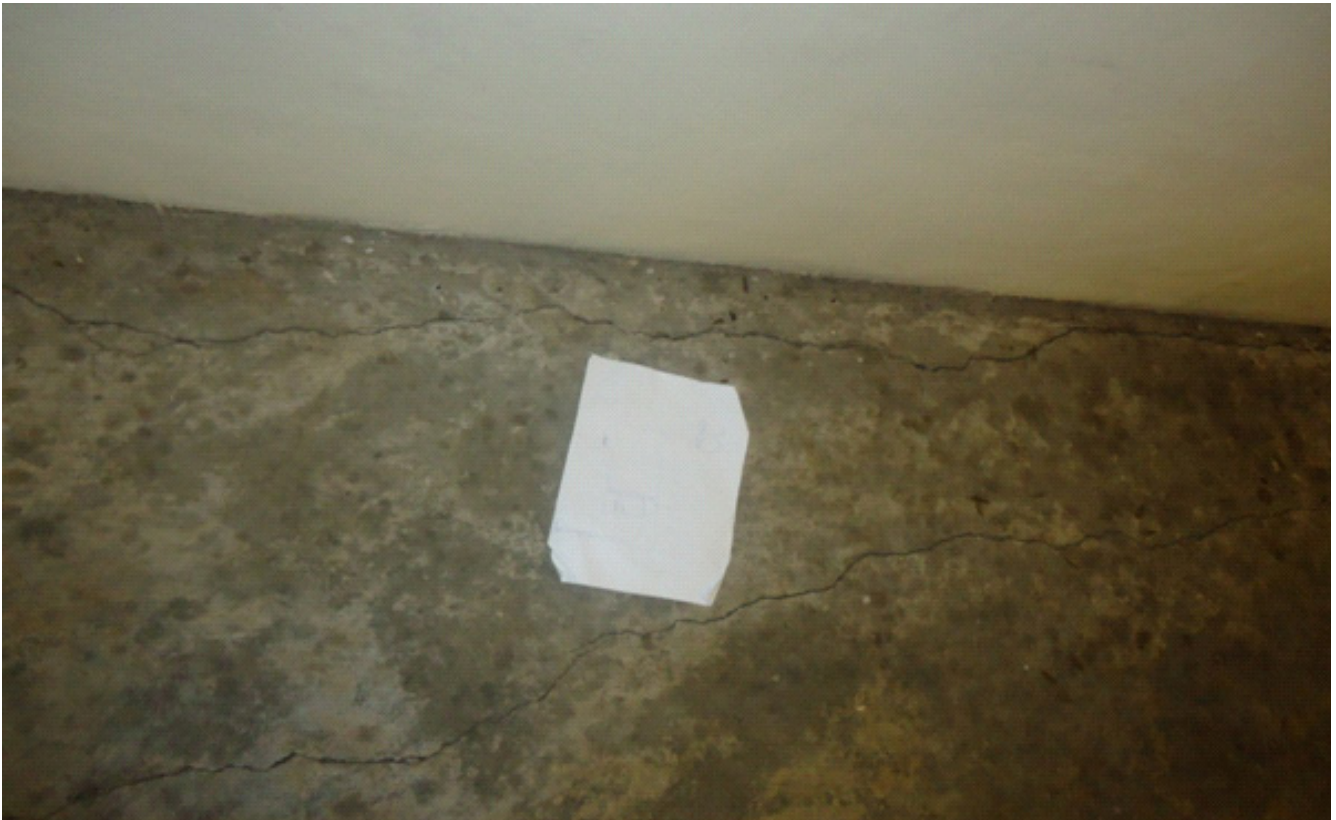
S-1: Cracks on Basement floor slab

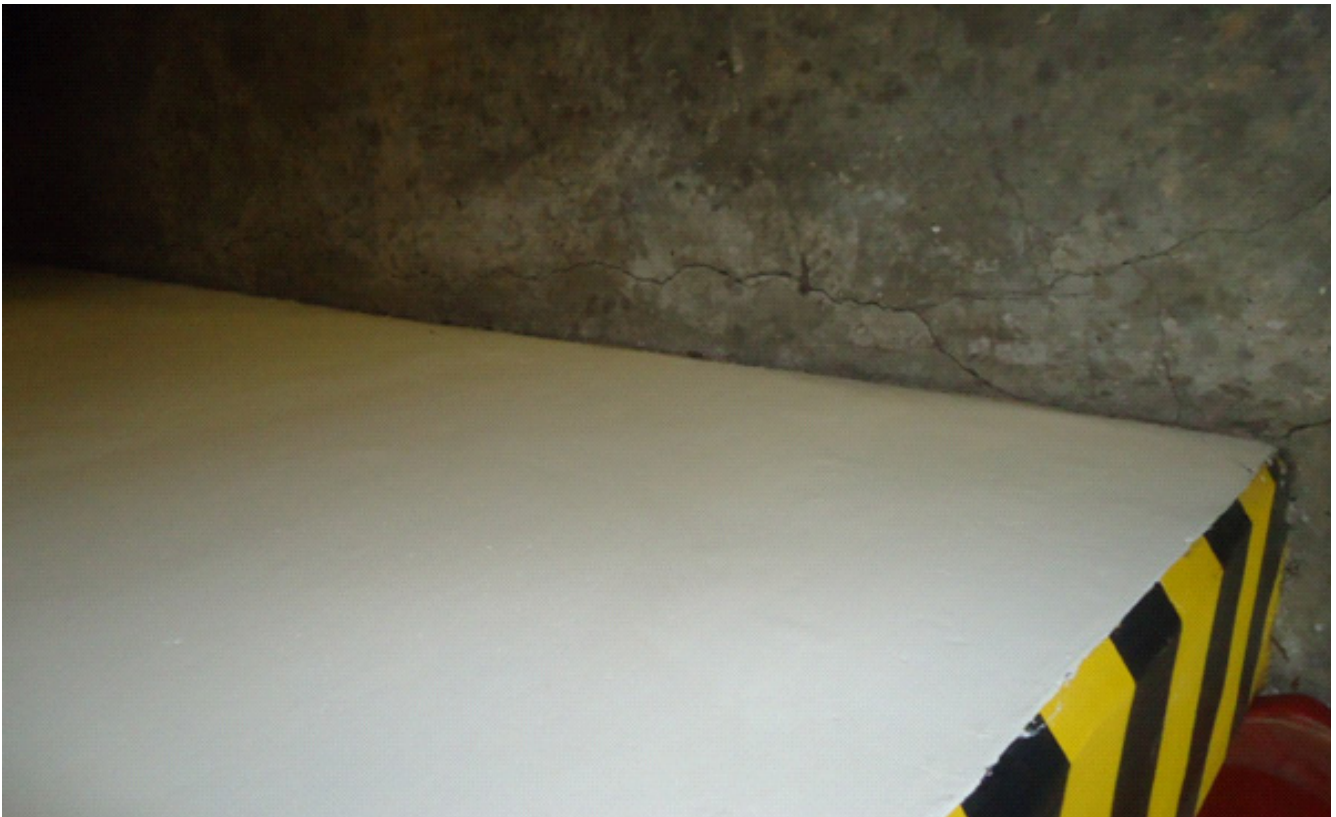
S-2: Cracks on Basement floor slab

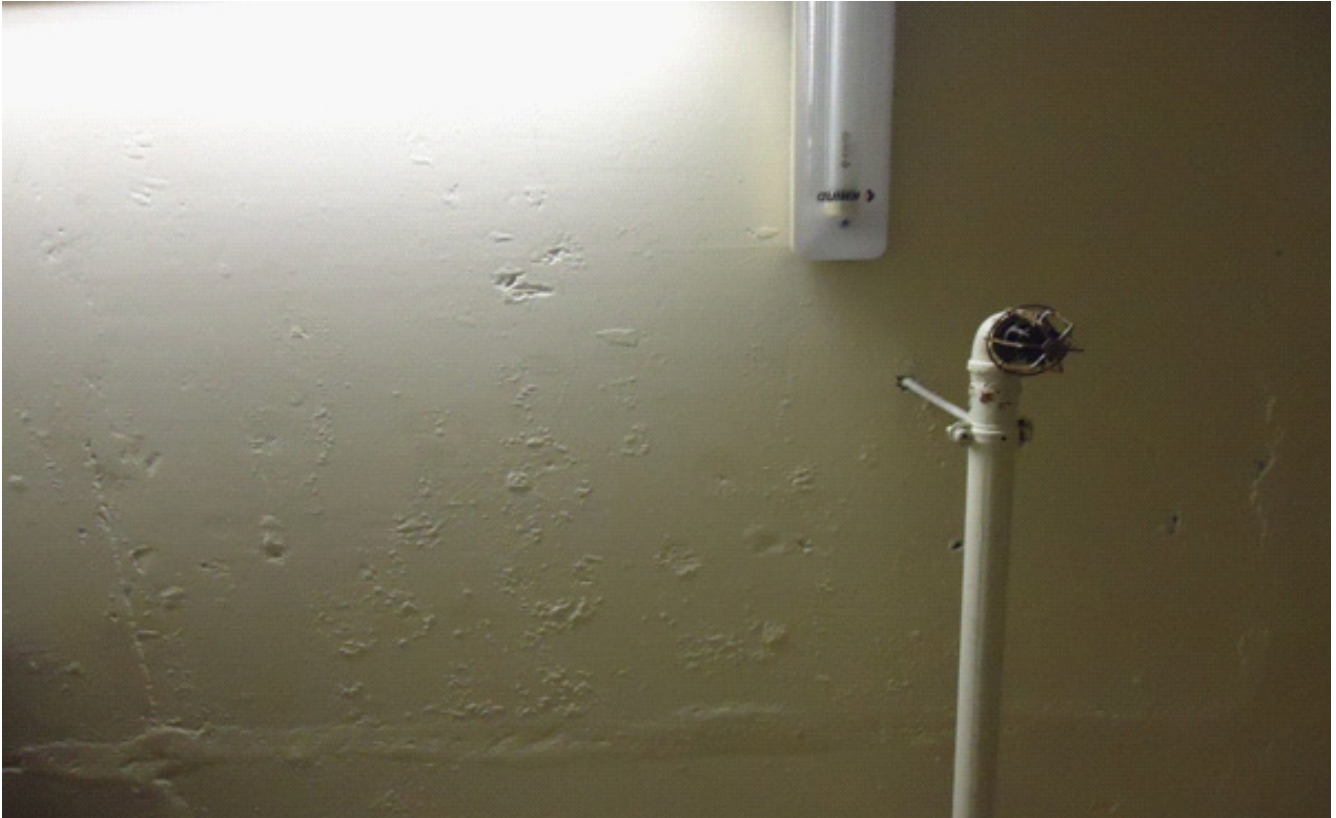
S-3: Spalling on slab soffit below swimming pool

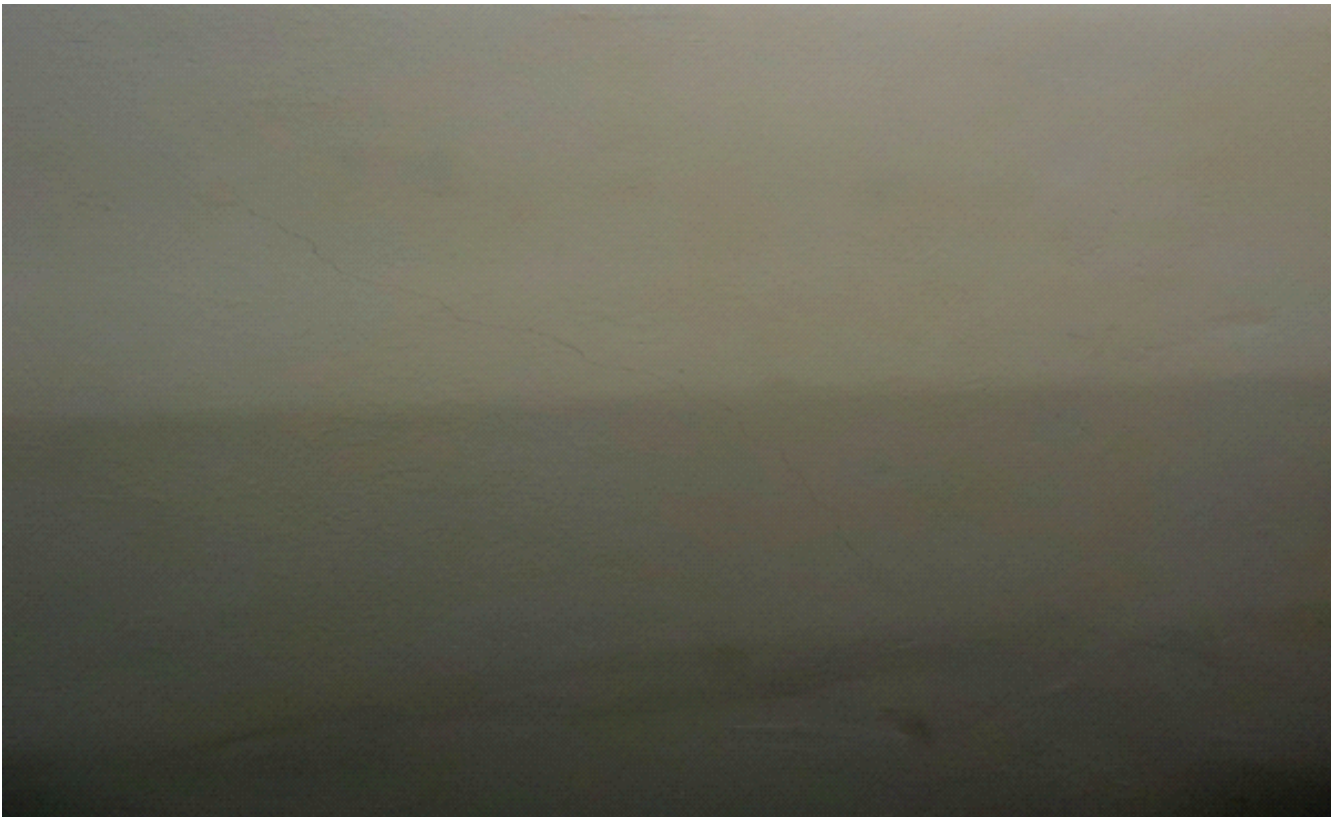
S-4: Vertical Crack on Retaining wall in sub-basement Electrical Room
Cracks on Basement floor slab

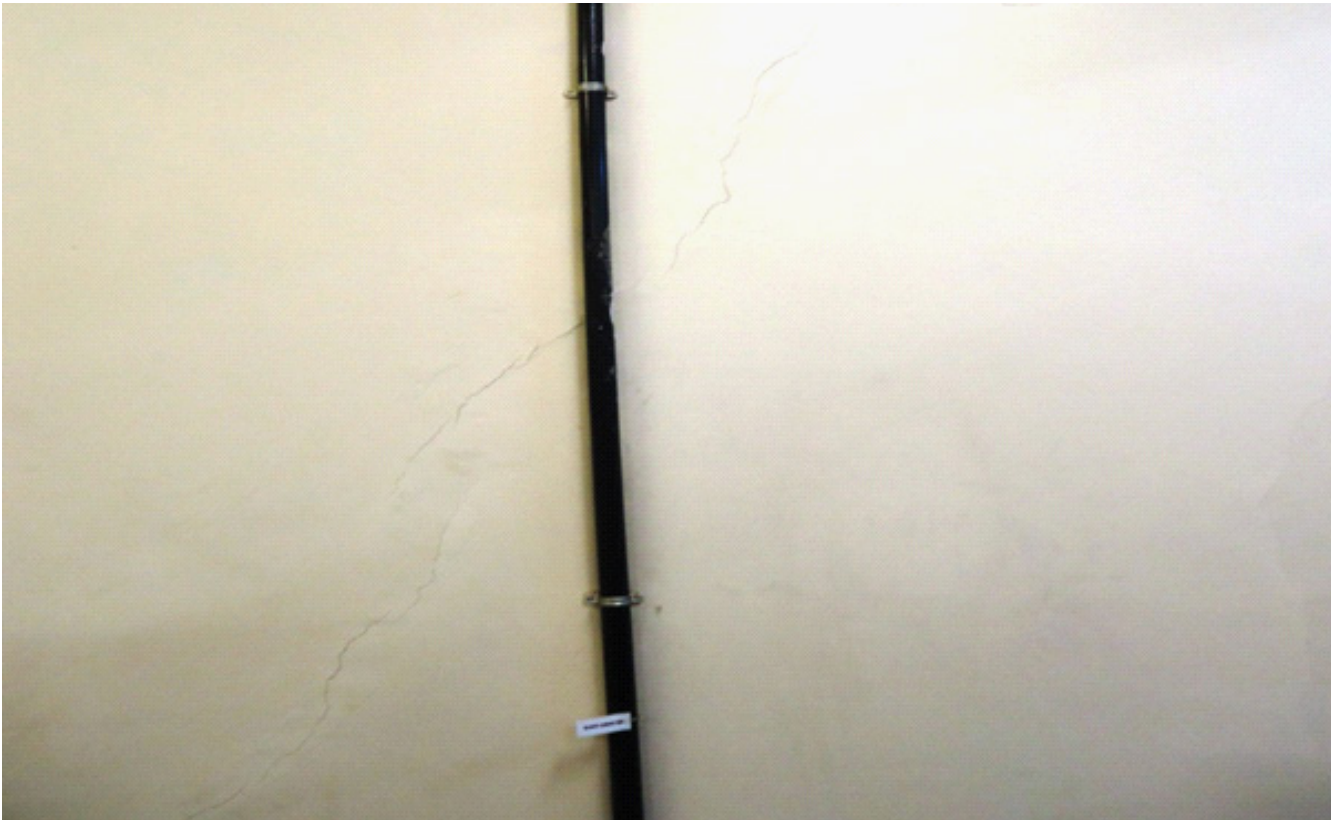
S-5: Vertical Crack on Slab soffit in sub-basement Electrical Room

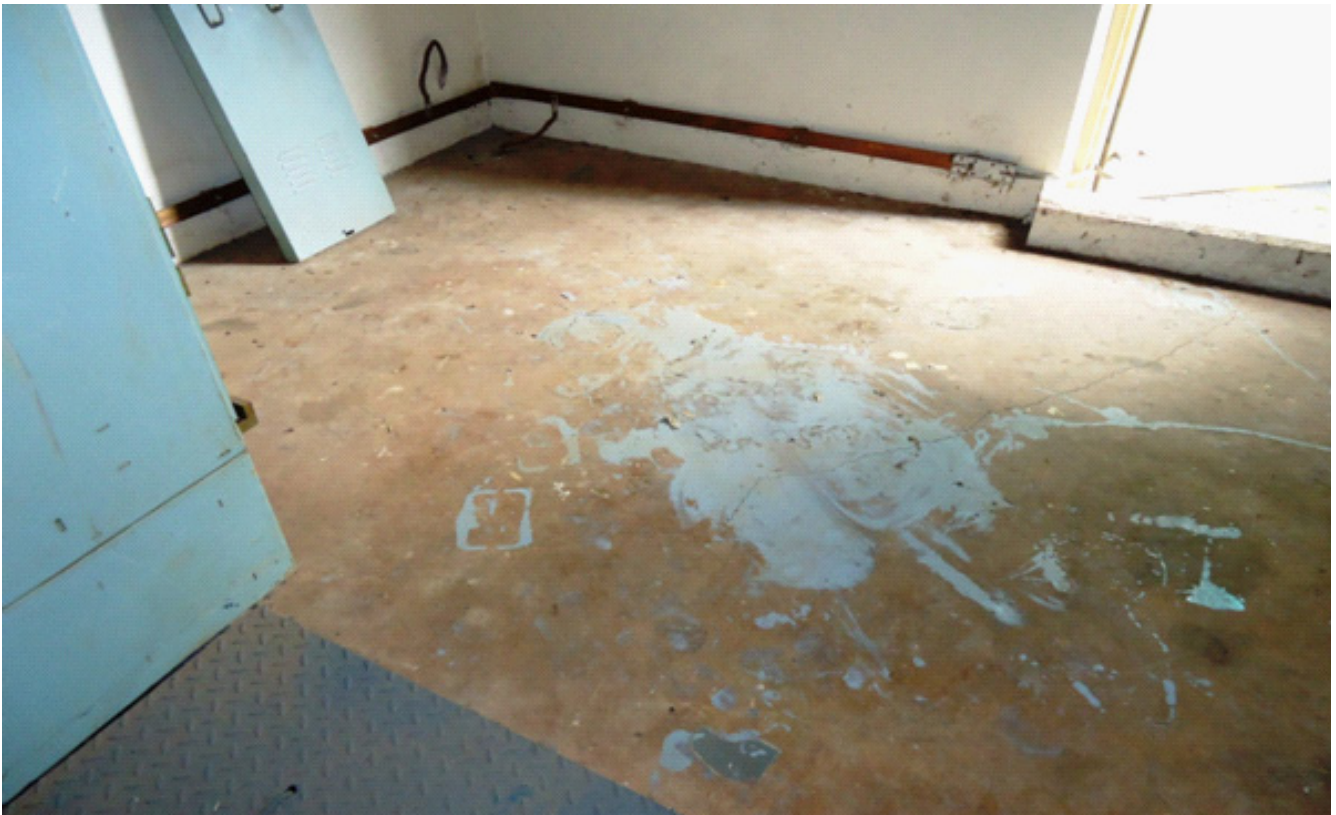
S-6: Crack on Floor Slab in Basement Electrical Transformer Room

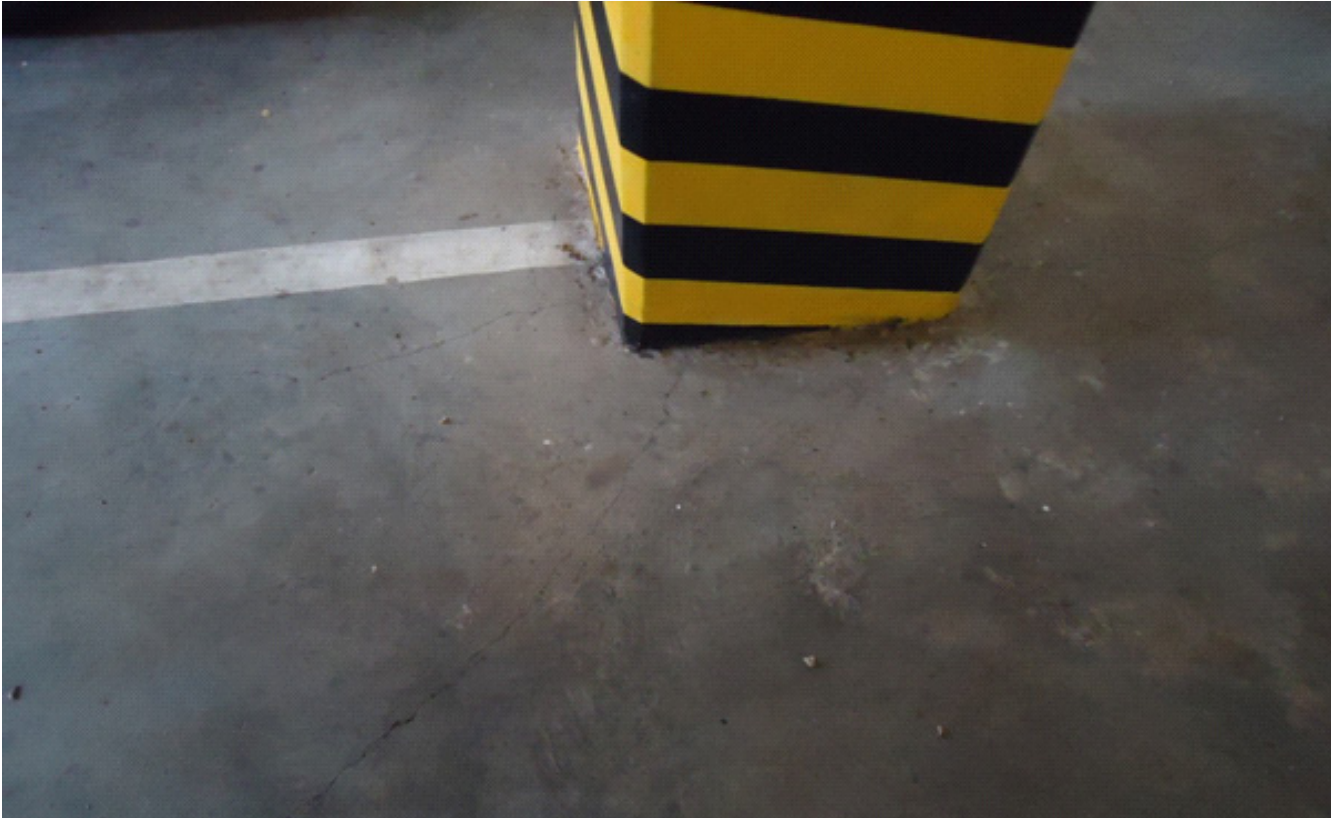
S-7: Radial Cracks of Floor Slab in Basement Columns

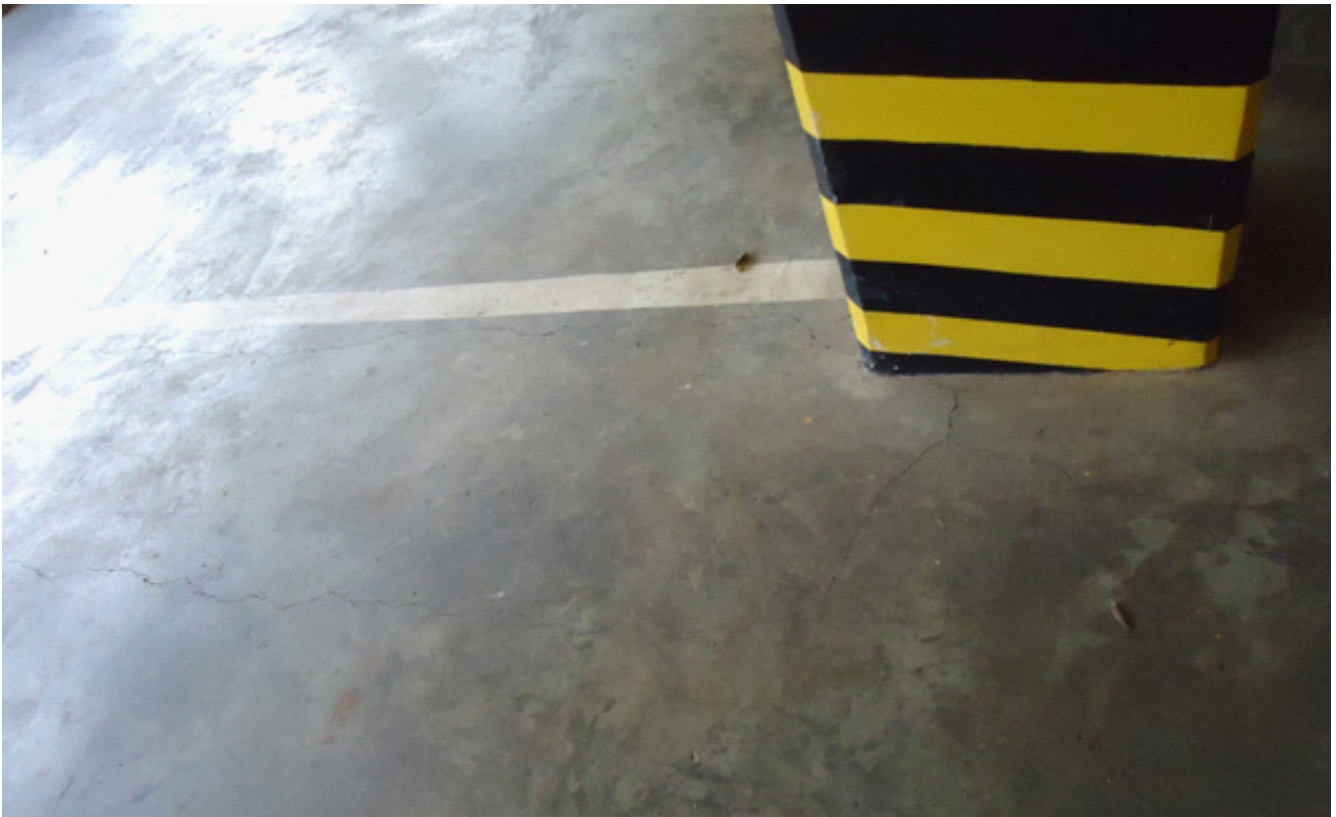
S-8: Radial Cracks on Floor Slab in Basement Columns

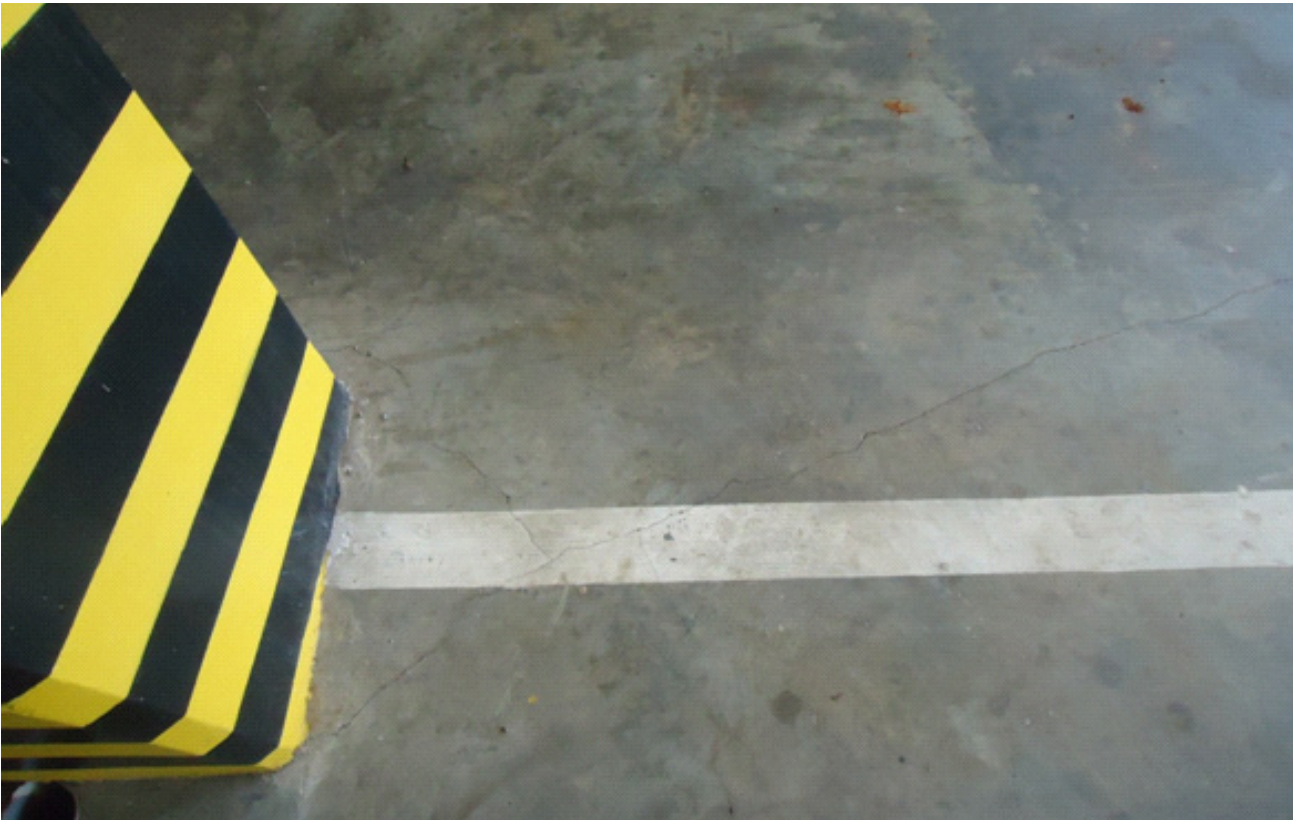
S-9: Radial Cracks on Floor Slab in Basement Columns

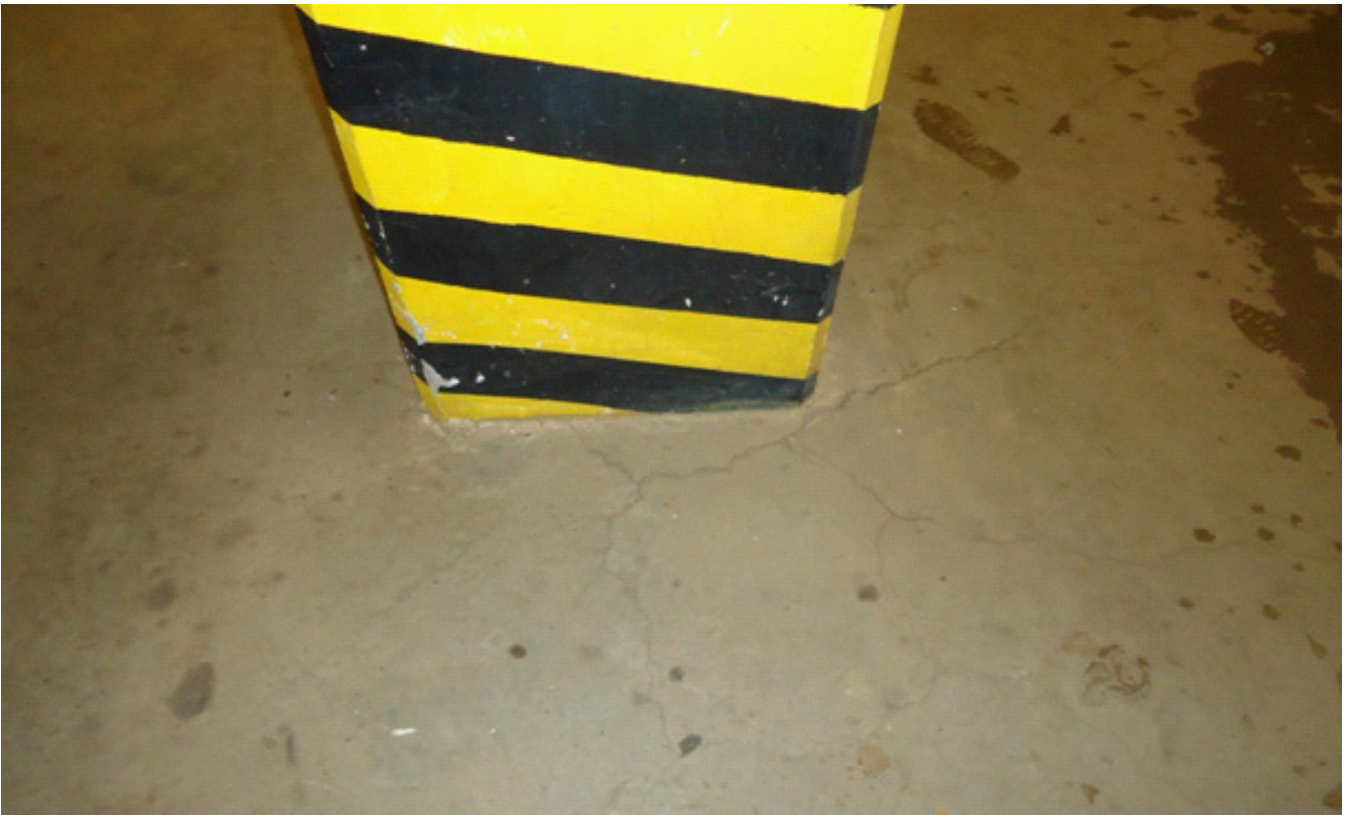
S-10: Radial Cracks on Floor Slab in Basement Columns

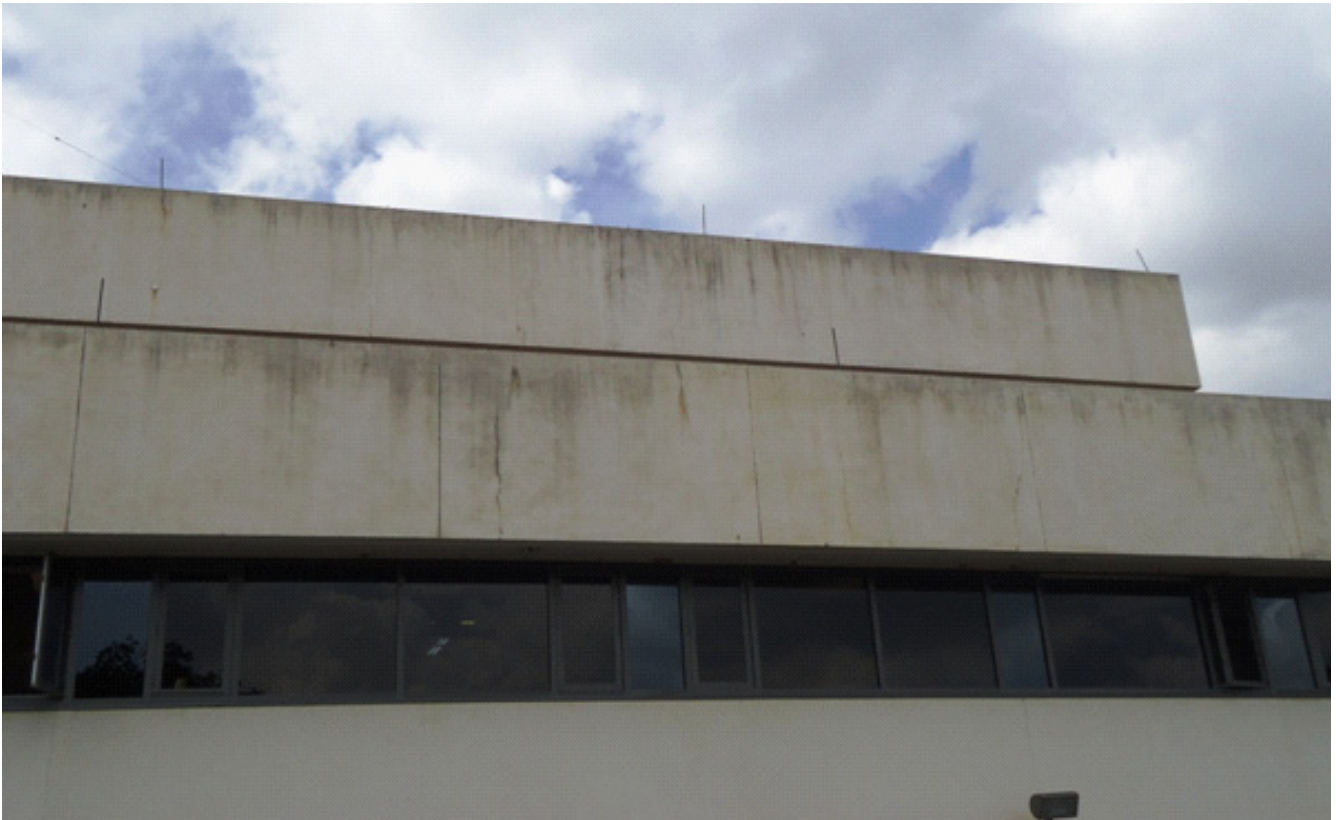
S-11: Vertical Cracks on Parapet Walls

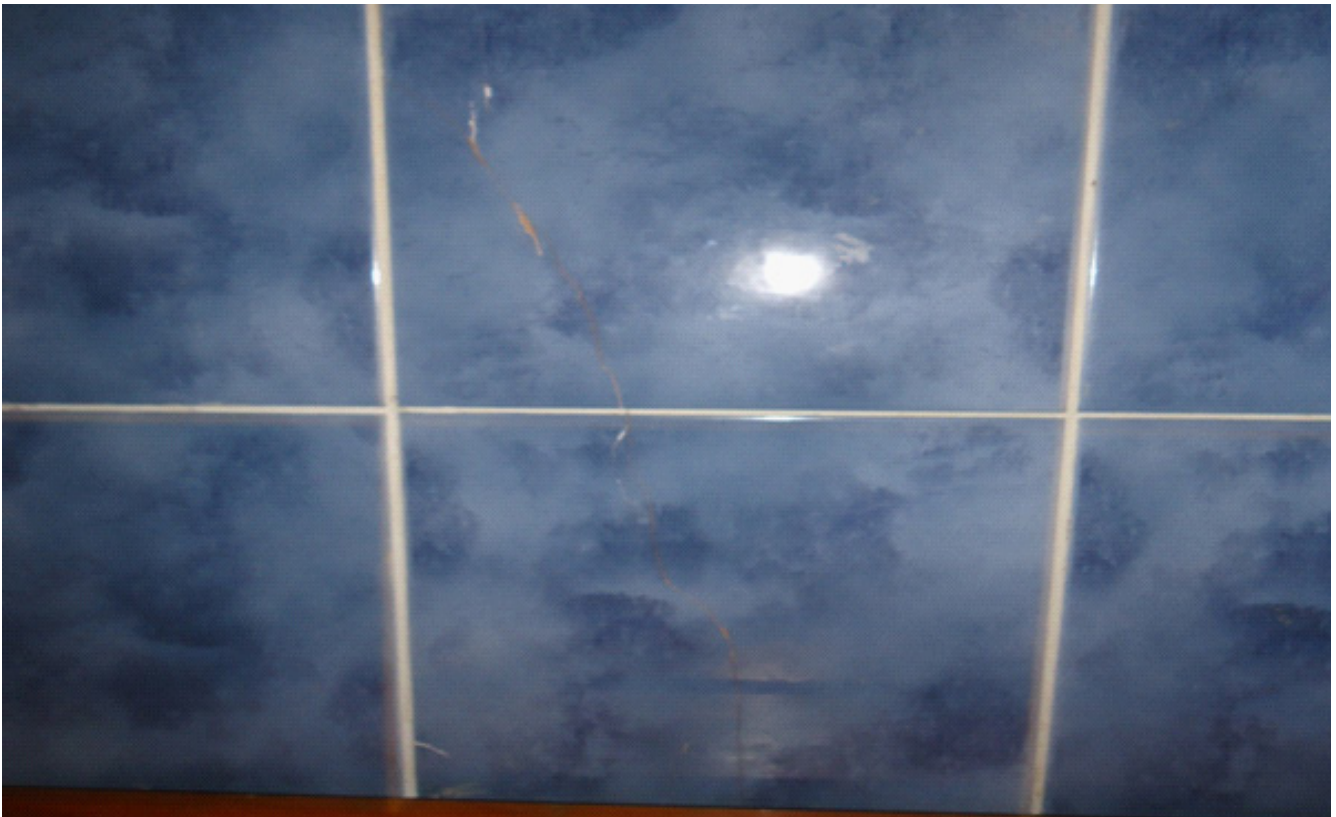
S-12: Vertical Cracks on Basement Men's Locker Room

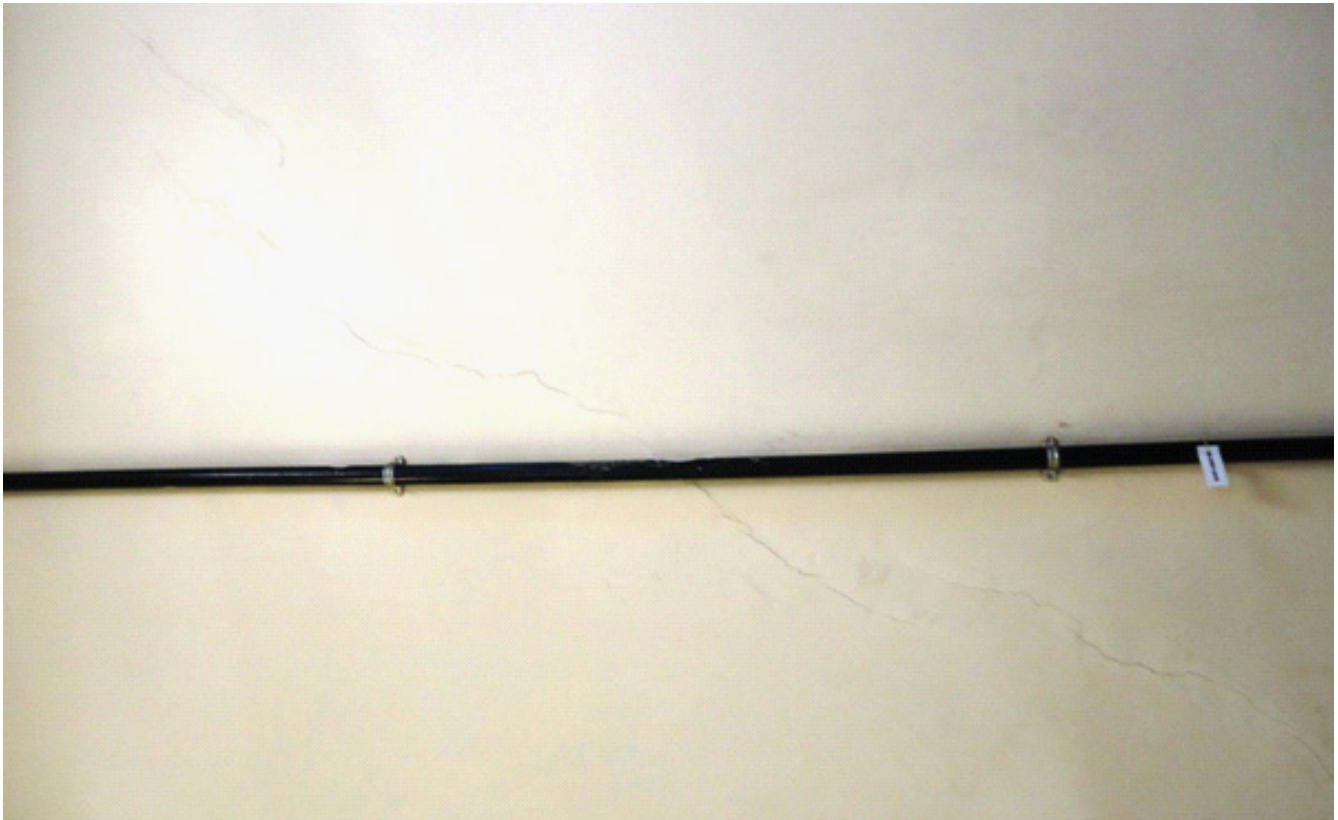
S-13: Cracks on Slab soffit on Sub-Basement Storage Area

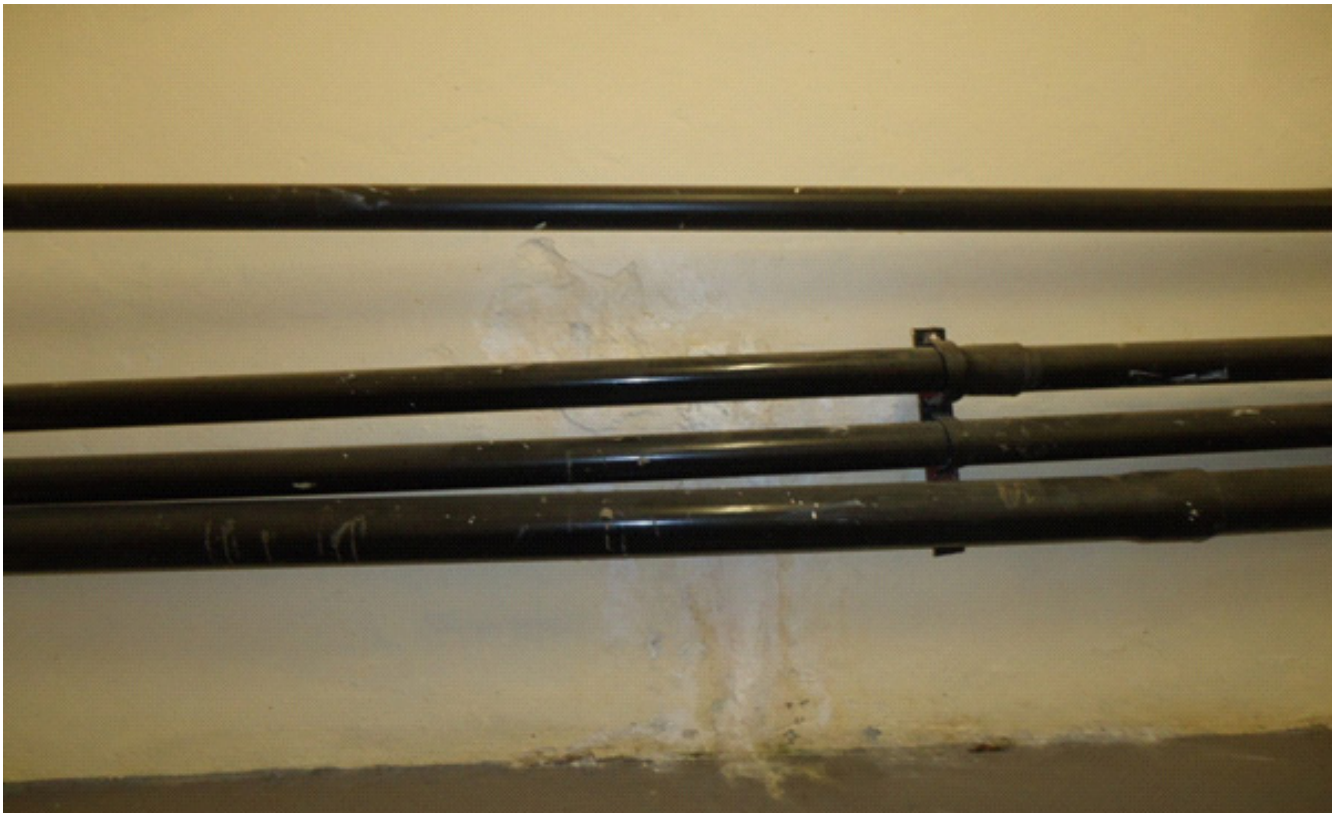
S-14: Efflorescence in pump room below swimming pool

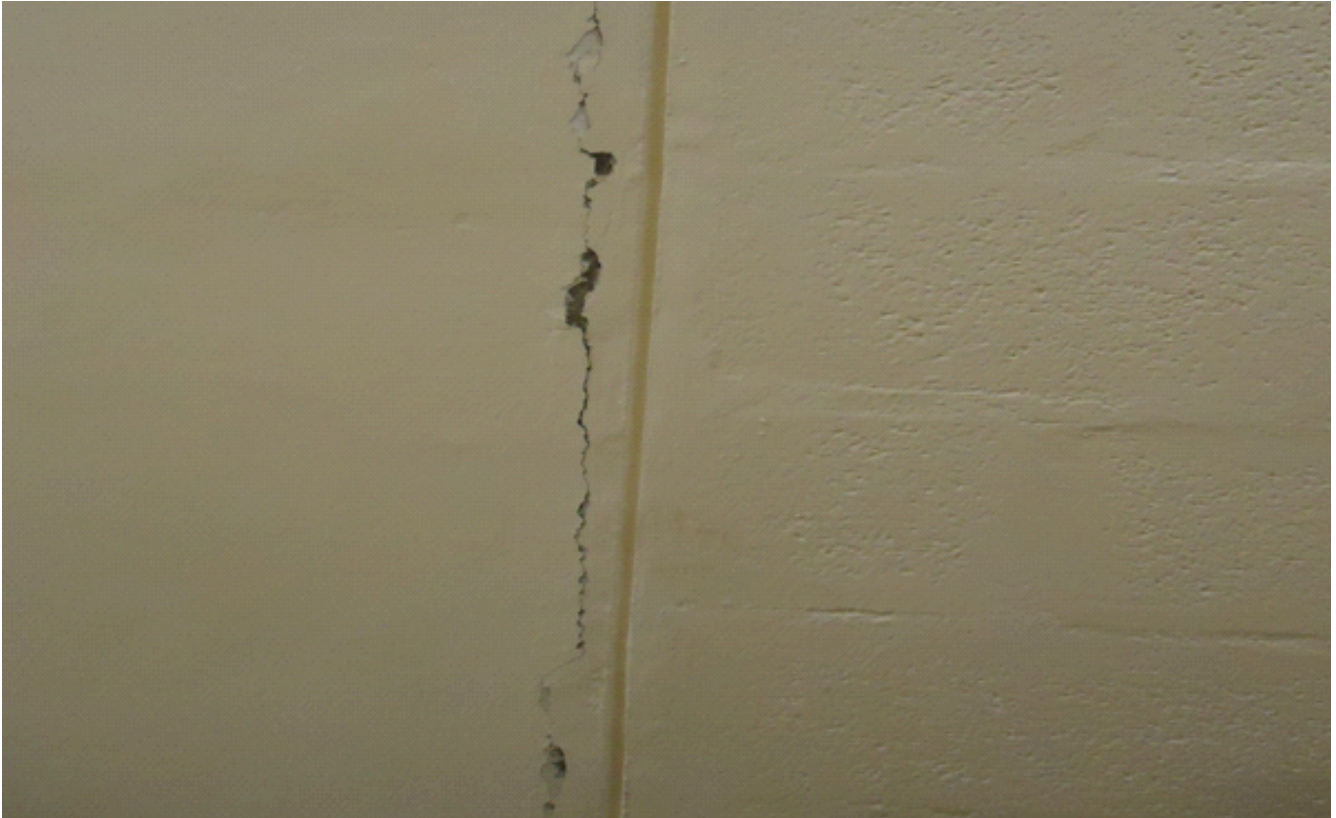
S-15: Crack on junction between masonry wall and concrete

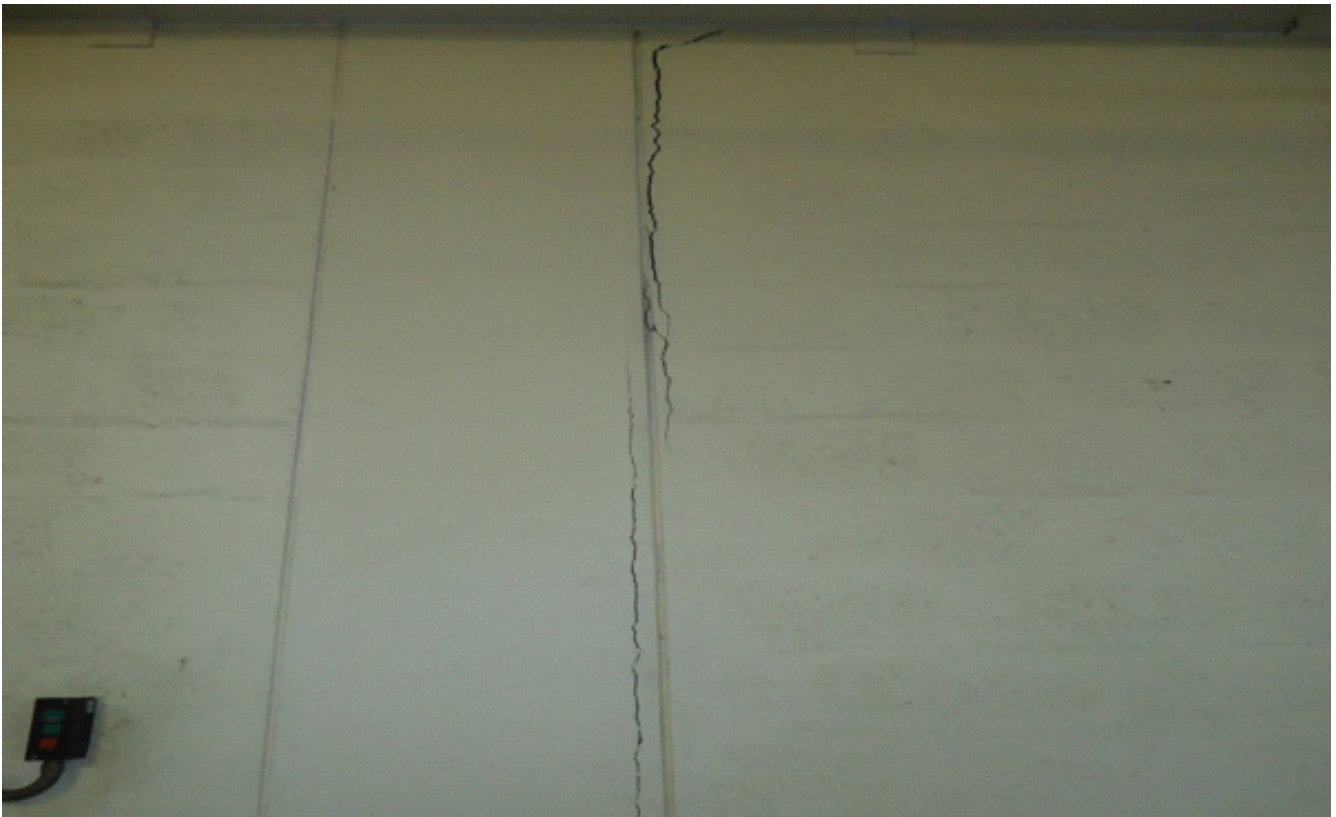
S-16: Crack on junction between masonry wall and concrete

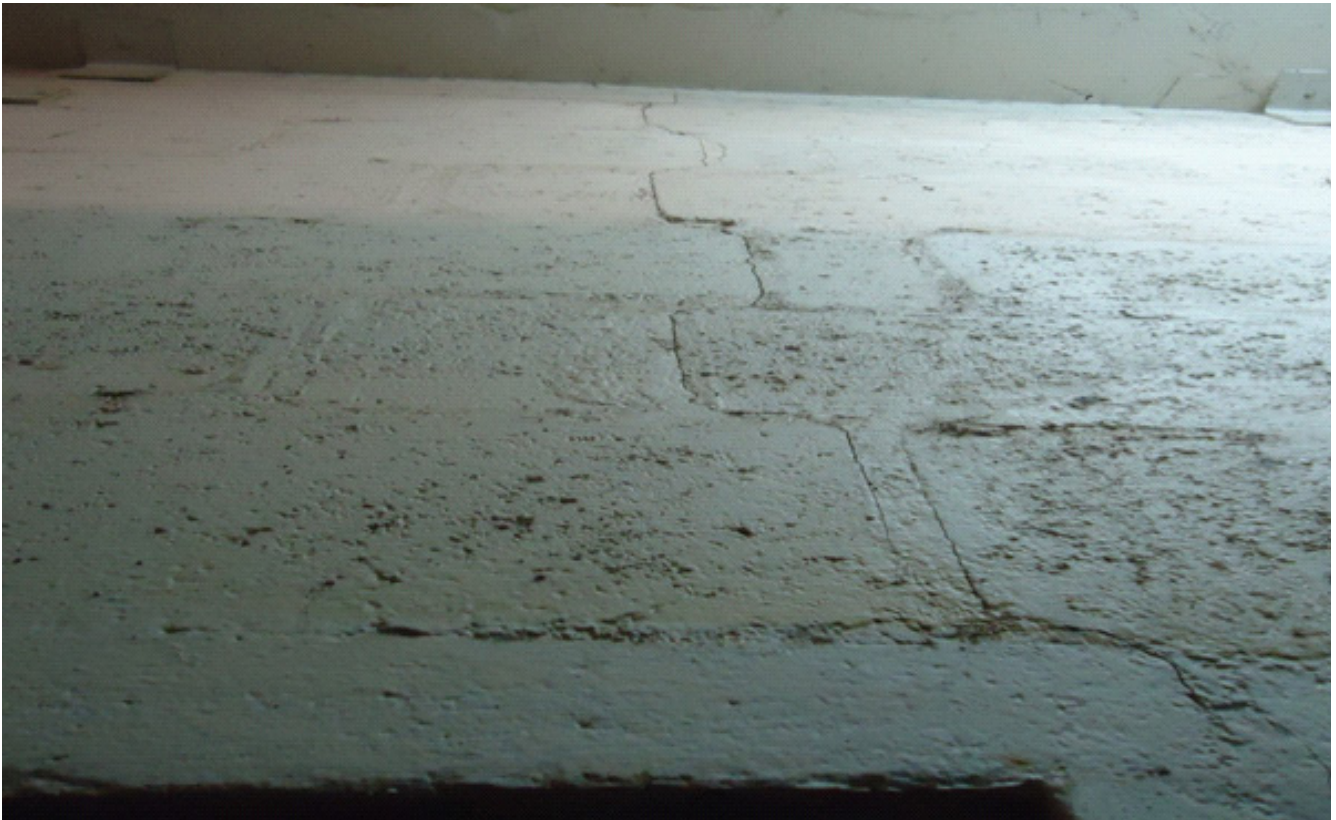
S-17: Cracks on masonry wall

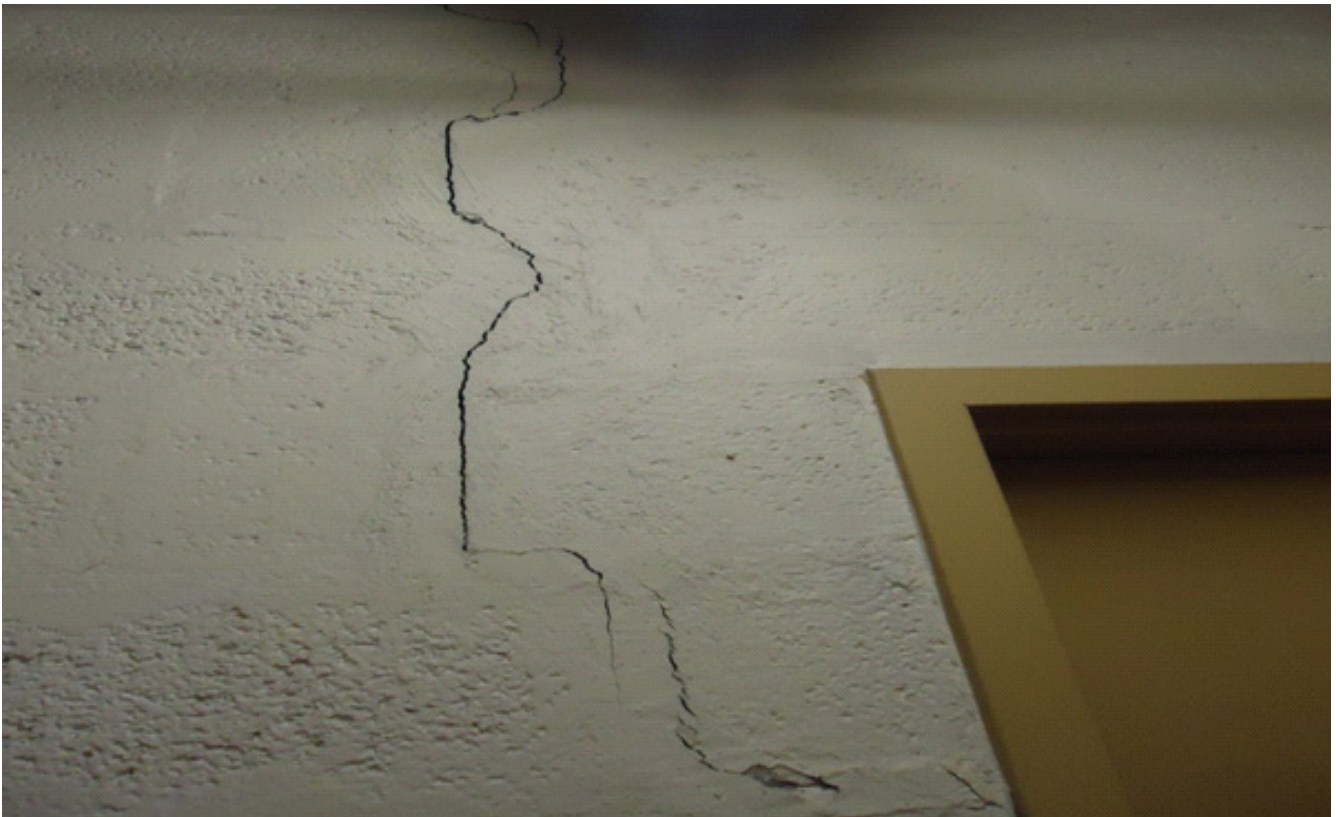
S-18: Crack on masonry wall

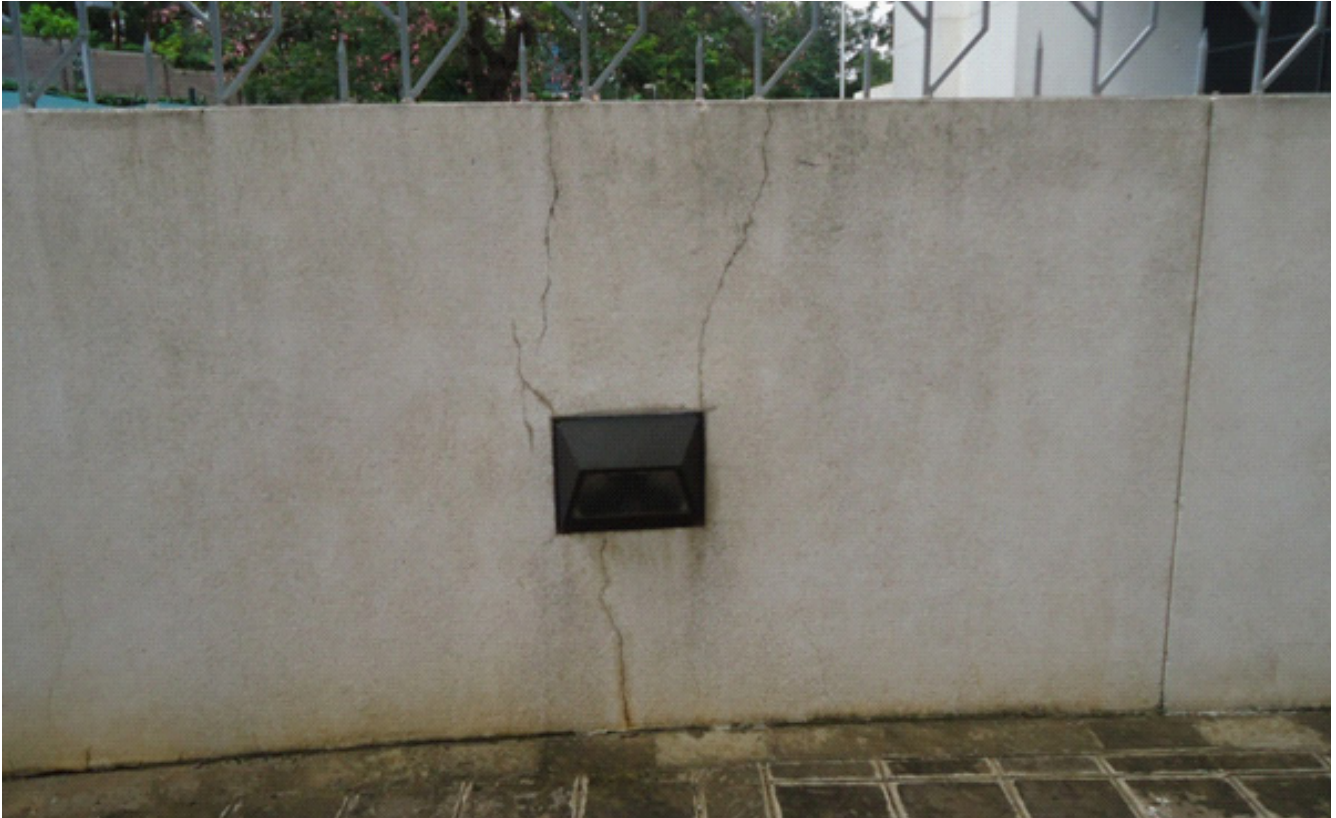
S-19: Cracks on ramp wall

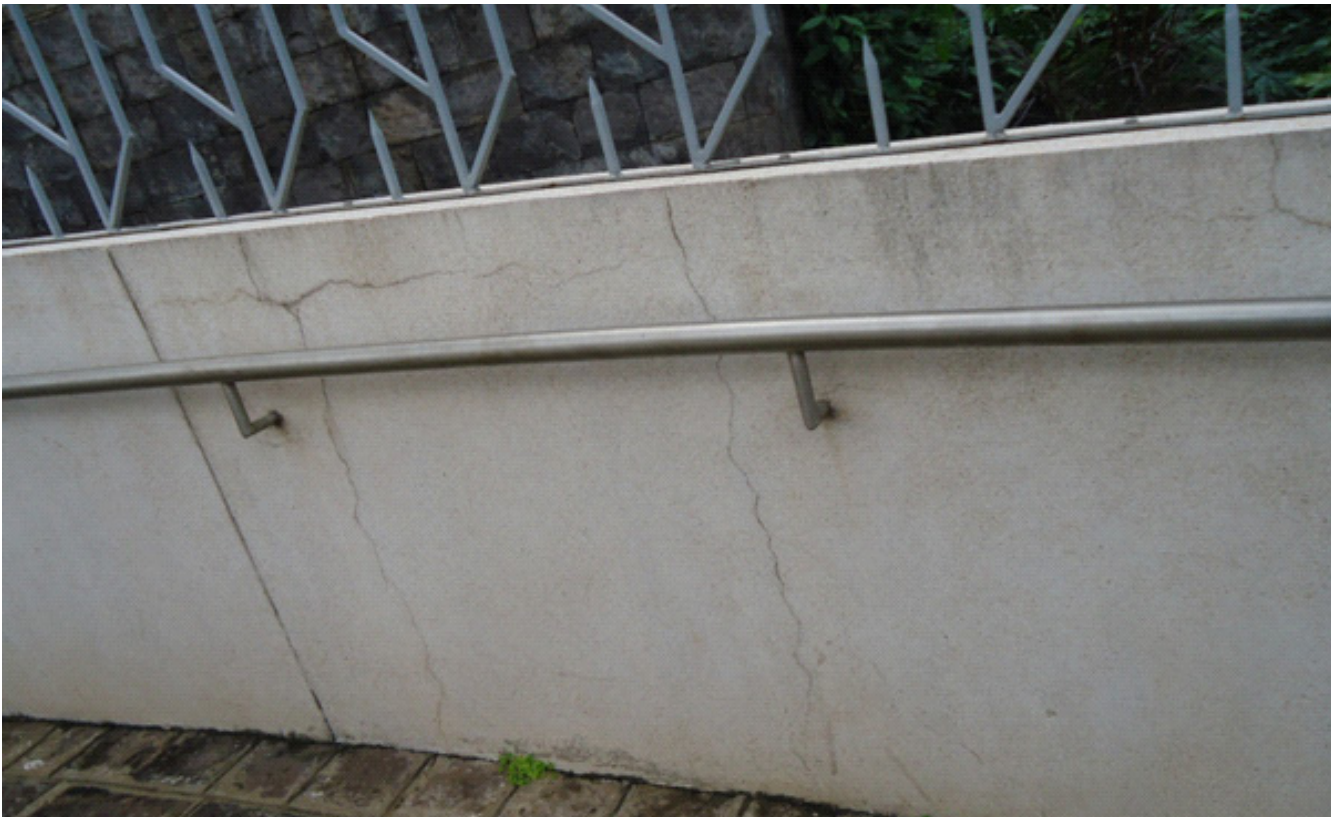
S-20: Cracks on ramp wall

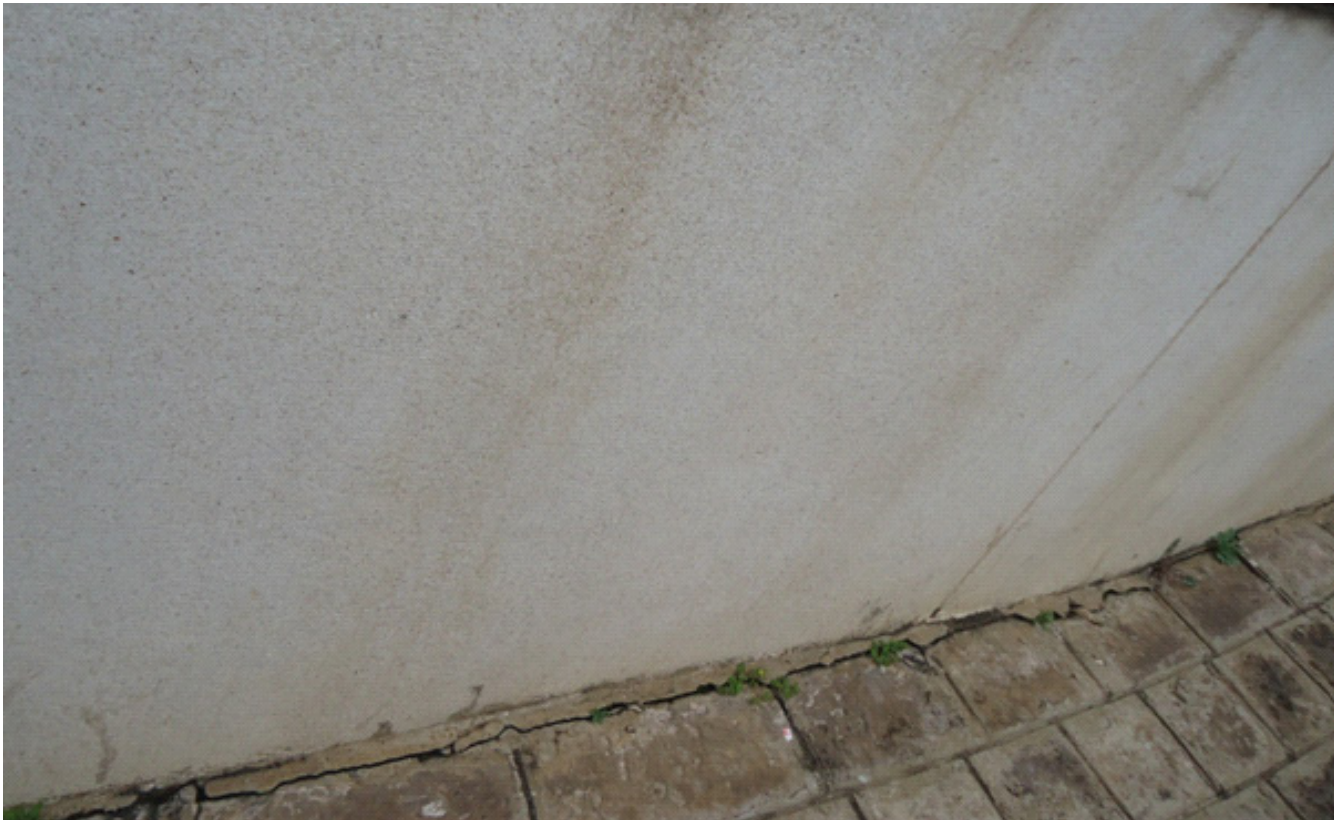
S-21: Separation of ramp wall from floor
