Preliminary Building Envelope, Structural and Space Optimization Study
Canadian Chancery,
Nairobi, Kenya

Final Submission
June 25th, 2013

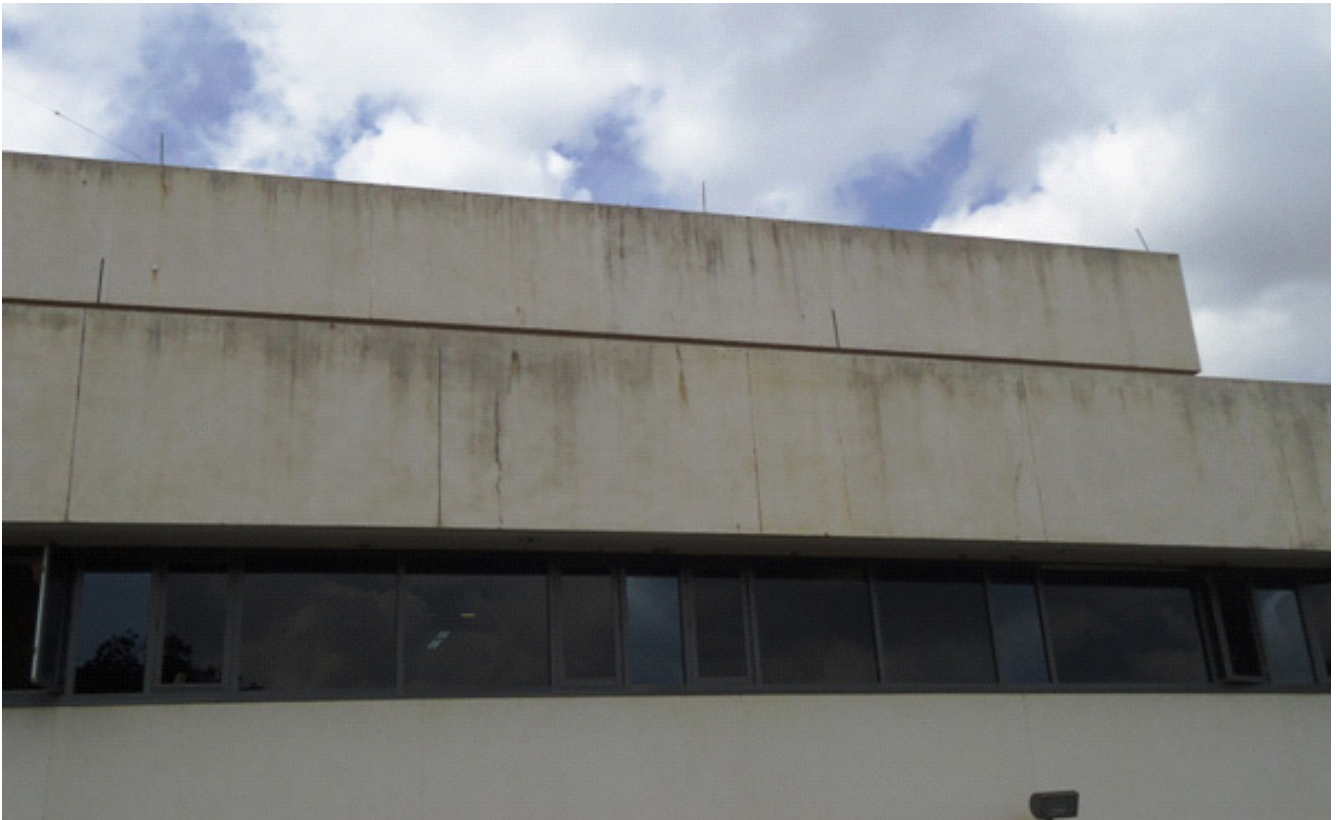
S-25: Cracks on Exterior walls

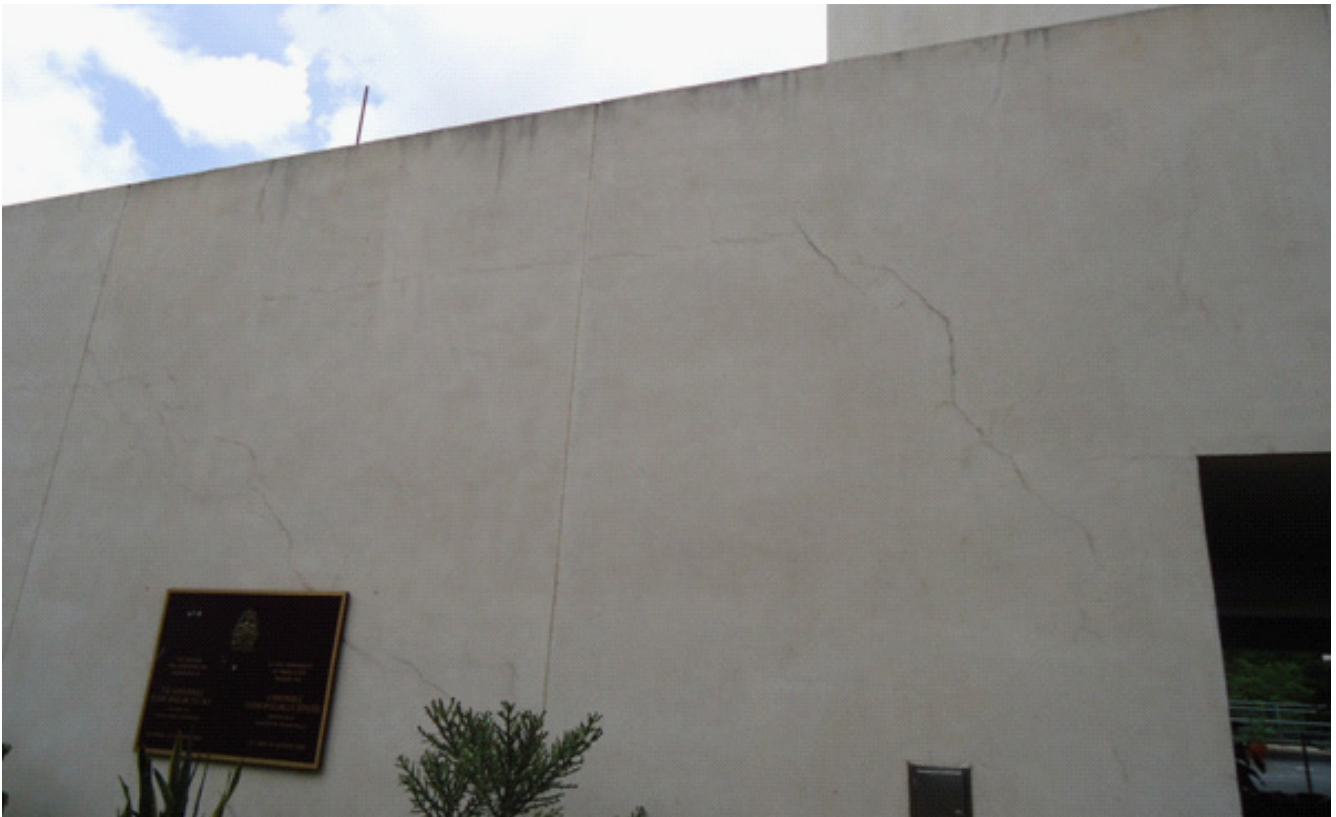
S-26: Crack on Exterior walls

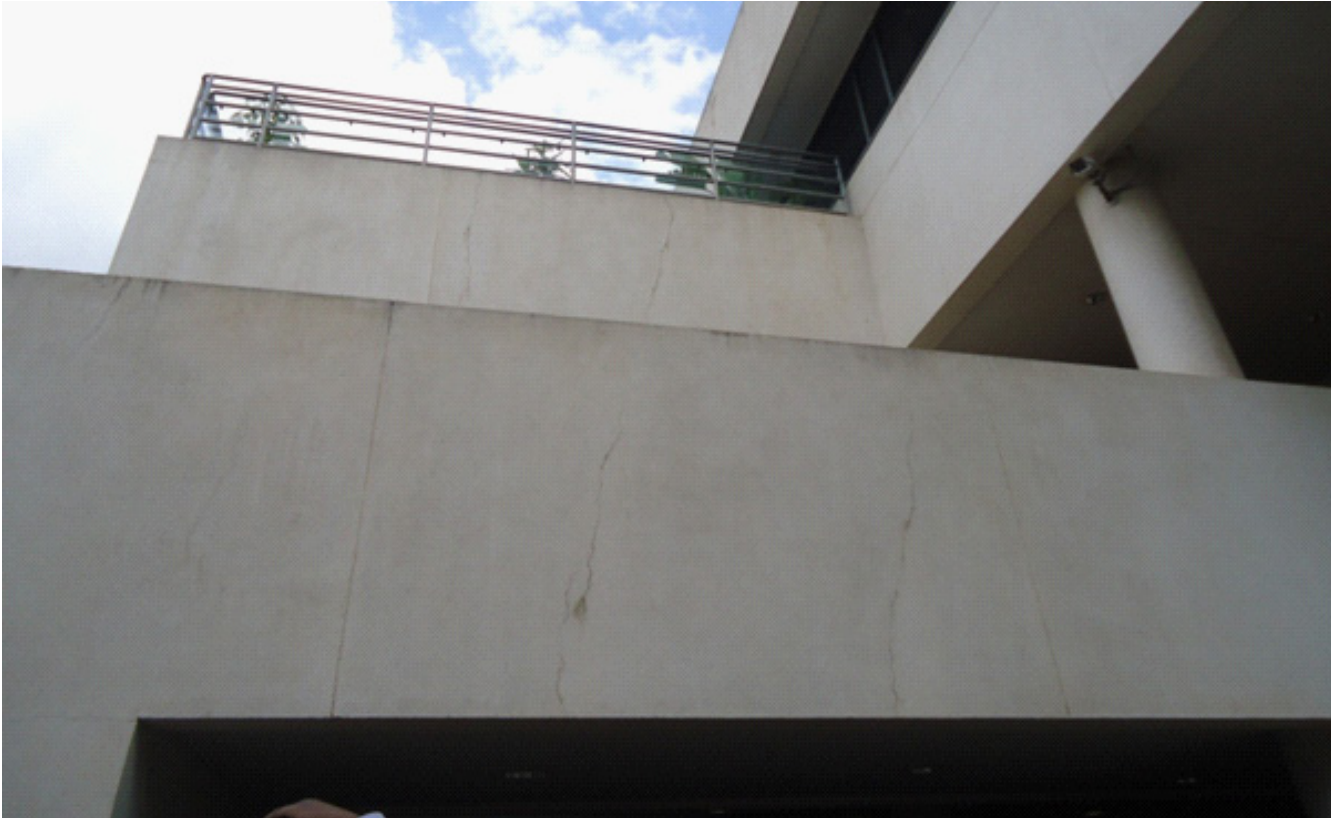
S-27: Cracks on exterior walls

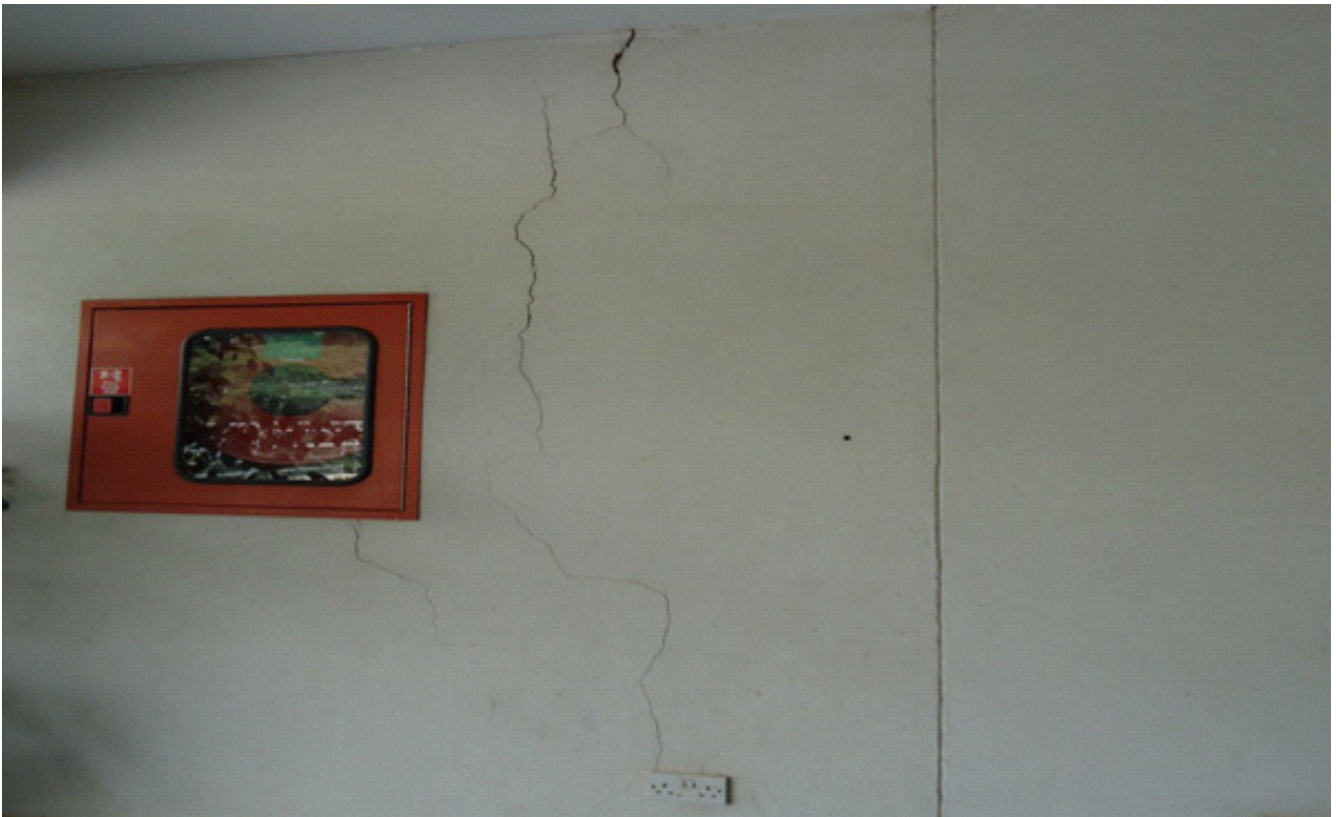
S-28: Cracks on exterior walls

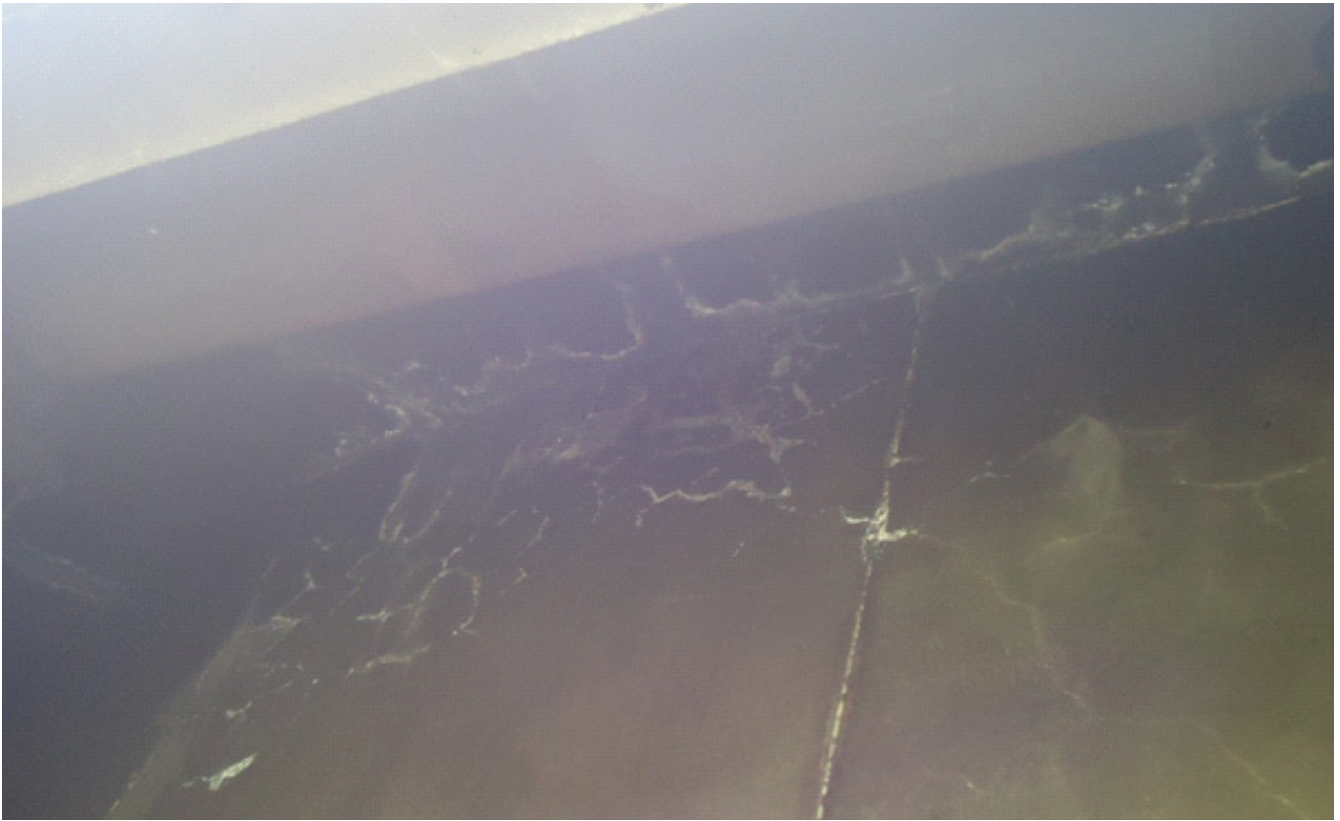
S-29: Spalling of wall and cracking at previous location of generator

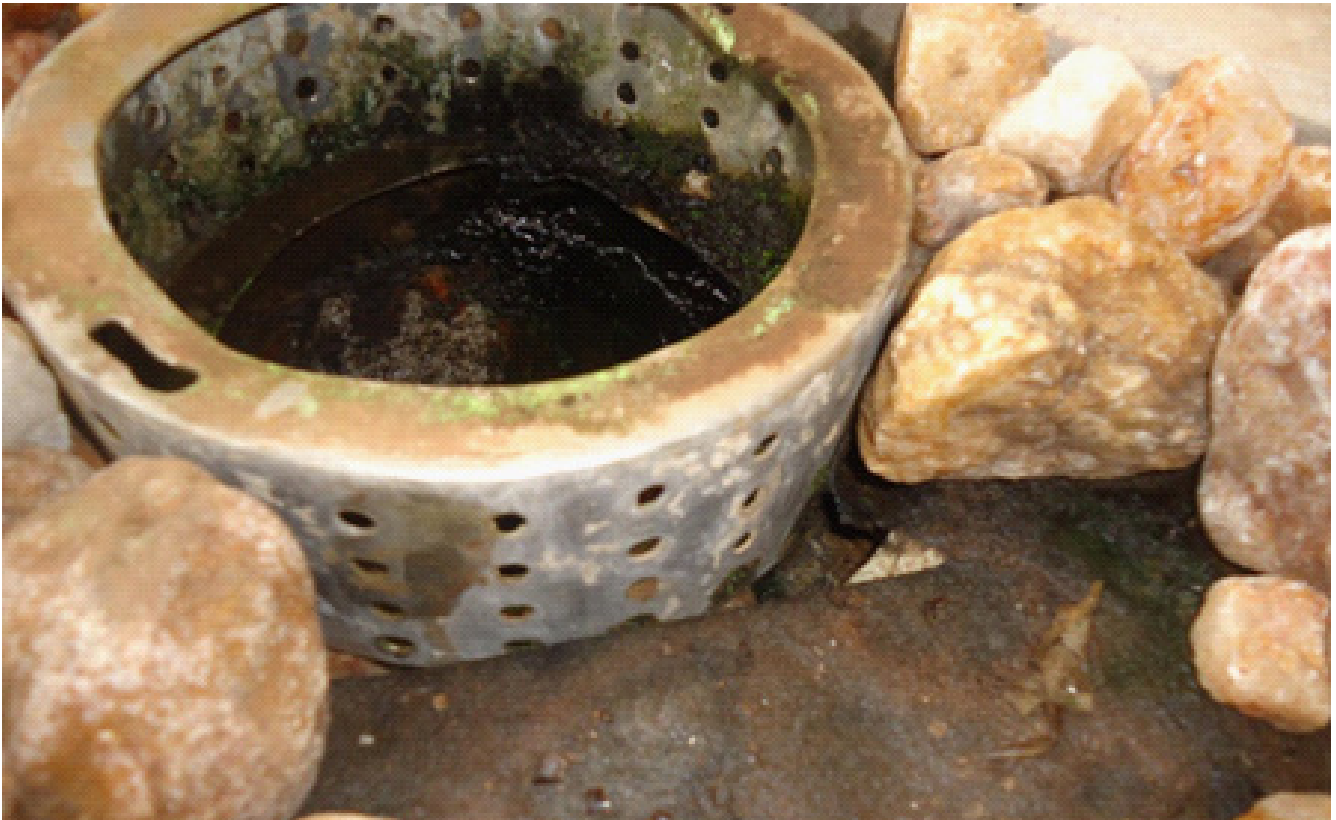
BE-1: Exposed Insulation

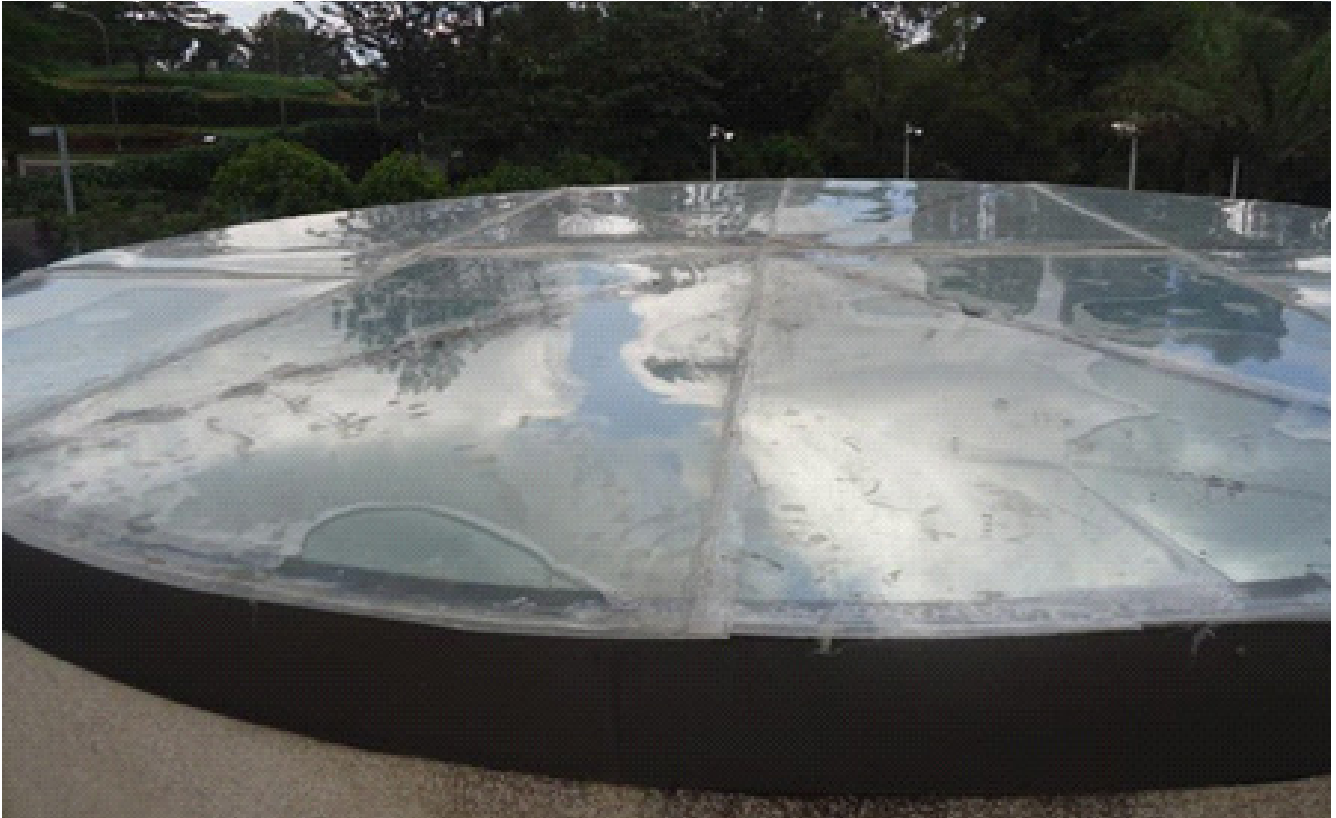
BE-5: Sky light, damaged glass roof assembly which requires replacement

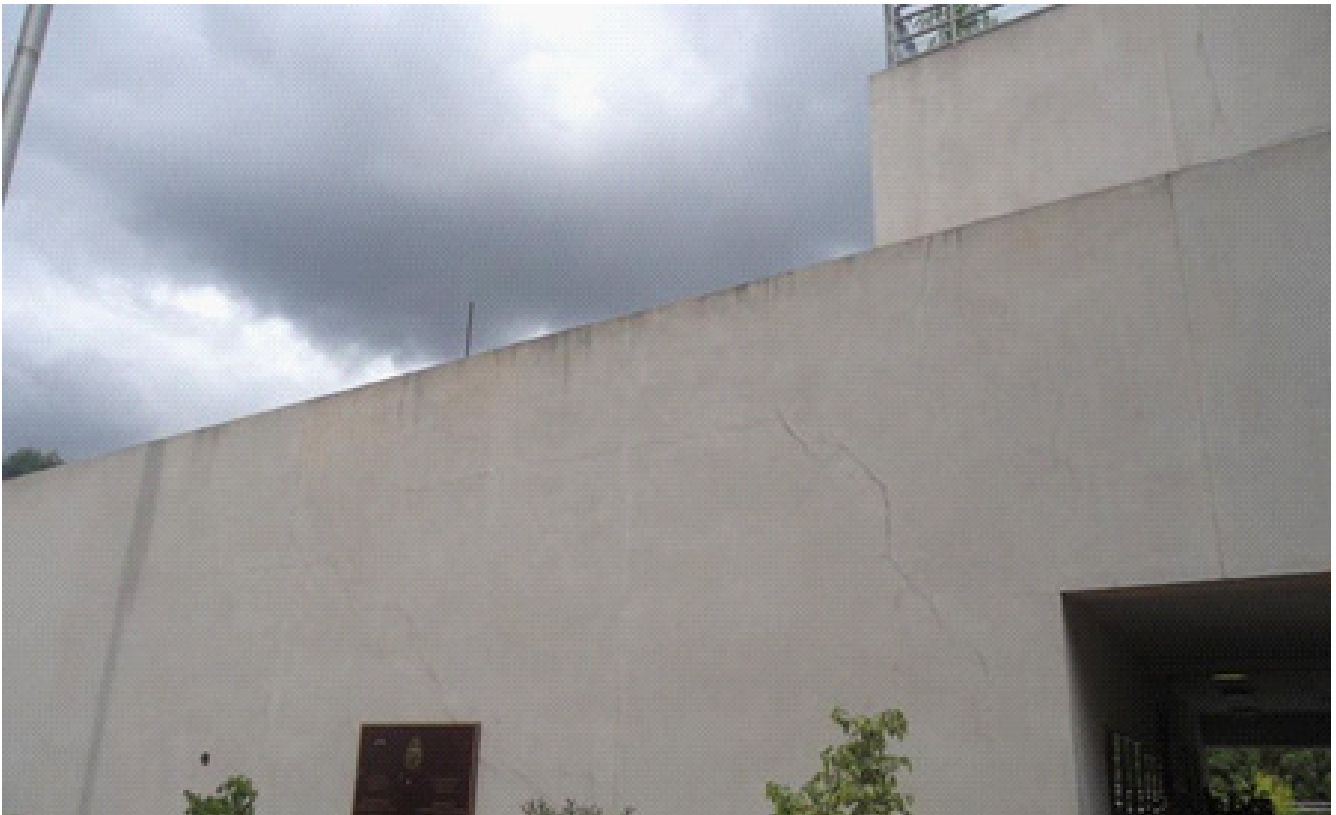
BE-10: Cracks on top of the wall finish

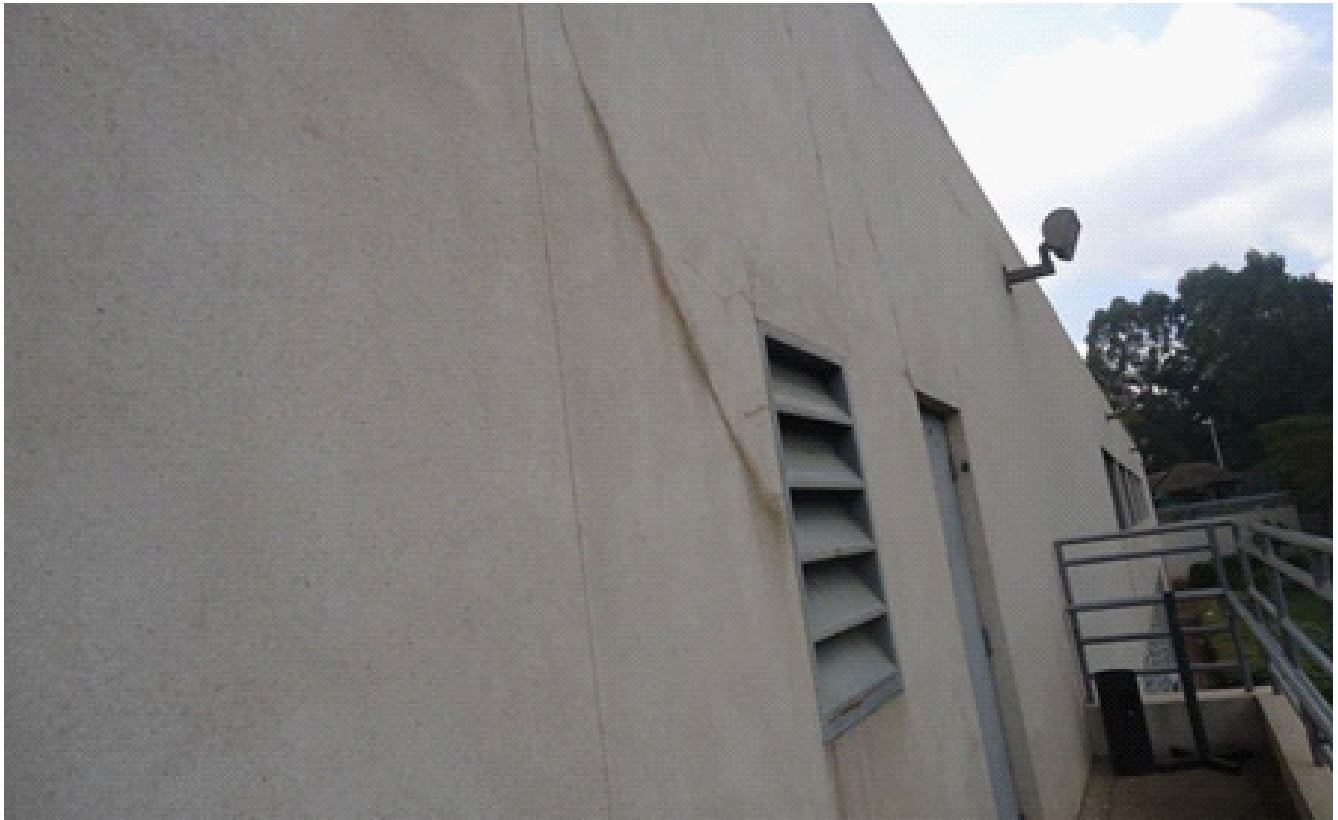
BE-11: Diagonal cracks on the wall which require rectification

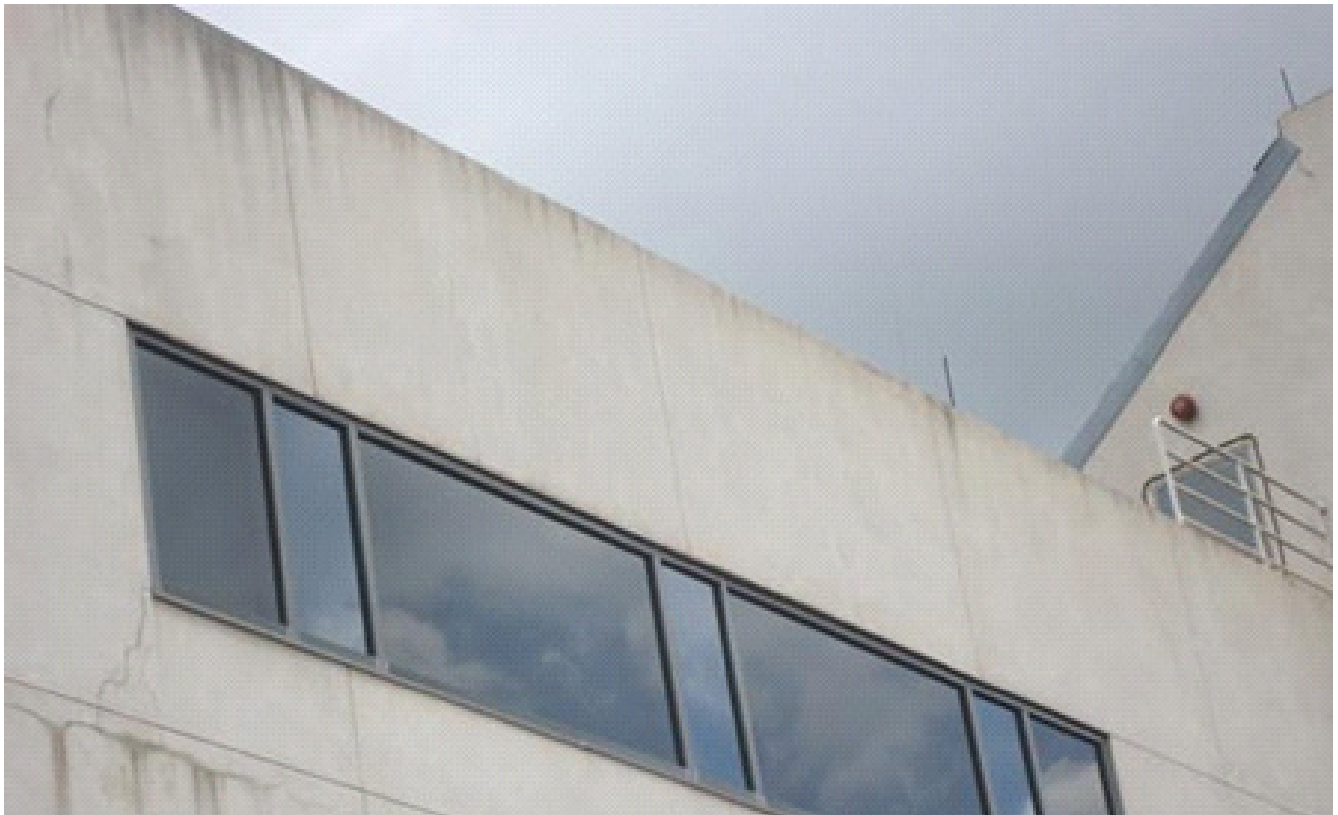
BE-12: Cracks on the edges of the windows with structural concerns

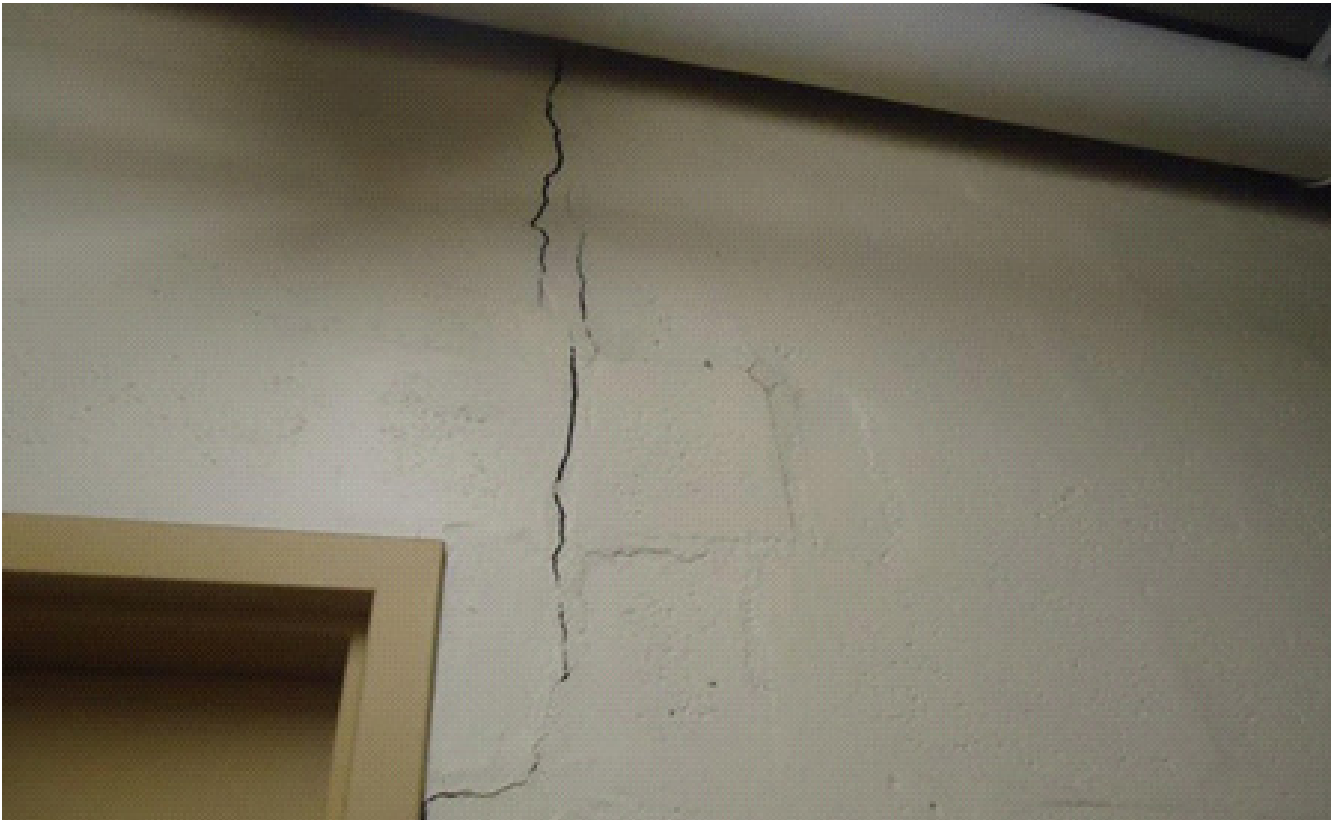
BE-13: Crack on the block work at the basement

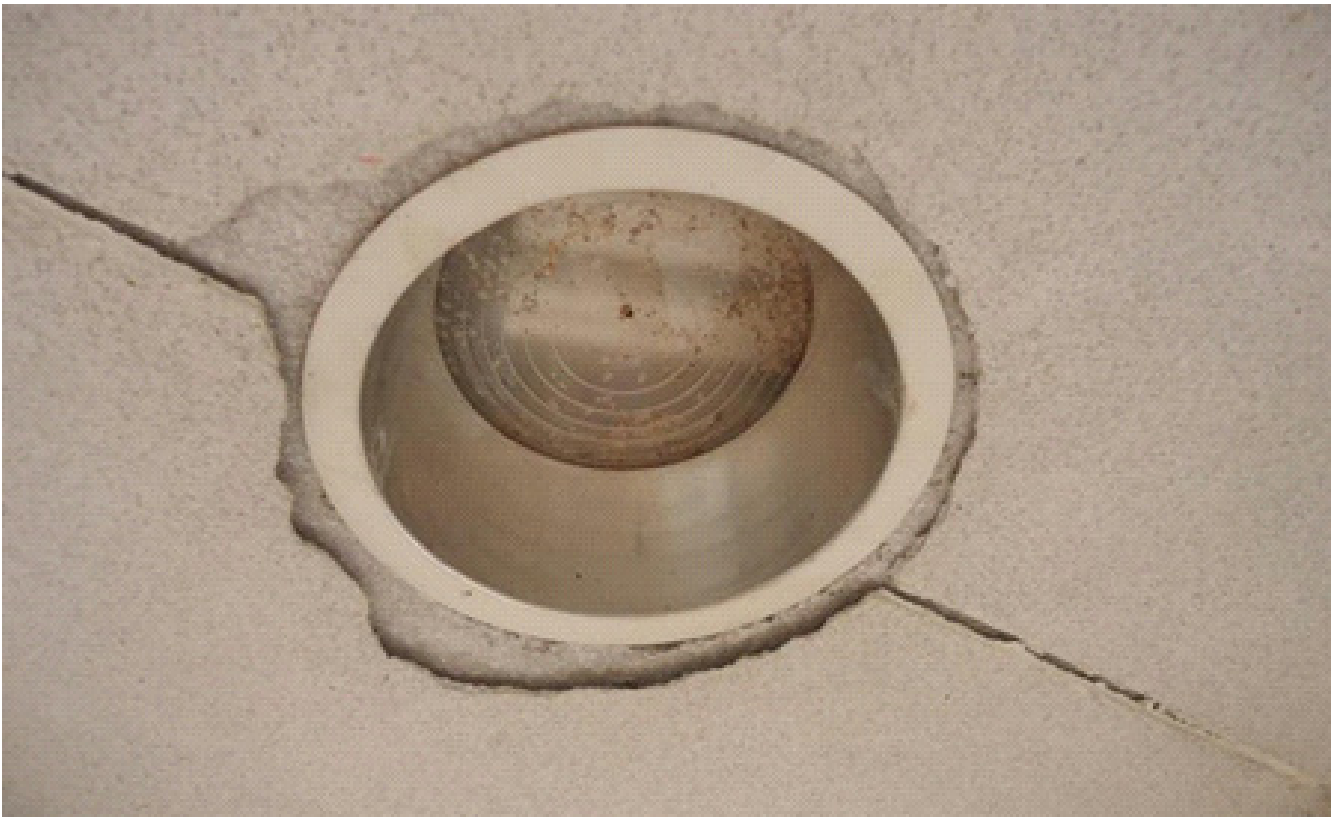
BE-14: Soffits with cracked

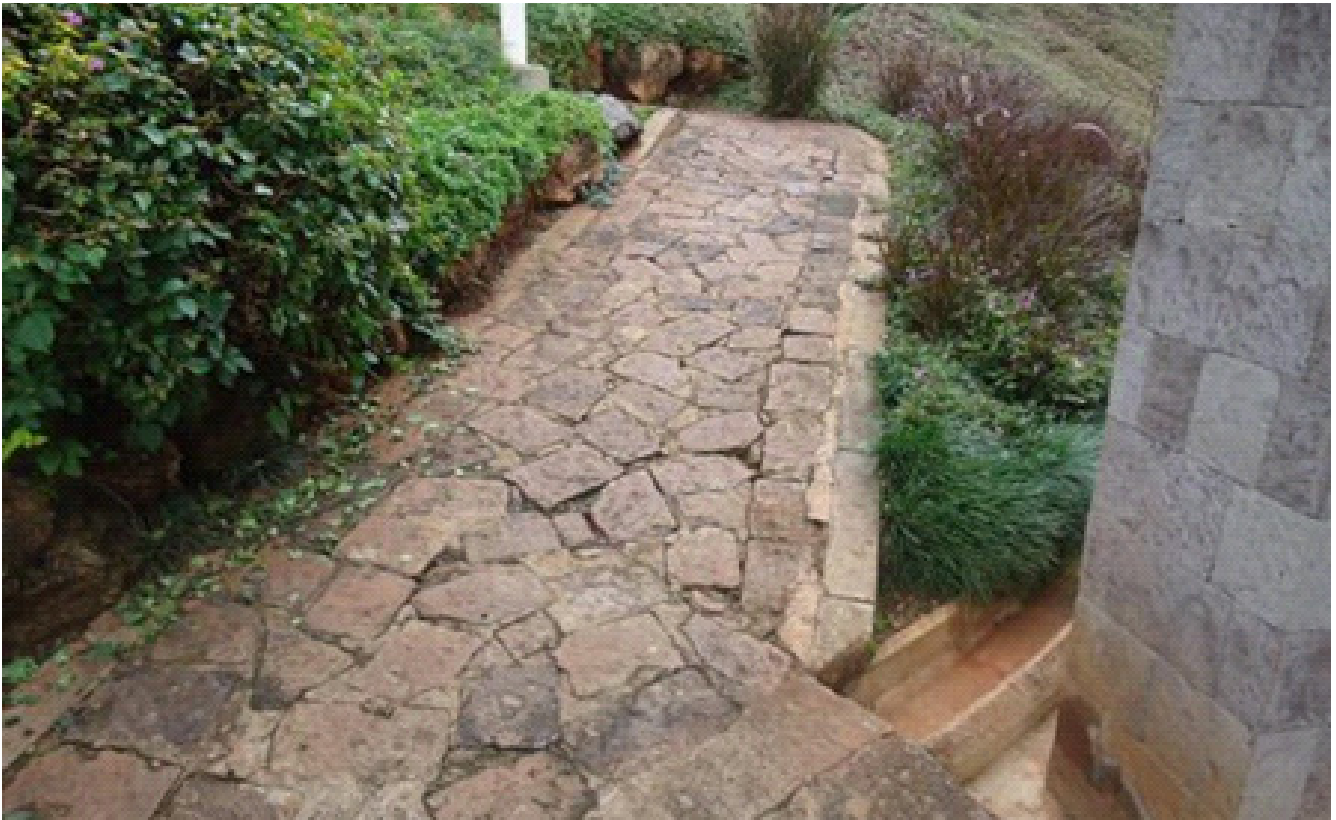
BG-1: Access to the public area

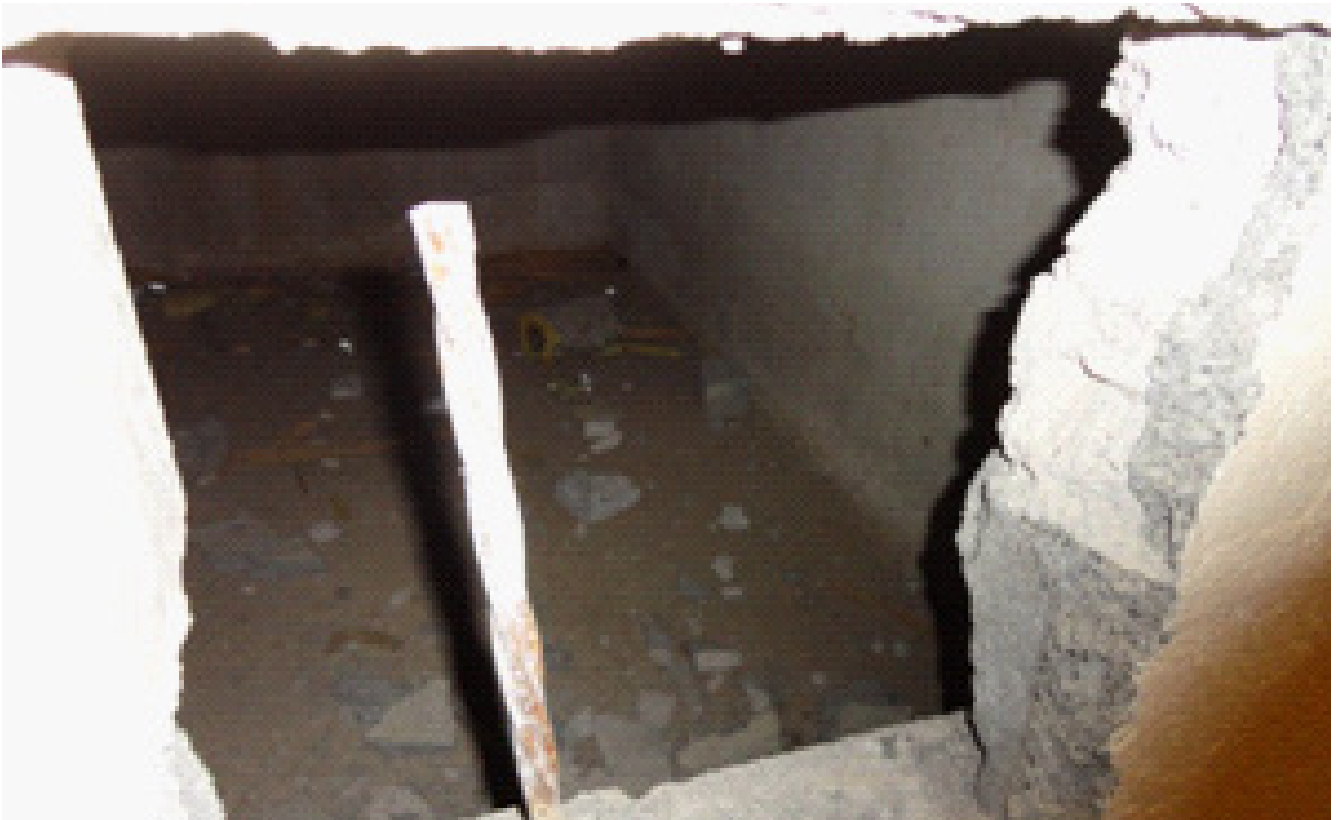
MS-9: Debris in Return Air Shaft (hole from electrical cupboard with broken fan)

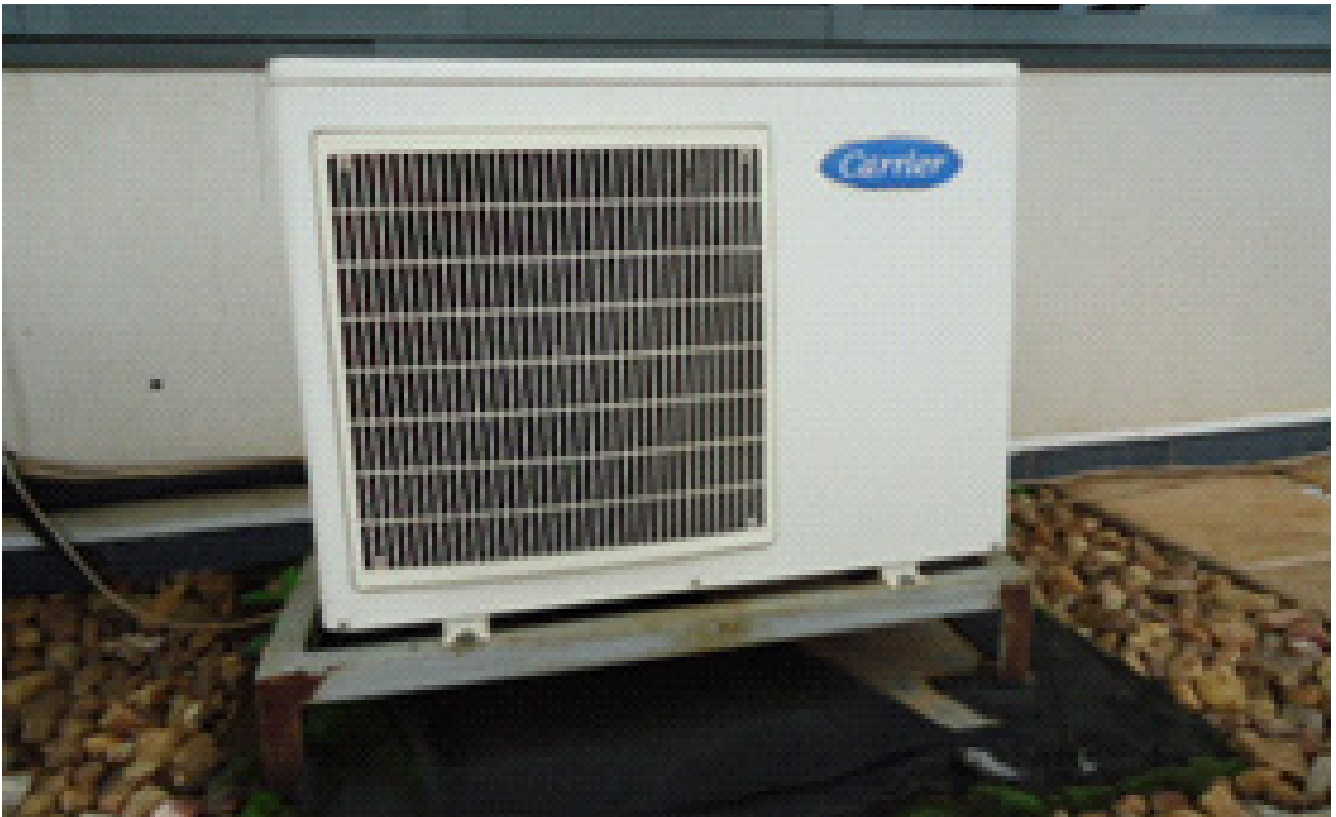
MS-10: Condenser Unit for Split Air-conditioner

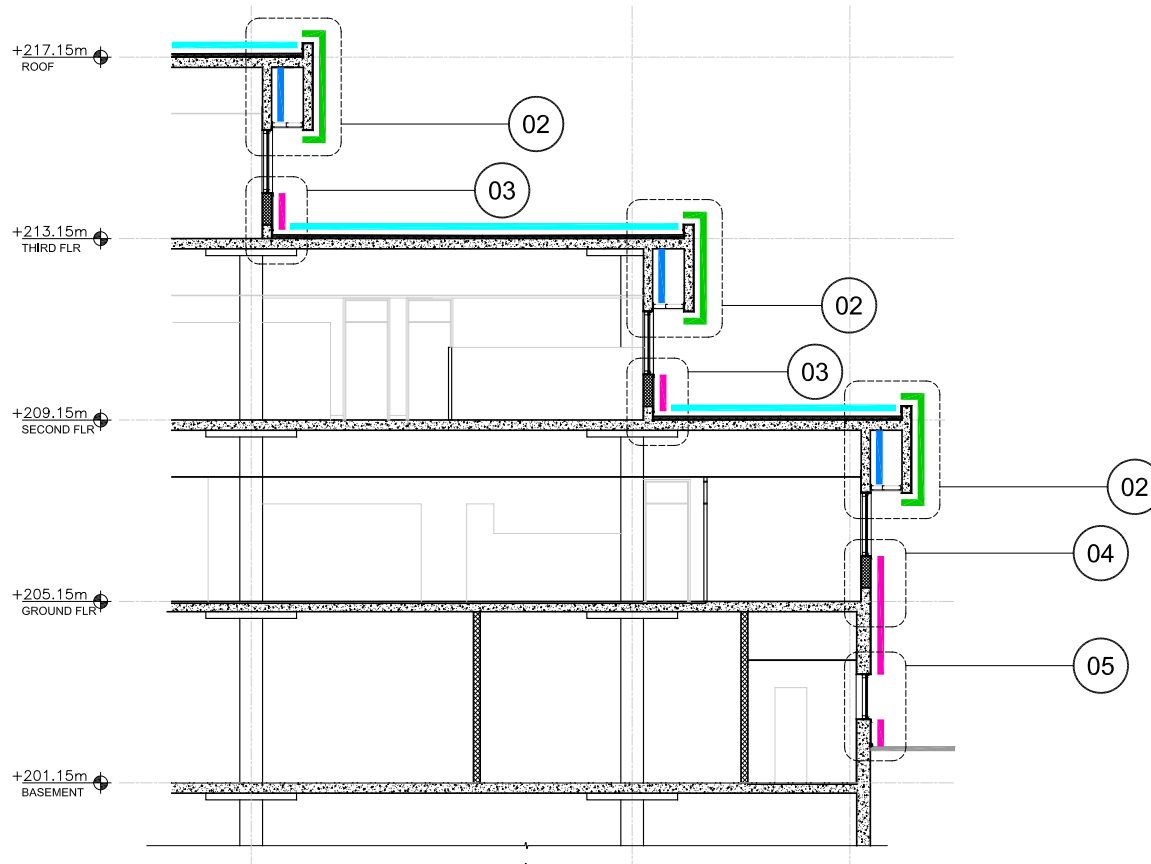
NEW CONSTRUCTION TO REMEDIATE ENVELOPE

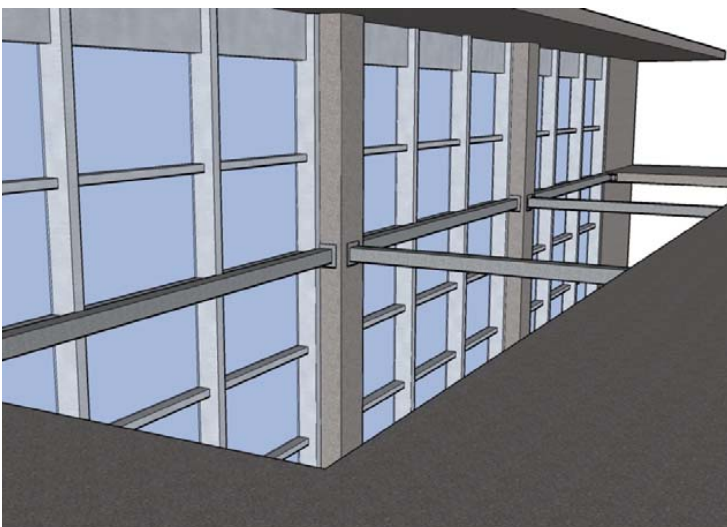
Figure 4.2.1: Option 1 internal view from Level 2

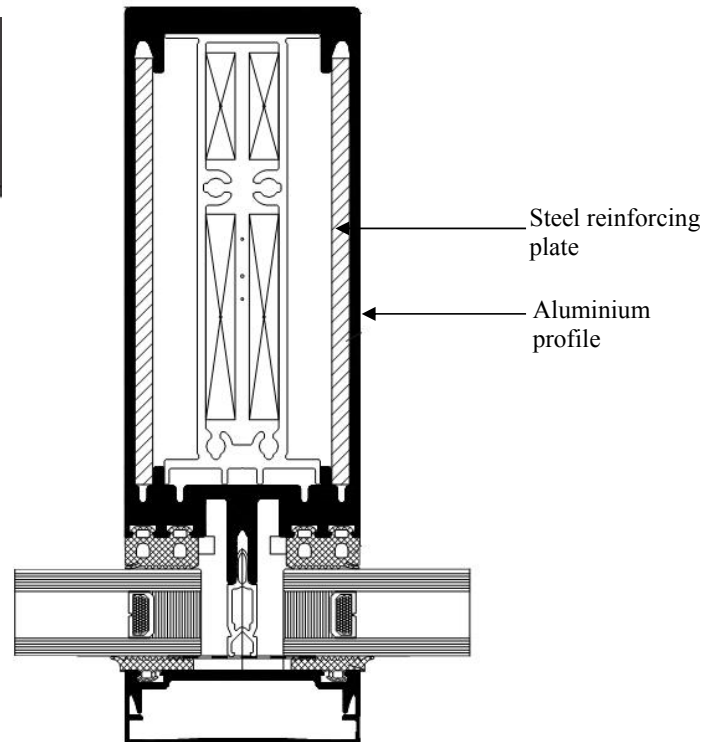
Figure 4.2.4: Reinforced aluminium section For blast enhanced condition inner face gaskets to be replaced (partially or fully as required by detailed design) with structural silicone sealant.

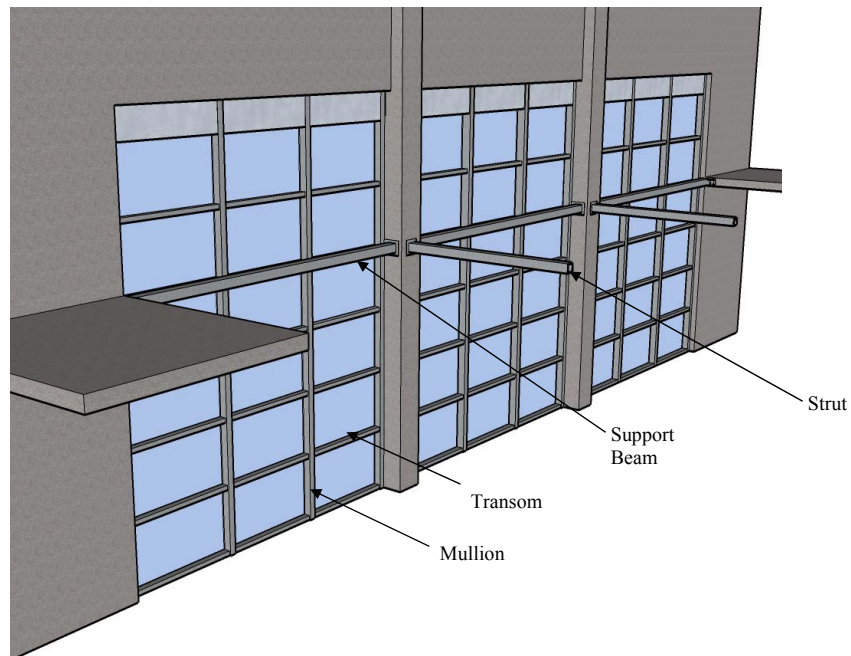
Figure 4.2.5 - Option 2 transom and mullions

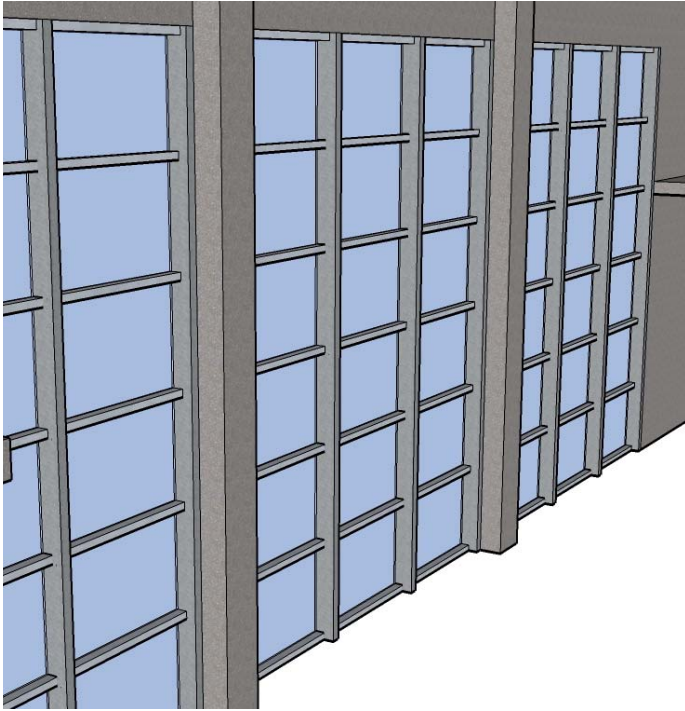
Figure 4.2.8 - Option 3 transom and mullions.

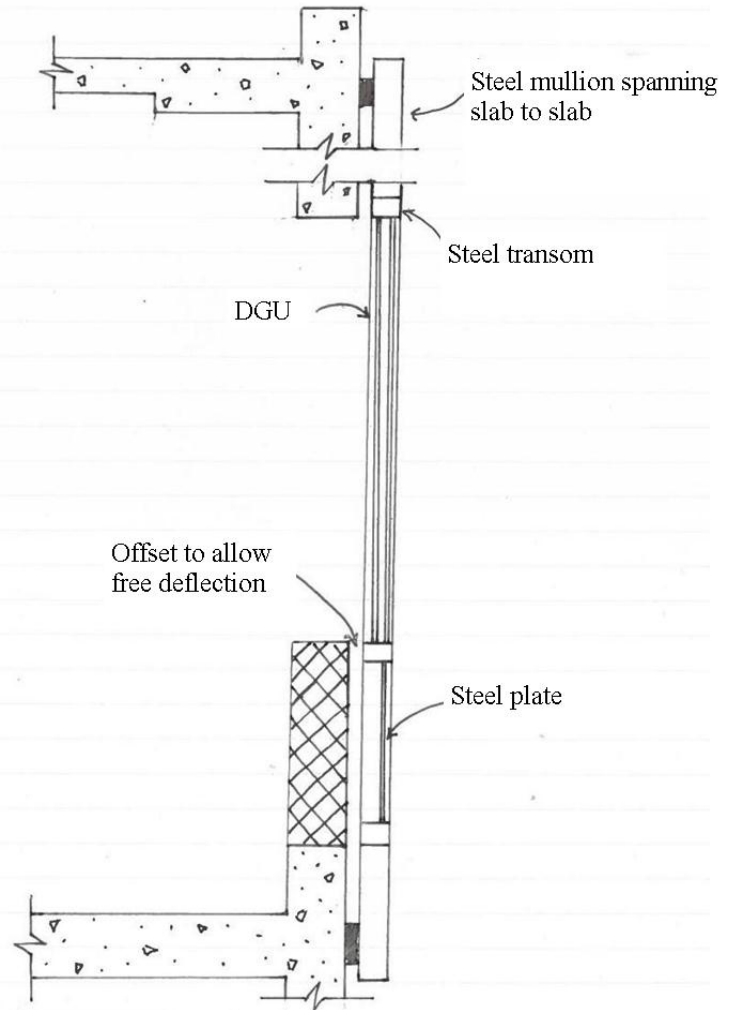
Figure 4.2.12 - Section through scheme for window replacement at high level. (Cladding and finishes omitted for clarity)

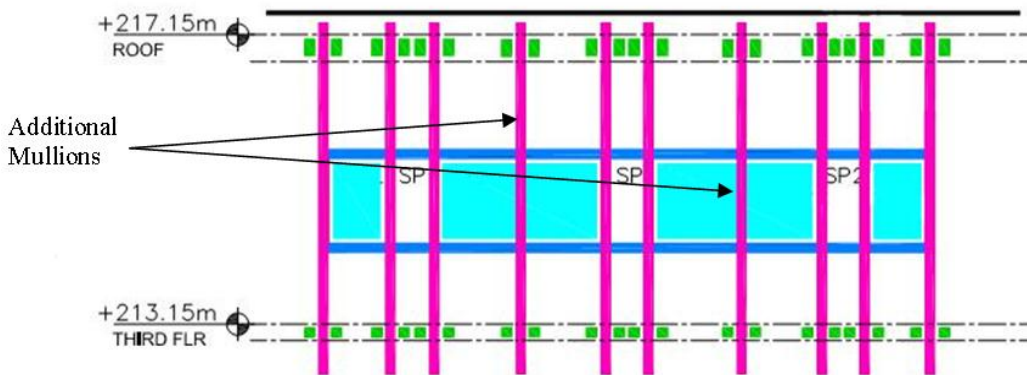
Figure 4.2.13 - Schematic drawing of the window coverings to be applied.

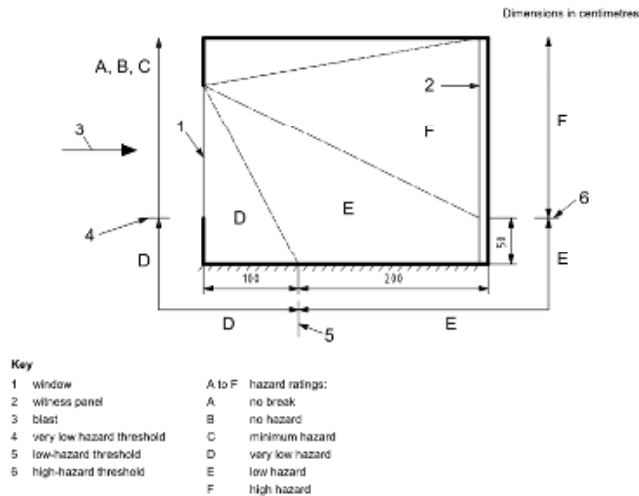
DFAIT's performance criterion is Level C – Minimum hazard (see below) in accordance with ISO16933:2007. It should be noted that, in terms of design by calculation, Level C is assumed when the pvb interlayer of laminated glass is not expected to tear.

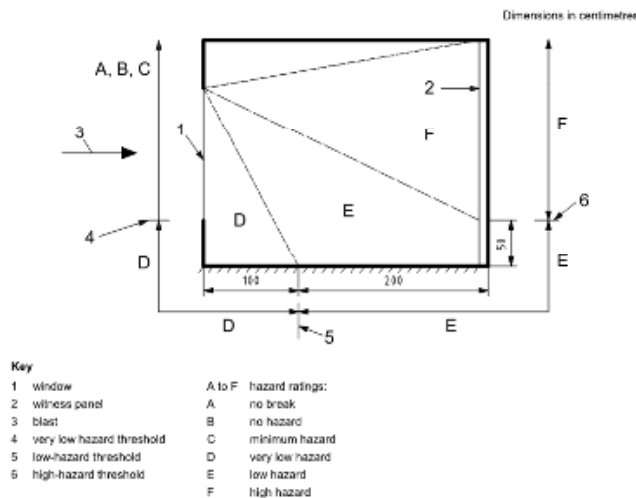
DFAIT's performance criterion is Level C – Minimum hazard (see below) in accordance with ISO16933:2007. It should be noted that, in terms of design by calculation, Level C is assumed when the pvb interlayer of laminated glass is not expected to tear.

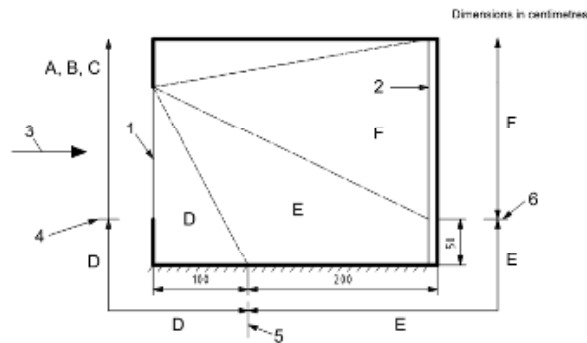
Key	
1 window	A to F hazard ratings:
2 witness panel	A no break
3 blast	B no hazard
4 very low hazard threshold	C minimum hazard
5 low-hazard threshold	D very low hazard
6 high-hazard threshold	E low hazard
	F high hazard

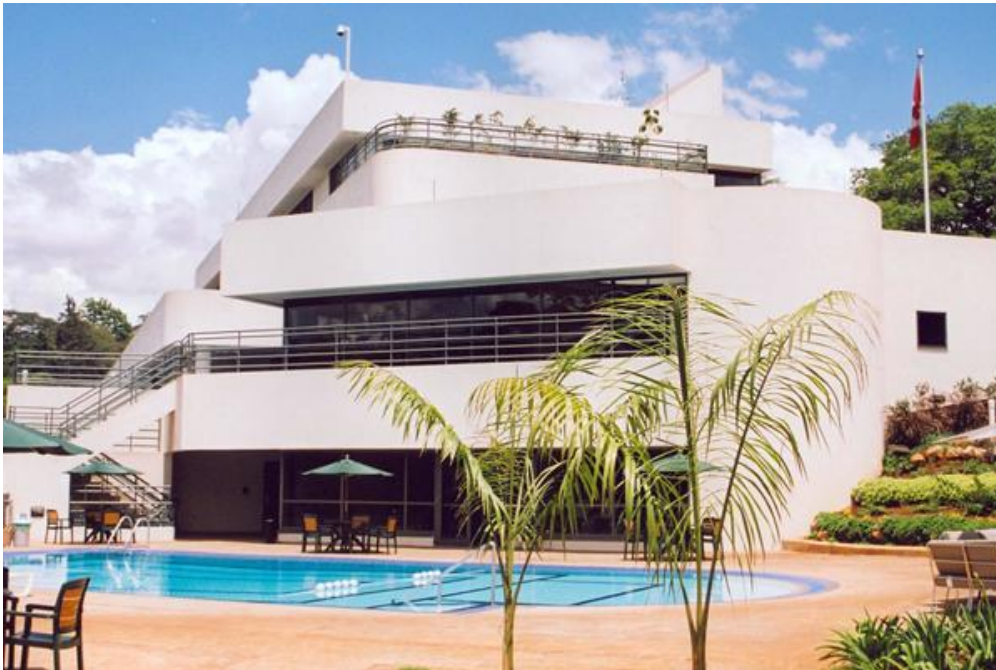
Figure 1: Picture of the Canadian High Commission in Nairobi

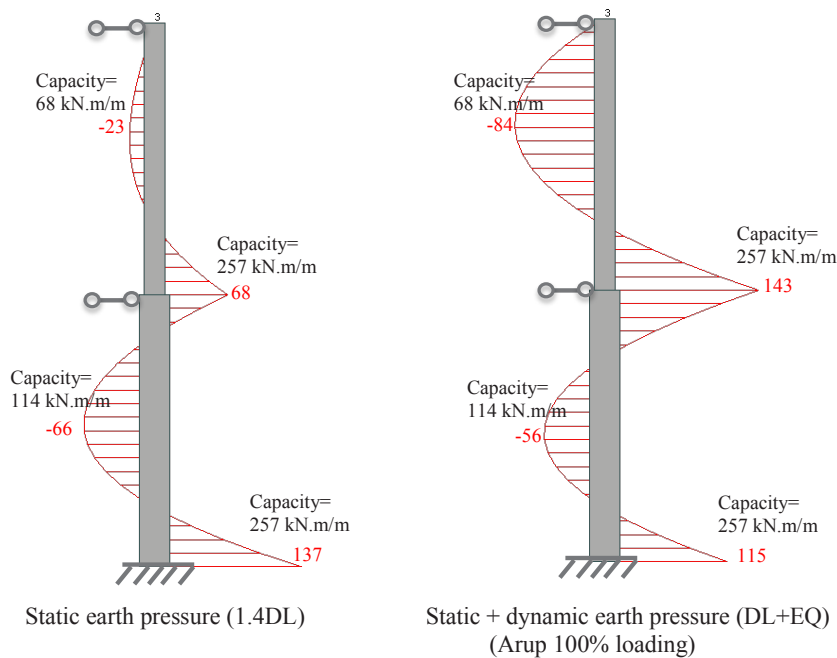
Figure 16: Retaining Wall bending capacity checking
