Preliminary Building Envelope, Structural and Space Optimization Study
Canadian Chancery,
Nairobi, Kenya

Final Submission
June 25th, 2013

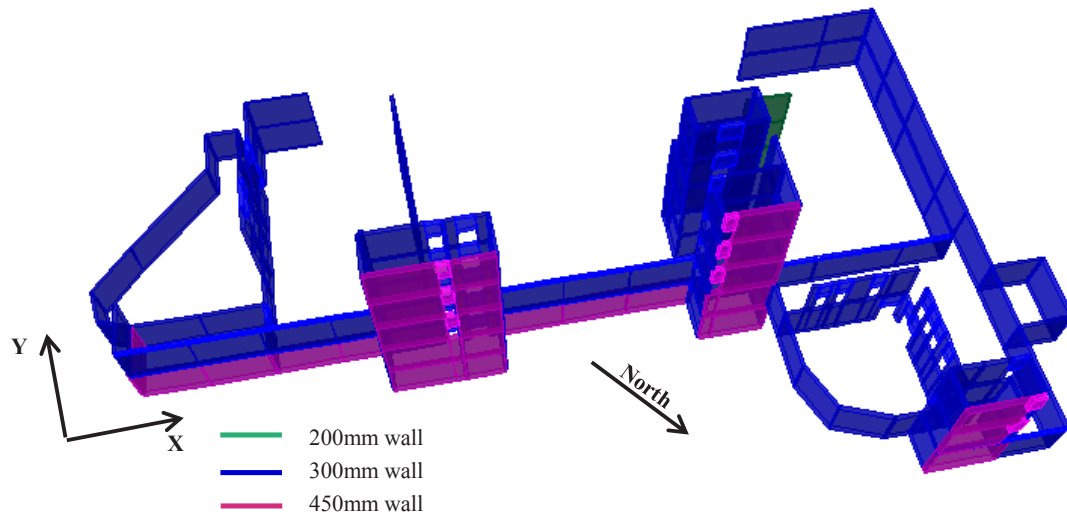
Figure 17: Outline of Finite Element Model of Lateral Force Resisting System (ETABS)

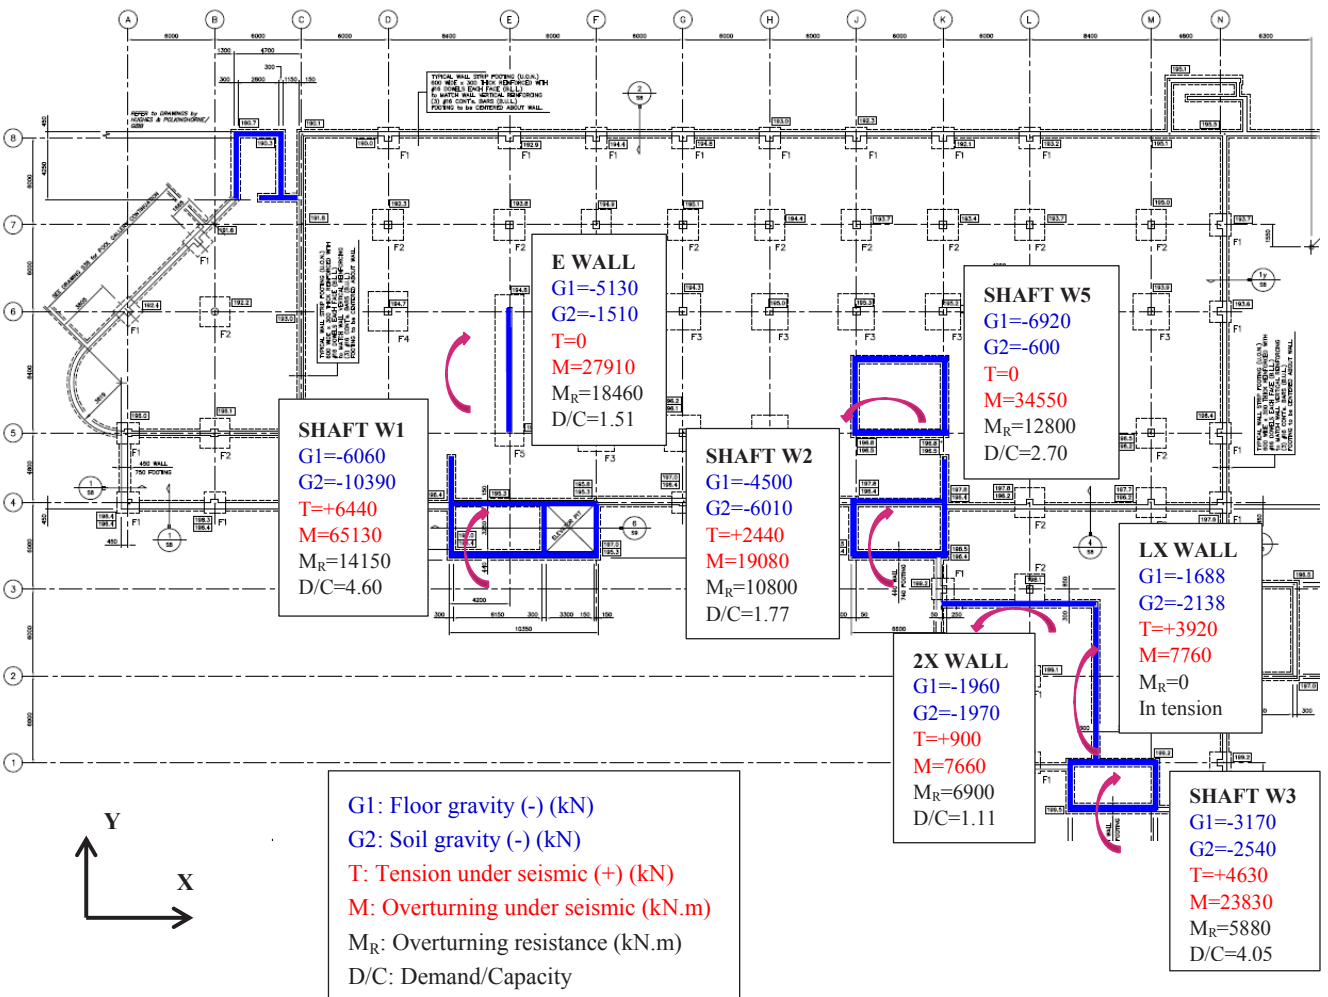
Figure 18: Walls and shafts overturning checking (Arup 100% loading)

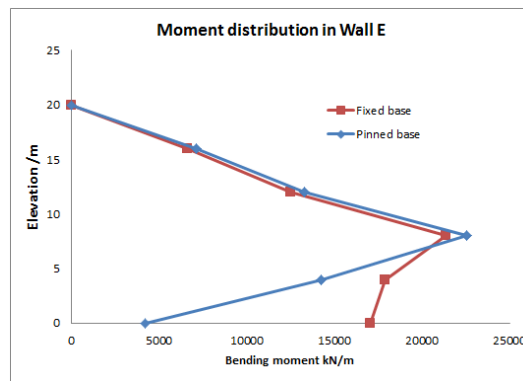
Figure 19 - Moment Distribution in Wall E

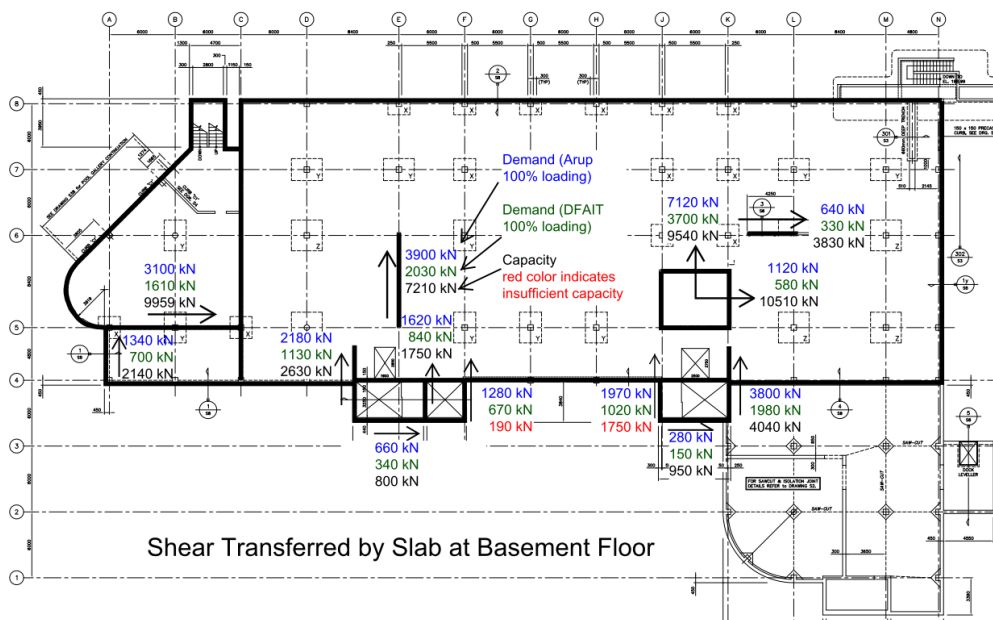
Figure 20: Diaphragm capacity evaluation to ensure the shear transfer

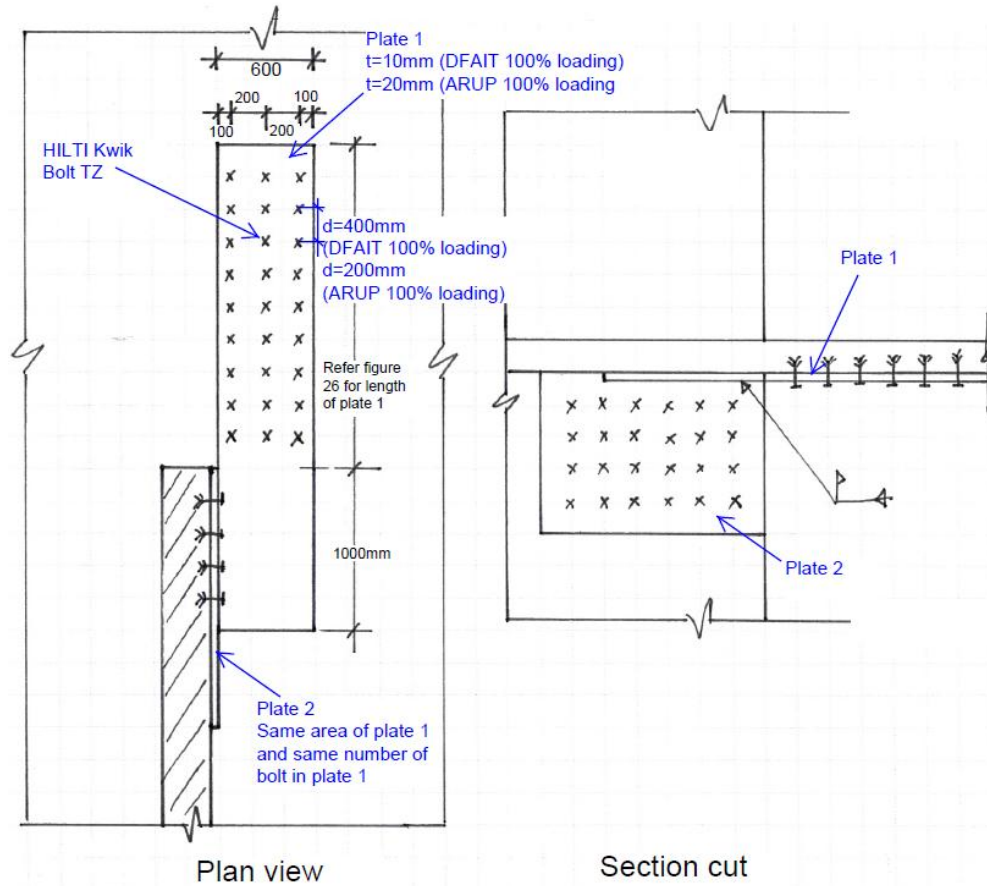
Figure 25: Typical details of diaphragms reinforcing

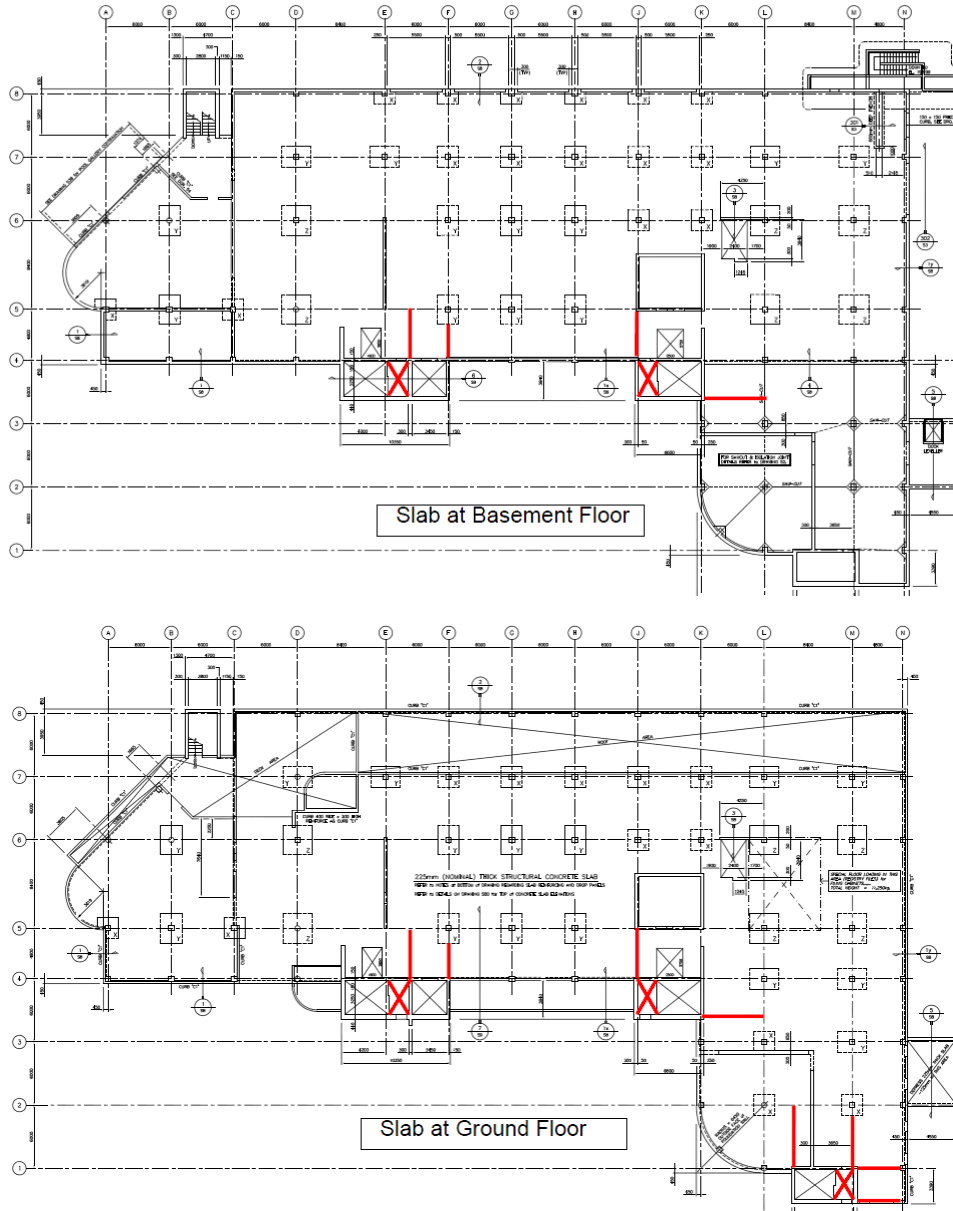
Figure 26: The layouts of recommended steel plate floor trusses

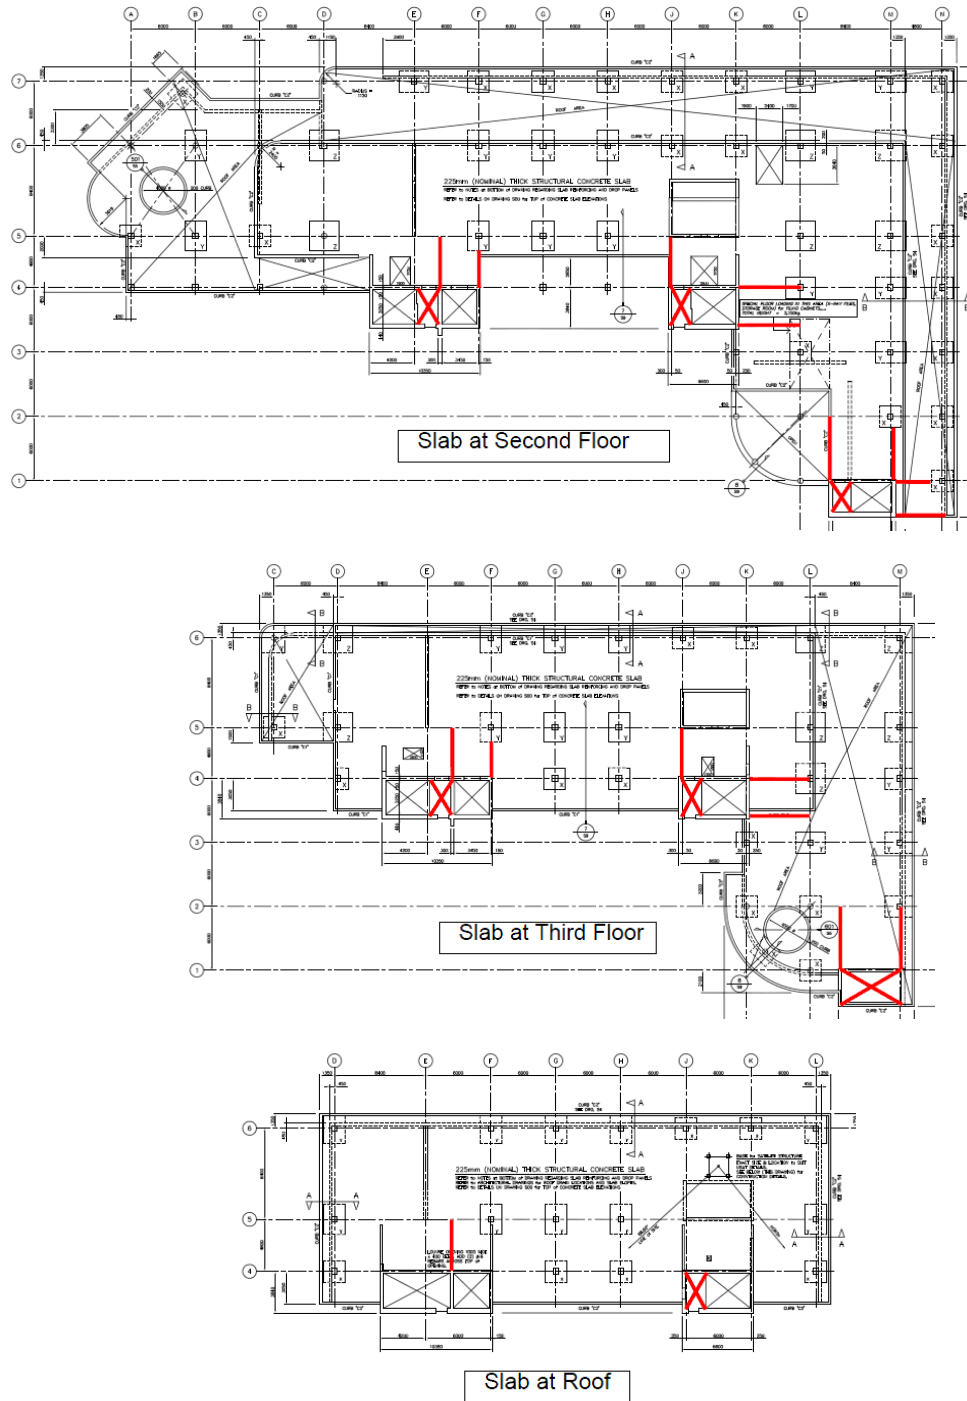
Figure26: The layouts of recommended steel plate floor trusses (Continued)

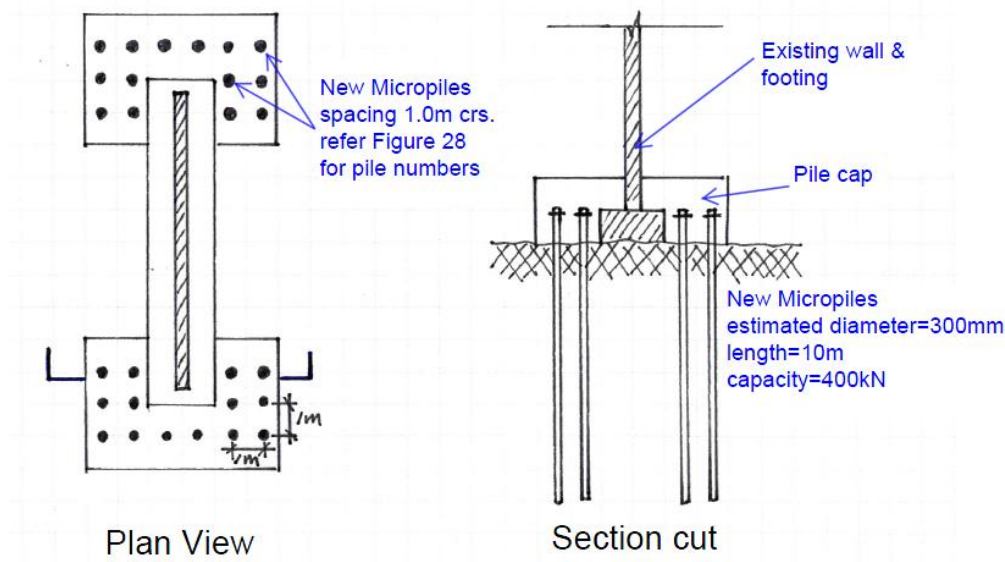
Figure 27: Typical details of foundation retrofit by micropiles

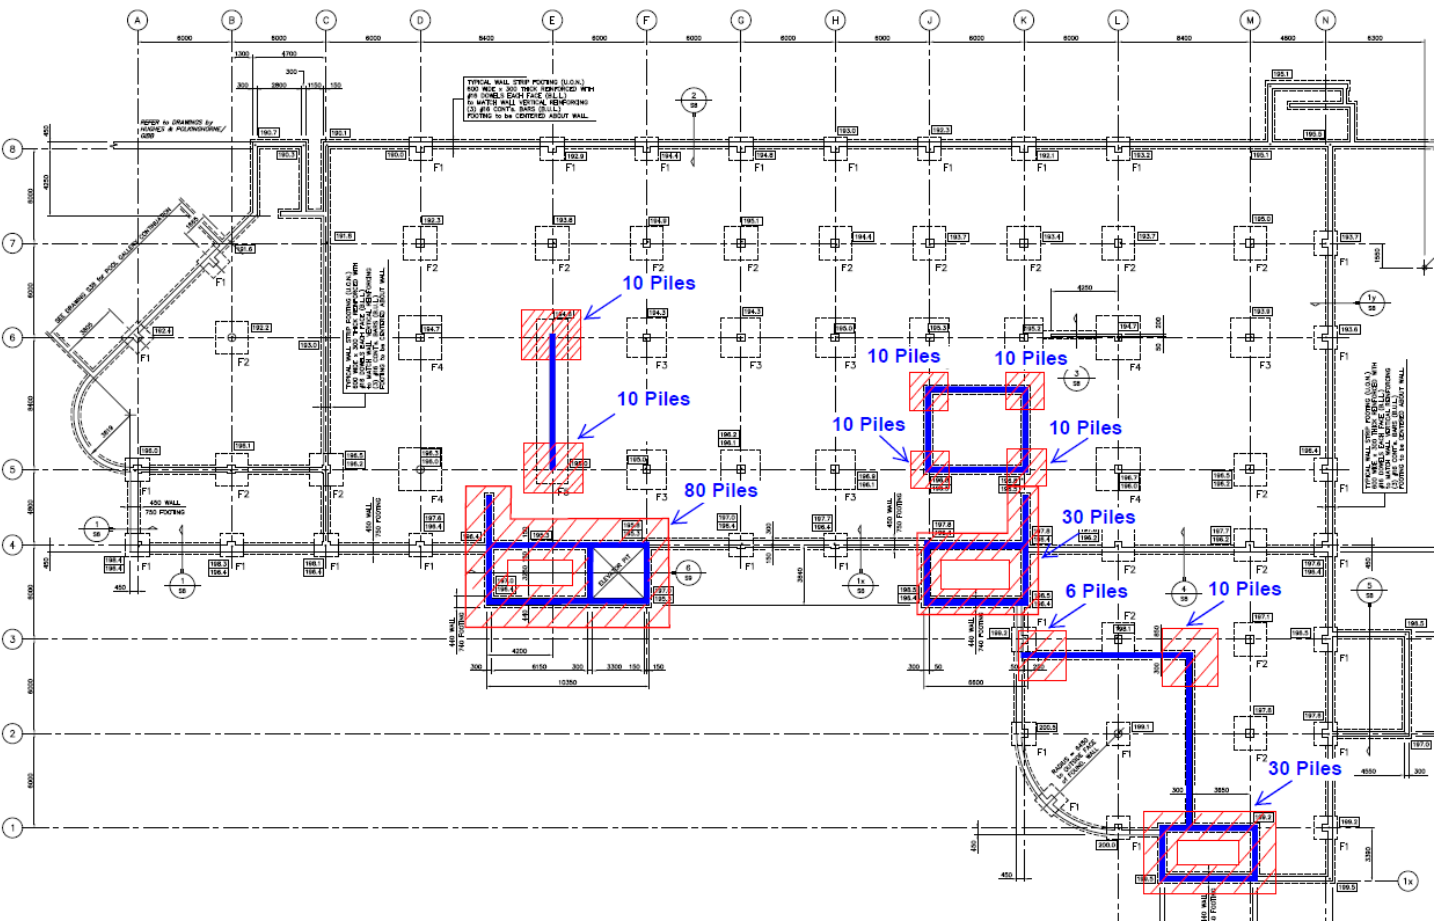
Figure 28: Layout of recommend retrofit area of foundation

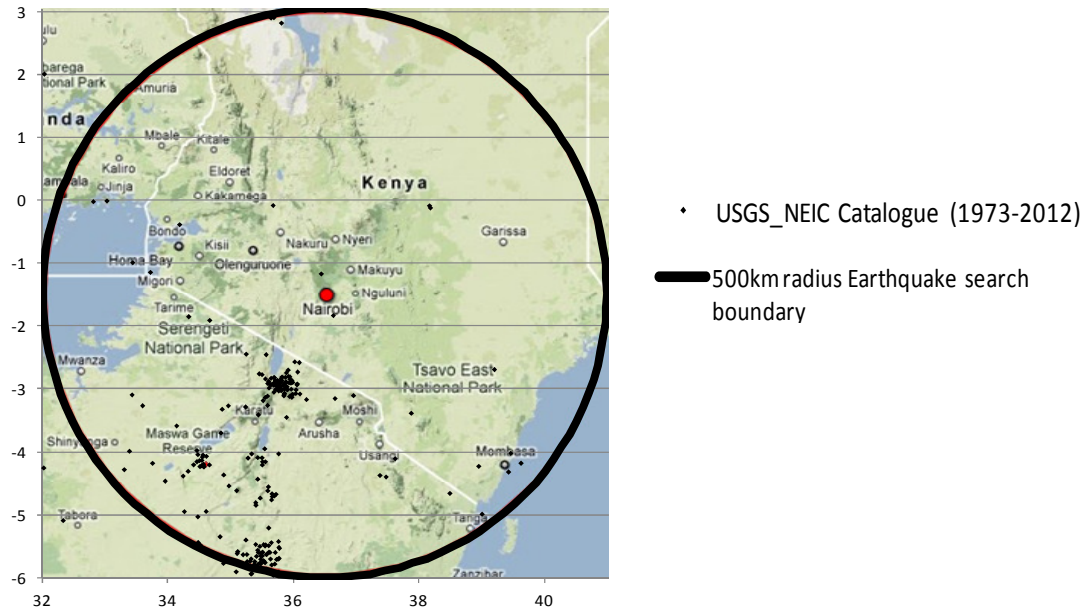
Figure 5- Regional seismicity 1973-2012 within 500km radius from the site

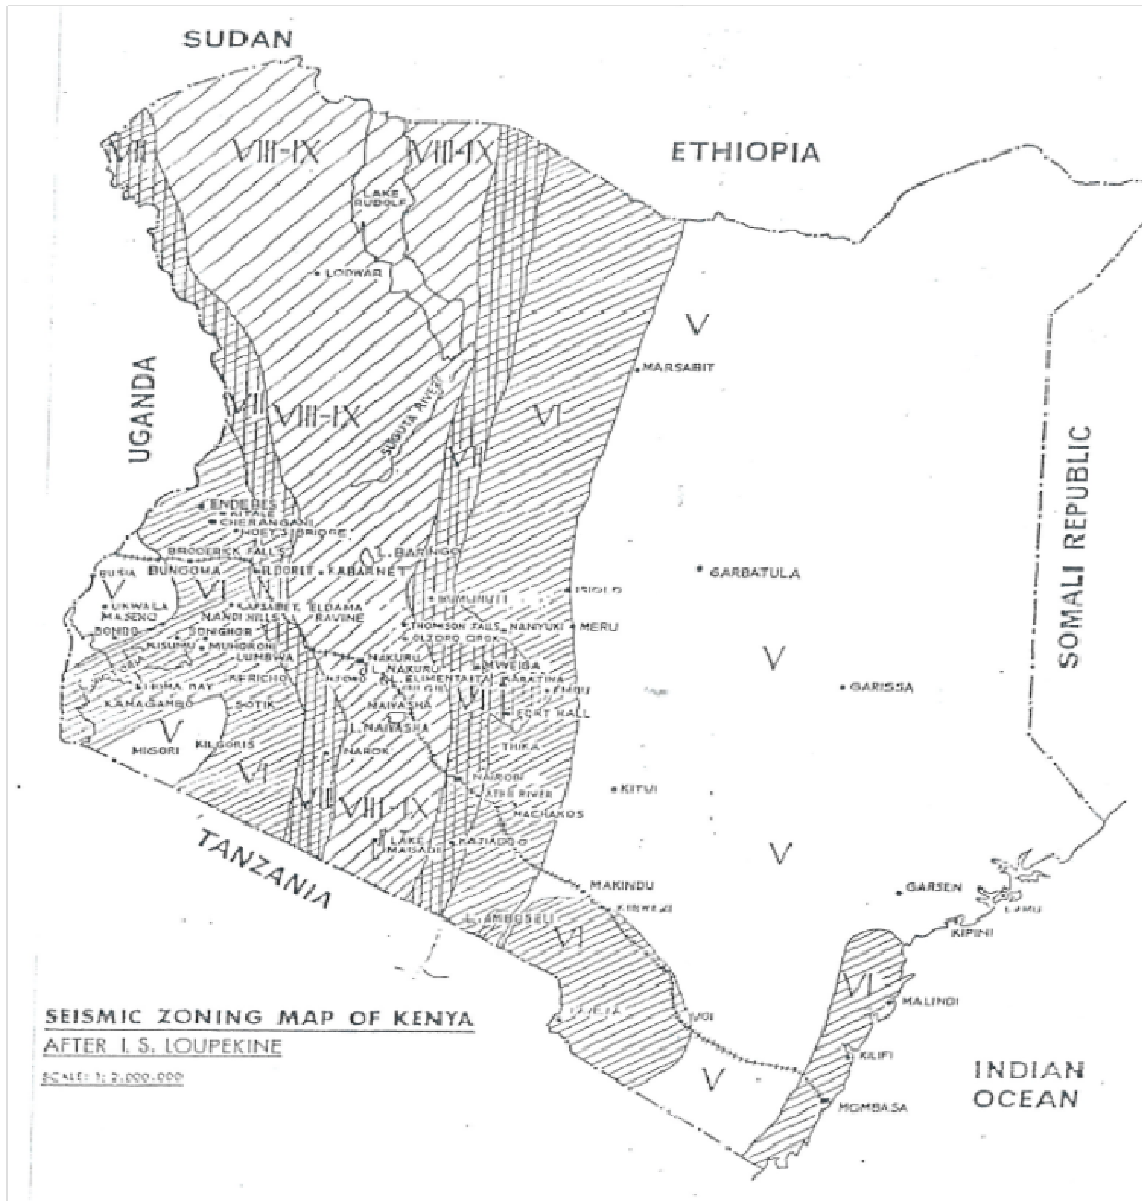
Figure 6- Seismic Hazard Zone Map of Kenya (Kenyan Guidance on Seismic Design, 1973).

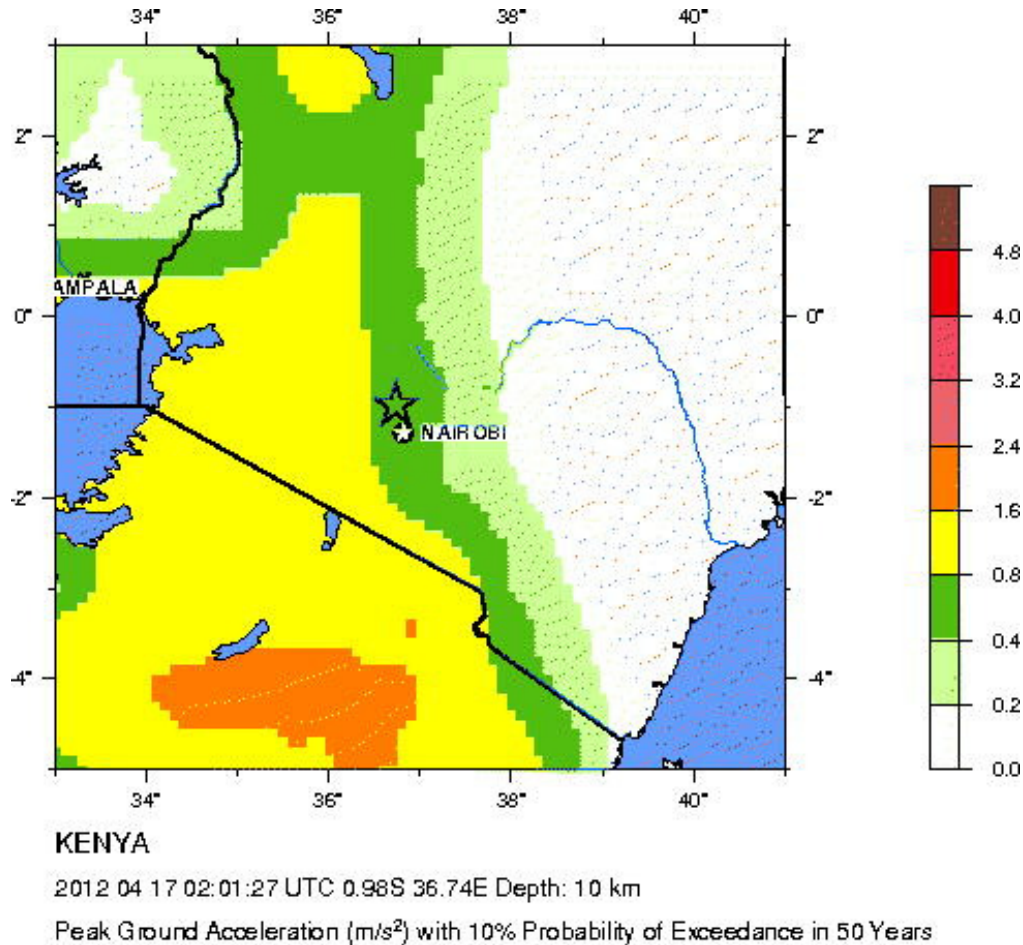
Figure 7- Peak Ground Acceleration (m/s²) with 475 years return period for Southern Kenya (GSHAP; Midzi et al., 1999)

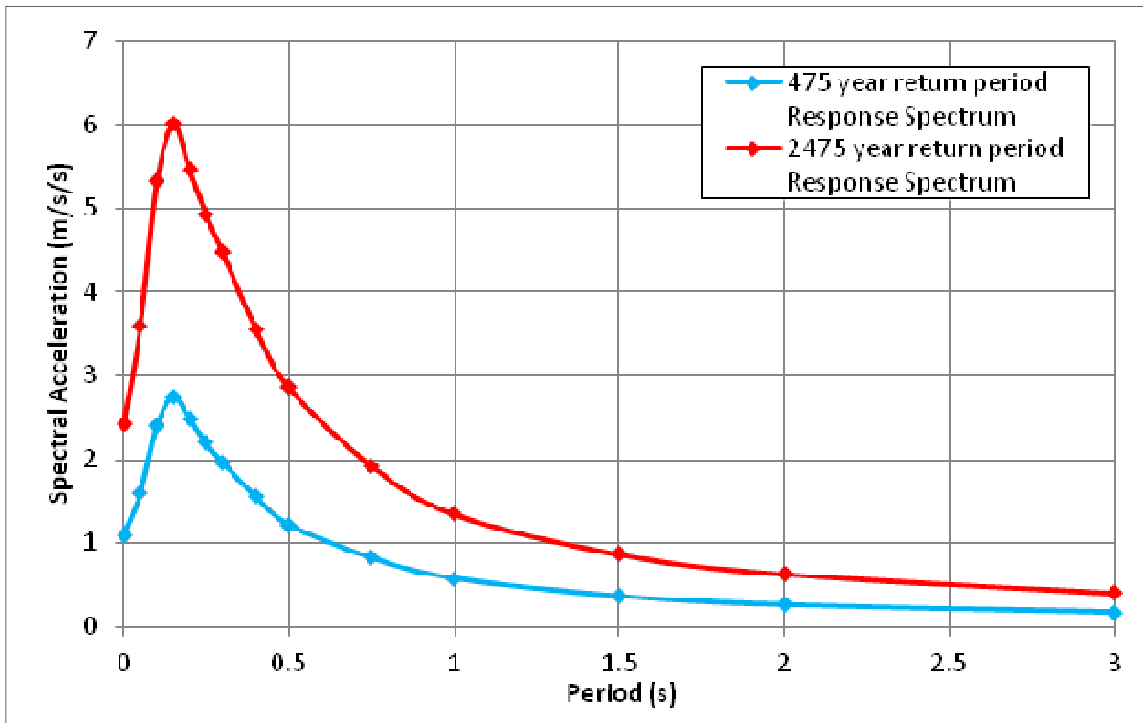
Figure 8- Response Spectra for 475 and 2475 year return periods after Arup (1991).

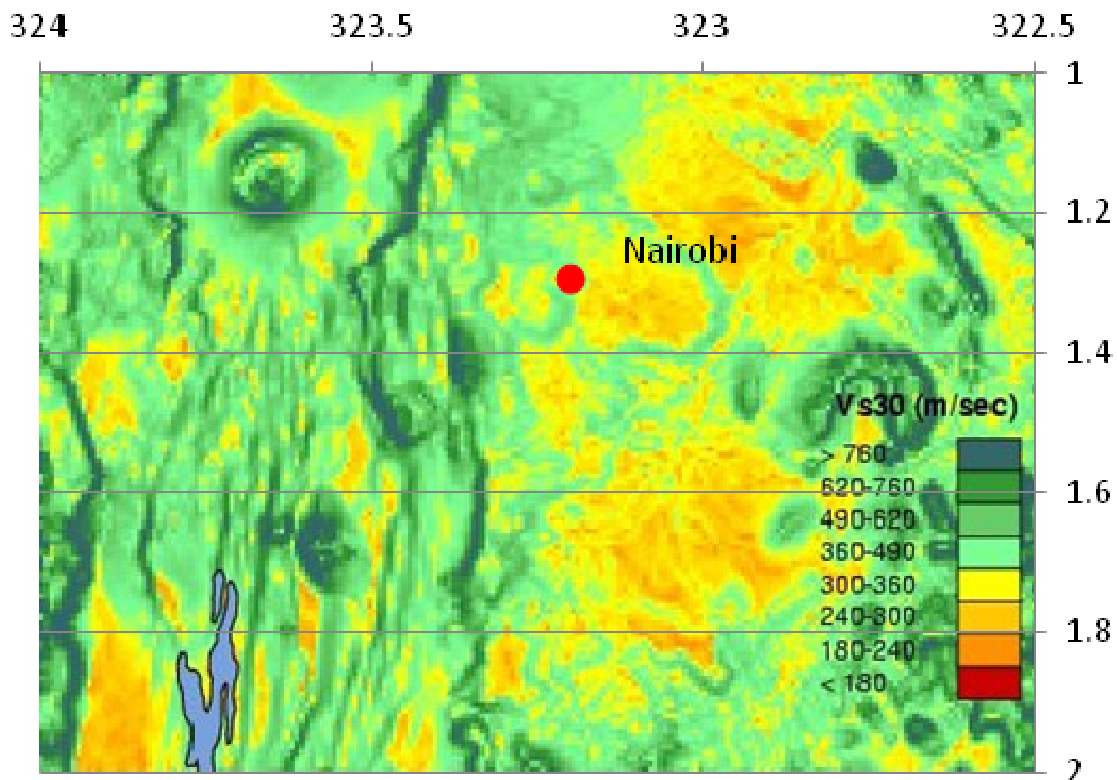
Figure 9- Vs,30 Map of Nairobi Region (USGS)

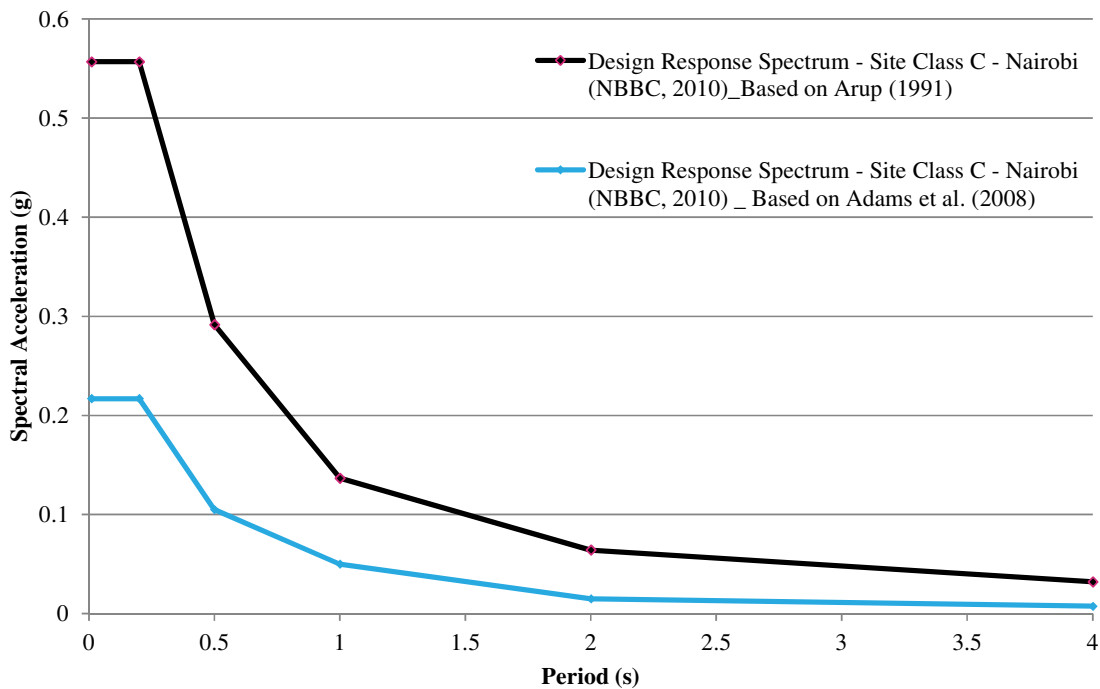
Figure 10- Design response spectrum for the site (NBBC, 2010)
