**HAZARDOUS BUILDING MATERIALS SURVEY
CANADIAN FOOD INSPECTION AGENCY SPACE,
NORTHWEST ATLANTIC FISHERIES CENTRE, ST. JOHN'S
NEWFOUNDLAND AND LABRADOR**

Submitted to:
Public Works and Government Services Canada
Environmental Services
The John Cabot Building
10 Barters Hill, PO Box 4600
St. John's, NL
A1C 5T2

March 2013

AMEC Project No. TF13076482

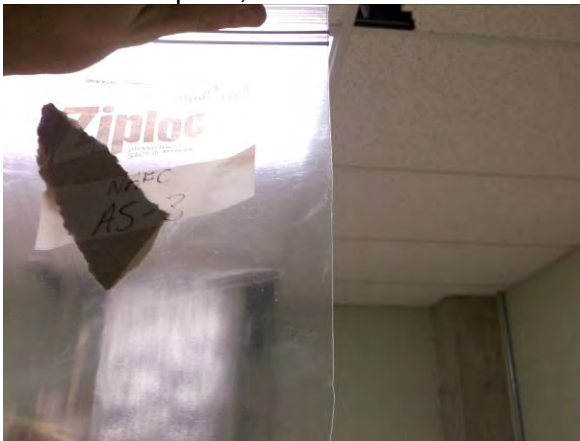
Sample ID	Description	Location Observed	Condition	Area (Approx.)	Analytical Result	ACM (Yes/No)
AS-03 / AS-28	Acoustic ceiling tile (2' x 4') with large and small pinhole pattern.	N20-101,-103,-104,-114,-121; O19-101; O21-105; P20-101,-103,-121; M21-106; M19-101,-102,-103.	Good	598 m ²	No asbestos detected	No
AS-19	Acoustic ceiling tile (2' x 4') with large fissure and pinhole pattern.	M21-106; N20-108,-108A,-115,-116,-118,-120,-122,-123; O21-104; P20-111,-112.	Good	3,383 m ²	1.0 % Chrysotile	No
AS-21	Acoustic ceiling tile (2' x 2') with large pinhole pattern and a texture finish.	M21-106; N20-106; P20-106,-108,-109,-110.	Good	185 m ²	No asbestos detected	No
AS-22	Acoustic ceiling tile (2' x 2') with pinhole and fleck pattern.	P20-108,-109.	Good	36 m ²	No asbestos detected	No

Photo 4: View of acoustic ceiling tile sample AS-03.

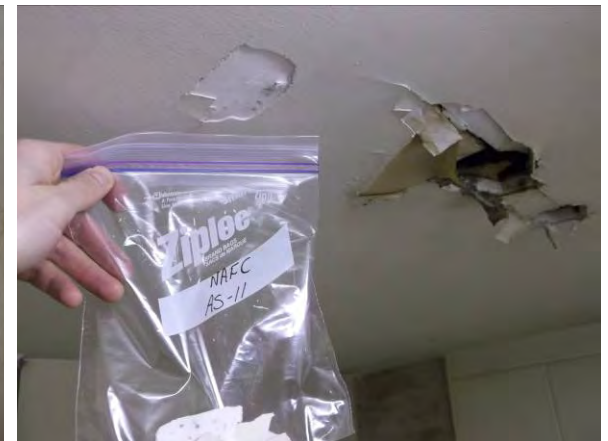
It should be noted that it is common for the asbestos content in troweled on materials, such as drywall joint compound within older buildings, to vary in concentration depending on the methods used to mix and place these materials. Due to this variability in asbestos content, all drywall joint compound throughout the CFIA Space of the building should be treated as an ACM.

Photo 12: View of drywall joint compound sample AS-11.

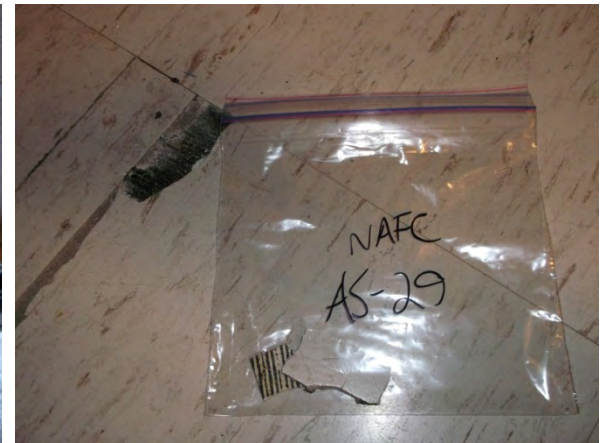
Chrysotile asbestos (3%) was detected in samples AS-29 and AS-41 at a level above the applicable *NL Asbestos Abatement Regulations (111/98)* (i.e., <1%) and therefore these materials (i.e. White with black streak pattern tiles and brown tiles with black mastic) are considered to be ACMs. AS-41 was encountered beneath vinyl floor tiles (i.e. brown with black mastic) in N20: 108, 108A, 115, 119, 119A and 120 and therefore the condition and quantity of this material is unknown. It should be noted that the brown floor tiles with black mastic was encountered beneath vinyl sheet flooring in some areas of the CFIA Space.

Photo 30: View of vinyl floor tile and mastic sample AS-29.

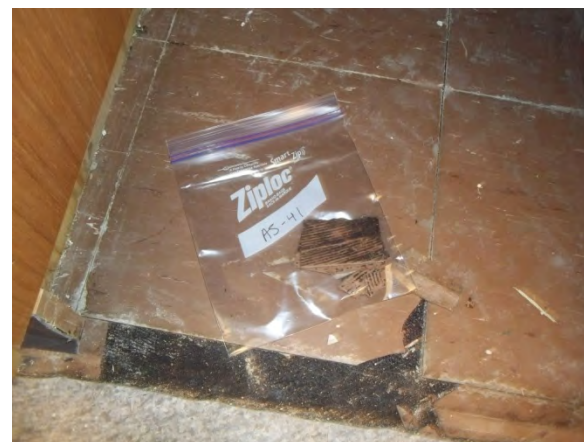
Photo 42: View of vinyl floor tile and mastic sample AS-41.

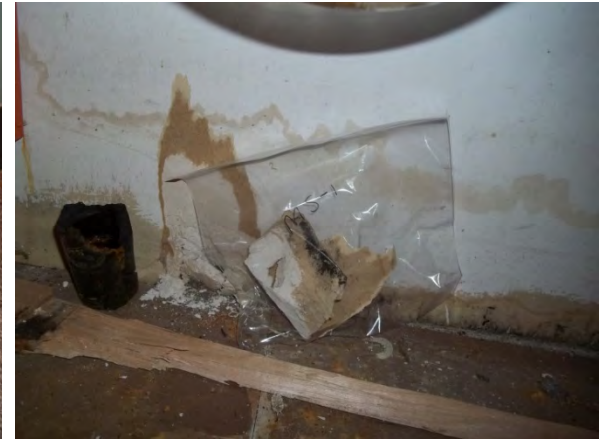
Photo 87: View of mould sample MS-01.

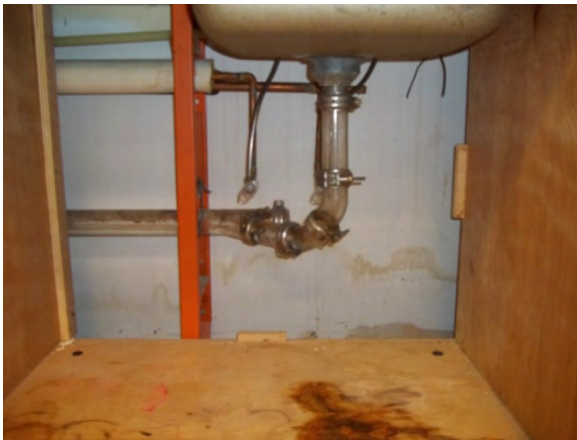
Mould	<ul style="list-style-type: none"> Areas of SVG and water staining were observed on walls under some sinks, on some acoustic ceiling tiles and on some areas of unfinished drywall (ceiling and walls). Results of the mould sampling program revealed that abundant mould growth was present in the sample collected from N20-119. It is important to note that several areas within the CFIA Space contain cooling and refrigeration rooms constructed of insulated panels. It has been AMEC's experience with similarly constructed coolers and freezers that water intrusion into hidden areas behind these panels can sometimes occur and result in mould growth. 	<ul style="list-style-type: none"> If the cooling and refrigeration rooms in the CFIA Space are removed or dismantled, it is recommended that any contractors working in these areas be advised of potential mould and if encountered, further assessment will be required to determine the extent and possible remediation of the mould impacted materials. Building materials with water damage or mould growth (suspected or confirmed) observed within the areas assessed should be remediated using abatement procedures as described in the 2010 EACO Mould Abatement Guidelines. The level of work precautions presented in these guidelines depend on the extent of building materials supporting visible mould growth as well as the estimated extent of hidden mould growth supporting material. The levels of work practise are described as Level 1 (small isolated area) for areas less than 1 m², Level 2 (medium area) for areas 1-10 m² or less than 1 m² in HVAC systems, Level 3 (large area) is described as more than 10 m² or more than 1 m² in HVAC systems.

Photo 88: View of water staining on drywall under a sink in N20-118.

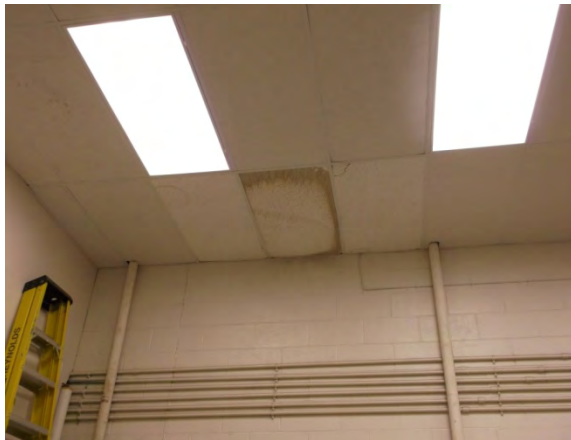
Photo 89: View of acoustic ceiling tile water stain in M19-101.

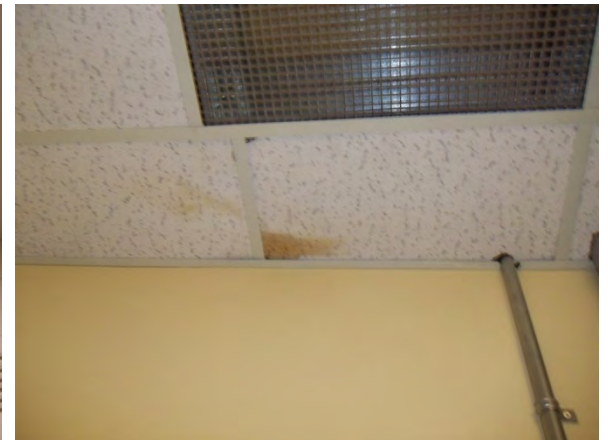
Photo 90: View of acoustic ceiling tile water stain in N20-108A.

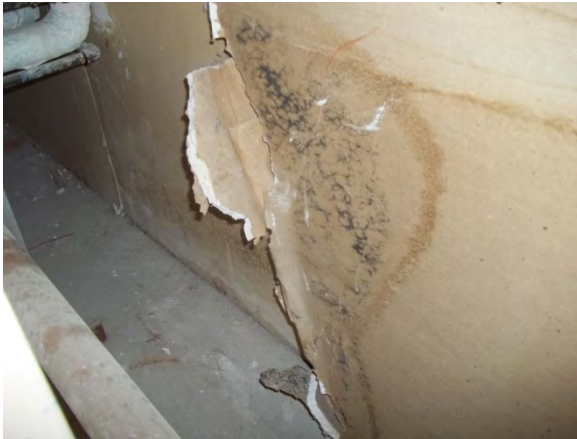
Photo 91: View of water staining and suspected visible mould growth on drywall in N20-125.

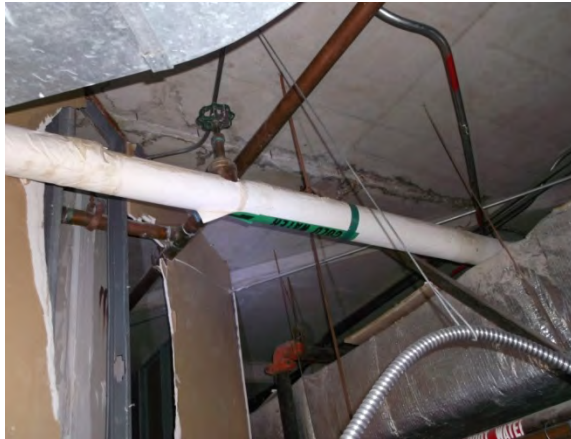
Photo 92: View of water staining and suspected visible mould growth above ceiling tiles in N20-101.

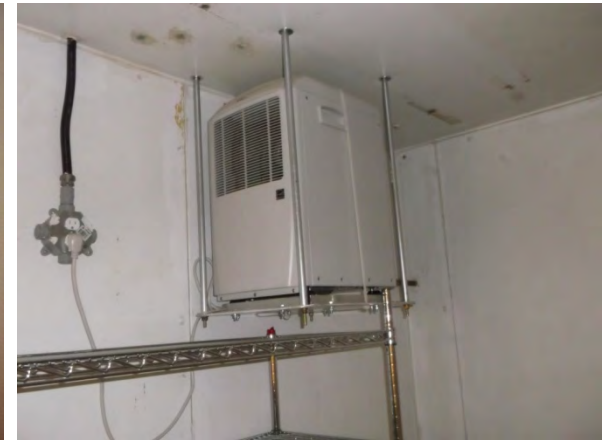
Potential Sources of ODS	<ul style="list-style-type: none"> Potential sources of ODSs identified during this assessment included a portable air conditioning unit, eight (8) cooling units, three (3) laboratory refrigeration units and three (3) domestic refrigerators. The types of refrigerants were not confirmed for the air conditioning unit, one (1) of the eight (8) cooling units, the laboratory refrigeration units and the domestic refrigerators at the time of this assessment. 	<ul style="list-style-type: none"> All ODSs should be removed by an approved contractor prior to disposing of the cooling and refrigeration units from the CFIA Space. The use, storage, operation, maintenance, decommissioning, and disposal of ODS containing equipment in general is regulated at both a Provincial and Federal level and must comply with the most recent NL Halocarbon Regulations and the Federal Halocarbon Regulations. The status of the potential ODS containing equipment should be confirmed through a mechanical contractor or consultant.

Photo 126: View of portable air conditioning unit.

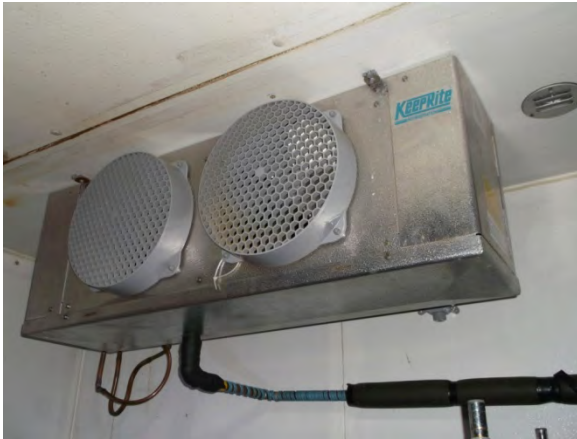
Photo 127: View of cooling unit.
