APPENDIX A

Site Photographs

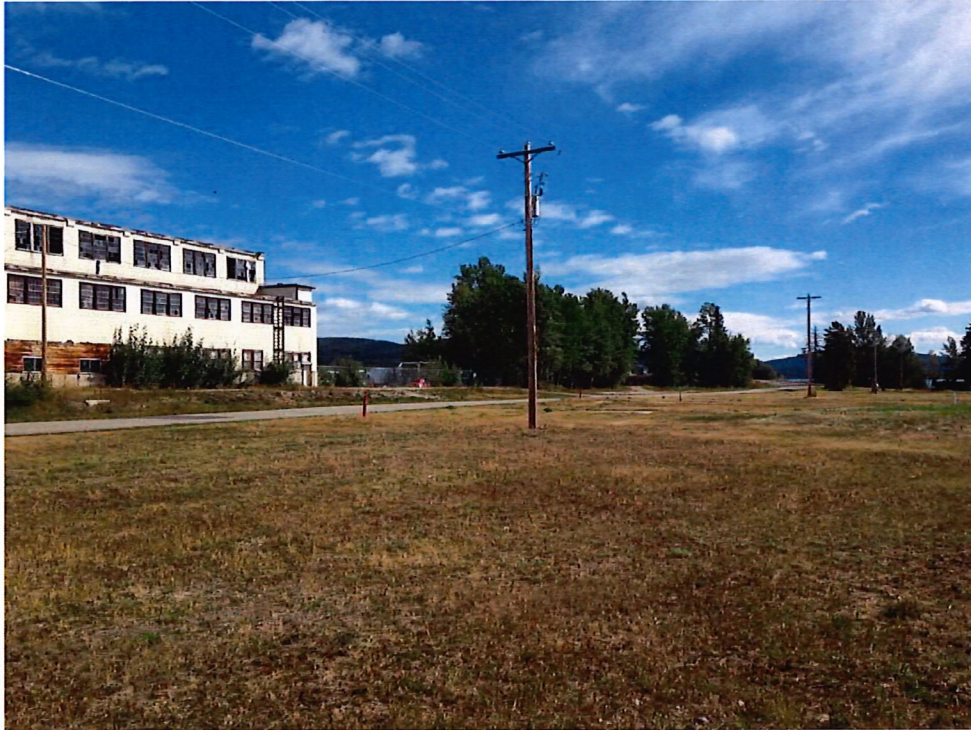
Photograph 1: Northeast view of AEC 6 and overhead power line

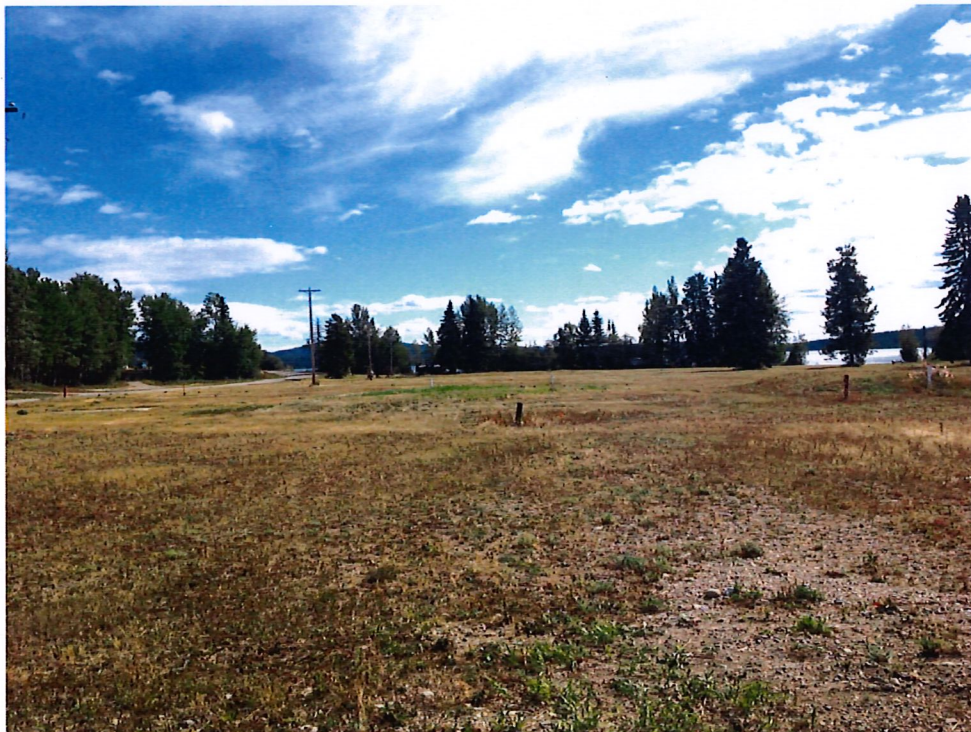
Photograph 2: South view of AEC 6 and septic field (right).

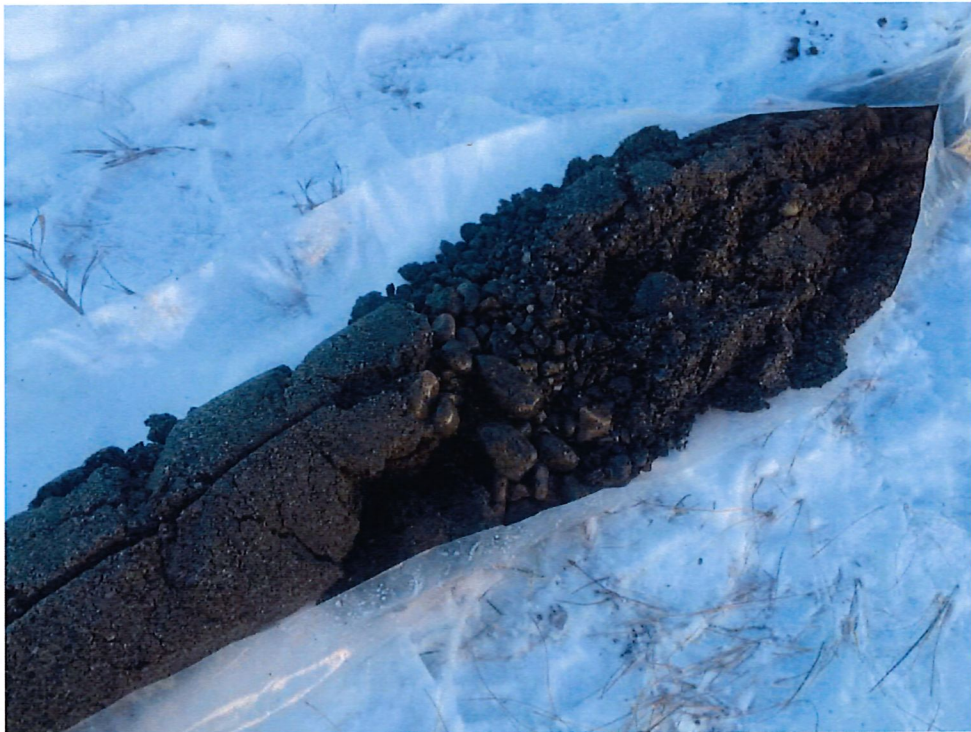
Photograph 3: AEC 6 Sample core of 6-BH15-29, showing coarse gravel and sand layers.

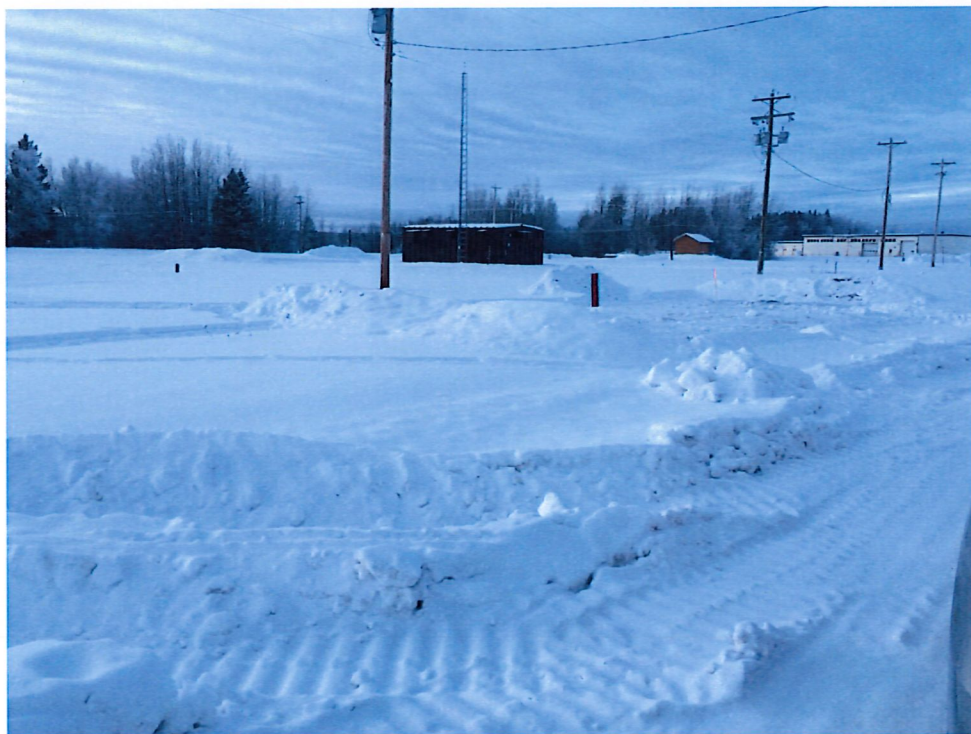
Photograph 4: Southwest view of AEC 6, looking towards MW05-6-9 and 6-BH15-30.

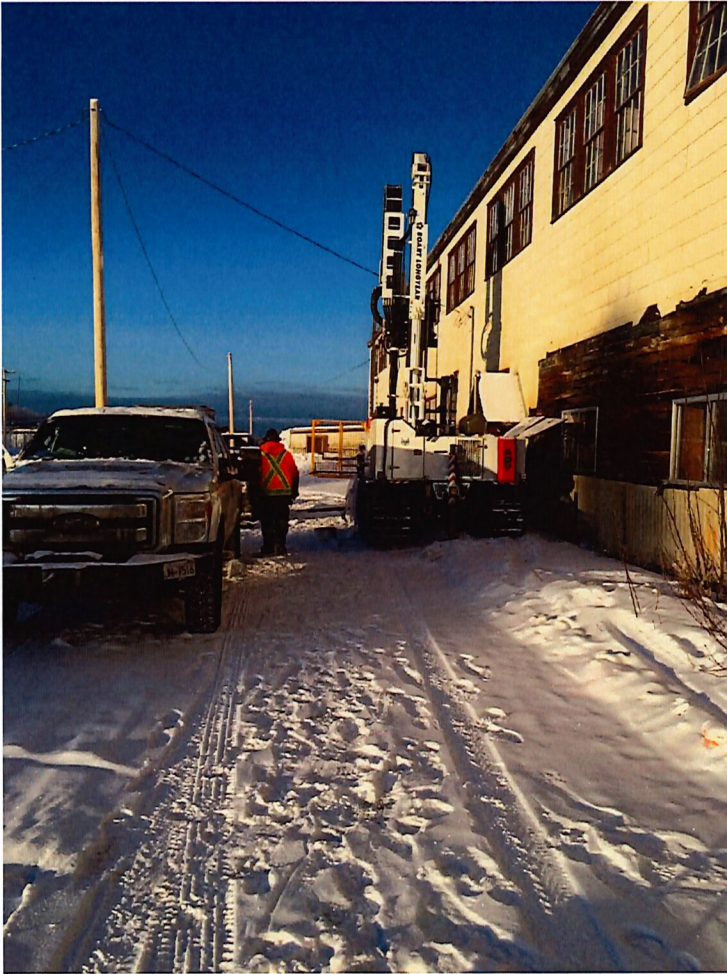
Photograph 5: AEC 6 drilling of location 6-BH15-35, adjacent to the Hangar building.

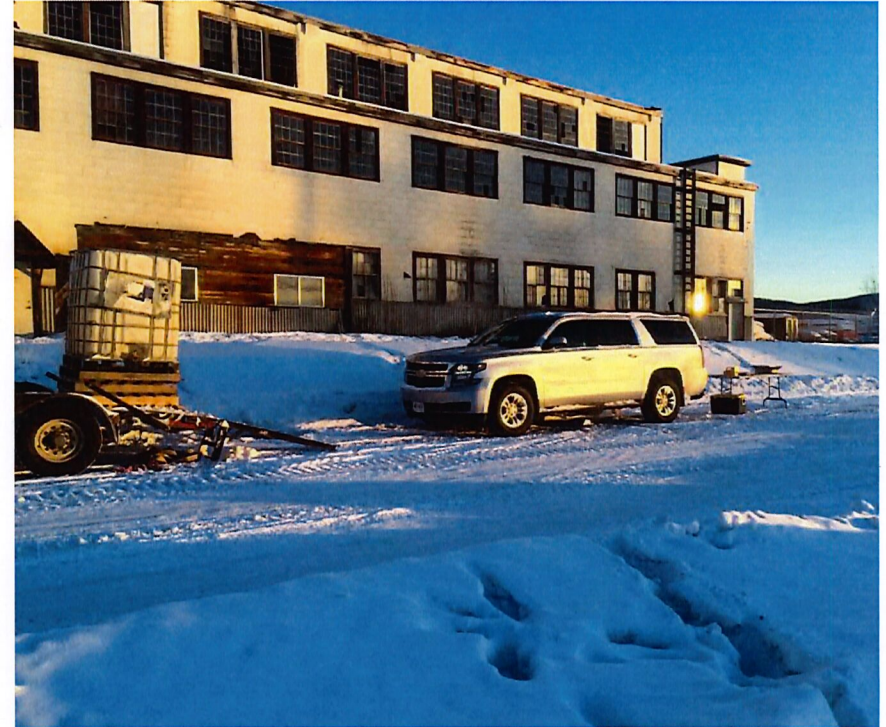
Photograph 6: Northeast view of AEC 6, looking towards 01TP06-1 and the Hangar building.

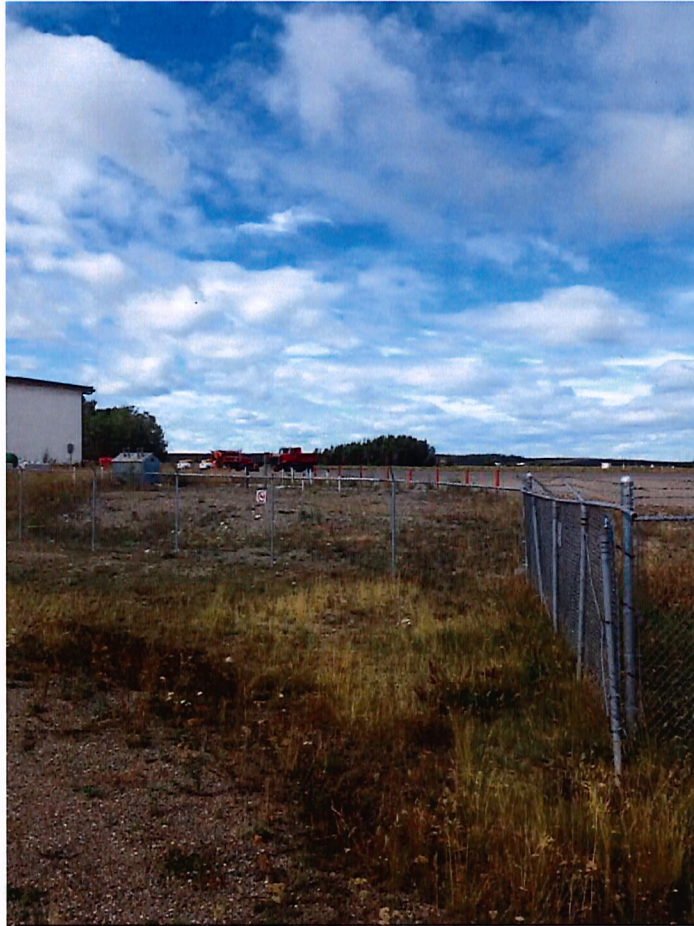
Photograph 7: Northwest view of AEC 7, showing current fence location and bollards.

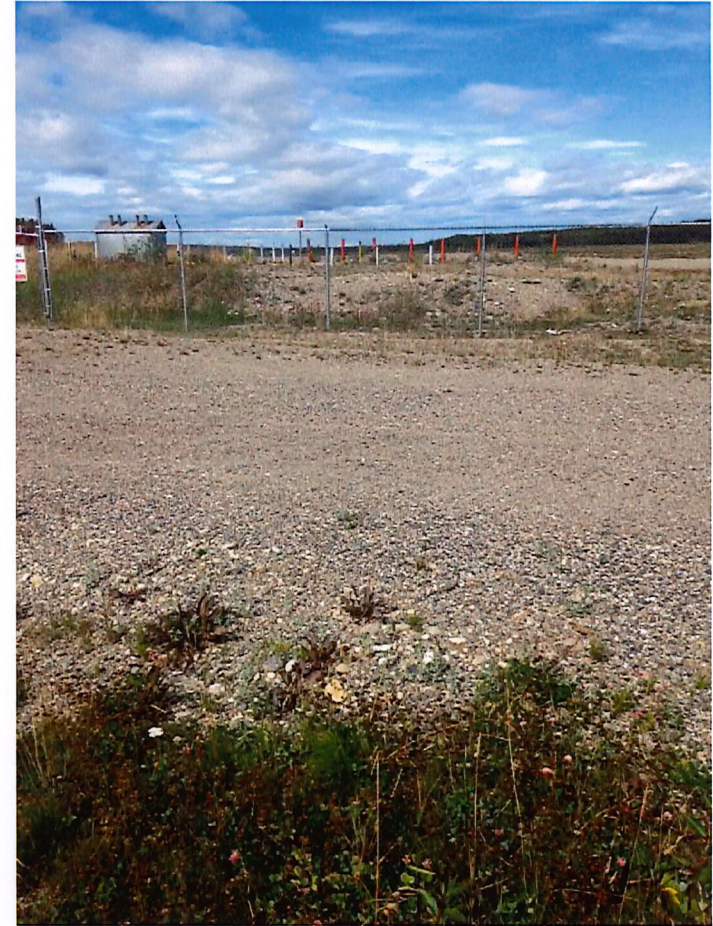
Photograph 8: North view of AEC 7, showing access road, current fence location and bollards.

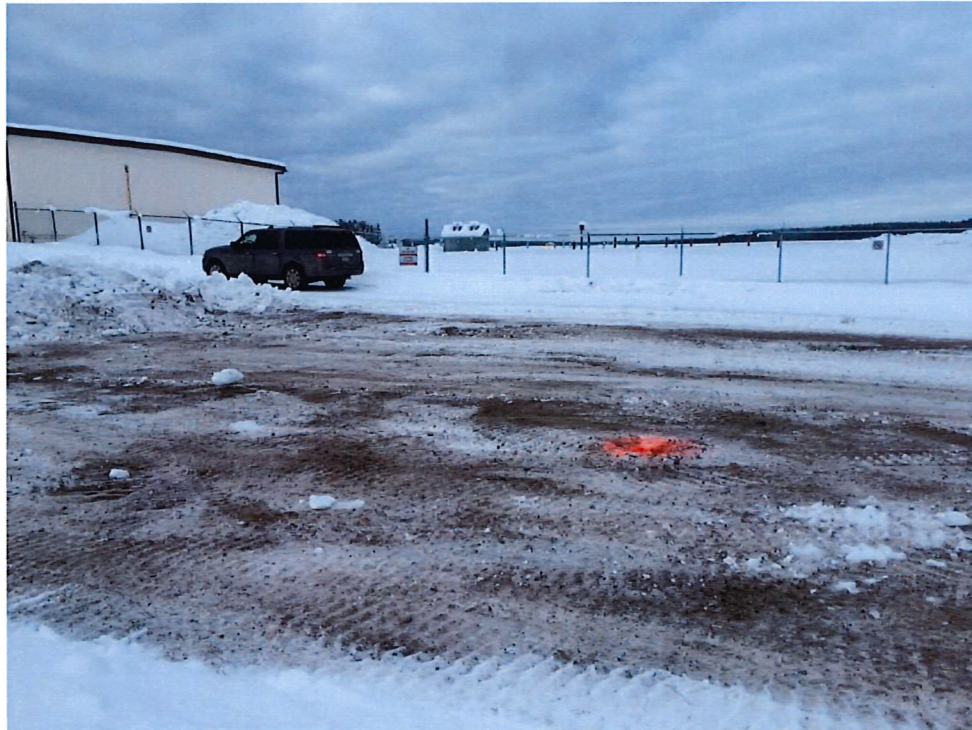
Photograph 9: Northwest overview of AEC 7.

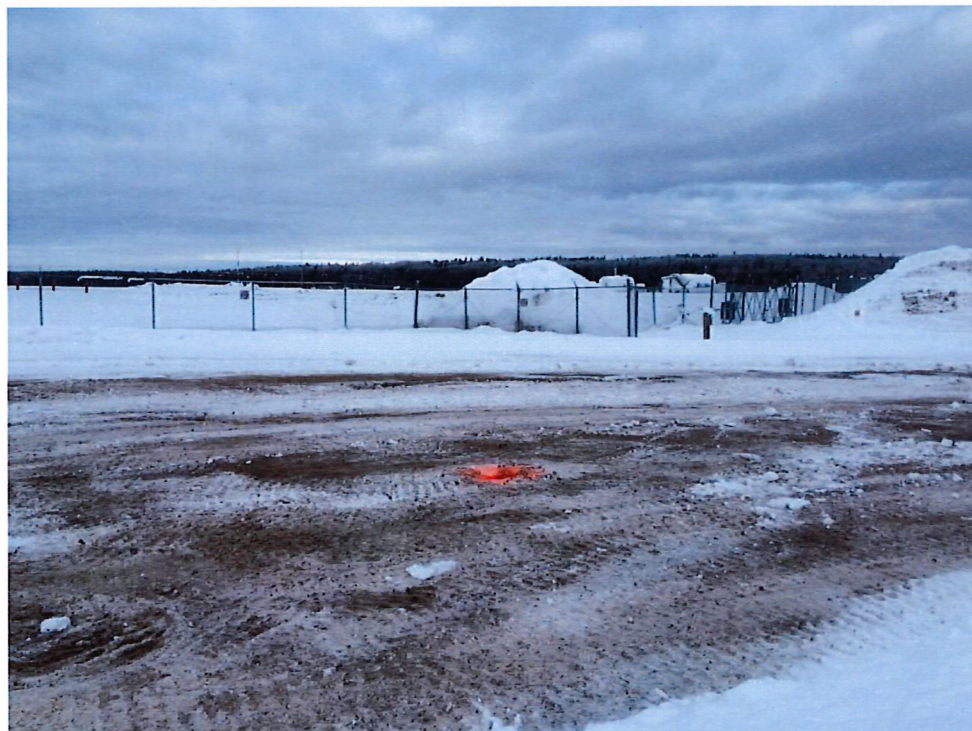
Photograph 10: Northeast view of AEC 7.

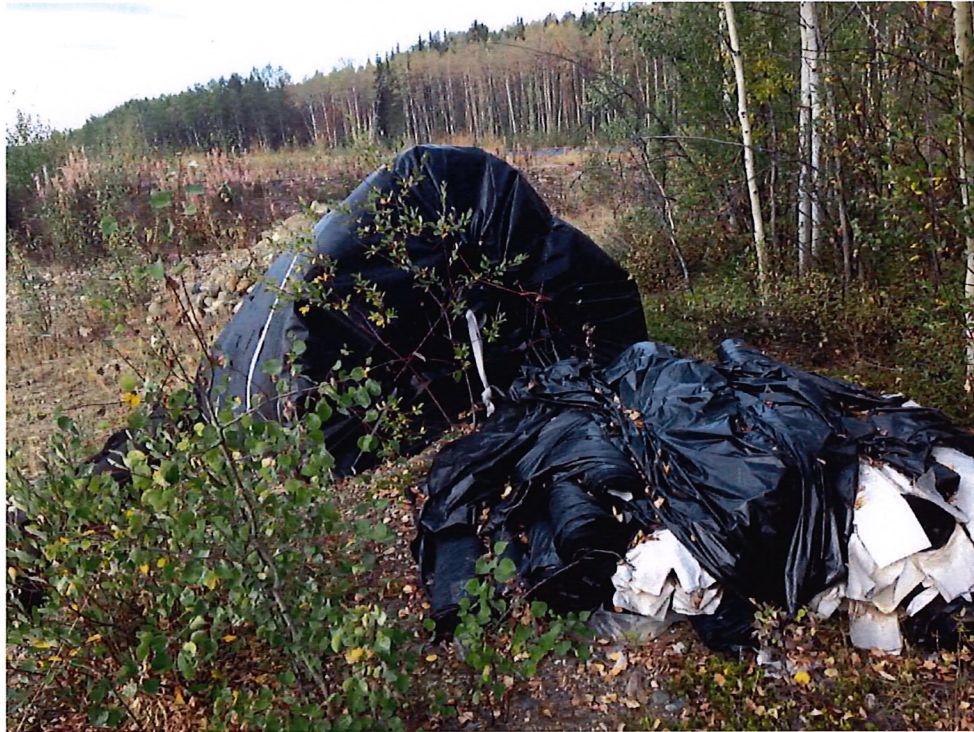
Photograph 11: Curtain liner roll supplied by PWGSC/TC.

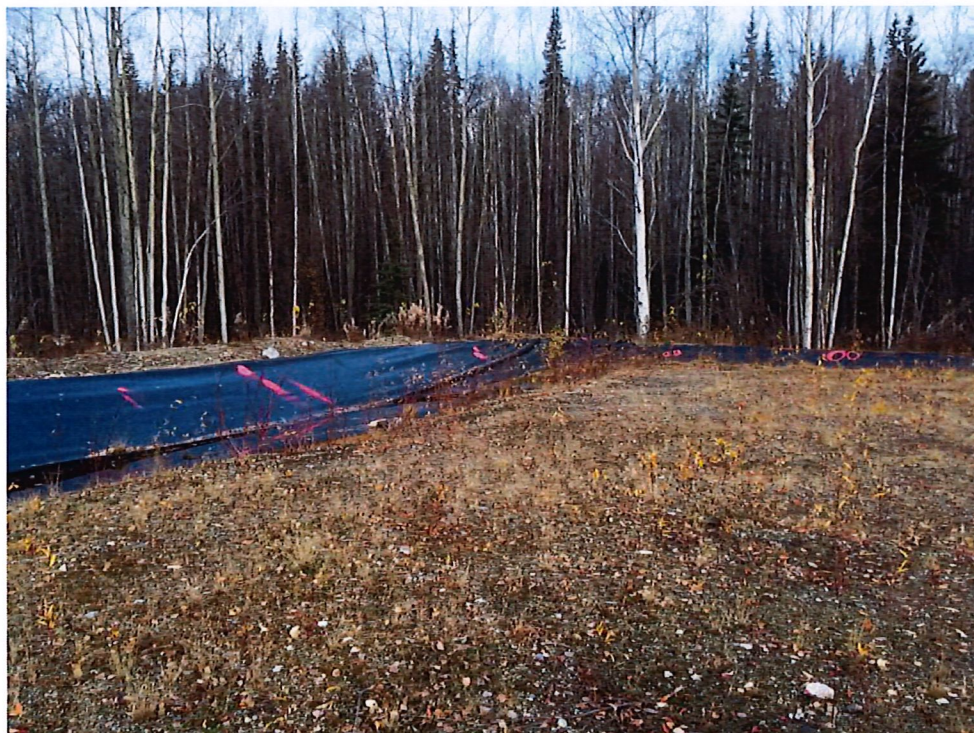
Photograph 12: Small to medium size liner perforations along LTF berm.

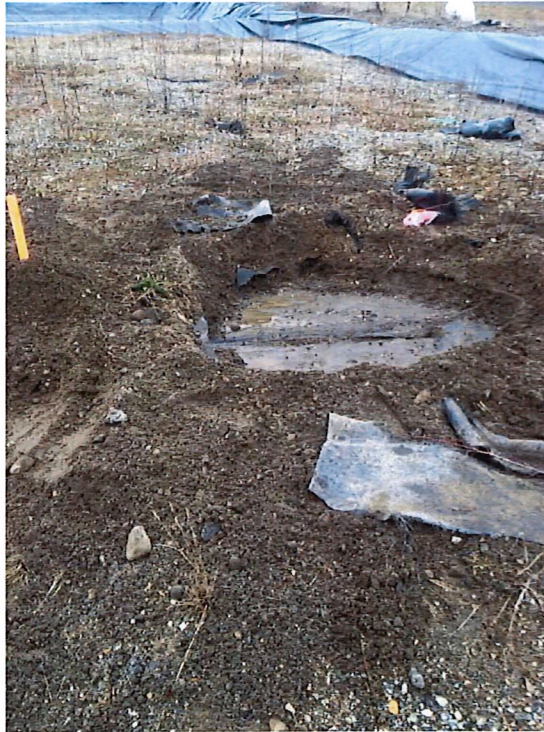
Photograph 13: Detailed view of LTF cell liner perforation.

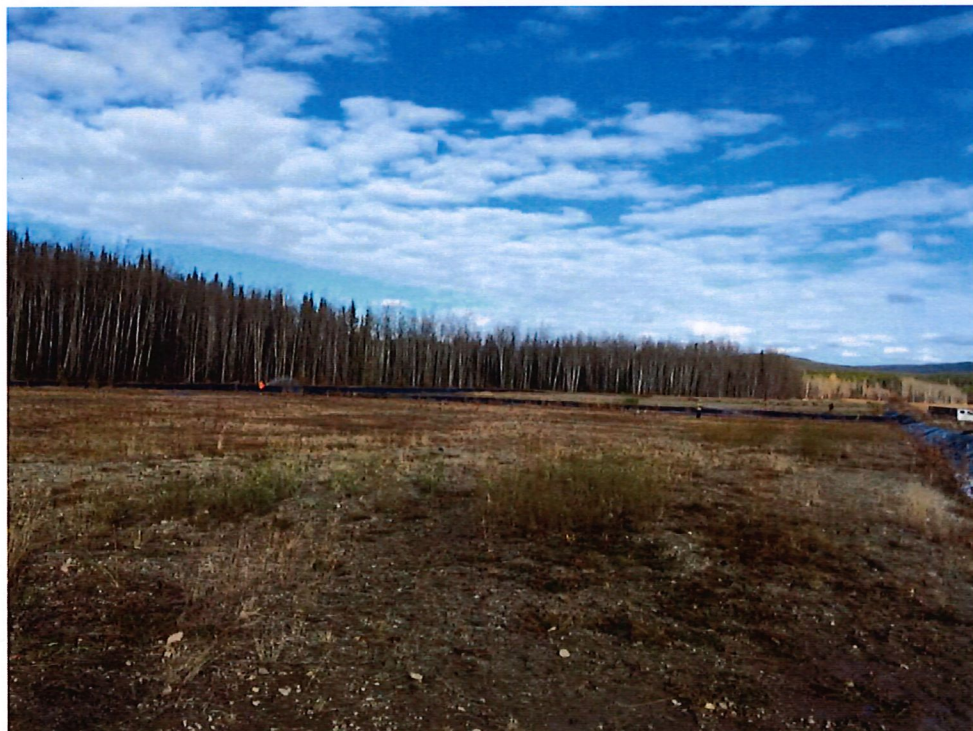
Photograph 14: Northeast view of Land Treatment Facility #4

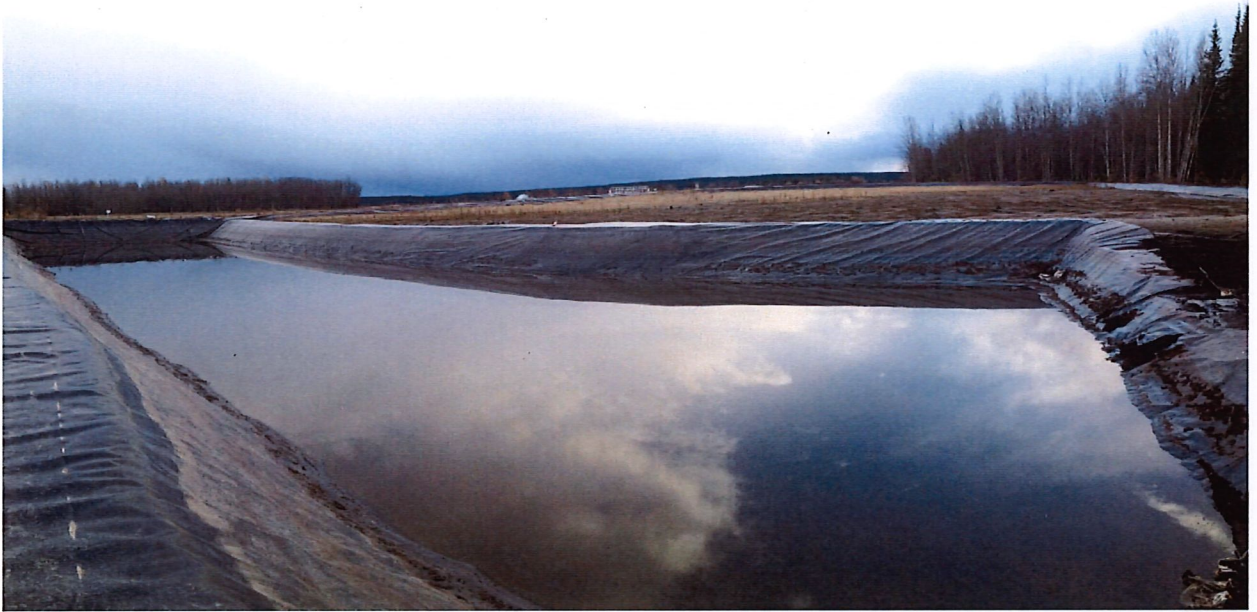
Photograph 15: Southwest view of Land Treatment Facility #4, showing central sump.

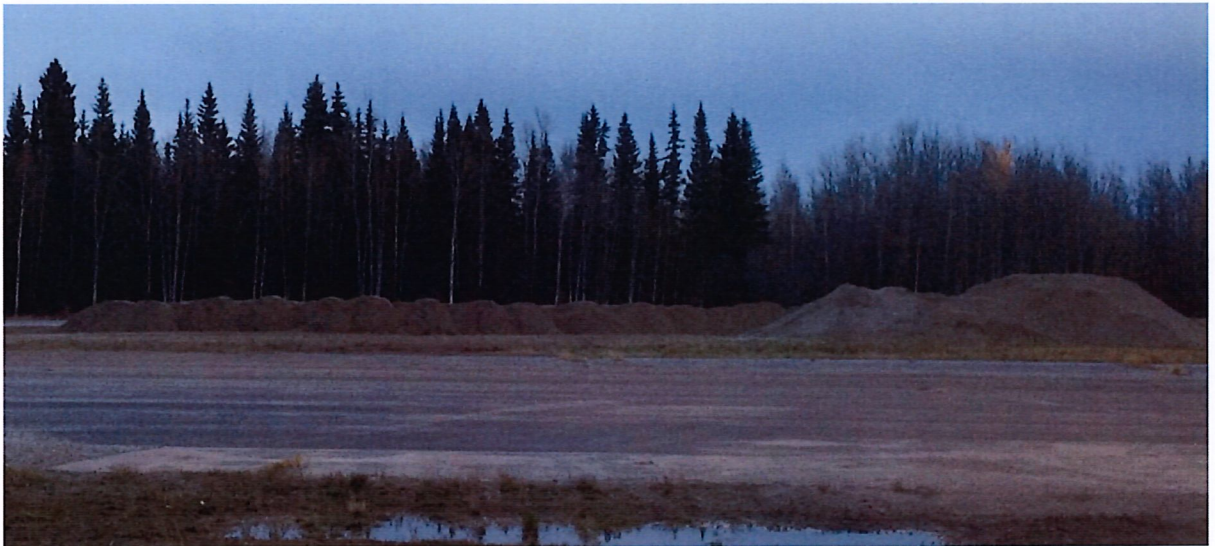
Photograph 16: View of Backfill Owner Supplied stockpile.
