HORSESHOE DAM REHABILITATION

GEOTECHNICAL DRILLING REPORT

SEPTEMBER 2015

Parks Canada Agency

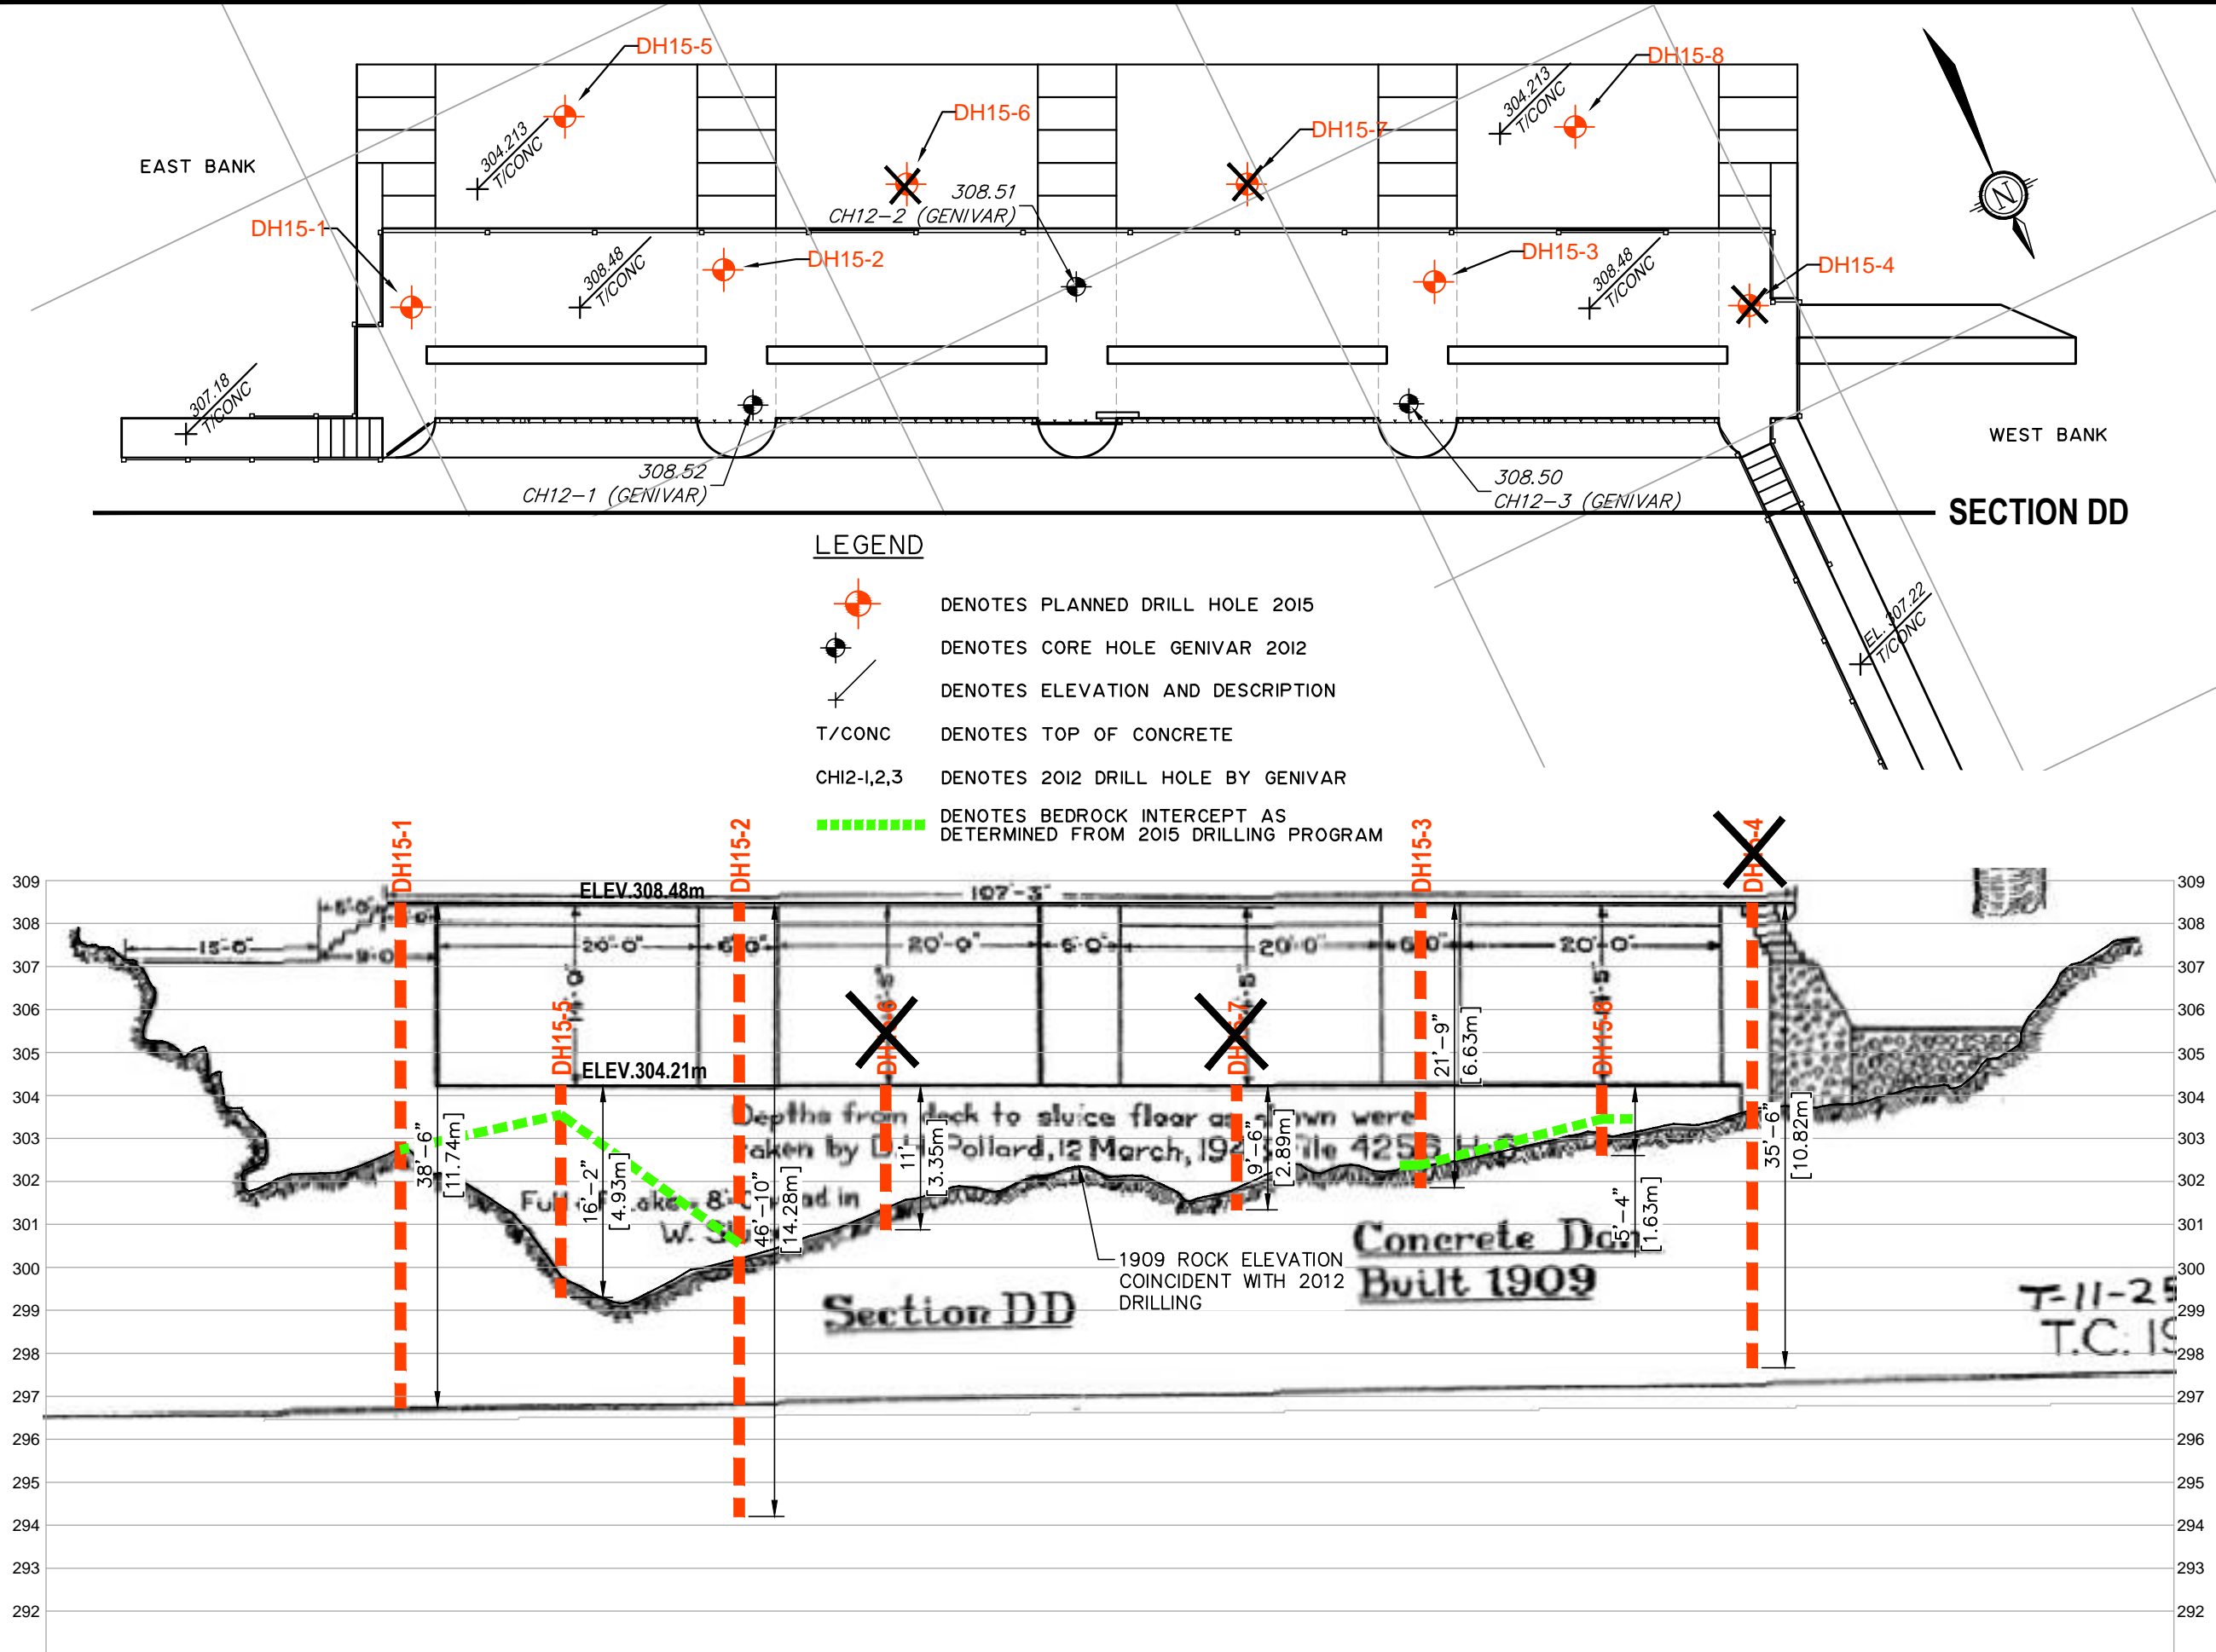
FIGURE 2

The bedrock/concrete elevations intersected in drillholes are plotted on Figure 2 included in Appendix A. With the exception of DH15-5, the bedrock/concrete interface was at or near the 1909 historical plot. For hole DH15-5, the bedrock was interpreted to have been intersected at 0.7 m from the hole collar. Drilling was extended a further 0.82 m within rock, without any concrete matrix intercepts. It may be possible that this was a very large boulder that was placed and concrete formed around it to form the apron, or alternately, may be solid bedrock.

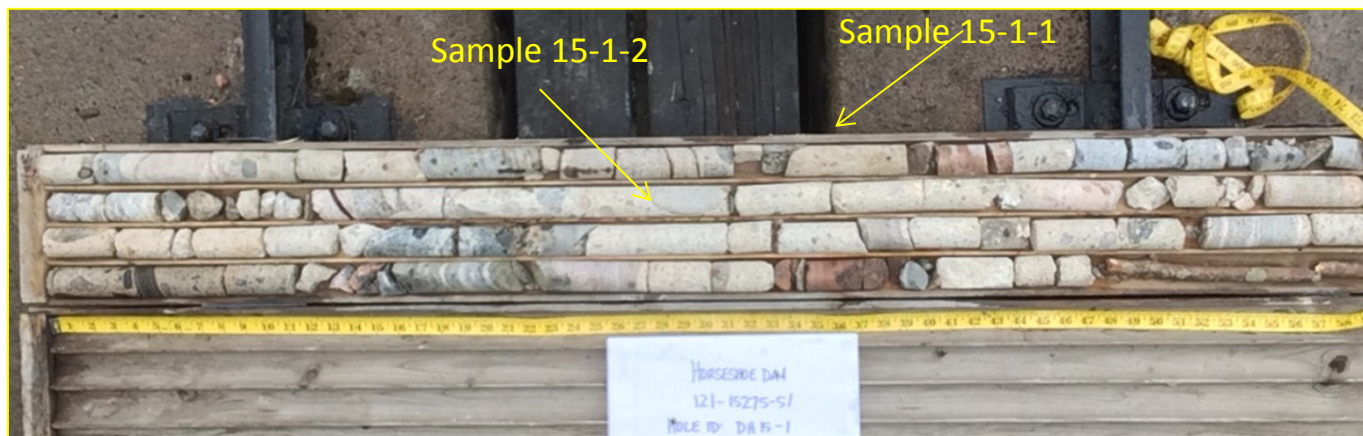
DH15-1 Box 1 of 2.
Concrete core of 30 mm size. Void at bottom of hole for last 30 cm (no core retrieved).

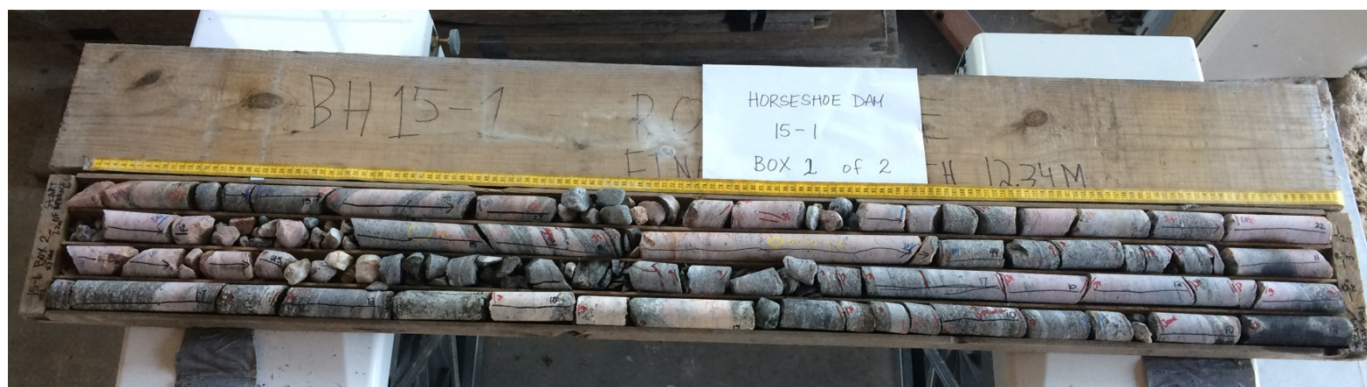
DH15-1 Box 2 of 2 showing rock core from 5.7 m to 11.7 m.
Feldspathic rich layered intrusive of moderate metamorphism with gneissic texture at 45 degrees to core axis. Medium to coarse grained with poorly defined foliation.

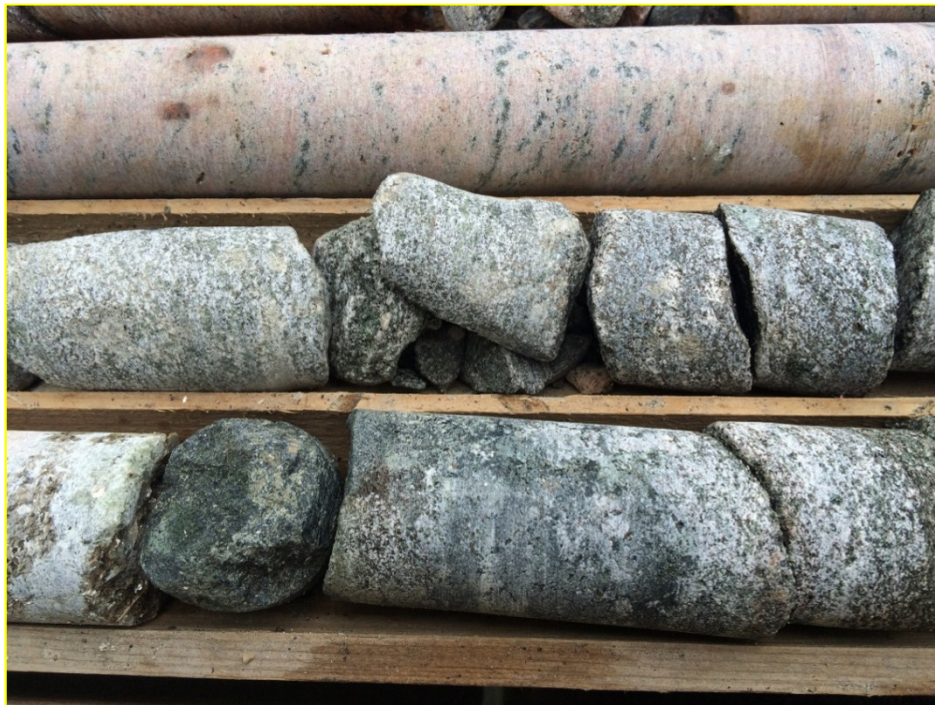
DH15-1 Box 2 of 2.

Detail of core showing medium to coarse grained units. Both dark banding and pink feldspathic banding are shown.

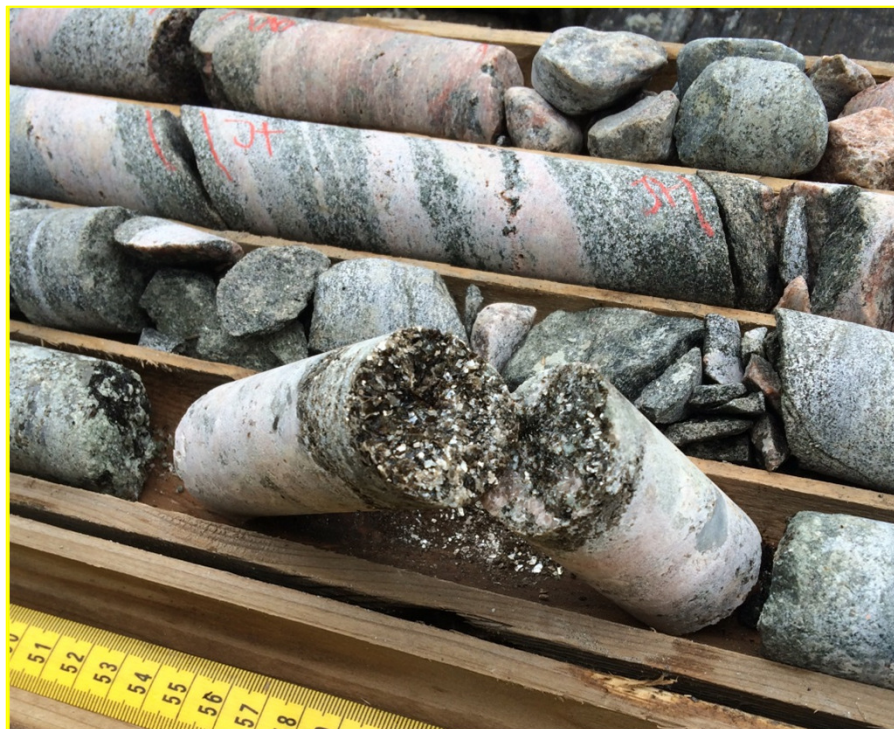
DH15-1 Box 2 of 2 showing detail of biotite seam

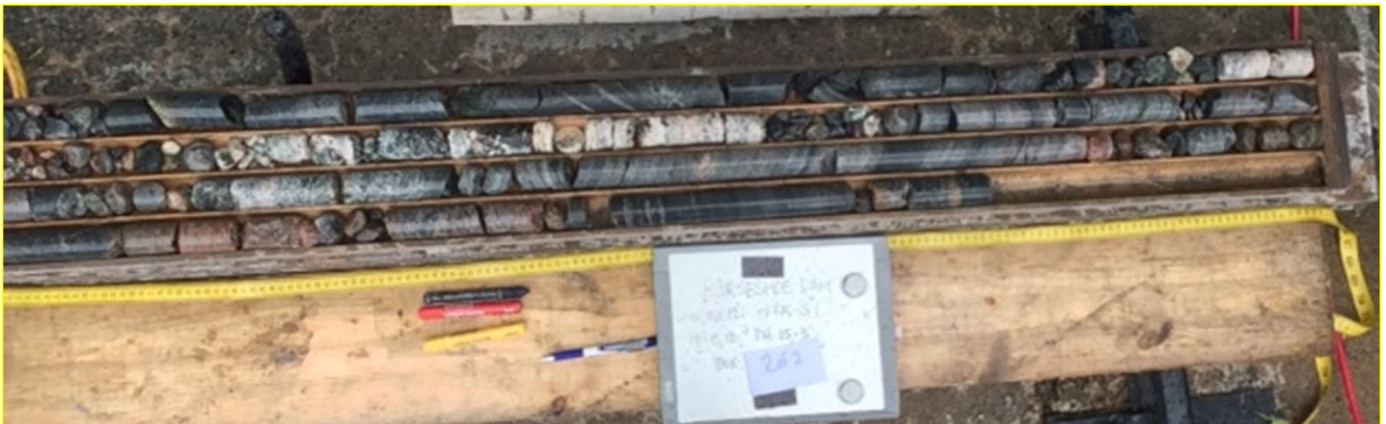
DH15-2 Box 2 of 2:
Mostly dark banded rock units with some pink to buff coloured feldspathic units.

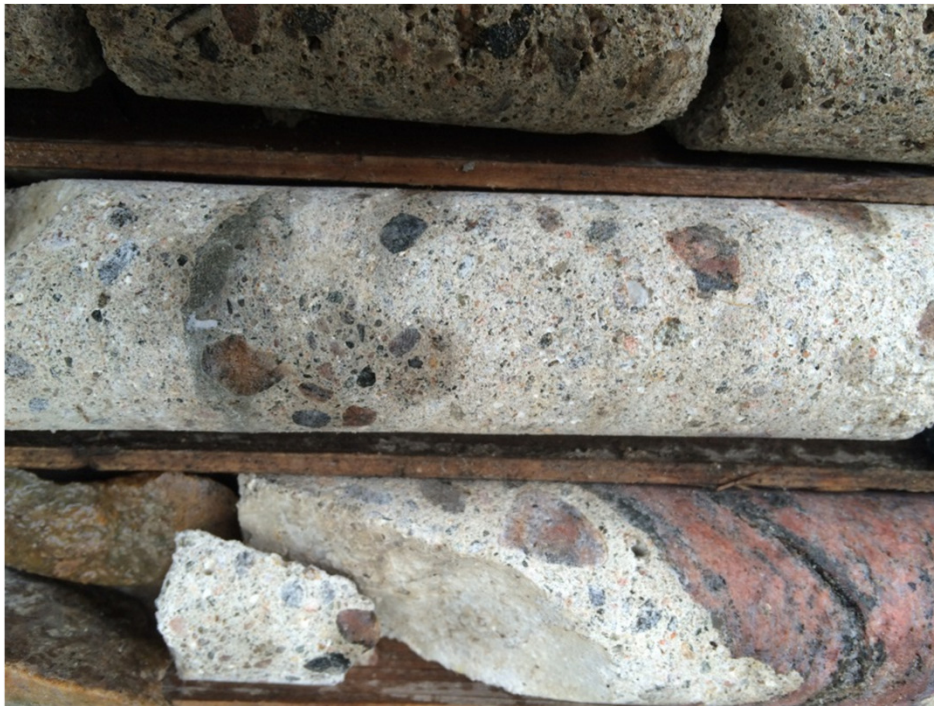
DH15-2 Box 1 of 2:
Detail of concrete with rounded to angular particles and granitic type aggregate material.

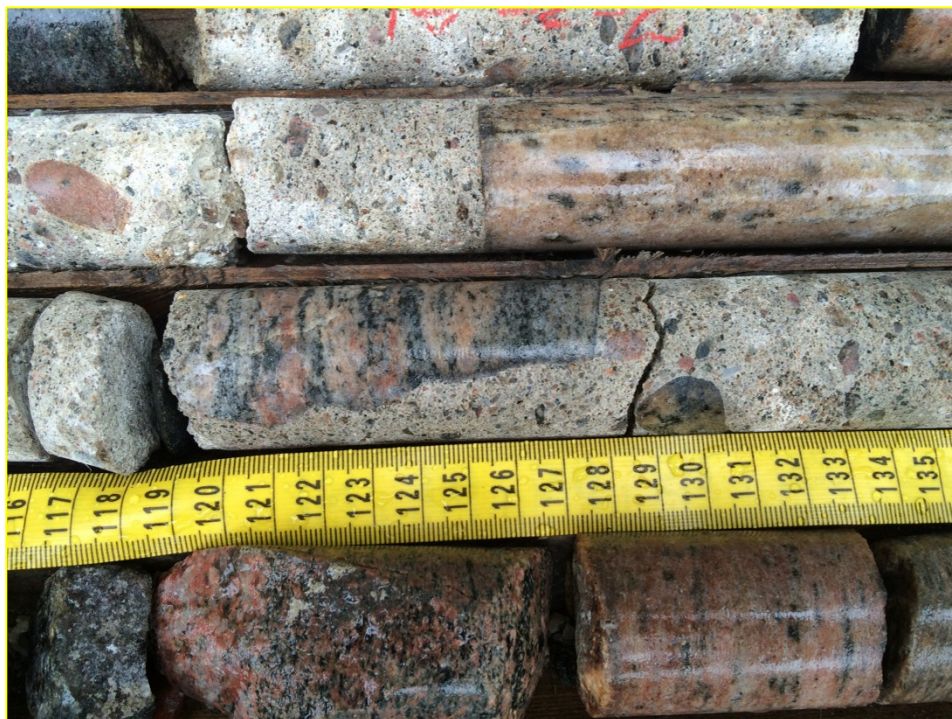
DH15-2 Box 1 of 2:
Detail of aggregate material and concrete.

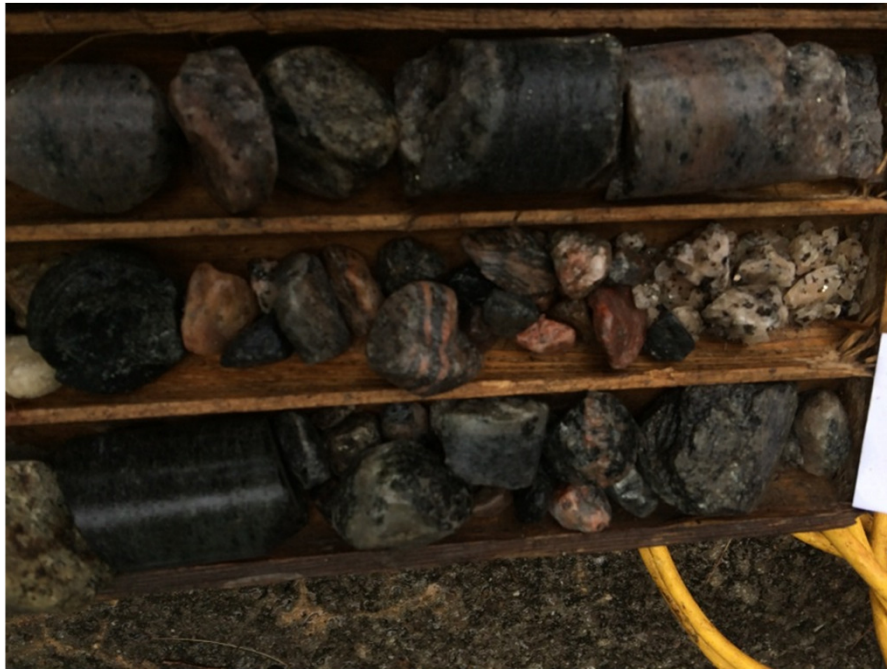
DH15-2 Box 2 of 2:
Detail of gouge zone in rock. Rounded to angular rock fragments of small size.

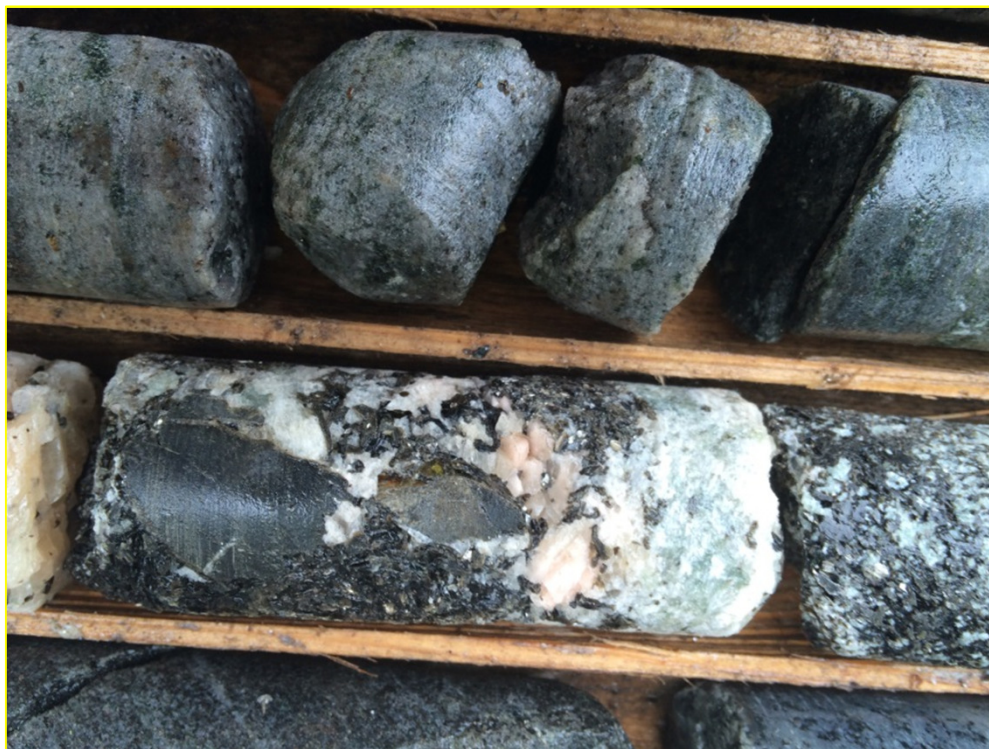
DH15-2 Box 2 of 2.
Detail of large biotite crystals with no preferred orientation.

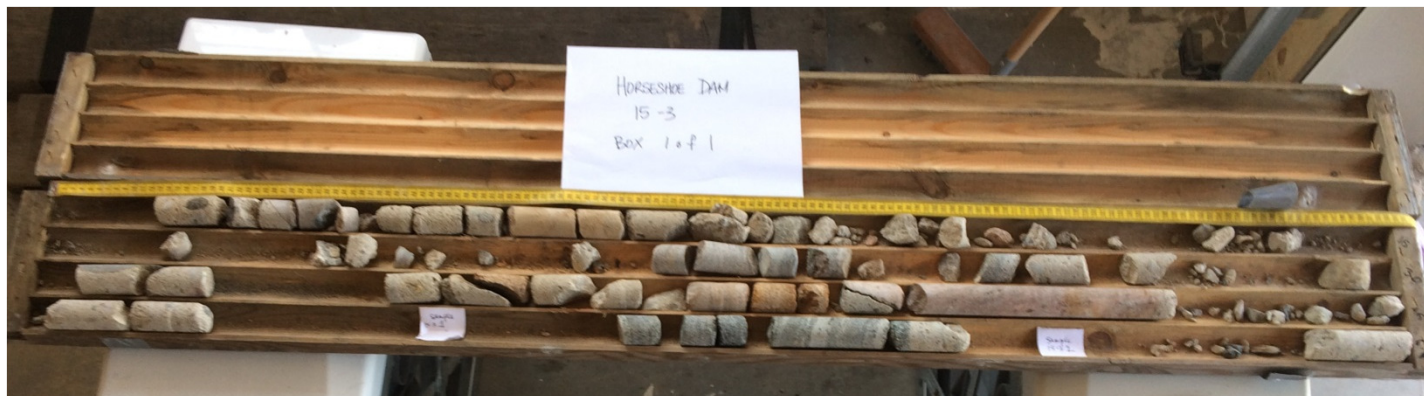
DH15-3 Box 1 of 1.
Concrete core showing poor recovery of core.

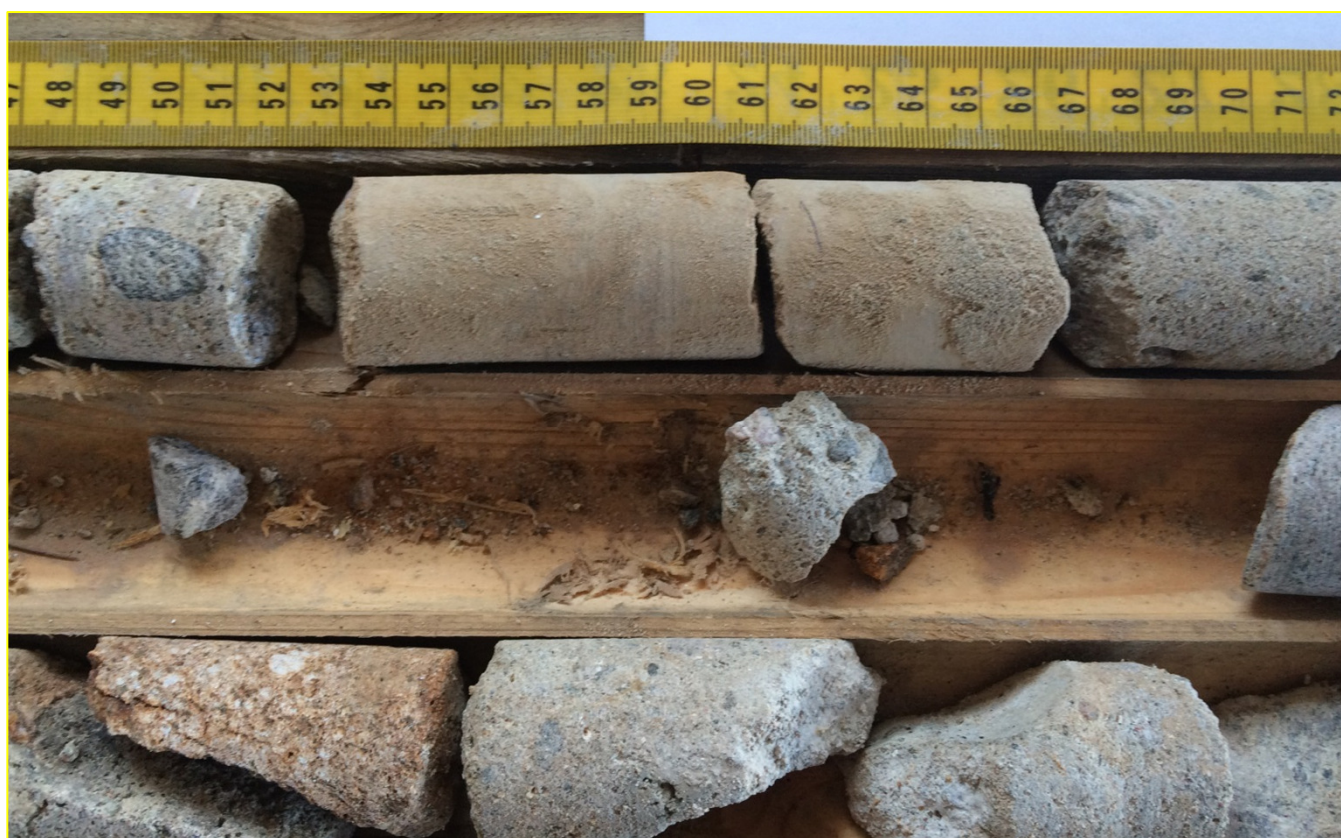
DH15-3 detail showing very friable concrete and poor recovery sections.

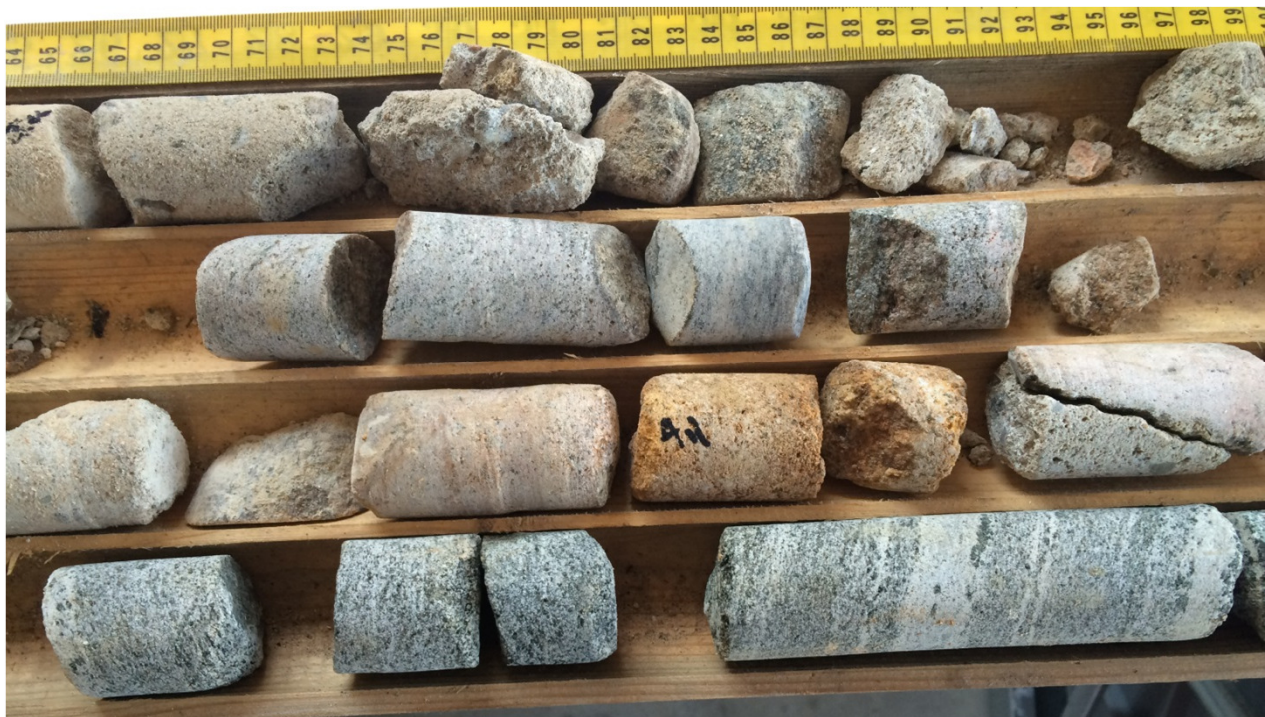
DH15-3 Box 1 Detail showing iron weathering within concrete core.

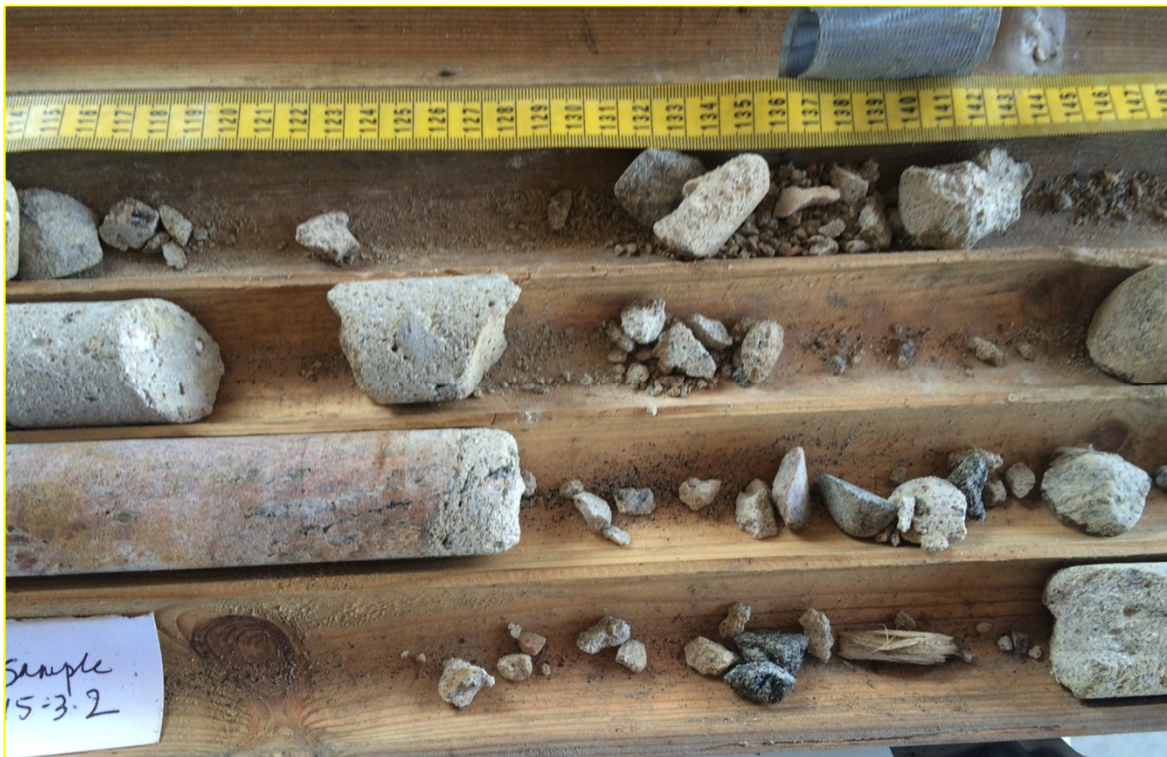
DH15-3 detail showing poor recovery.

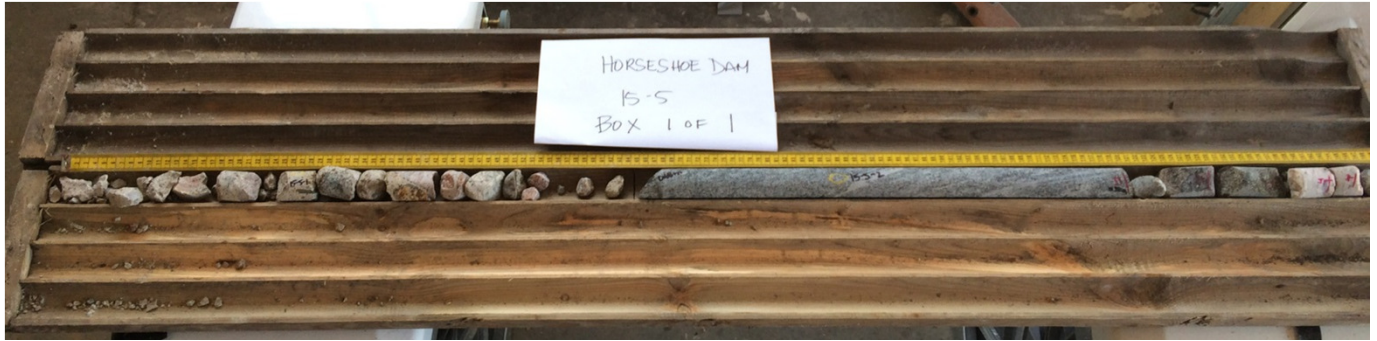
DH15-5 Box 1 of 1:
concrete core at the top left and bedrock on the right of box.

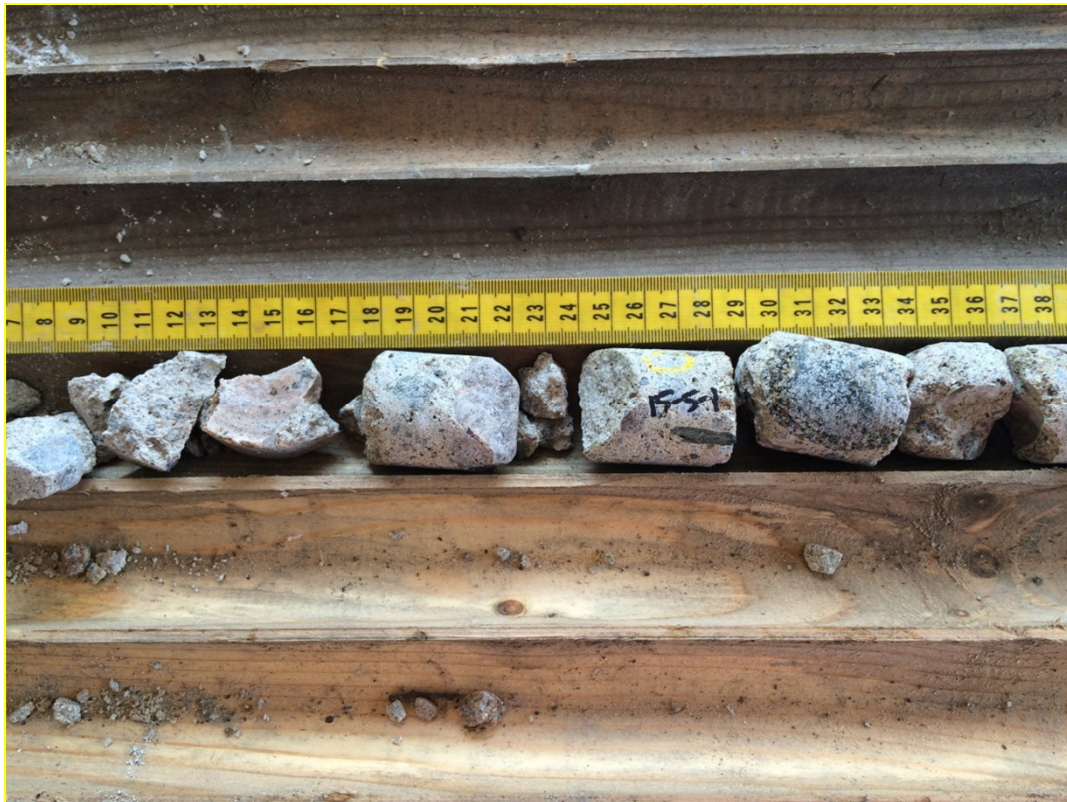
DH15-4 detail showing poor concrete and small sample size of sample 15-5-1.

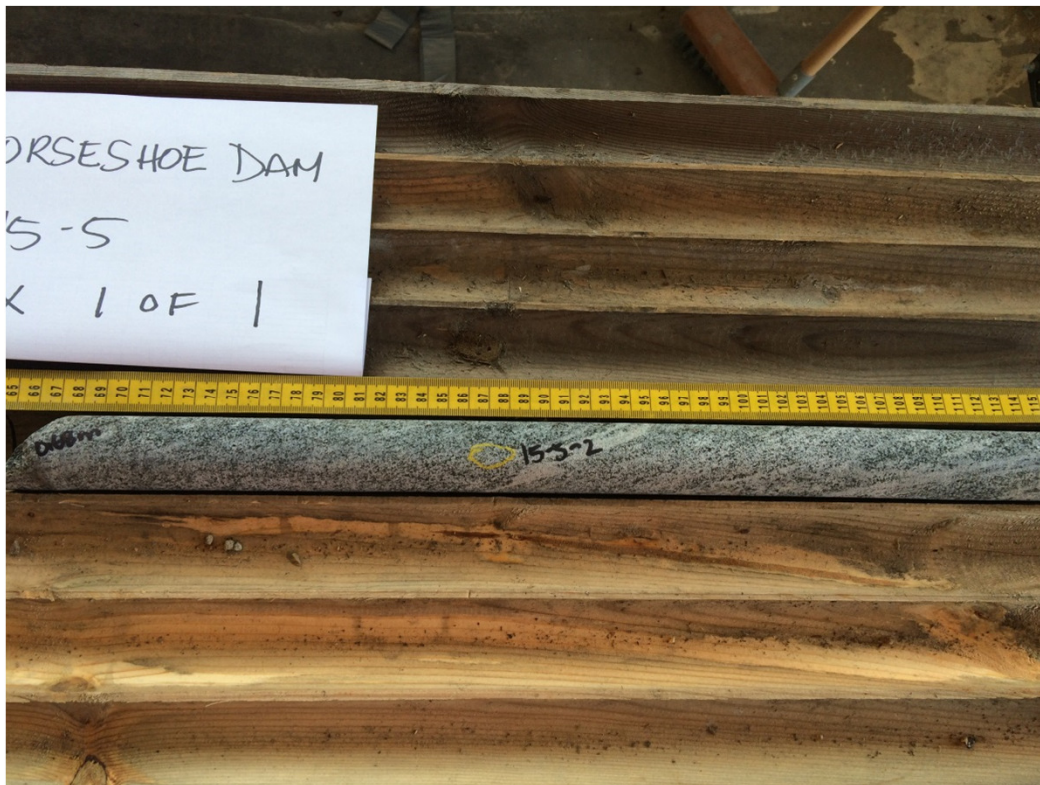
DH15-5 Box 1 of 1:
detail of bedrock section of very good rock quality. Sample 15-5-2.

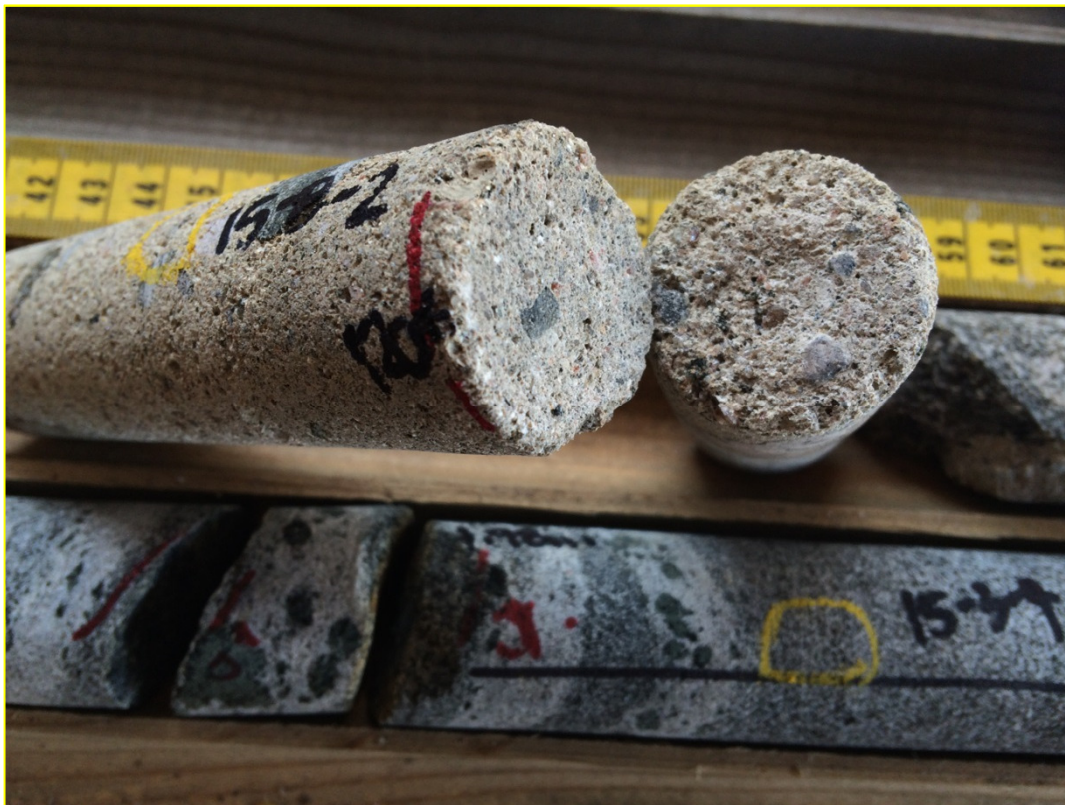
DH15-8 detail showing concrete cold joint within concrete core at 0.51 m from collar.

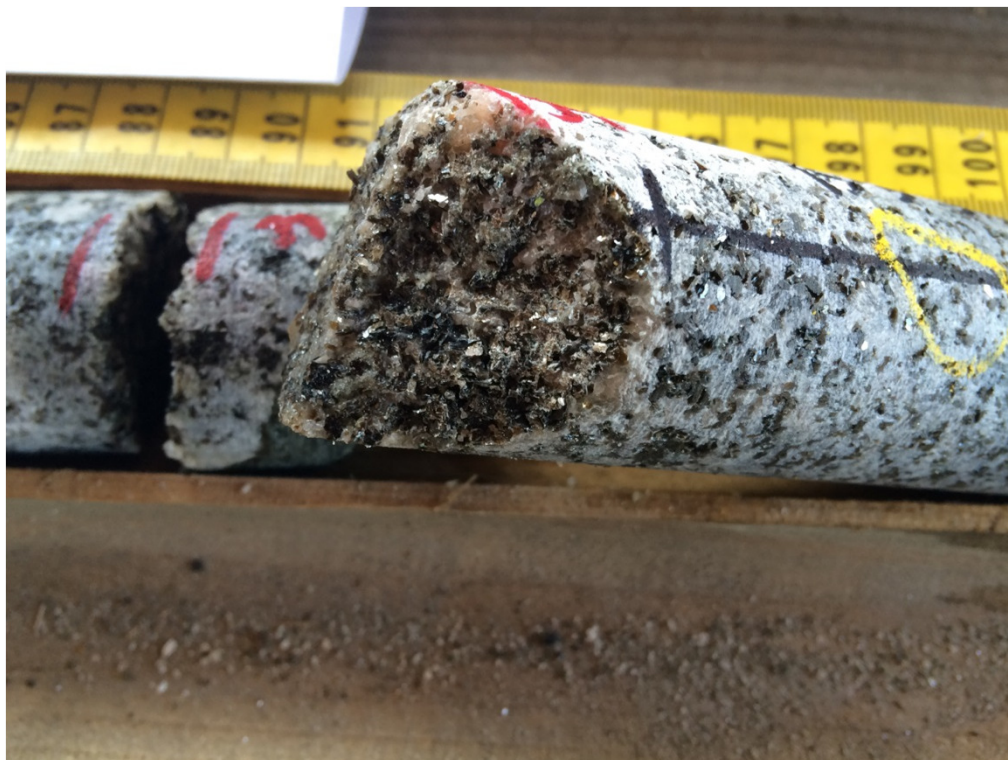
DH15-8 detail showing biotite foliation at 1.21 from hole collar

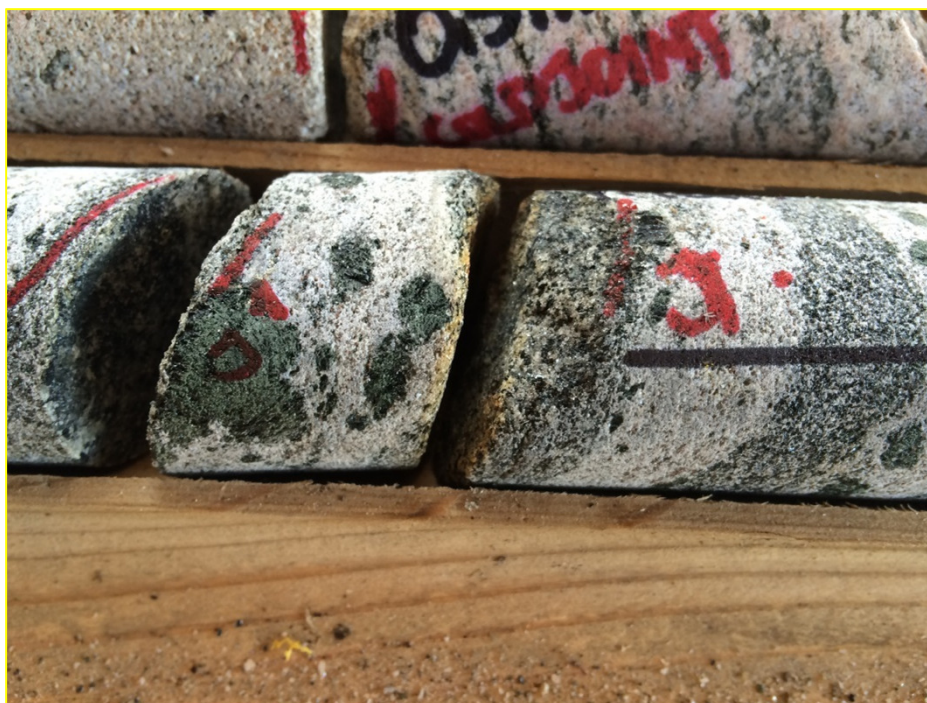
DH15-8 detail showing large chlorite crystals and chlorite foliation/alteration.

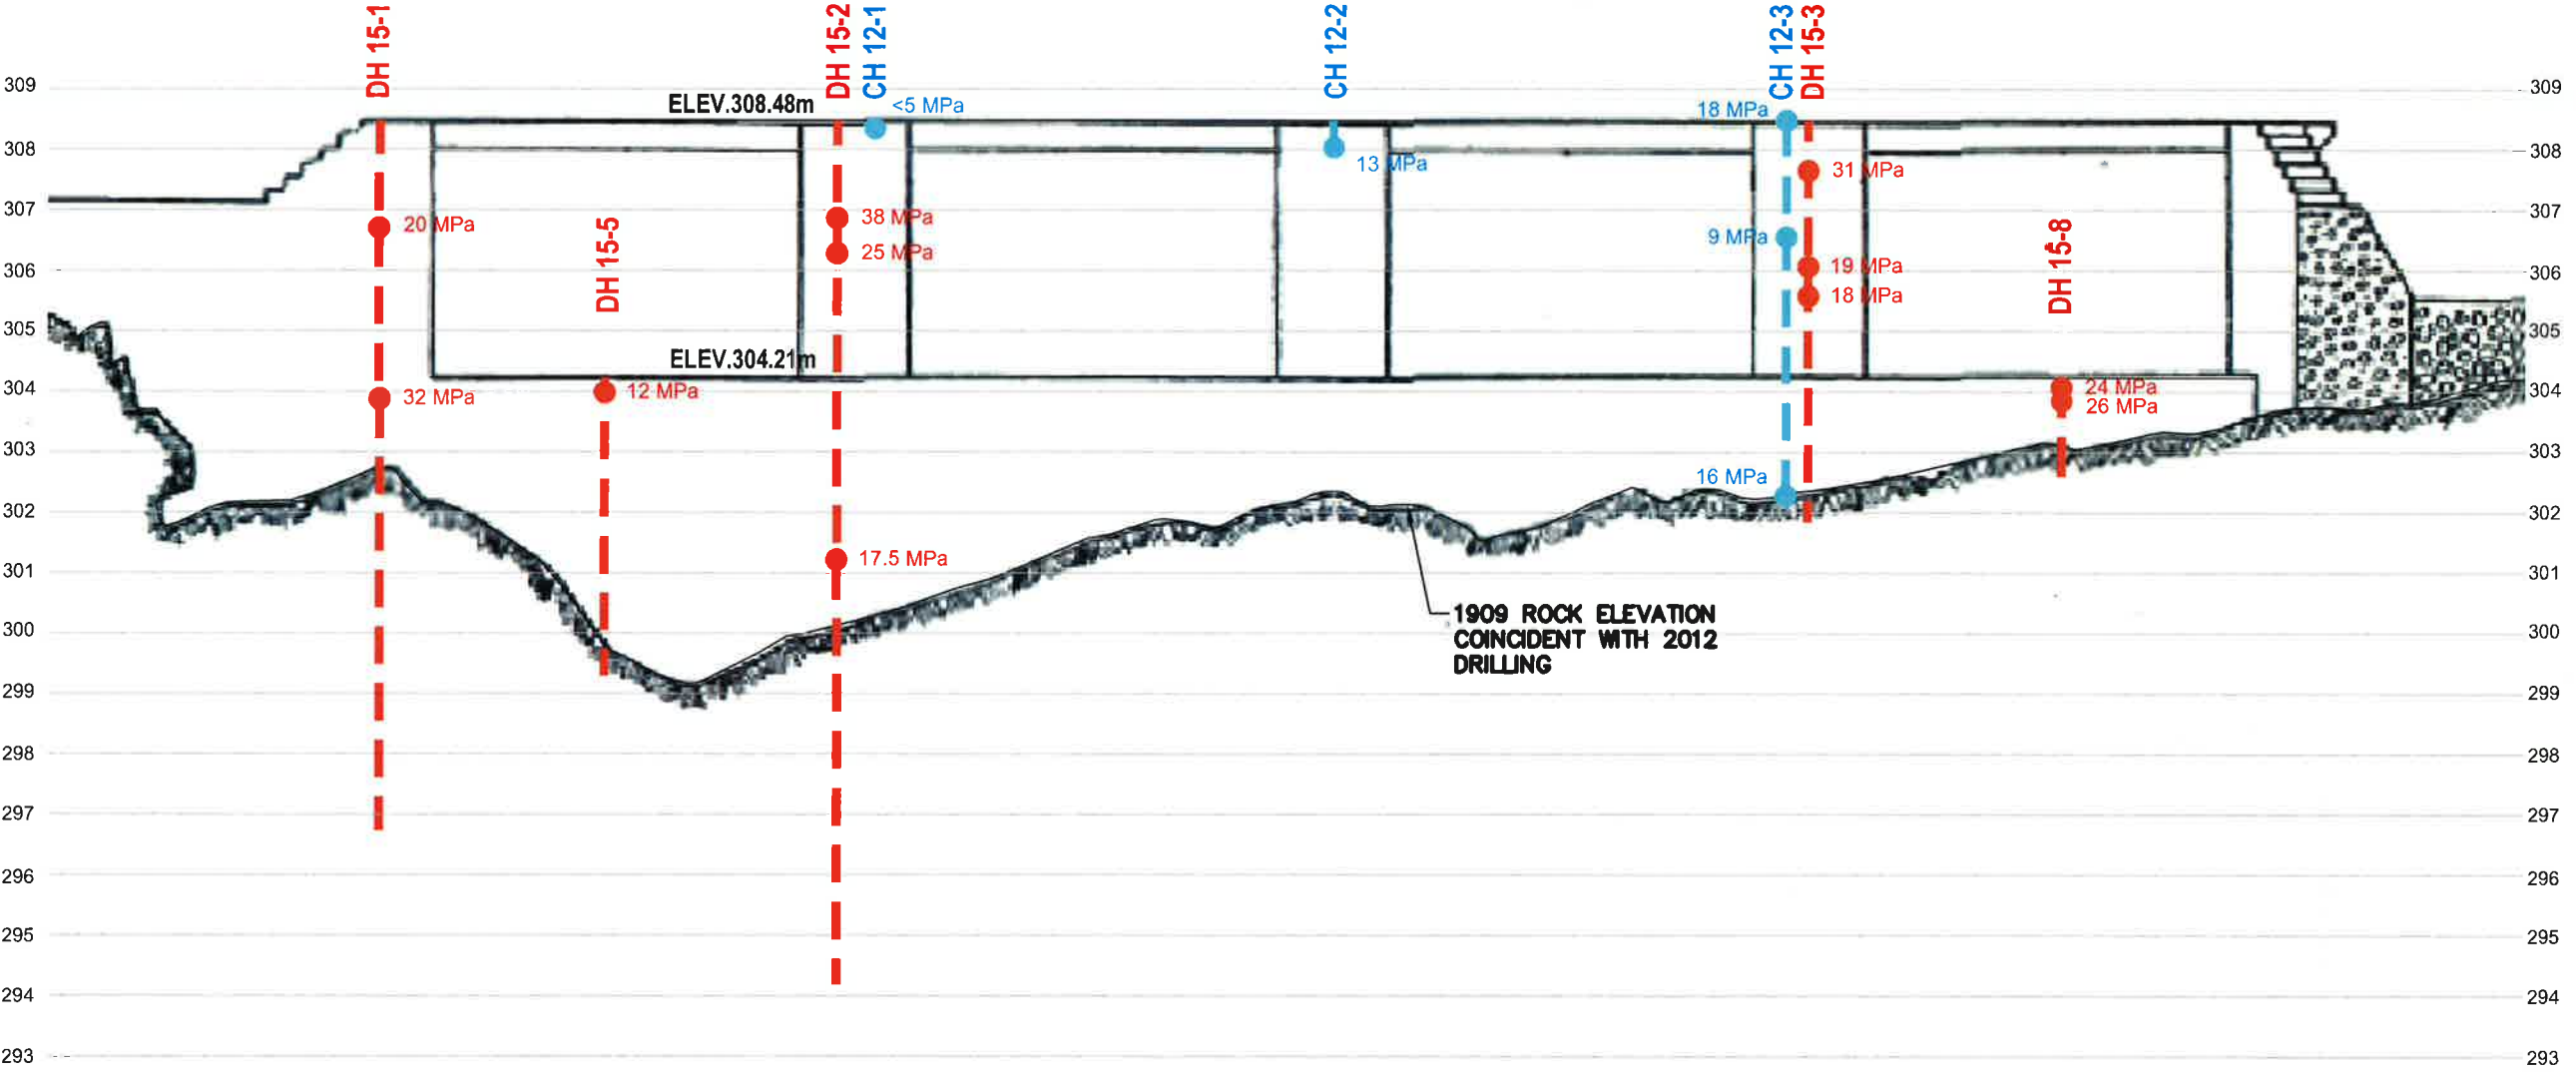
TITLE:
**CONCRETE TESTING
RESULTS**

The dam has variable poor quality concrete with low compressive strength that ranged from 7 MPa to 59 MPa, with an average of 18 MPa for diametral and 33 MPa for axial PLT at the sampled conditions. The concrete, as in the 2012 campaign, was found to be relatively porous without any steel reinforcement. Horizontal cold joints within the concrete were located within two drillholes.
