September 29, 2016

**Subject:** Bulk Asbestos Sampling Program - FINAL  
Northwest Atlantic Fisheries Centre, Pods H7, H17, O17, and All Penthouses  
E. White Hills Road, St. John's, NL  
Our ref.: P-0010737-0-02-202

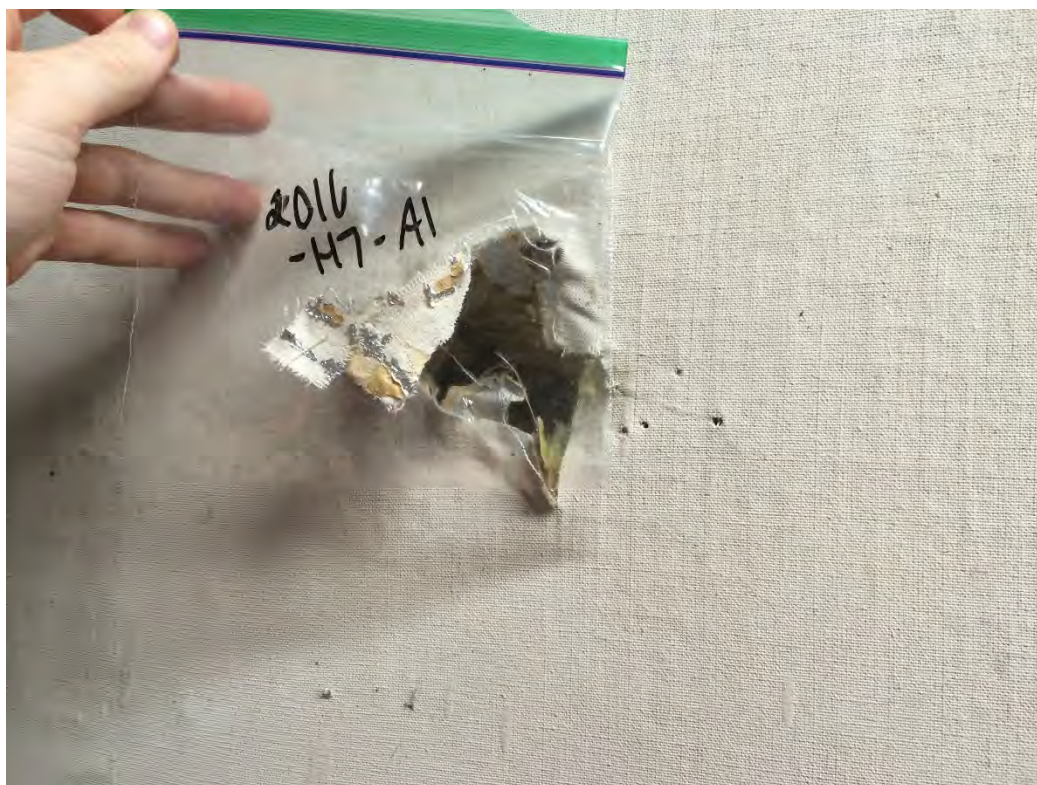
Photo 1: Asbestos sample A1, ductwork wrap in Pod H7. No asbestos detected.

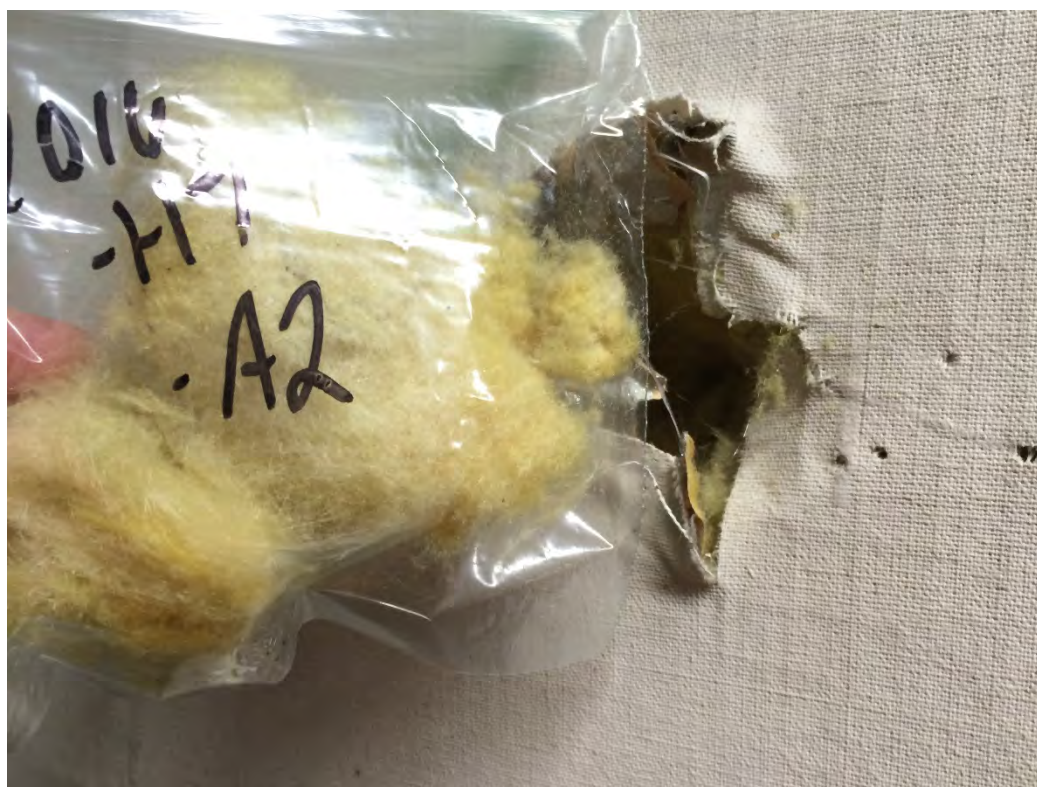
Photo 2: Asbestos sample A2, fibreglass insulation on ductwork in Pod H7. No asbestos detected.

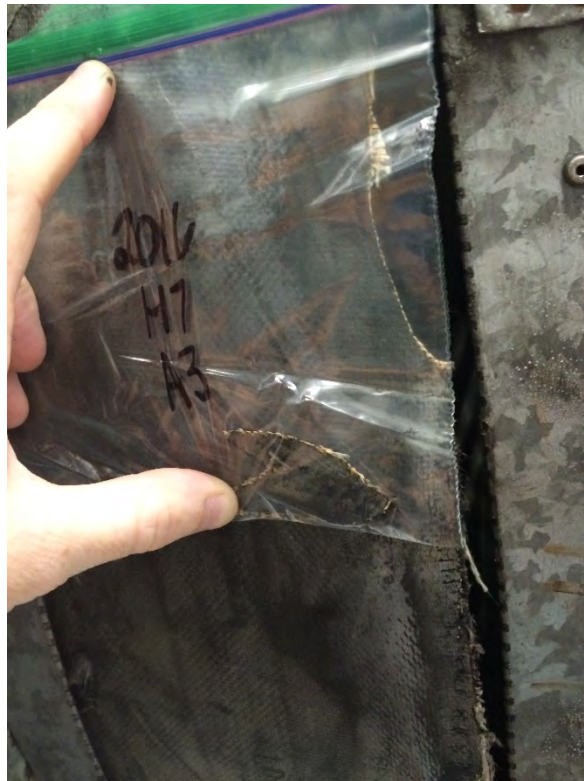
Photo 3: Asbestos sample A3, ductwork expansion fabric in Pod H7, Transformer Vault. No asbestos detected.

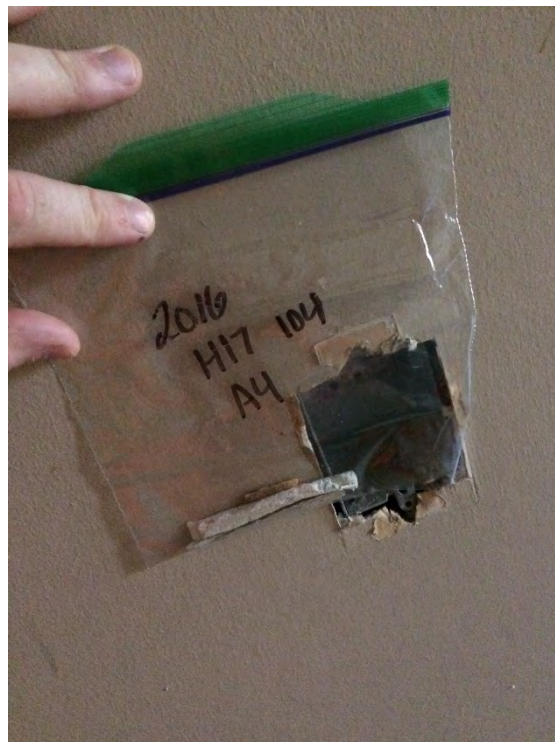
Photo 4: Asbestos sample A4, drywall joint compound collected wall of H17-104. No asbestos detected.

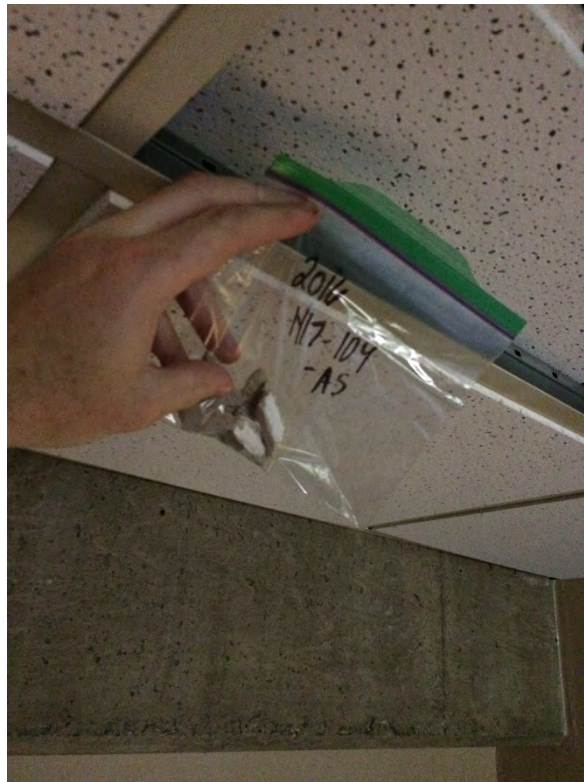
Photo 5: Asbestos sample A5, 24" x 24" ceiling tile with big and small dots patten, collected from H17-104. No asbestos detected.

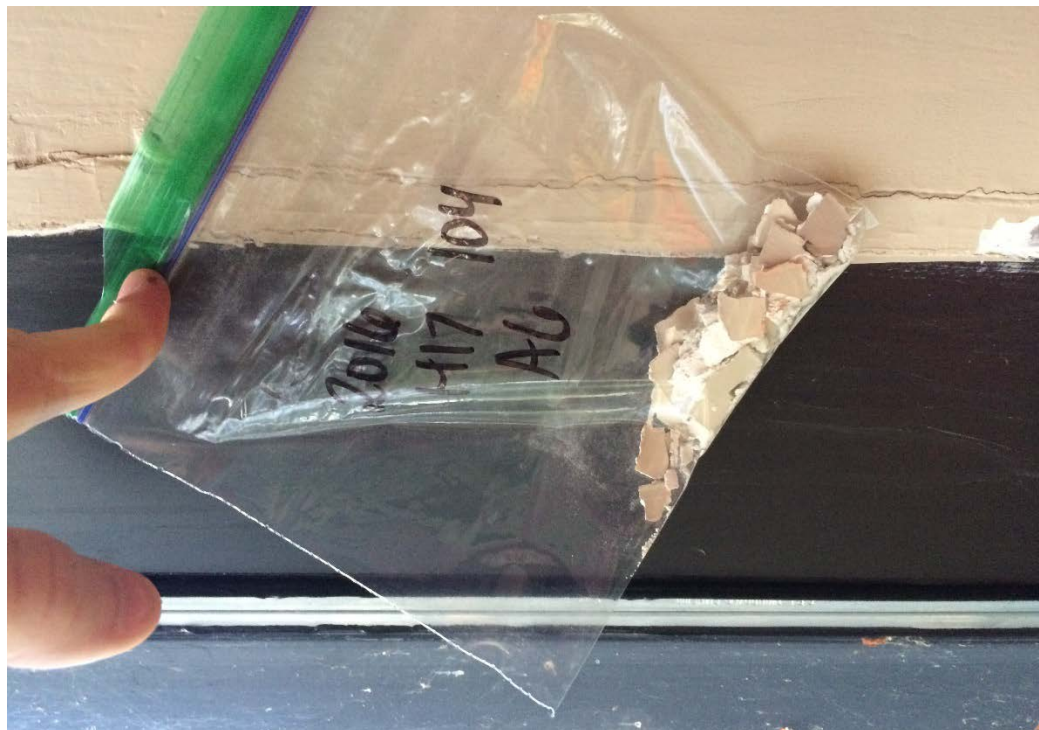
Photo 6: Asbestos sample A6, drywall joint compound collected from wall of H17-104. No asbestos detected.

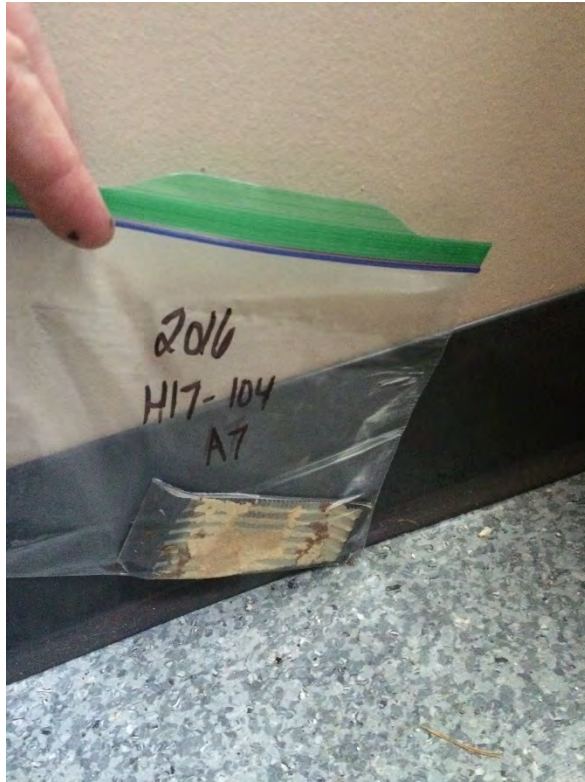
Photo 7: Asbestos sample A7, dark brown vinyl baseboard and adhesive collected from H17-104. No asbestos detected in floorboard or adhesive.

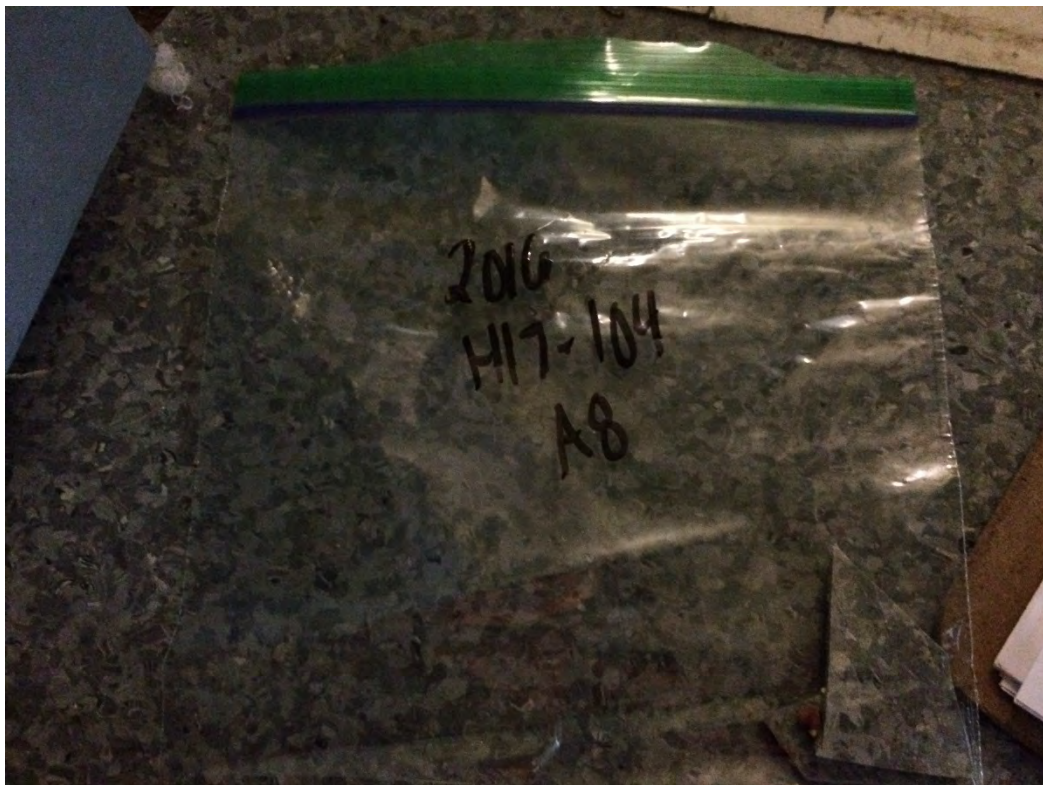
Photo 8: Asbestos sample A8, 12" blue vinyl floor tile and adhesive collected from H17-104. No asbestos detected in tile or adhesive.

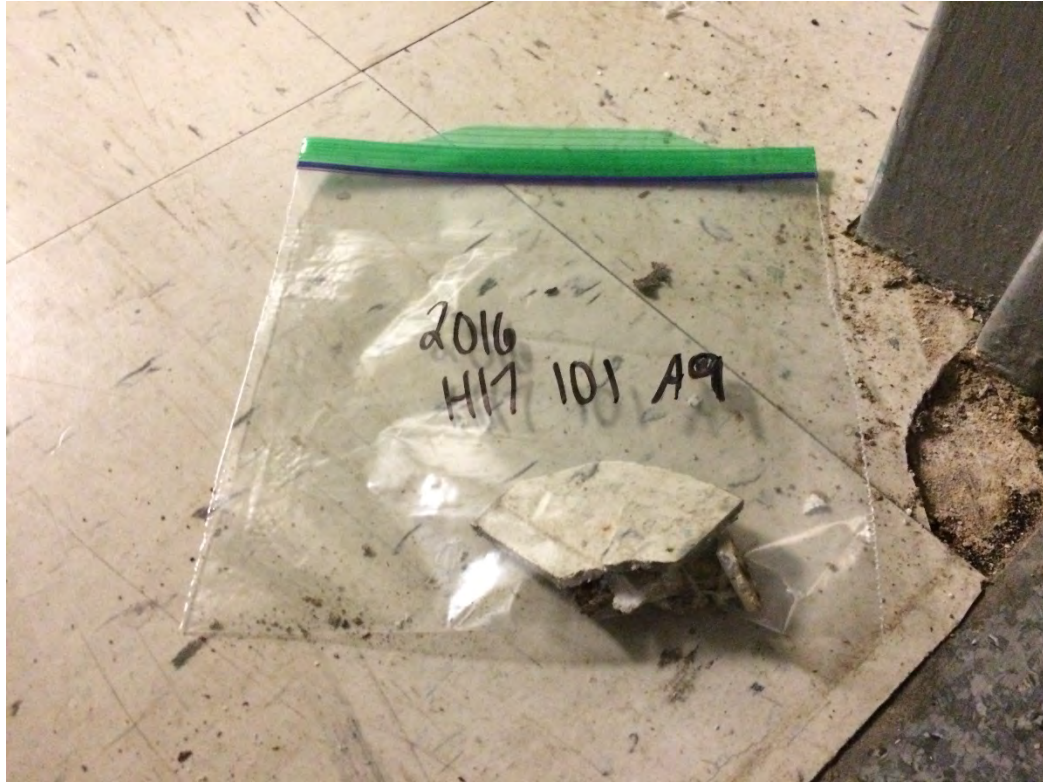
Photo 9: Asbestos sample A9, 12" white vinyl floor tile with grey specks and adhesive collected from H17-101. No asbestos detected in tile or adhesive.

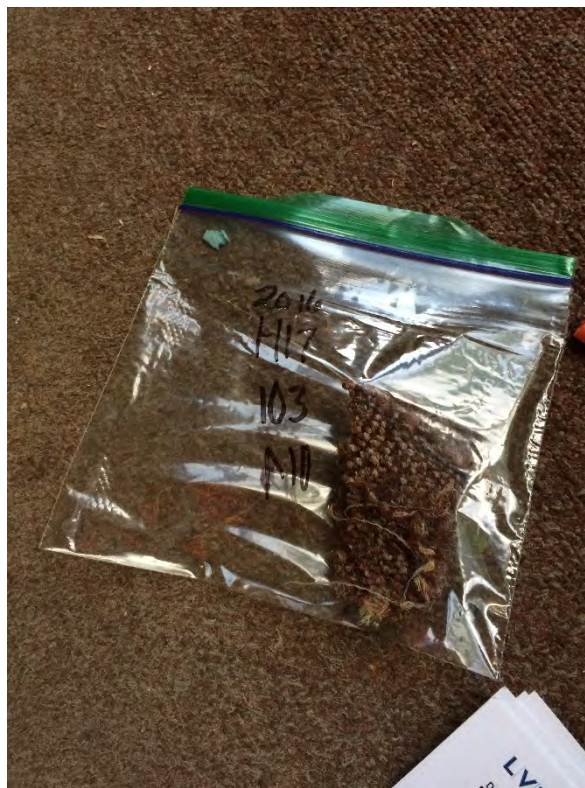
Photo 10: Asbestos sample A10, red carpet and adhesive collected from H17-103. No asbestos detected in carpet or adhesive.

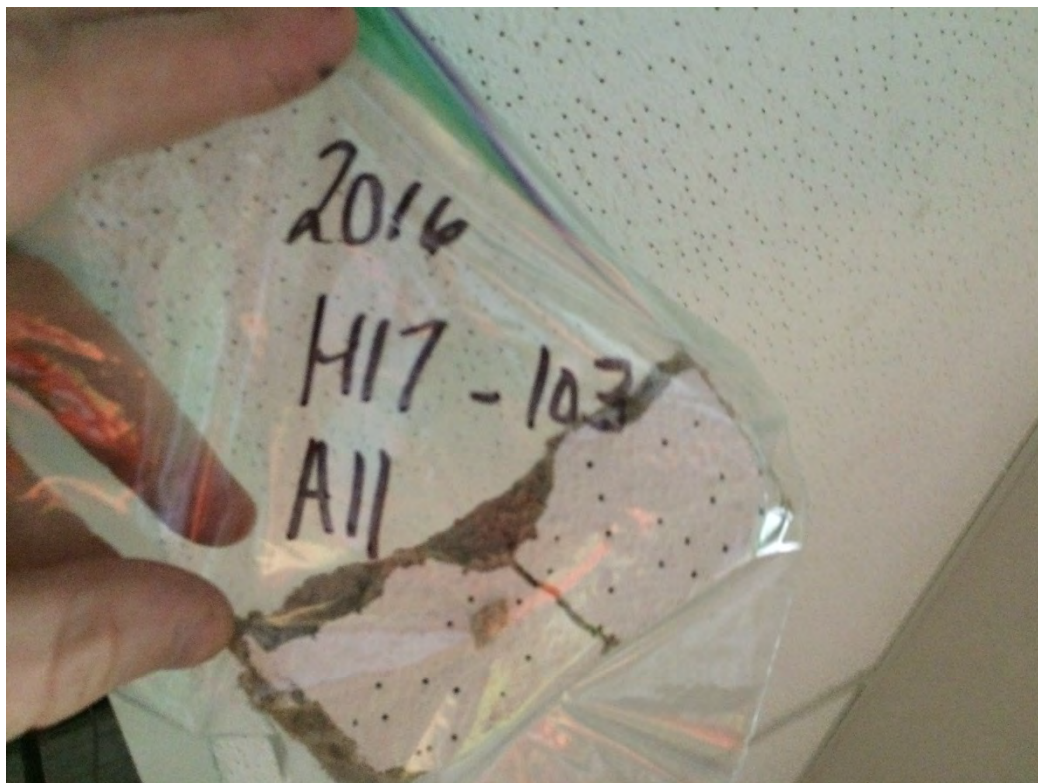
Photo 11: Asbestos sample A11 (and duplicate A31), ceiling tile with small dots pattern collected from H17-103. No asbestos detected.

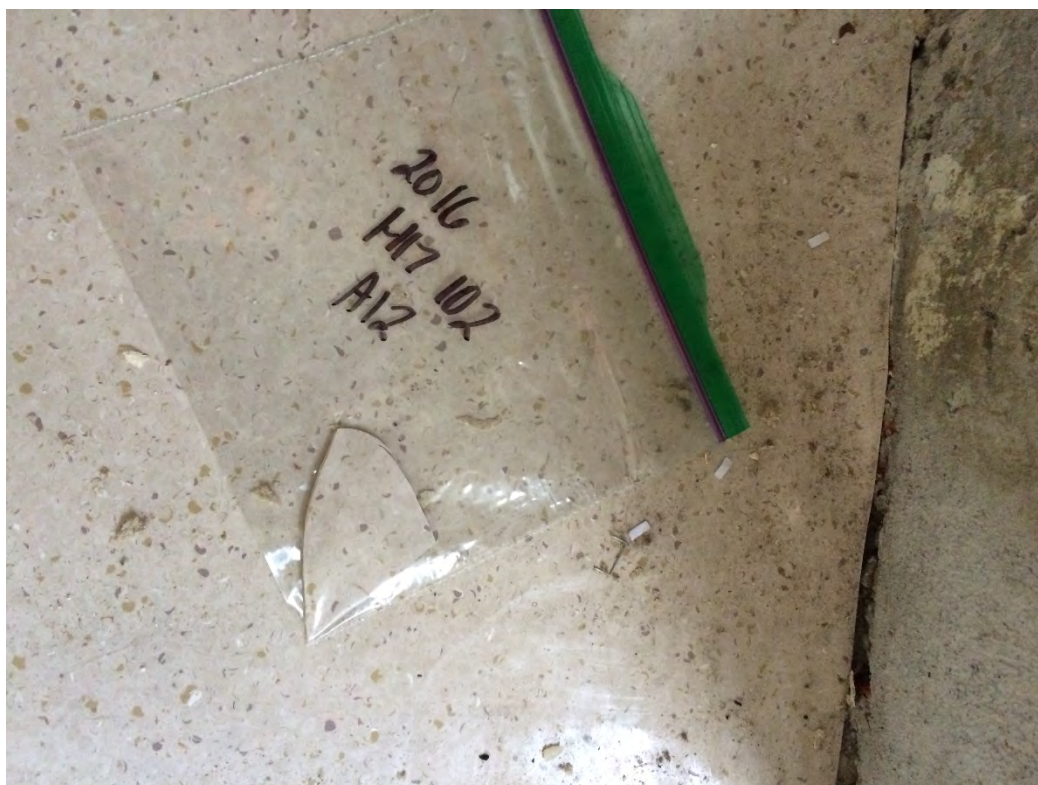
Photo 12: Asbestos sample A12, white seamless vinyl floor with brown specks and adhesive collected from H17-102. No asbestos detected in flooring or adhesive.

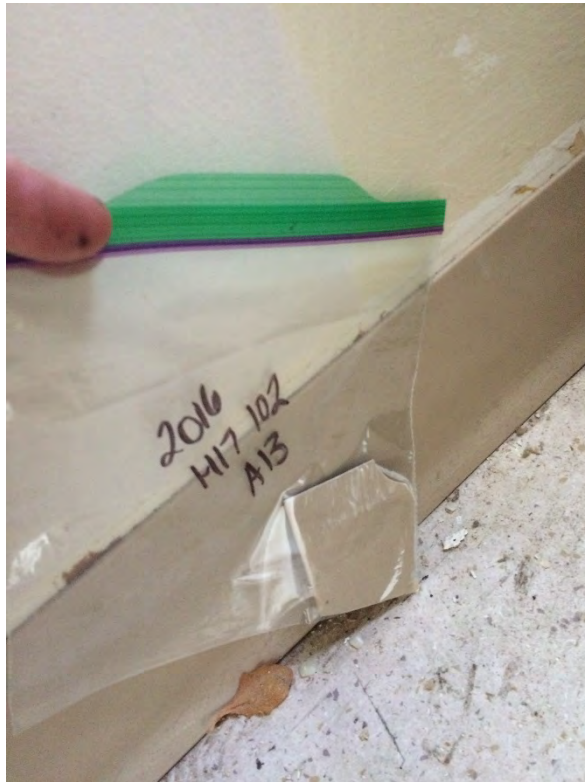
Photo 13: Asbestos sample A13, light brown vinyl baseboard and adhesive from collected from H17-102. No asbestos detected in floorboard or adhesive.

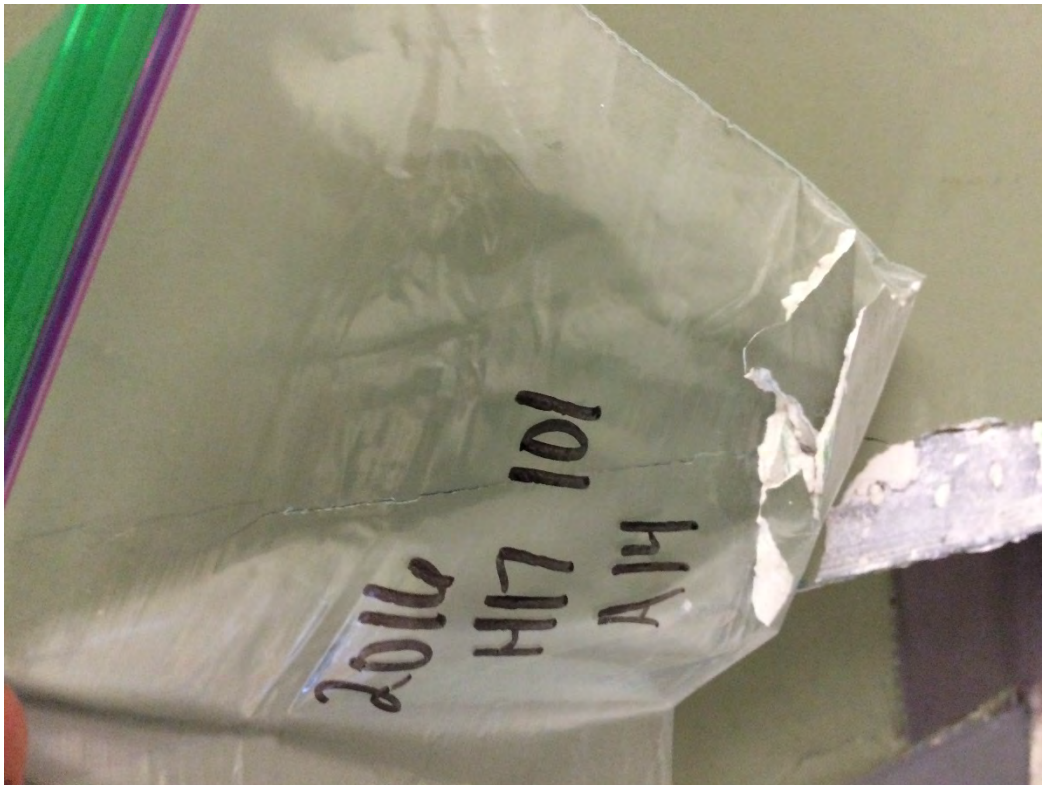
Photo 14: Asbestos sample A14, drywall joint compound collected from wall in H17-101. No asbestos detected.

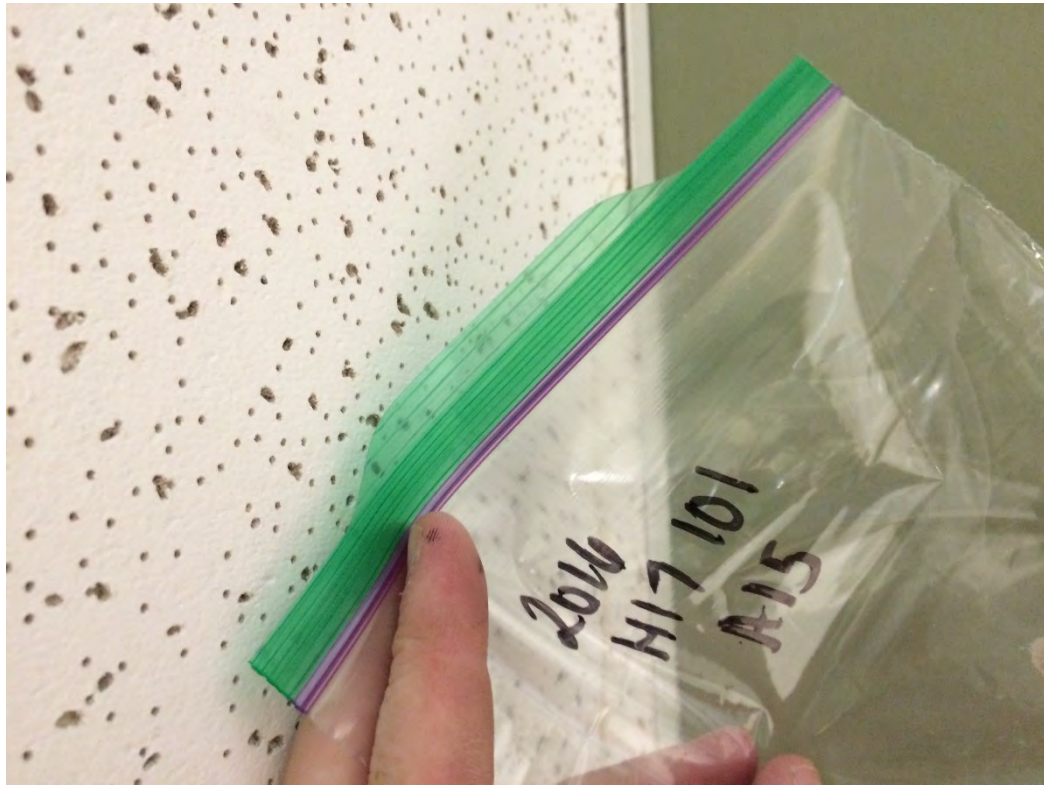
Photo 15: Asbestos sample A15, 24" x 48" ceiling tile with small dots and small gouges pattern collected from H17-101. No asbestos detected.

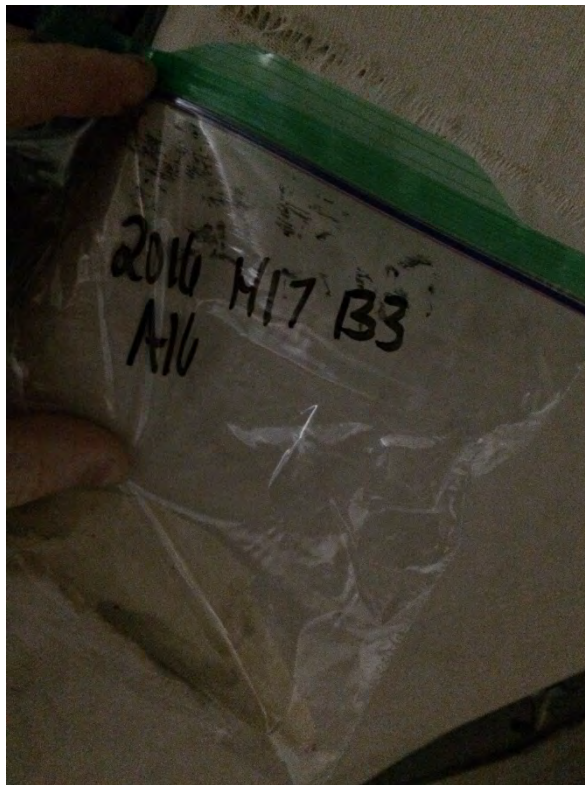
Photo 16: Asbestos sample A16, ductwork wrap collected from H17-B3. No asbestos detected.

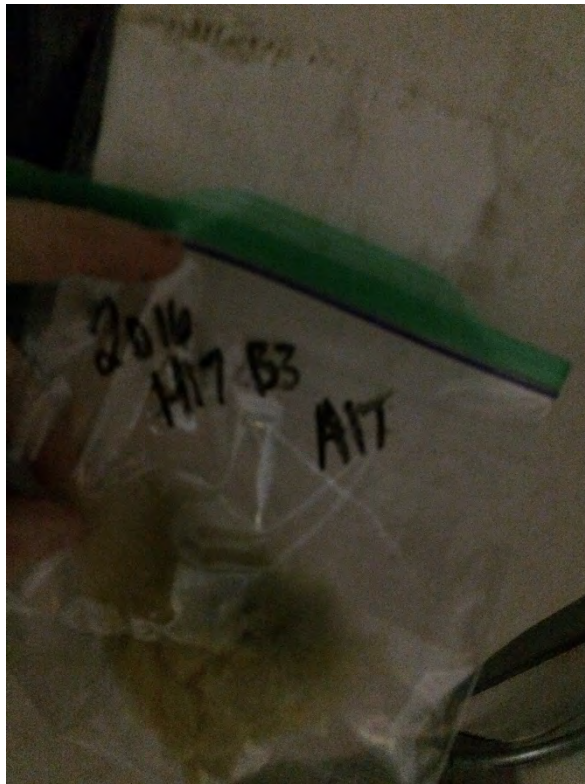
Photo 17: Asbestos sample A17 (and duplicate A32), fibreglass insulation collected from ductwork in H17-B3. No asbestos detected.

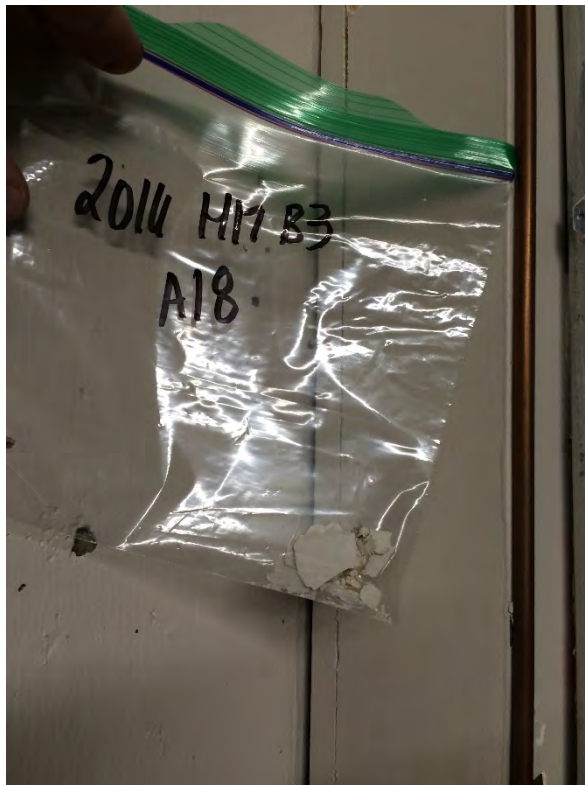
Photo 18: Asbestos sample A18, drywall joint compound collected from wall in H17-B3. No asbestos detected.

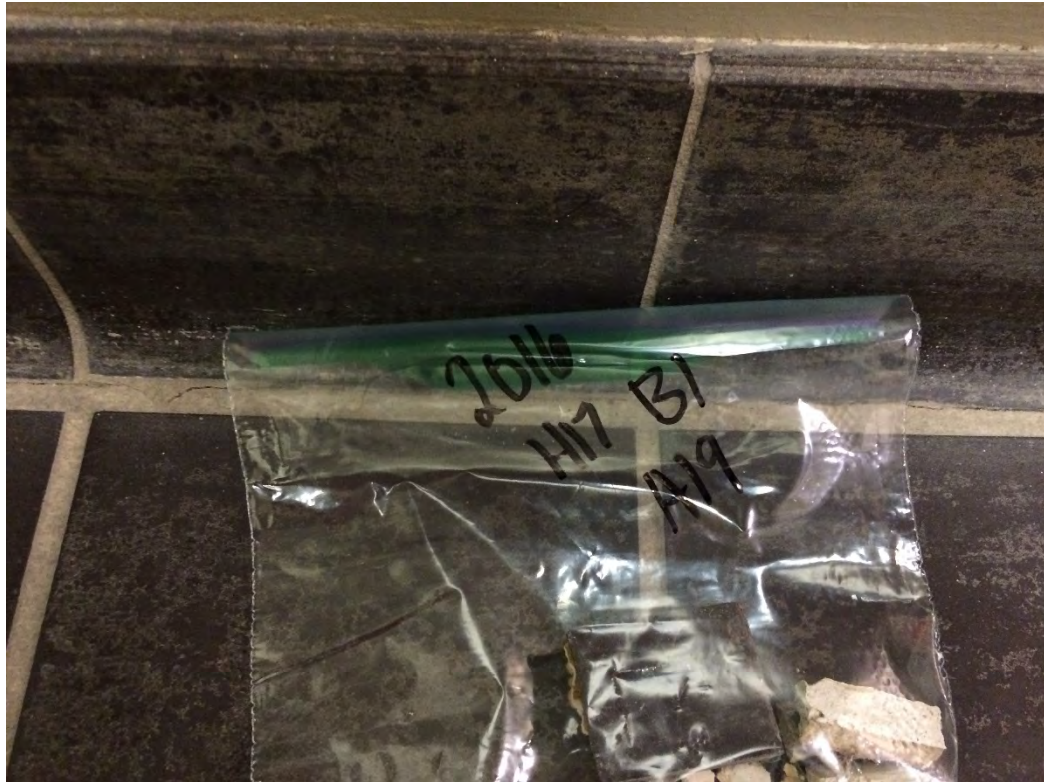
Photo 19: Asbestos sample A19, dark grey ceramic floor tile, grout and adhesive collected from H17-B1. No asbestos detected in the tile, grout or adhesive.

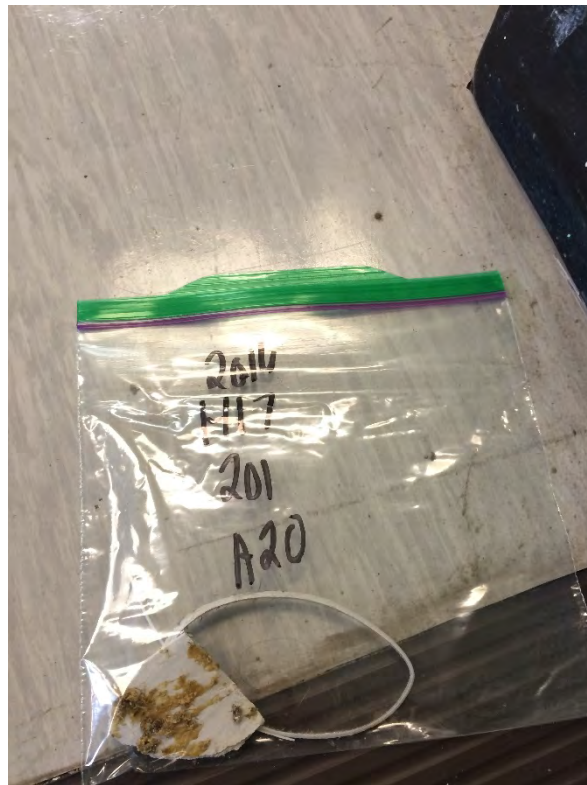
Photo 20: Asbestos sample A20, white seamless vinyl floor with grey specks and adhesive collected from H17-201. No asbestos detected in flooring or adhesive.

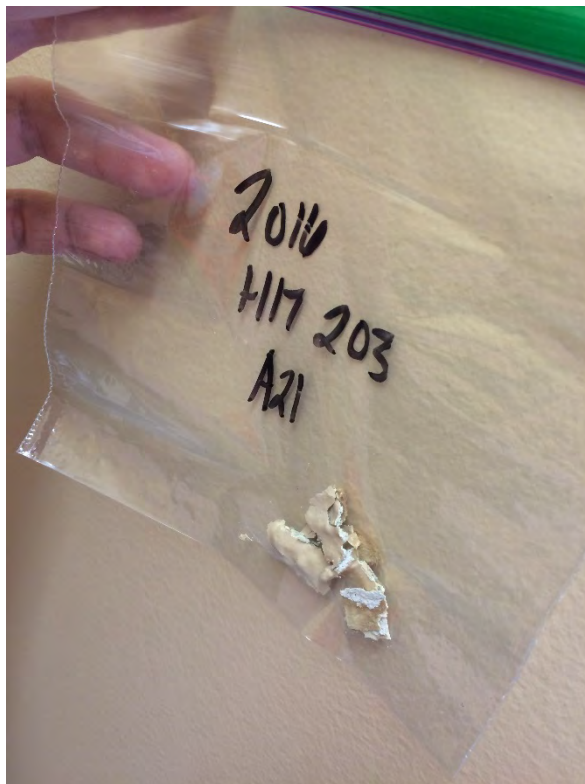
Photo 21: Asbestos sample A21, drywall joint compound collected from wall in H17-203. No asbestos detected.

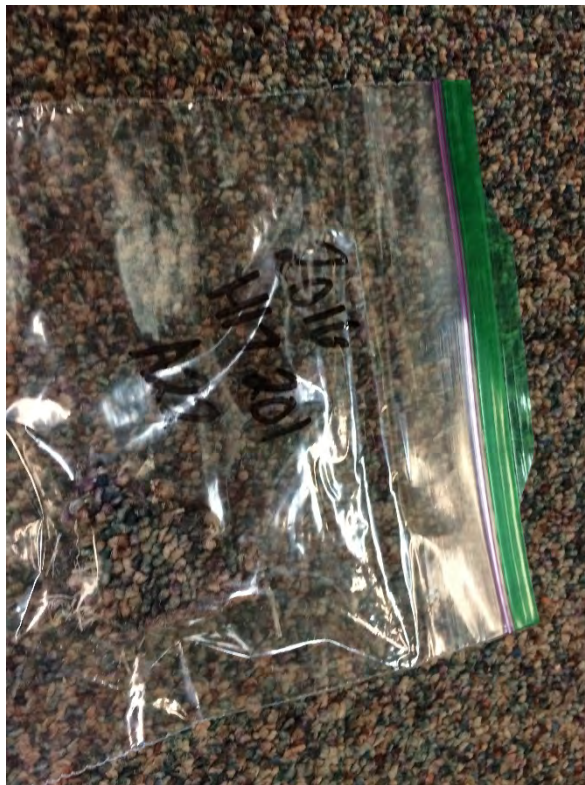
Photo 22: Asbestos sample A22, mixed speckled carpet and adhesive collected from H17-201. No asbestos detected in carpet or adhesive.

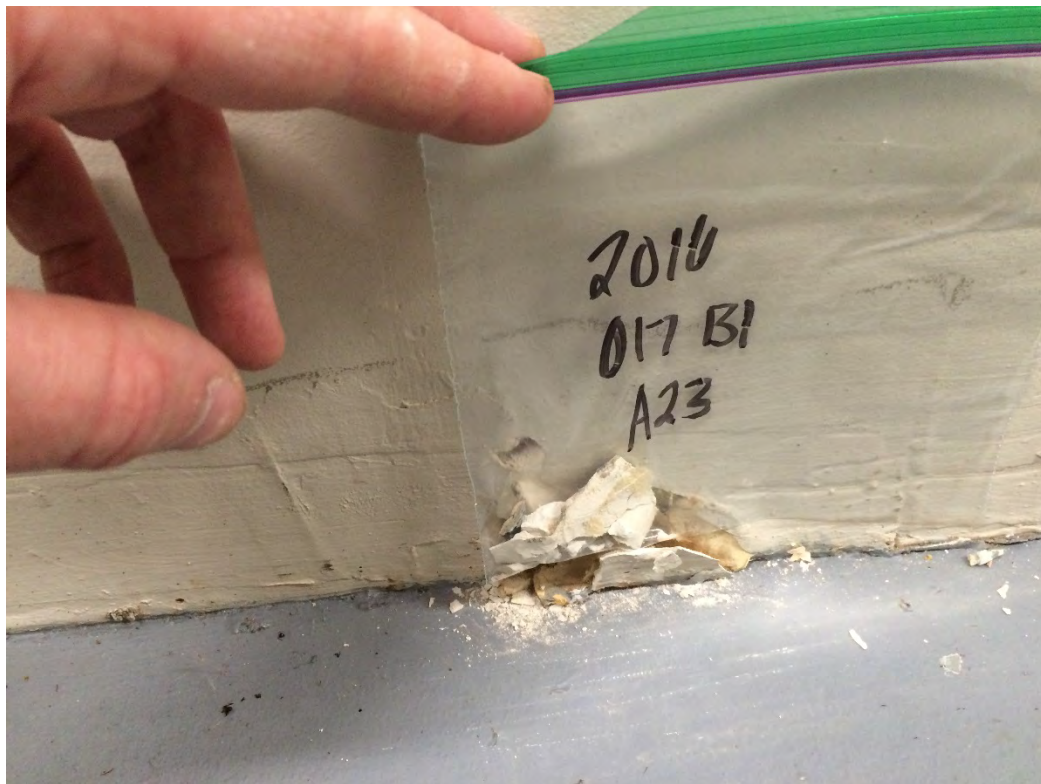
Photo 23: Asbestos sample A23, drywall joint compound collected from wall of O17-B1. No asbestos detected.

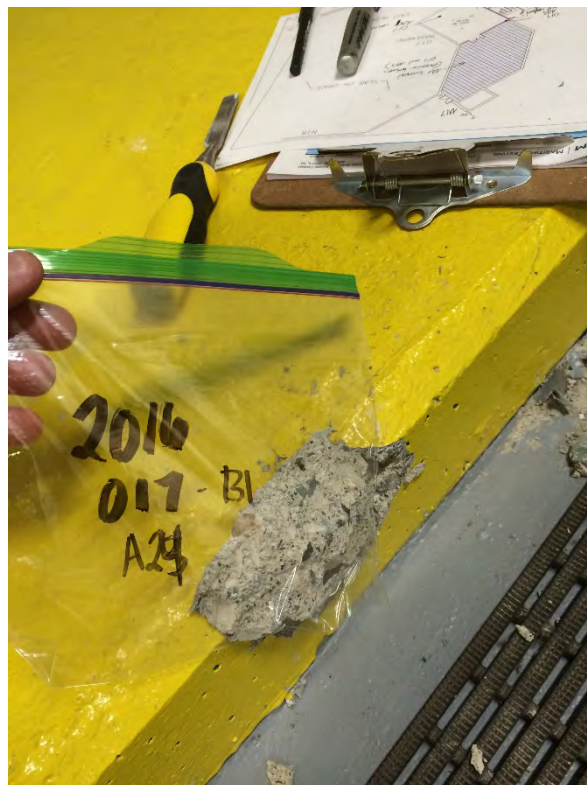
Photo 24: Asbestos sample A24, concrete slab O17-B1. No asbestos detected.

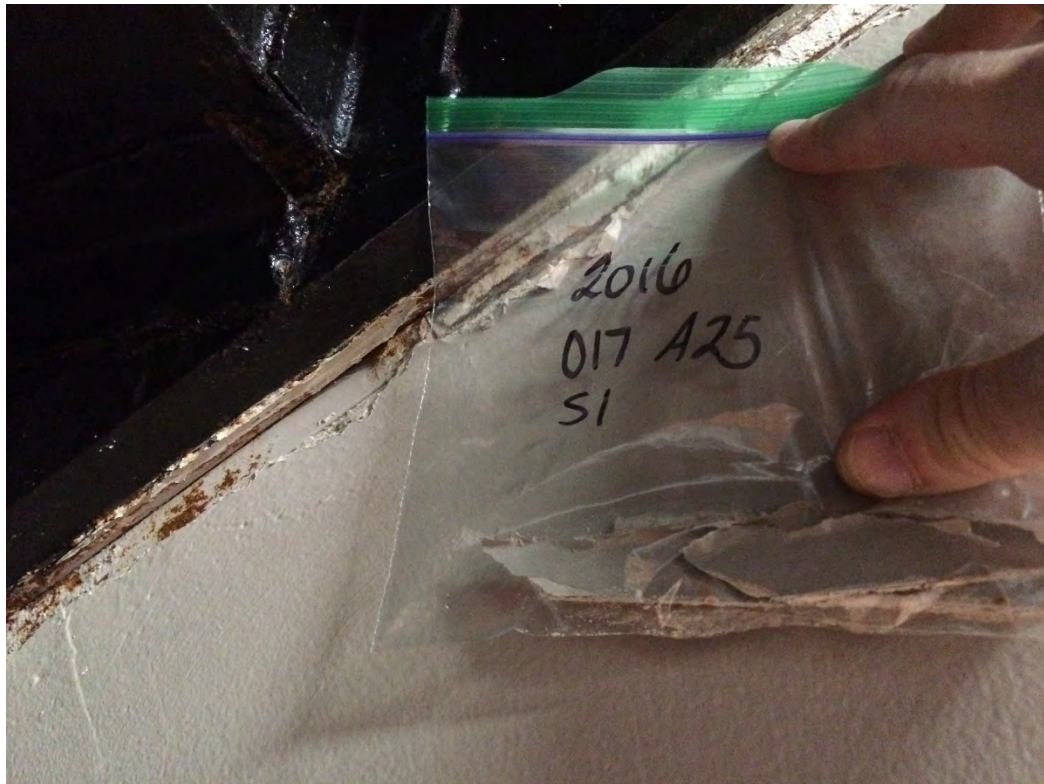
Photo 25: Asbestos sample A25, drywall joint compound collected from wall in O17-S1. No asbestos detected.

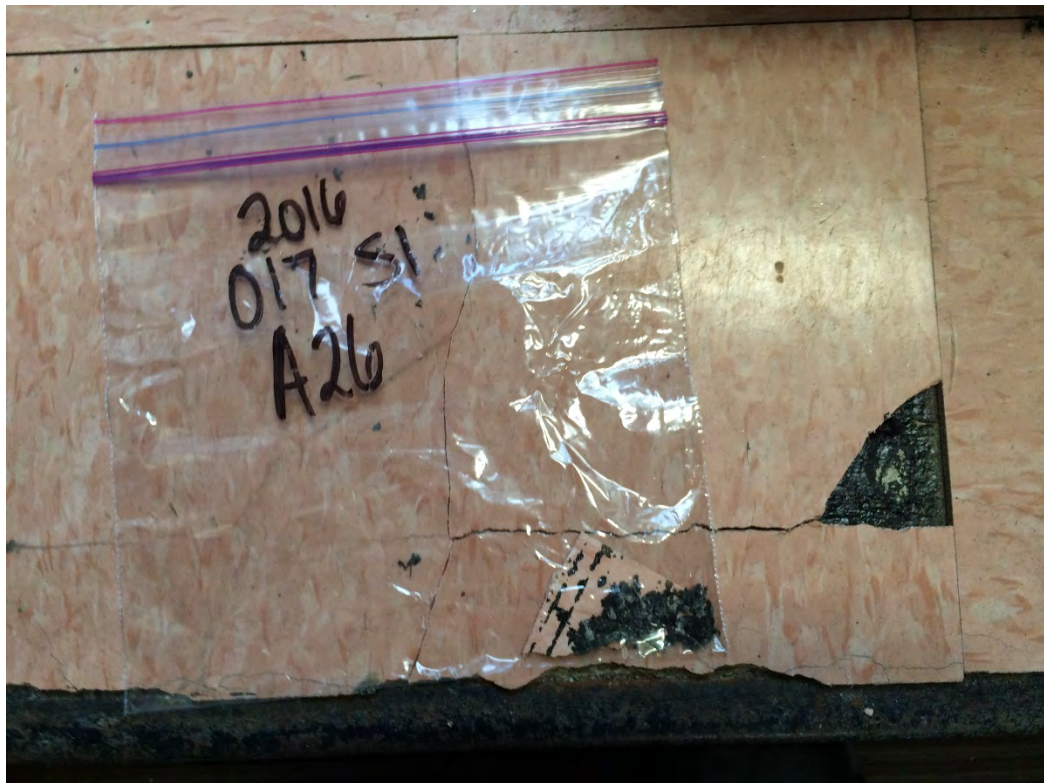
Photo 26: Asbestos sample A26, 12" x 12" pink vinyl floor tile and adhesive collected from O17-S1. No asbestos detected in tile or adhesive.

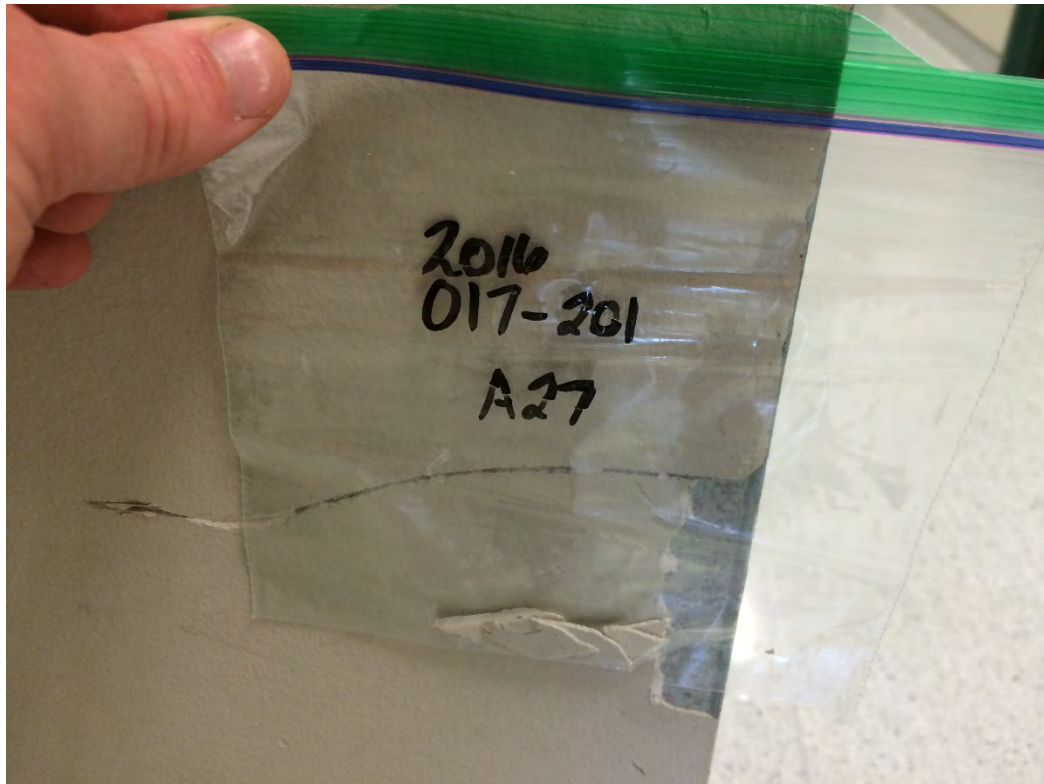
Photo 27: Asbestos sample A27, drywall joint compound collected from wall in O17-201. No asbestos detected.

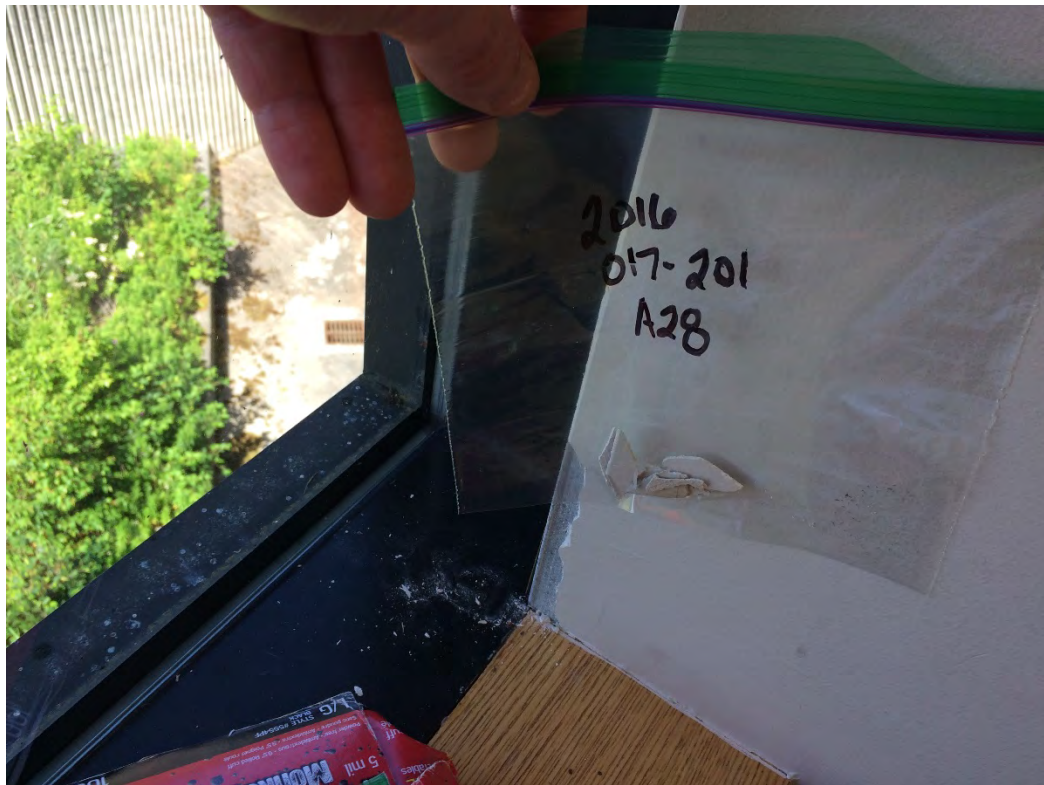
Photo 28: Asbestos sample A28, drywall joint compound collected from wall in O17-201. No asbestos detected.

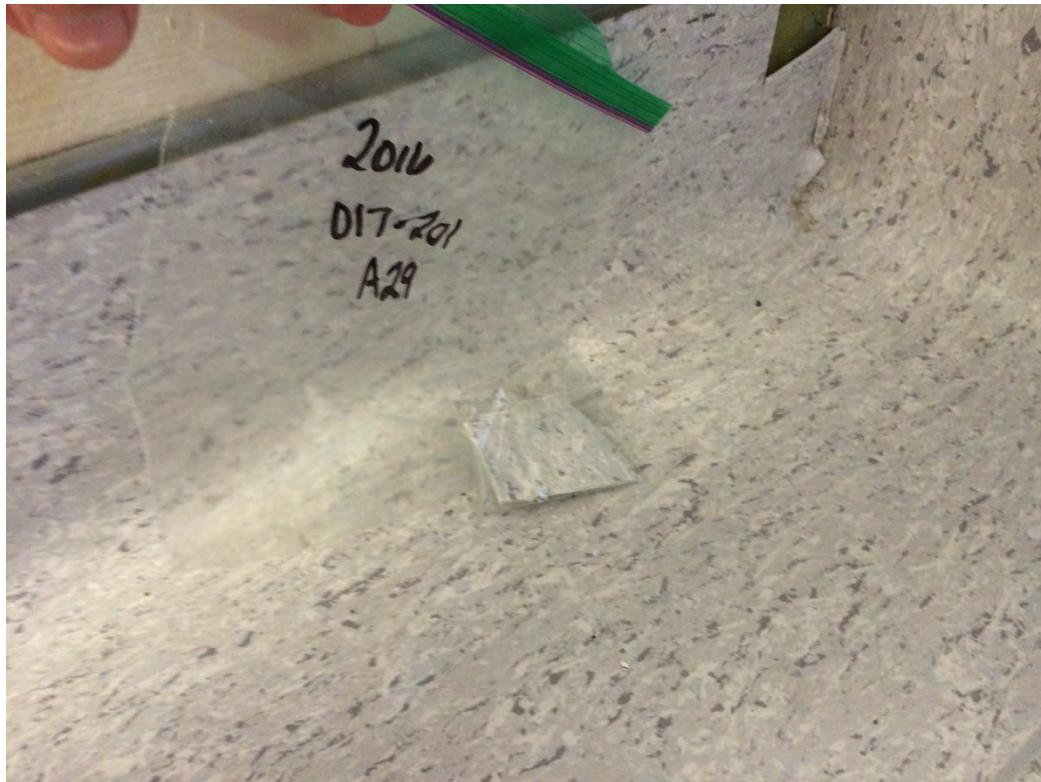
Photo 29: Asbestos sample A29, light grey seamless vinyl flooring with dark specks and adhesive collected from O17-201. No asbestos detected in flooring or adhesive.

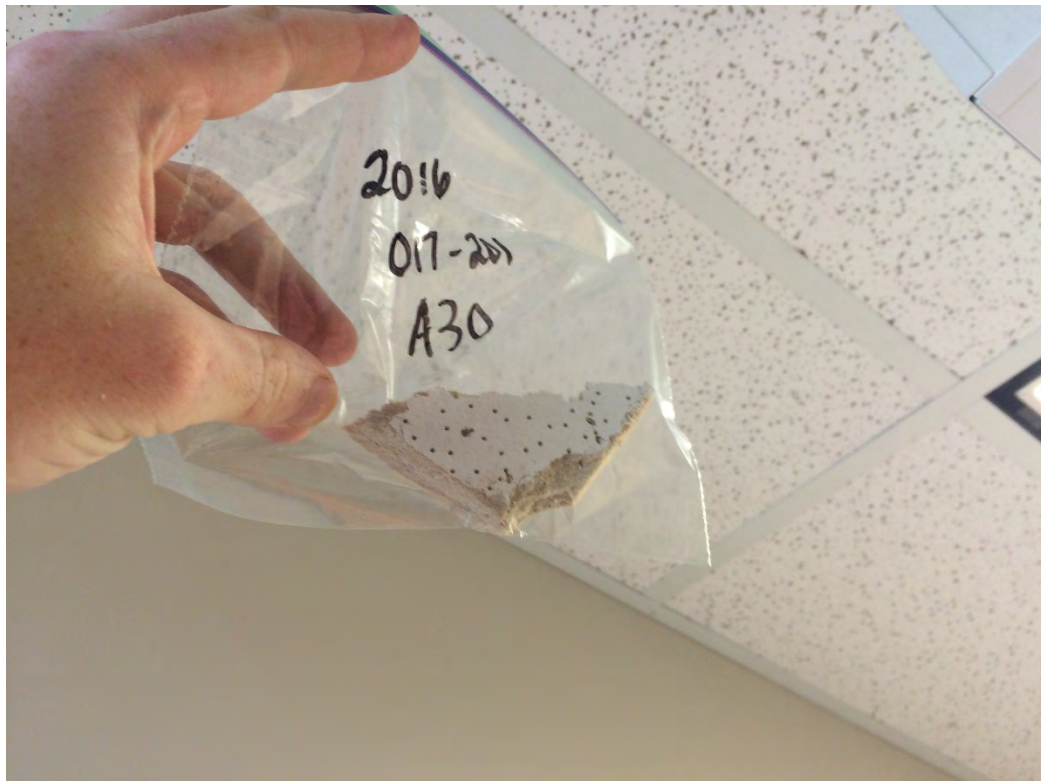
Photo 30: Asbestos sample A30, 24" x 24" ceiling tile with small dots and large gouges pattern collected from O17-201. No asbestos detected.

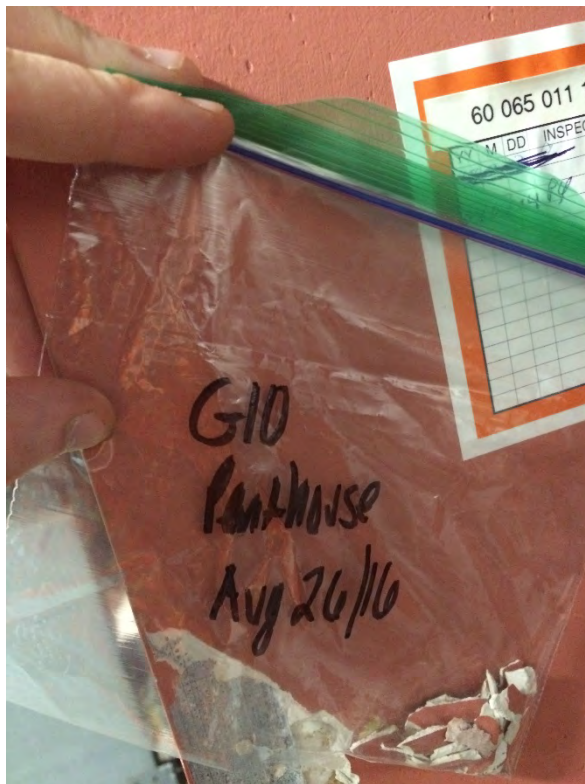
Photo 31: Asbestos sample A34, drywall joint compound collected from wall in penthouse of Pod G10. No asbestos detected.

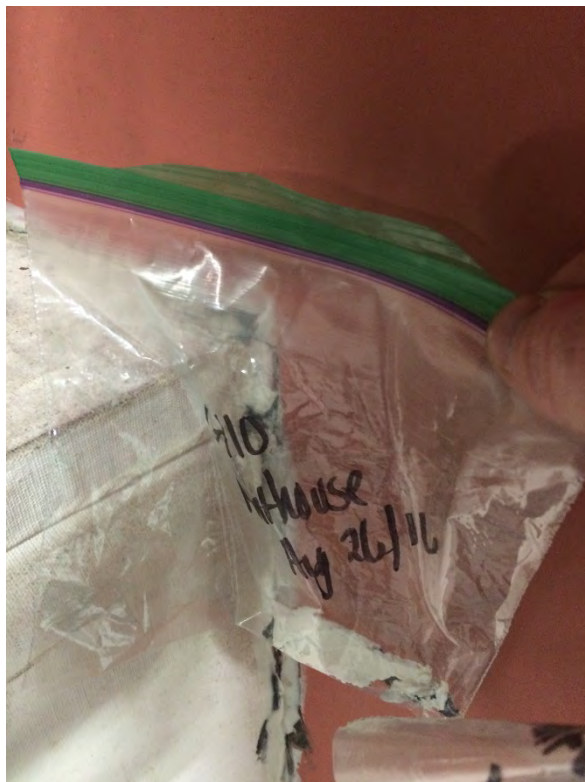
- Ductwork sealant (caulking), where the ductwork passes through wall, in the penthouse of Pod G10 contains 2% chrysotile asbestos. The sealant is considered non-friable. The sealant was not observed in other penthouses.

Photo 32: Asbestos sample A35, ductwork sealant (caulking), collected where ductwork passes through wall in penthouse of Pod G10. The material contains **2% chrysotile asbestos**.

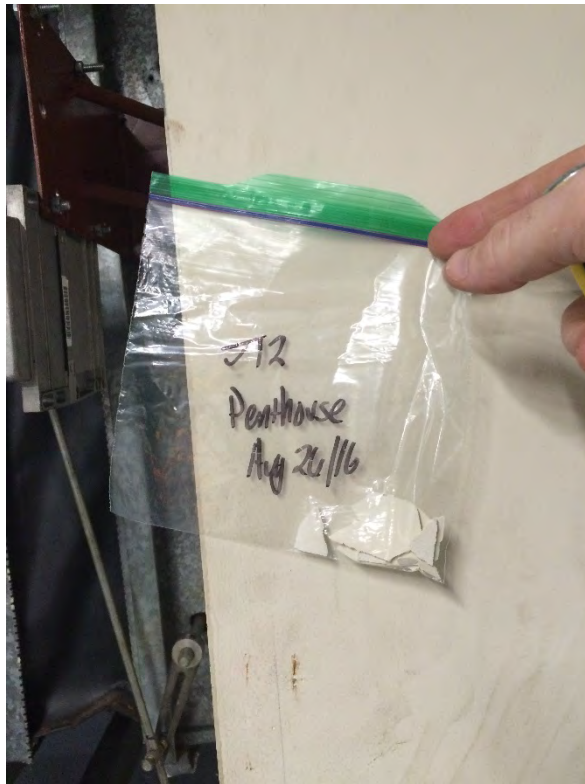
Photo 33: Asbestos sample A36, drywall joint compound collected from wall of penthouse in Pod J12. No asbestos detected.

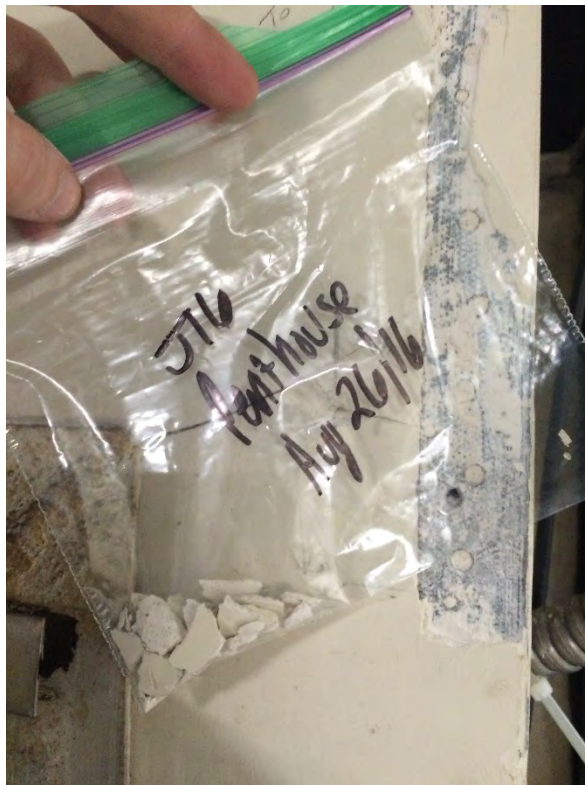
Photo 34: Asbestos sample A37, drywall joint compound collected from wall of penthouse in Pod J16. No asbestos detected.
