September 29, 2016

**Subject:** Bulk Asbestos Sampling Program - FINAL  
Northwest Atlantic Fisheries Centre, Pods H7, H17, O17, and All Penthouses  
E. White Hills Road, St. John's, NL  
Our ref.: P-0010737-0-02-202

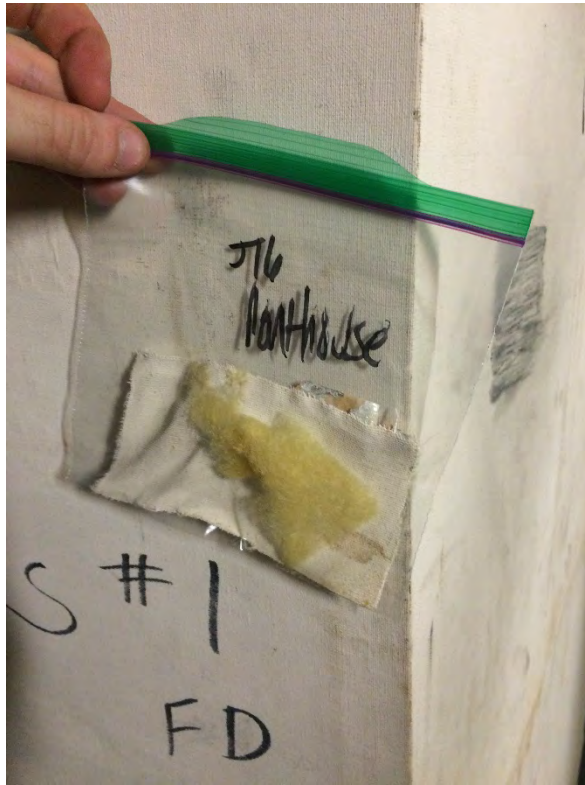
Photo 35: Asbestos sample A38 and A39, ductwork wrap and fibreglass insulation collected from penthouse in Pod J16. No asbestos detected.

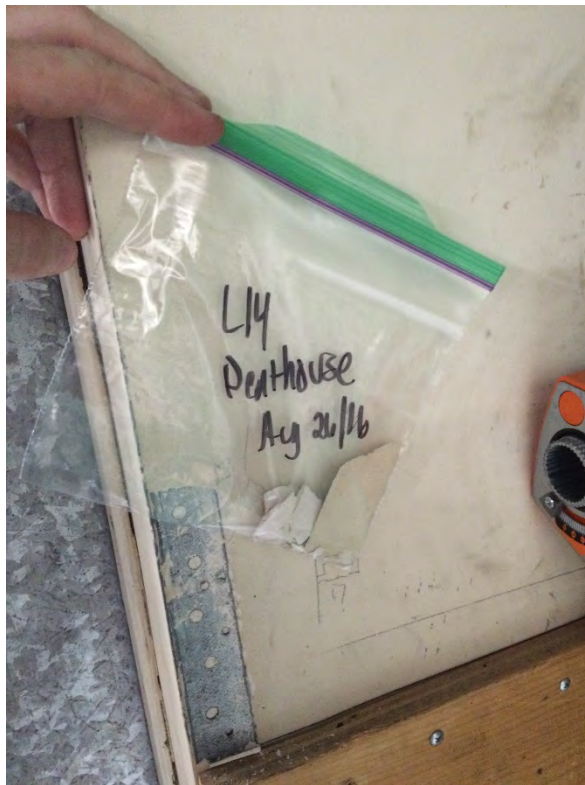
Photo 36: Asbestos sample A40, drywall joint compound collected from wall of penthouse in Pod L14. No asbestos detected.

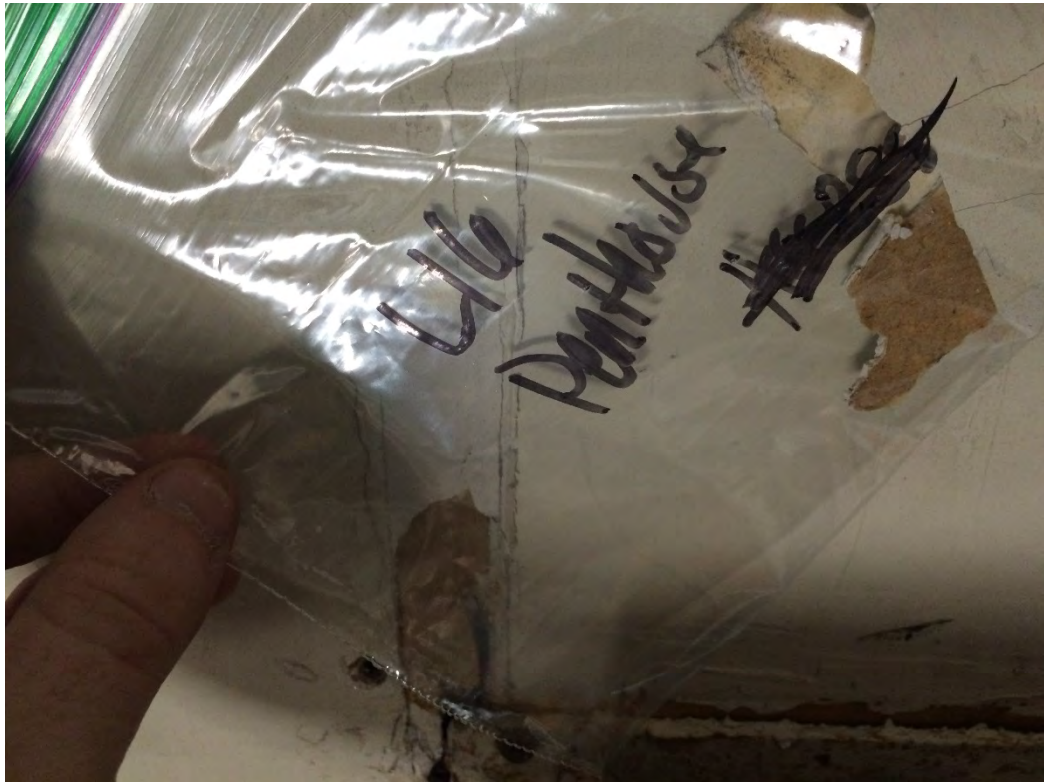
Photo 37: Asbestos sample A41, drywall joint compound collected from wall of penthouse in Pod L16. No asbestos detected.

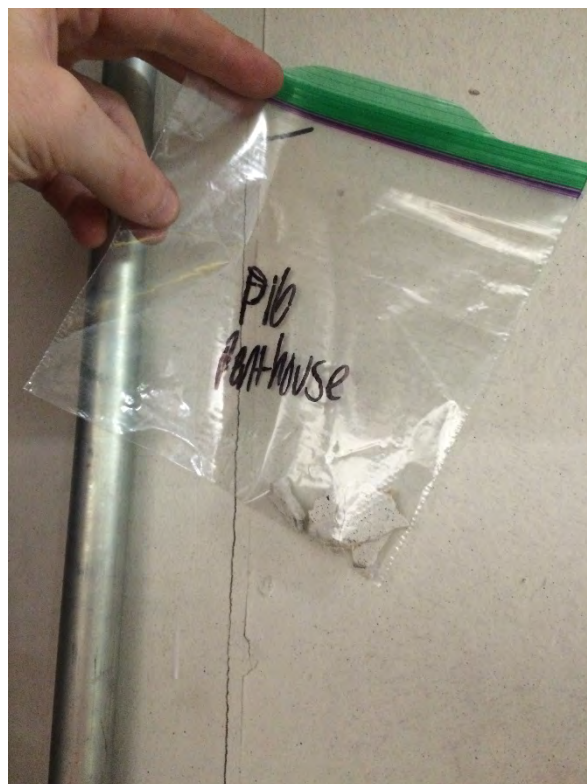
- Drywall joint compound in the penthouse of Pod P16 contains 3% chrysotile asbestos. The drywall joint compound should be considered friable.
  - During the 2002 asbestos assessment, samples of drywall joint compound were collected sparingly throughout the facility. The results of those samples were then conservatively applied to all areas of the building. As a result, drywall joint compound throughout the NAFC has been identified as asbestos-containing. However, no drywall joint compound samples were previously collected directly from the penthouses. During the current assessment, samples of drywall joint compound were collected from each penthouse where drywall was observed (Pods G10, G18, J12, J16, L14, L16 and P16). Joint compound in Pod P16 was found to contain asbestos, while all other samples were found to not contain asbestos. Therefore, it is our opinion that the drywall joint compound in all penthouses, other than Pod P16, is non-asbestos containing.

Photo 38: Asbestos sample A42, drywall joint compound collected from wall of penthouse in Pod P16. Joint compound contains 3% chrysotile asbestos.

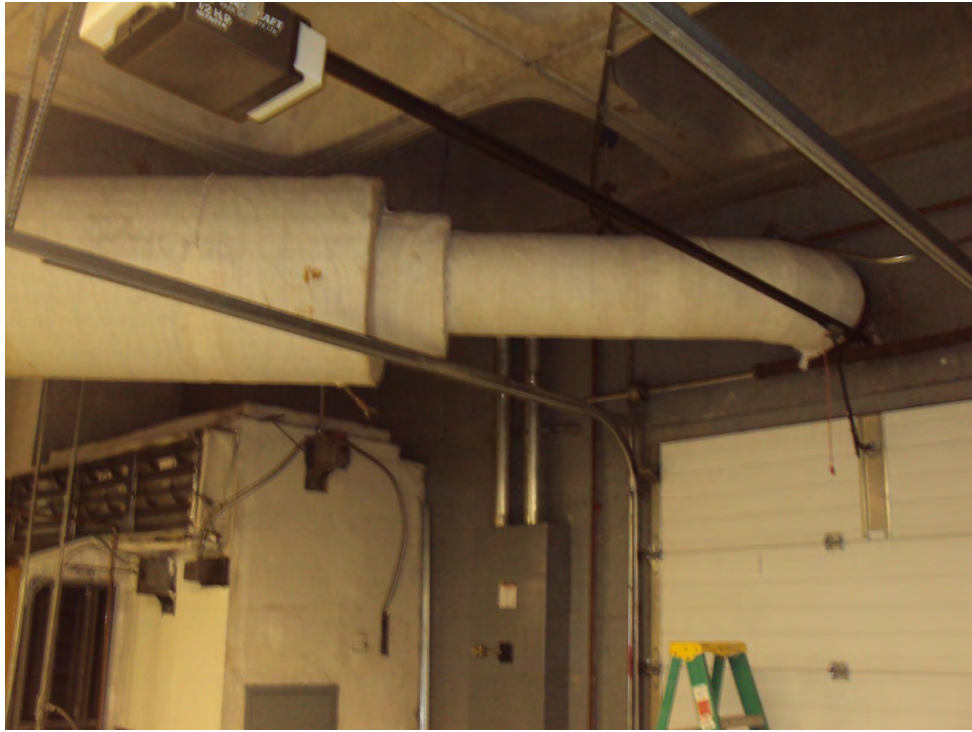
- A white, powdery parging cement and weaved-fabric wrap were identified on a large diameter duct in Substation 1 in Building H7 in 2012 (see Photo 39 in Appendix 2). The parging cement was found to contain 3% chrysotile asbestos and is considered highly friable. The weaved-fabric wrap was found to contain 90% chrysotile asbestos and is considered friable.
- No other ACMs were identified in Pod H7.

Photo 39: Hot air duct in Building H7 (Substation). Both the weaved, fabric wrap and the underlying paring insulation were sampled in 2012 and found to be asbestos containing. The wrap contains **90% chrysotile asbestos** and the insulation contains **3% chrysotile asbestos.** (Photo taken during 2012 assessment)
