**XCG File No. 1-336-191-01**

December 2, 2014

**DESIGNATED SUBSTANCES AND  
HAZARDOUS MATERIALS SURVEY  
CANADA'S COAST GUARD BASE  
PARRY SOUND, ONTARIO  
R.064667.007**

**PUBLIC WORKS AND GOVERNMENT SERVICES CANADA**

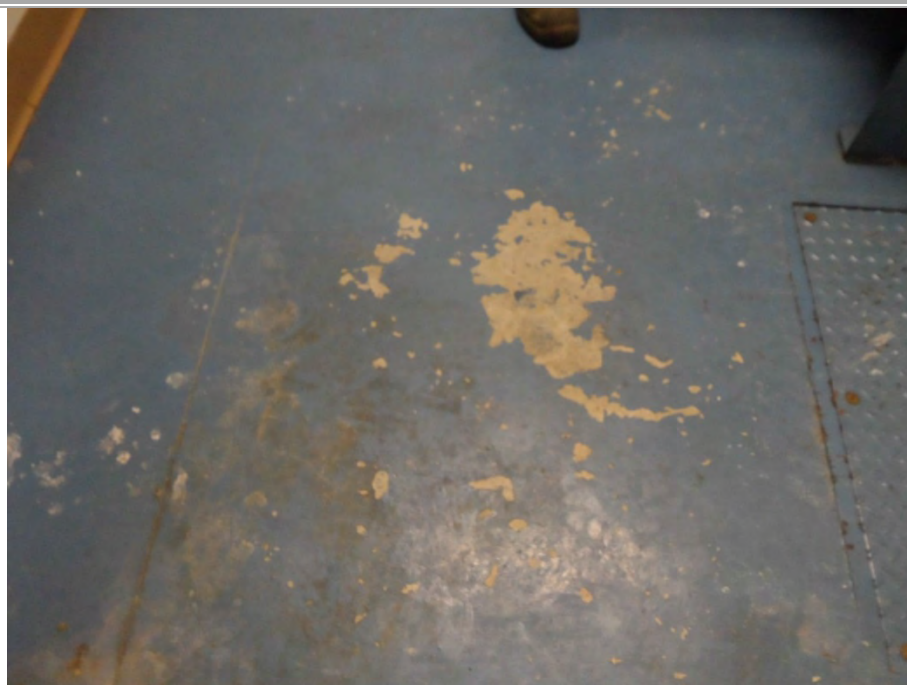
**Photo 1: Main Building Room 179 blue interior floor paint – Lead-containing (Sample 179-P-12).**

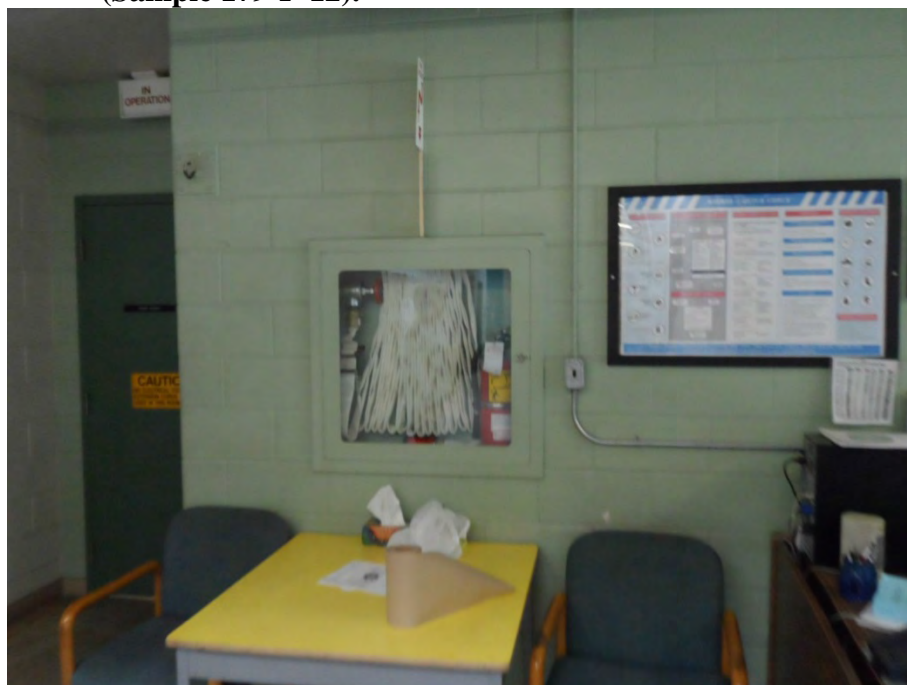
**Photo 2: Main Building Room 123 Light green interior wall paint – Lead-containing (Sample 123-P-18).**

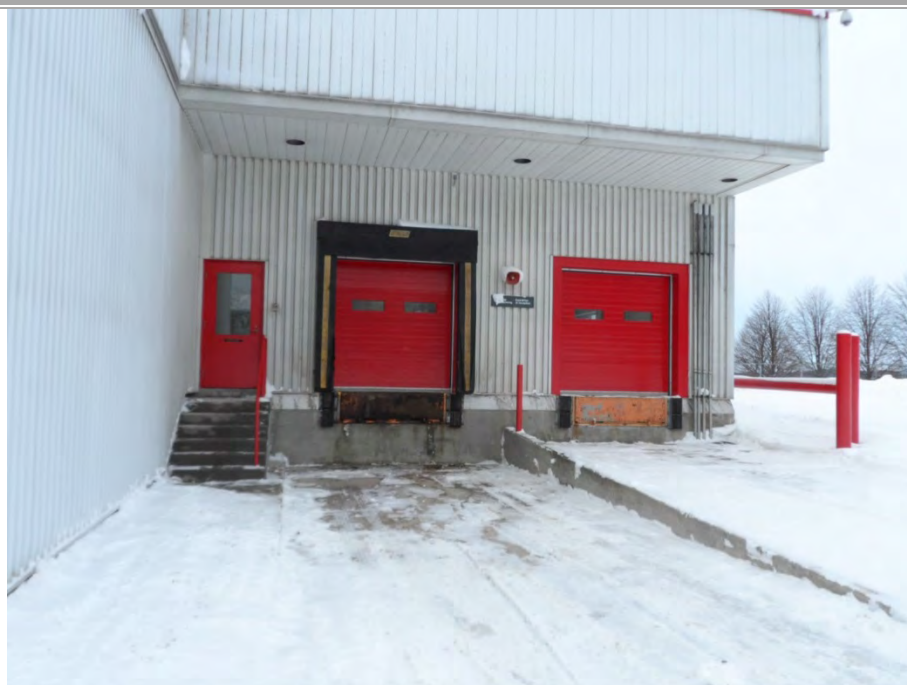
**Photo 3: Main Building exterior red trim paint–Lead-containing (Sample Admin-P-29).**

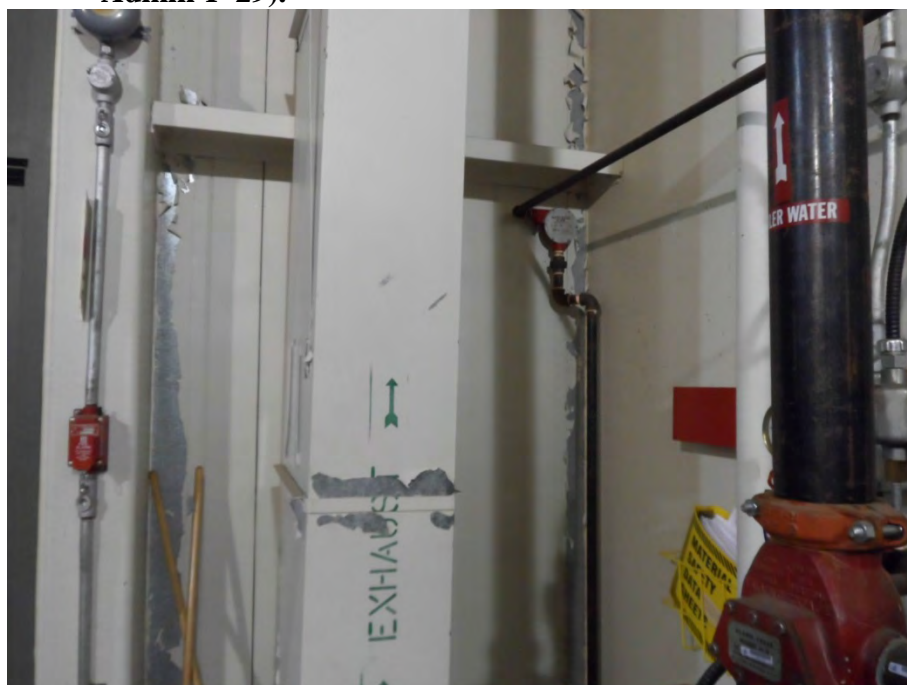
**Photo 4: Hazard Storage Building cream interior wall paint – Lead-containing (Sample Haz-P-25).**

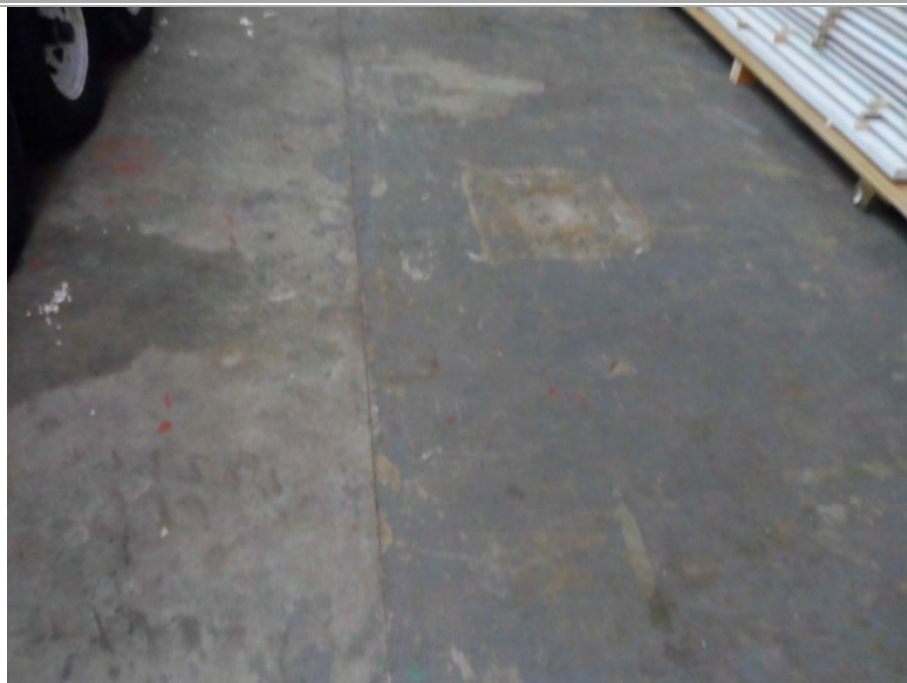
**Photo 5: Ship stores grey floor paint – Lead-containing (Sample SHP-P-27).**

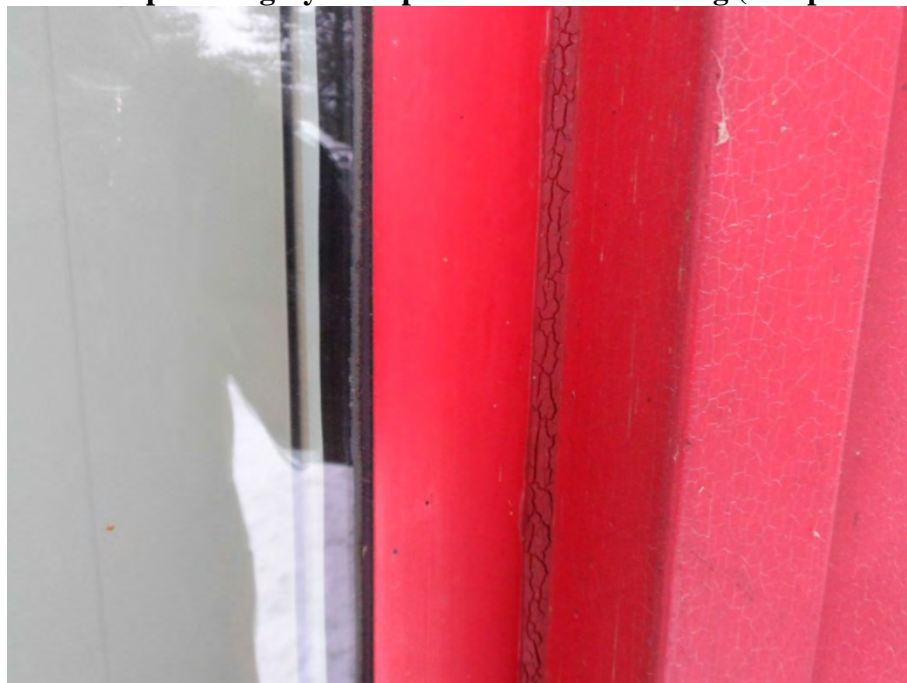
**Photo 6: Main Building exterior red siding – Lead-containing (Sample Admin-P-29).**

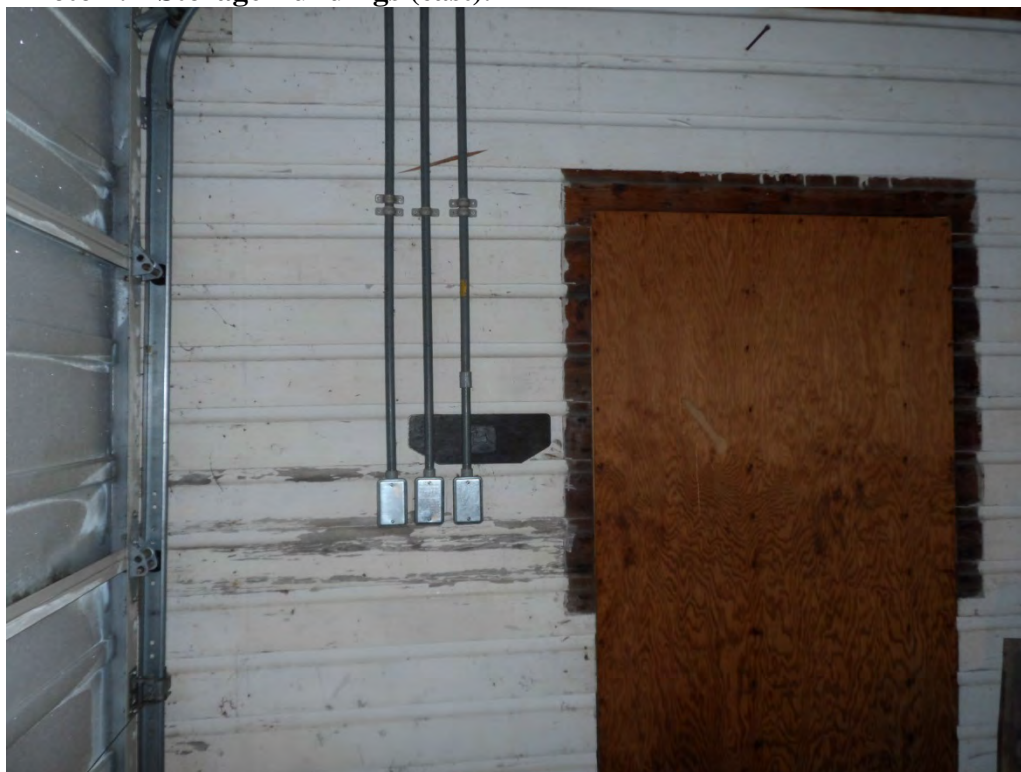
**Photo 8: Storage Building (east) white interior siding paint – Lead-containing (Sample STR1-P-31).**

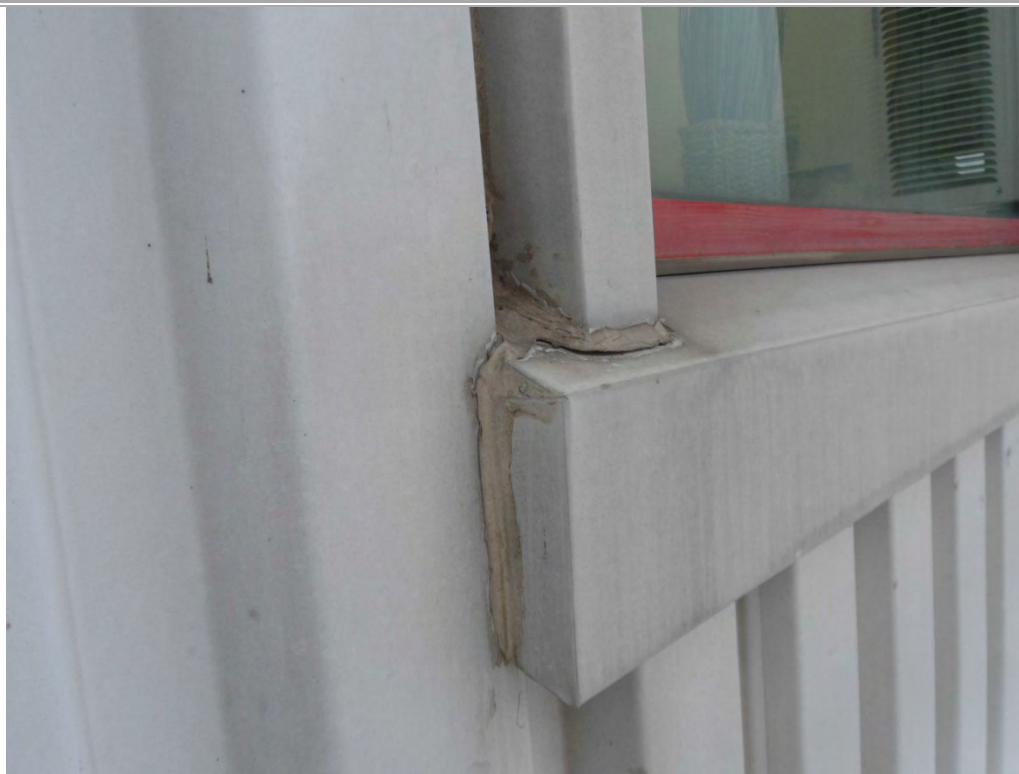
As identified in above Table 4, sample Admin-P-30 was laboratory reported as “Void” due to insufficient sample to analyze. This was due to the extremely thin well adhered factory finish on the grey exterior siding. XCG recommends that the grey exterior siding be treated as lead-containing. In order to collect sufficient sample volume, XCG estimates approximately >2 square metres of paint would need to be removed, which exceeds normal sample collection expectations.

**Photo 9: Main Building grey exterior siding paint - Lead-Containing (Sample Admin-P-30).**

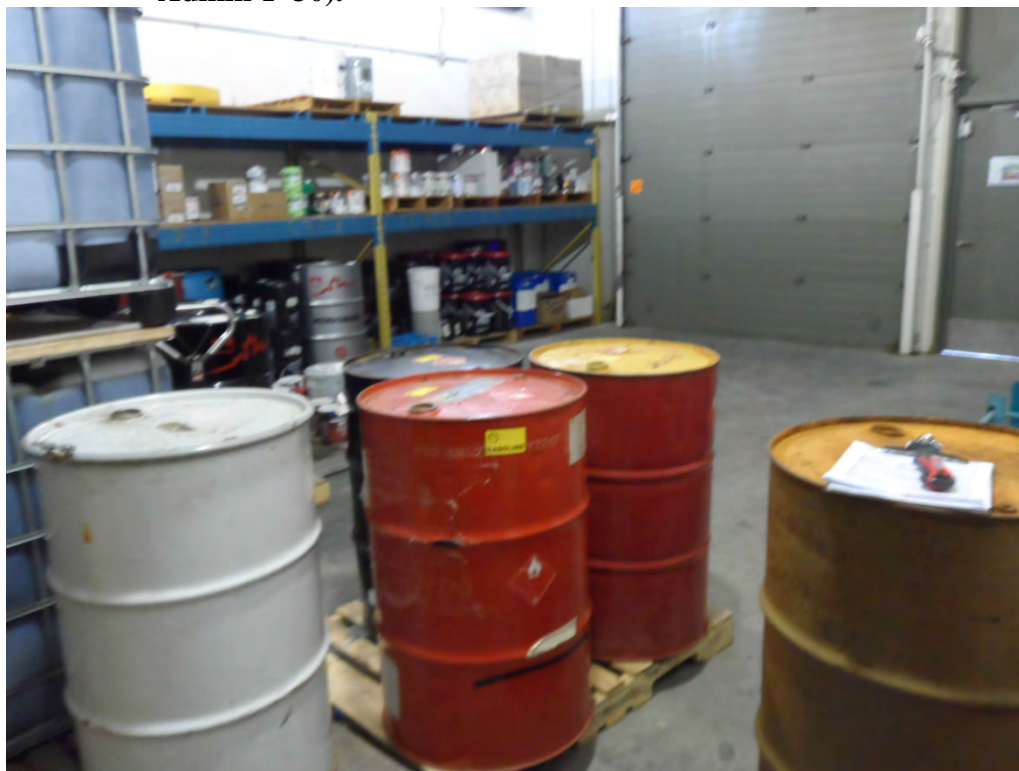
**Photo 10: Flammable Storage.**

**Based on observations made during the site reconnaissance, no obvious issues/concerns were observed related to the on-site storage of chemicals. It is recommended that an environmental compliance audit be conducted to assess whether the fuel, oil, waste oil and chemicals are being stored and managed in accordance with applicable legislation and federal policies/procedures. This compliance assessment was beyond the scope of this DSHMS.**

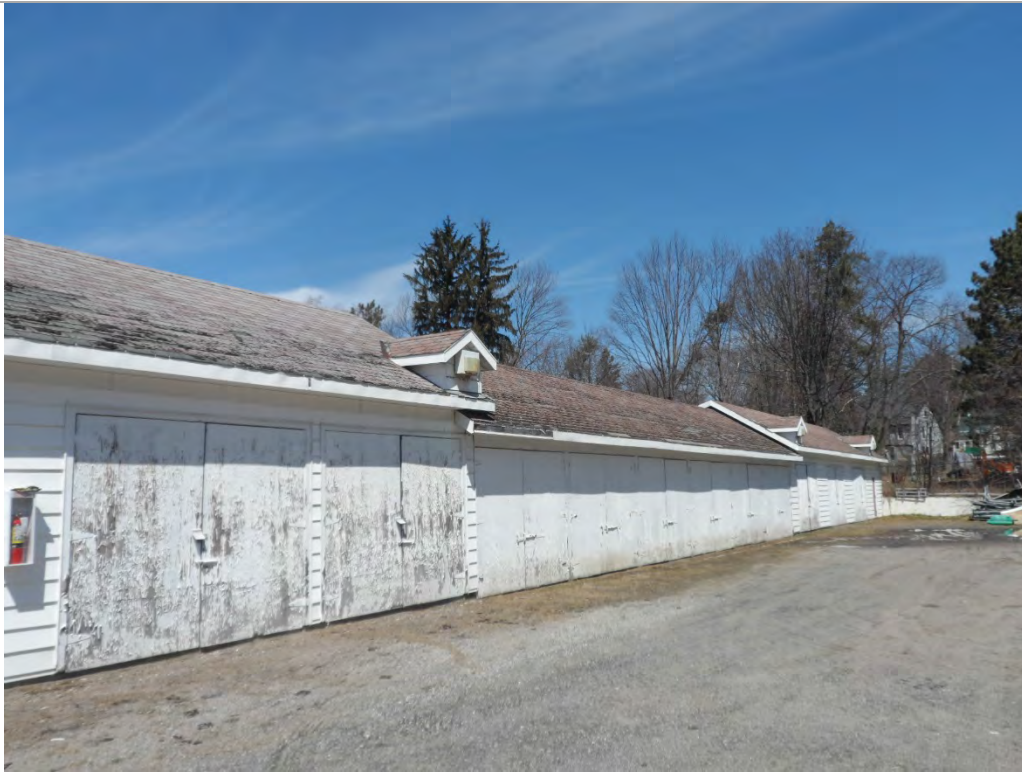
**Photo 13: Compound Storage ACM Sample CS-SHL-07A,B,C.**

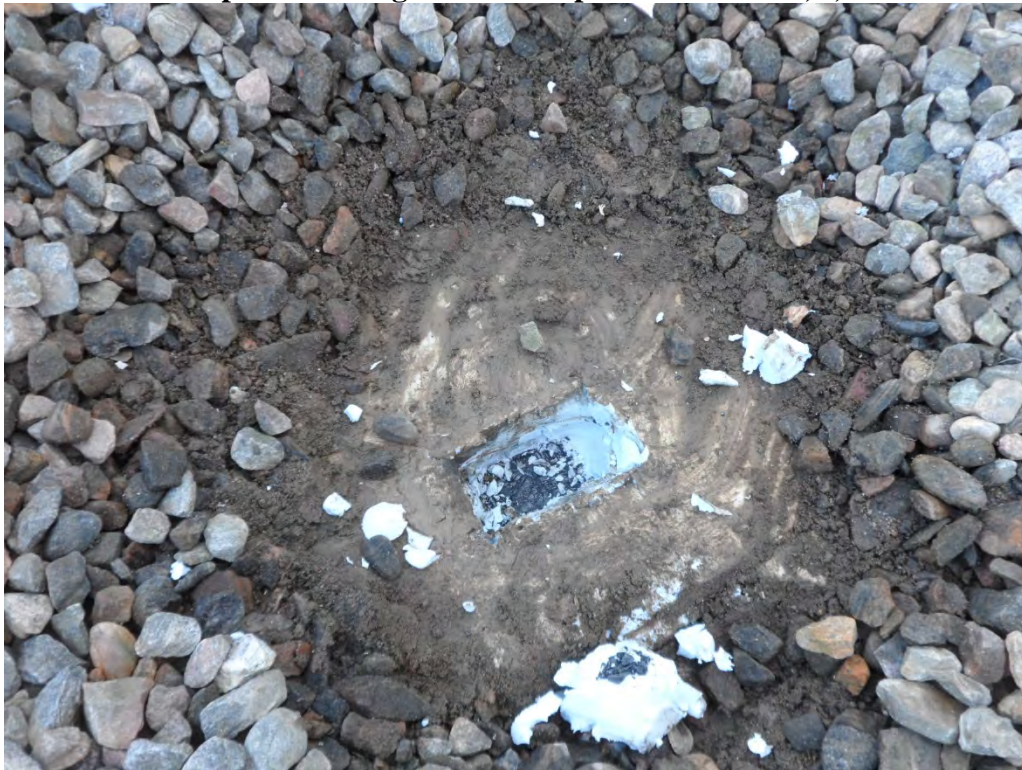
**Photo 14: Main Bldg. ACM Sample MB-RF-02A.**

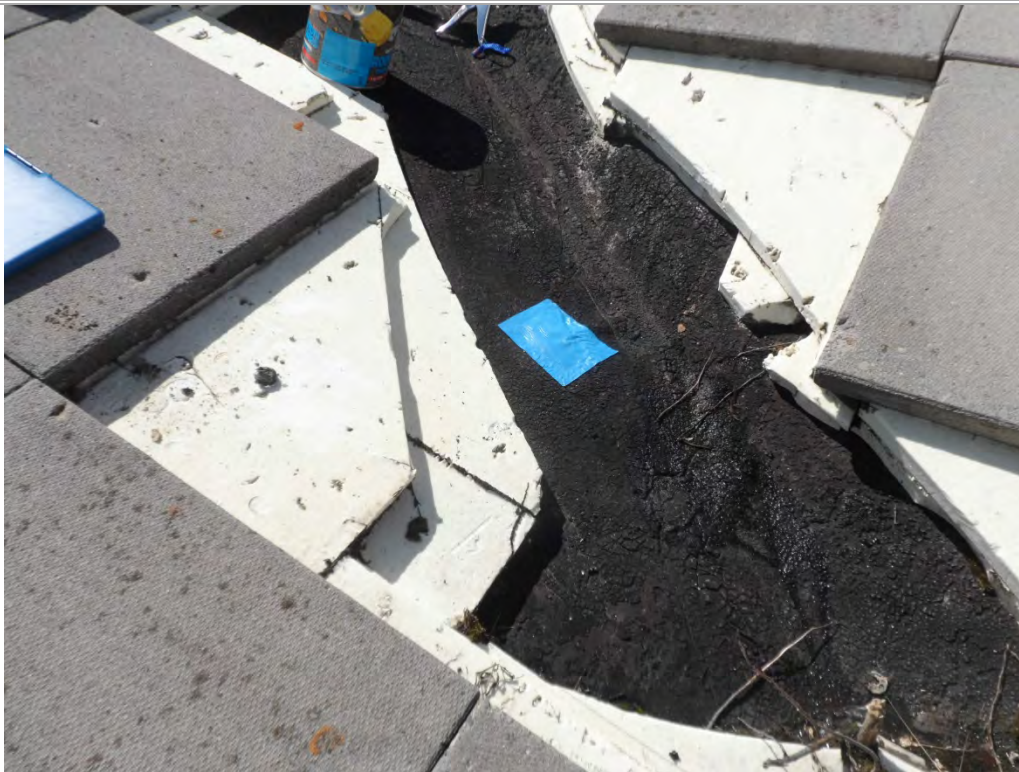
**Photo 15: Main Bldg. ACM Sample MB-RF-02C.**

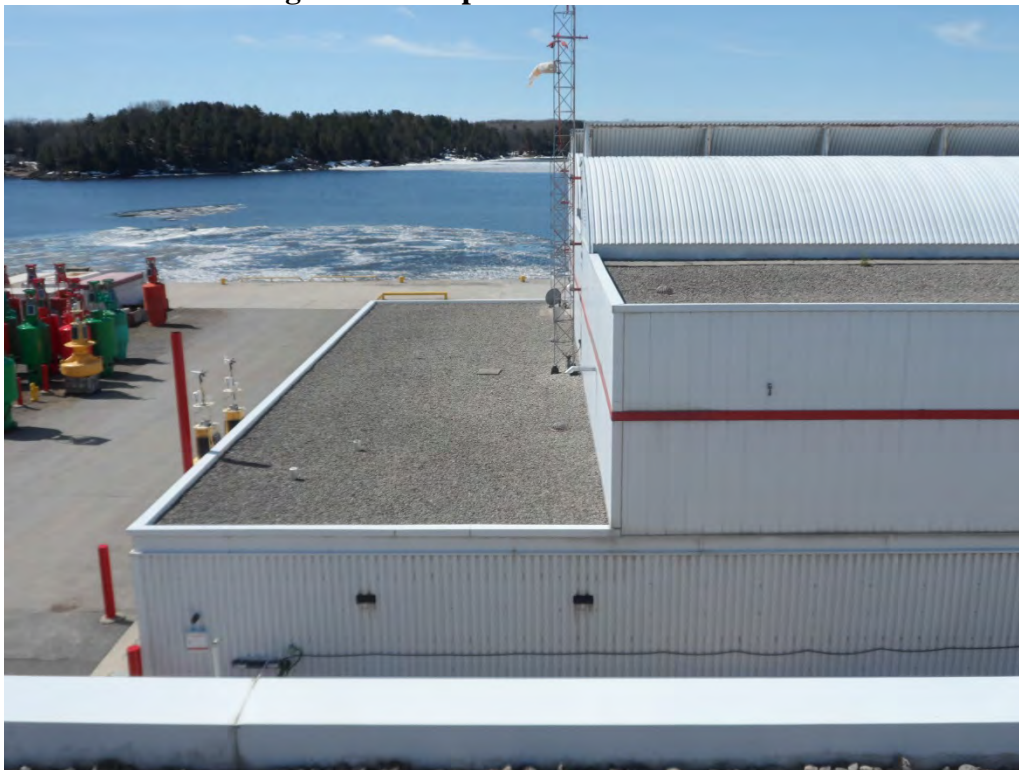
**Photo 16: Helicopter Hanger ACM Sample HH-RF-03A,B,C and HH-RB-04A,B,C.**

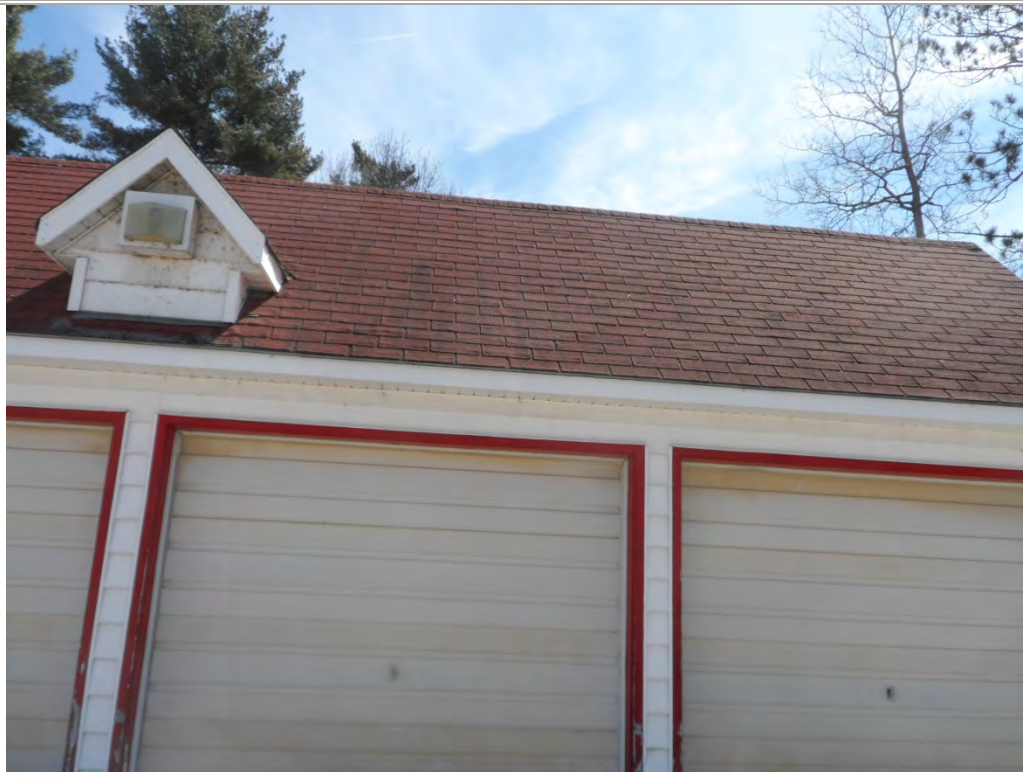
**Photo 17: Storage Buildings ACM Sample SB-SHL-06A,B,C.**

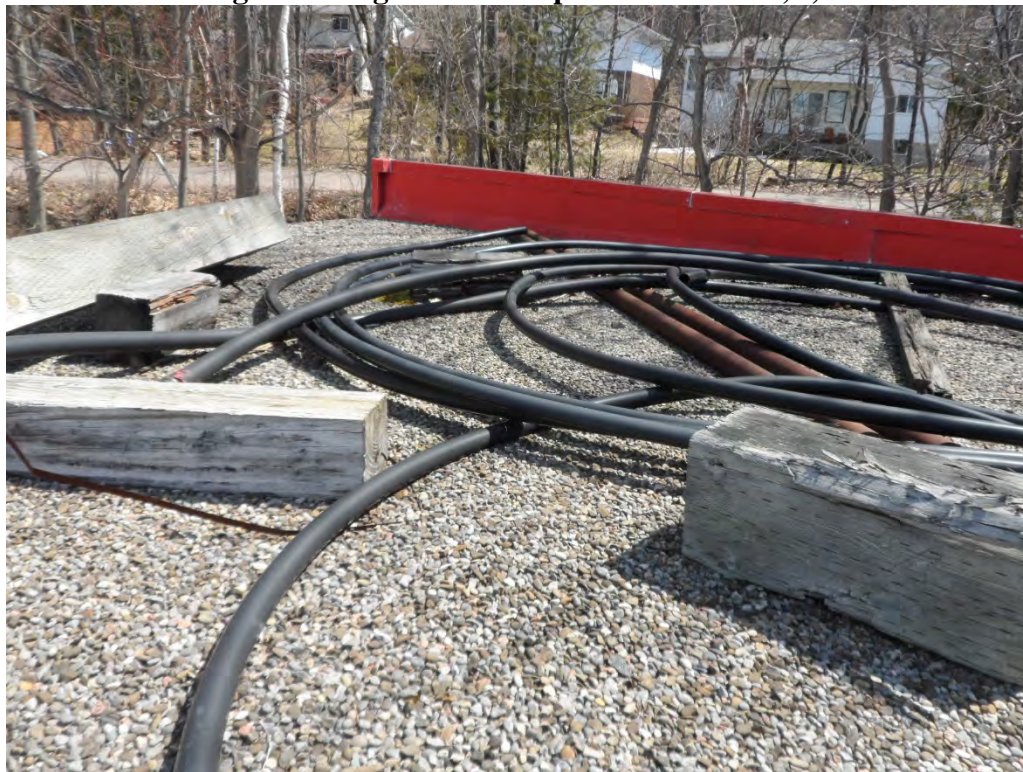
**Photo 18: Winch House ACM Sample WH-RF-05A,B,C.**

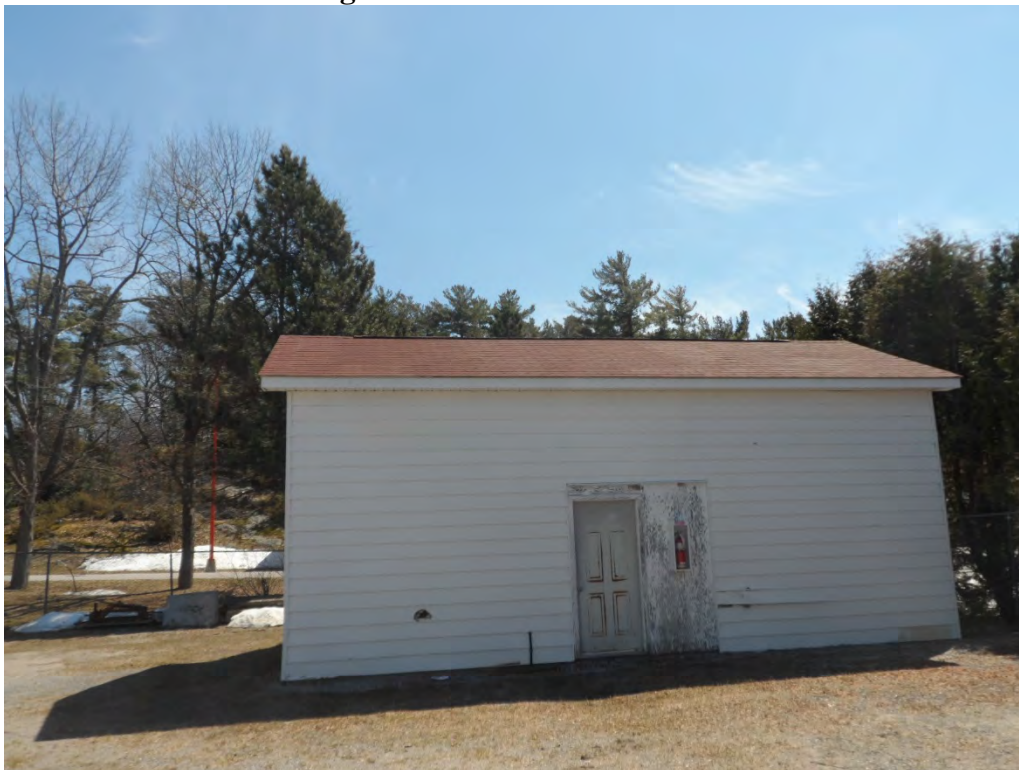
**Mould/water damage was observed within the storage building identified as “Garage (Samuel Risley Storage)” located near the entrance to the subject site. The mould/water damage was observed on the underside of the plywood ceiling and was most likely caused by a leaking roof. On-site staff commented that the leaking roof has been repaired. No other evidence of mould/water damage was observed; however, numerous on-site staff commented that the Main building has had reported leaks recently. Based on the comments made by on-site staff, the potential for mould growth exists, even if not observed during XCG’s site reconnaissance.**

**Photo 20: Garage (Samuel Risley Storage) recently replaced shingle roof.**

Based on observations made during the assessment, XCG recommends further investigation of the ceiling and attic space of the building identified on-site as “Garage (Samuel Risley Storage).” As a result of historic roof leakage, there was mould growth and significant water staining observed on the underside of the plywood ceiling. The potential for additional mould exists within the attic space.
