Stantec Consulting Ltd.
845 Prospect Street, Fredericton, NB E3B 2T7

August 21, 2015
File: 121811235.300

Reference: Suspect Asbestos-Containing Materials and Lead Paint Sampling, Chignecto South and Point Wolfe Campgrounds, Fundy National Park, Alma, New Brunswick

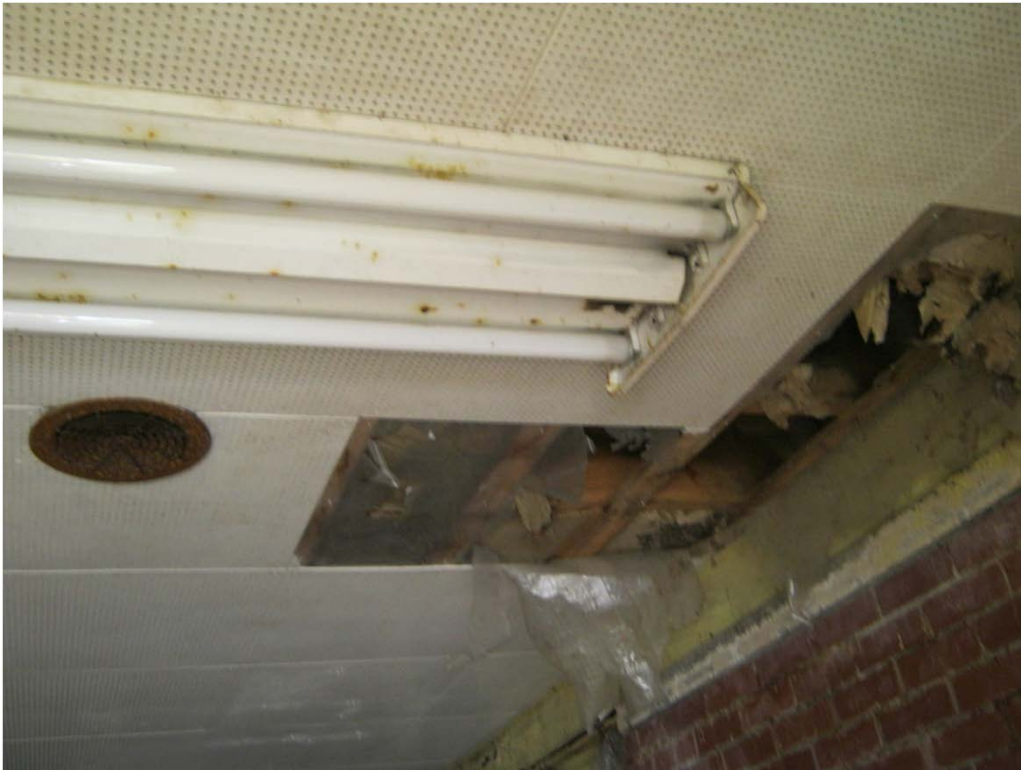
- "Transite" cement board panels observed screwed/nailed to interior and exterior walls and ceilings in several buildings;
- Corrugated "Transite" roofing materials used on several buildings;
- Green asphalt shingles on one building; and
- Black caulking (painted grey) debris located at one building.

These non-friable ACMs were observed to be generally in GOOD condition with the exception of broken pieces of "Transite" cement board panels, corrugated "Transite" roofing material and black caulking observed amongst the debris of the partially demolished Washroom/Kitchen Shelter #7 (WKS 7) structure located in the Chignecto South Campground.

PHOTO 9: View of asbestos-containing 2' x 2' perforated "Transite" cement board ceiling panels (off-white colour) observed in building L9 located at the Point Wolfe Campground.

Any work involving the disturbance, repair (i.e., encapsulation) or removal of the above noted confirmed and presumed ACMs should be conducted by a qualified contractor using Asbestos Work Procedures as defined by A Code of Practice for Working with Materials Containing Asbestos in New Brunswick (N.B. Regulation 92-106) and Federal Directive 057.

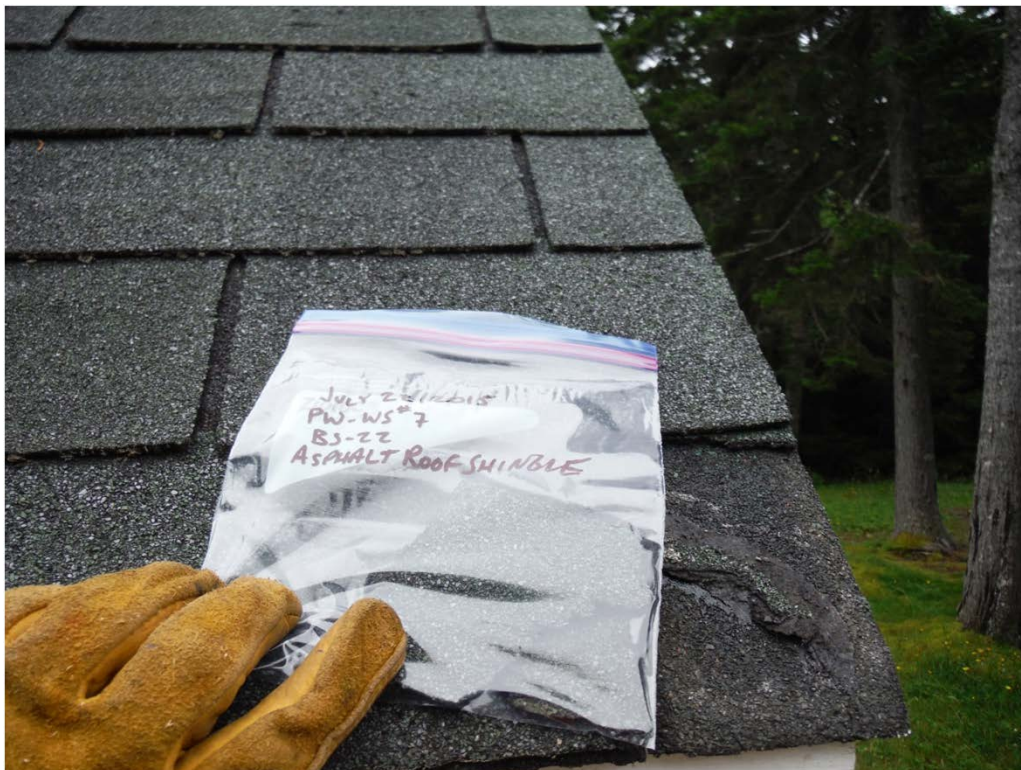
Based on the lab identifying Chrysotile asbestos in green asphalt shingles from two buildings (one sample at 3.1% and the other at 0.55%), all green asphalt shingles on Chignecto South and Pointe Wolfe Campground buildings should be presumed to be asbestos-containing.

PHOTO 10: View of sample PW-BS-22 (green asphalt shingle) obtained from the roof of building WS 7 located in the Point Wolfe Campground. This shingle sample was found to contain **0.55% Chrysotile asbestos**.

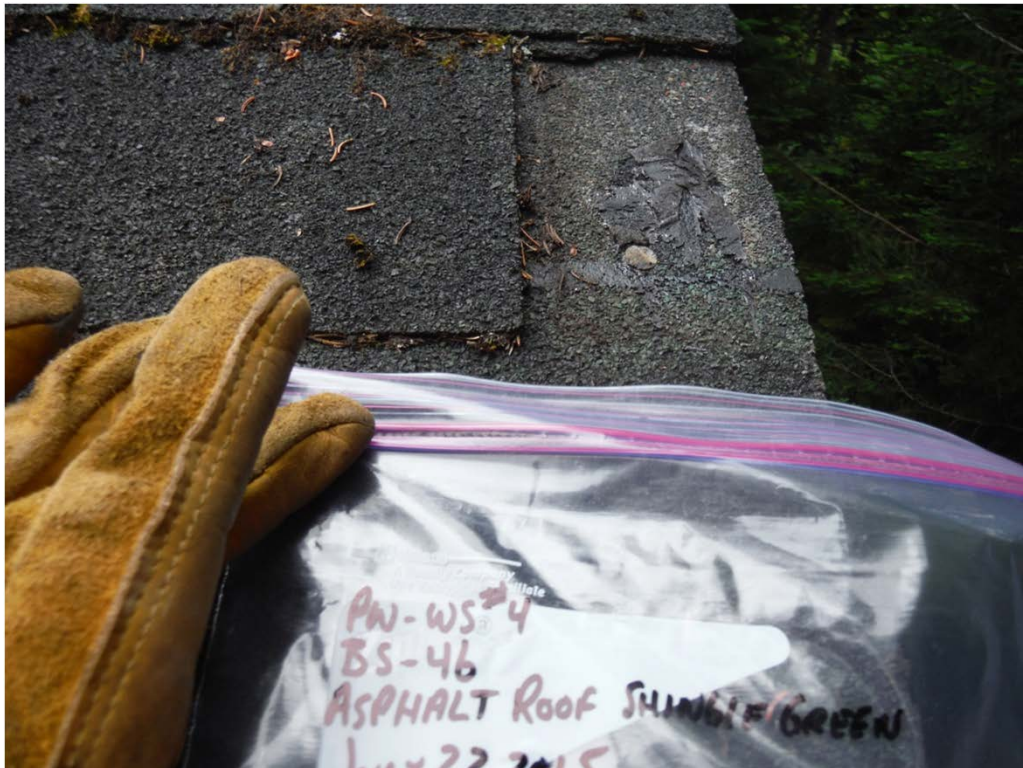
PHOTO 11: View of sample PW-BS-46 (green asphalt shingle) obtained from the roof of building WS 4 . This shingle sample was found to **3.1% Chrysotile asbestos**.

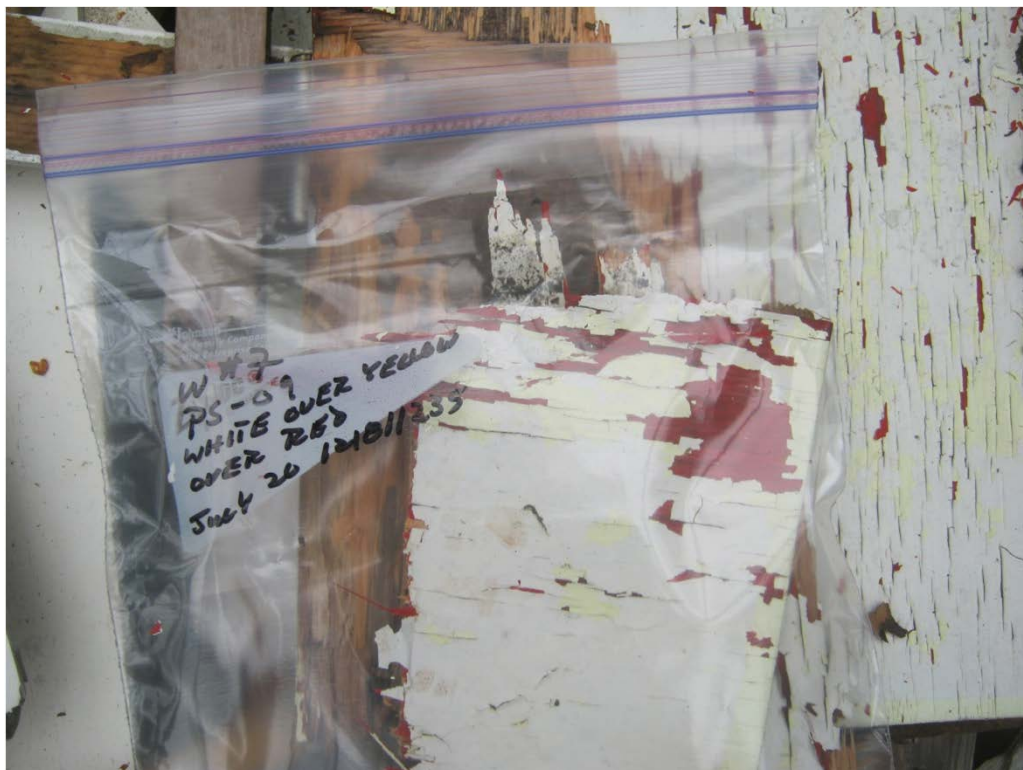
- White over yellow over red paint (C-PS-09) present on one wood door associated with the mostly demolished Washroom Kitchen Shelter 7 (WKS 7) structure. The paint was generally in GOOD condition (*i.e.* paint is well adhered to substrate);
- White paint chips (C-PS-16) on the exterior window trim on the Washroom Kitchen Shelter 2 (WKS 2) structure. The paint was generally in FAIR condition (*i.e.* some paint is loose and is becoming detached from substrate).

PHOTO 12: View of paint sample C-PS-09 (white over yellow over red paint on wood substrate) found to be lead-containing. This paint sample was obtained from a wood door of the partially demolished building WKS 7 located at the Chignecto South Campground.

Paint samples (C-PS-09, PW-PS-01, and PW-PS-03) were found to have a lead-concentration above 1,000 mg/kg and to have a lead leachate concentration less than 5 mg/L. These materials can be disposed of at a Regional Solid Waste Landfill provided permission is obtained from the facility.

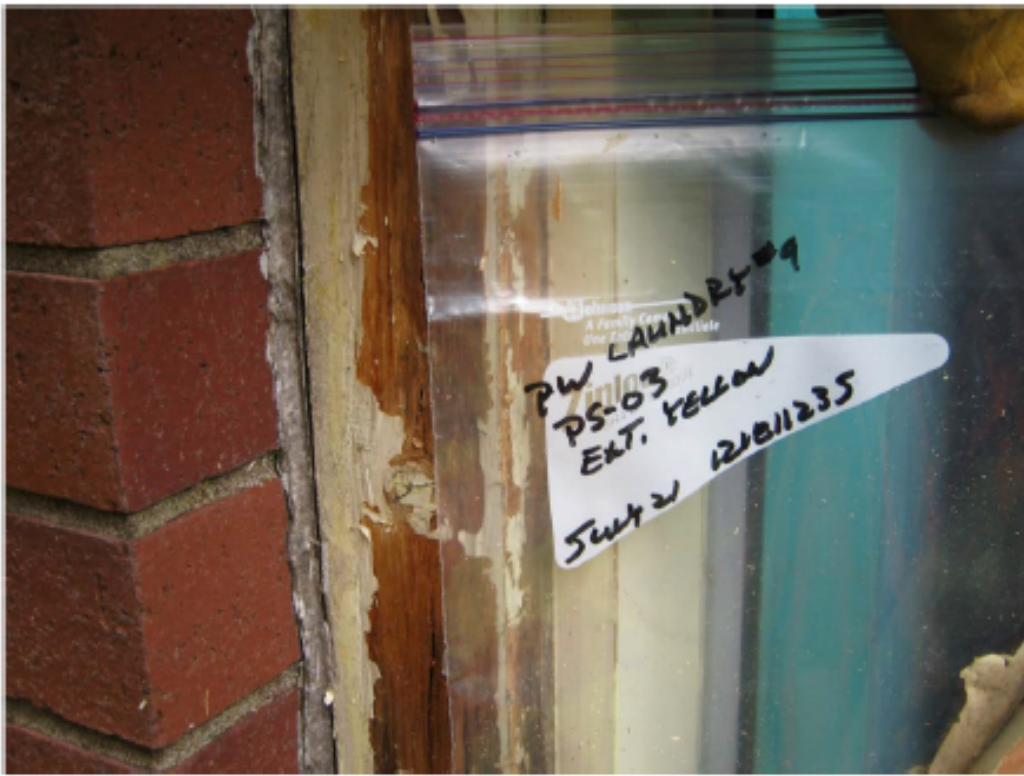
- Black over white paint (PW-PS-01) on exterior plywood at the Laundry building (L9). The paint was generally in GOOD condition.
- Yellow paint (PW-PS-03) on exterior doors, wood panels and masonry areas on the Laundry Building (L9). The paint was generally in GOOD condition.

PHOTO 15: View of location of paint sample PW-PS-03 (yellow paint on wood substrate) found to be lead-containing. This yellow colour paint was observed on the exterior doors, wood panels, and masonry of building L9 located at the Point Wolfe Campground.

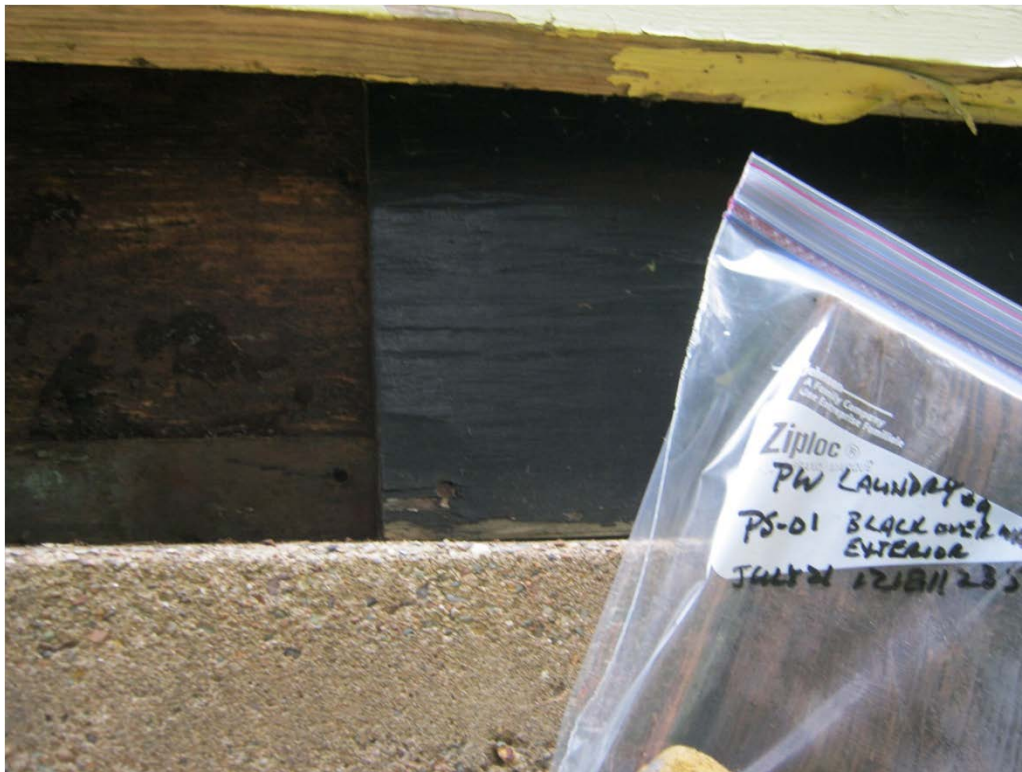
PHOTO 14: View of location of paint sample PW-PS-01 (black over white paint on wood substrate) found to be lead-containing. This sample was obtained from the exterior plywood on building L9 located at the Point Wolfe Campground.
