7.0 RECOMMENDATIONS

6.1.4 **PARK ADMINISTRATION BUILDING**

EBA Engineering Consultants, LTD (a Tetra Tech co)
 Project Location: Banff Townsite, Banff National Park
 Alberta

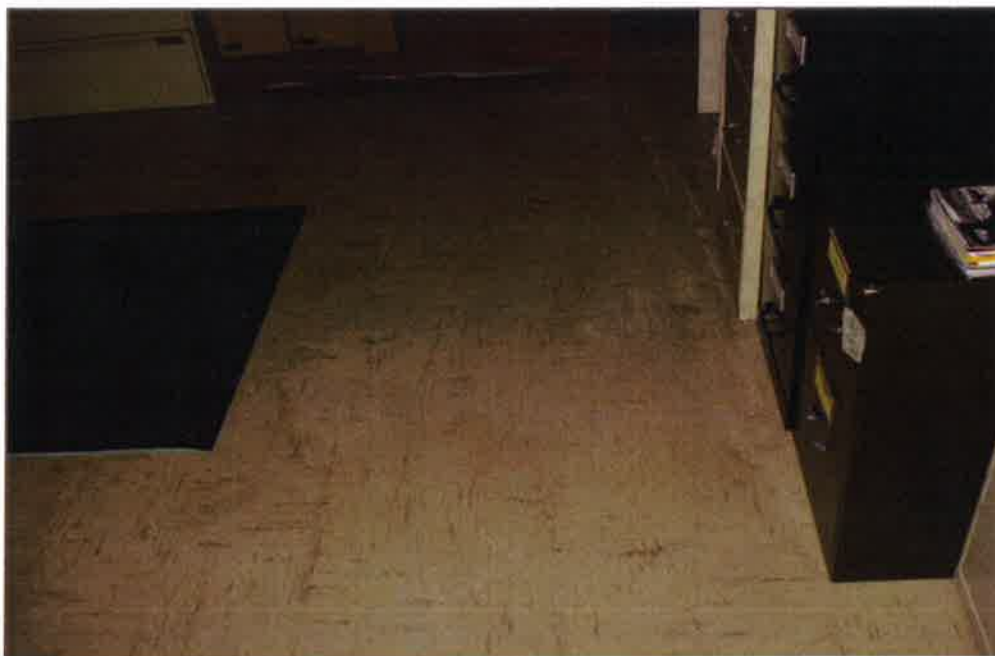
- λ Asbestos-containing 12"x12" dark beige vinyl floor tile (Tetra Tech sample No. Admin-001), located in the basement records room. The ACM was deemed to be in good condition at the time of assessment as depicted in photograph number 15.

Photo 15: Asbestos containing 12"x12" dark beige vinyl floor tile located in the basement records room. EBA sample No.Admin-001.

ACMs were identified within the subject buildings. During demolition/renovation activities, ensure these materials are removed and disposed of in accordance with the requirements of the Alberta Asbestos Abatement Manual, August 2011. Identified ACMs should be managed, removed and disposed of in accordance with the requirements of the Transportation of Dangerous Goods Act. Specifically, Tetra Tech recommends that the identified ACMs should be managed, removed and disposed of in accordance with the following requirements:

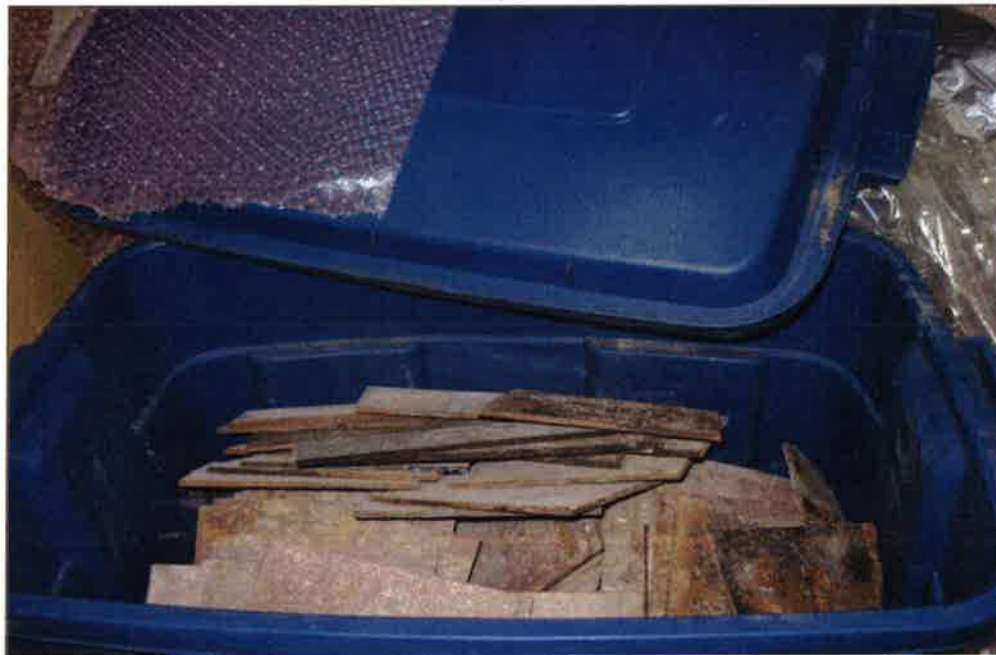
- λ Asbestos-containing 6"x6" brown vinyl floor tile (Tetra Tech sample No. Admin-004) sampled from a stock pile of floor tiles located within the Boiler room as shown in photograph number 16 and 17. The floor tile was visually confirmed in multiple areas of the subject building.

- λ Asbestos-containing 4"x4" black vinyl floor tile (Tetra Tech sample No. Admin-010) sampled from a stock pile of floor tiles located within the Boiler room as shown in photograph number 16 and 17. The floor tile was visually confirmed in multiple areas of the subject building.

Photo 16: Asbestos containing 6"x6" brown vinyl floor tiles and 4"x4" black vinyl floor tiles. EBA sample No.Admin-004 and Admin-010. These floor tiles were visually identified on the first floor.

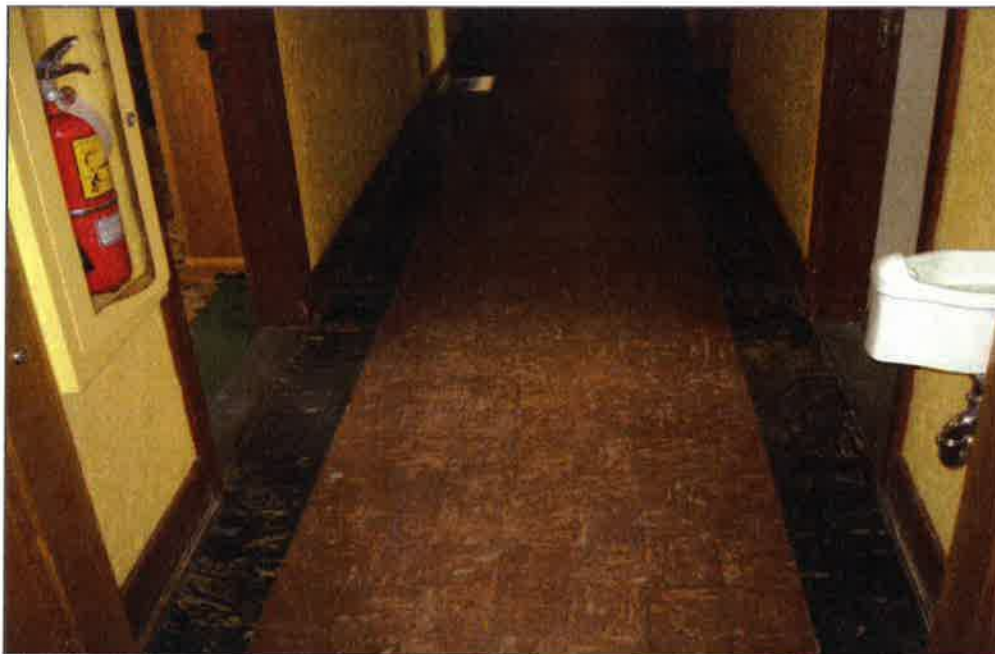
Photo 17: Asbestos containing 6"x6" brown vinyl floor tiles and 4"x4" black vinyl floor tiles as seen on the first floor. EBA sample No.Admin-004 and Admin-010.

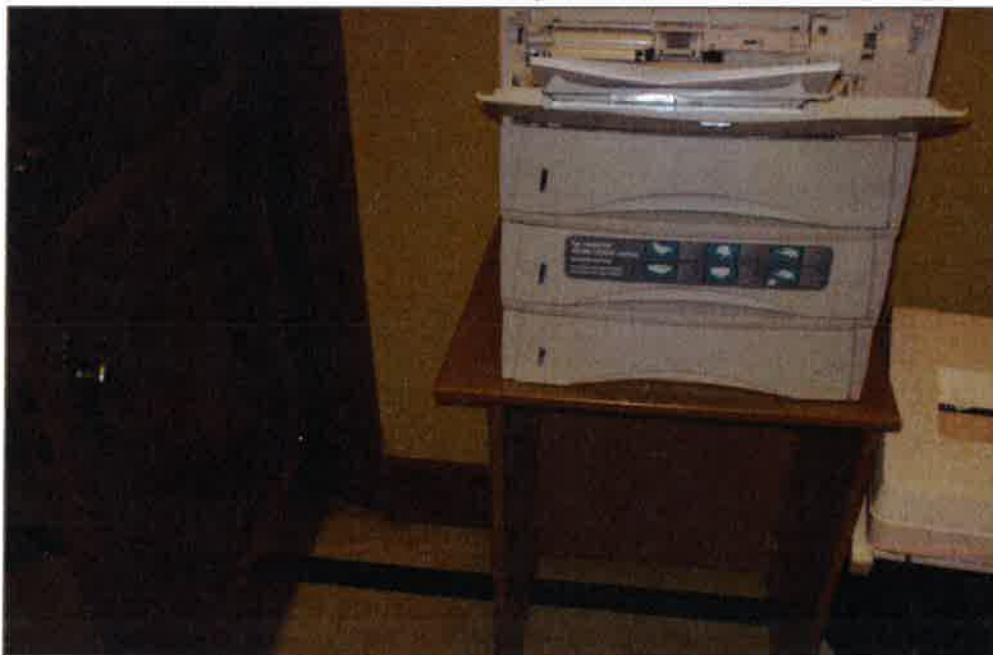
- λ Asbestos-containing texture coating (Tetra Tech sample No. Admin-012) located on the wall of the main floor photocopy room. The ACM was deemed to be in good condition at the time of assessment as depicted in photograph number 18.

Photo 18: Asbestos containing texture coat on the wall of the Photocopy room on the main floor. EBA sample No.Admin-012.
