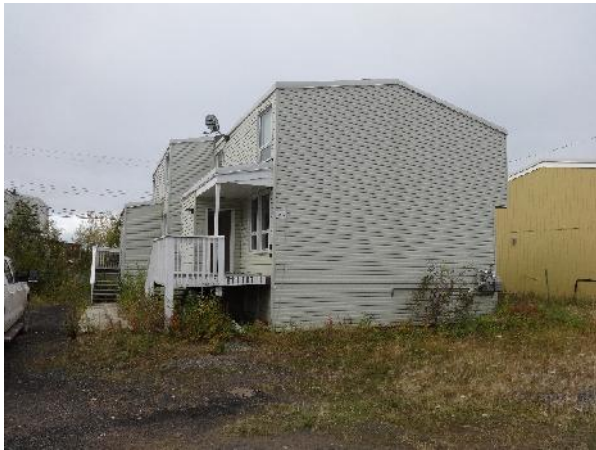
Photo 1: View of exterior 66/68 Alder Drive. Attached overhead lines located on south side of building.

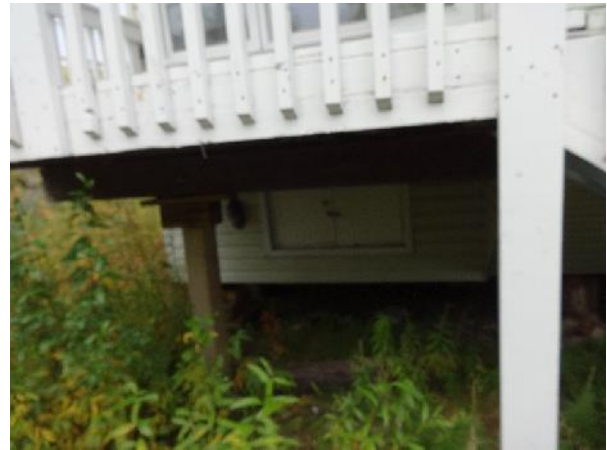
Photo 2: View of one of four exterior crawlspace entry points to 66/68 Alder Drive.

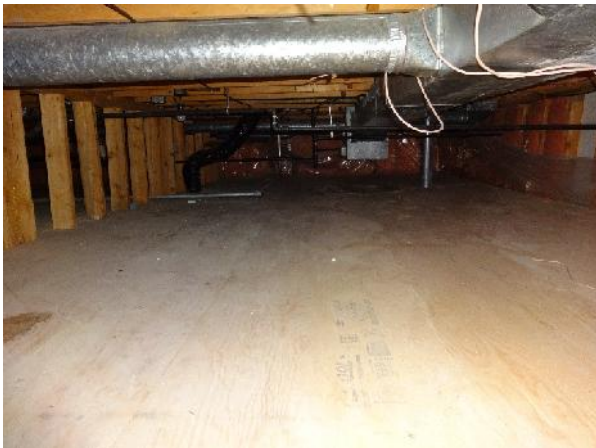
Photo 3: View of structural members and associated piping within crawlspace of 66 and 68 Alder Drive. Crawlspace is approximately 1.1 m in height.

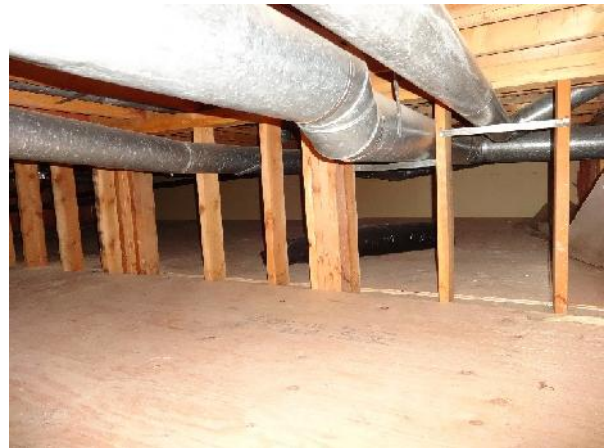
Photo 4: View of structural members and associated piping within crawlspace of 66 and 68 Alder Drive.

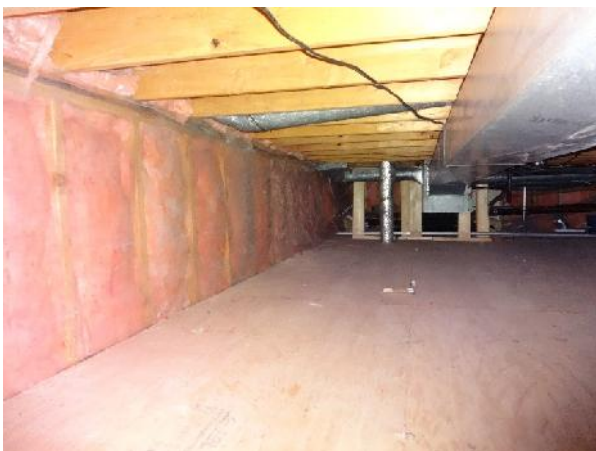
Photo 5: View of structural members and associated piping within crawlspace of 66 and 68 Alder Drive.

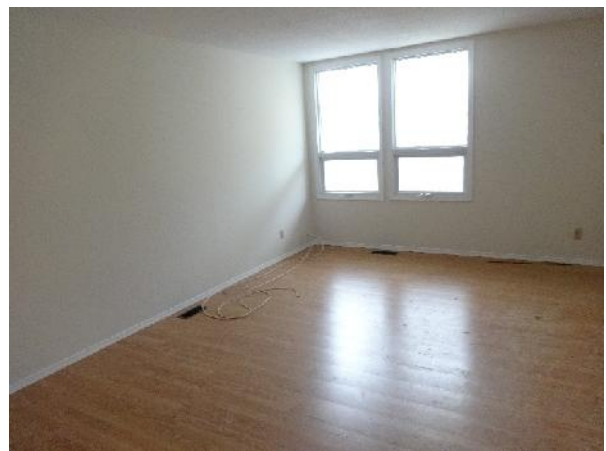
Photo 6: View of interior living room at 66 and 68 Alder Drive. Ceiling height of approximately 2.4 m.

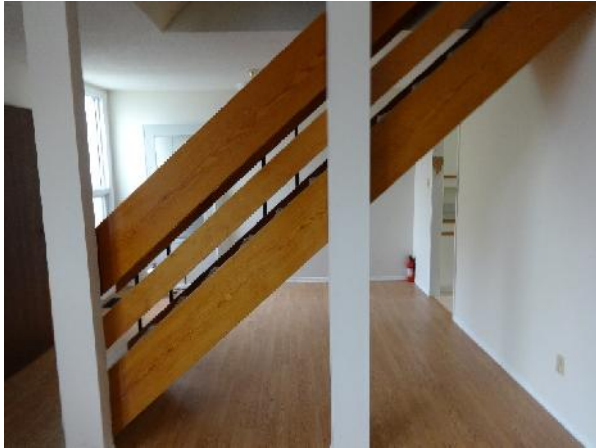
Photo 7: View of interior stairwell located between living room and dining room at 66 and 68 Alder Drive

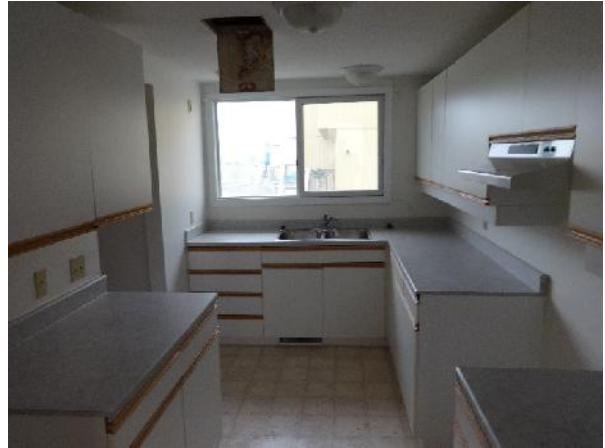
Photo 8: View of interior kitchen at 66 and 68 Alder Drive. Ceiling height of approximately 2.4m.

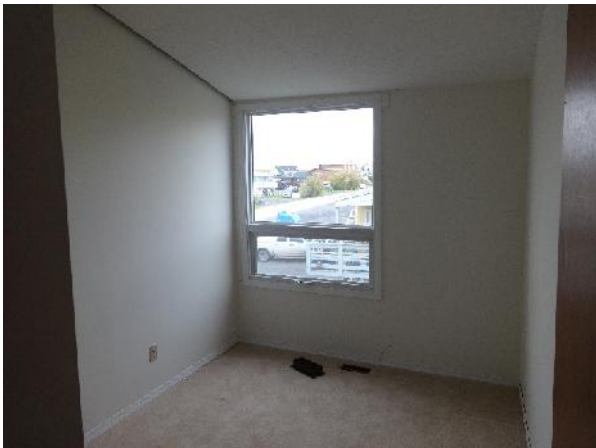
Photo 9: View of second floor bedroom at 66 and 68 Alder Drive with ceiling pitch and approximate ceiling height of 2.6 m.

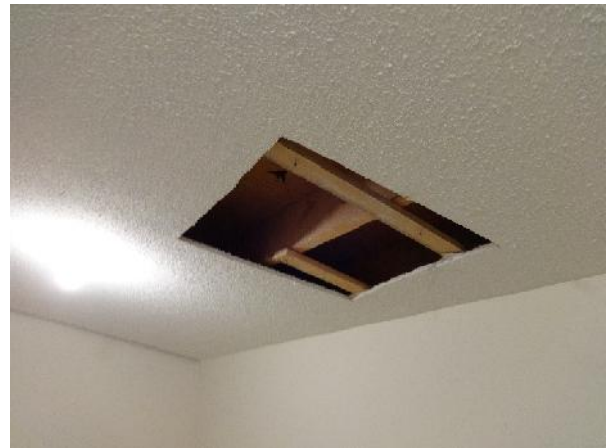
Photo 10: View of ceiling cavity with wood trusses at 66 and 68 Alder Drive.

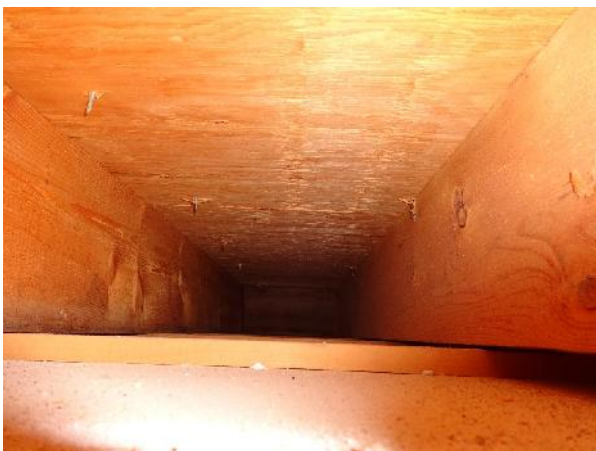
Photo 11: View of initial ceiling cavity directly underneath gypsum board ceiling followed by plywood at 66 and 68 Alder Drive.

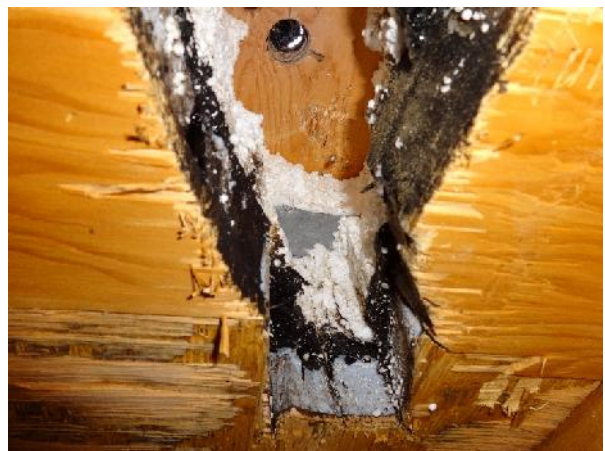
Photo 12: View of roof building material layers above initial interior plywood associated with the ceiling system at 66 and 68 Alder Drive. Building layers include from interior to exterior: plywood, sheeting insulation, asphalt paper, sheeting insulation, plywood and asphalt.

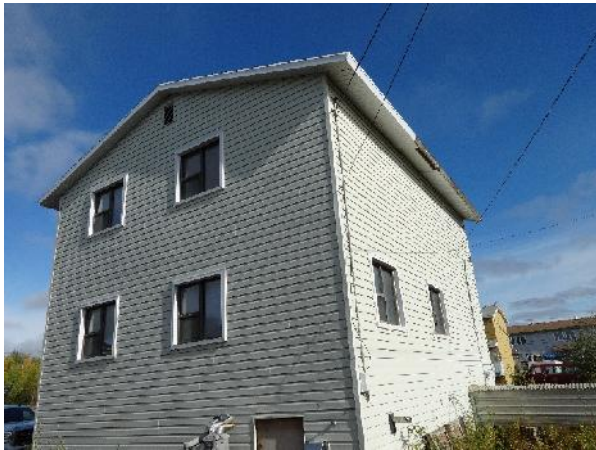
Photo 73: View of exterior 15 Nanuk. Height of roof is approximately 7.0 m from ground level. Attached overhead lines located on south side of building.

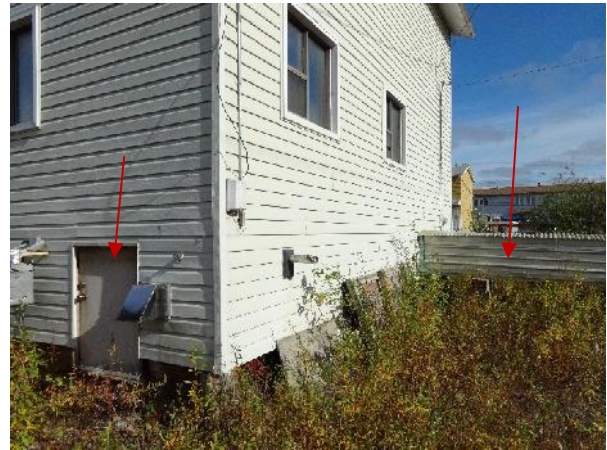
Photo 14: View of door access to crawlspace underneath building and utility corridor located on west and south side of 15 Nanuk, respectively.

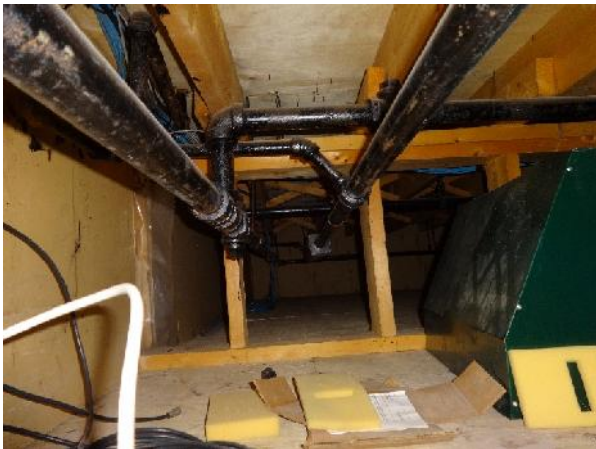
Photo 15: View of structural members within crawlspace of 15 Nanuk Place. Crawlspace is approximately 1.0 m in height.

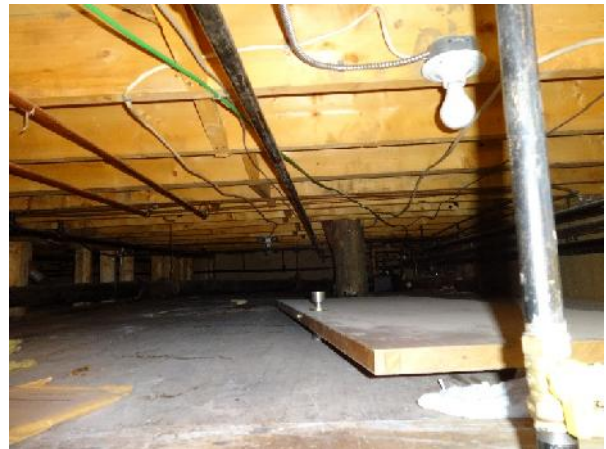
Photo 16: View of structural members within crawlspace of 15 Nanuk Place.

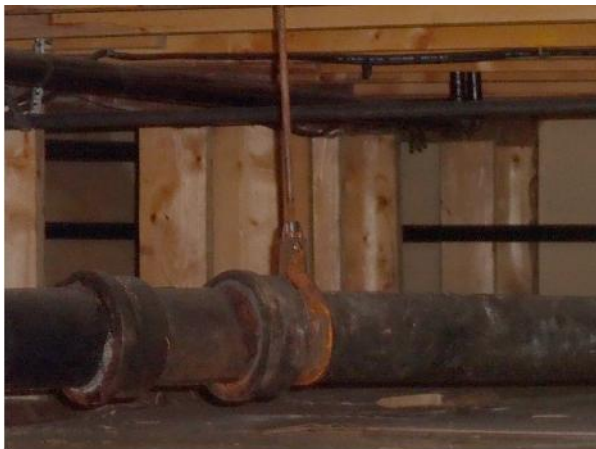
Photo 17: View of cast iron pipe within crawlspace of 15 Nanuk Place.

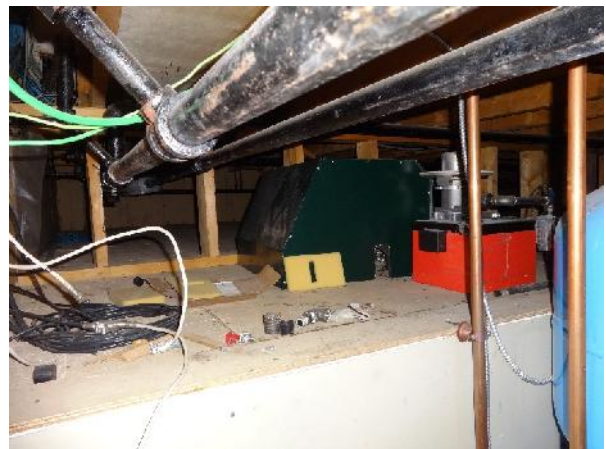
Photo 18: View of mechanical systems and associated piping located within crawlspace of 15 Nanuk Place.

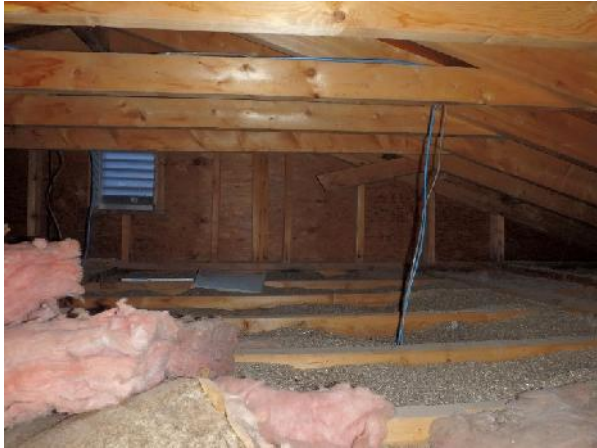
Photo 19: View of structural members within attic space of 15 Nanuk Place.

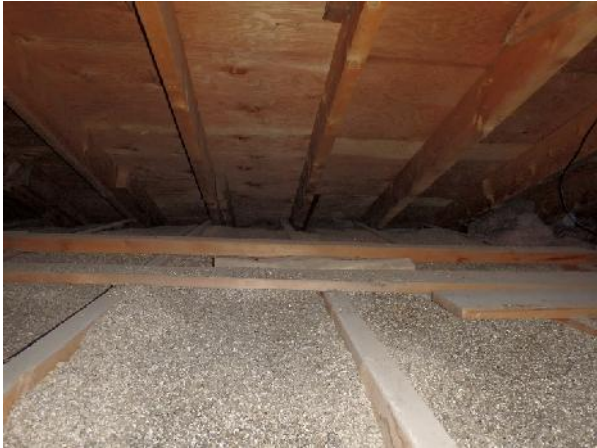
Photo 20: View of structural members within attic space of 15 Nanuk Place.

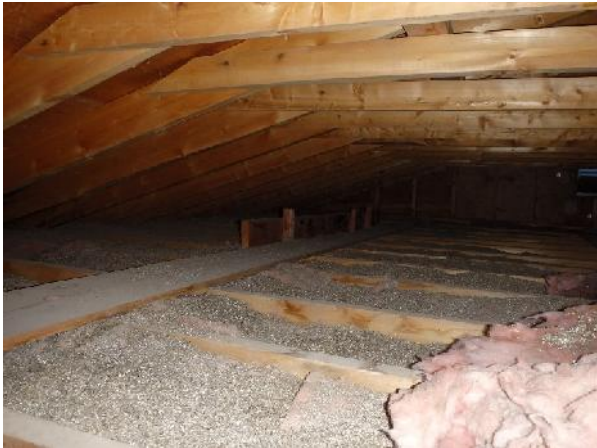
Photo 21: View of structural members within attic space of 15 Nanuk Place.

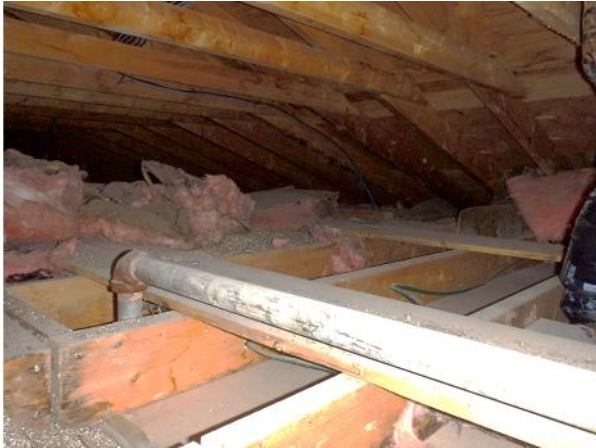
Photo 22: View of structural members and associated piping within attic space of 15 Nanuk Place.

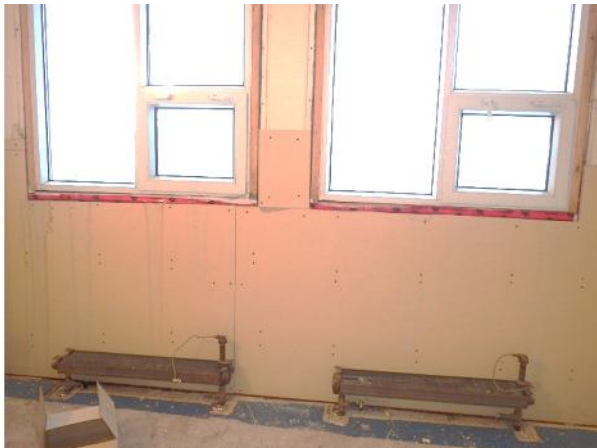
Photo 23: View of wall radiant heat fixtures in living room.

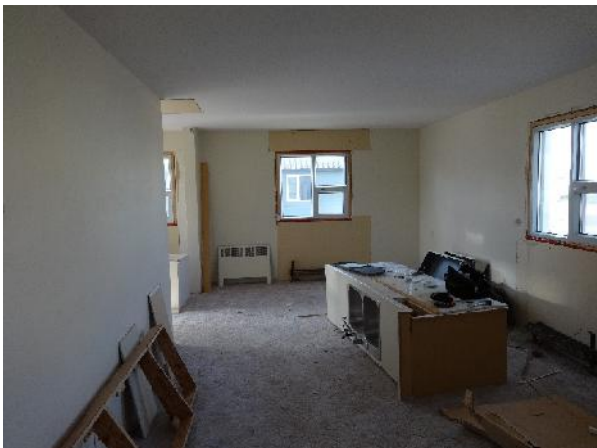
Photo 24: View of interior living room with ceiling height of approximately 2.4 m.

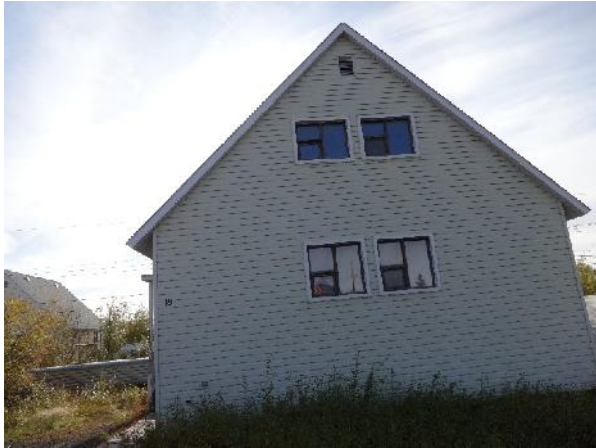
Photo 25: View of exterior 18 Camsell Place. Attached overhead lines located on south side of building.

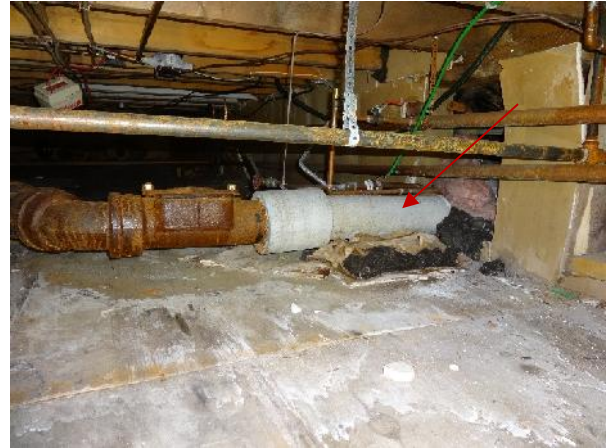
Photo 86: View of associated piping within crawlspace at 18 Camsell Place from exterior entry point..

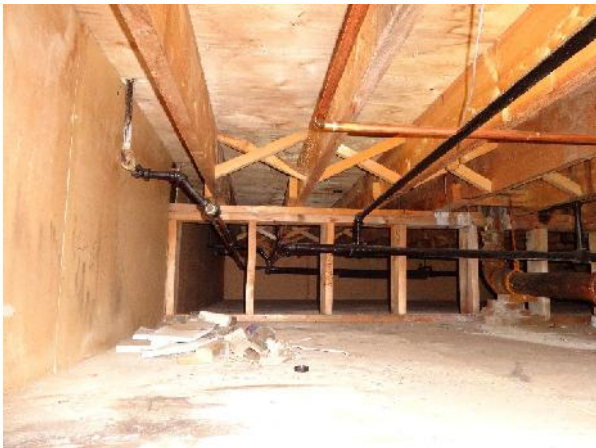
Photo 27: View of structural members within crawlspace of 18 Camsell Place. Crawlspace is approximately 0.9 m in height.

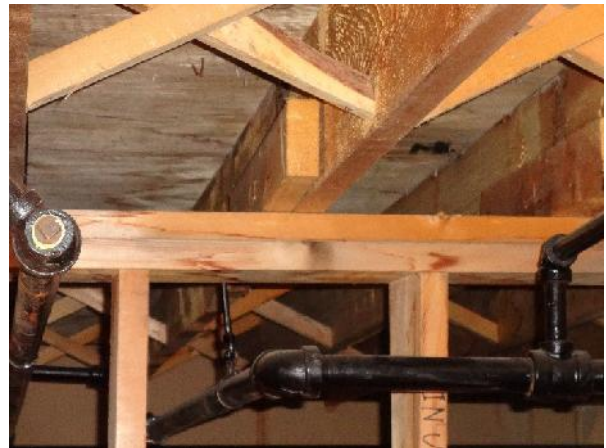
Photo 28: View of structural members within crawlspace of 18 Camsell Place.

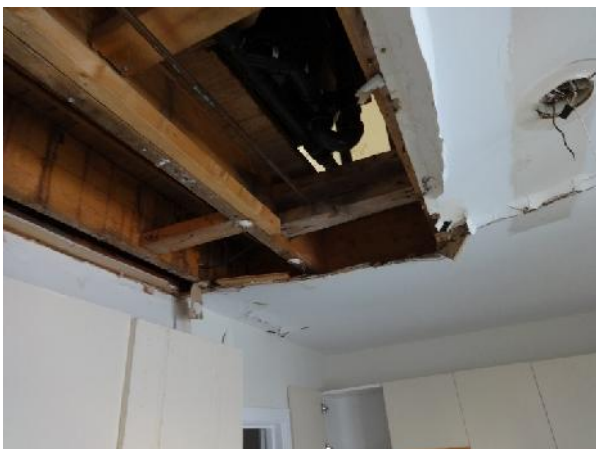
Photo 29: View of structural members located in ceiling cavity of 18 Camsell Place.

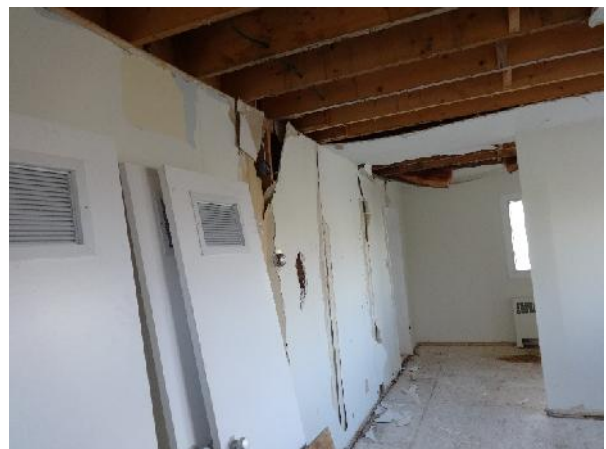
Photo 30: View of ceiling joists located in 18 Camsell Place. Ceiling height is approximately 2.4 m.

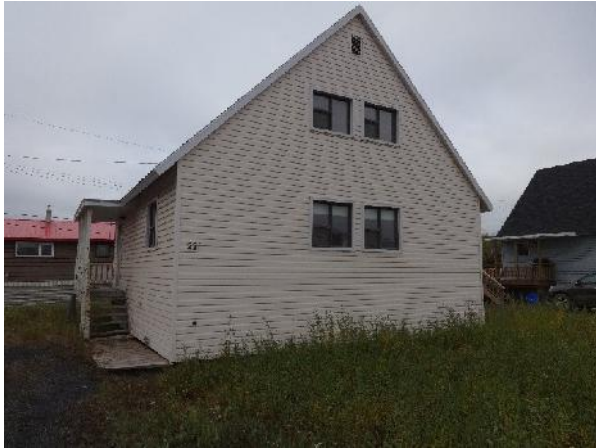
Photo 31: View of exterior 221 Mackenzie Road building. Attached overhead lines located on south side of building.

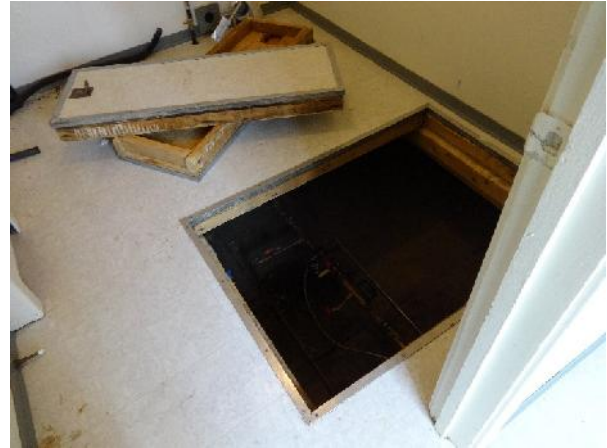
Photo 32: Additional crawlspace access in back entrance at 221 Mackenzie Road.

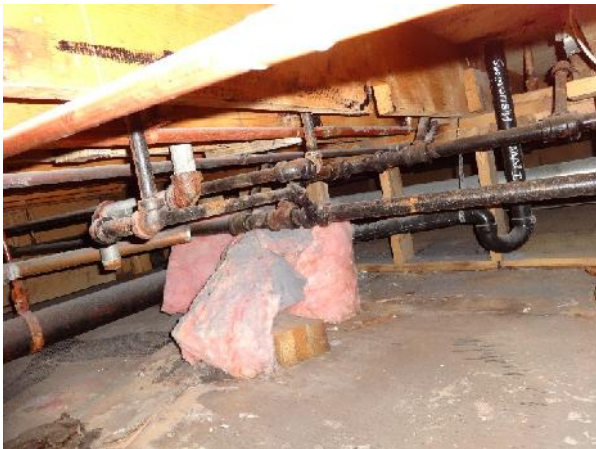
Photo 33: View of structural members and associated piping within crawlspace of 221 Mackenzie Road. Crawlspace is approximately 1.0 m in height.

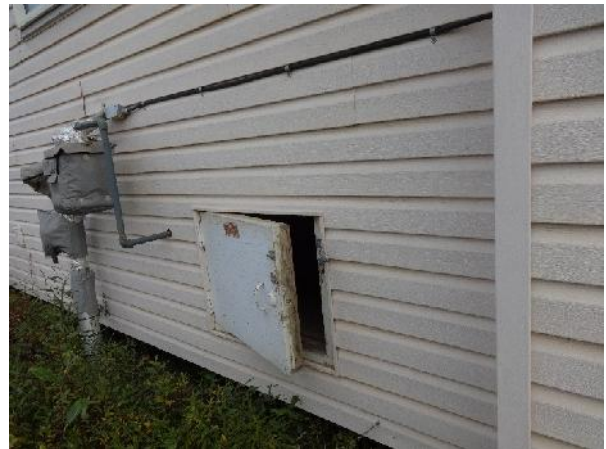
Photo 34: View of exterior crawlspace entry at 221 Mackenzie Road.

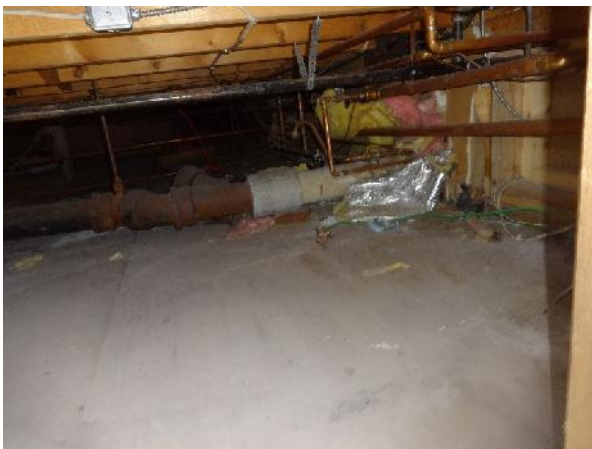
Photo 35: View of associated piping within crawlspace of 221 Mackenzie from exterior entry point.

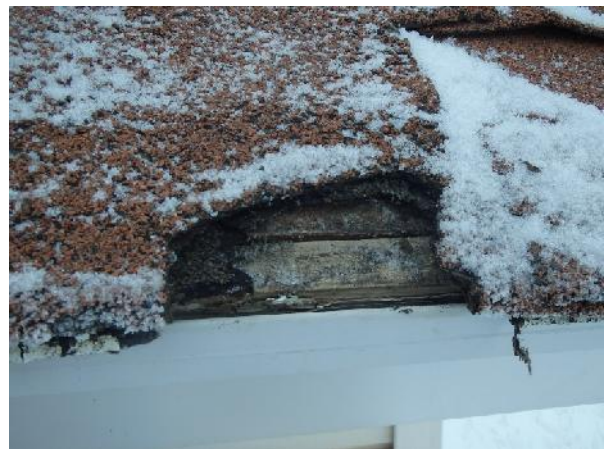
Photo 36: View of wood lath underneath asphalt shingles at 221 Mackenzie Road.

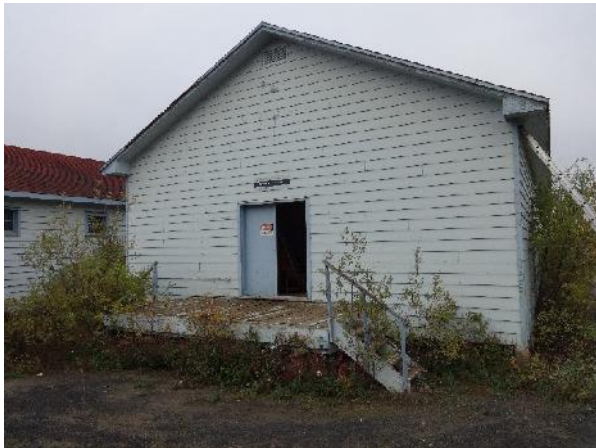
Photo 37: View of exterior Warehouse #3 building located in PWGSC compound. Exterior building height is approximately 6.0 m from ground level.

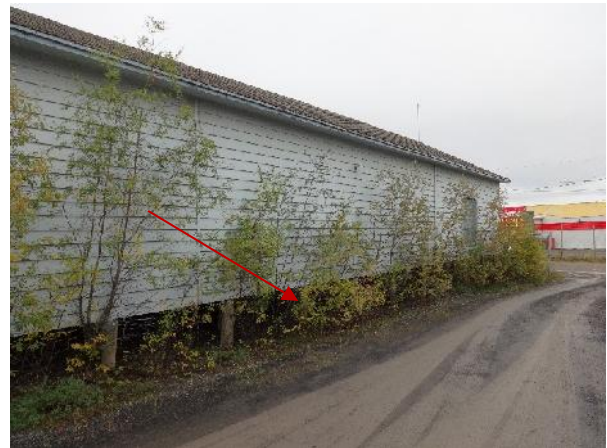
Photo 38: View of access to crawlspace underneath Warehouse #3 building.

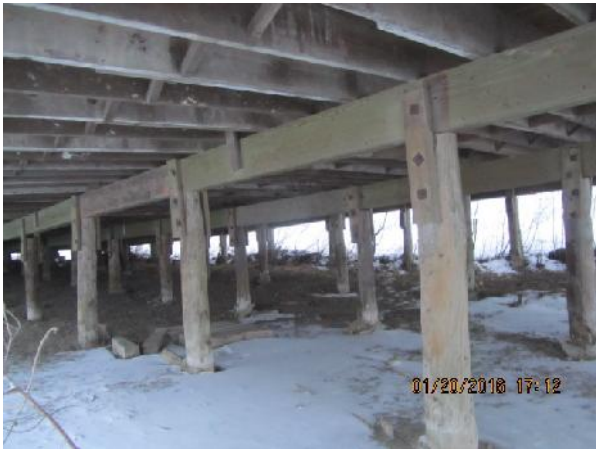
Photo 39: View of structural members under crawlspace of Warehouse #3. Approximately 1.0 m crawlspace height underneath building.

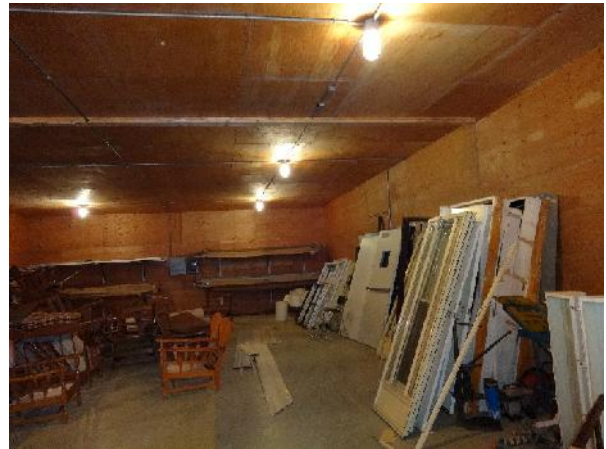
Photo 40: View of interior finishing within Warehouse #3 building.

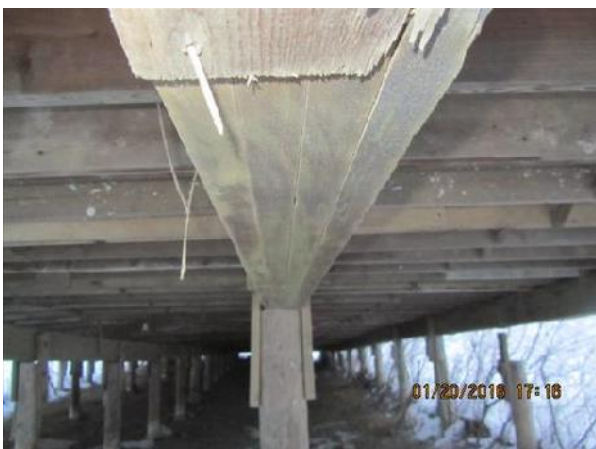
Photo 41: View of 4-ply beam under Warehouse #3.

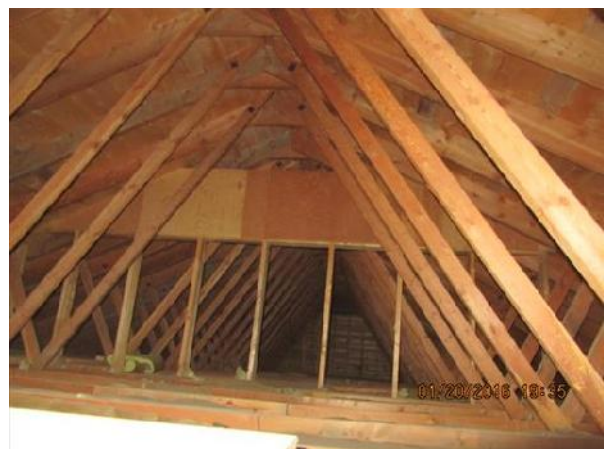
Photo 42: View of roof trusses at Warehouse #3.

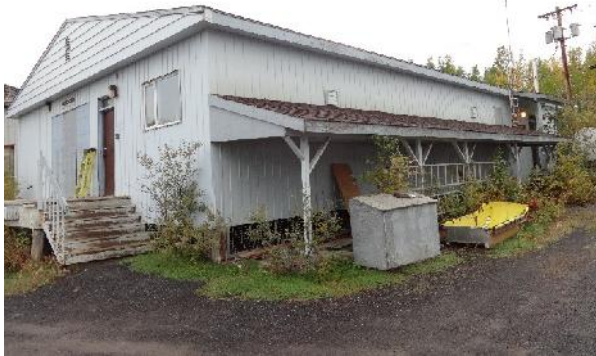
Photo 43: View of exterior Trade Shop building located in PWGSC compound. Approximately 1.0 m crawlspace height underneath building.

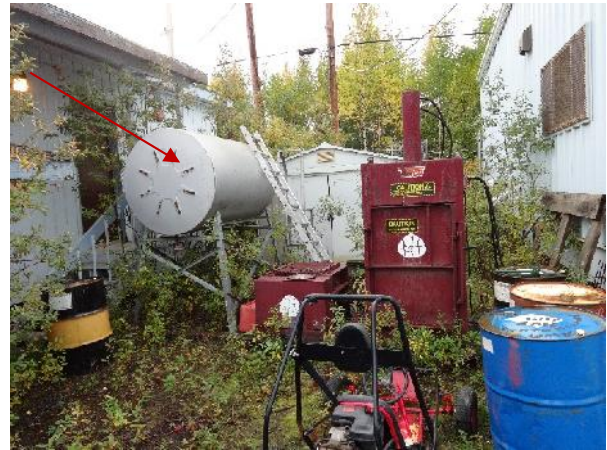
Photo 44: View of above ground storage tank (AST) located directly south of Trade Shop building. AST has an approximate volume of three 3 m^3 .

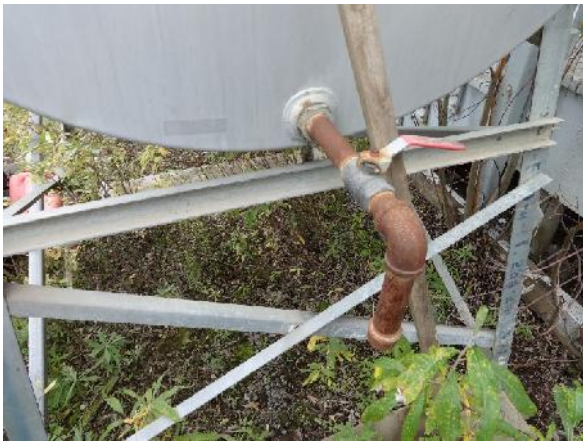
Photo 45: View of disconnected discharge line on AST south of Trade Shop. The AST has been disconnected and is a standalone containment used to store former heating diesel oil. No visual staining observed under AST.

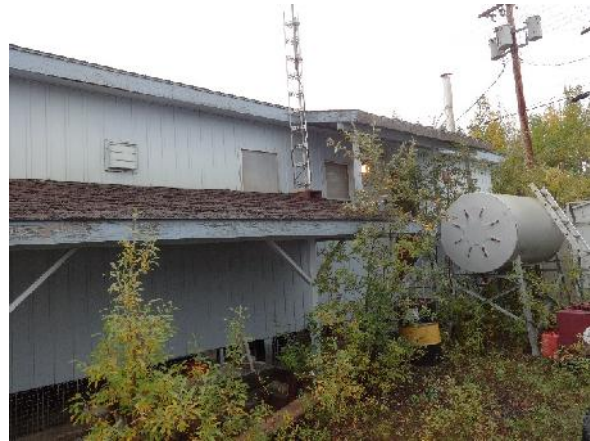
Photo 46: View of overhead power lines located directly east of Trade Shop on right of way, rail line.

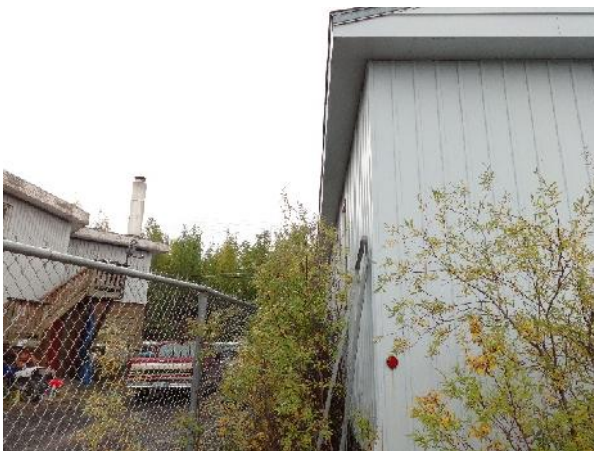
Photo 47: View of fence line for property boundary approximately 1.5 m north of Trade Shop building.

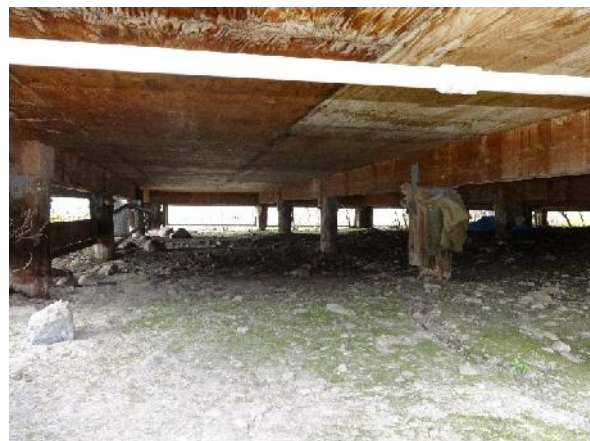
Photo 48: View of structural members within crawlspace of Trade Shop.

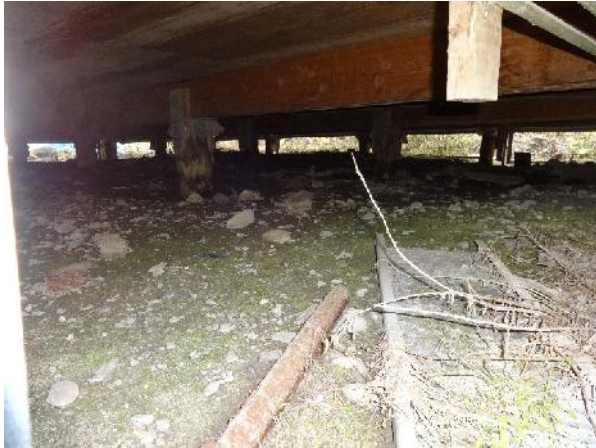
Photo 49: View of structural members within crawlspace of Trade Shop.

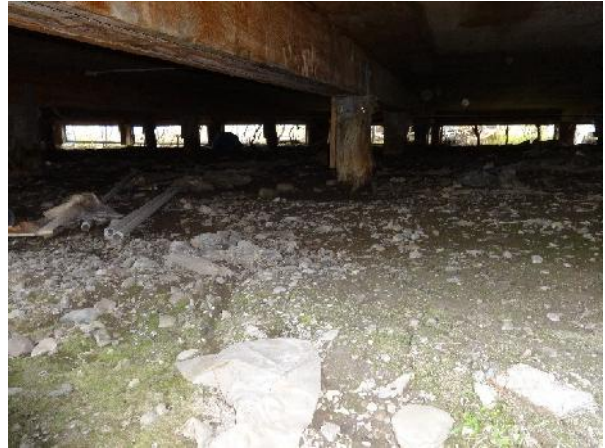
Photo 50: View of structural members within crawlspace of Trade Shop.

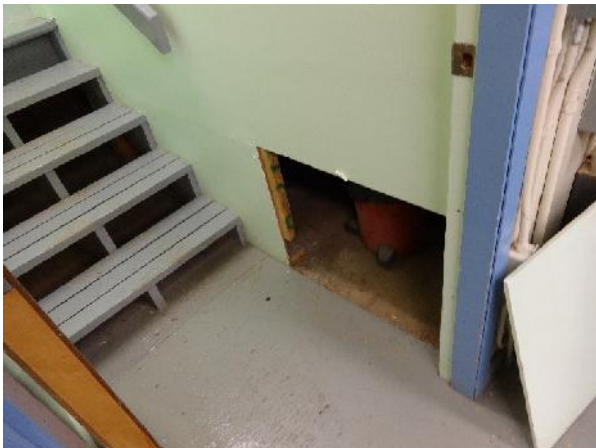
Photo 51: View of access point to interior crawlspace underneath bathroom in the Trade Shop. Crawlspace has an approximate height of 0.8 m. Bathroom is raised above main floor level of Trade Shop.

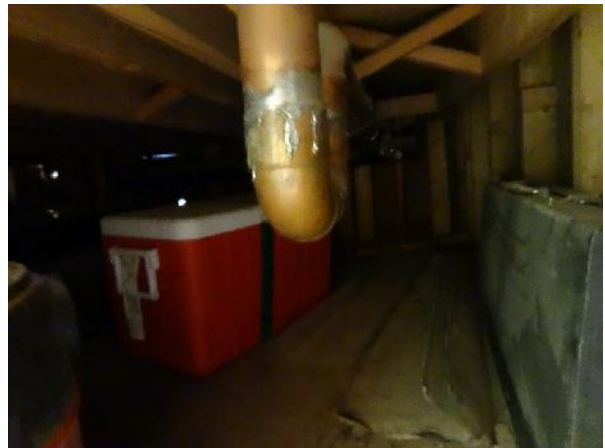
Photo 52: View of crawlspace underneath bathroom of Trade Shop.

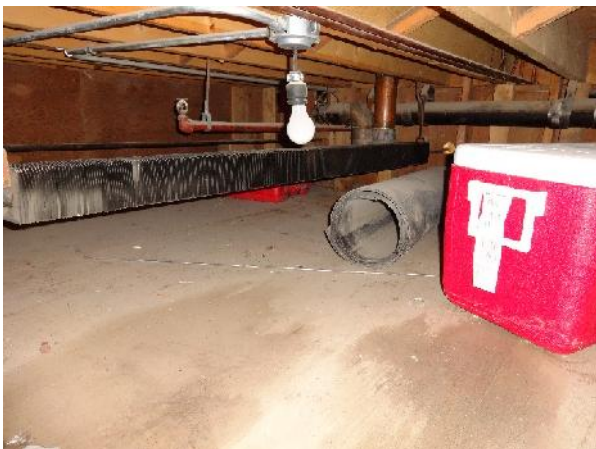
Photo 53: View of structural members within crawlspace under bathroom of Trade Shop.

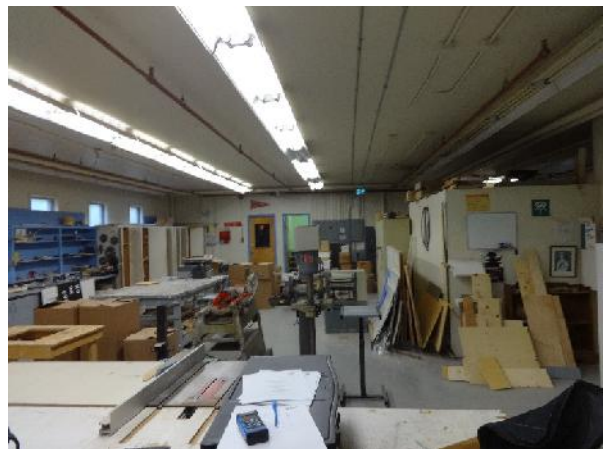
Photo 54: View of interior portion of Trade Shop with ceiling height of approximately 3.0 m.

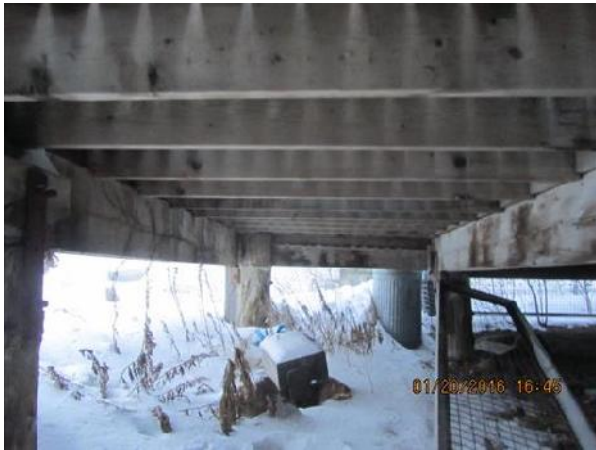
Photo 55: View of structural components under front porch of Trade Shop.

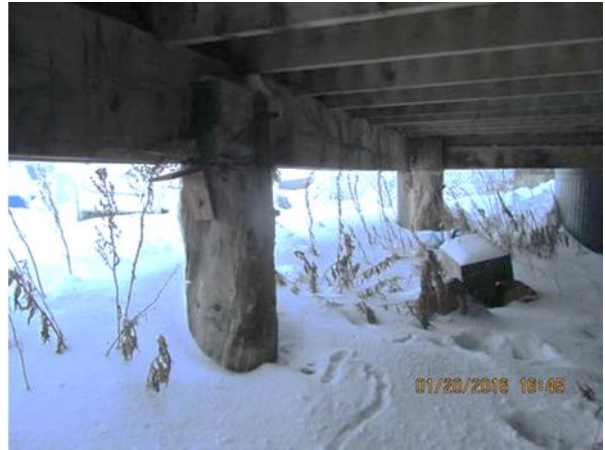
Photo 56: View of pile along edge at Trade Shop.

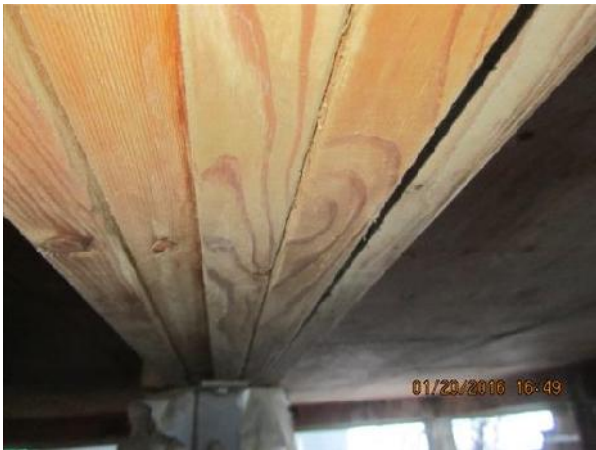
Photo 57: Main floor beam (typical) at Trade Shop.

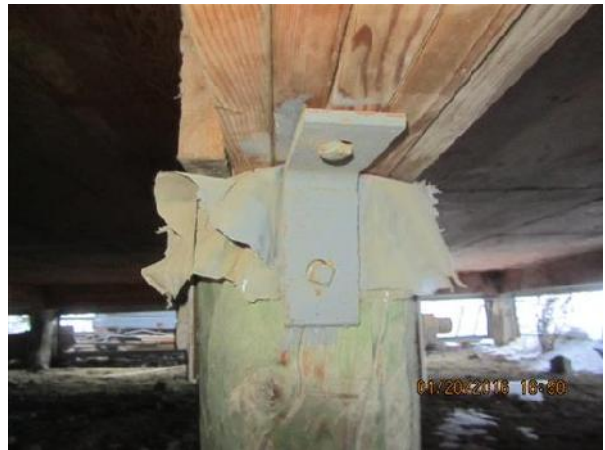
Photo 58: Pile/beam connection at Trade Shop.

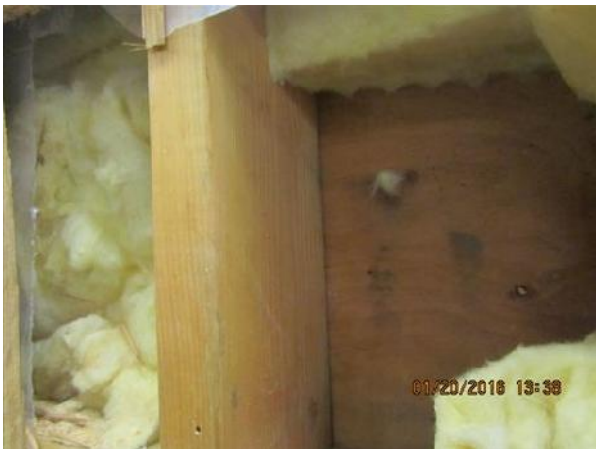
Photo 59: View of wall stud sheeting and insulation at Trade Shop.

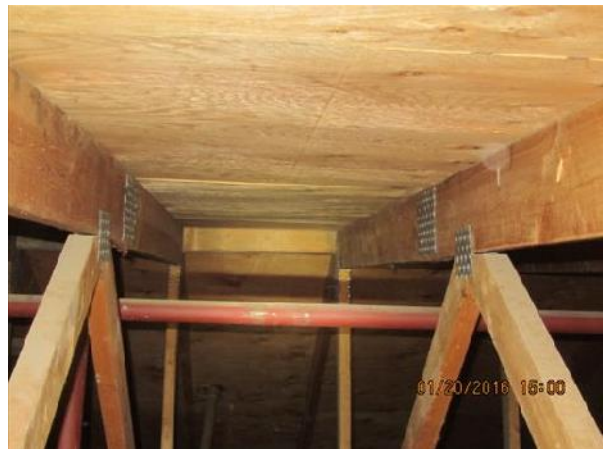
Photo 60: View of roof truss members and truss/sheeting connection at Trade Shop.
