**LIMITED STRUCTURAL BUILDING EVALUATION REPORT
66 & 68 ALDER DRIVE
INUVIK, NORTHWEST TERRITORIES**

Prepared for:

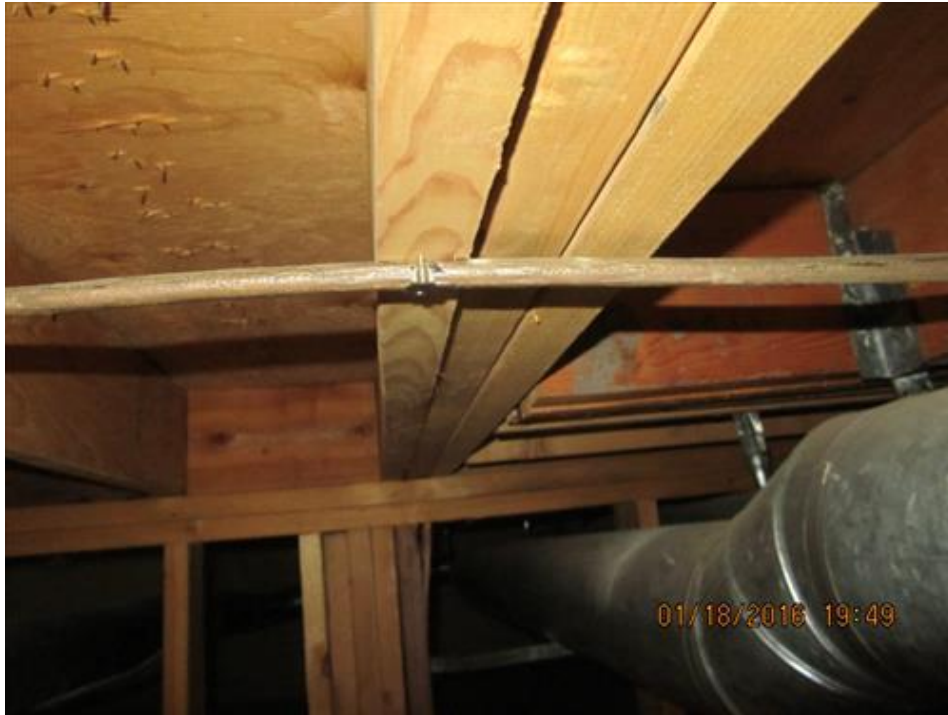
Photograph 9- Built-up beam noted within crawl space supporting the ground floor

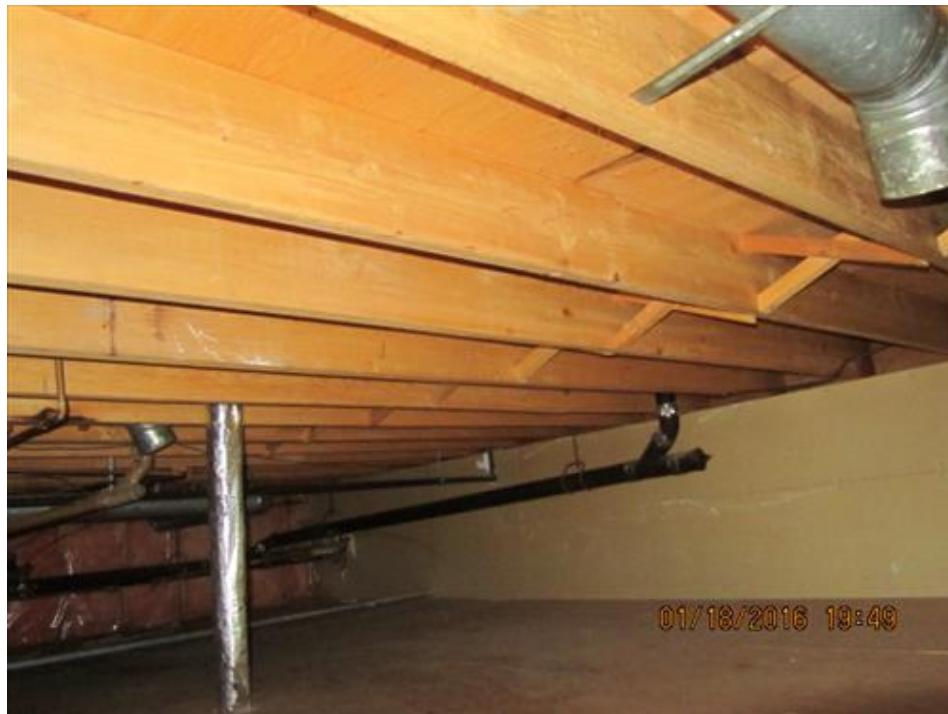
Photograph 10- Joists and cross bracing noted within the crawl space supporting the ground floor

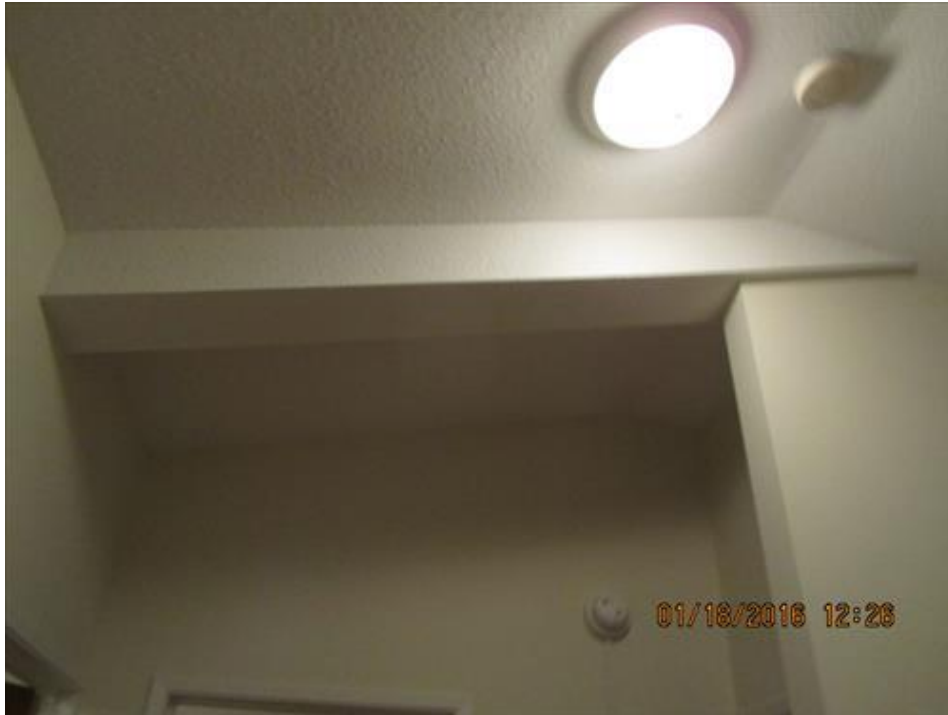
Photograph 11-Beam within the ceiling of the second floor in House #66

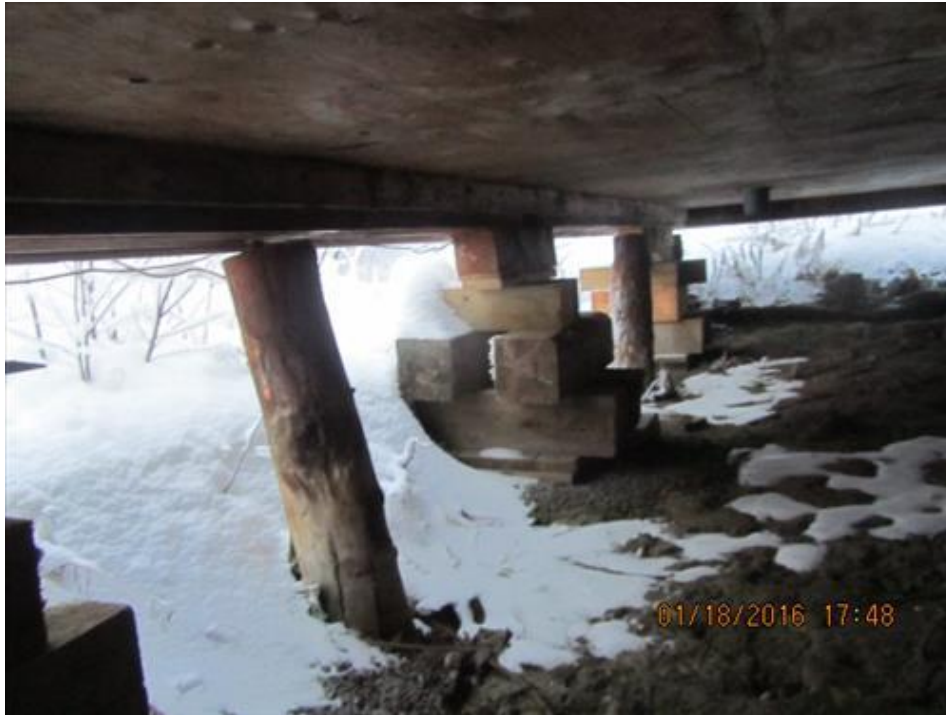
Photograph 17- Failed piles and temporary supports along the south end of House #68

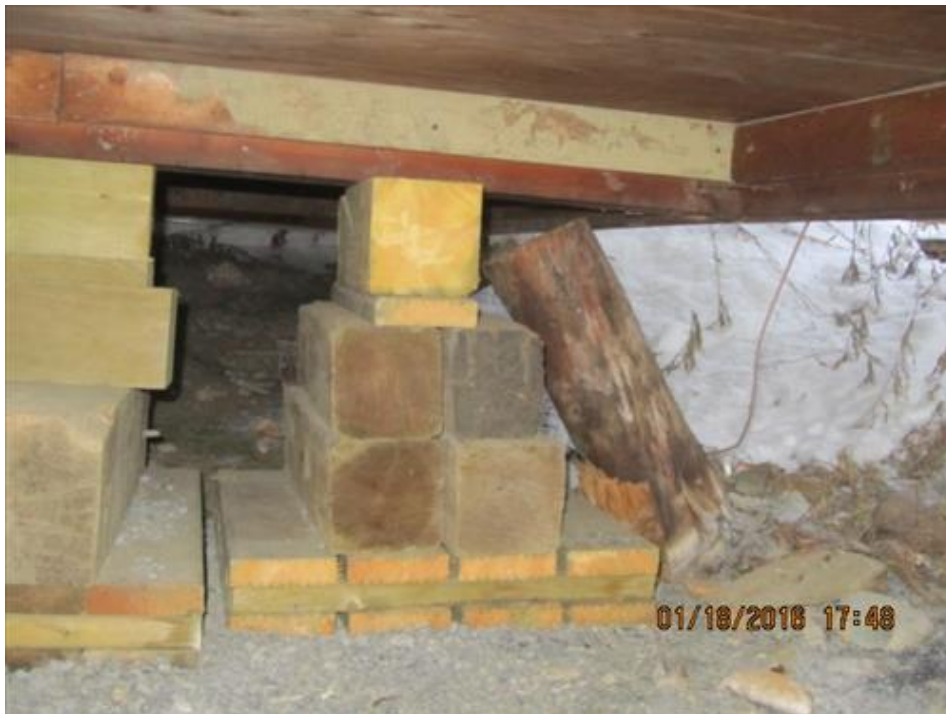
Photograph 18- Failed pile along the east edge of House #68 and constructed temporary support

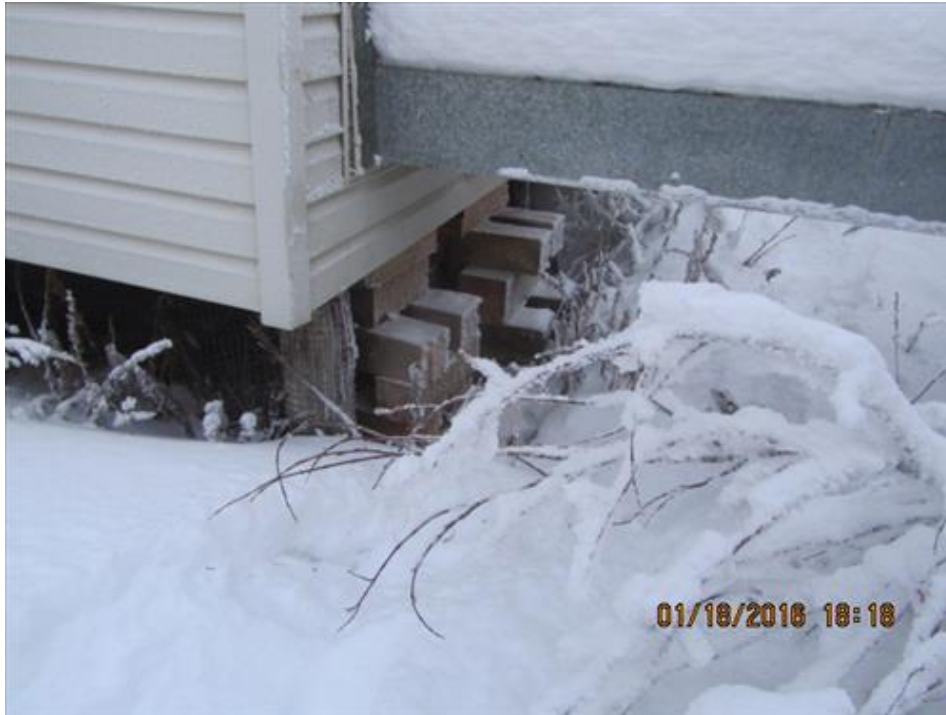
Photograph 19- Failed pile at the southwest corner of House #68, with temporary placed crib blocking support

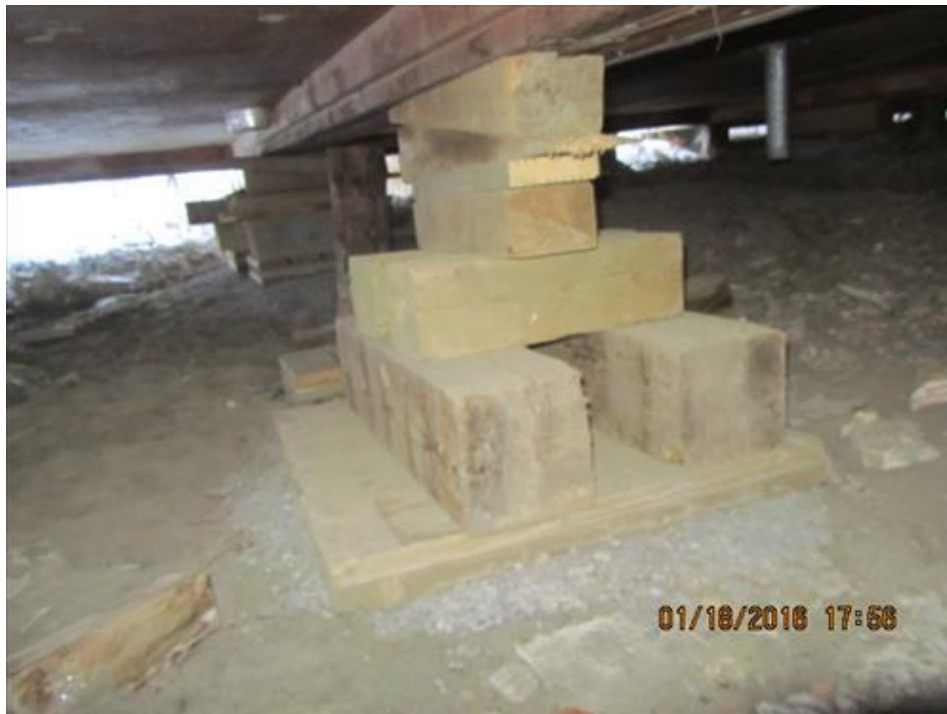
Photograph 20- Failed piles replaced with temporary blocking, placed on wood pallets, bearing onto prepared granular pad-Typical

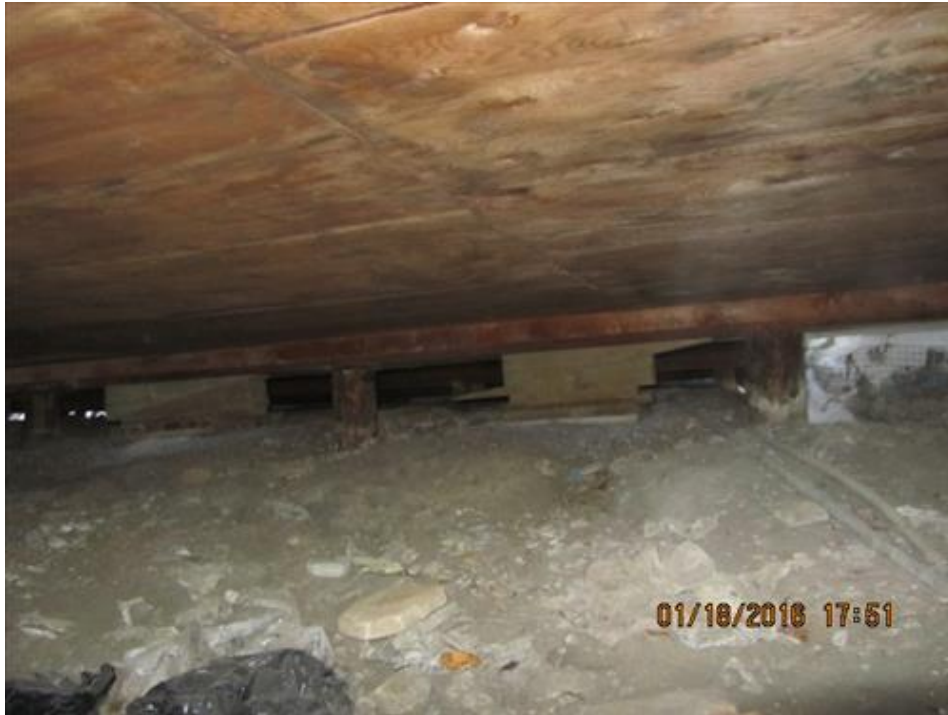
Photograph 21- Temporary supports provided at the north end of building

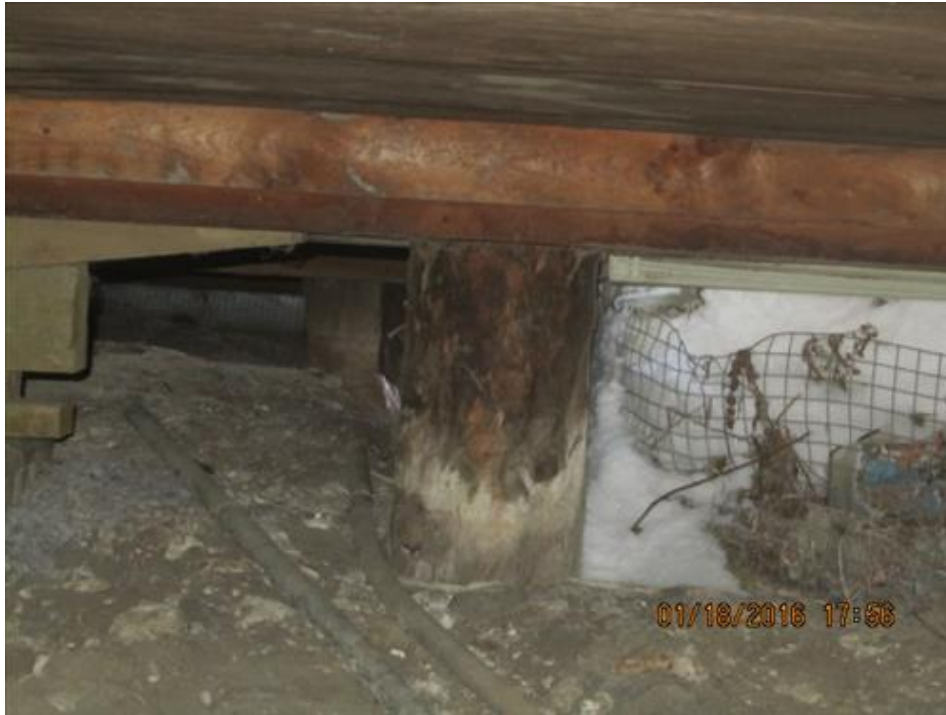
Photograph 23- Severe exposure to elements and heavy staining of the perimeter piles

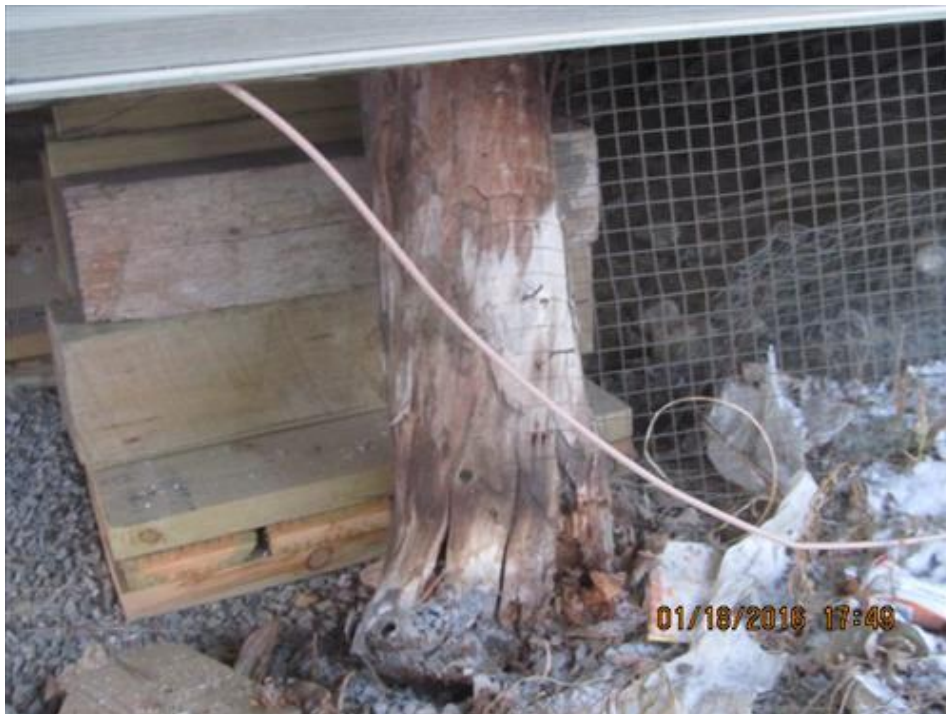
Photograph 24- Decayed pile at the southwest corner of House #66

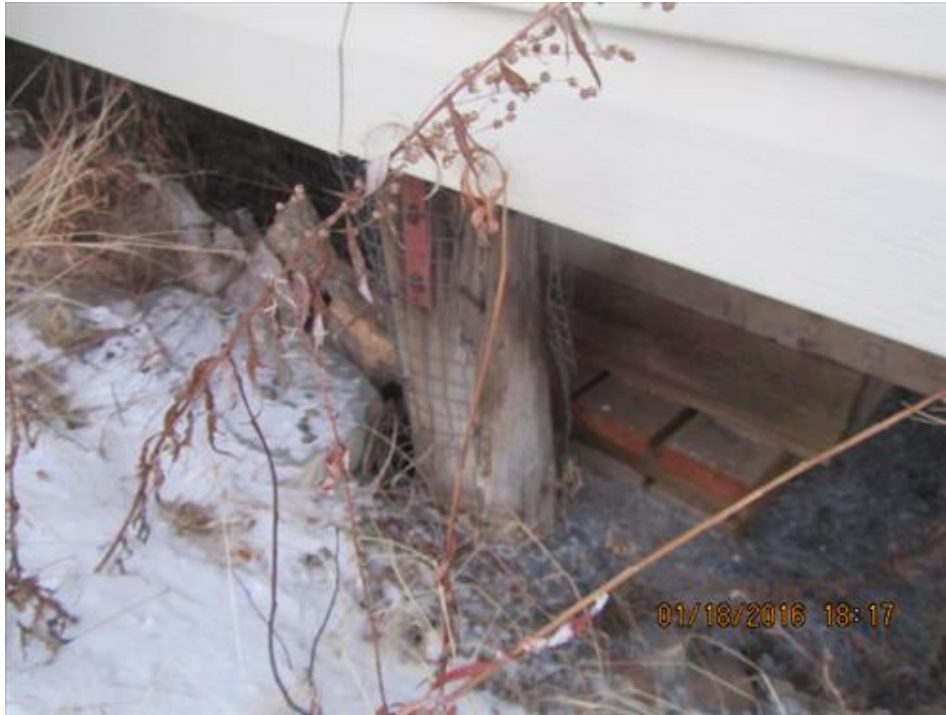
Photograph 25- Decaying pile along the west perimeter

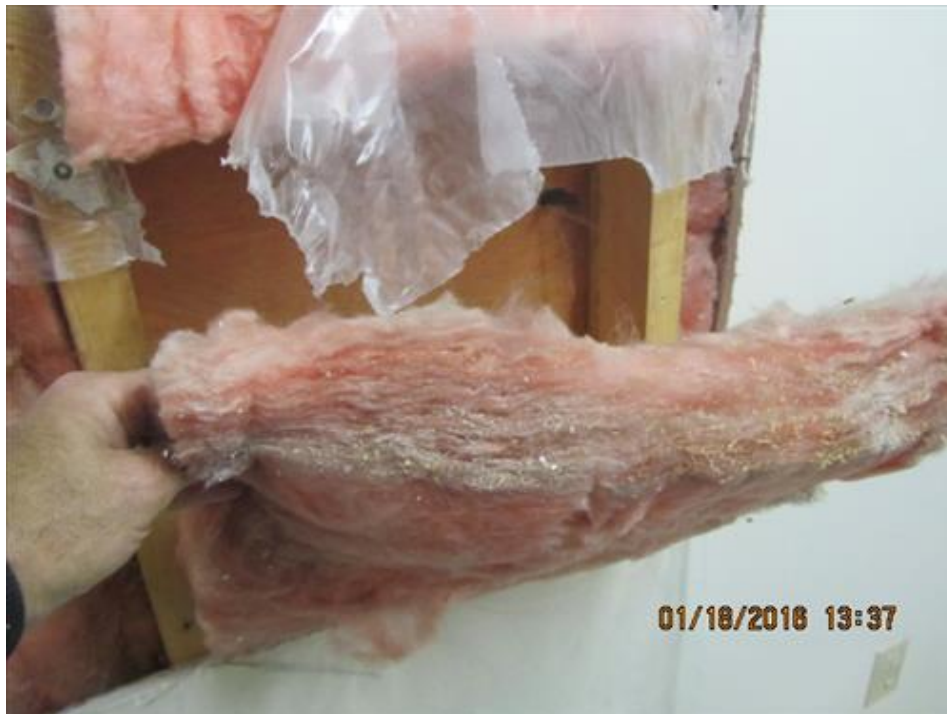
Photograph 26- Condition of studs and sheathing observed within the intrusive cut-out at ground floor level on north wall of House #66

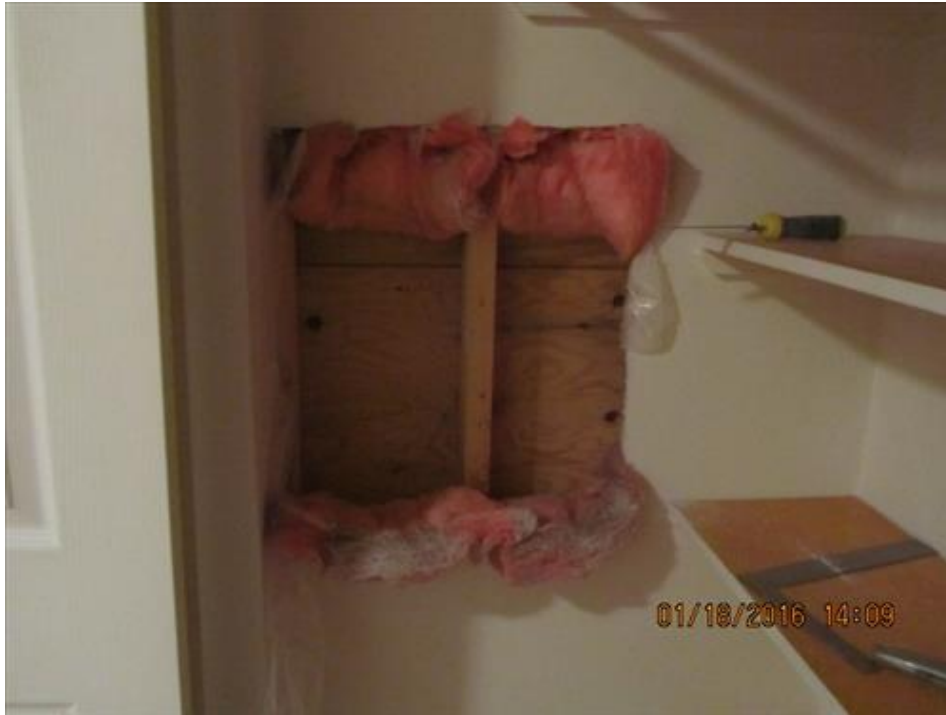
Photograph 27- Condition of studs and sheathing observed within the intrusive cut-out at the second floor level north wall of House #66

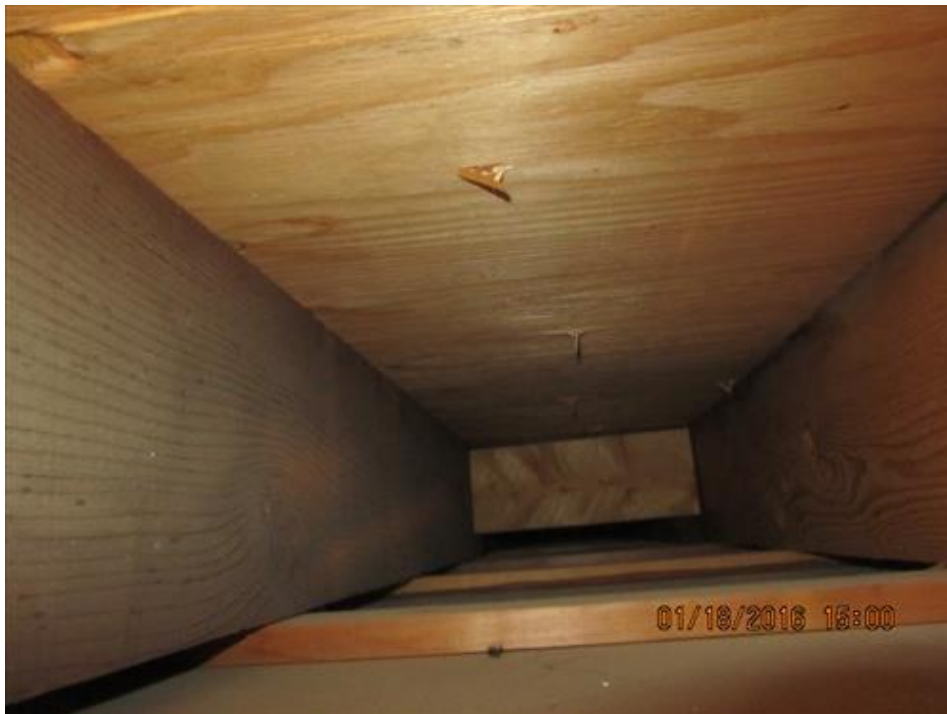
Photograph 28-Condition of ceiling joists and roof sheathing within the plenum of second floor utility room in House #66

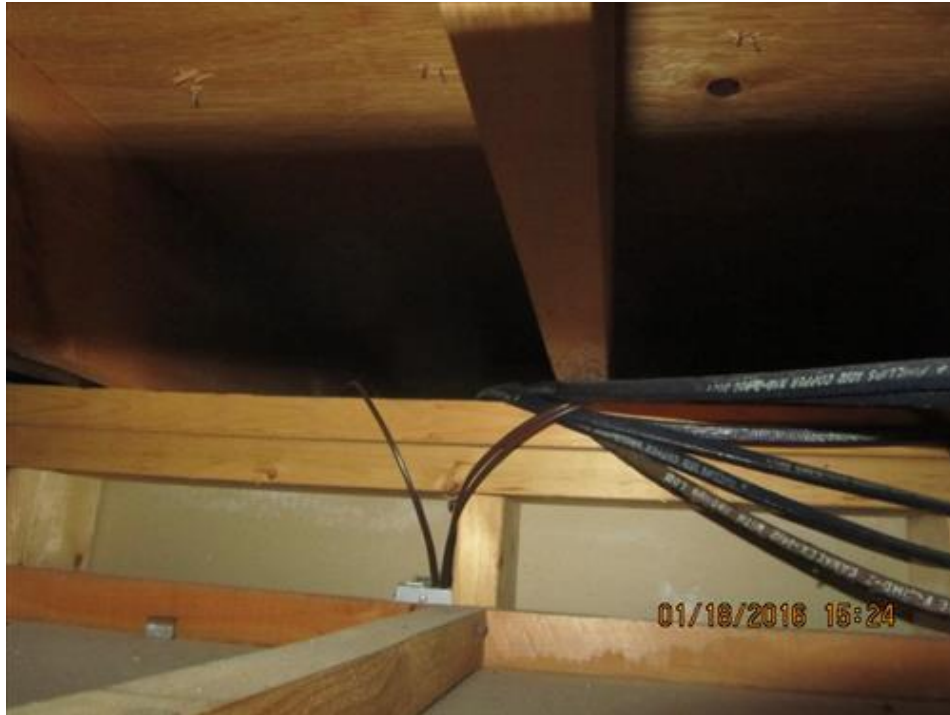
Photograph 29- Condition of second level floor joists and load bearing studs, viewed through the plumbing maintenance hatch within the ceiling of kitchen in House #66

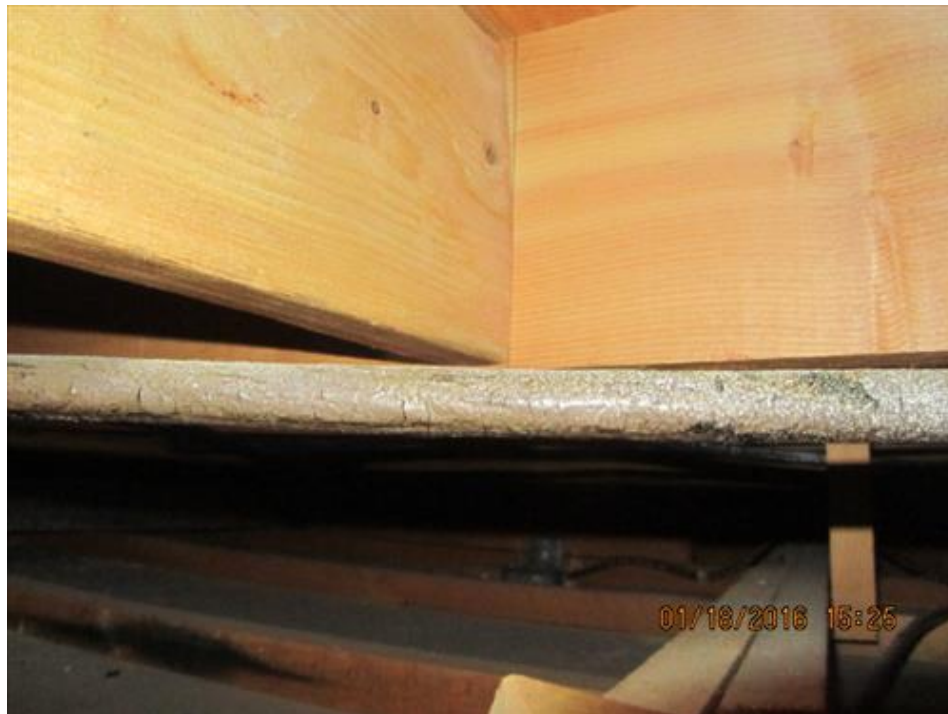
Photograph 30- Condition of second level floor joists, viewed through the plumbing maintenance hatch within the ceiling of kitchen in House #66

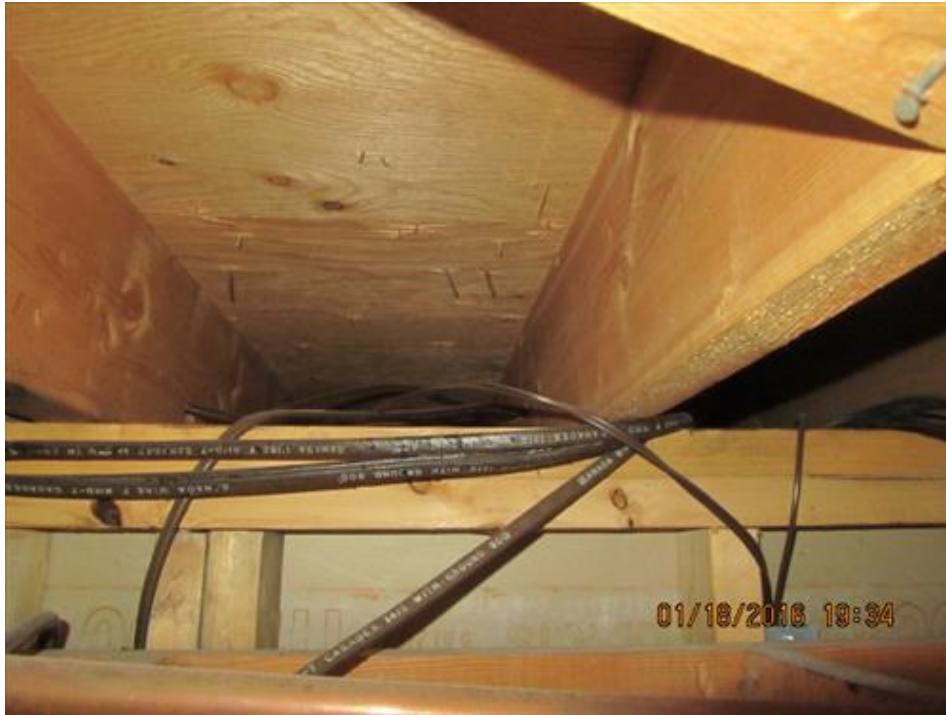
Photograph 31- Condition of second level floor joists and load bearing studs, viewed through the plumbing maintenance hatch within the ceiling of kitchen in House #68

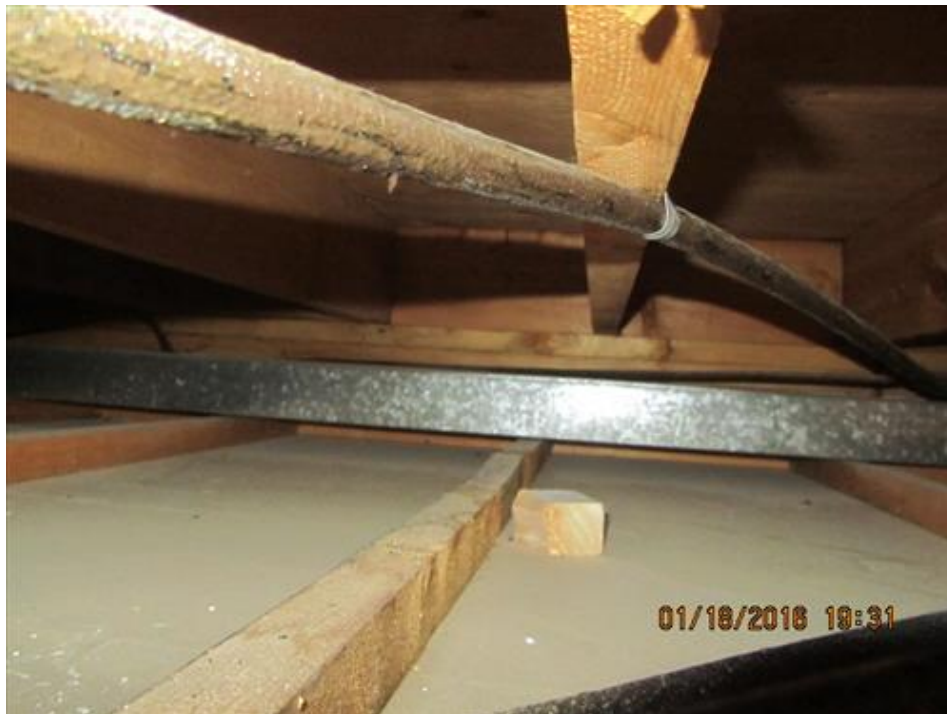
Photograph 32- Condition of second level floor joists and loadbearing studs, viewed through the plumbing maintenance hatch within the ceiling of kitchen in House #68

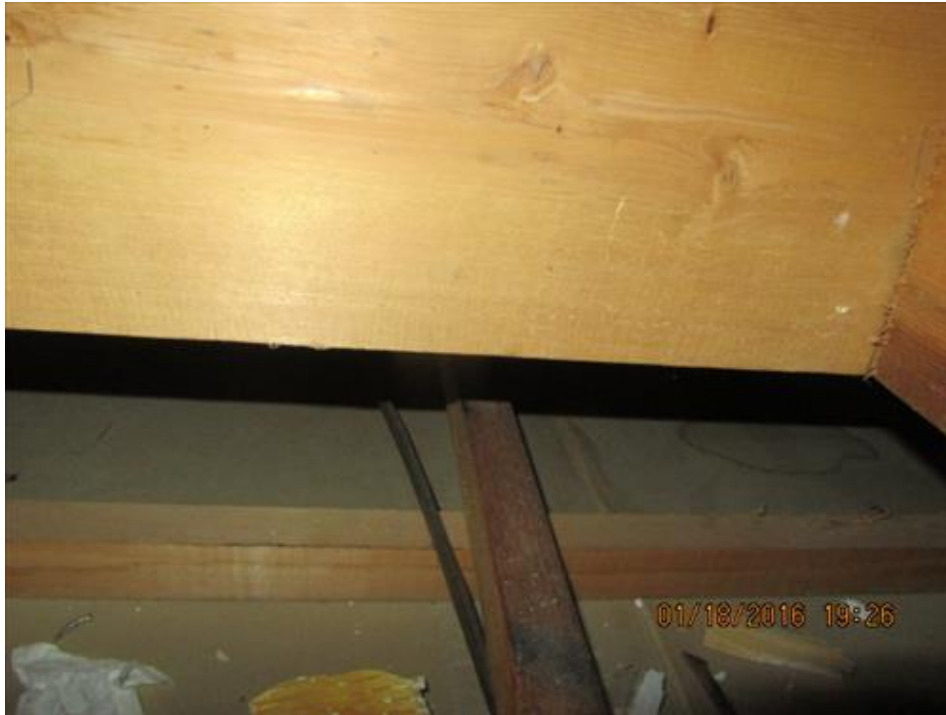
Photograph 33- Condition of second level floor joists, viewed through the plumbing maintenance hatch within the kitchen ceiling of House #68

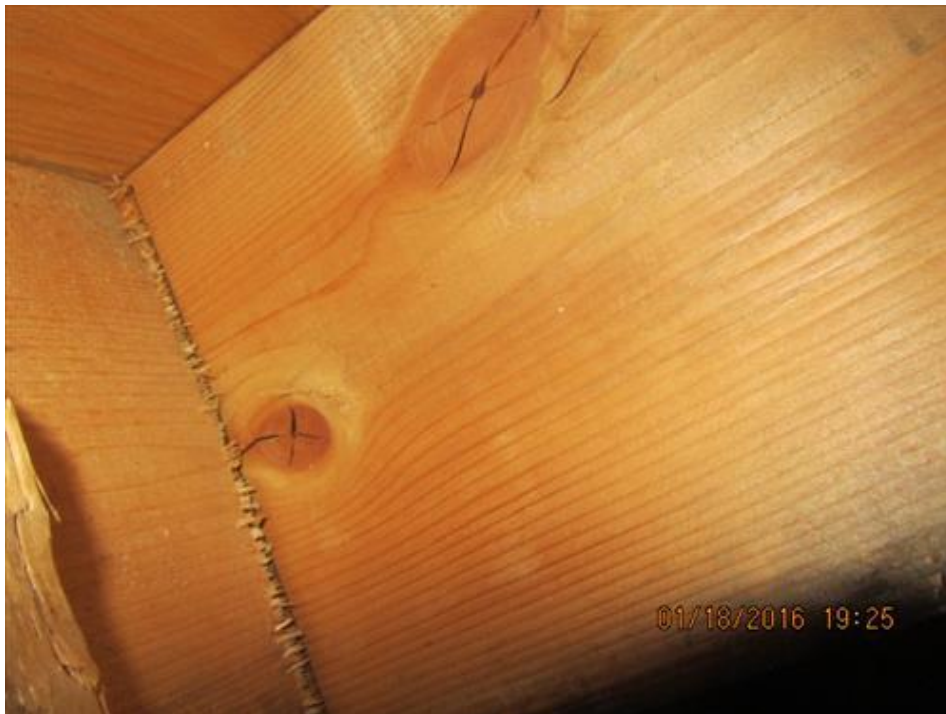
Photograph 34- Cracks and splitting in the second floor joist of House # 68

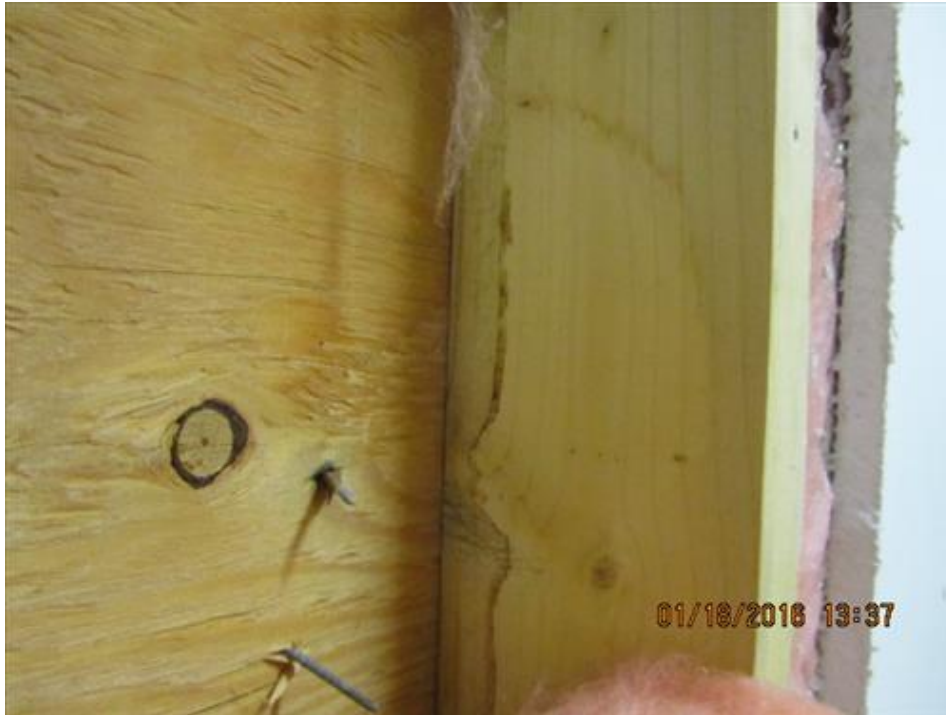
Photograph 35- Water stain at the intersection of the stud and exterior plywood sheathing, noted within the cut-out in the laundry room of house #66

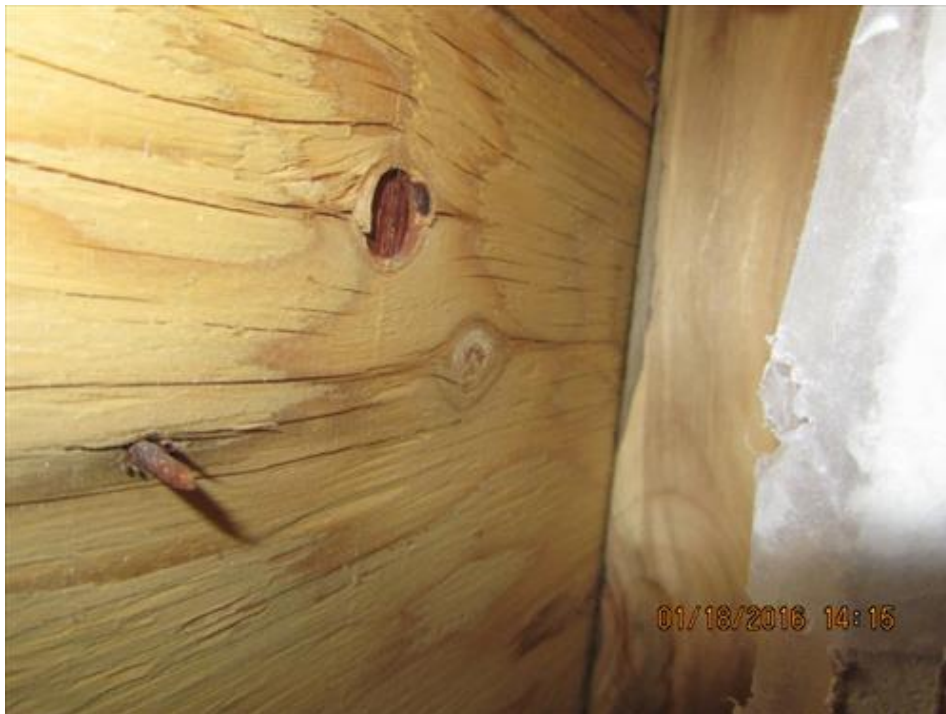
Photograph 36- Minor water stain and aging exterior plywood sheathing, noted within the cut-out in the second floor bedroom of house #66

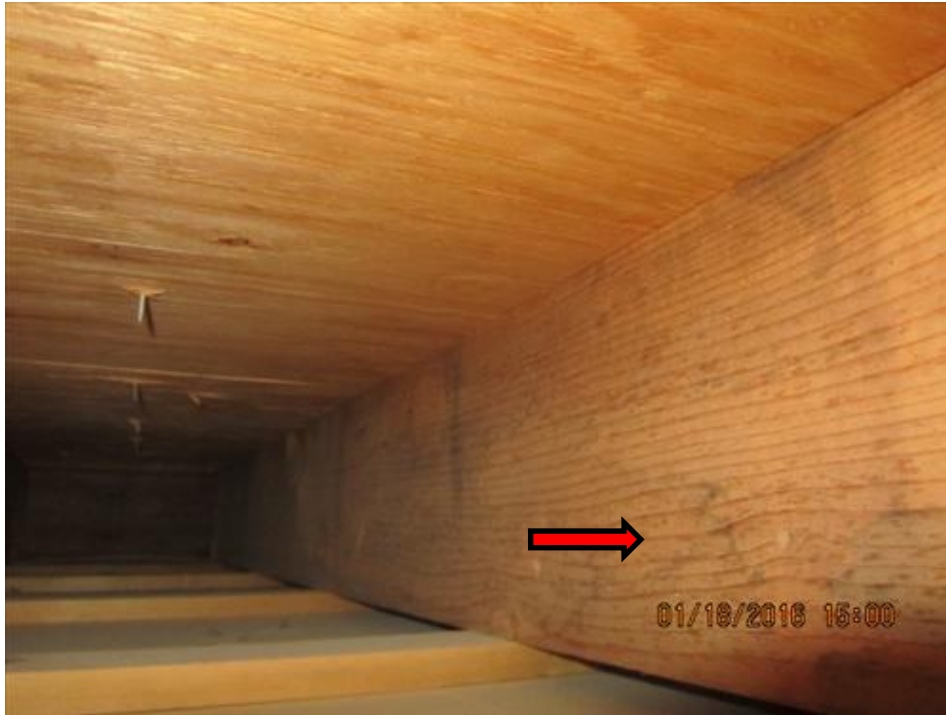
Photograph 37- Minor Water stain noted within the ceiling joist along the west wall of utility room on the second floor of House # 66

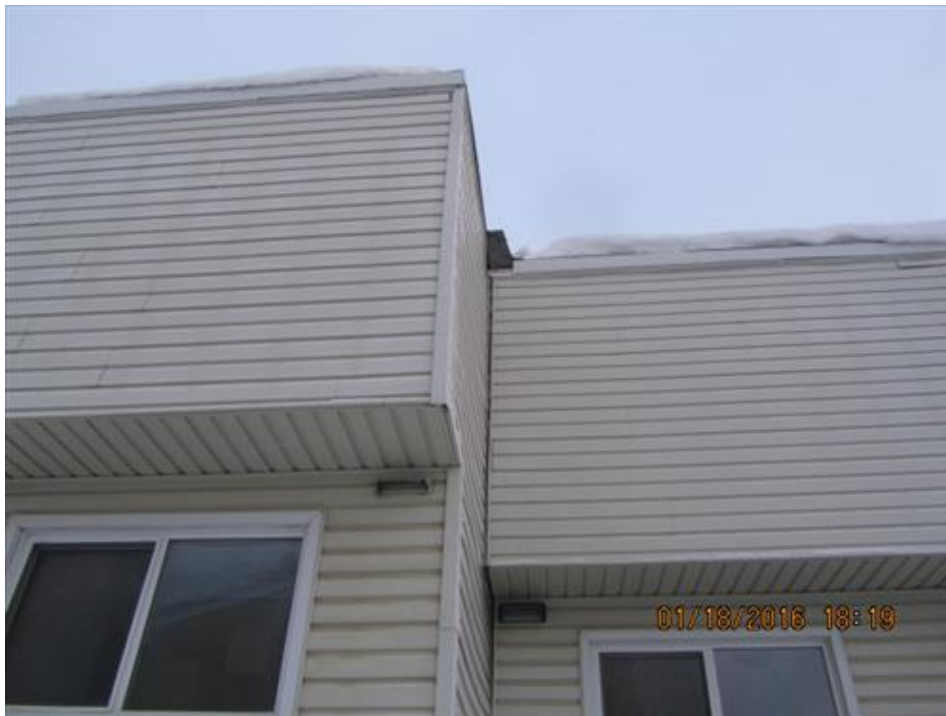
Photograph 38- Separation between Houses #66 and 68 at the top on west elevation

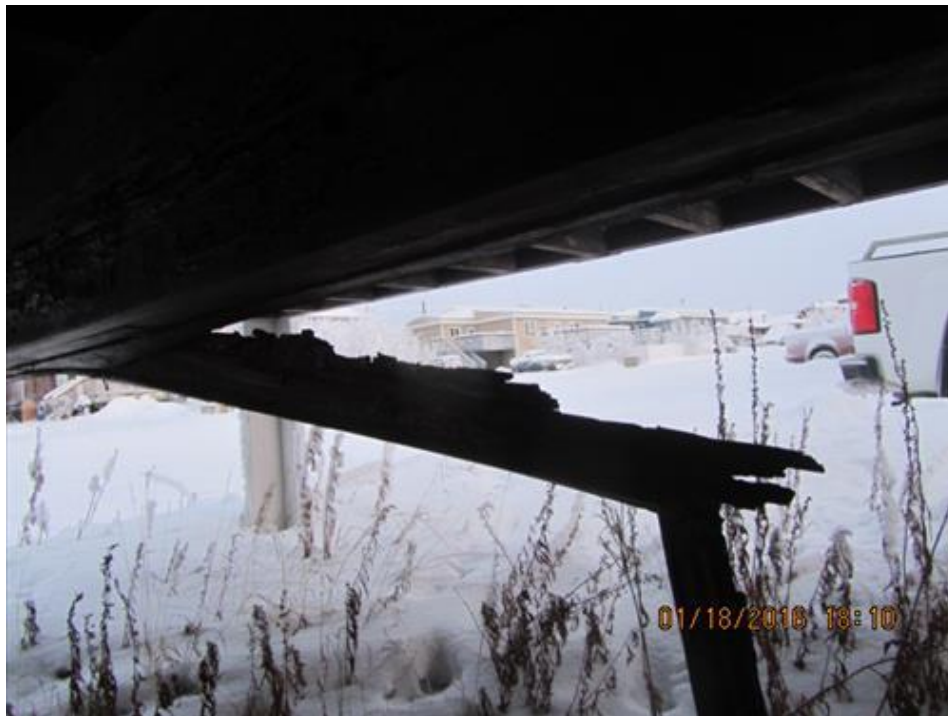
Photograph 42- Decayed and severely damaged beam under the front porch of House #66

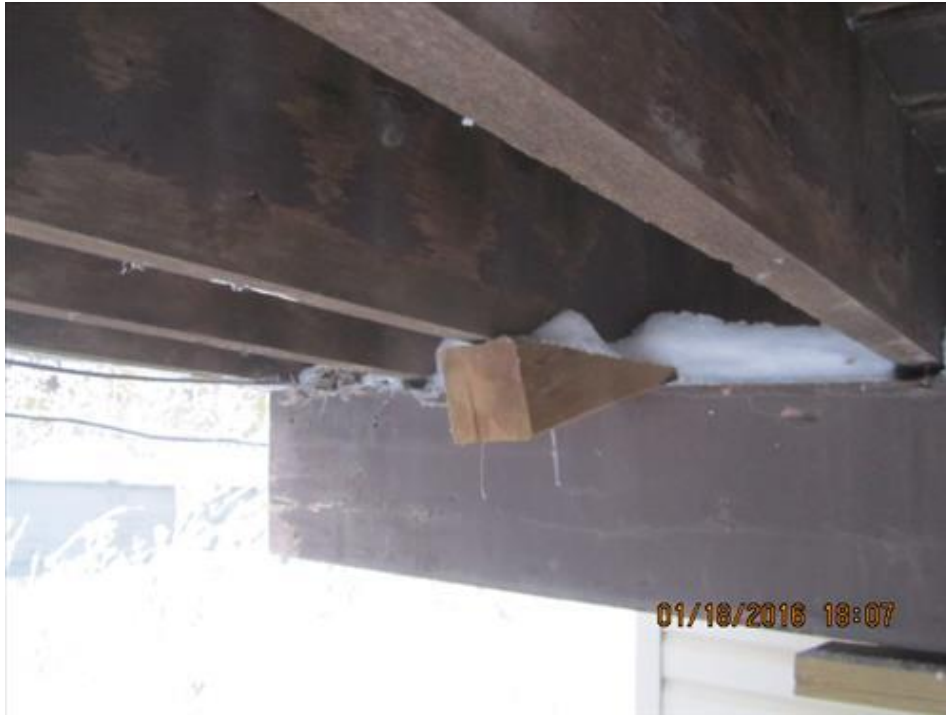
Photograph 43- Condition of joist supporting the front porch of House #68. Note the wedge placed due to the twist of the beam

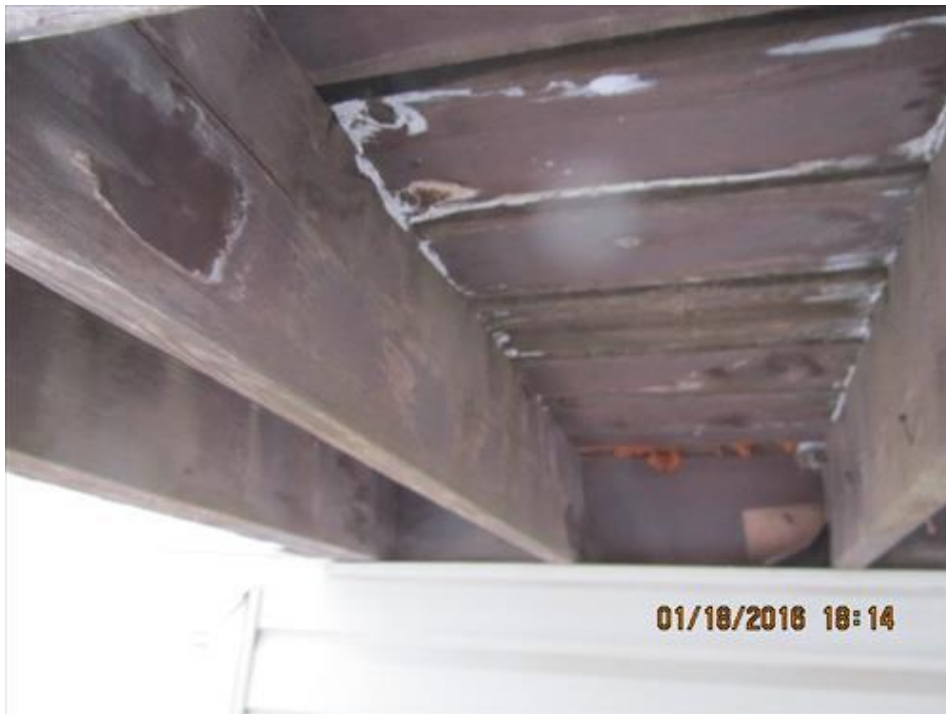
Photograph 44- Condition of beams and joist under the rear porch

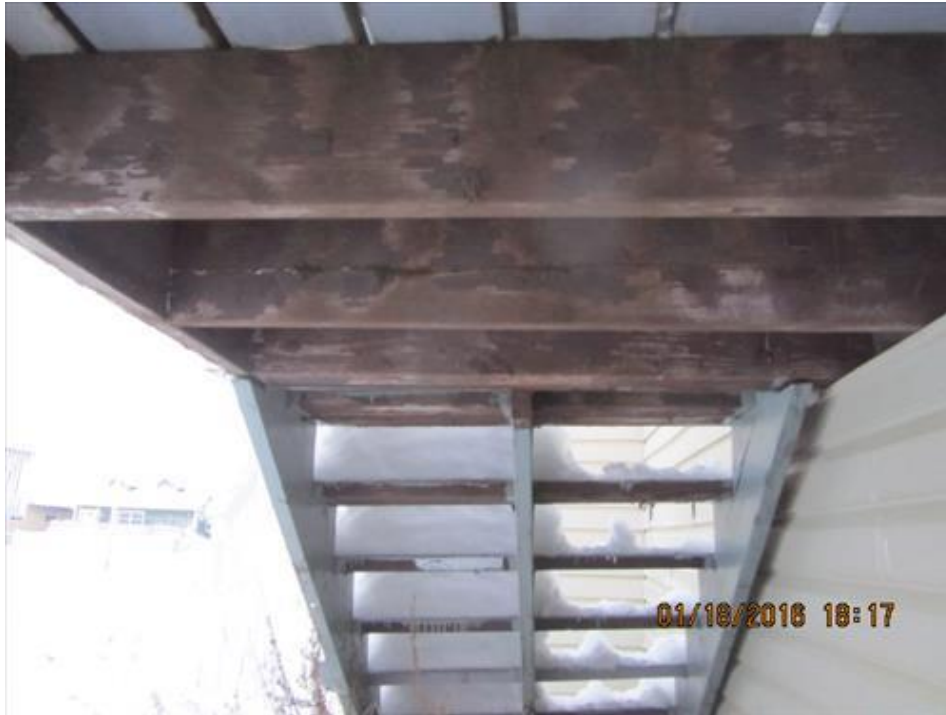
Photograph 45- Condition of beams and joist under the rear porch

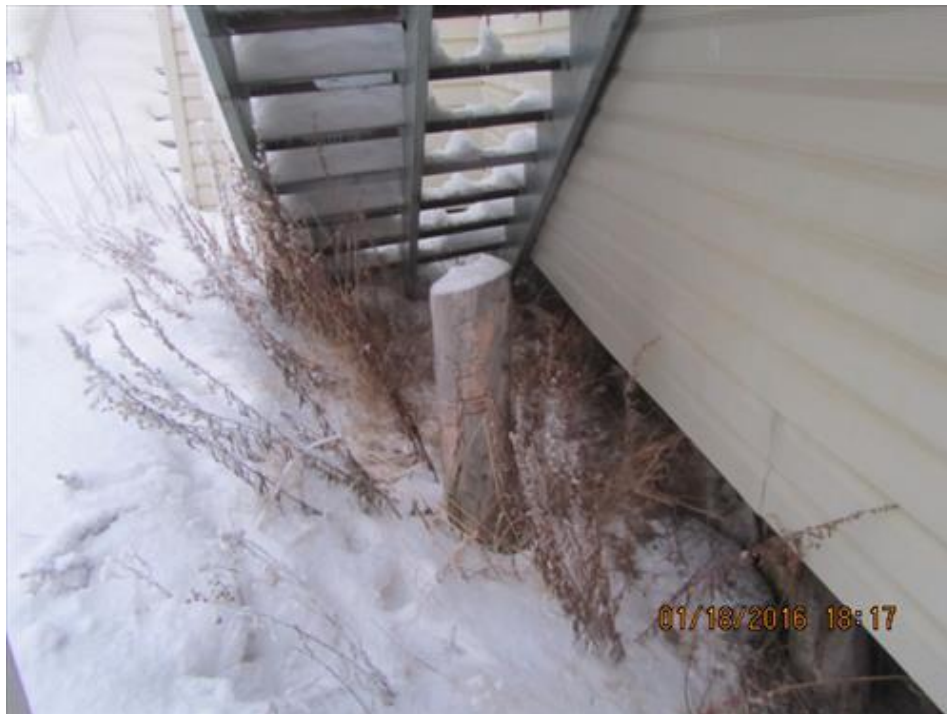
Photograph 46- Abandoned pile under the rear stairs

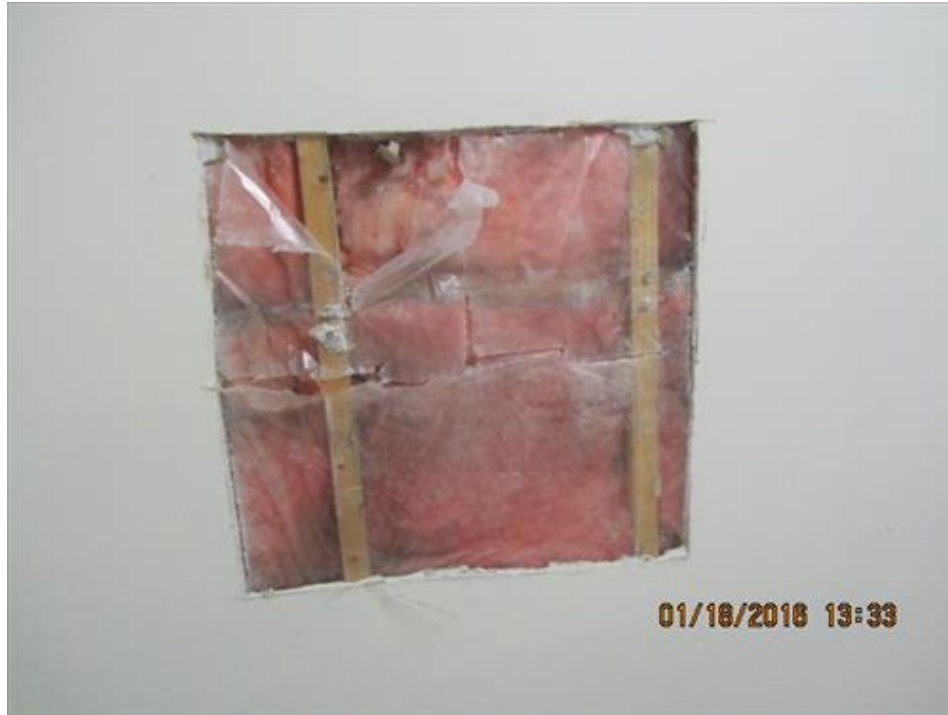
Photograph 47- Exterior wall components noted within the cut-out in ground floor laundry room

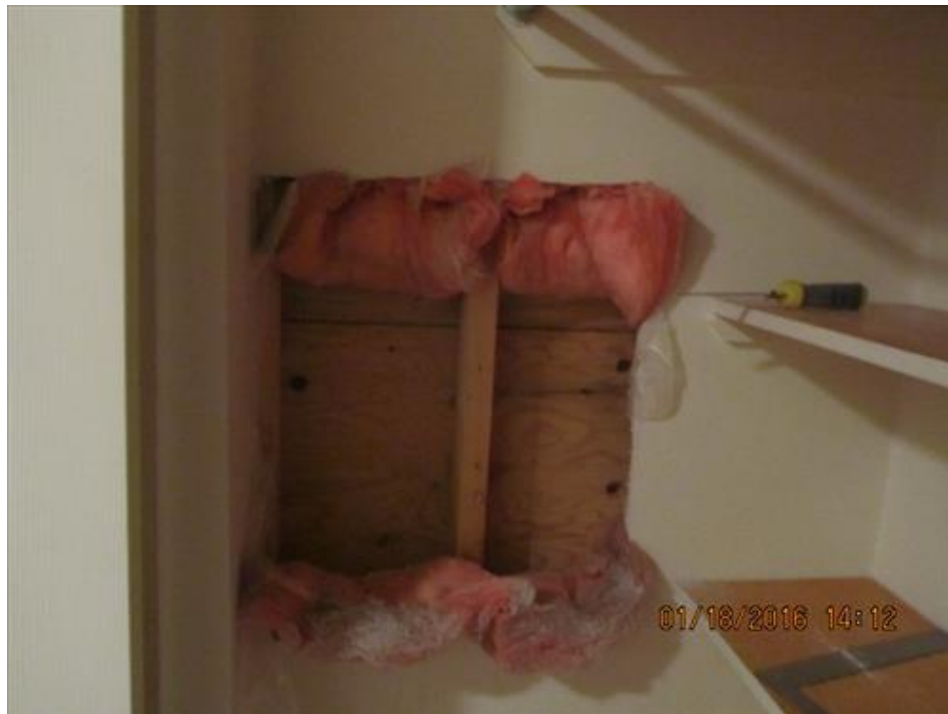
Photograph 48- Exterior wall components noted within the cut-out in second floor bedroom

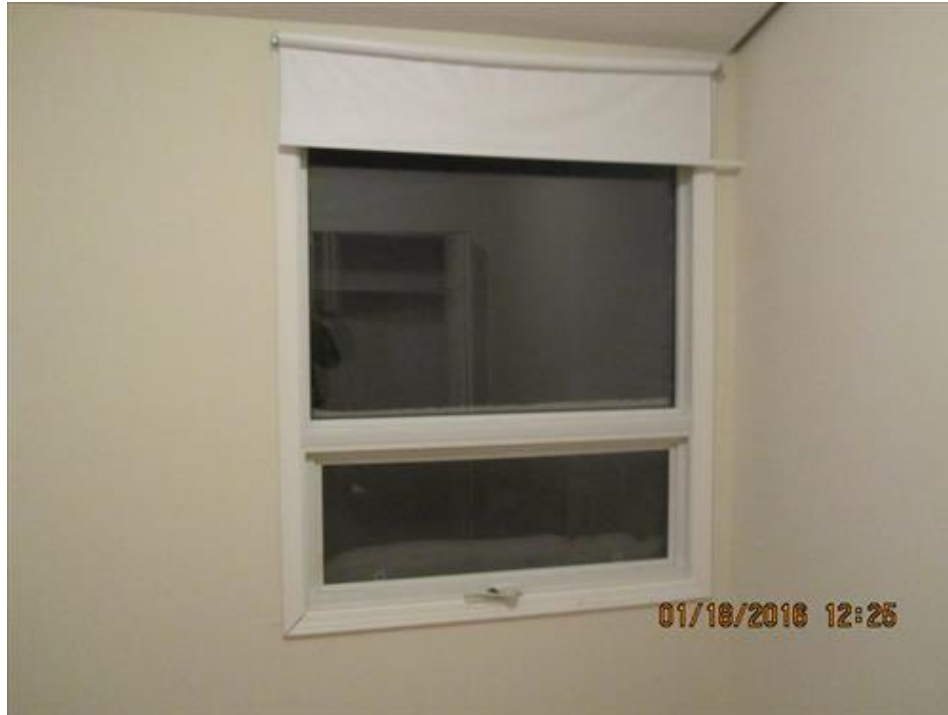
Photograph 49- Typical windows

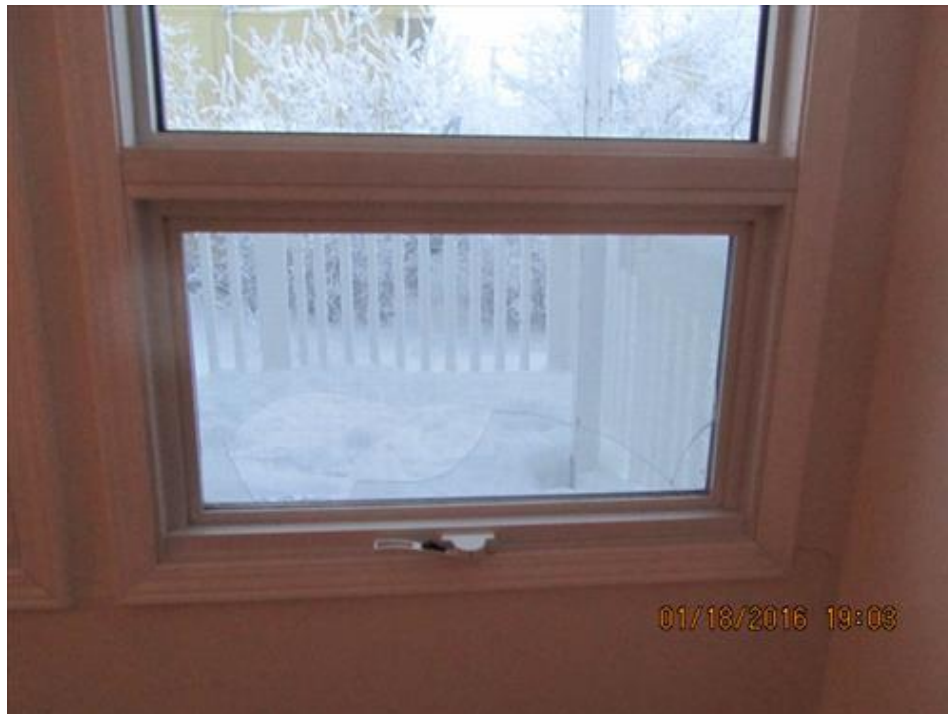
Photograph 50- Broken glass of the window located in sitting/living room of House #68
