**LIMITED STRUCTURAL BUILDING EVALUATION REPORT
66 & 68 ALDER DRIVE
INUVIK, NORTHWEST TERRITORIES**

Prepared for:

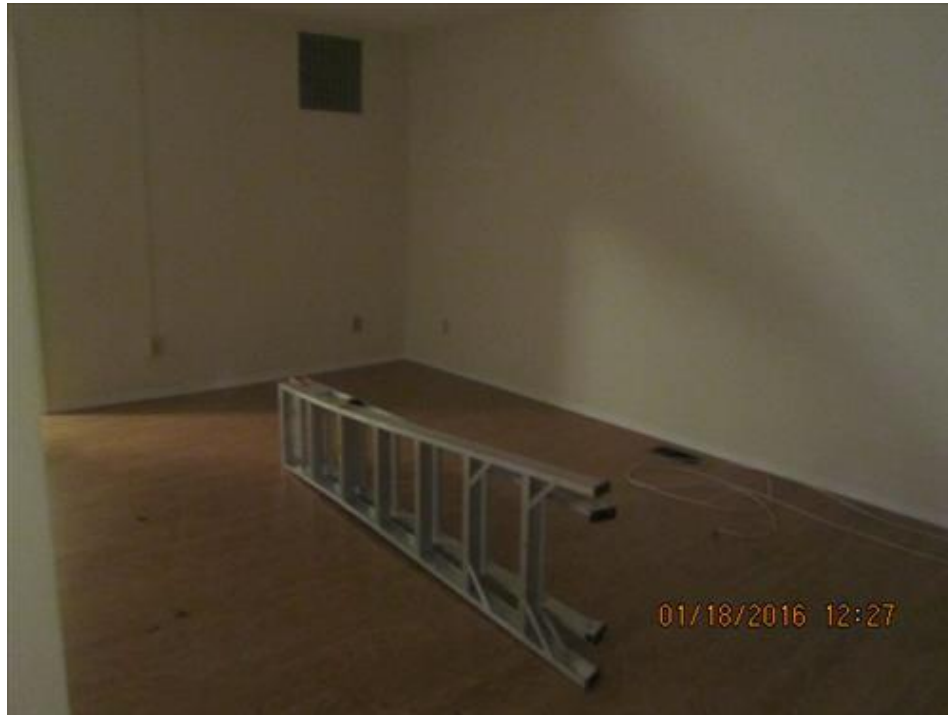
Photograph 51- Ground floor sitting/living room-House # 66

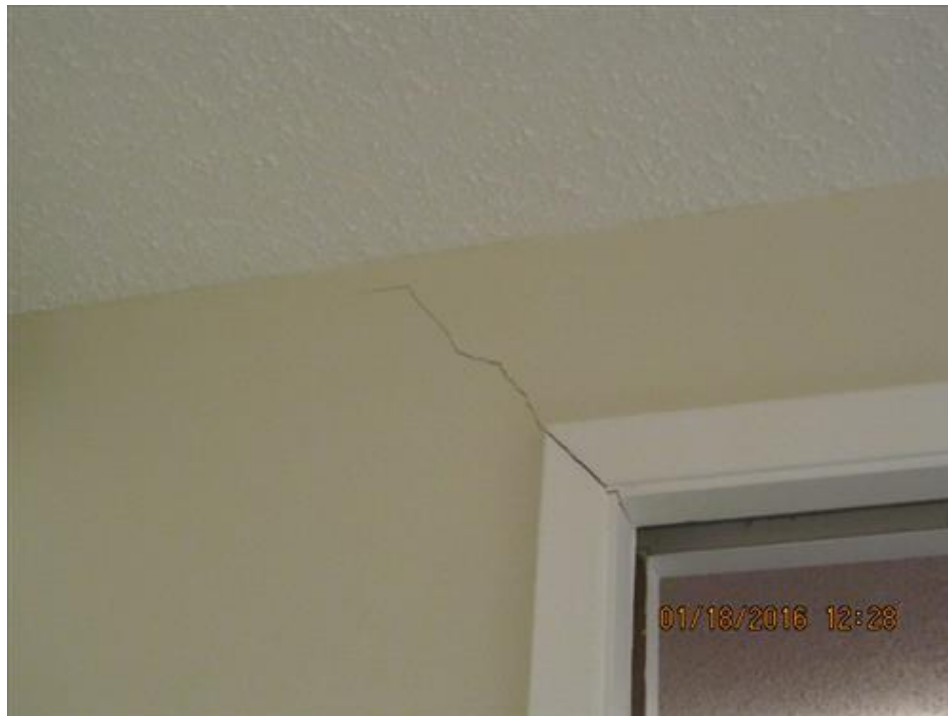
Photograph 64-Diagonal crack above the opening between the kitchen and dining room, on dining room side-House #66

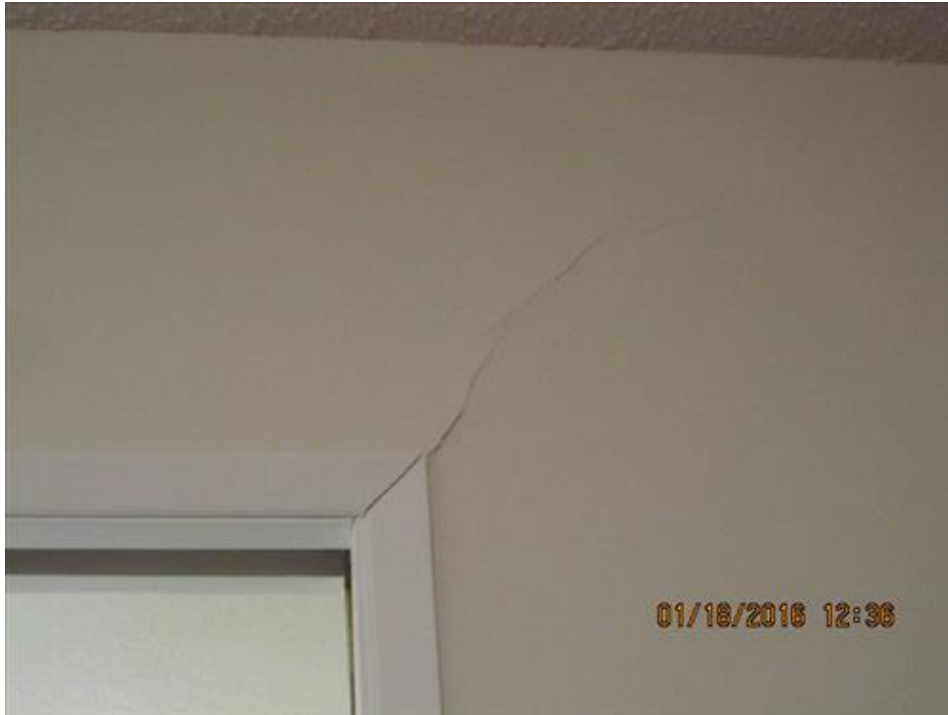
Photograph 65- Diagonal crack above the opening between the kitchen and dining room, on Kitchen side-House #66

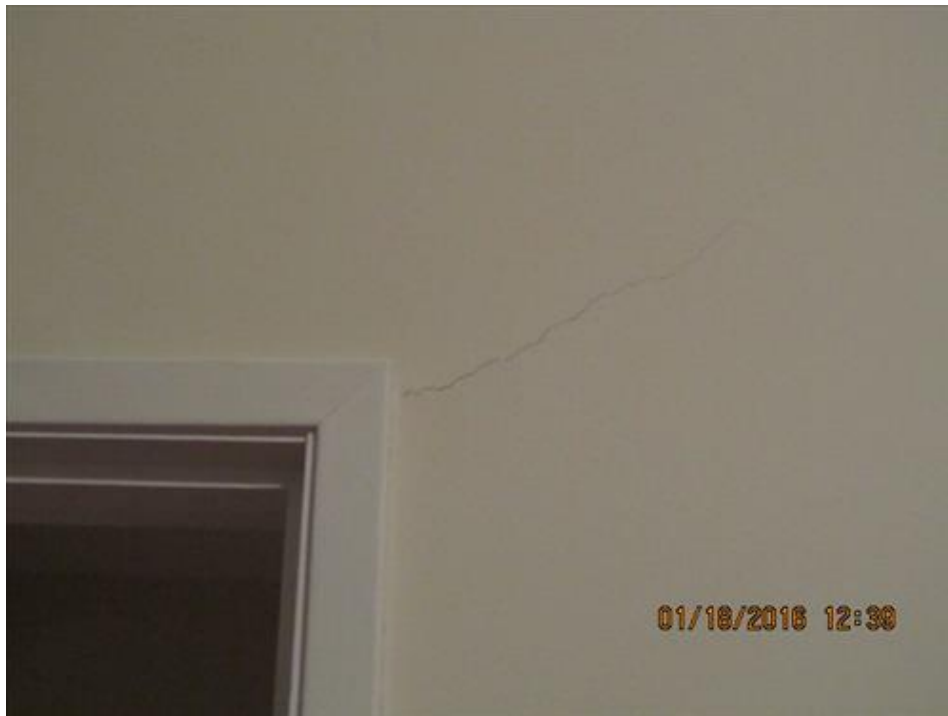
Photograph 66- Diagonal crack above the door of second floor north bedroom-House #66

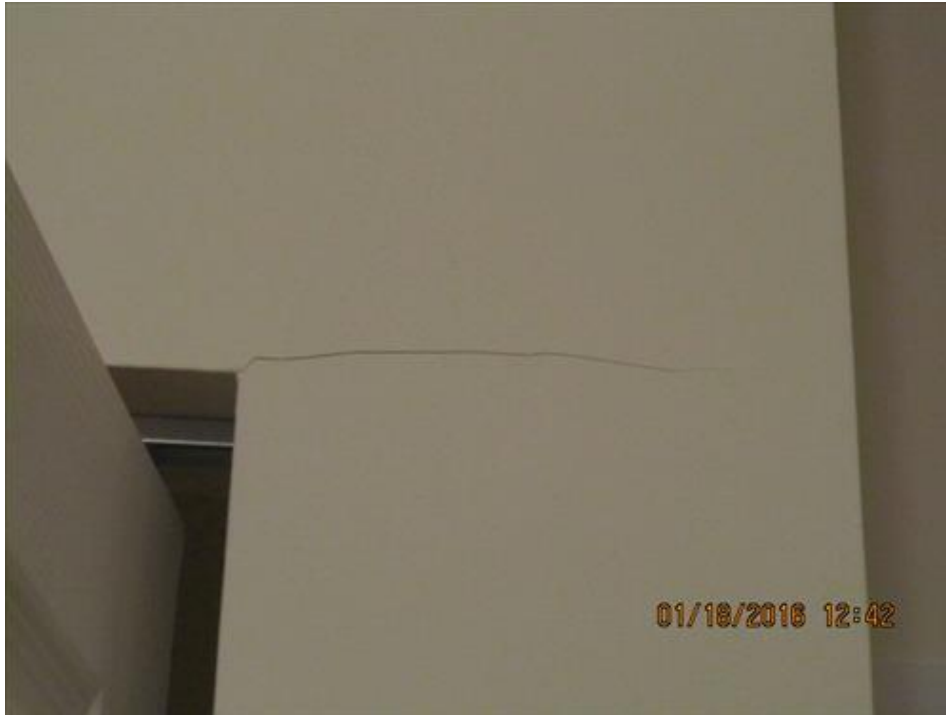
Photograph 67- Horizontal crack above the closet in second floor south bedroom-House #66

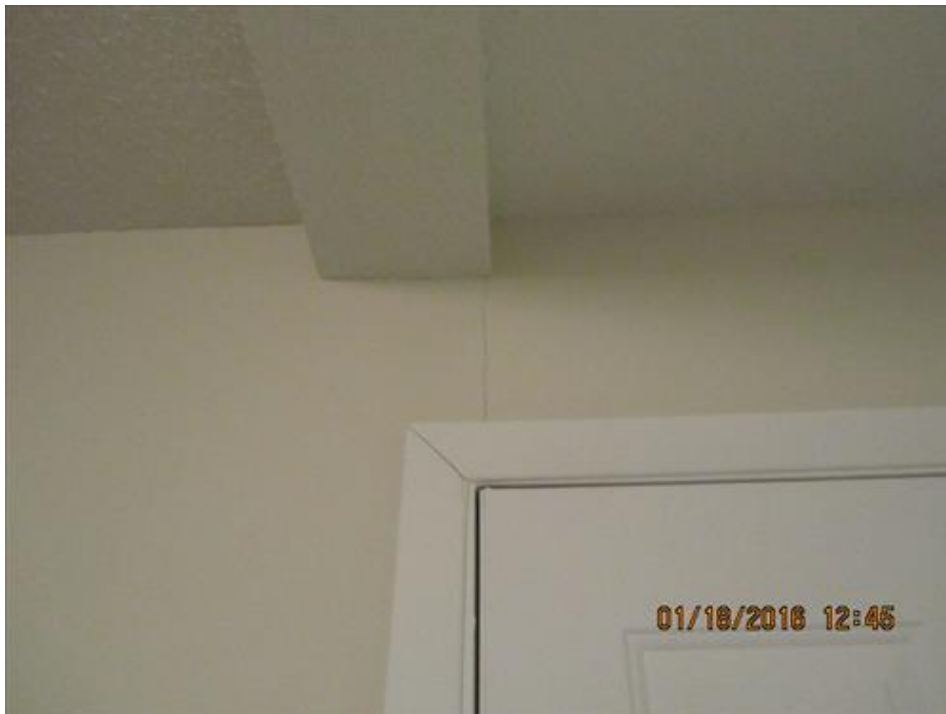
Photograph 68- Vertical crack within the east wall above the main entrance door and below the beam supporting the second floor-House #66

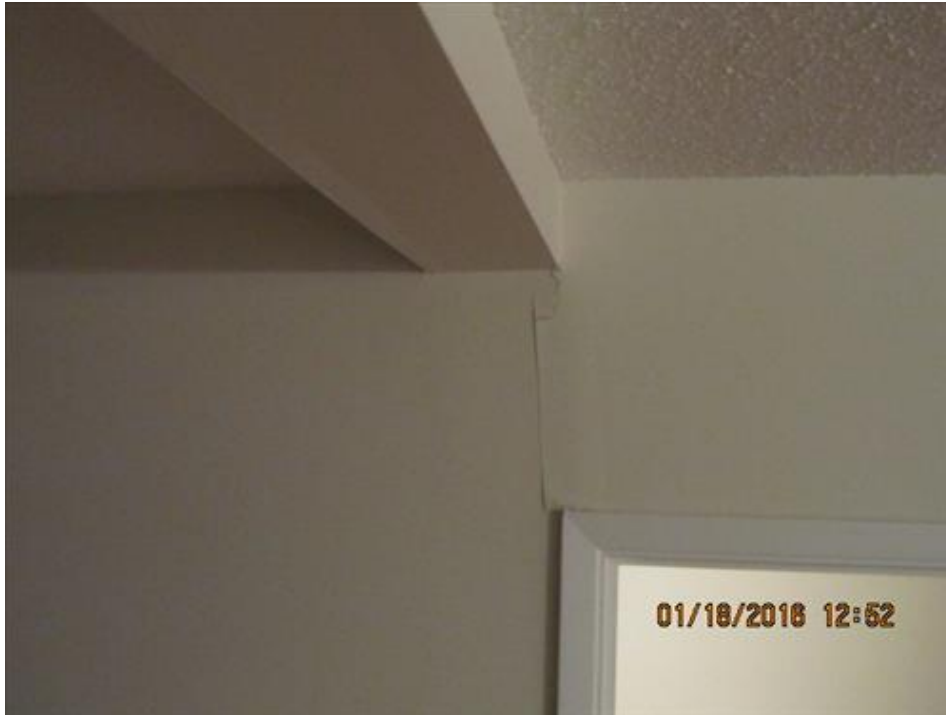
Photograph 69- Vertical crack within the interior loadbearing wall above the opening between the living/sitting room and back foyer and below the beam supporting the second floor-House #66

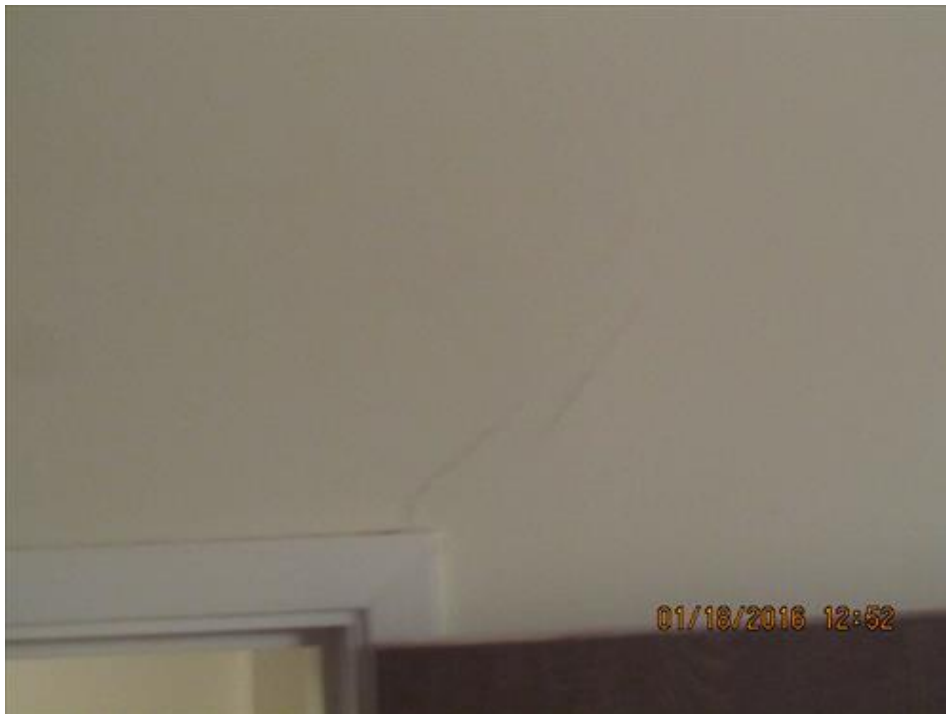
Photograph 70- Diagonal crack above the secondary door to outside within the west exterior wall

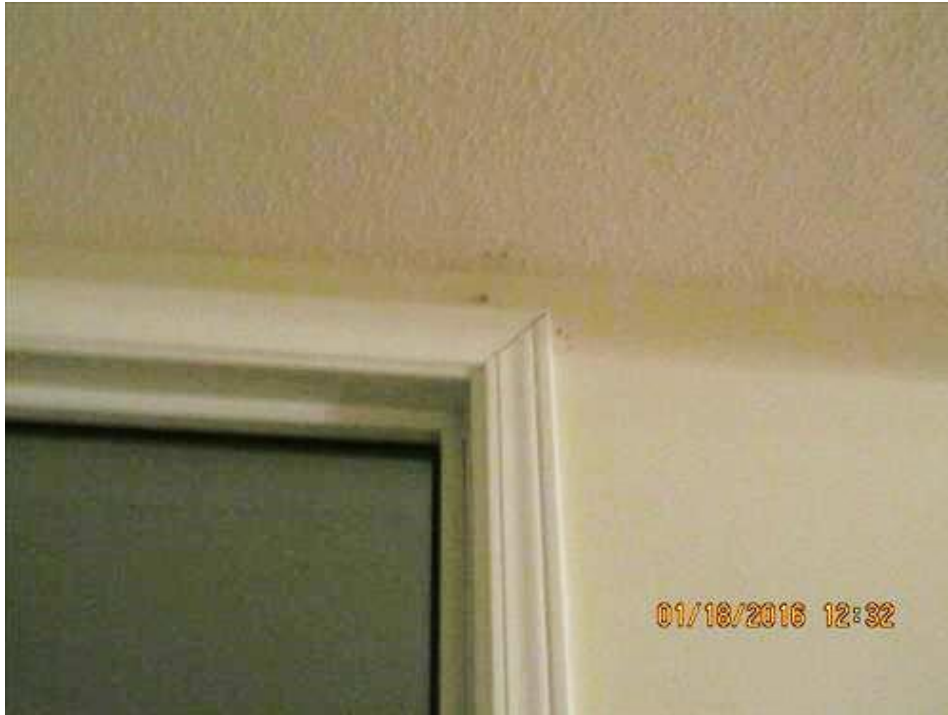
Photograph 71- Open window frame mold joint at the top right corner of window in sitting/living room-House #66

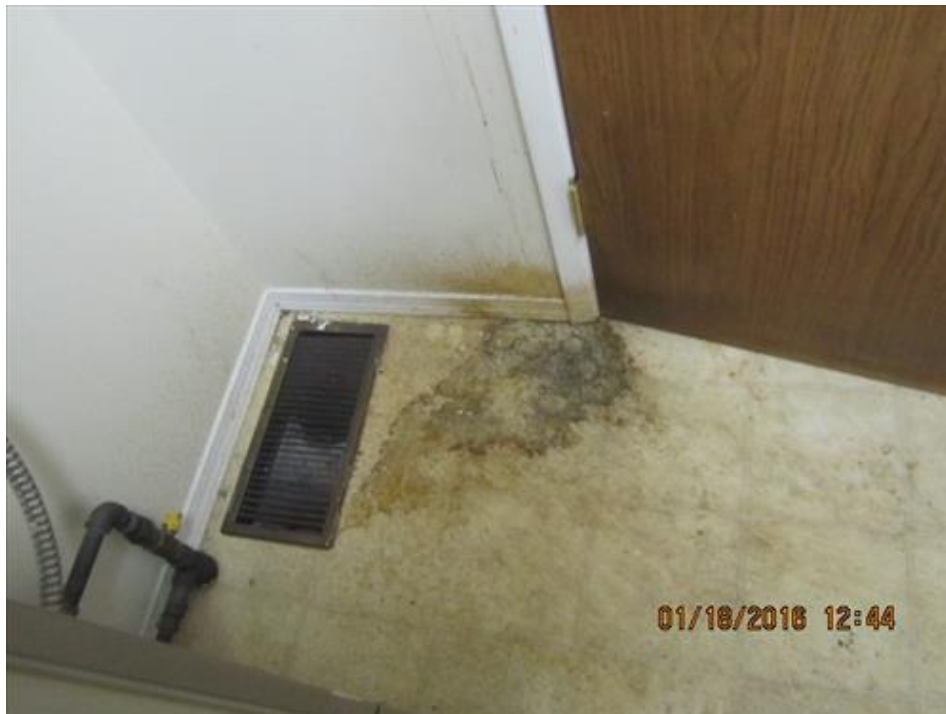
Photograph 78- Heavy stain within the furnace room floor, adjacent to the furnace-House #66

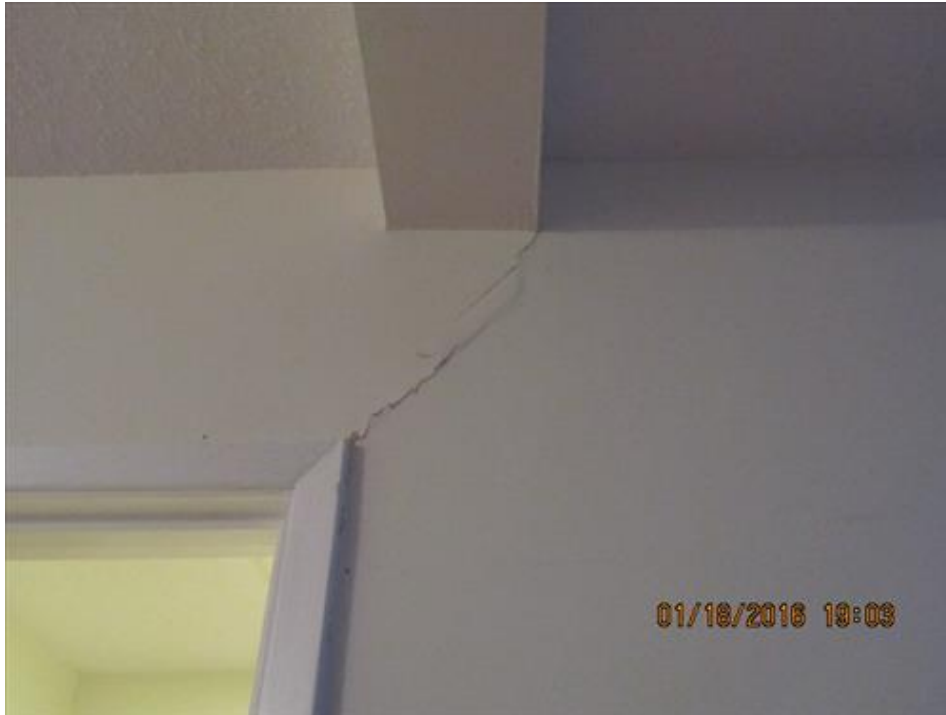
Photograph 79- Diagonal crack under the second floor beam and door opening from foyer to living/sitting room-House 68

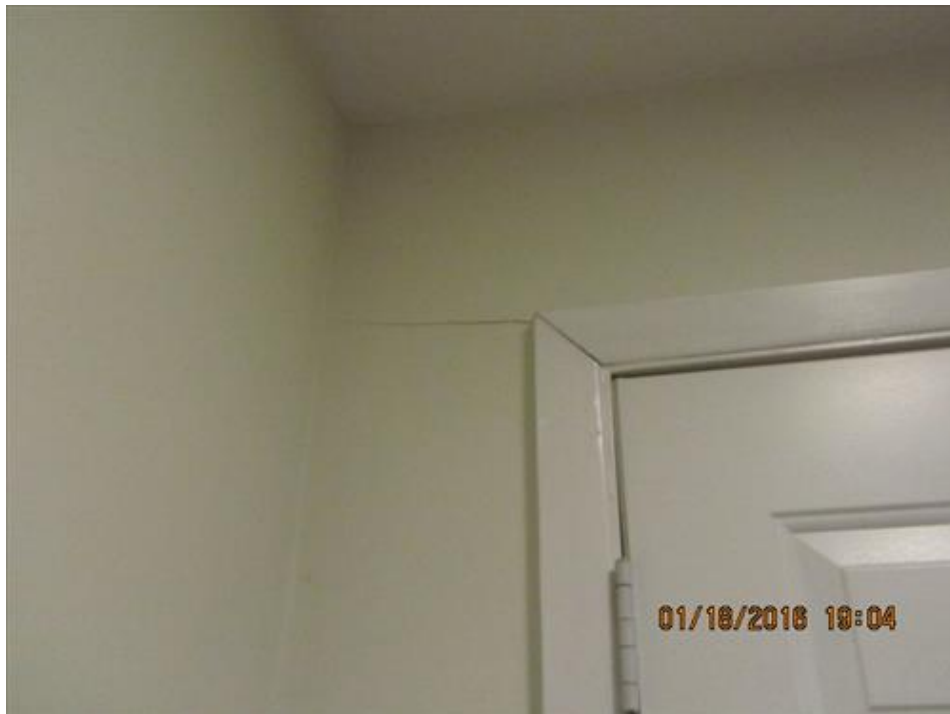
Photograph 80- Horizontal crack at the corner of the main entrance door to front foyer – House 68

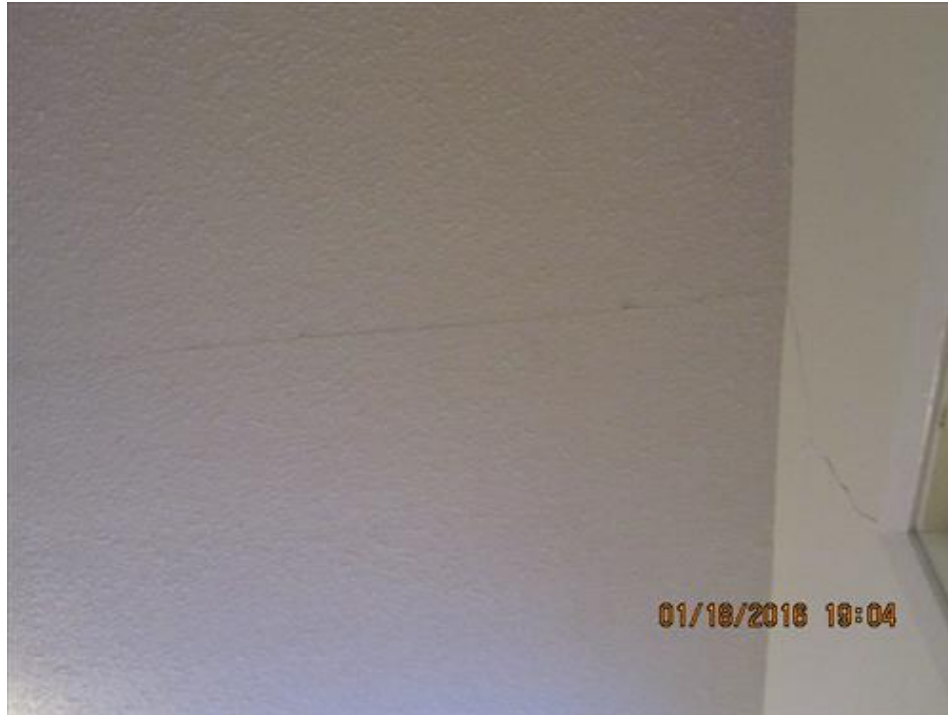
Photograph 81- Vertical crack above the door from front foyer and within the ceiling-House 68

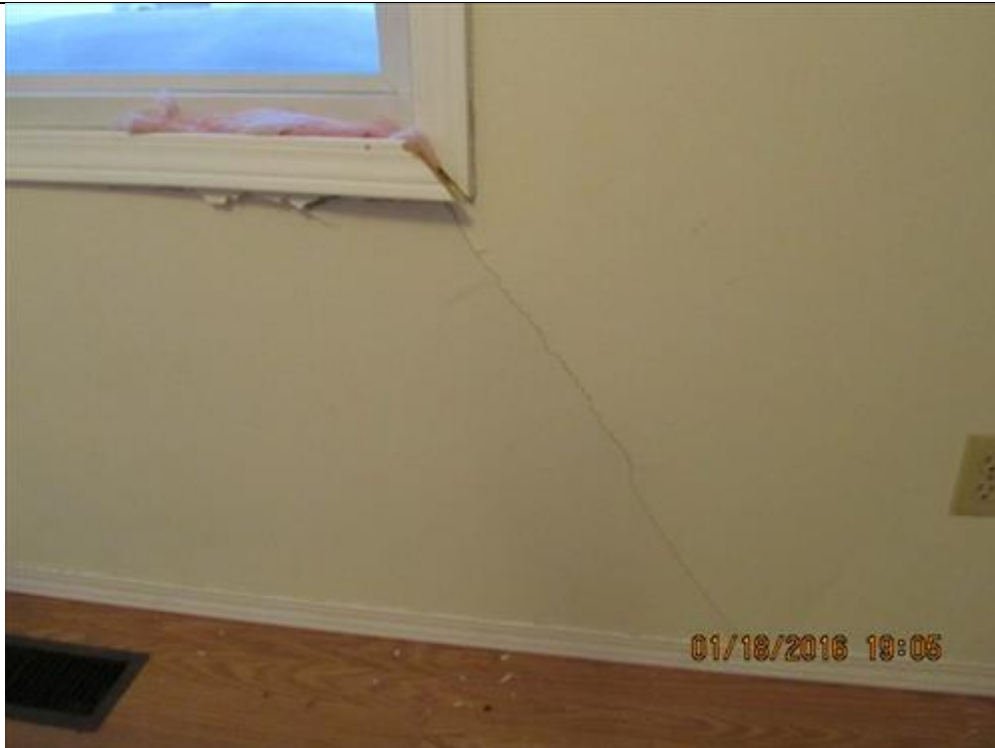
Photograph 82- Severe radial crack and bulging of wall at the lower right corner of north window within the east exterior wall, in sitting/living room-House #68

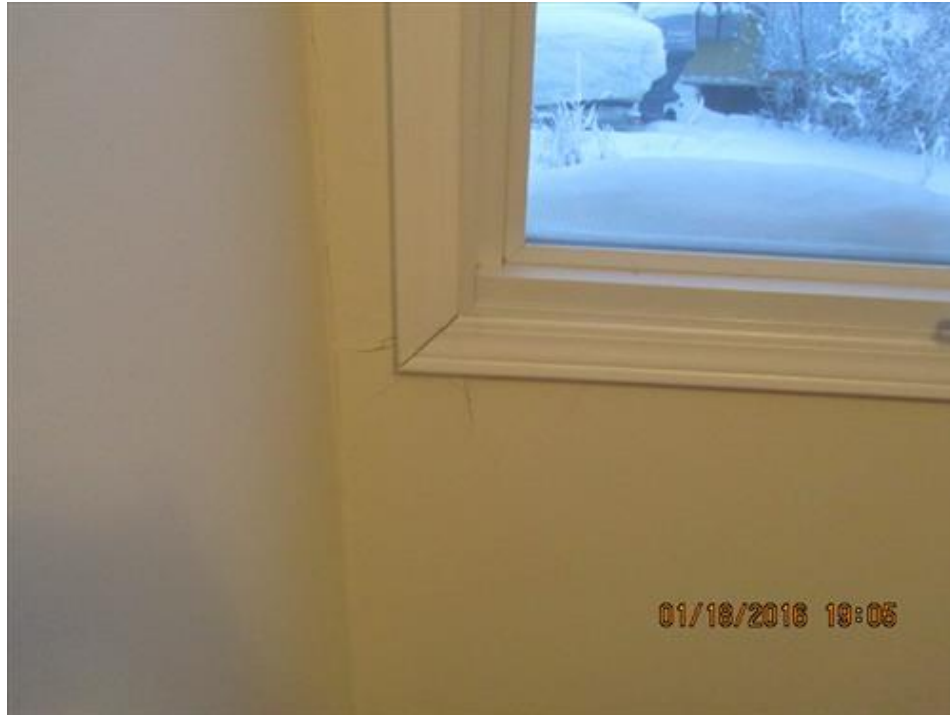
Photograph 83- Cracks at the lower left corner of north window within the east exterior wall, in sitting/living room-House #68

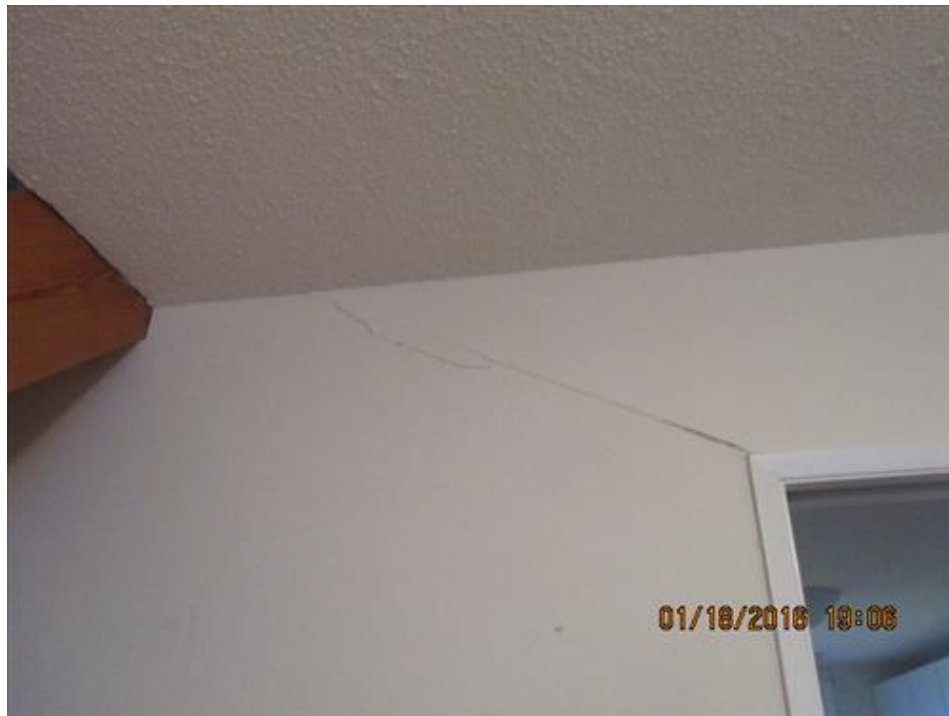
Photograph 84- Severe diagonal crack above the opening between the kitchen and dining room on dining room side-House #68

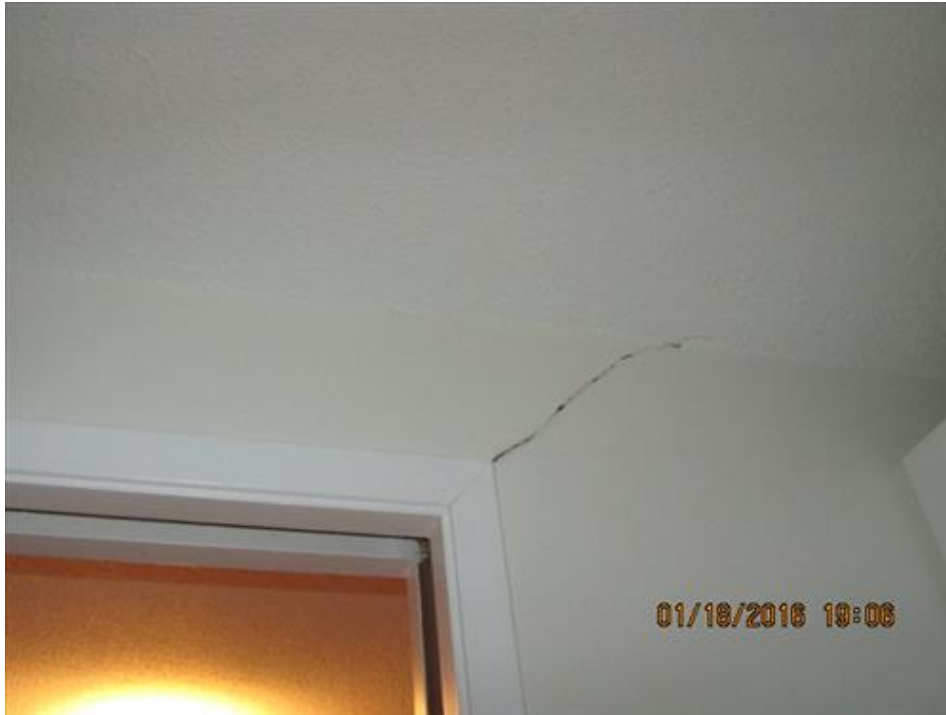
Photograph 85- Severe diagonal crack above the opening between the kitchen and dining room on kitchen side-House #68

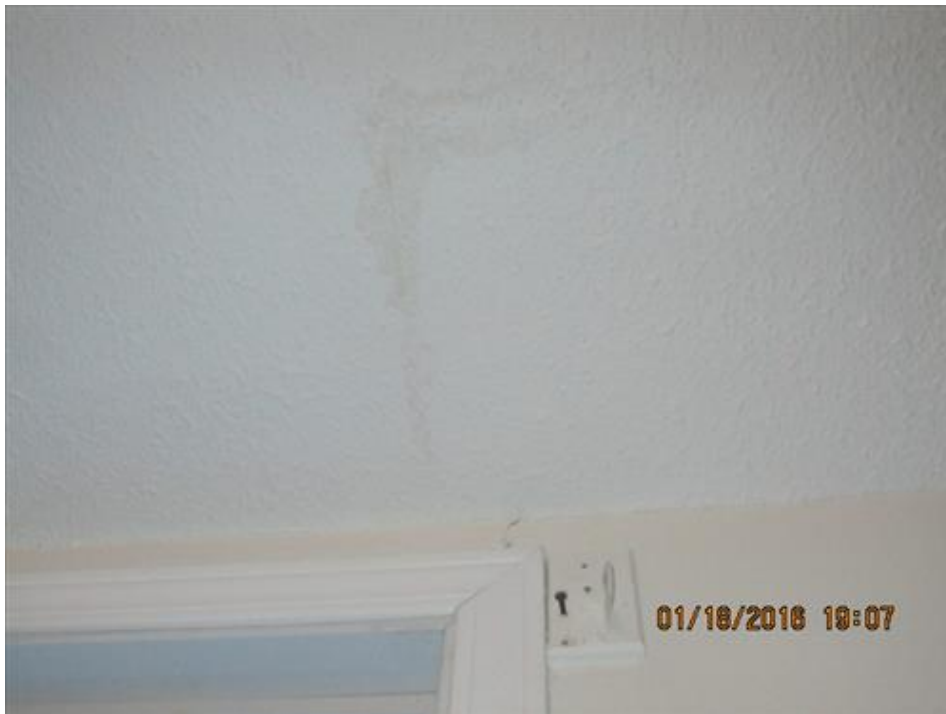
Photograph 86- Crack above the top right corner of the window in the kitchen and within the ceiling

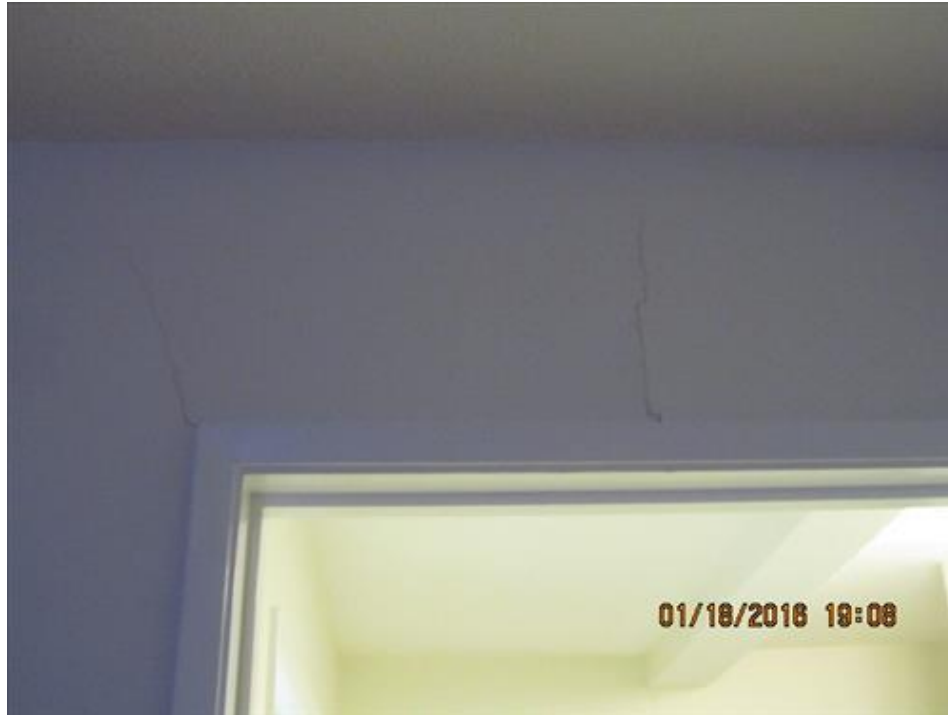
Photograph 87- Vertical and diagonal cracks above and at the corner of the door between the middle hall and back foyer-House #68

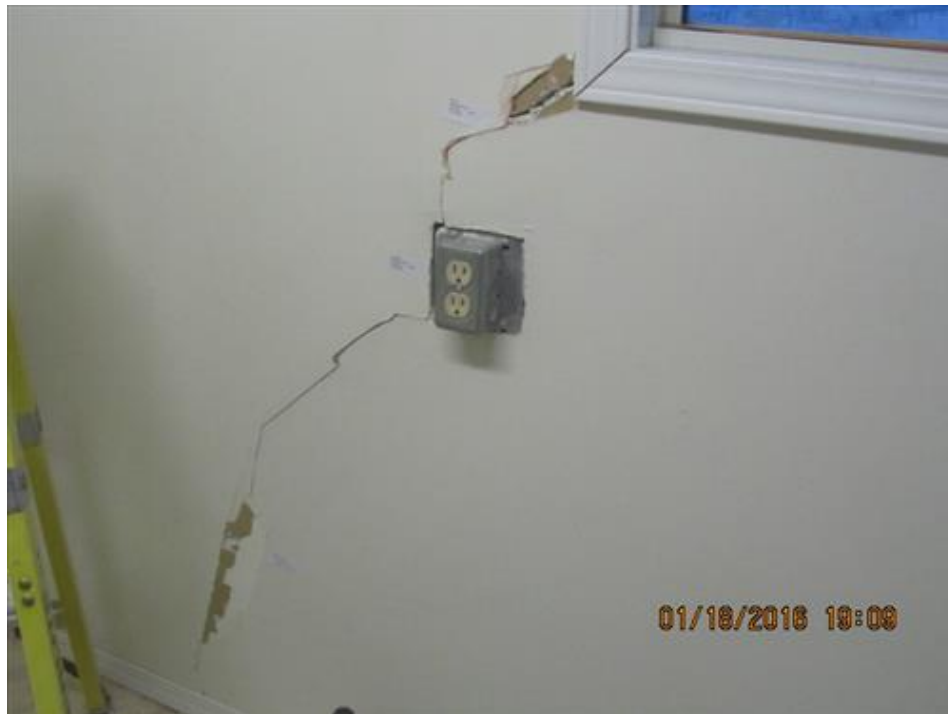
Photograph 88- Severe diagonal crack at the lower left corner of the window of the furnace room within the west exterior wall-House#68

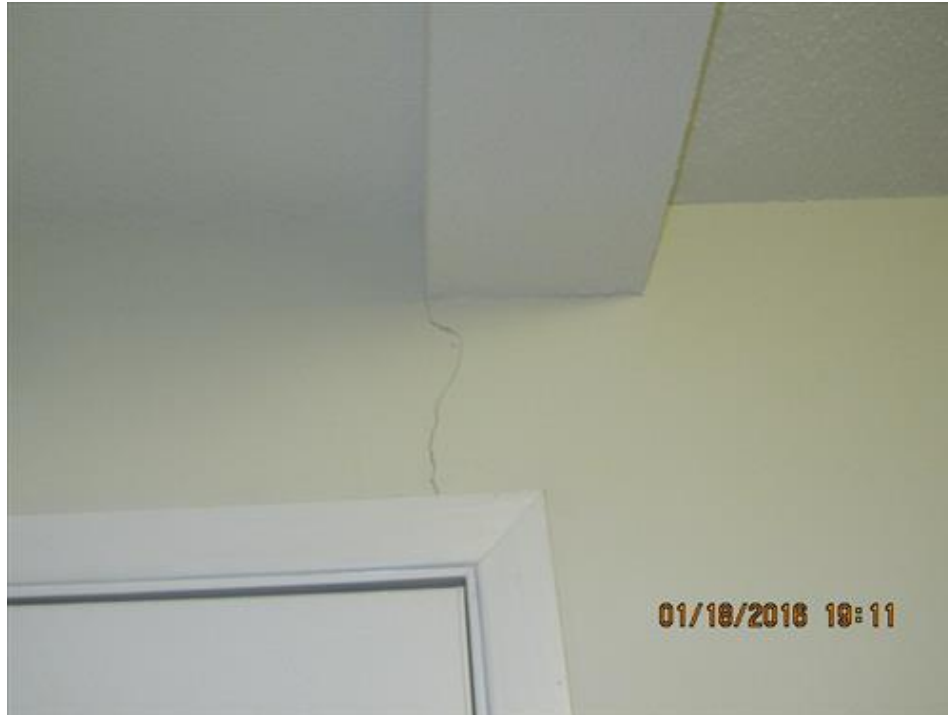
Photograph 89- Vertical crack below the beam and above the back door within the west exterior wall- House #68

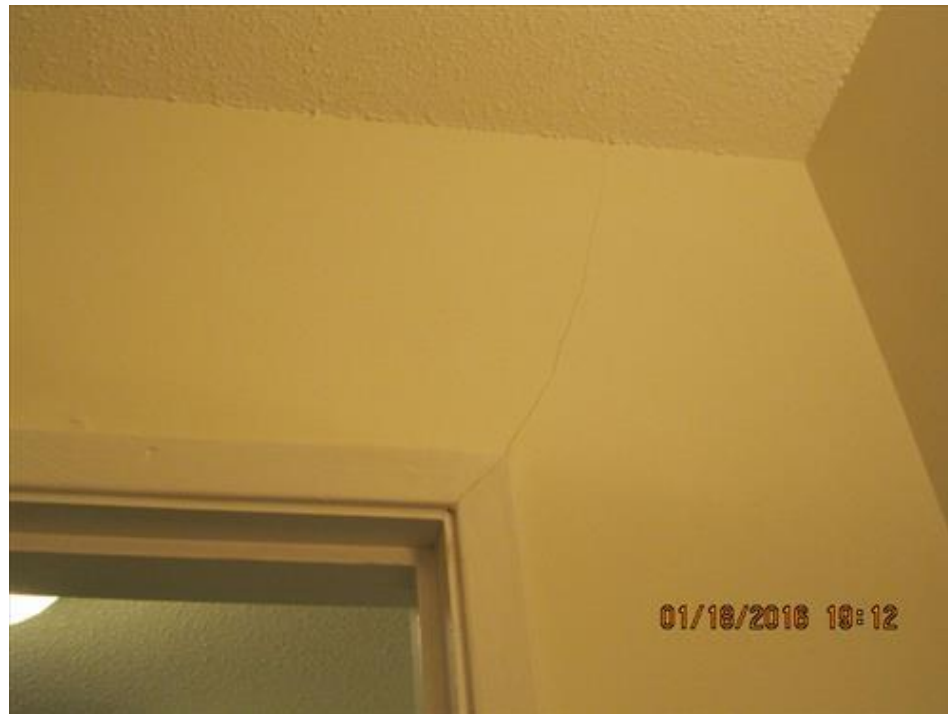
Photograph 90- Radial crack above the ground floor washroom door –House #68

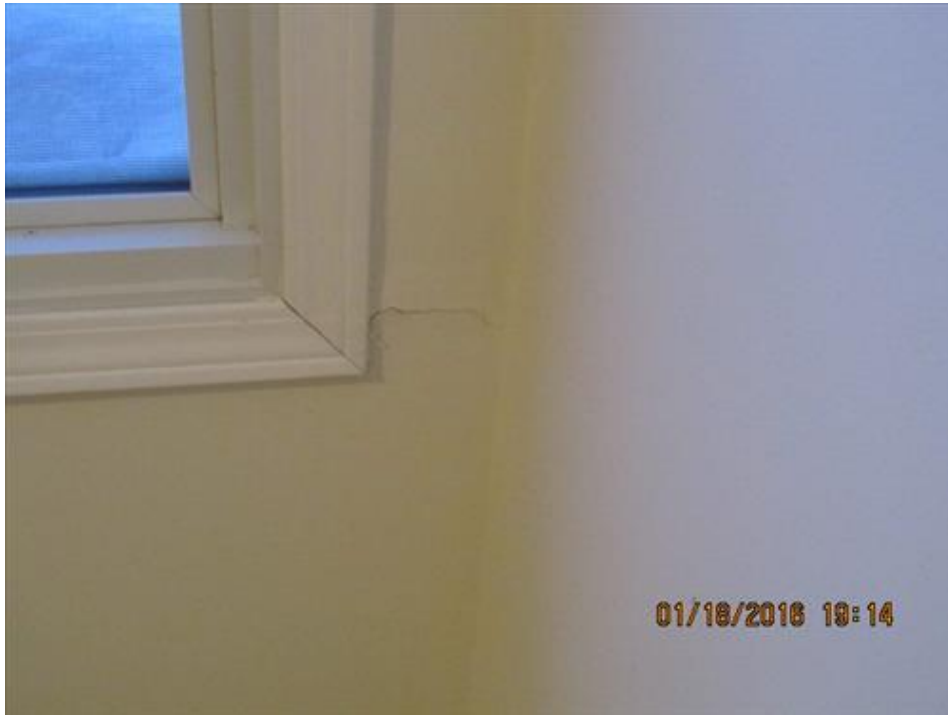
Photograph 91- Horizontal crack at the lower right corner of the window in south bedroom on second floor-House #68

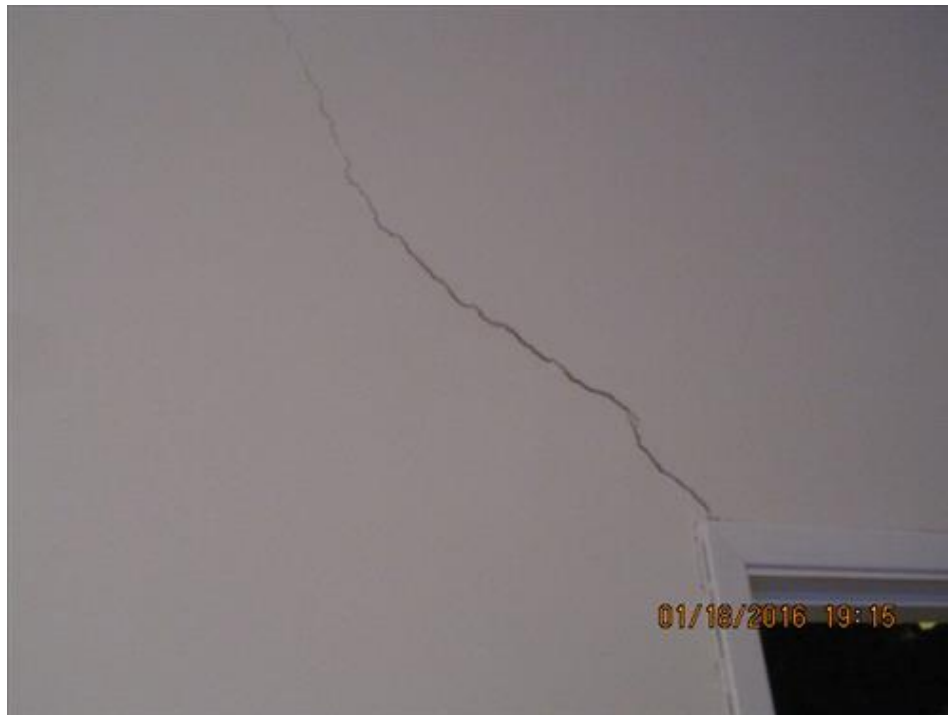
Photograph 92- Severe diagonal crack at the top corner of the south bedroom door on second floor-House #68

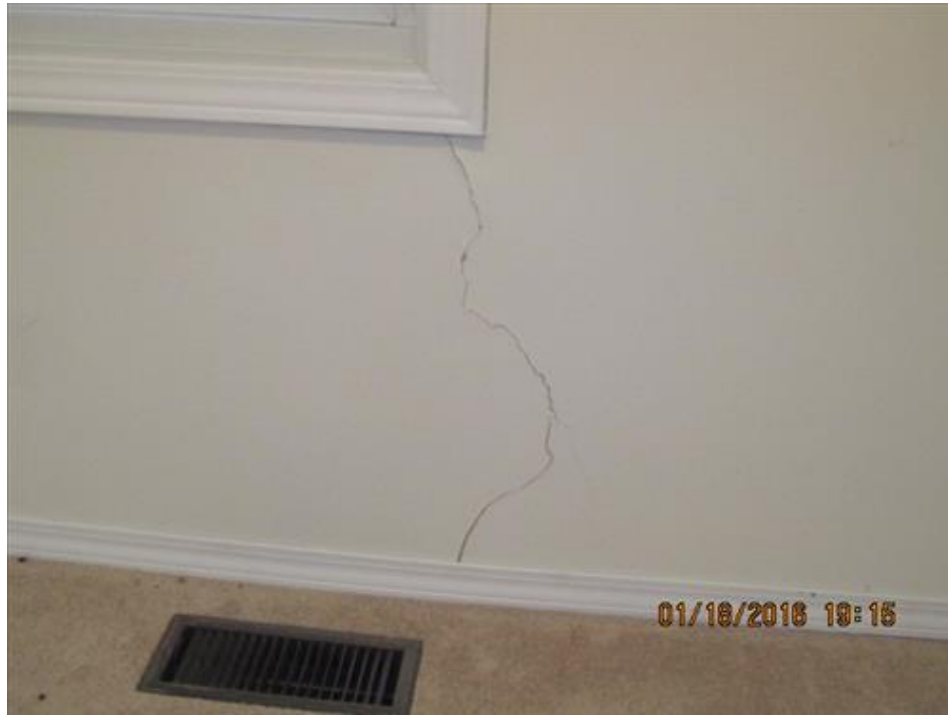
Photograph 93- Severe vertical crack at the lower left corner of the north bedroom window on second floor-House #68

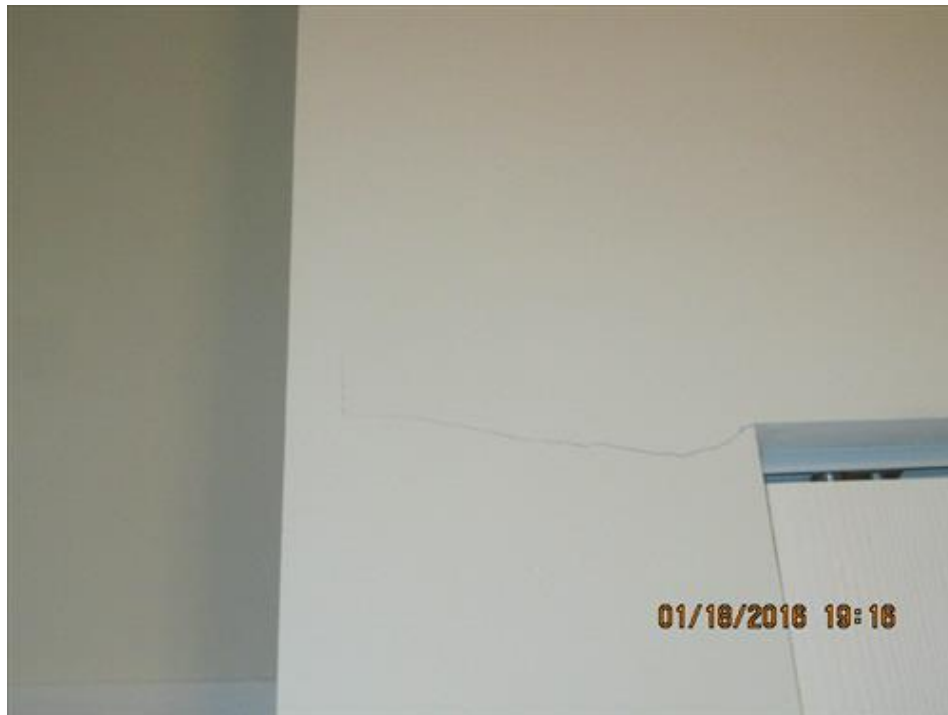
Photograph 94- Horizontal crack at the top left corner of the closet within the north bedroom on second floor-House #68

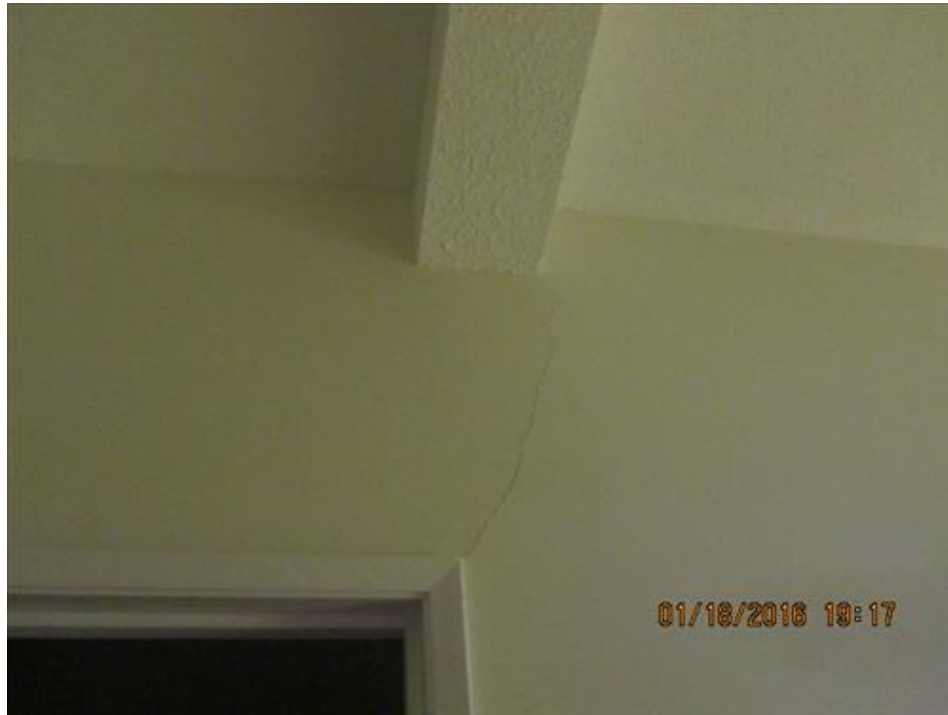
Photograph 95- Diagonal crack above the door to utility room on second floor, on hall side-House #68

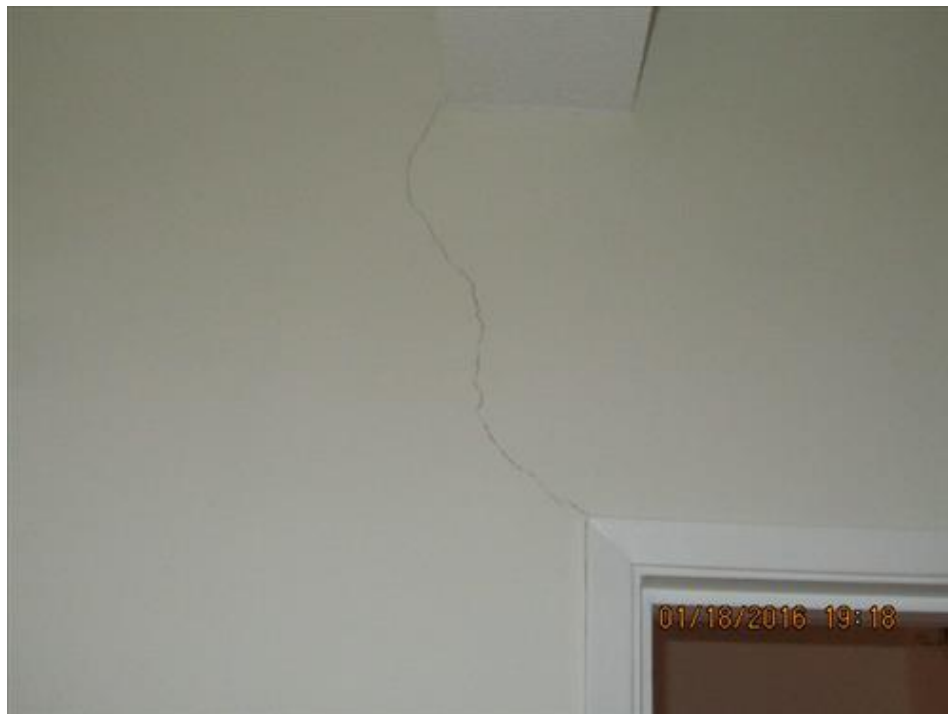
Photograph 96- Diagonal crack under the ceiling beam and above the door of utility room on second floor, on utility room side-House #68

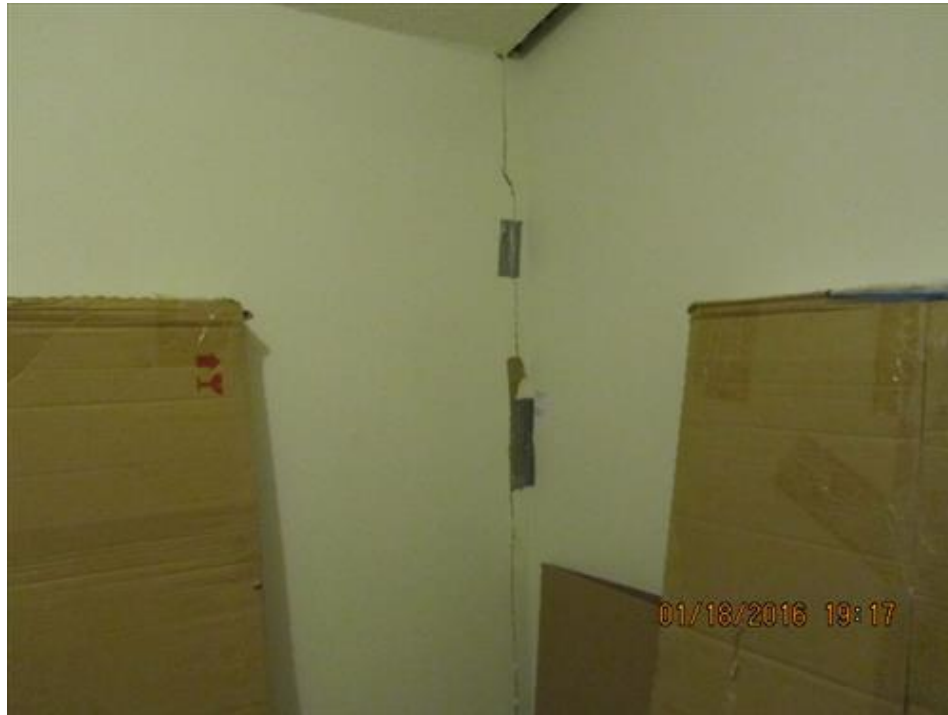
Photograph 97- Severe vertical crack at the northwest corner of utility room on second floor-House #68 (location of separation in party wall with House #66)

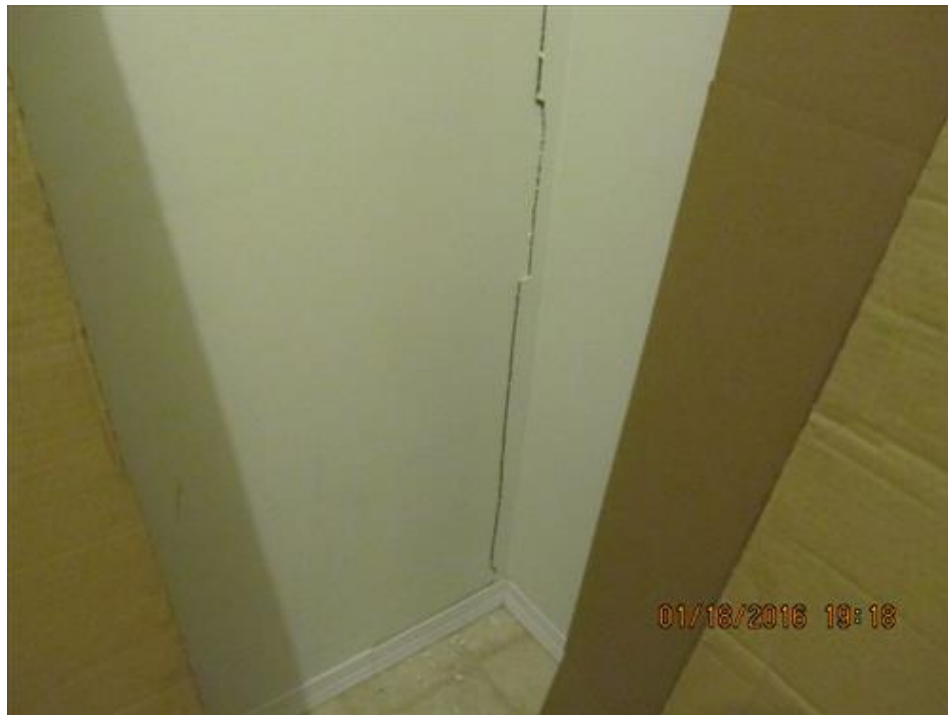
Photograph 98- Close-up of severe vertical crack at the northwest corner of utility room on second floor-House #68 (location of separation in party wall with House #66)

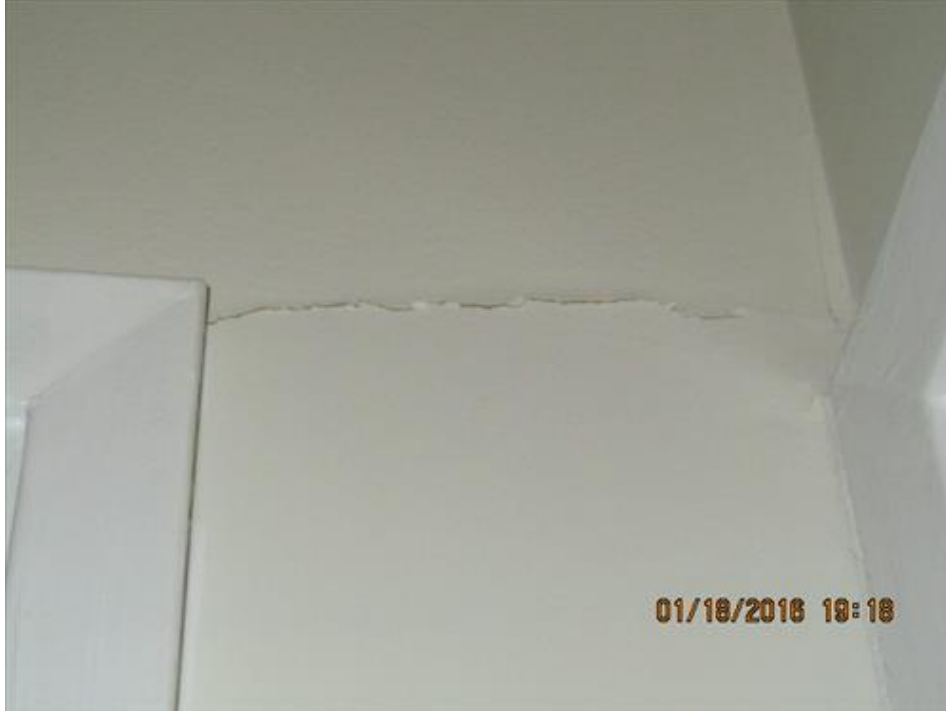
Photograph 99- Severe horizontal crack at the corner of the door of the bedroom, located at the southwest corner of second floor-House # 68

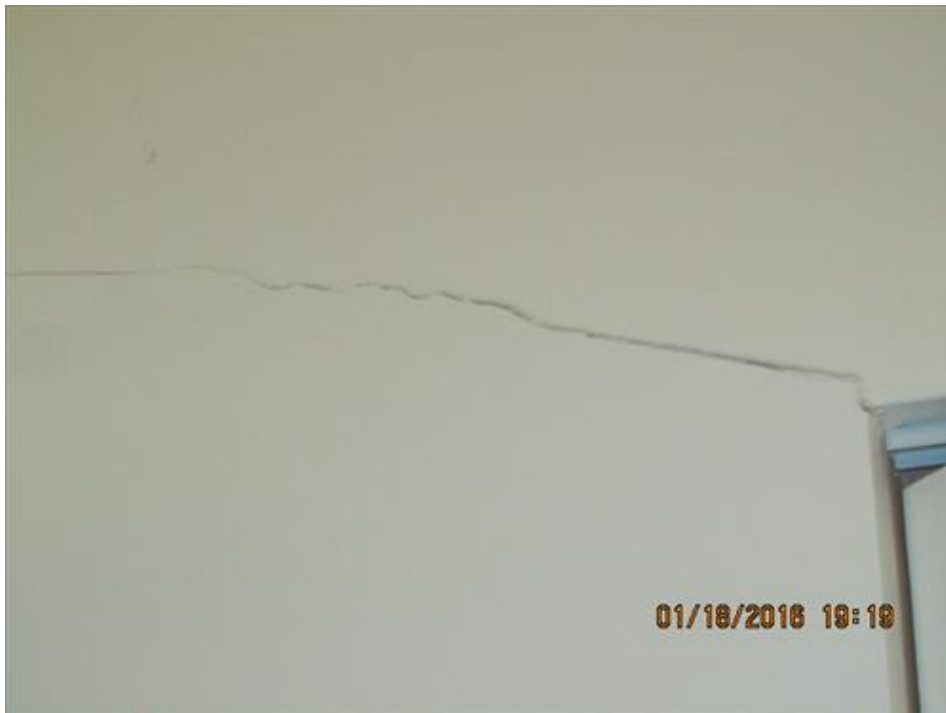
Photograph 100- Severe horizontal crack at the corner of closet door of the bedroom, located at the southwest corner of second floor-House # 68
