**LIMITED STRUCTURAL BUILDING EVALUATION REPORT
66 & 68 ALDER DRIVE
INUVIK, NORTHWEST TERRITORIES**

Prepared for:

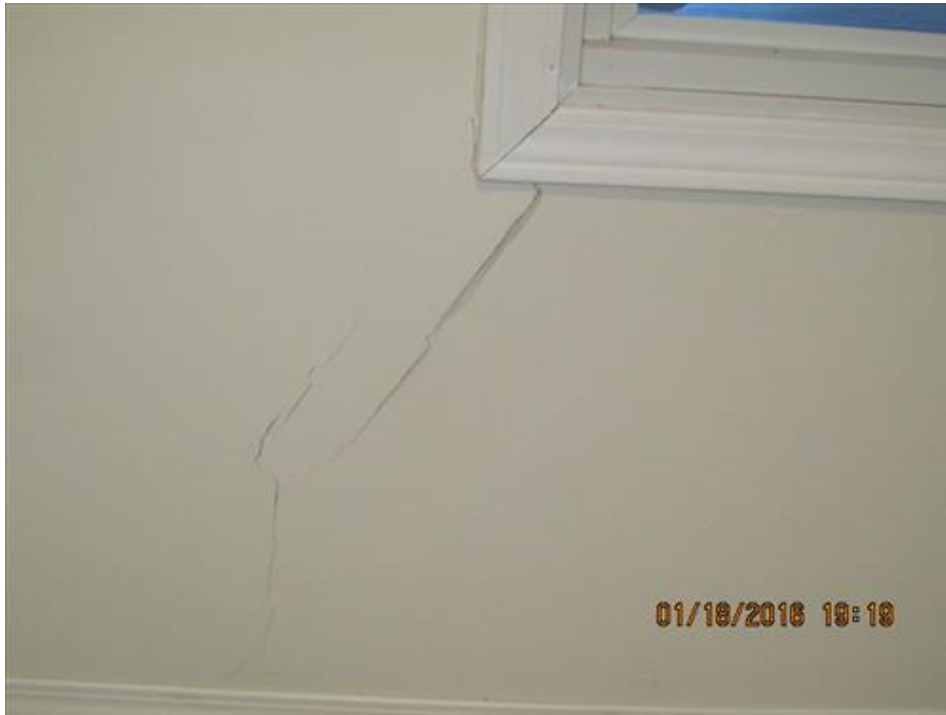
Photograph 101- Severe diagonal cracks at the lower left corner of the window, located at the southwest corner bedroom on second floor-House # 68

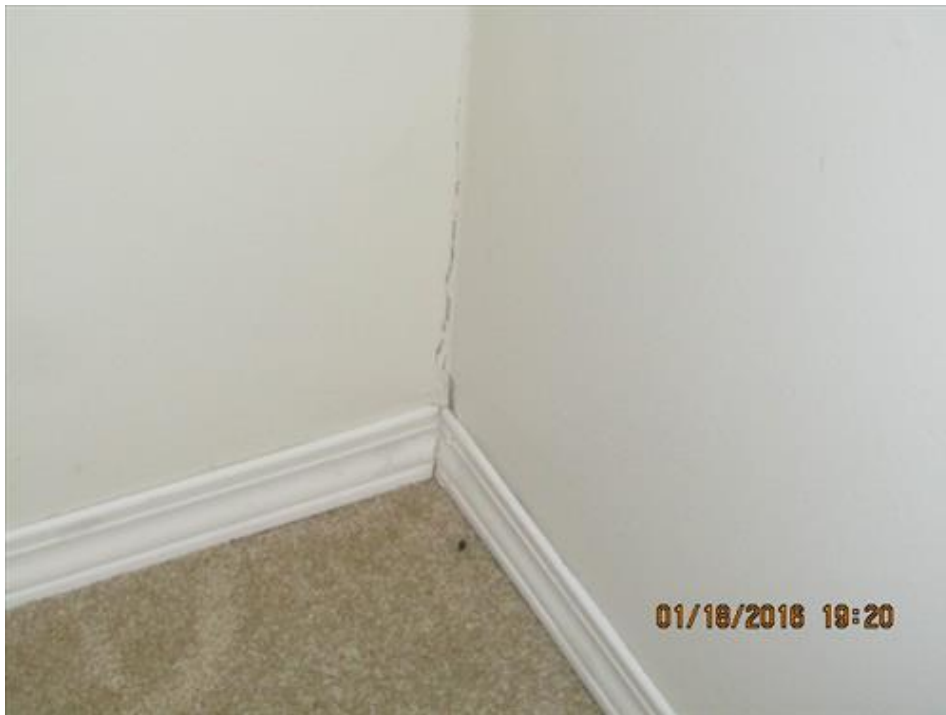
Photograph 102- Severe vertical crack at the south west corner of the located at the southwest corner of second floor-House # 68

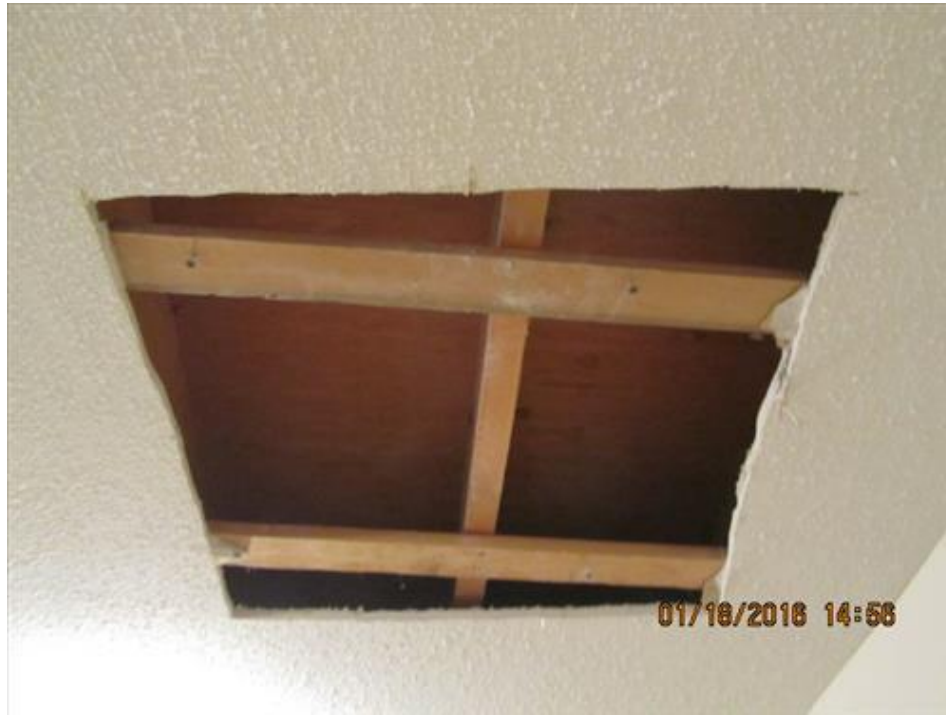
Photograph 103- Roof Joist and lower layer deck sheathing observed through cut-out – House #66

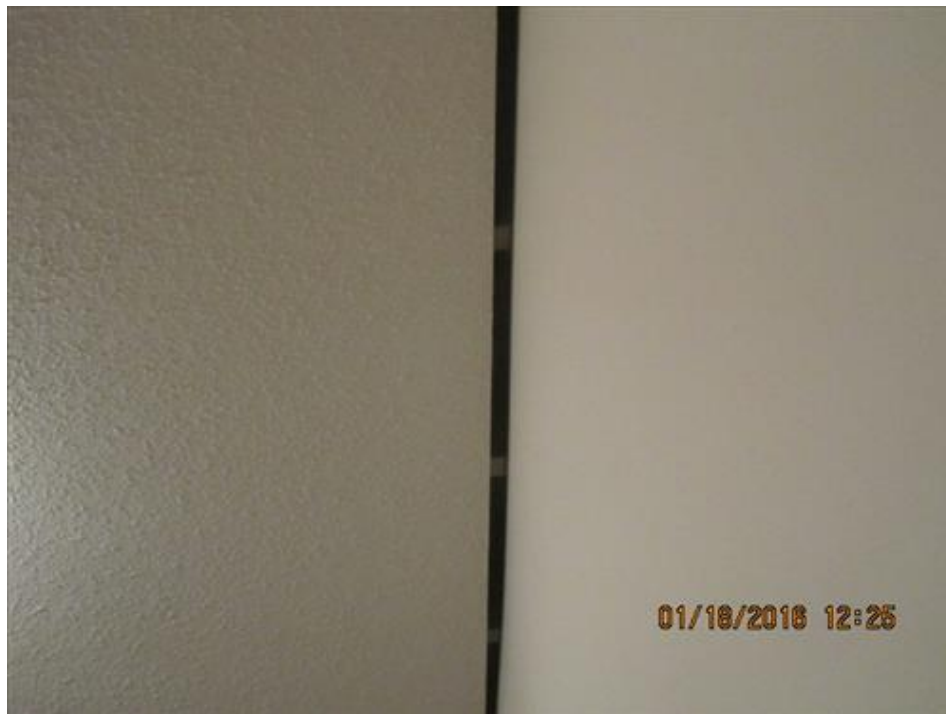
Photograph 104- Perimeter ventilation gap at the intersection of the wall and ceiling on second floor of House #66 (typical)
