# Addendum/Addenda

No./N° 2
-------------

Project Description / Description de projet  S77 laser Labs Chilled Water System Modifications		
Solicitation No./ N° de sollicitation  16-22099	Project No./N° de projet  4060	W.O. No./N° d'ordre de travail
Departmental Representative / représentant ministériel  Allan Smith	Date  2016 Nov 23	
<b>Notice:</b> This addendum shall form part of the tender documents and all conditions shall apply and be read in conjunction with the original plans and specifications.		<b>Nota:</b> Cet addenda fait partie intégrale des dossiers d'appel d'offres; toutes les conditions énoncées doivent être lues et appliquées en conjonction avec les plans et les devis originaux.

**DESIGNATED SUBSTANCES SURVEY  
BUILDING S-77  
OTTAWA, ONTARIO**

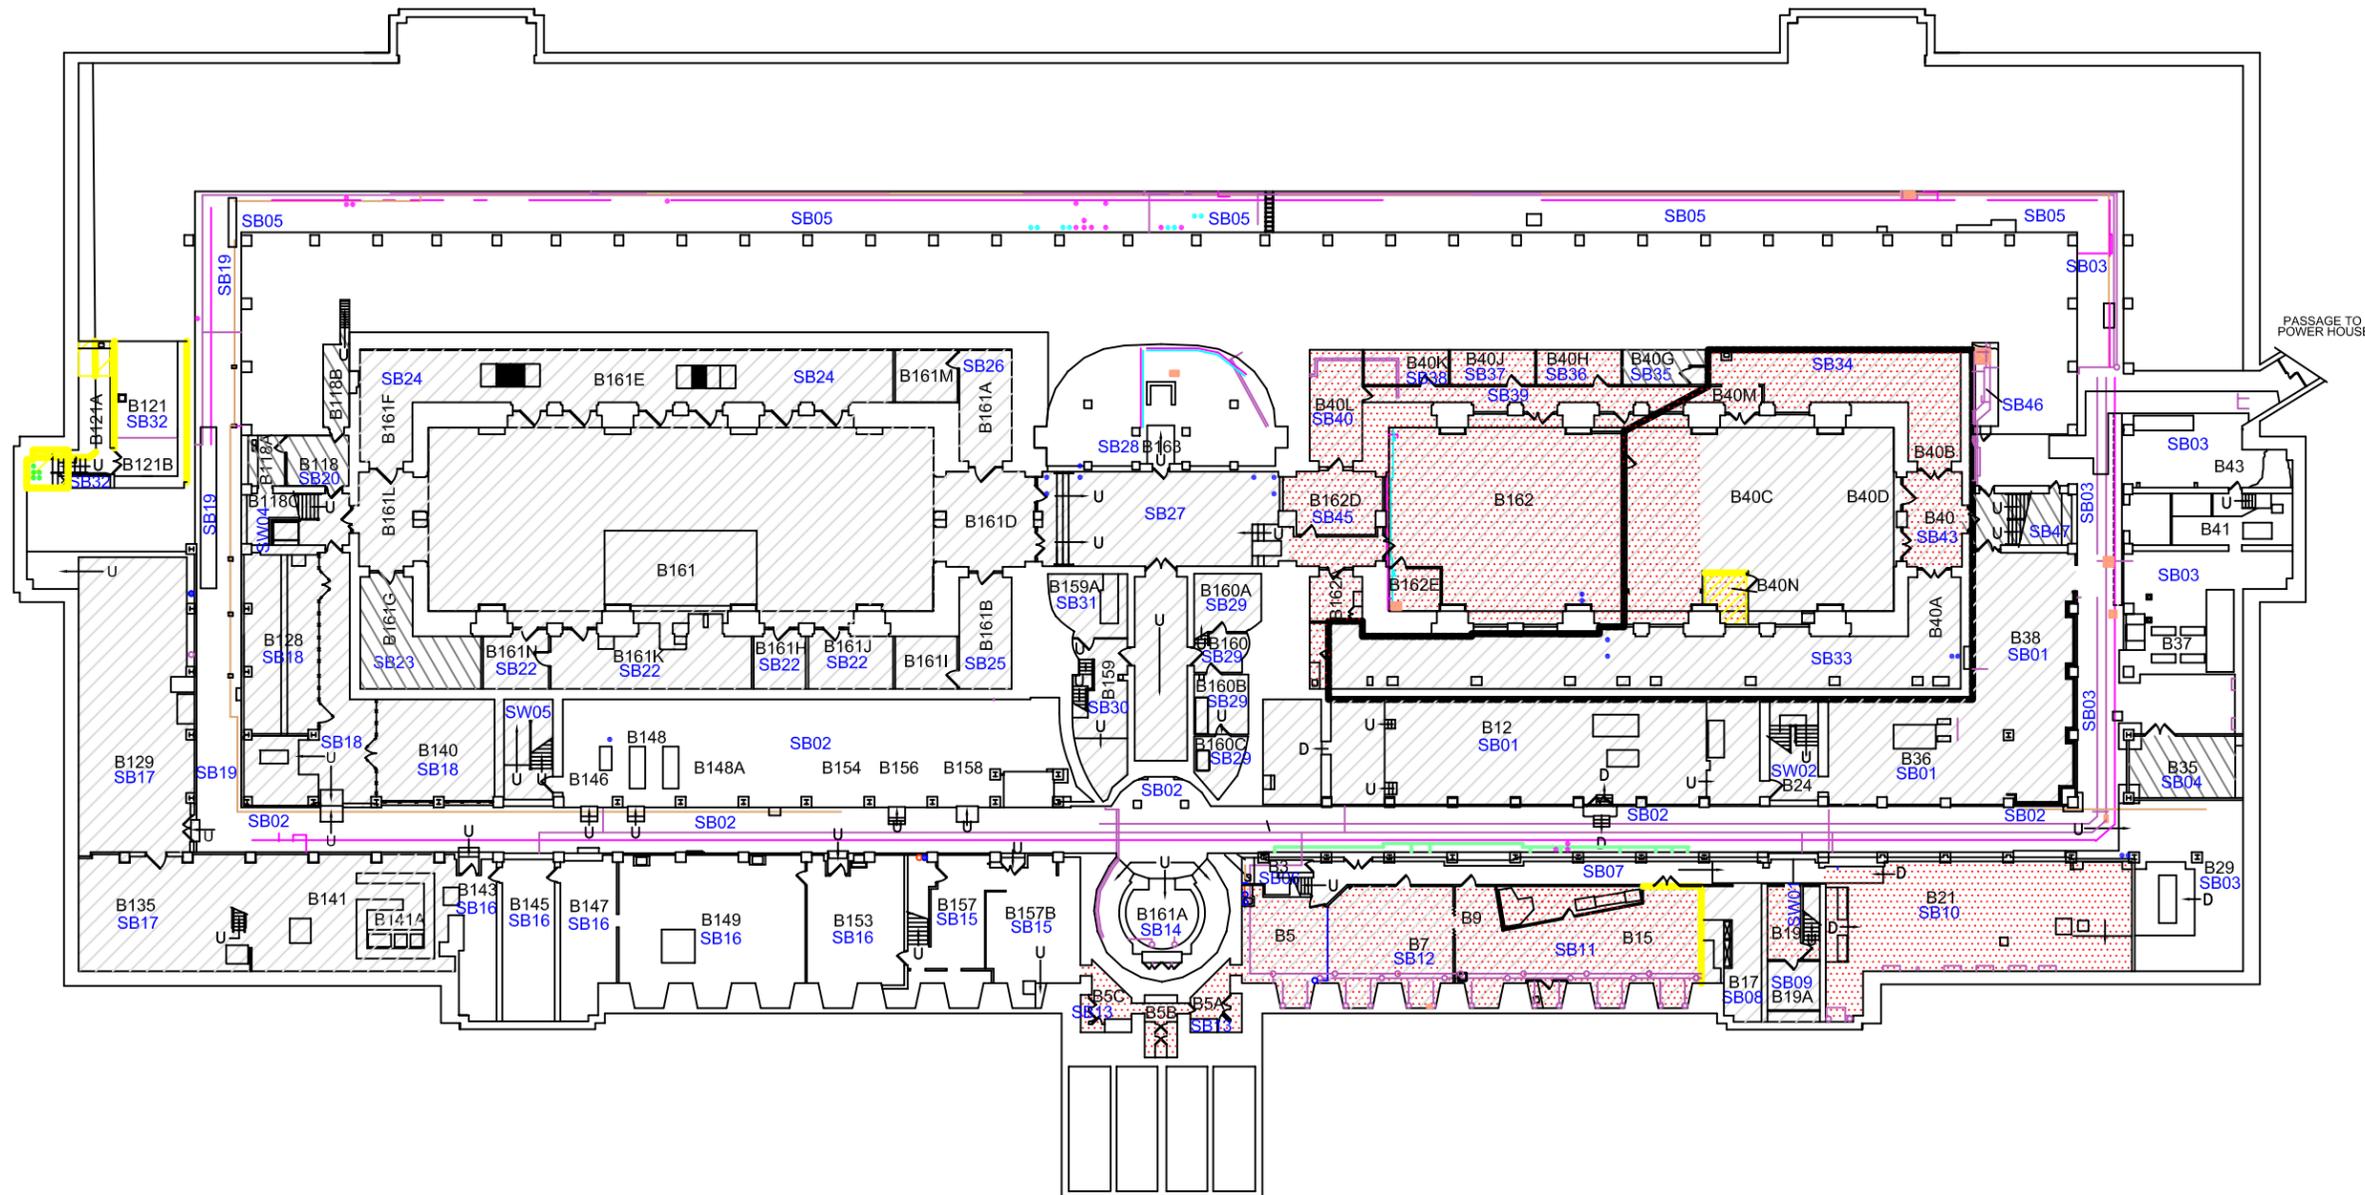
**SB-1**

**SUB-BASEMENT  
ASBESTOS  
LOCATIONS**
