PARKS CANADA
PACIFIC RIM NATIONAL PARK RESERVE
PACIFIC RIM HIGHWAY
“2016 WILDLIFE AND DANGER TREE ASSESSMENT”

Location:	Tofino, British Columbia
Site Coordinates:	Latitude: 49° 4' 21"N, Longitude: 125° 45' 58"W
Site Activities:	Ministry of Transportation Public Highway within the Pacific Rim National Park.
Site Facilities/Targets:	Pacific Rim Highway #4
Level Of Disturbance:	1
Date Assessed:	June 29 – August 12, 2016
Assessor's Names:	Darin Brown, RFT, DTA #P2174, and Dean McGeough, RPF, DTA #P0004

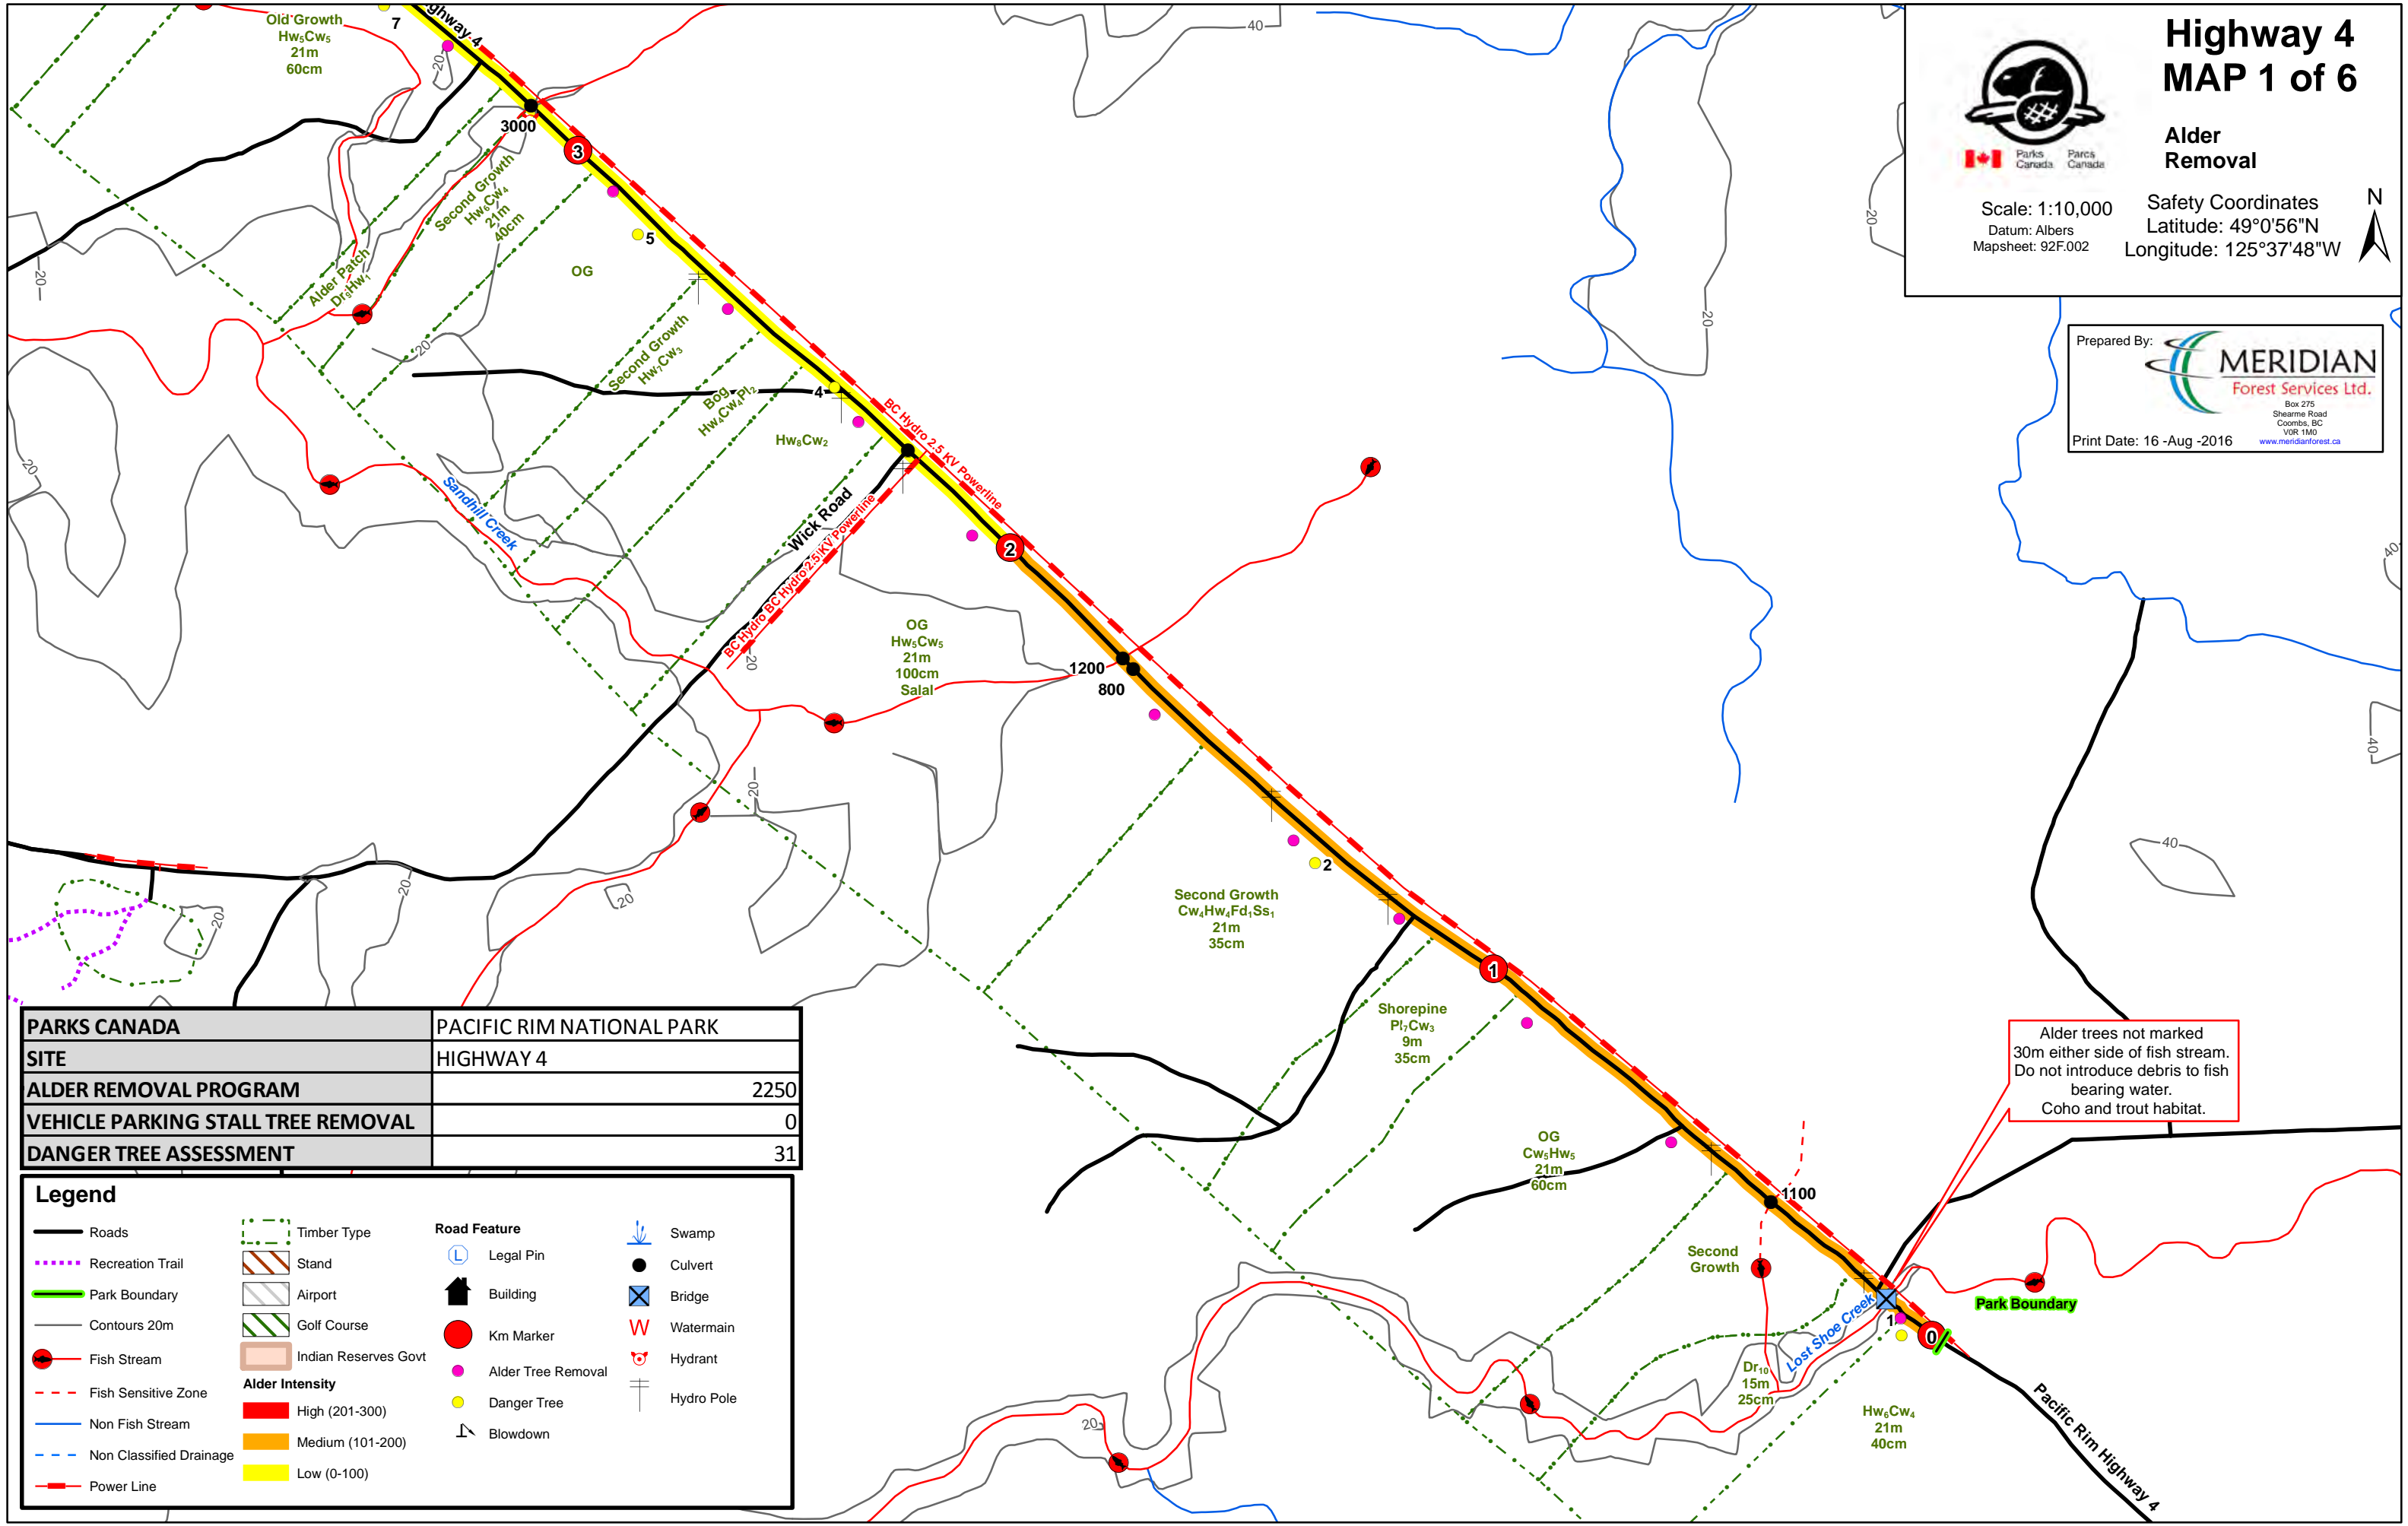
Highway 4 MAP 1 of 6

Alder trees not marked
30m either side of fish stream.
Do not introduce debris to fish
bearing water.
Coho and trout habitat.

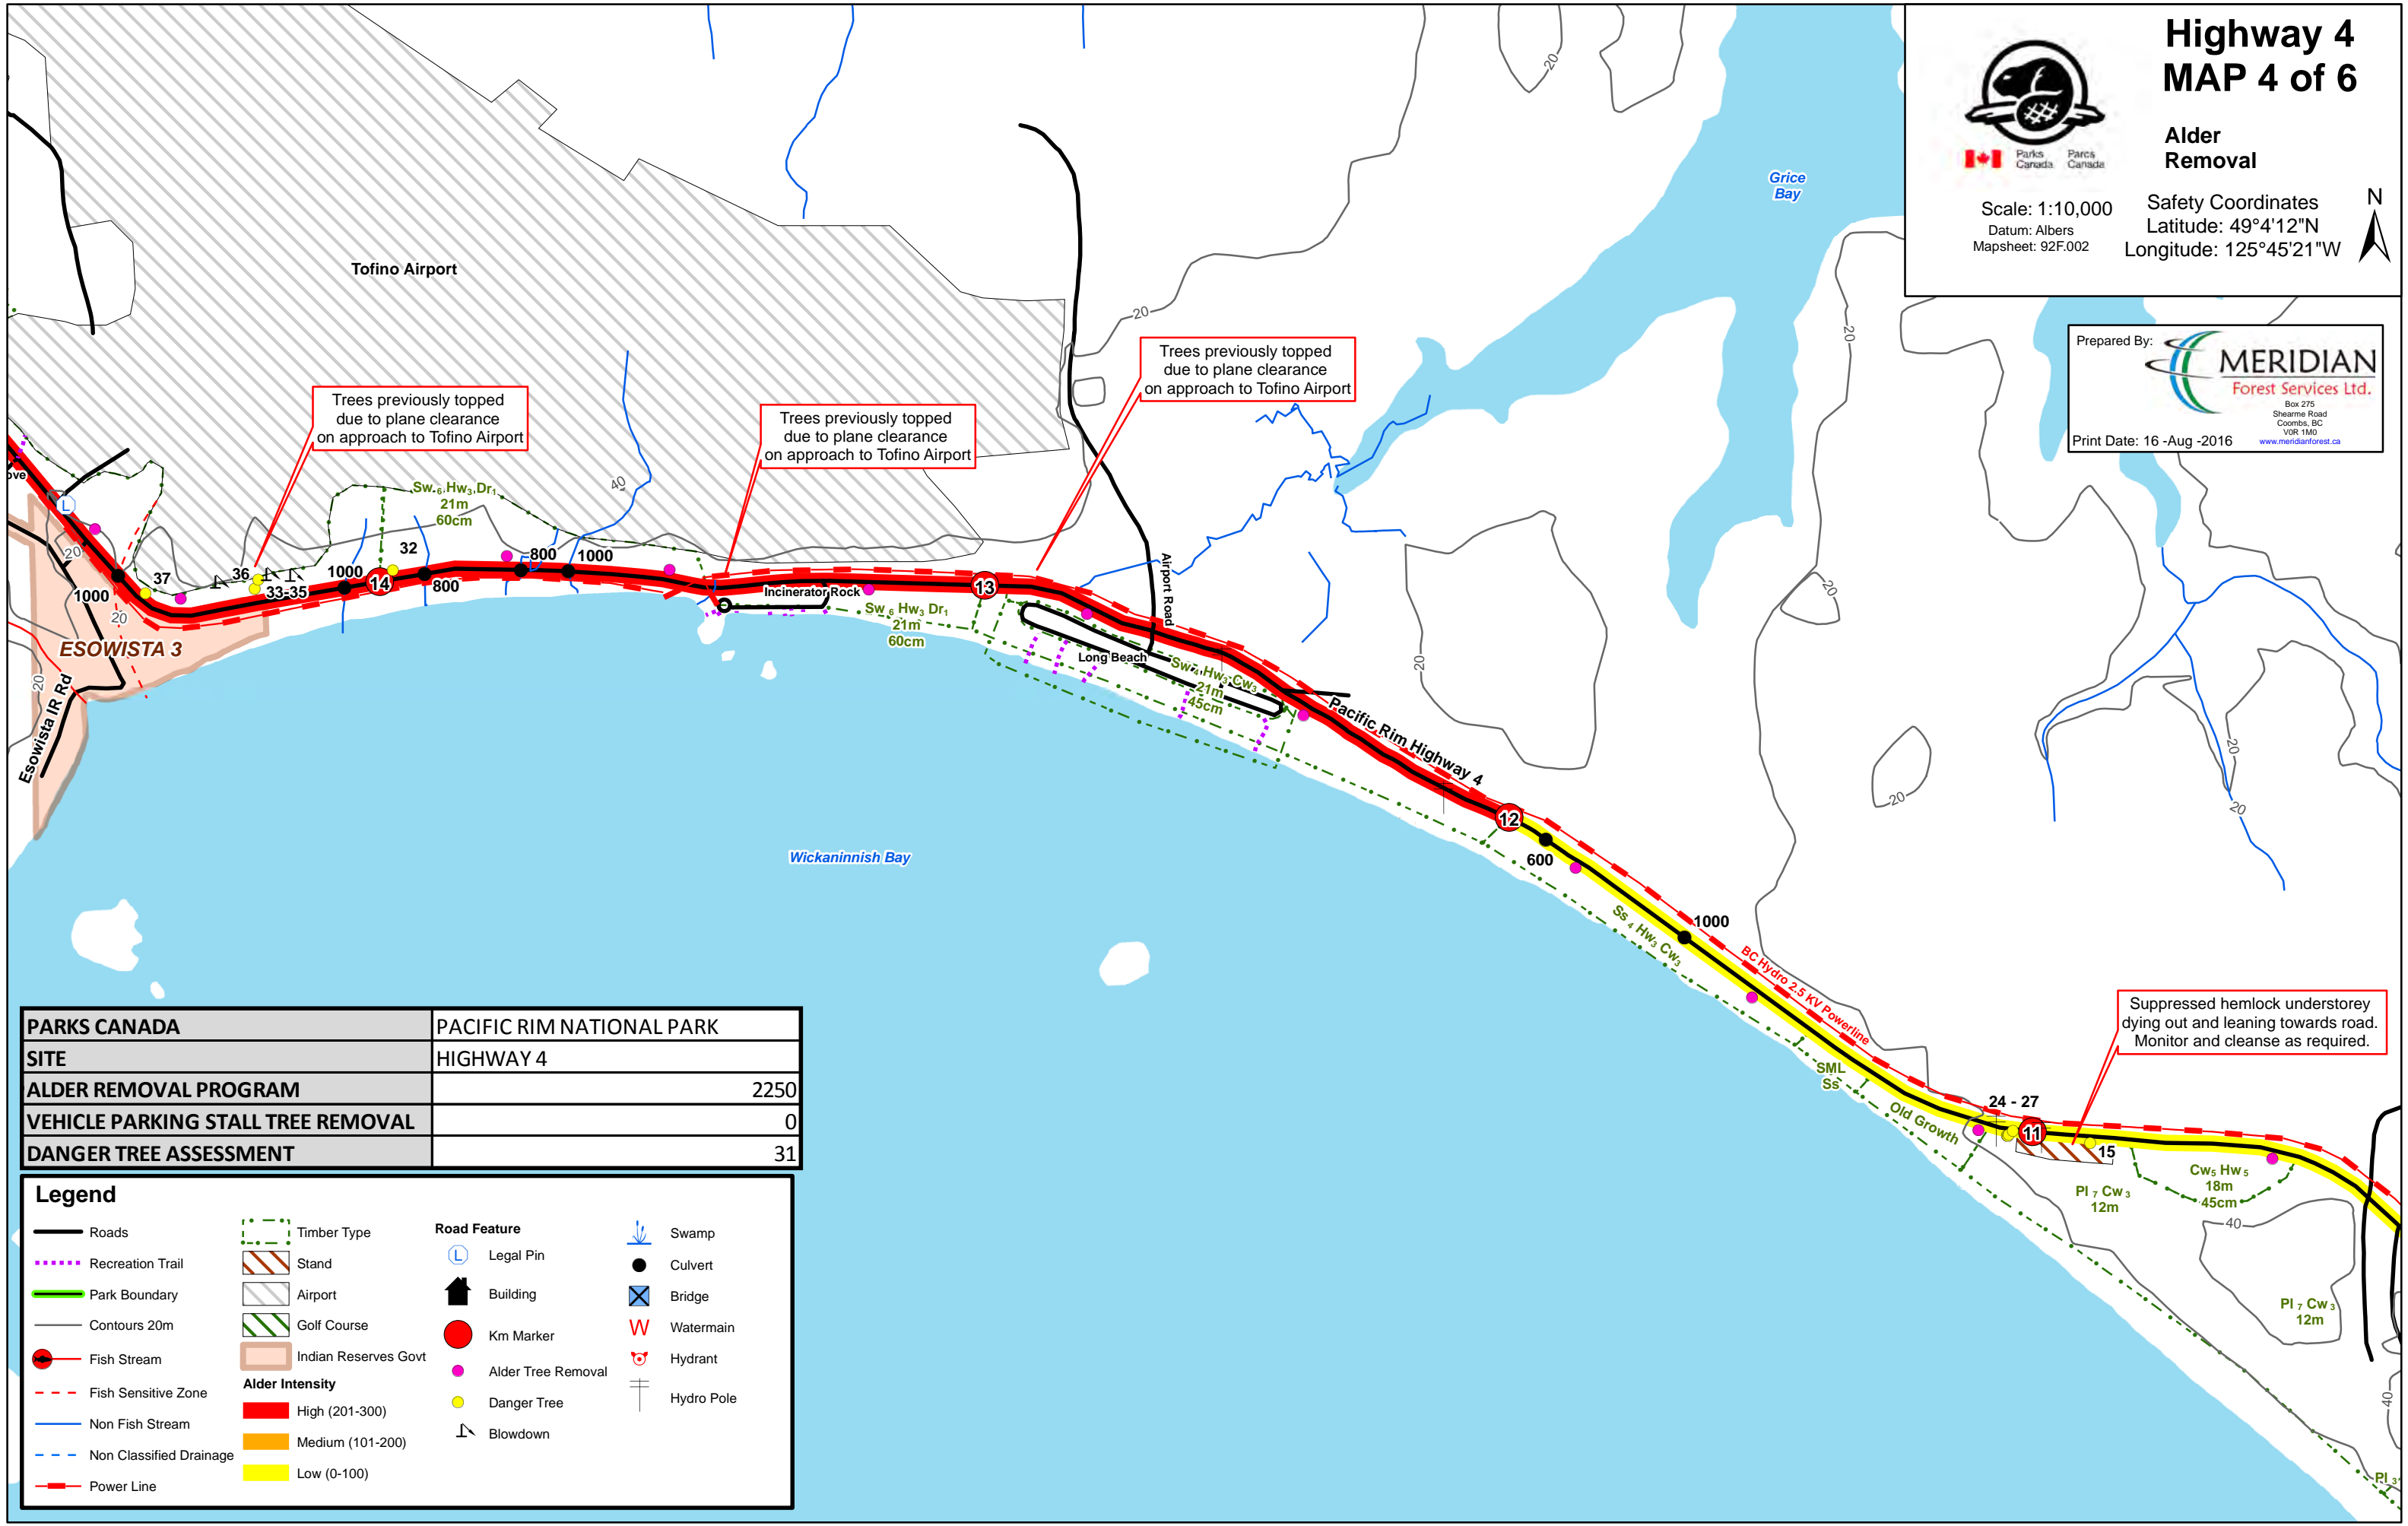
Highway 4 MAP 4 of 6

Suppressed hemlock understorey dying out and leaning towards road. Monitor and cleanse as required.
