**KINGSTON MILLS SWING BRIDGE**

**RIDEAU CANAL**

**GEOTECHNICAL INVESTIGATIONS**

**KINGSTON MILLS SWING BRIDGE**  
**RIDEAU CANAL**  
**KINGSTON, ONTARIO**  
**GEOTECHNICAL INVESTIGATION REPORT**

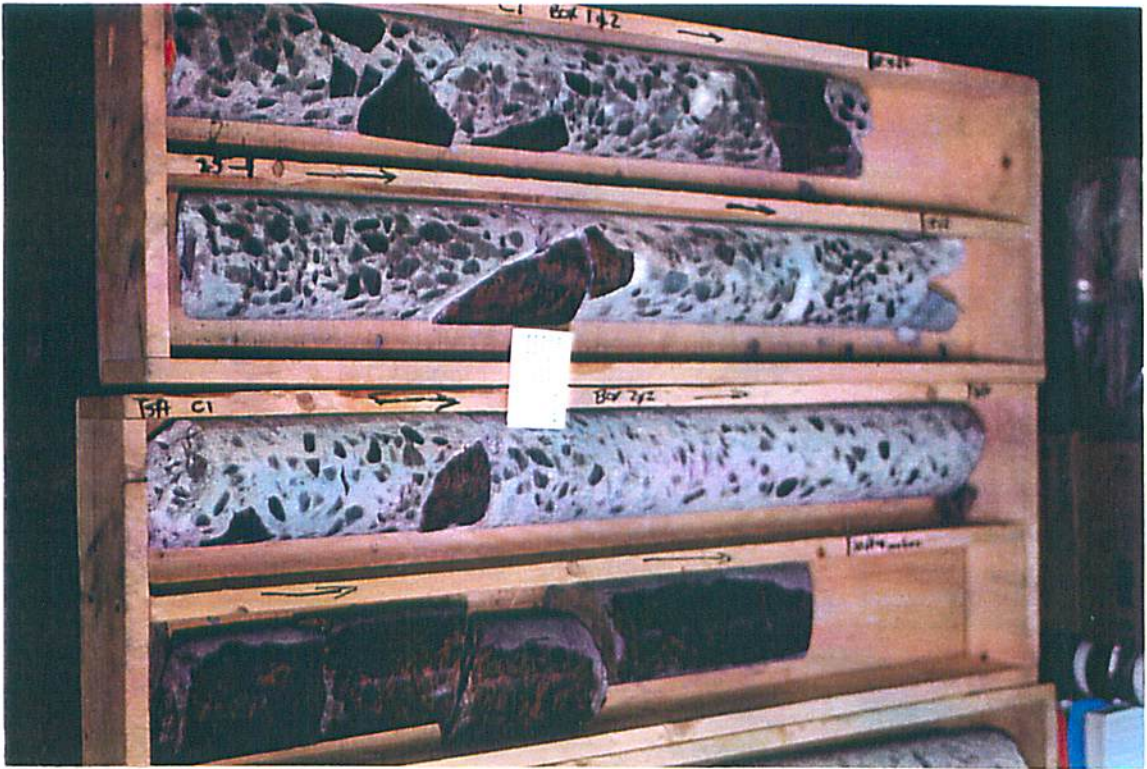
Photo No. 1-  
CORE NUMBER C-1

**Core # C1** was taken in the west abutment (south side). There is a presence of micro-fissures in the cement paste and limestone aggregate and reaction rims are visible. There does not appear to be any bond between syenite blocks (up to 170 mm size) with the cement paste; the syenite blocks may have been thrown into the concrete pour to minimize the quantity of concrete and were not cleaned of dust which might explain the lack of bond.

The abutment is founded on bedrock (syenite) and the interface between concrete and bedrock is tight. The core penetrated 700 mm into bedrock before terminating the hole. The total length of core was 3.05 m.

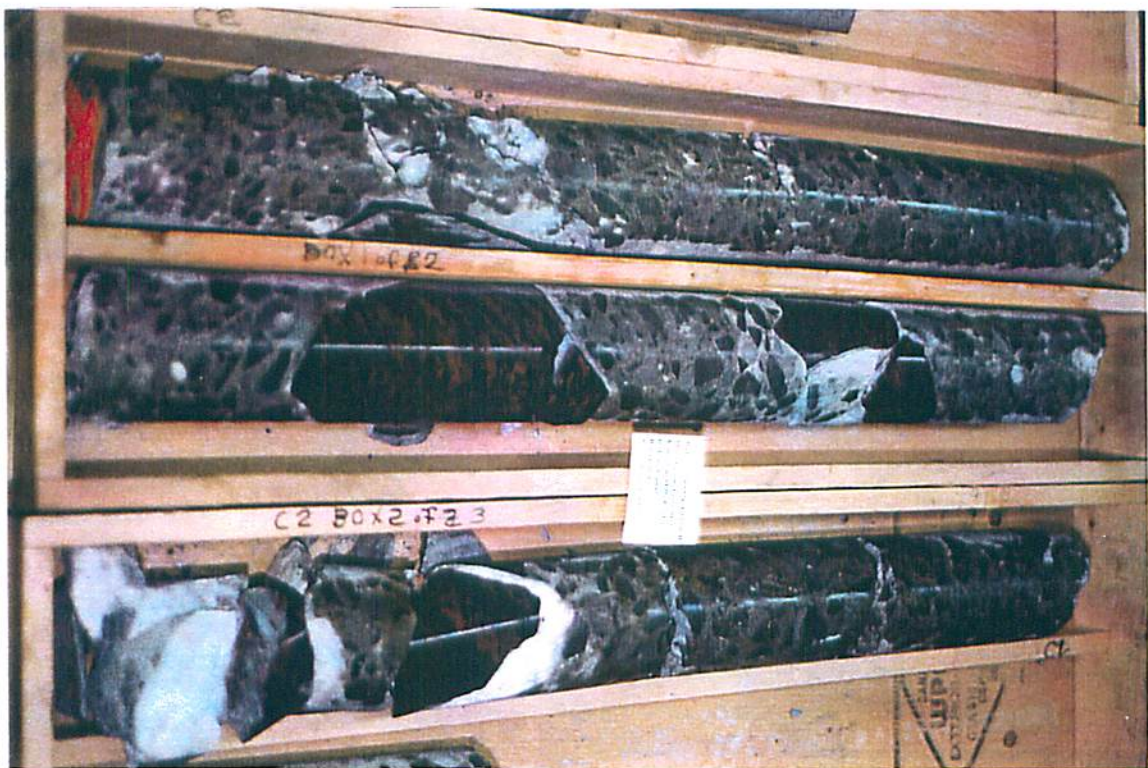
Photo No. 2  
CORE NUMBER C-2

**Core # C2** was taken in the east abutment (north side). The top 300 mm of the core exhibits many open micro-fissures in the cement paste. There are micro-fissures in the cement paste and through limestone aggregate and reaction rims are visible in the upper 1,800 mm. Honeycombing is present in the bottom portion of the core. Syenite blocks 100 to 300 mm were found throughout the length of core without any bond with the cement paste. Due to the proximity of the lock wall, it was discovered that the abutment was founded on rockfill (backfill for the lock wall) and not on bedrock and for this reason the coring was discontinued. The length of core was 3.75 m.

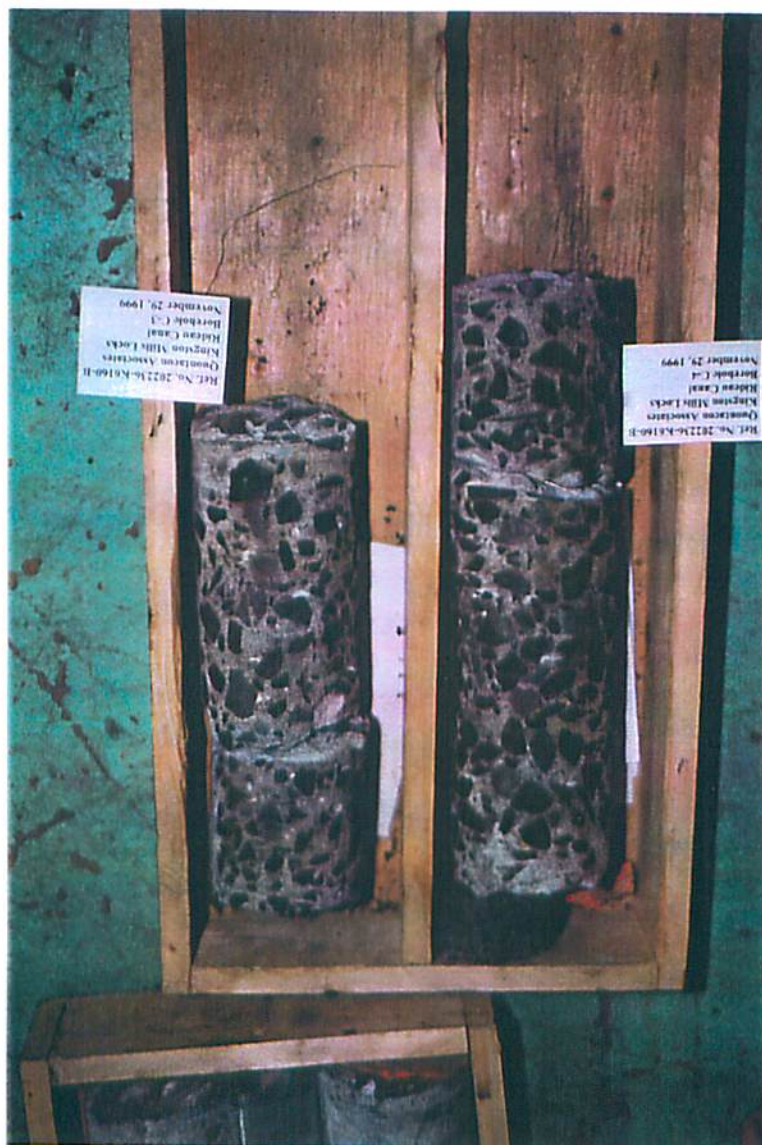
Photo No. 3  
CONCRETE CORE C3 AND C4

**Cores # C3 and C4** were taken in the counterweight. There was about 50 mm of asphalt overlying concrete. No waterproofing membrane was found. There are no micro-fissures or reaction rims visible in the core. The lengths of cores C3 and C4 were 300 and 400 mm respectively.

Low strength concrete (fill-type) of the counterweight appears to be in good condition. However, there is no bond between the asphalt and concrete and no waterproofing membrane was present.

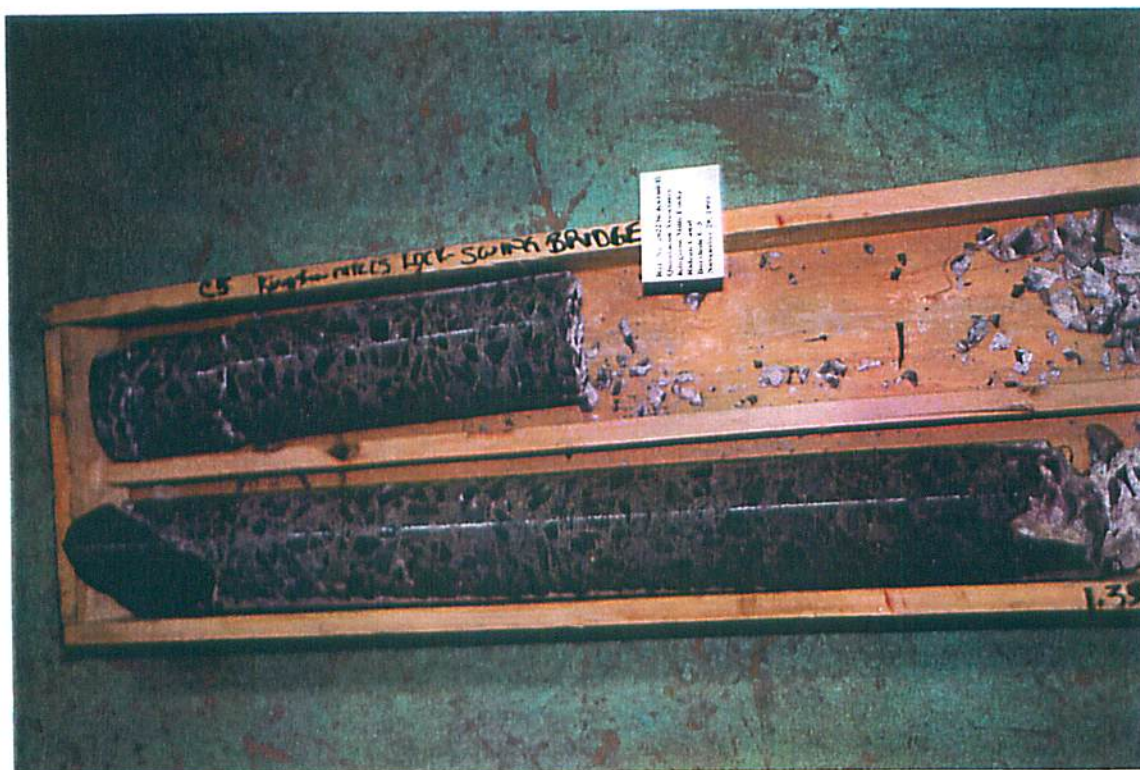
Photo No. 4  
CORE NUMBER C-5

**Core # C5** was taken in the pivot pier (north side). The coring was done on an incline, similar to that on the south side. The top 50-75 mm was totally disintegrated concrete. Open micro-fissures in the cement paste and coarse aggregate in the top 300 mm and closed micro-fissures to a depth of 1,300 mm were found. There were syenite cobbles also present. It was surprising to discover that the pivot pier is founded on a layer of medium to stiff clay with traces of gravel overlying bed rock. A split-spoon sampler was penetrated through clay to refusal in bedrock. Rock core could not be obtained due to presence of clay layer. The total length of core was 1.98 m.

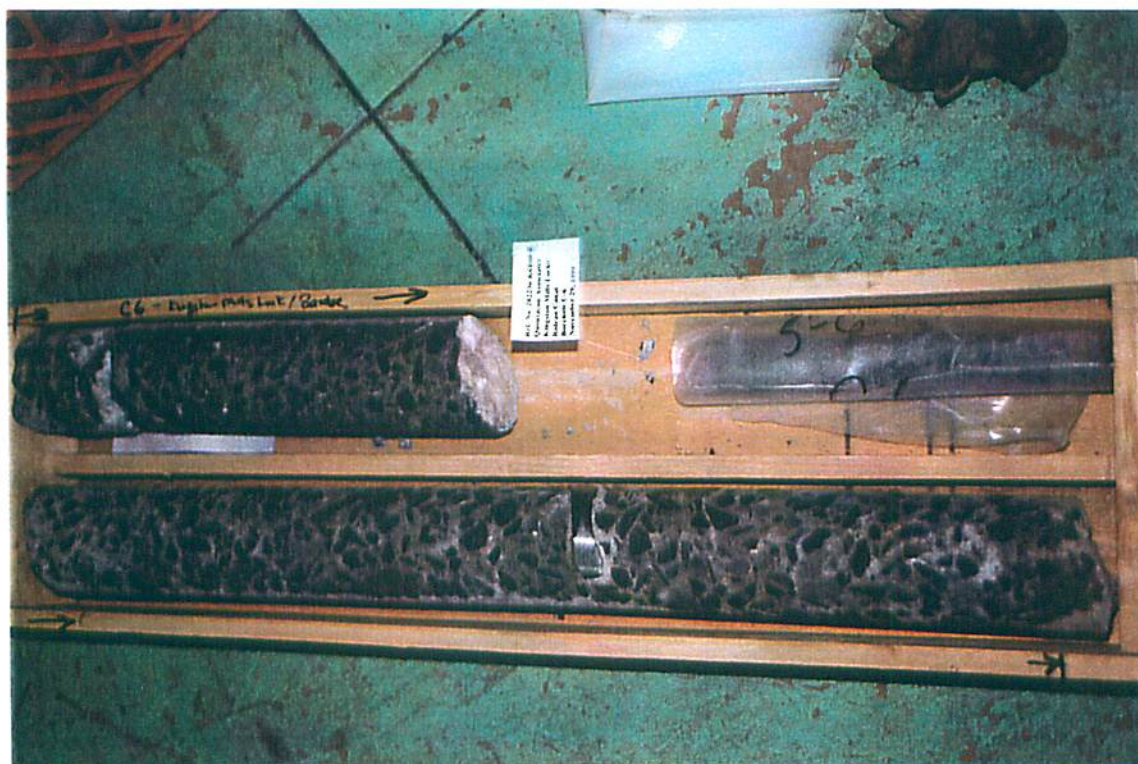
Photo No. 5  
CORE NUMBER C-6

**Core # C6** was taken in the pivot pier (south side) at an incline to the vertical (1 in 5). The top 50-75 mm of concrete was found to be unsound (disintegrated), the remaining core appeared to be good except the presence of open and closed micro-fissures in the paste and coarse aggregate. Some reaction rims also visible. Like on the north side, the pivot pier was founded on a 300 mm layer of stiff to medium clay with traces of gravel over the bedrock. A split-spoon sampler was used to penetrate the clay until refusal in bedrock. It was not possible to obtain a rock core. The total length of core was 1.61 m.
