DESIGN BRIEF

Client: Park or FU:	Rideau Canal NHS	Client Project No.:	
Project Title:	Kingston Mills Lock 46		
Client - Responsible Officer:	Bill Pratt, P. Eng. Asset Manager	Tel.:	(613) 283-7199 ext 250
CST for Parks Canada Manager:	John Mazhar, P. Eng., Program Manager	Tel.:	(613) 938-5976
CST ONTARIO Project No. :	453177

**KMILLS LOCK #46
DESIGN BRIEF**

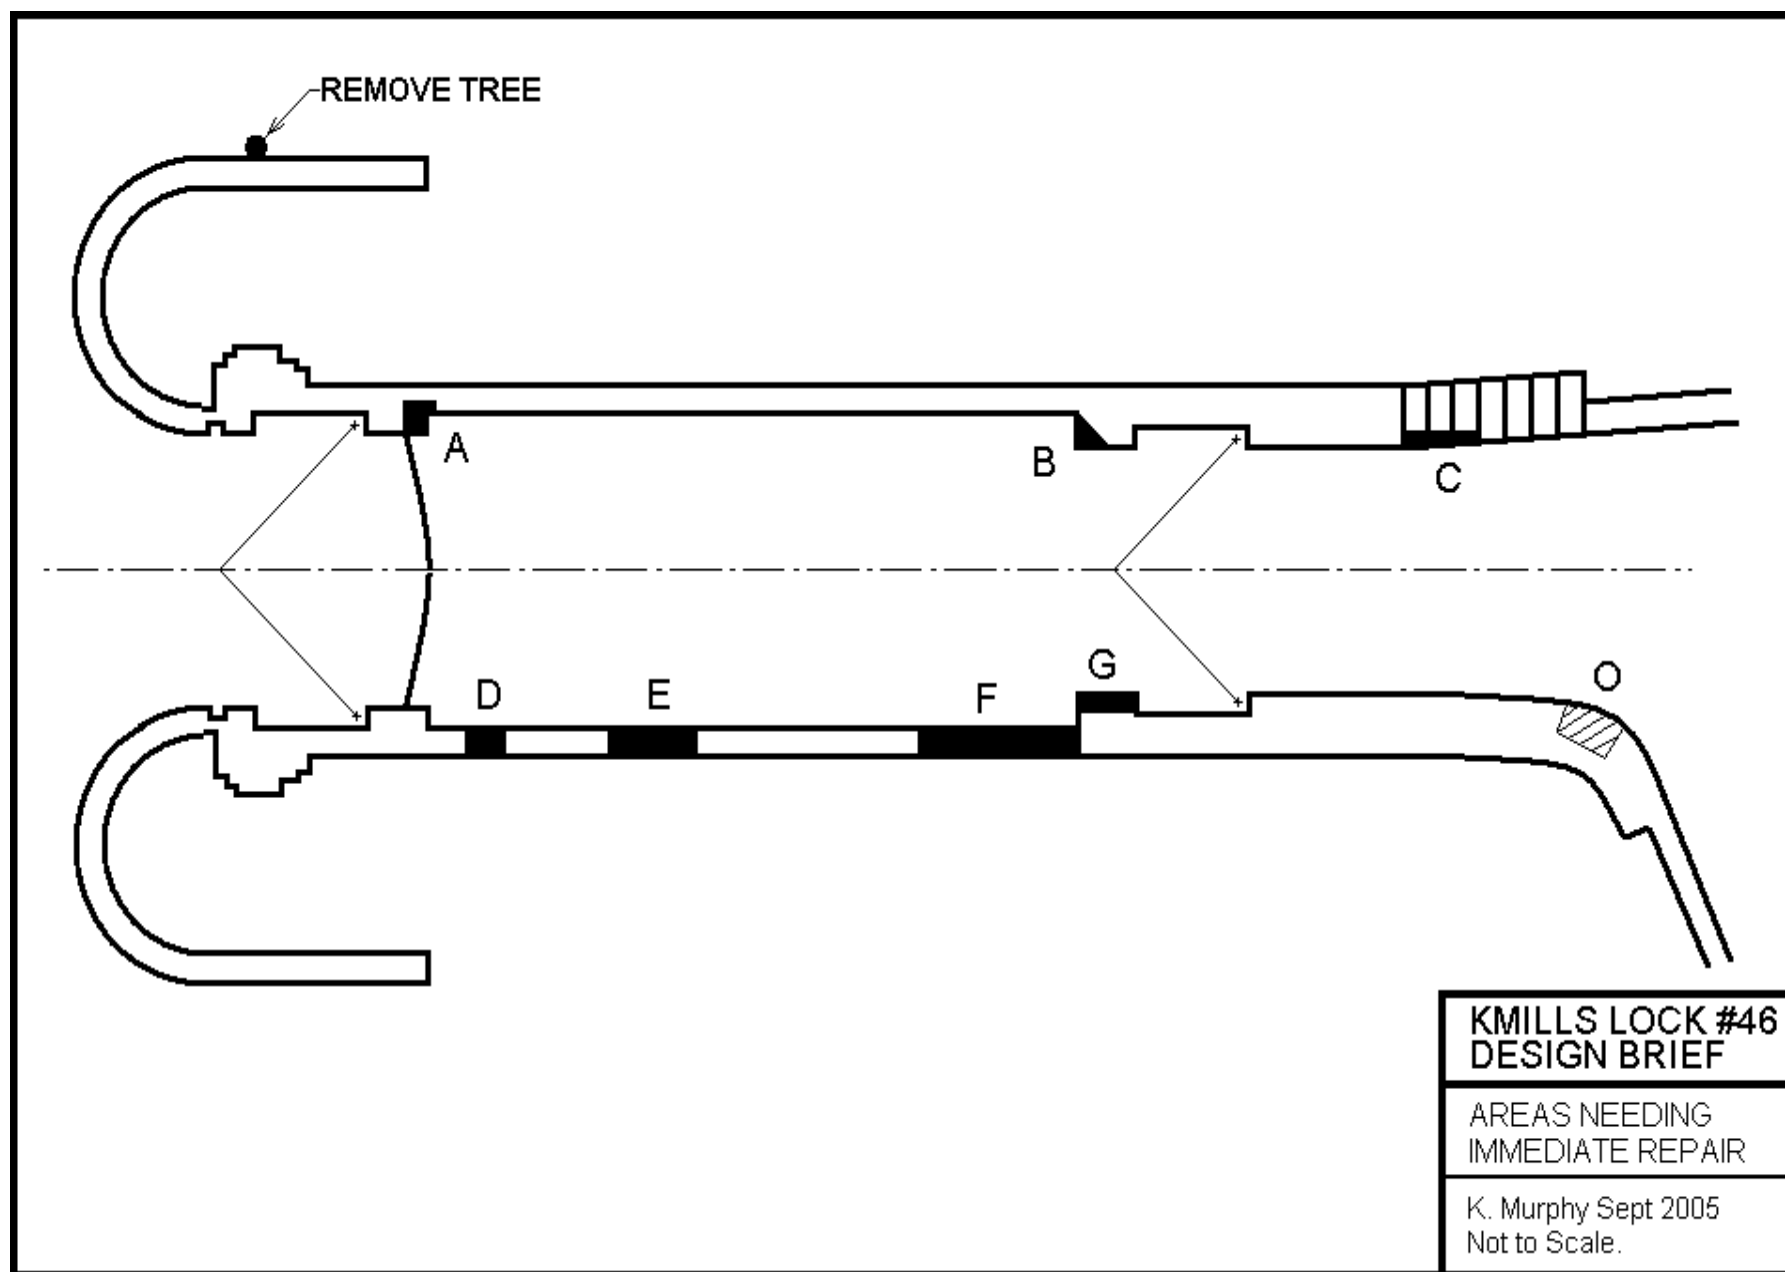
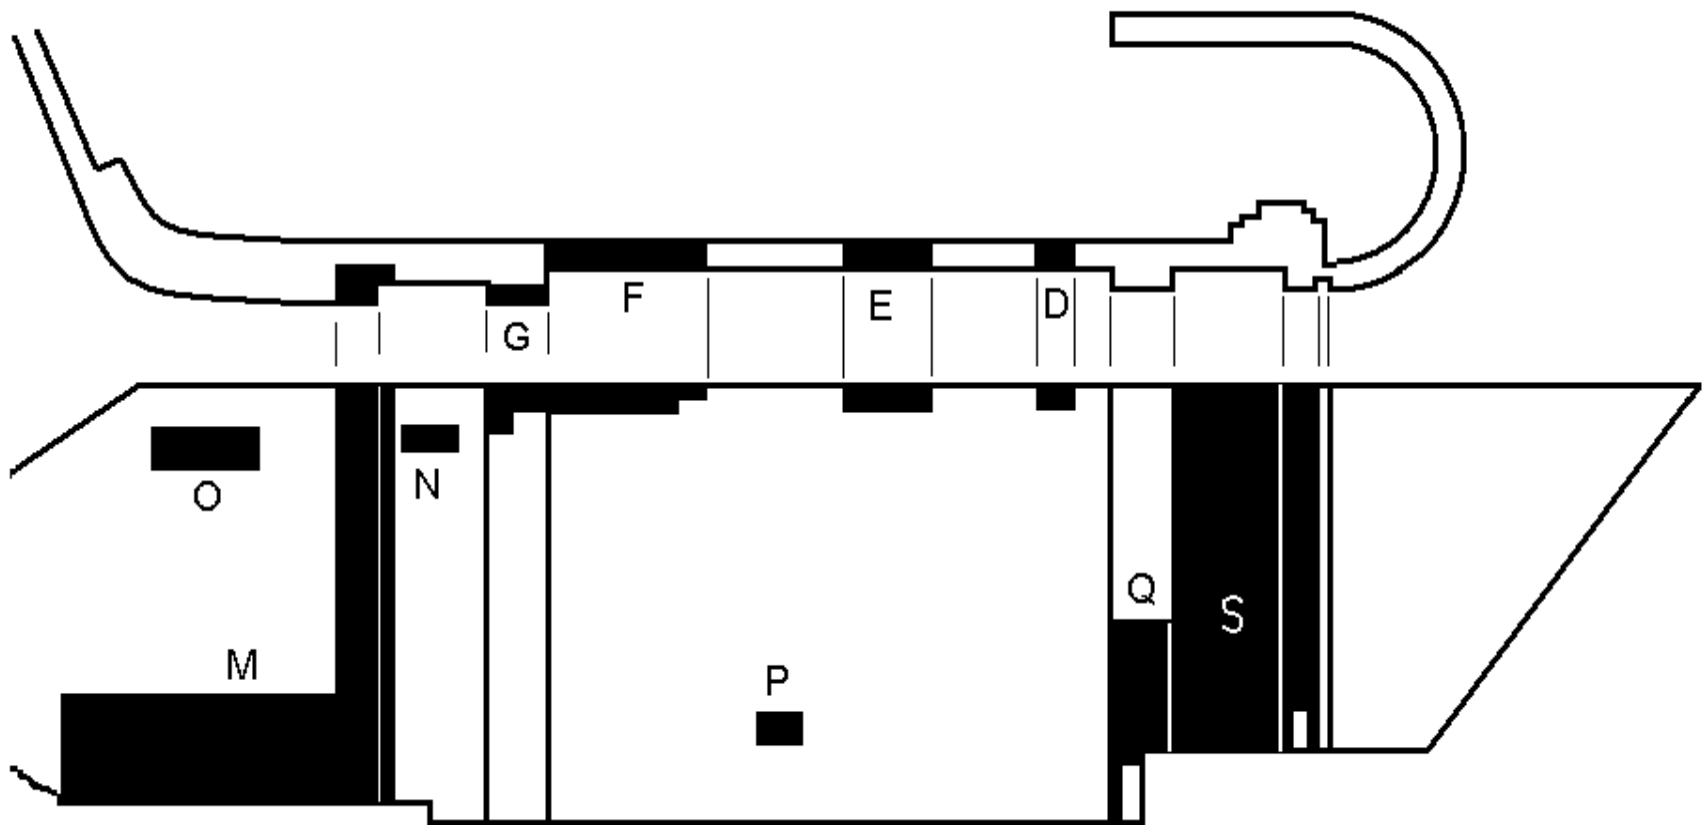
OPTION 1 - STABILIZATION
Spalling Areas on L Wall

Some work should be done immediately at areas of coping or high on the wall where there is a danger of spalling concrete chunks falling on boaters below. This work should be done as soon as possible. The cost estimate below assumes the work is done by outside forces: some cost savings would occur if the repair was being done in-house.

Another alternative would be **Option 1 (Stabilization)**. This option involves removing only the friable surface layer of failed concrete (about a foot to 18" deep), but not the underlying AAR affected concrete. It would produce the same aesthetic result as Option 2 involving large areas of concrete visible at the monoliths and lower wing walls. It will not give as long lasting a result as Option 2 since the underlying concrete will continue to deteriorate and reflection cracks / debonding of the overlay material will occur in a decade or so. It could, if desired, be done to prolong the life of the structure for another 10 to 15 years whilst awaiting funding for Option 3.

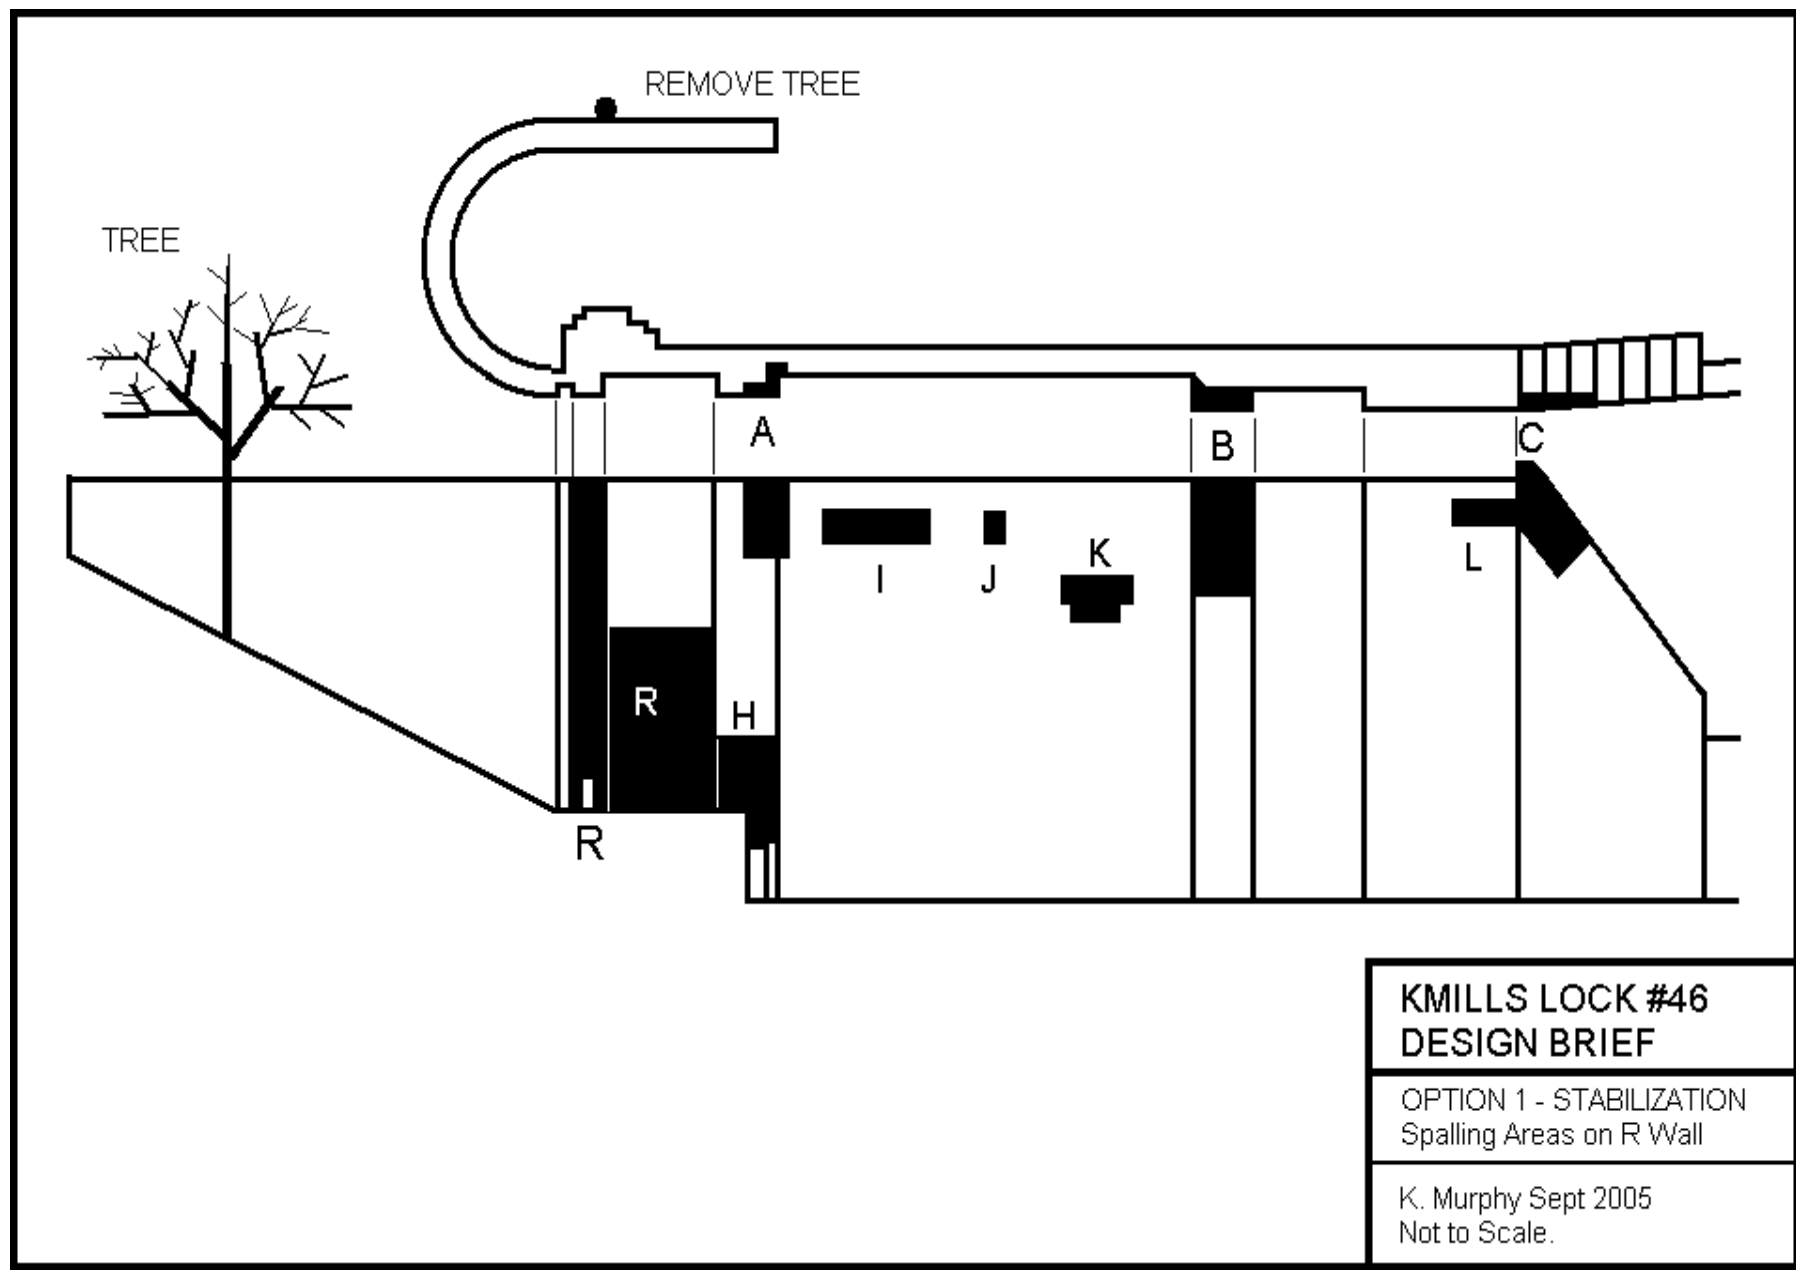
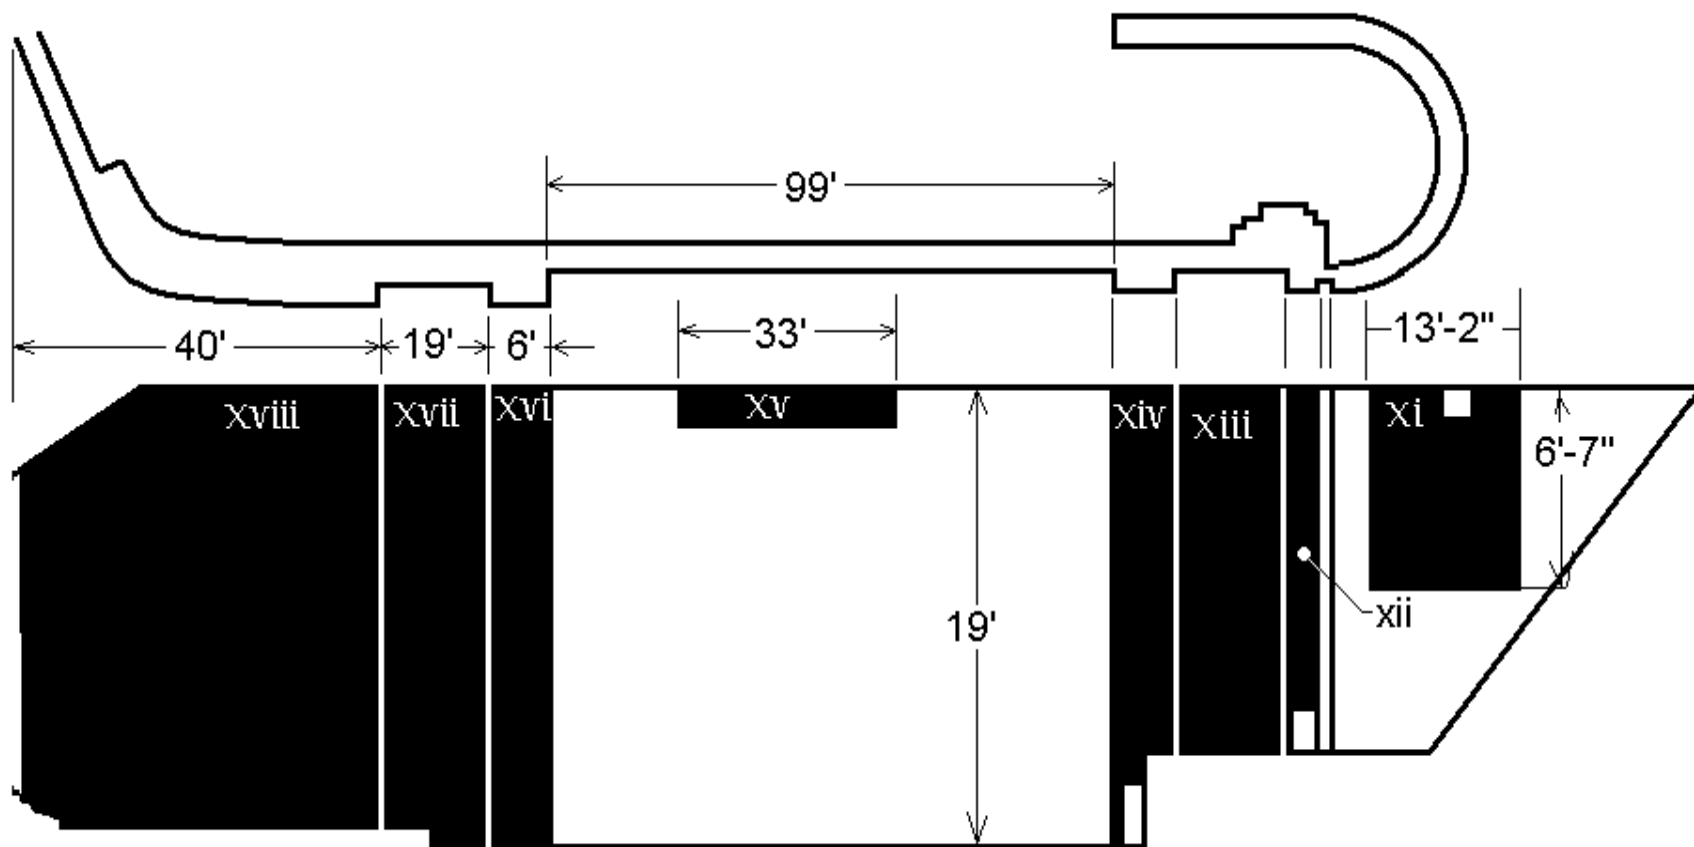
OPTIONS 2 & 3
 Map of Concrete vs. Stone
 Left Wall

At some point between the original construction and about mid-20th century, repairs to the upper and lower monoliths and wing walls were done with plain (un-reinforced) concrete blocks laid to imitate masonry. Most of the boreholes Jacques Whitford did were into this material, which is spalling badly in the outer 4" to 18" due to freeze-thaw action. Furthermore, I had two petrographic analyses done to investigate the composition of this concrete and its alkali-aggregate reactivity condition.

The investigation also determined that there is indeed some alkali-silicate reactivity going on in this concrete, with the Potsdam sandstone in the aggregate being the most likely culprit. In fact, significant damage has already occurred to this concrete as its mean Damage Rating Index (DSI) is 124---and DSI's of greater than 40 are considered indicative of significant alkali-silicate reactivity. Further, the petrographer estimated that an expansion of 0.23% has already occurred

Ideally, **Option 3 (Full Restoration in Masonry)** would be selected. This would mean the lock would be repaired with materials and techniques most compatible with the original fabric. This is the most sympathetic to the original construction and most aesthetically pleasing. Such a repair acknowledges the locks as originally being masonry structures and maximizes the “Principle of Respect” (CRM §1.4). It would, however, involve the loss of the old concrete blocks---the CRM “Principle of Value” (§1.1) does not normally allow the sacrificing of later materials. But in this case where over 50% of the material has already failed by freeze-thaw action and the other 50% is subject to AAR, this material is already lost. This repair also assumes that 25% of the extant masonry will require adhesive crack repairs and a total of 10 cu. metres of stone will be found to be too fractured and will have to be replaced with new. Option 3 represents a fairly high level of intervention, but it is a sympathetic repair that will address most of the on-going deterioration and which will give a long-lasting result. It is, however, the most expensive option.

Alternatively, **Option 2 (Functional Rehabilitation in Concrete)** could be selected. This would involve removing failed concrete and stone material with new concrete. This would involve removing both the friable surface layer and the AAR-affected concrete. Extant stone in good condition would be retained, raked and pointed. Again, the cost estimate assumes that 25% of the extant masonry will require adhesive crack repairs and a total of 10 cu. metres of stone will be found to be too fractured and will have to be replaced with new. The use of large amounts of modern reinforced concrete means the repair that is not as sympathetic to Colonel By’s original construction as that of restoration in masonry. Like Option 3, Option 2 represents a fairly high level of intervention. Since the AAR-affected concrete is removed, this option will also give long-lasting results, but not as long-lasting as Option 3 since concrete is not as durable as stone. It is considerably less expensive than Option 3.
