**SUMMARY REPORT FOR KINGSTON MILLS  
LOCKS 46, 47, 48 & 49  
REHABILITATION PROJECT  
KINGSTON, ONTARIO**

**Prepared for:  
Public Works and Government Services Canada**

**ECO Grouting Specialists Limited**

**Date: December 20, 1995**

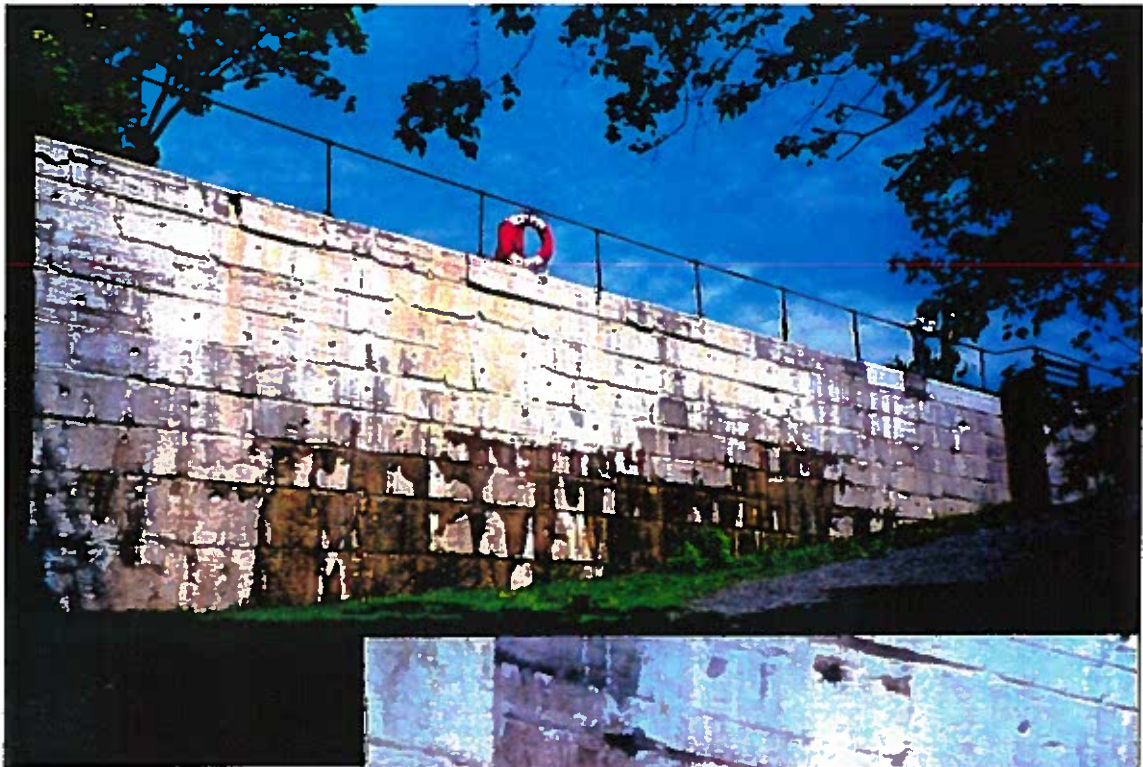
P1 : (Above) Exterior face of the free standing wall (East wall of Lock No. 47.

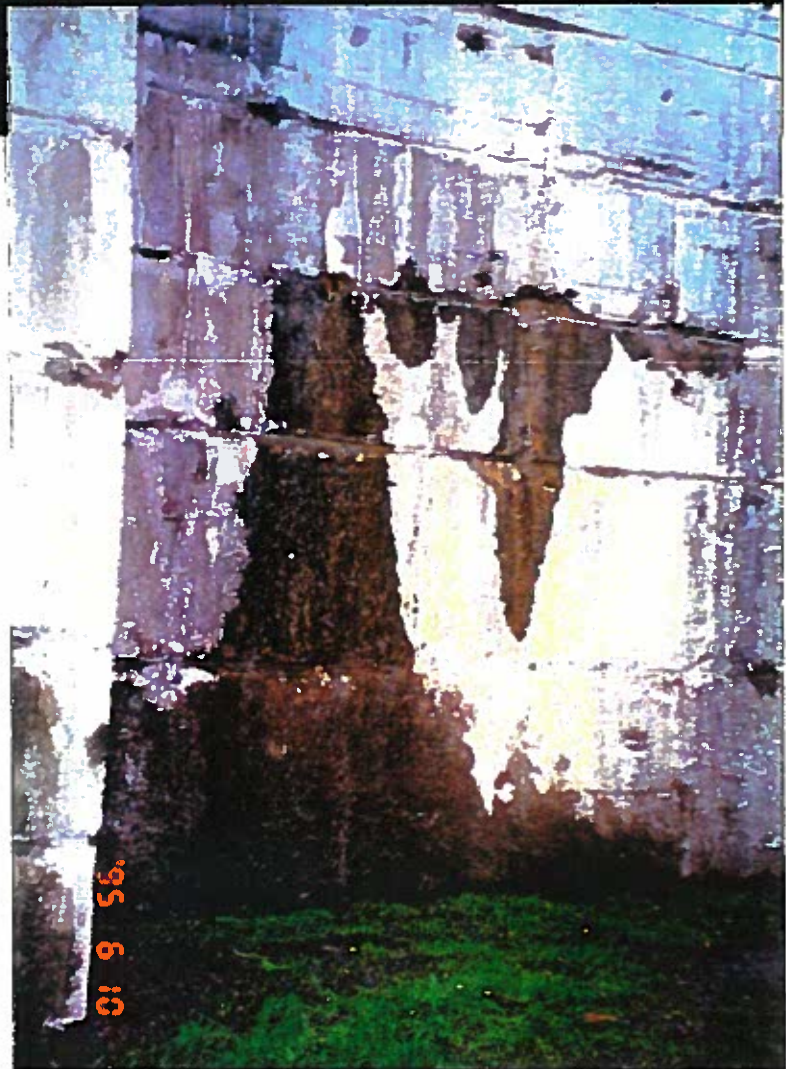
P2 : (Below) View of exterior face of East wall of Lock No. 47. Close-up of downstream section of wall, adjacent to Monolith No. 6.

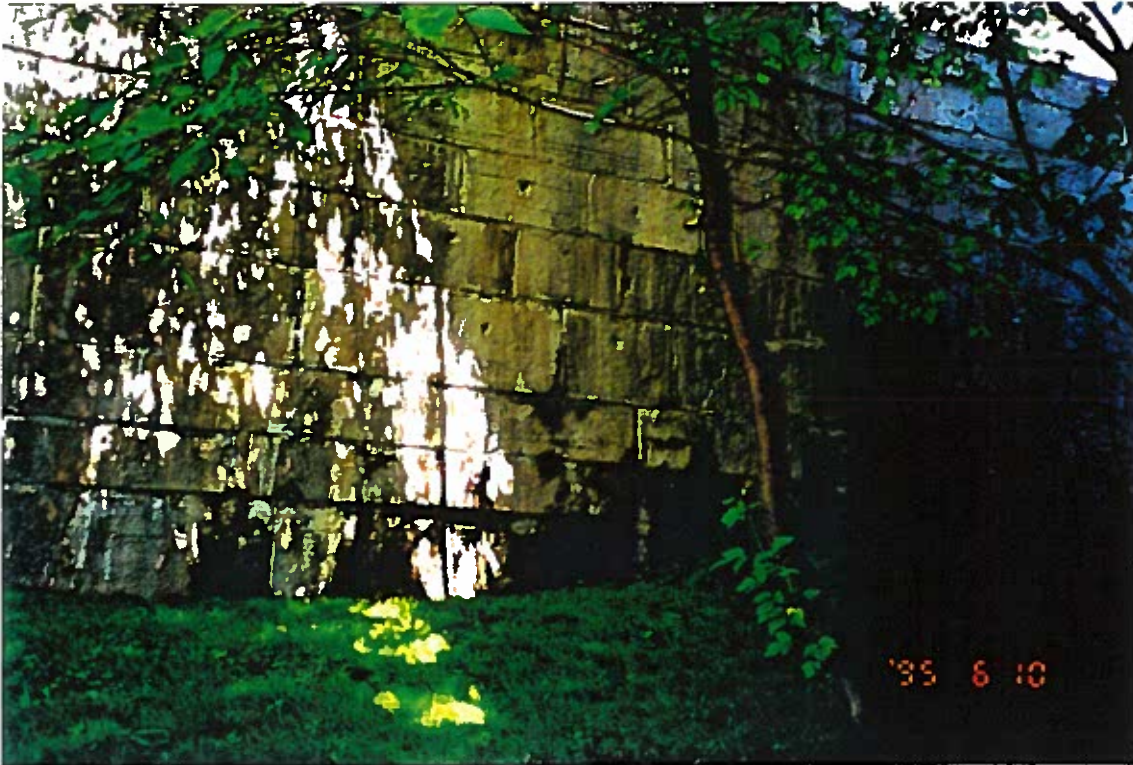
P3 : (Above) View of exterior side of Monolith No. 6 (free standing monolith structure)

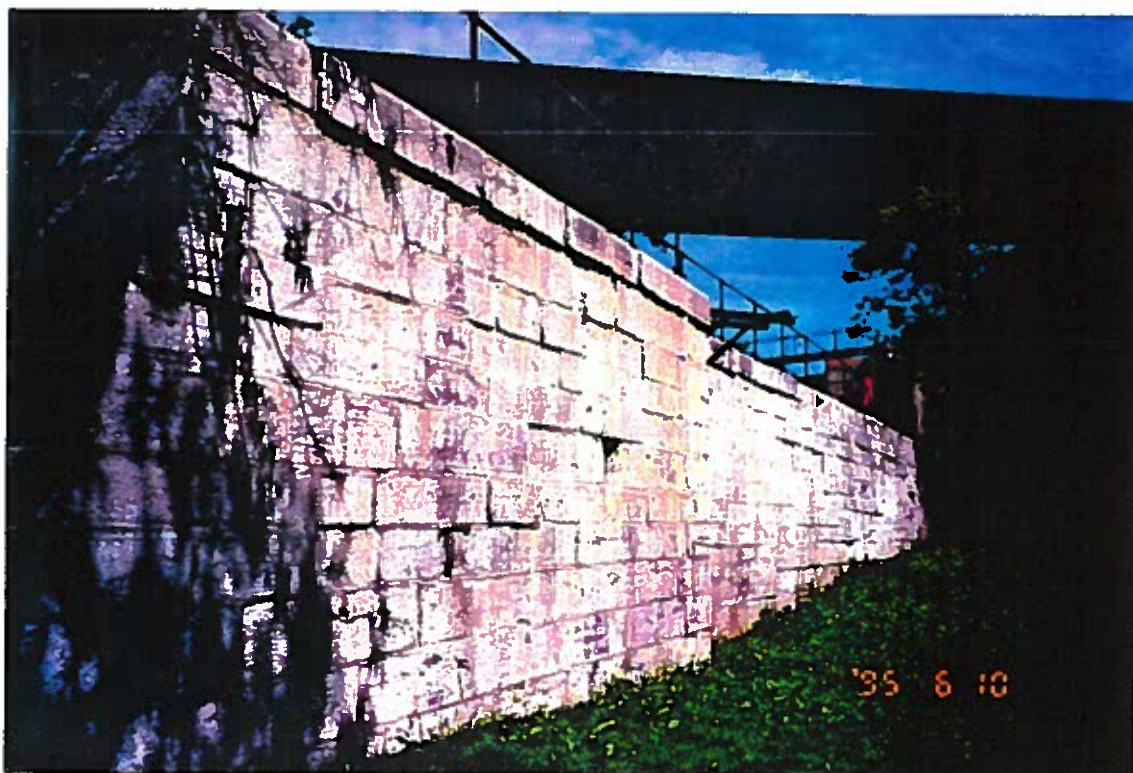
P4 : (Below) View of exterior side of Lock No. 48 east chamber wall (free standing structure)

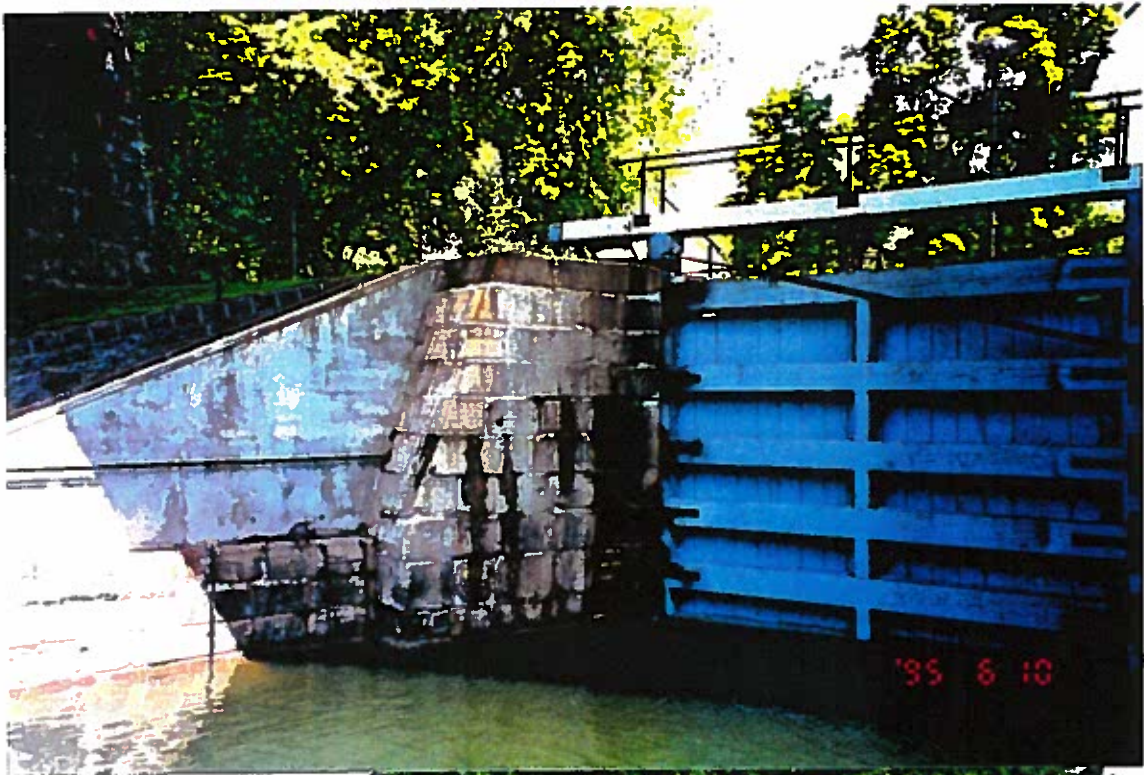
P5: (Above) View of Monolith No.5

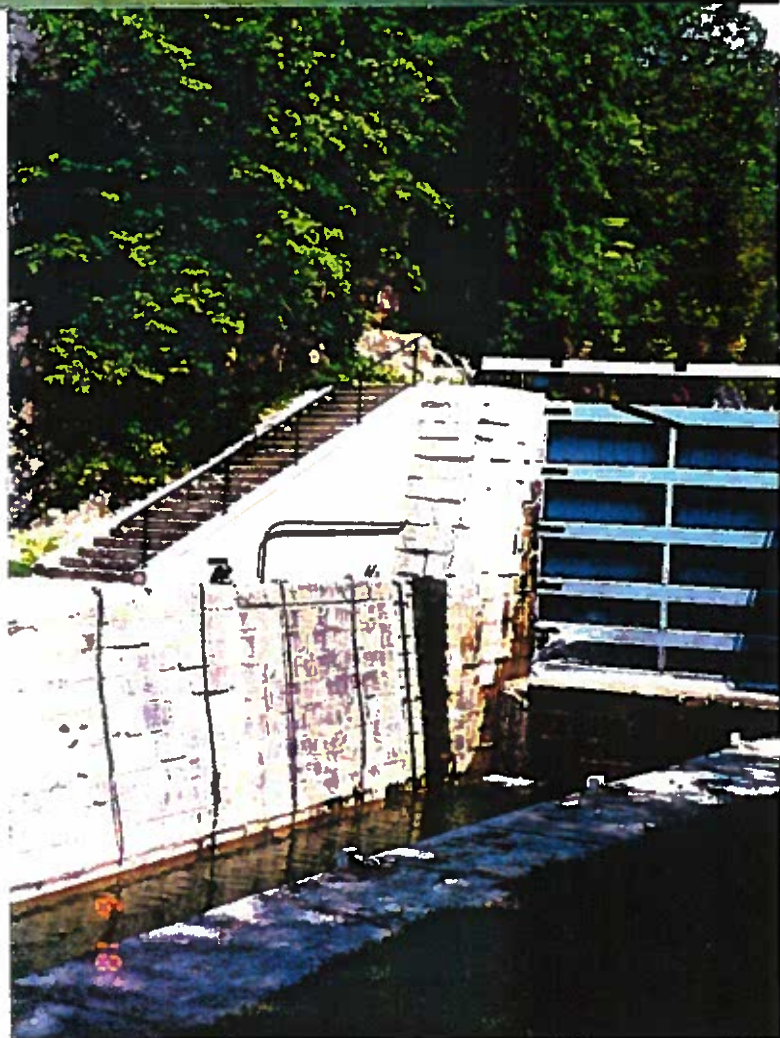
P6: (Below) View of Monolith No.3 and upstream portion of East Chamber wall of Lock No. 49.

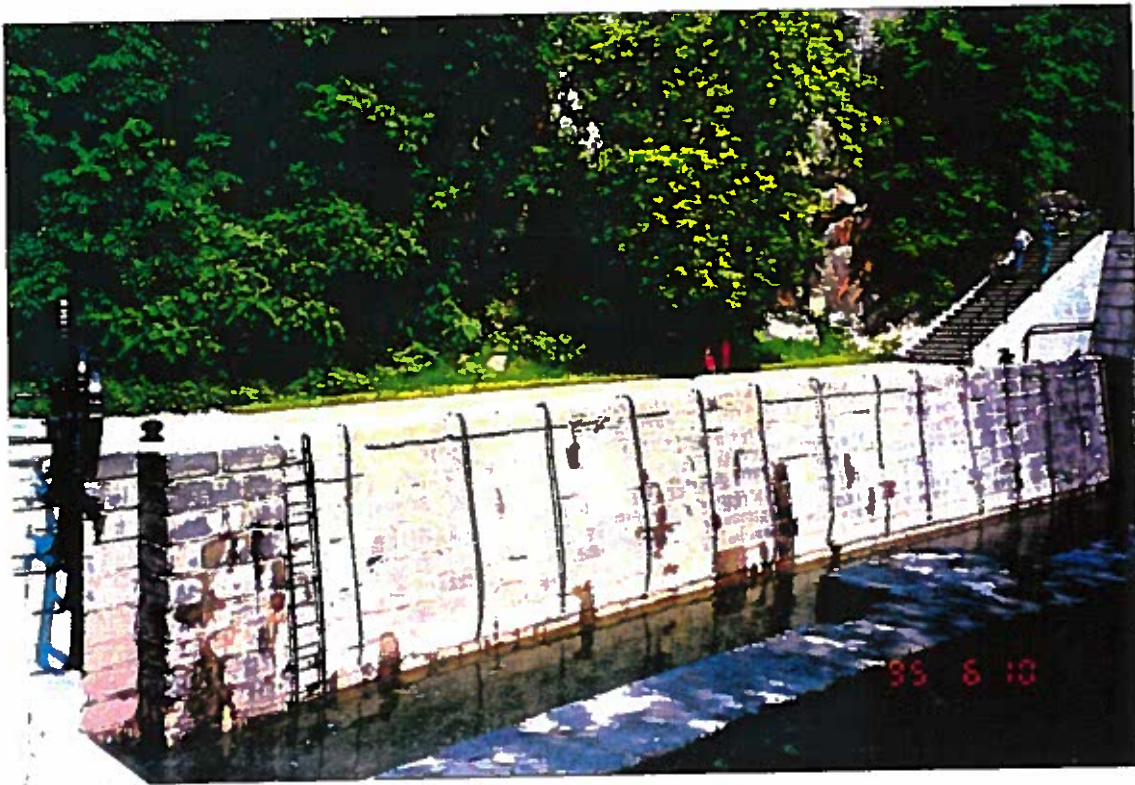
Issue No. 5: The general grouting of the west chamber wall of Lock No. 49 is of concern. Given that no recorded grouting operations had taken place in the last fifteen years at this location, it was believed that grout takes would have been appreciably greater. The difference between the west wall and east wall of Lock No. 49 were the specific site conditions encountered at the time of drilling and grouting. The west wall had flag stones removed, thus exposing the limestone screening to the elements and drilling operations. The drilling and air/water activities that followed created contamination of the grout holes. Similar to the wingwall downstream of

P7: (Above) View of west chamber wall of Lock No. 49 and upstream portion of Monolith No.1

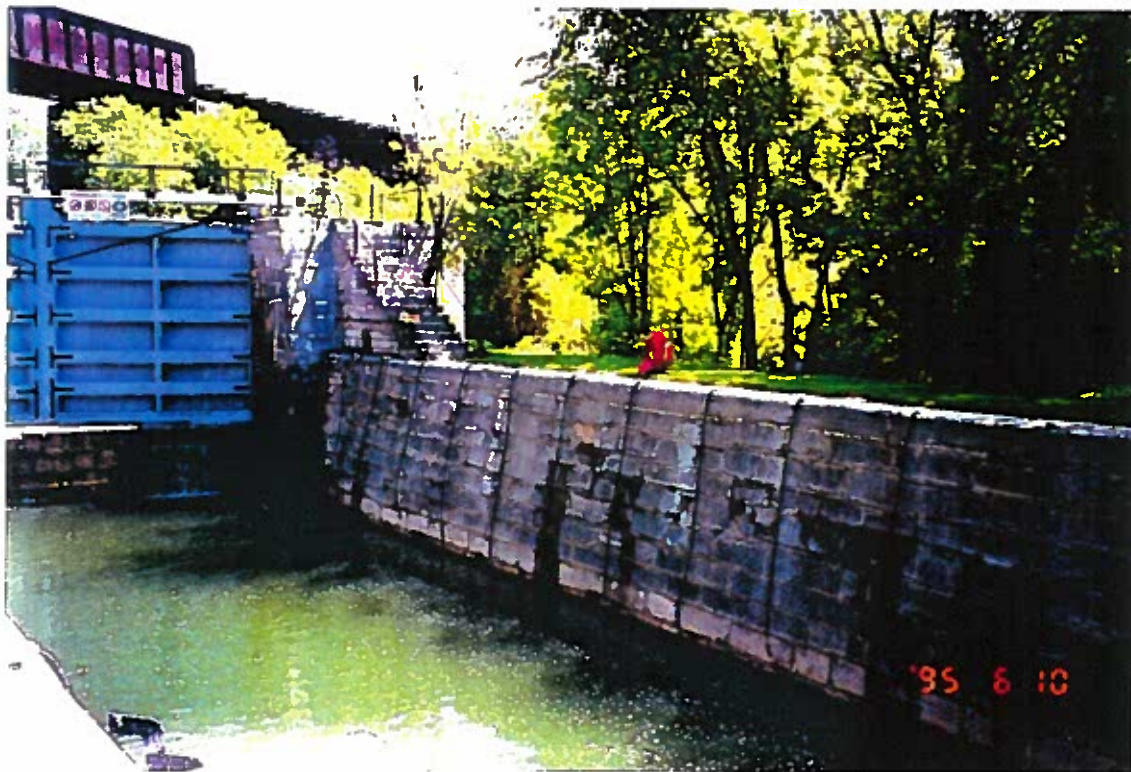
P8: (Below) View of east chamber wall of Lock No. 49 and downstream portion of Monolith No. 1

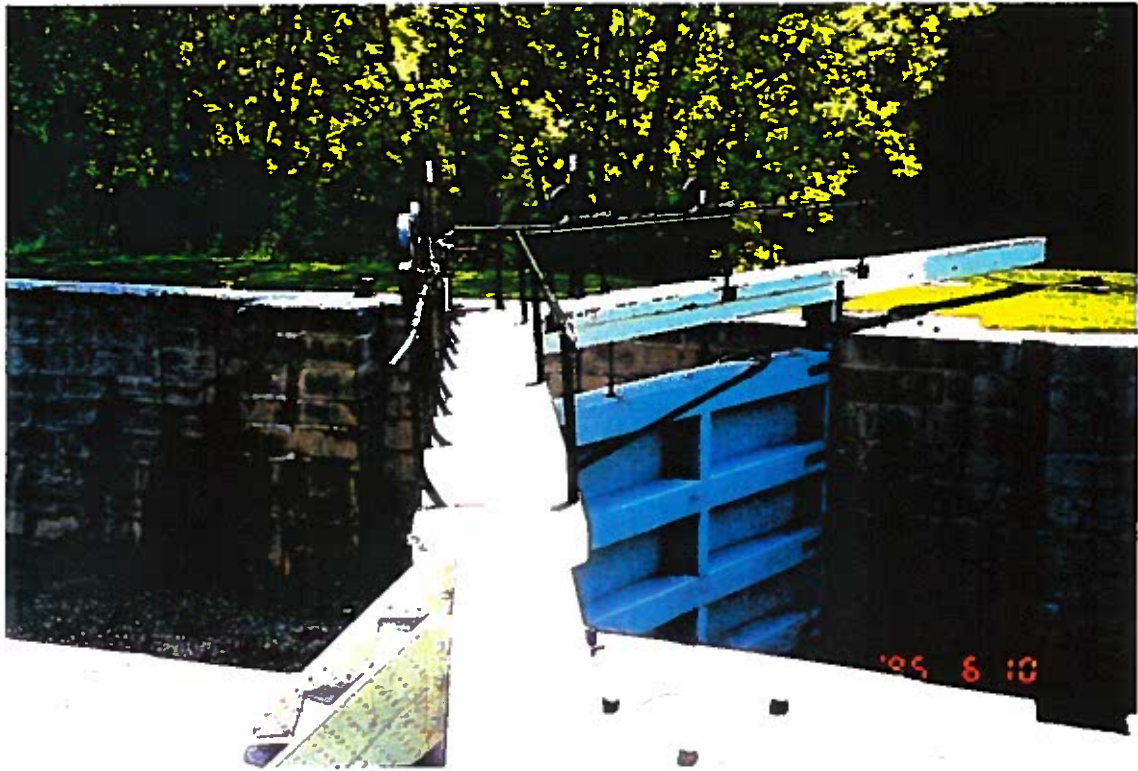
P9: View of Monolith No. 2 and downstream portion of the east chamber wall of Lock No. 49.
