CANADA CENTRE FOR INLAND WATERS (CCIW)

Burlington, Ontario

LEVEL 2 (Life Cycle)
BUILDING CONDITION REPORT
September 2009

**Environment Canada
Canada Centre for Inland Waters (CCIW)
NWRI BUILDING**

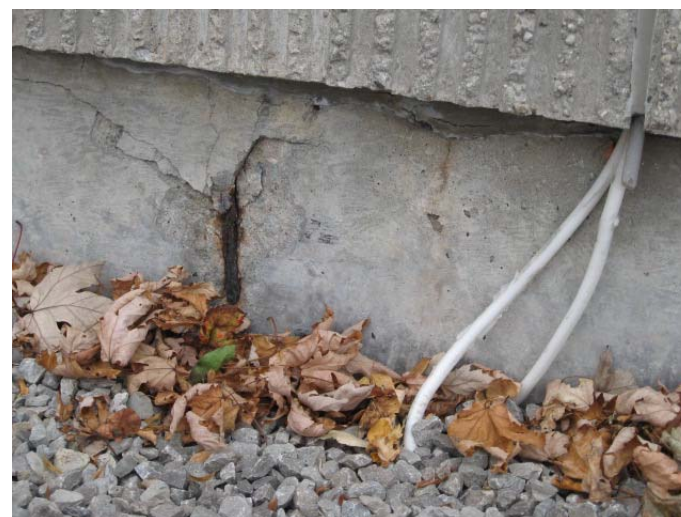
AR-012 – Exposed rebar/deteriorating concrete at foundation, and undersized sealant backer rods falling out from behind wall panel.

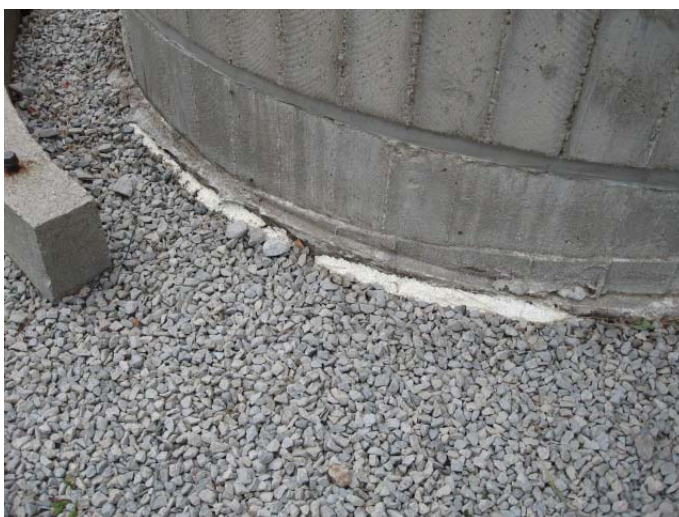
AR-015 – Exposed foundation insulation at A&L stairwell foundation.

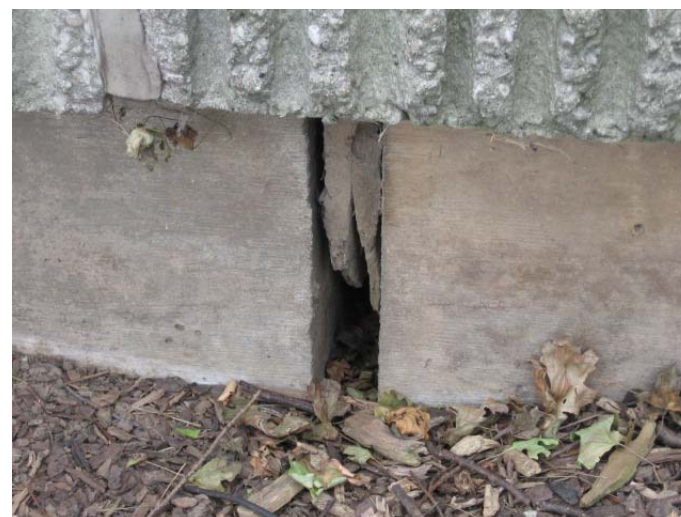
AR-016 – Unexplained void in foundation at Hydraulics lab north elevation.

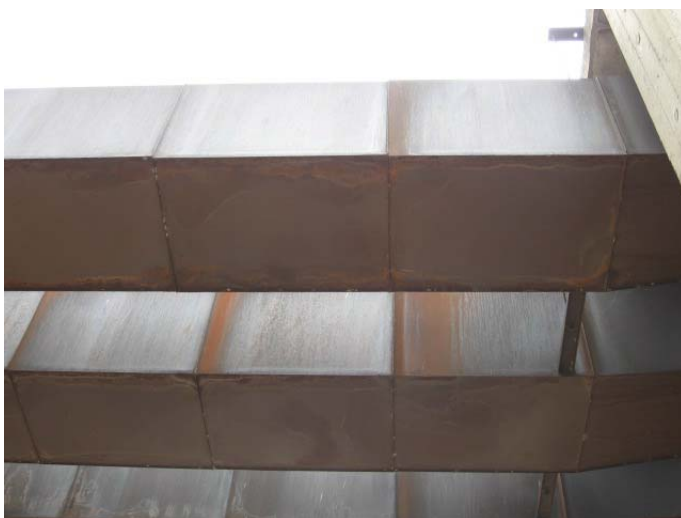
AR-019 – Underside of rusting metal breechings at Boiler Plant.

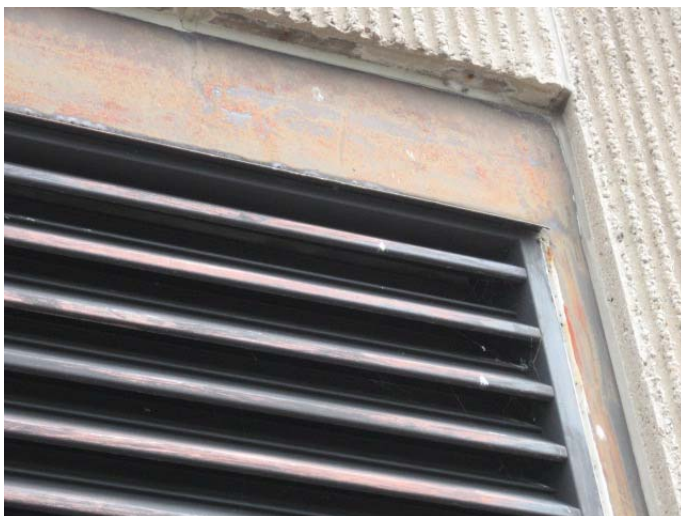
AR-031 – Deteriorated paint finish and rusting metal surfaces at louvre.

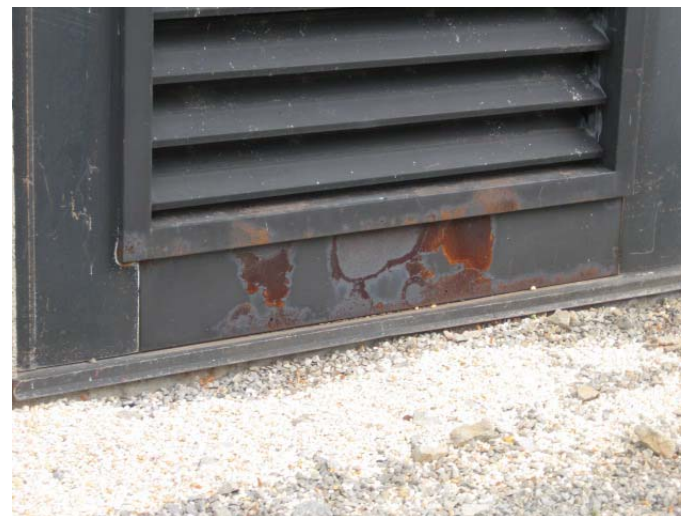
AR-032 – Deteriorated paint finish and rusting metal surfaces at Boiler Plant wall metal panel.

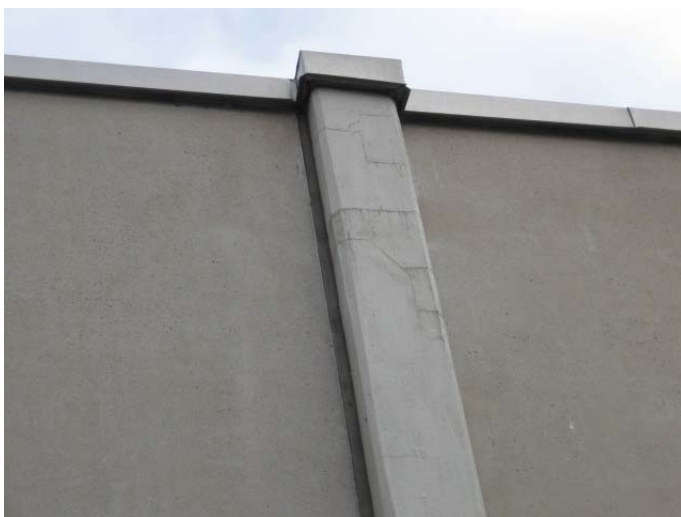
AR-035 – Cracks in cementitious coating on exposed column at
R&D west elevation.

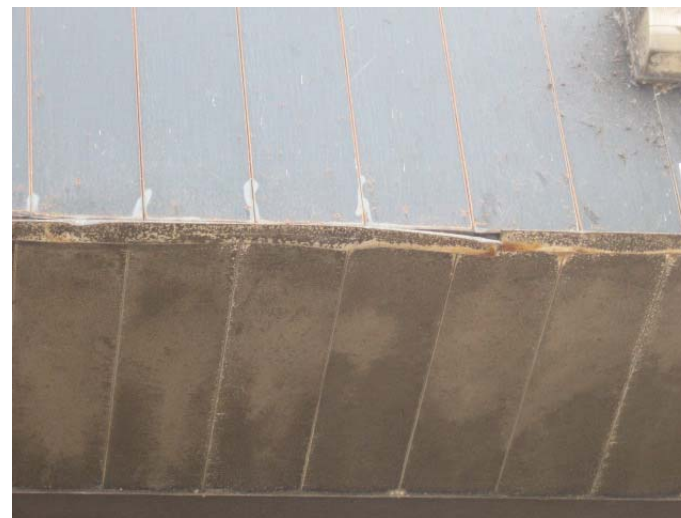
AR-038 – Deteriorated paint finish and damaged components at overhead door canopy siding/soffit.

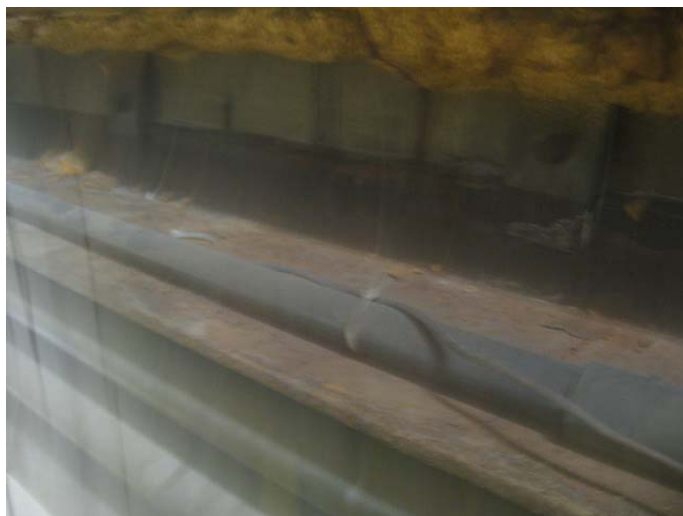
AR-039 – Water and rusting metal structure from active leak in Boiler Plant north wall (upper level).

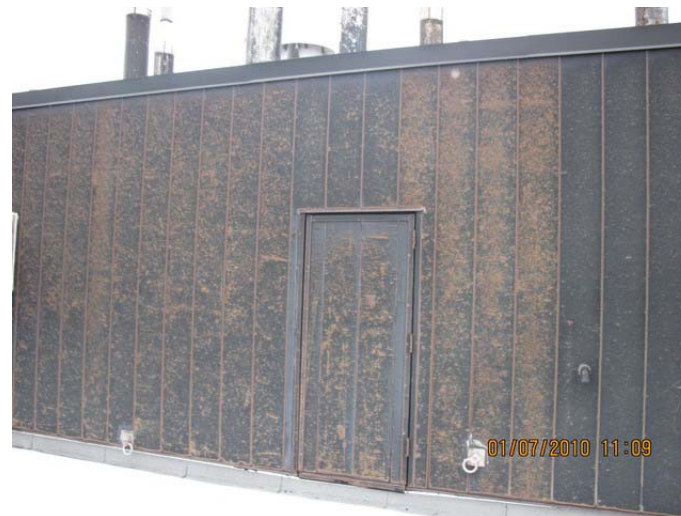
AR-040 – Deteriorated paint finish and rusting metal surfaces at A&L Mechanical penthouse west elevation metal panel wall.

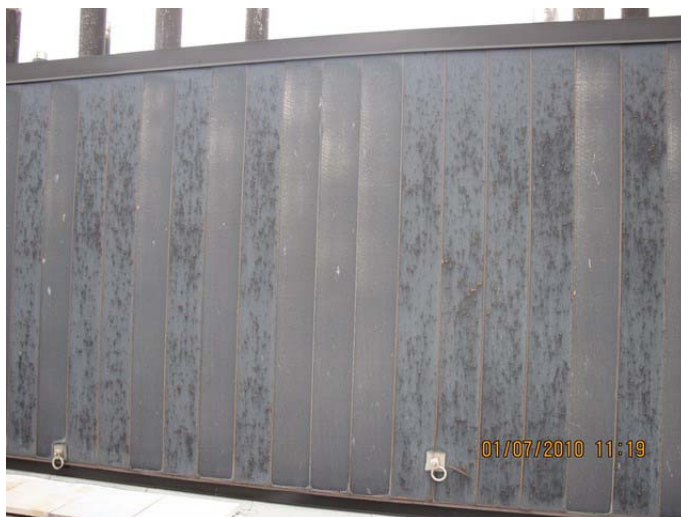
AR-041 – Deteriorated paint finish and rusting metal surfaces at A&L mechanical penthouse east elevation metal panel wall.

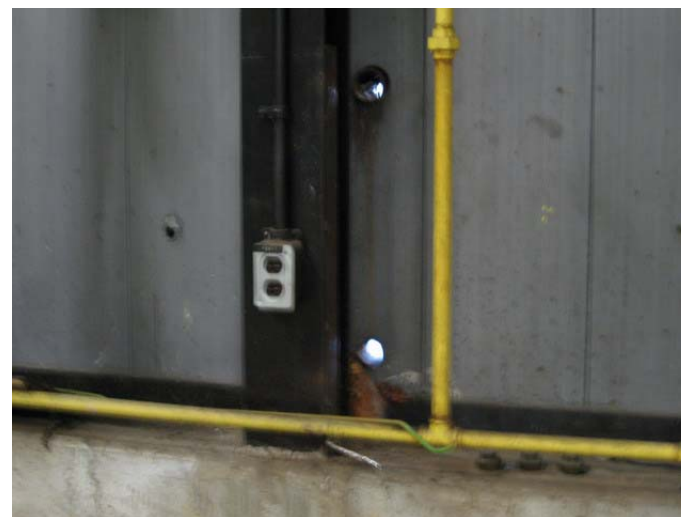
AR-042 – Unsealed openings in R&D mechanical penthouse metal panel wall.

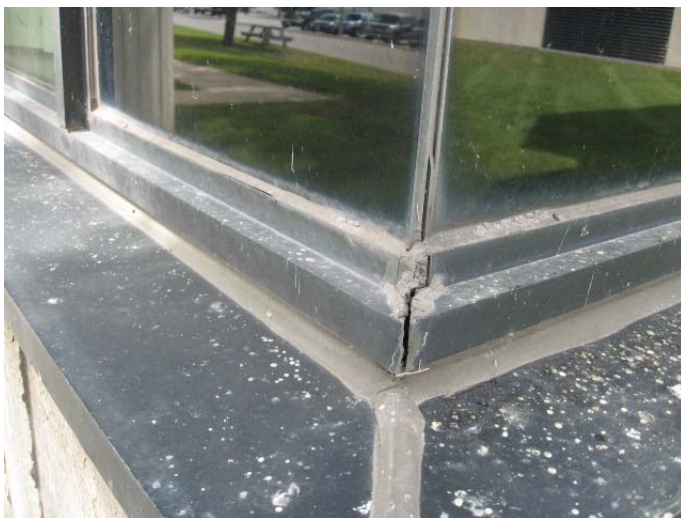
AR-045 – Open joints at window glazing/finishing at Hydraulics Lab office.

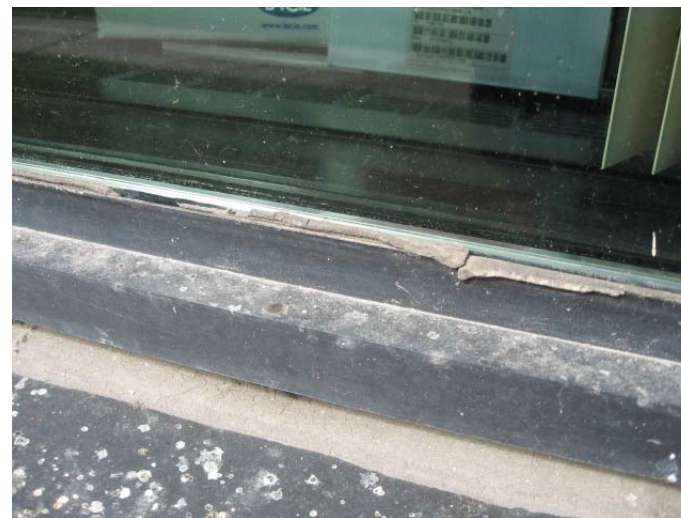
AR-046 – Deteriorated window sealants, both at frame and glazing.

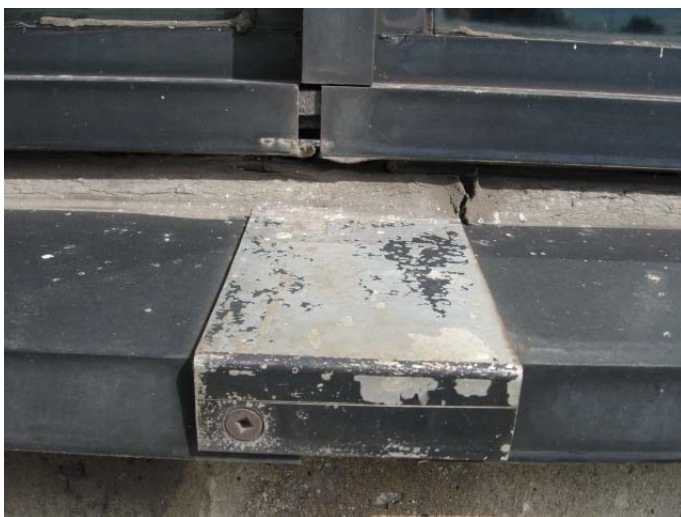
AR-047 – Open joints, deteriorated sealants and deteriorated paint finish at window framing.

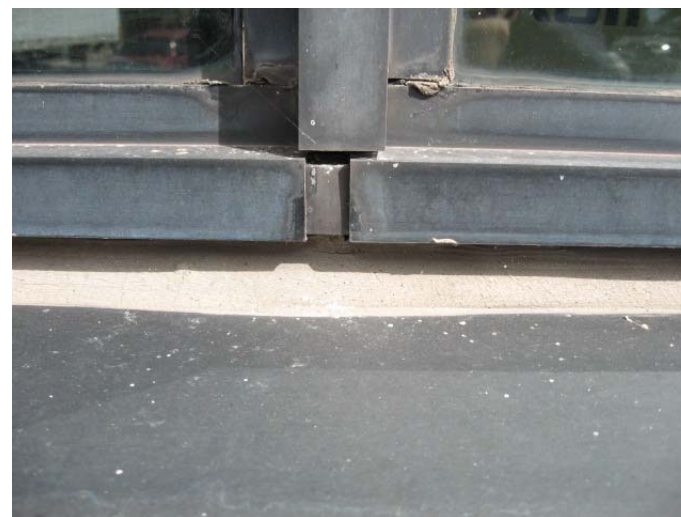
AR-048 – Open joints and deteriorated sealants at window framing.

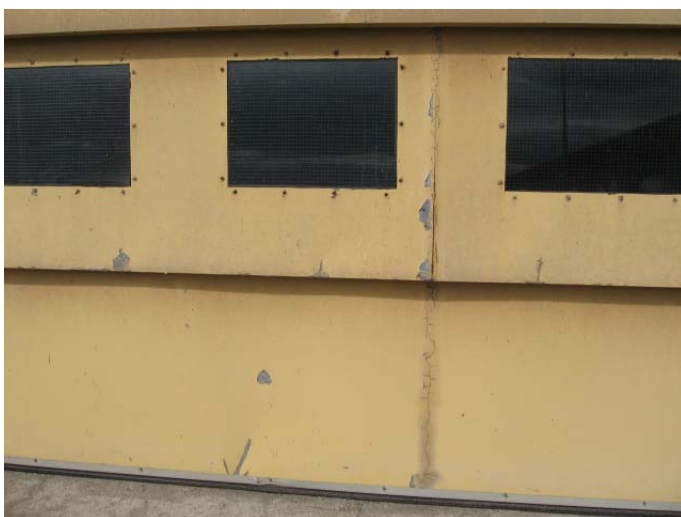
AR-051 – Deteriorated paint finish and rusting metal surfaces at overhead door panels.

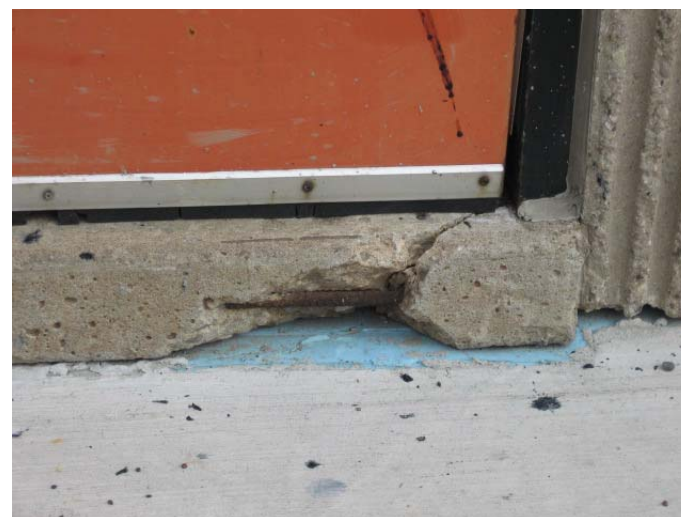
AR-052 – Deteriorating concrete door sill at Boiler Plant (Door 15).

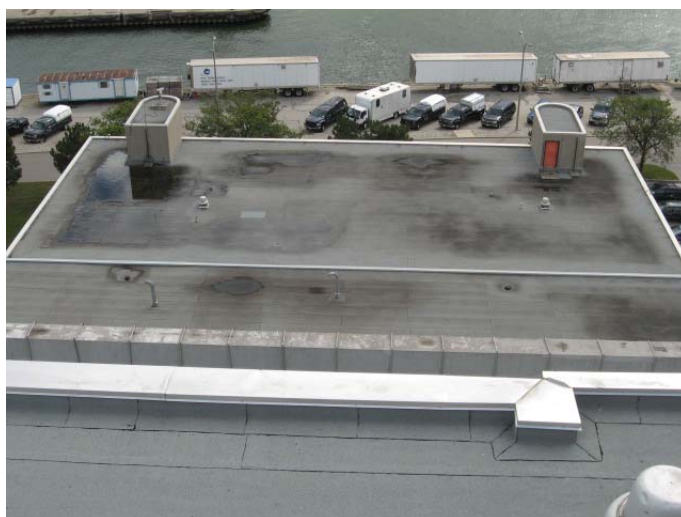
AR-063 – Darker stained locations indicate locations of standing water throughout roof areas.

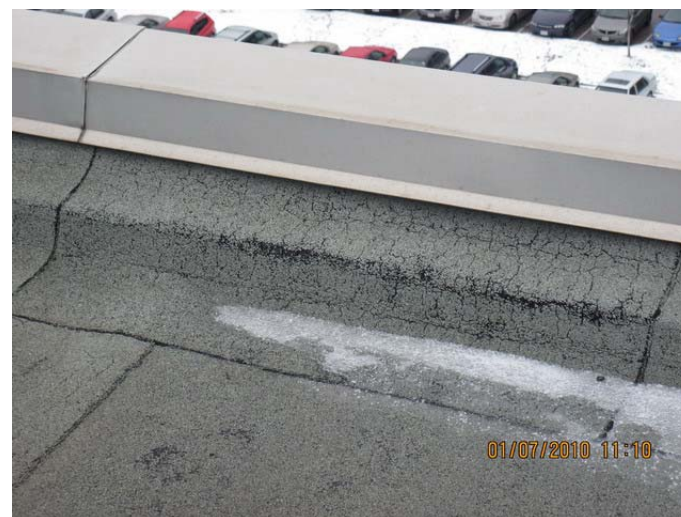
AR-064 – Cracking of membrane and loss of granular material at SBS membrane roof flashing.

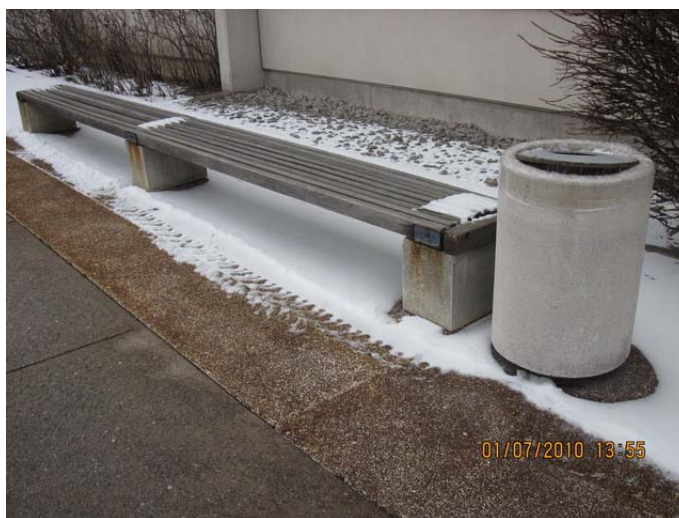
AR-075 – Rusting metal components and stained surfaces at exterior bench.

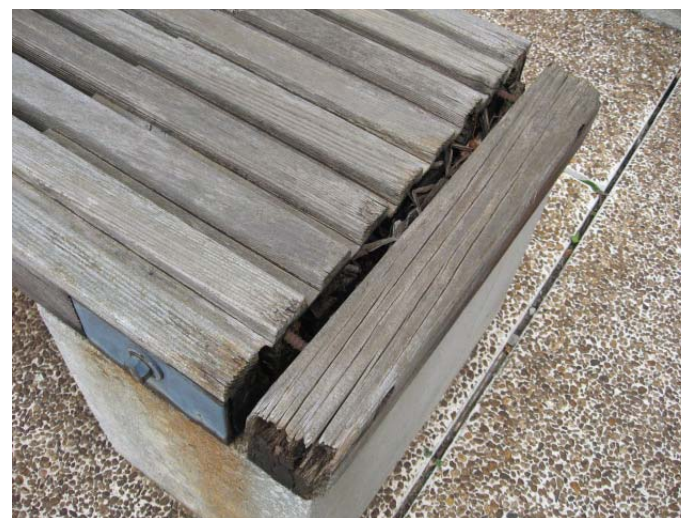
AR-076 – Deteriorating wood components at exterior bench.

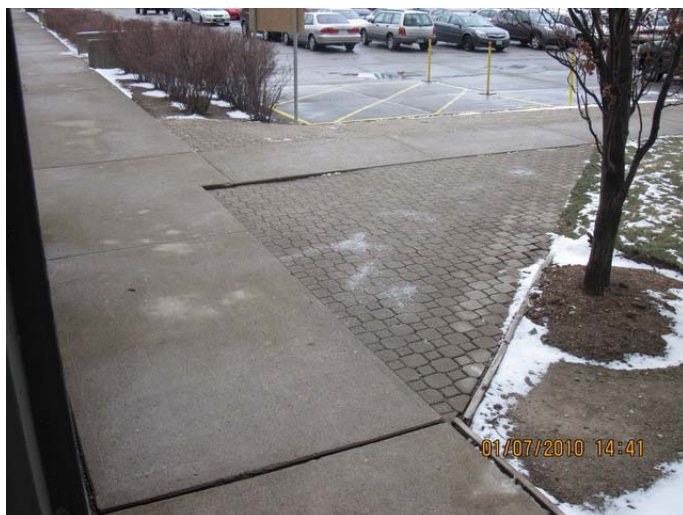
AR-077 – Settled/sunken unit pavers at Mall north entrance creating tripping hazard.

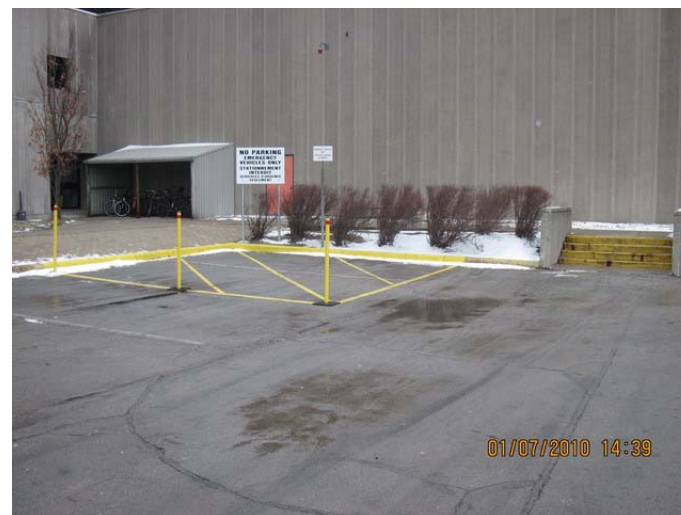
AR-078 – Key building access point at Mall north entrance restricted by bicycle storage.

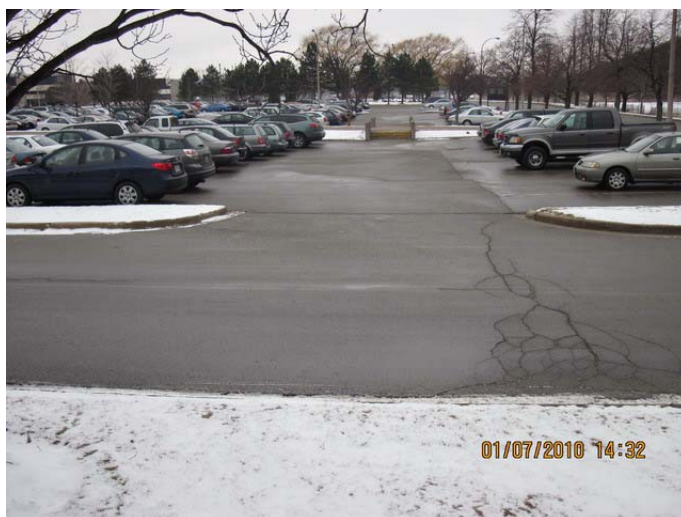
AR-083 – Cracking/alligating of asphalt pavement at driveway and throughout parking area.

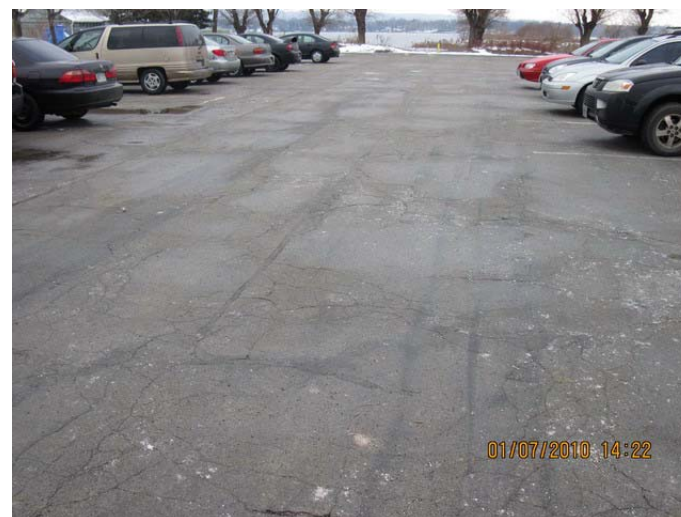
AR-084 – Cracking/alligating of 'residential grade' asphalt pavement throughout driveway.

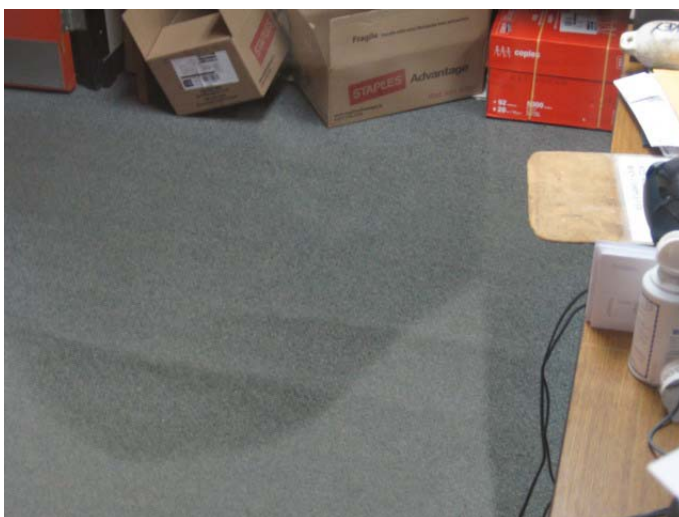
AR-099 – Wrinkling throughout carpet in individual office area.

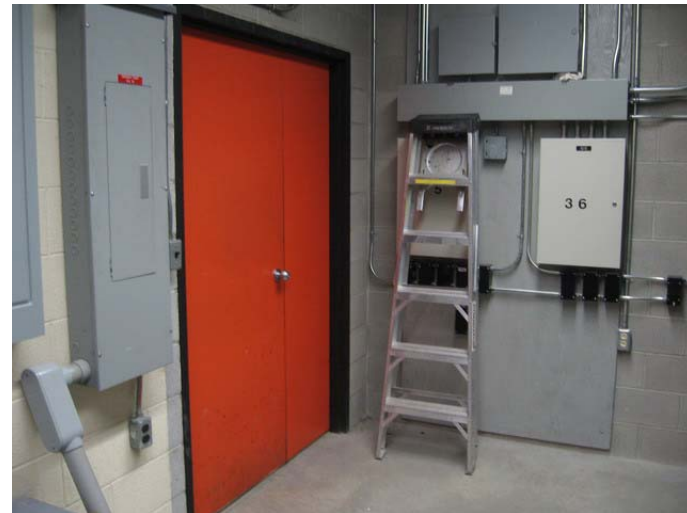
AR-128 – Equipment stored in service room – aluminum ladder with electrical equipment no less.

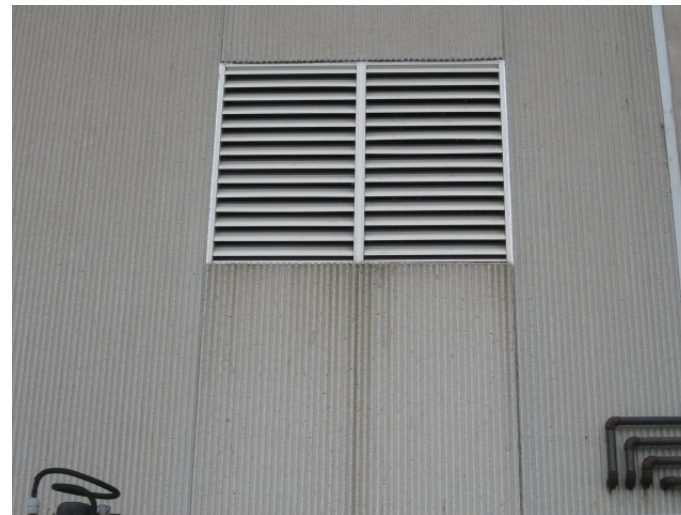
AR-006 – Stained wall surfaces below louver without sill.

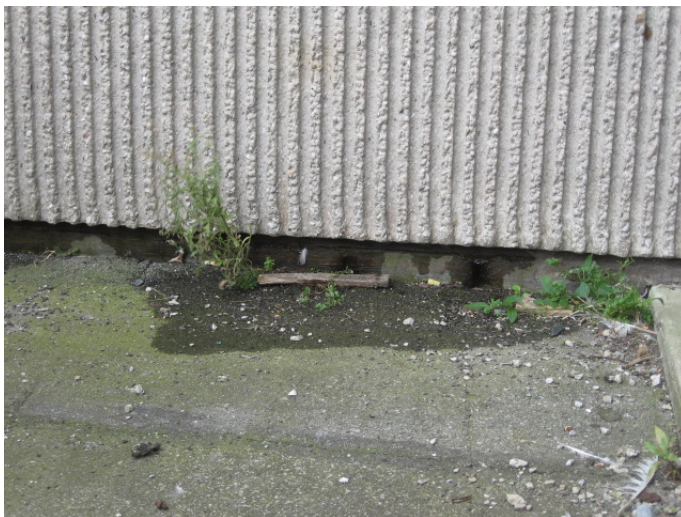
AR-007 – Moisture leakage through wall.

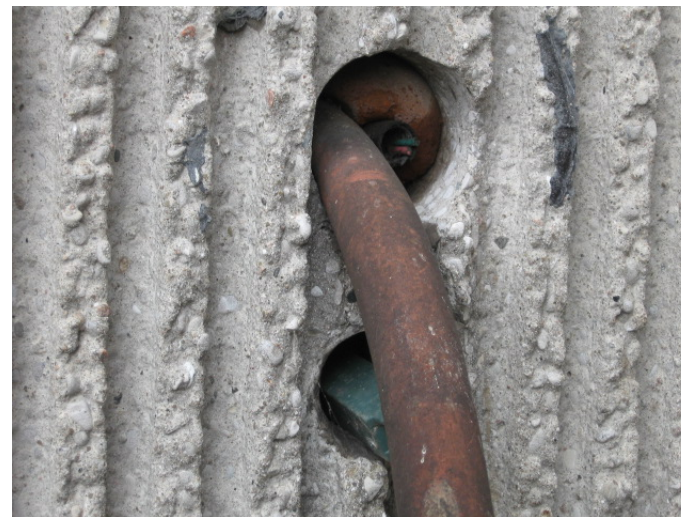
AR-008 – Unsealed wall penetrations.

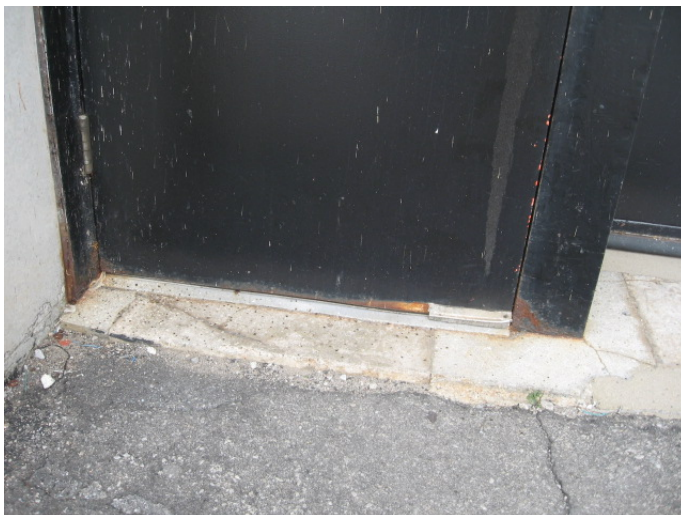
AR-011 – Deteriorated paint finish and rusting metal surfaces at exterior door.

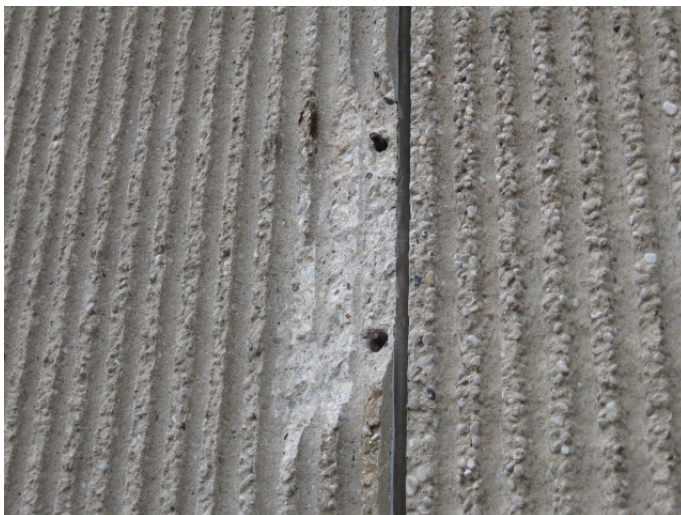
AR-015 – Holes and deteriorated concrete surface at wall panel.

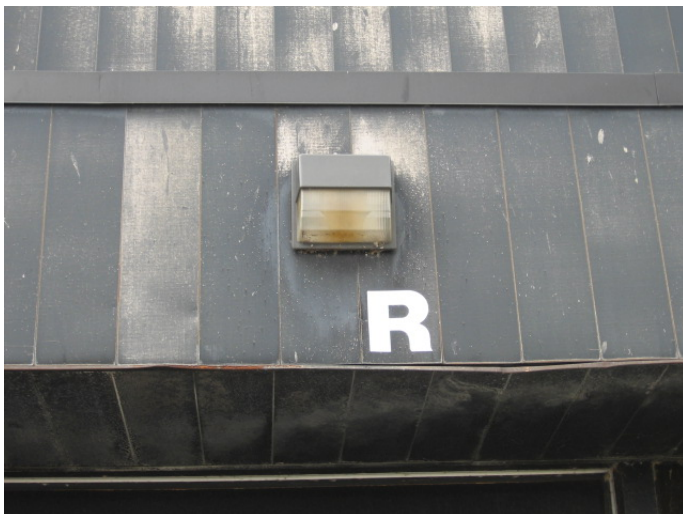
AR-017 – Deteriorated paint finish and damaged soffit at canopy.

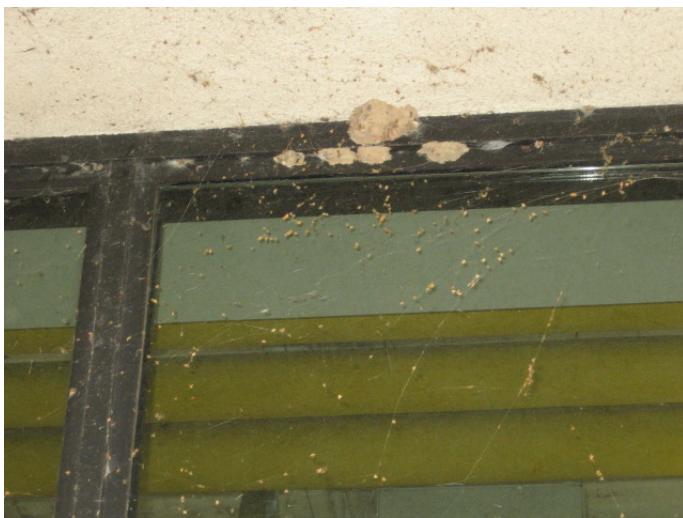
AR-019 – Dirty surfaces (nests, webs, debris, etc.) at walls and soffits.

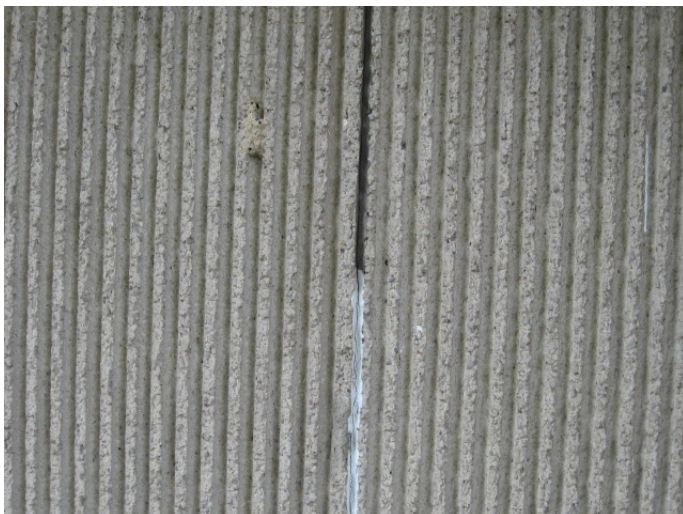
AR-021 – Missing sealant at precast concrete panel joints.

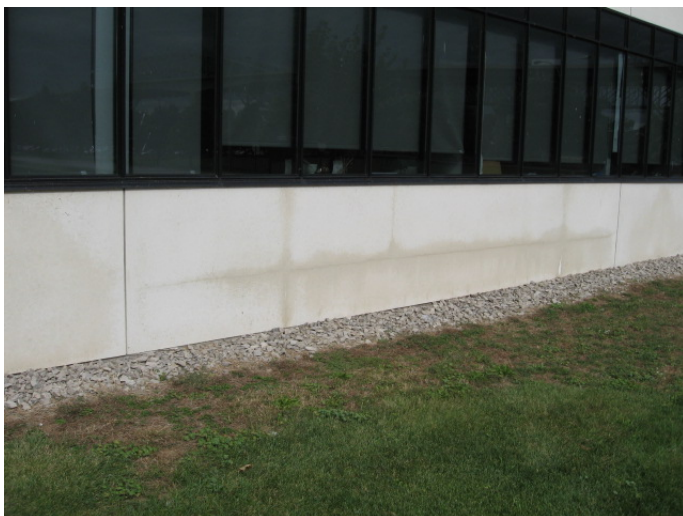
AR-023 – Defective precast concrete panel at 'east-end' addition.

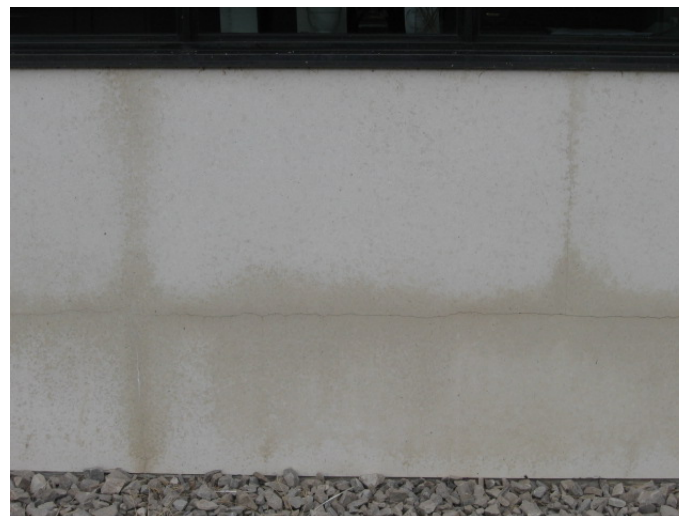
AR-024 – Cracks and discolouration at precast concrete panel.

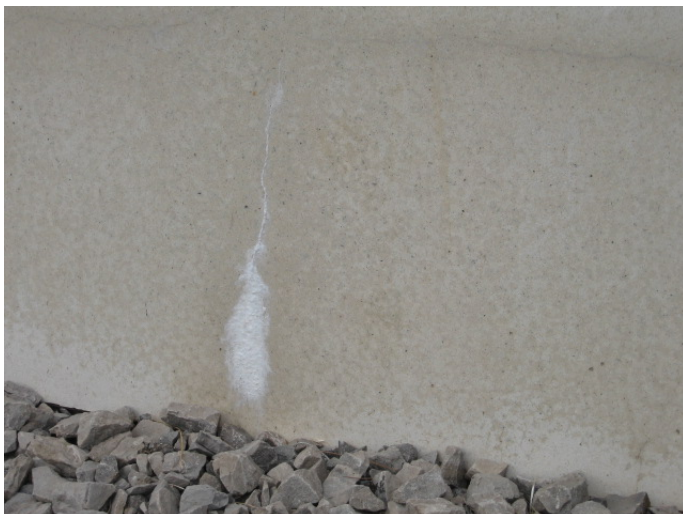
AR-025 – Efflorescence accumulating around cracks in precast concrete panel.

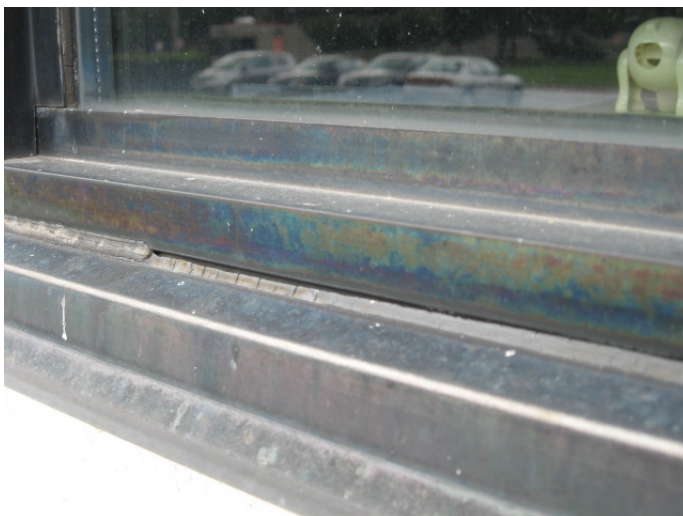
AR-027 – Deteriorating sealants at 'east-end' addition windows.

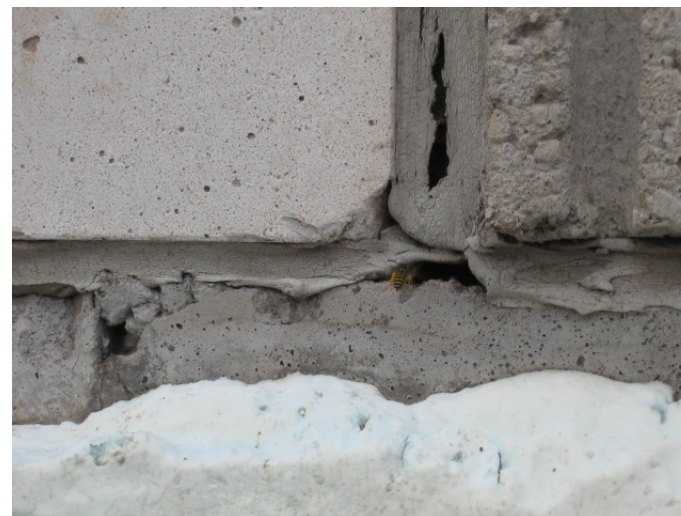
AR-028 – Open wall joints at 'east-end' addition - now an active wasp nest.

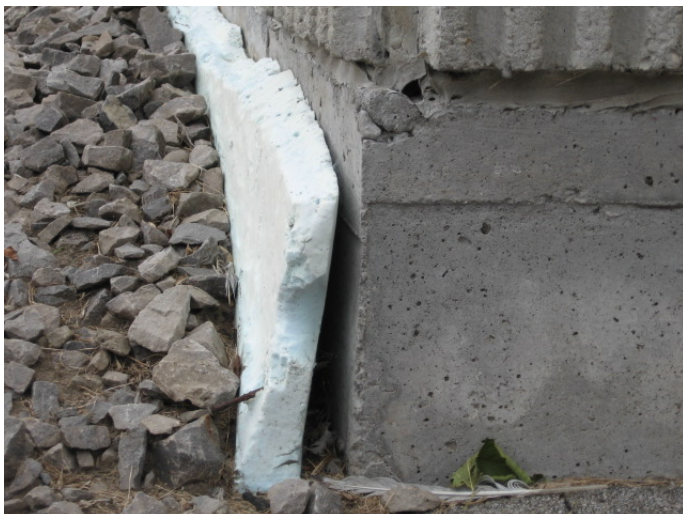
AR-029 – Exposed, shifted and deteriorating foundation insulation.

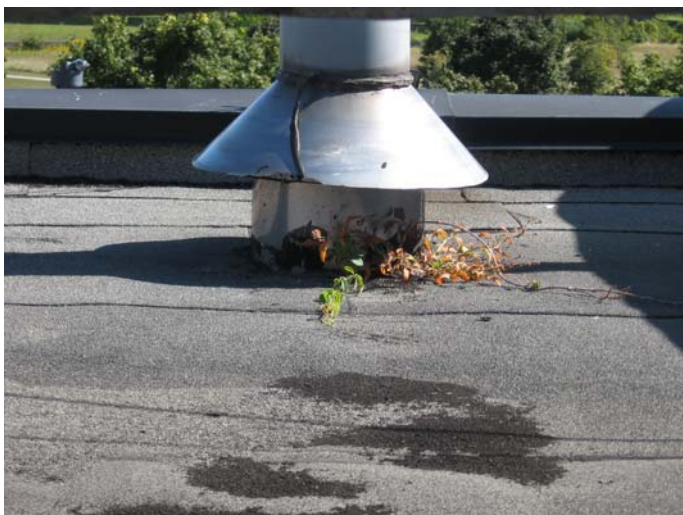
AR-031 – Vegetation growth at SBS membrane stack flashing.

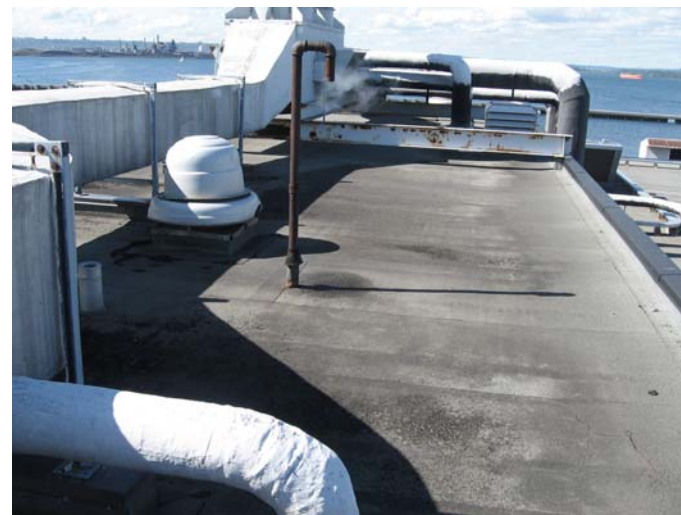
AR-032 – PH roof (north side) looking west - rusting metal equipment supports and stained SBS membrane with sediment/debris build-up.

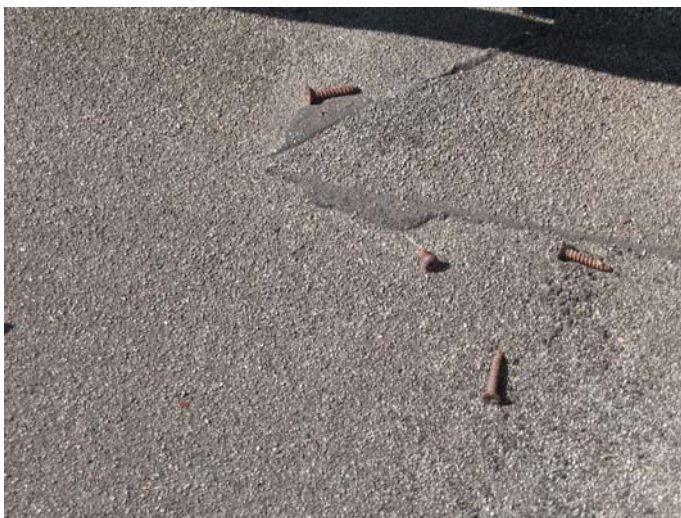
AR-035 – Old fasteners lying on SBS membrane - a puncture waiting to happen.

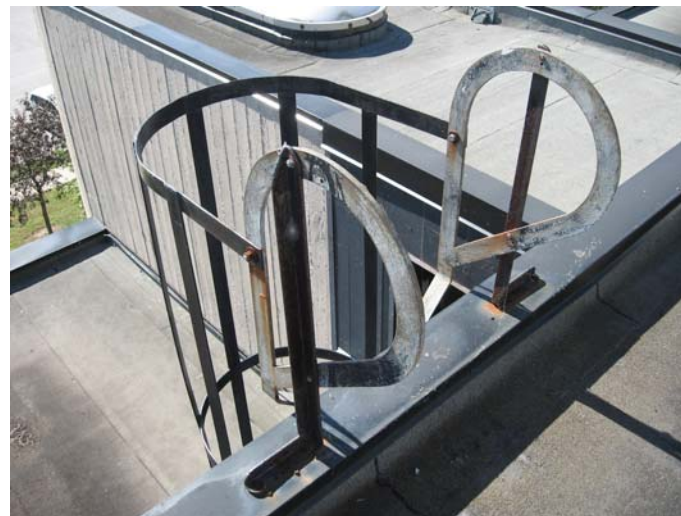
AR-038 – Deteriorating paint finish and rusting metal surfaces at PH roof access ladder.

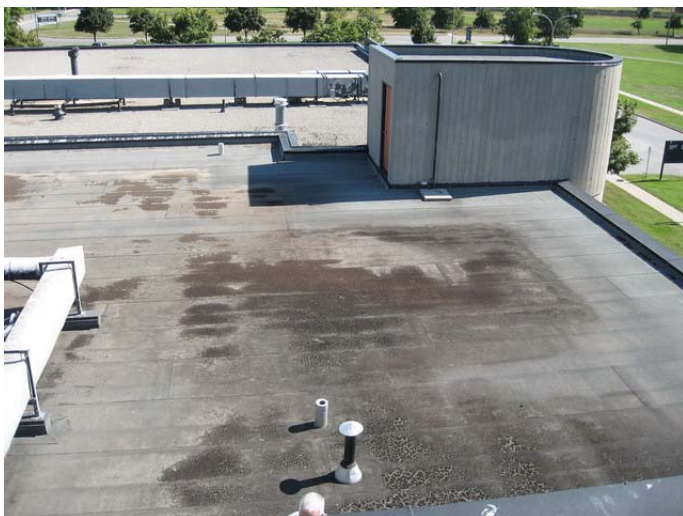
AR-039 – Staining and sediment build-up indicating standing water areas throughout SBS roof.

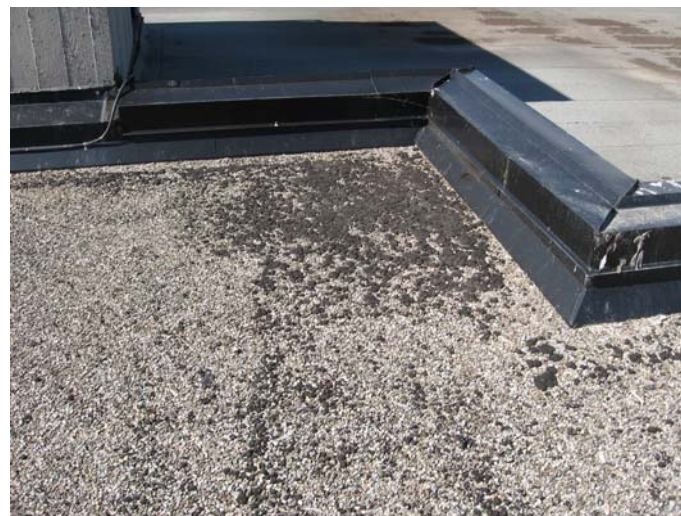
AR-040 – Asphalt bleed-through at field area on BUR.

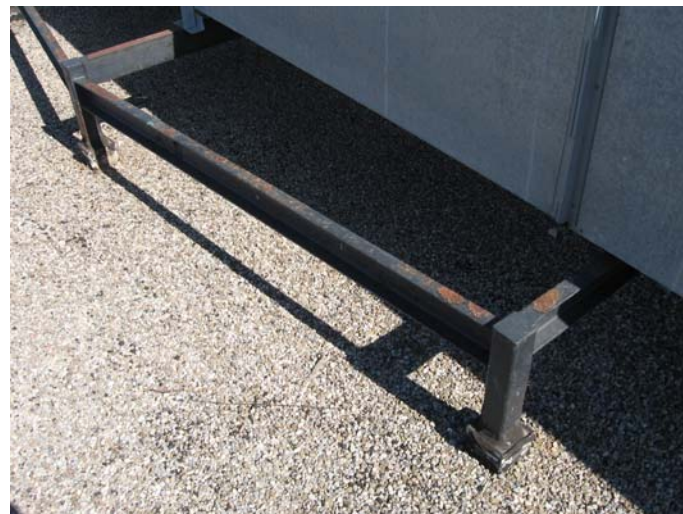
AR-042 – Deteriorating paint finish and rusting metal surfaces at equipment support frame.

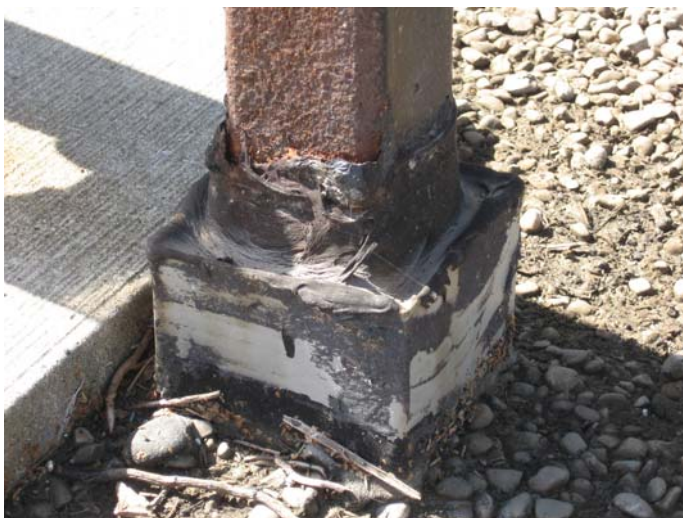
AR-043 – Deteriorated filler in equipment support frame pitch pockets.

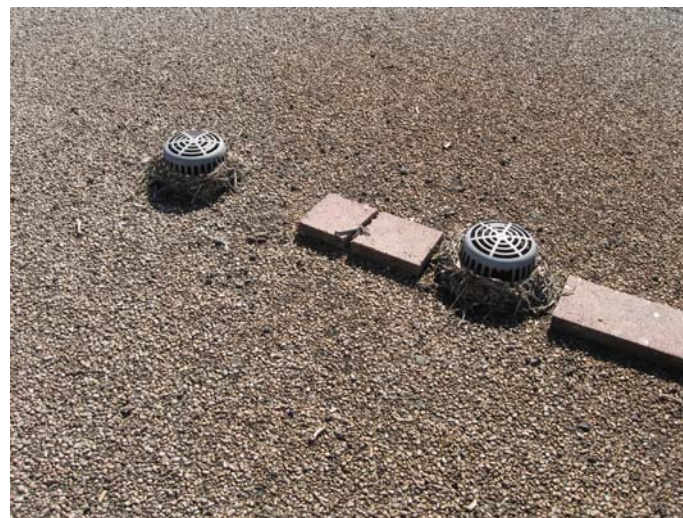
AR-044 – Debris around BUR area drains.

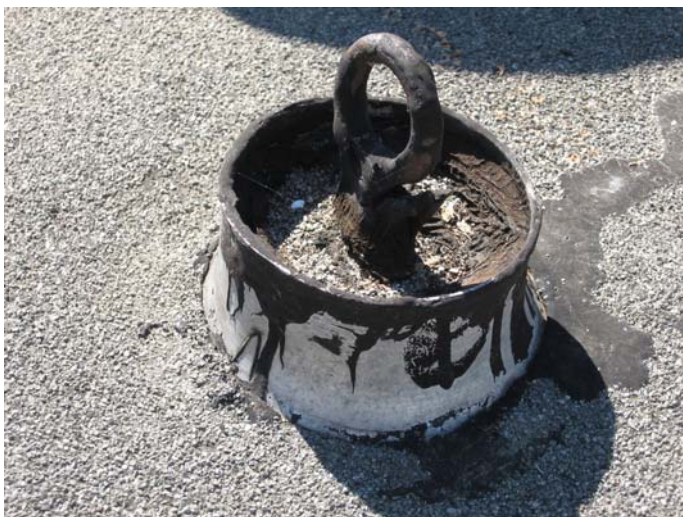
AR-047 – Deteriorated filler in abandoned pitch pocket.

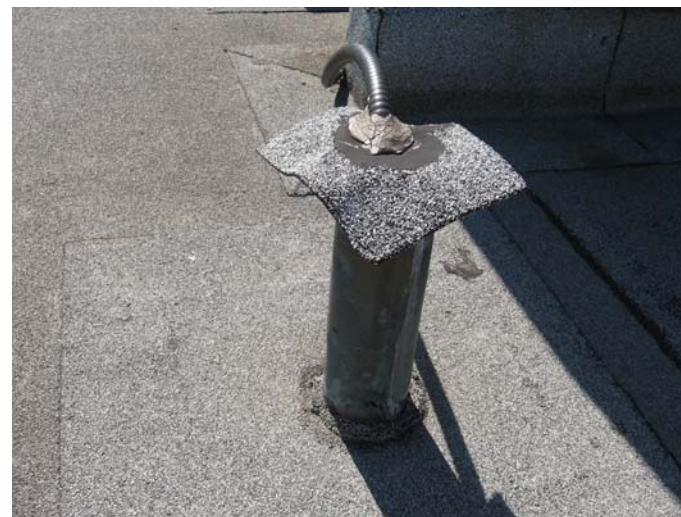
AR-048 – If this is your idea of an acceptable roofing detail . . . you may be a redneck.

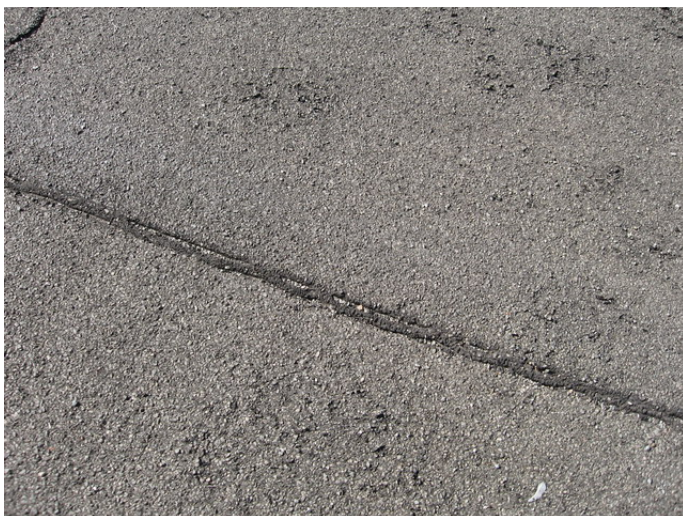
AR-051 – Asphalt bleed-out at SBS membrane roll edges.

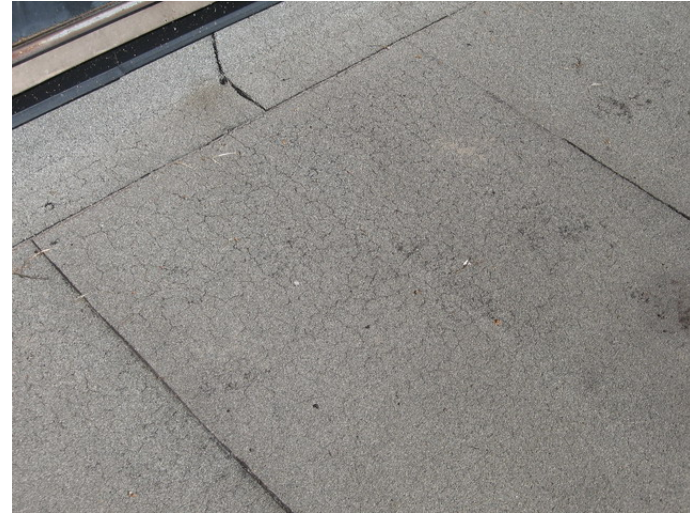
AR-054 – Cracking of SBS membrane surface in field.

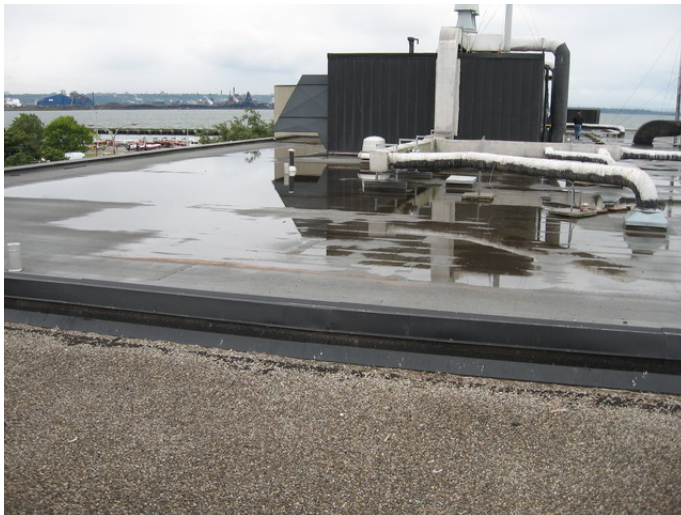
AR-055 – Ponding throughout main roof.

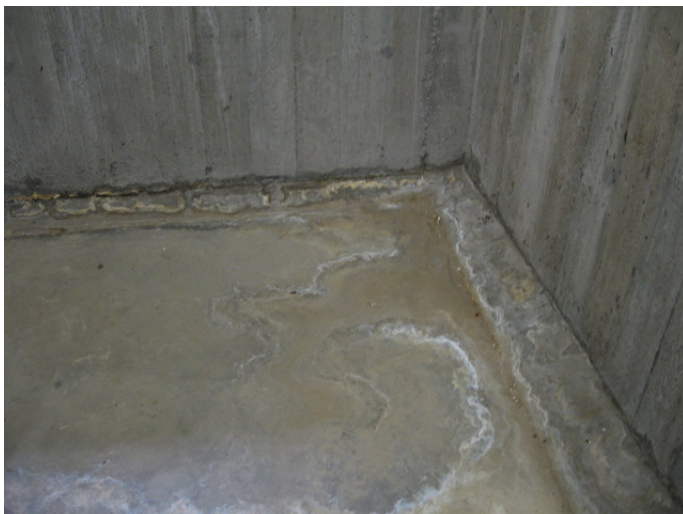
AR-057 – Water stained surfaces at basement level.

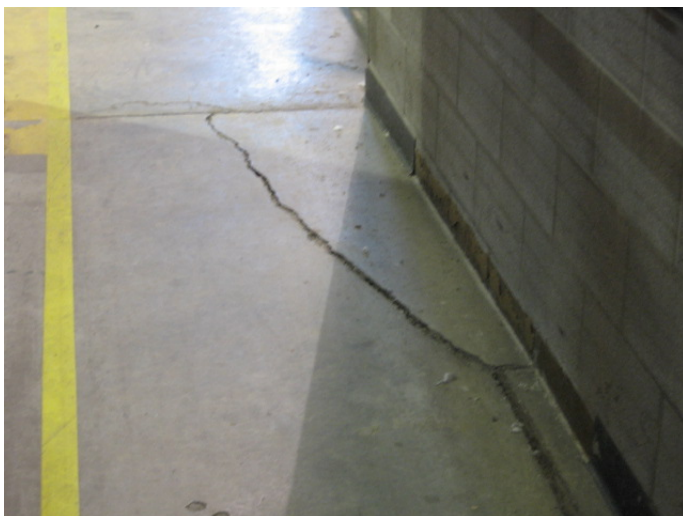
AR-059 – Cracked/shifted concrete floor in high-bay area.

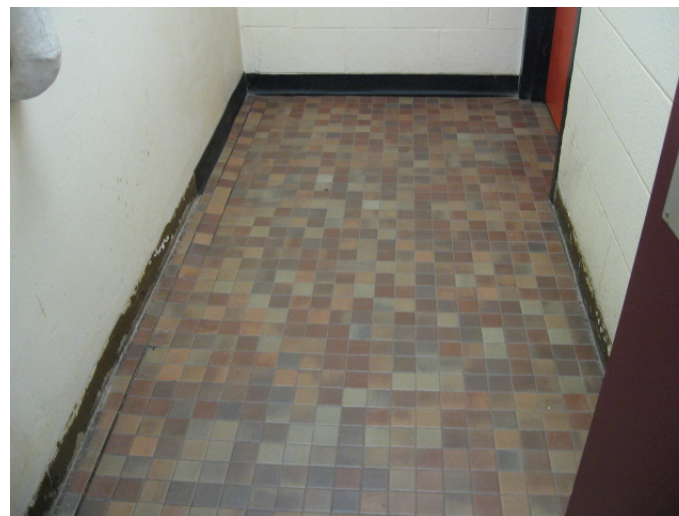
AR-060 – Shifted floor in 1st floor washroom/change room vestibule.

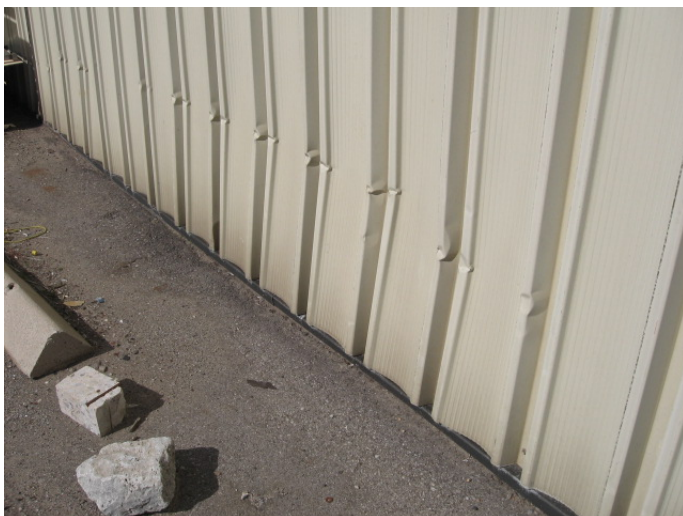
AR-007 – Damaged metal siding at south elevation.

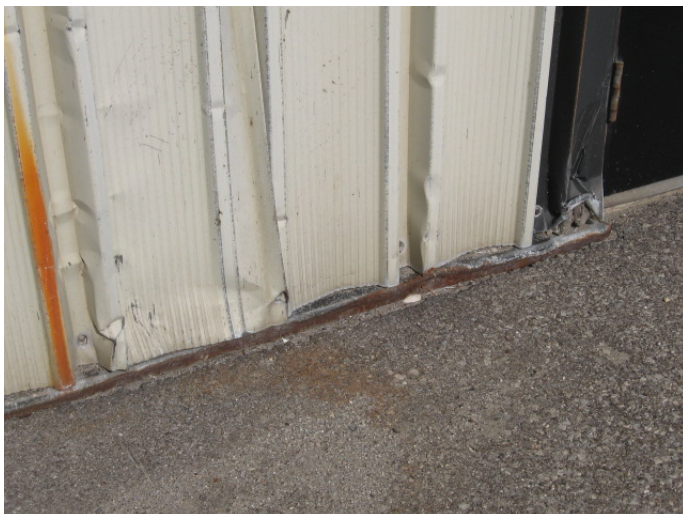
AR-009 – Damaged metal siding at south elevation.

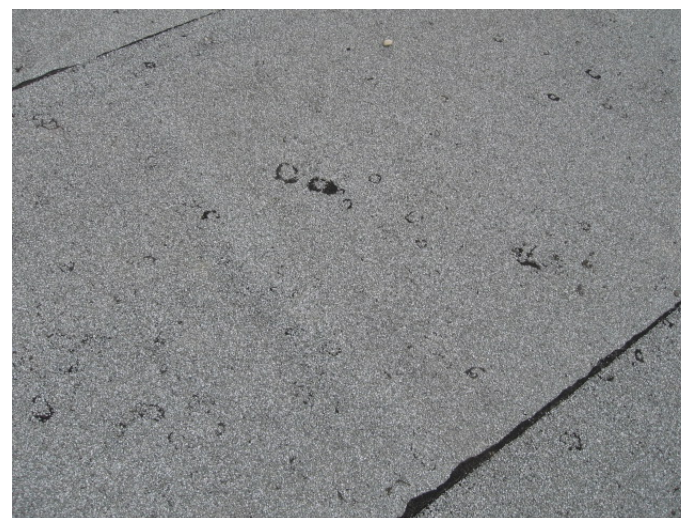
AR-020 – Damage to granular surface of SBS membrane - cause of marks unknown.
