CANADA CENTRE FOR INLAND WATERS (CCIW)

Burlington, Ontario

LEVEL 2 (Life Cycle)
BUILDING CONDITION REPORT
September 2009

**Environment Canada
Canada Centre for Inland Waters (CCIW)
NWRI BUILDING**

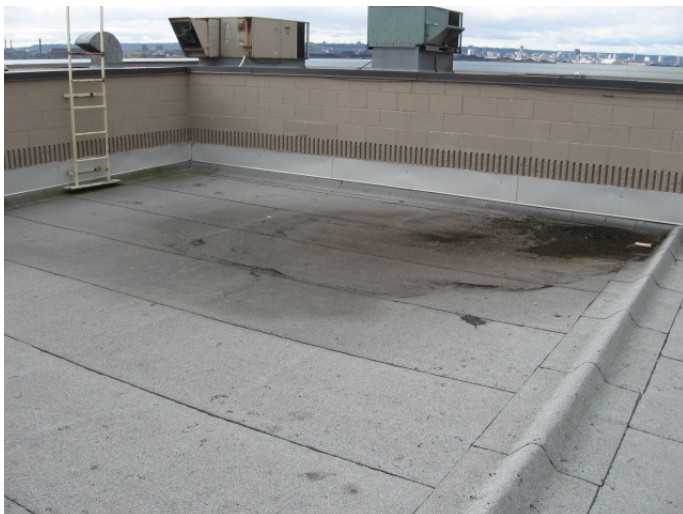
AR-021 – Staining and debris at warehouse area roof from standing water.

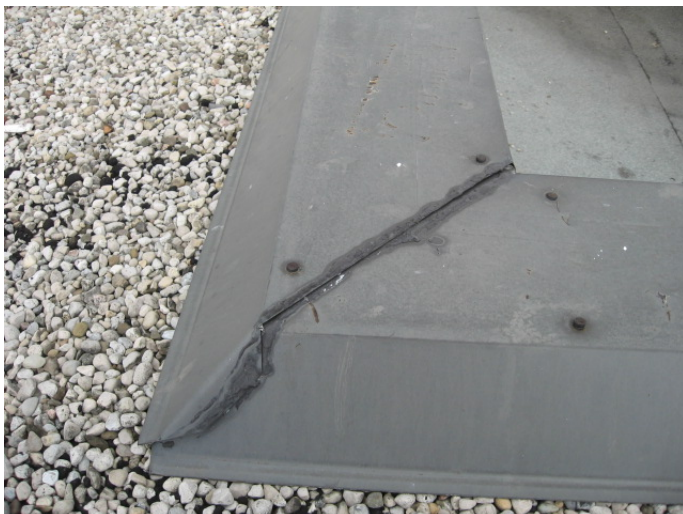
AR-025 – Deteriorated sealant at joints BUR metal counter flashing.

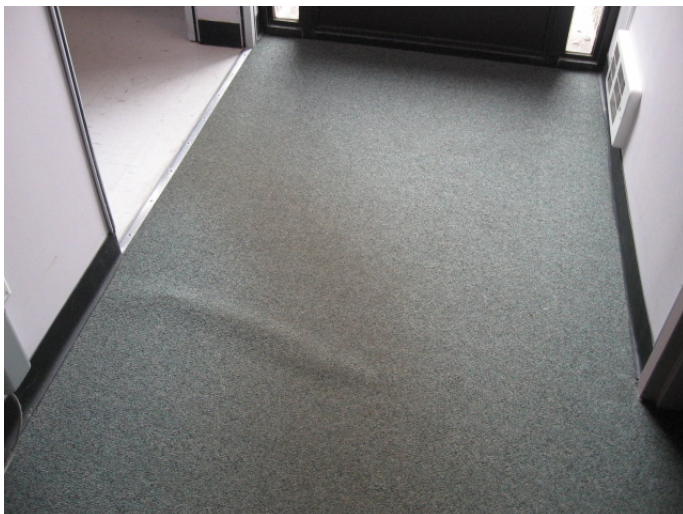
AR-029 – Wrinkled and stained carpet flooring in 1st floor corridor.
