**APPENDIX B:**  
**Pre-Demolition Hazardous Building**  
**Materials Assessment**  
**January 2016**

**Bunk House Compound**

# PRE-DEMOLITION HAZARDOUS BUILDING MATERIALS ASSESSMENT

## Bunk House Compound, Waterton, Alberta

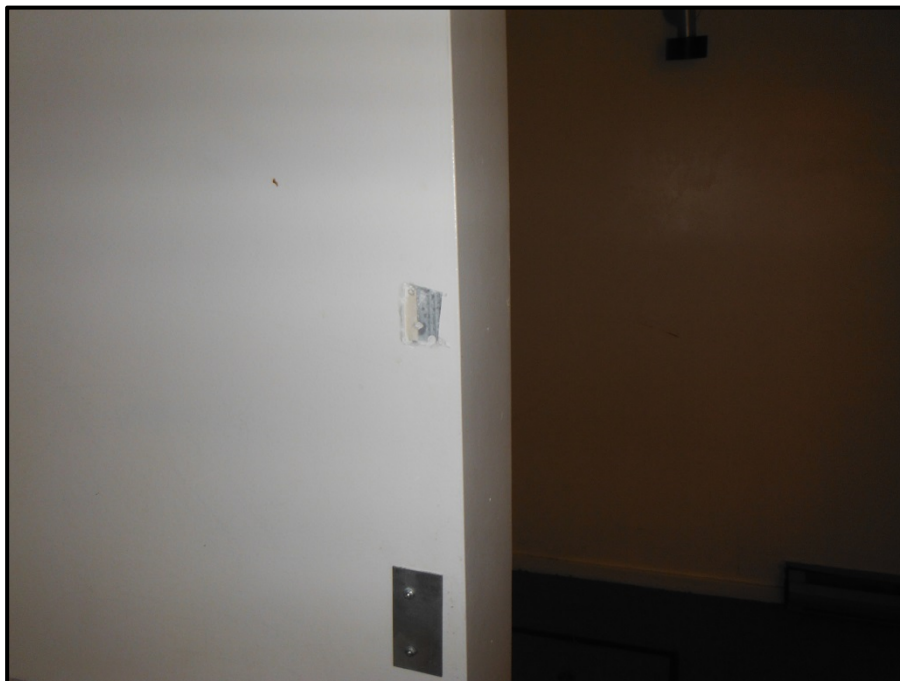
- Beige Mosaic Sheet Flooring – Entrance of Unit 16; and
- Drywall Joint Compound – All Units, All Drywall

**Photograph 2: Asbestos-Containing Drywall Joint Compound, Bunkhouse Compound**

Prior to any demolition or renovation activities, ACM that may be impacted must be removed. The work should be completed by workers certified by Alberta OHS. Throughout the abatement activities, appropriate air monitoring and inspections should be conducted by qualified personnel to document that contamination is contained and ACM are removed and disposed of appropriately. It is recommended that a proper scope of work and asbestos removal specifications be written to scope the complete and proper removal of the identified ACM.

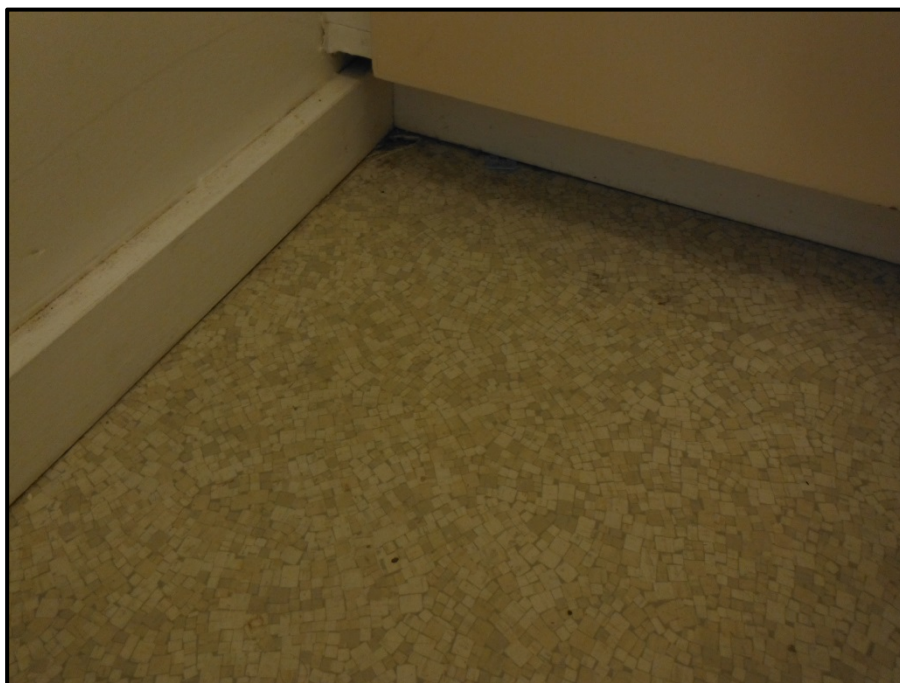
**Photograph 3: Asbestos-Containing Beige Mosaic Sheet Floor, Unit 16**

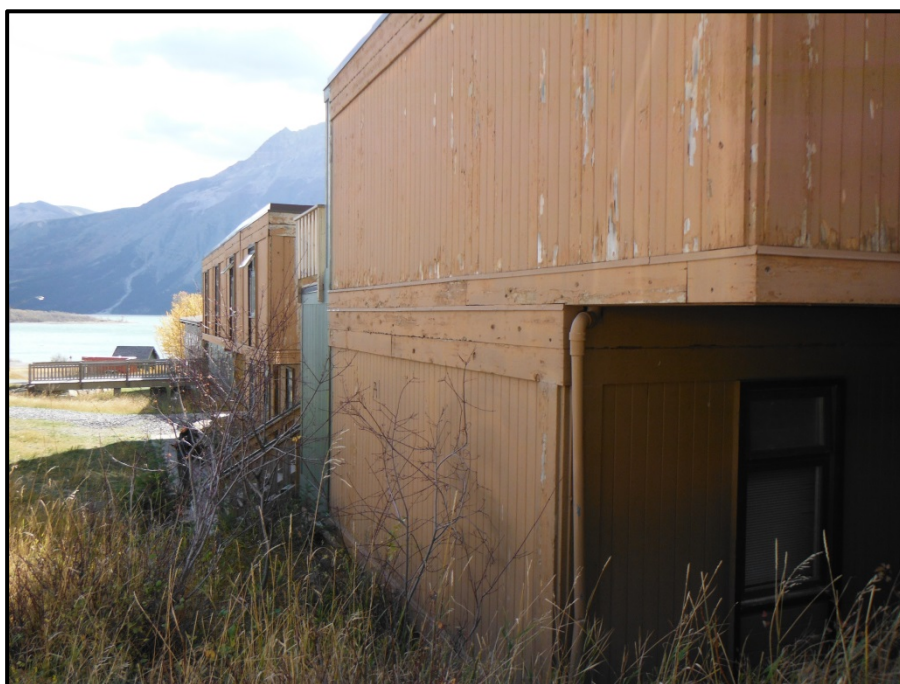
- Brown Paint on Wood Siding/Trim – Exterior (poor condition);
- Off-White Paint on Drywall/Wood Trim – All Units (good condition); and
- Beige Paint on Wood Doors/Cabinets – All Units (good condition).

**Photograph 4: Lead-Containing Brown Paint on Wood Siding/Trim – Exterior, Bunkhouse Compound**

Lead-containing paint in poor condition should be abated prior to demolition. The lead containing paint that is flaking or loose (poor condition) should be abated following methods and requirements outlined in the Alberta OHS *Lead at the Work Site Bulletin*. The lead-containing paint waste should be analyzed for lead leachability by toxicity characteristic leaching procedure (TCLP) prior to transportation and disposal. The transportation and disposal of lead-containing waste materials must be conducted in accordance with the requirements of AEP and the Federal Transportation of Dangerous Goods Act and Regulations, current to the date of the work. The AEP Waste Control Regulation prescribes the disposal pathways for lead-containing waste.

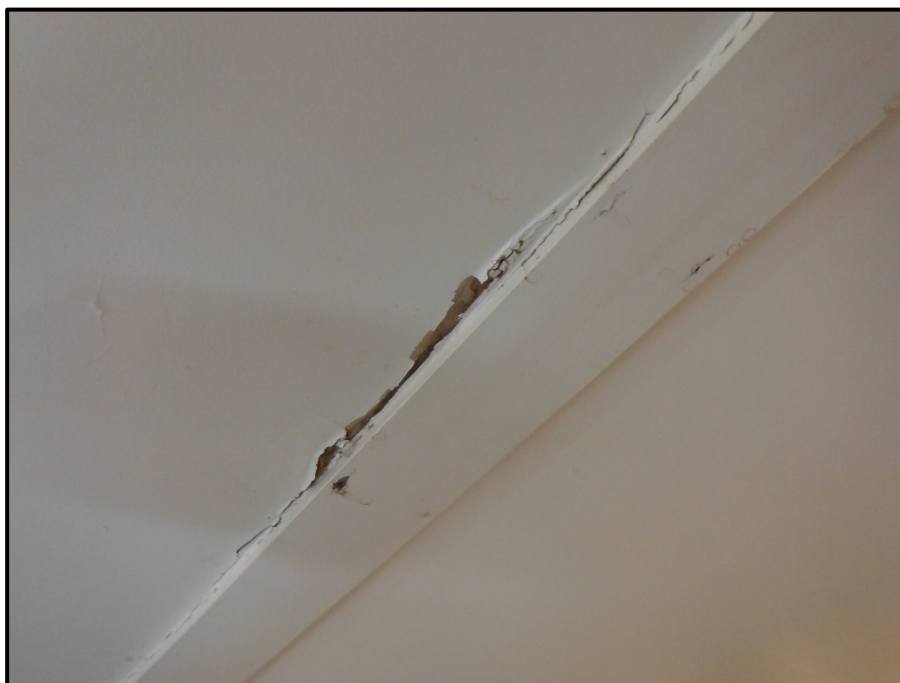
**Photograph 5: Lead-Containing Off-White Paint on Drywall/Wood Trim – Interior, Bunkhouse Compound**

Lead-containing surfaces with any amounts of lead that will be impacted through maintenance, renovation, or demolition activities in a manner likely to cause some level of airborne lead-containing dust or fumes, (i.e., welding, torch cutting, grinding, sanding or sandblasting) should be controlled through the development and implementation of an Exposure Control Plan. The exposure control plan should include safe work procedures to address the lead exposure hazard during the maintenance, renovation, or demolition activities. The safe work procedures should include procedures to minimize dust during construction and demolition, procedures for proper containment, collection, clean-up and disposal of debris to prevent contamination in other areas, the use of proper cleaning tools, selection and use of proper personal protective equipment, and other applicable procedures.

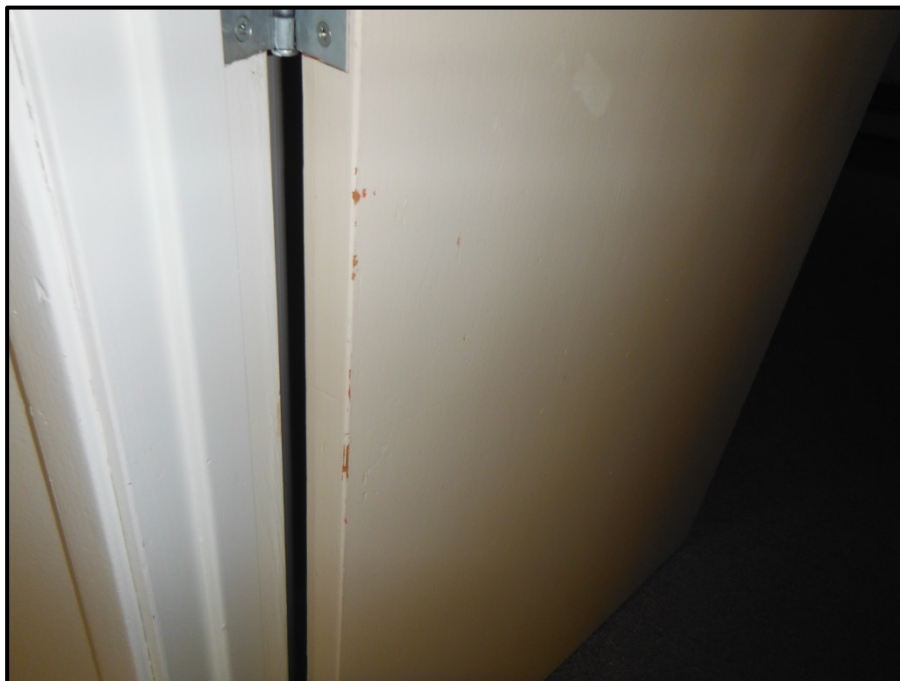
**Photograph 6: Lead-Containing Beige Paint on Wood Doors/Cabinets – Interior, Bunkhouse**

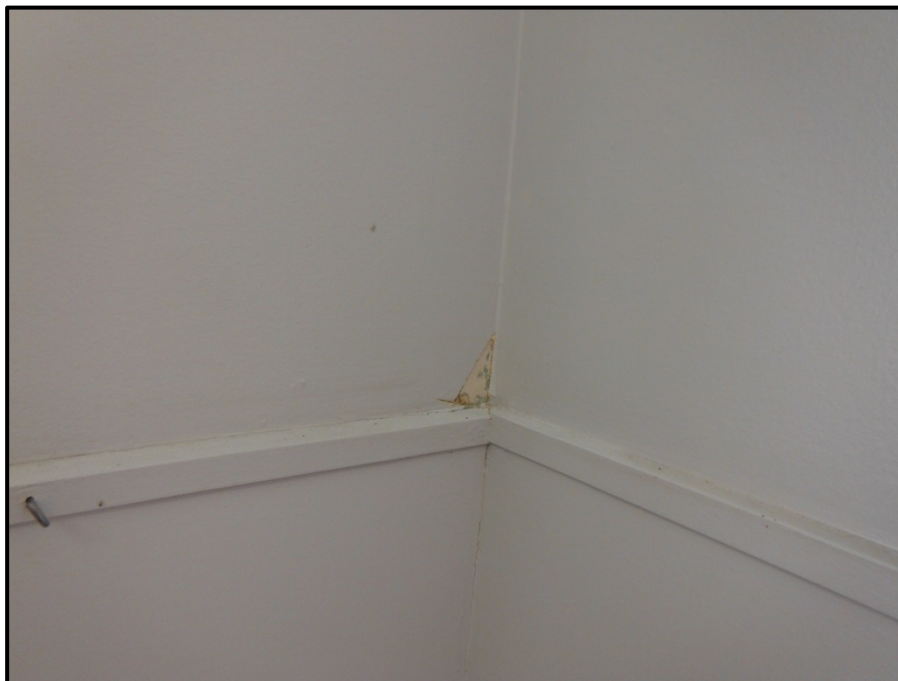
**Photograph 2: Asbestos-Containing Drywall Joint Compound, Lot 20**

Prior to any demolition or renovation activities, ACM that may be impacted must be removed. The work should be completed by workers certified by Alberta OHS. Throughout the abatement activities, appropriate air monitoring and inspections should be conducted by qualified personnel to document that contamination is contained and ACM are removed and disposed of appropriately. It is recommended that a proper scope of work and asbestos removal specifications be written to scope the complete and proper removal of the identified ACM.

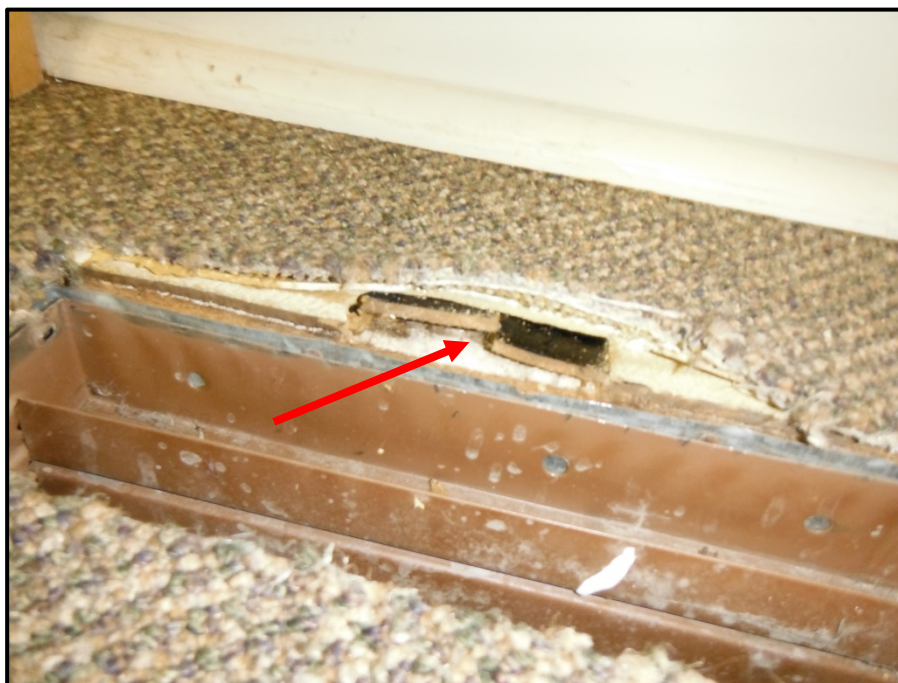
**Photograph 3: Asbestos-Containing Vinyl Flooring Tile Beneath Sheet Flooring / Carpet, Lot 20 – Post Office**

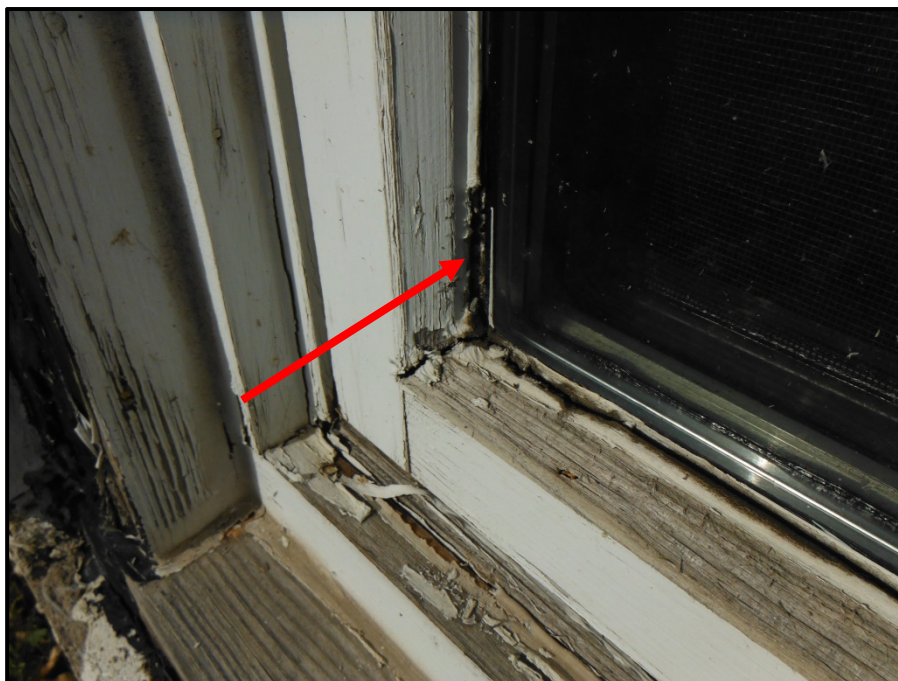
**Photograph 4: Asbestos-Containing Grey Window Putty, Exterior, Lot 20 – Exterior of Residence**

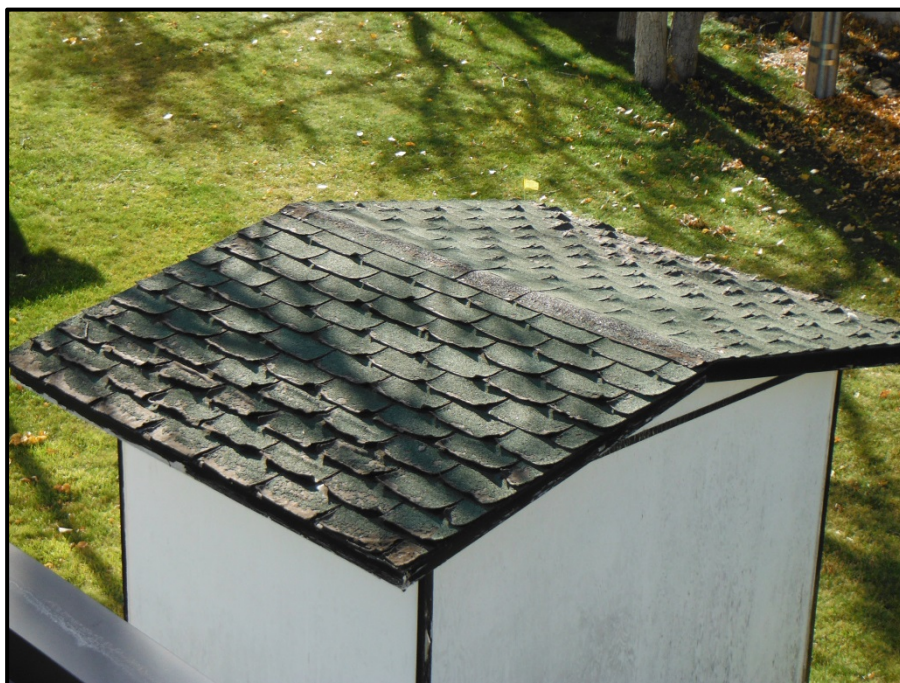
**Photograph 5: Asbestos-Containing Asphalt Roofing Shingles, Shed, Lot 20 – Exterior of Residence**

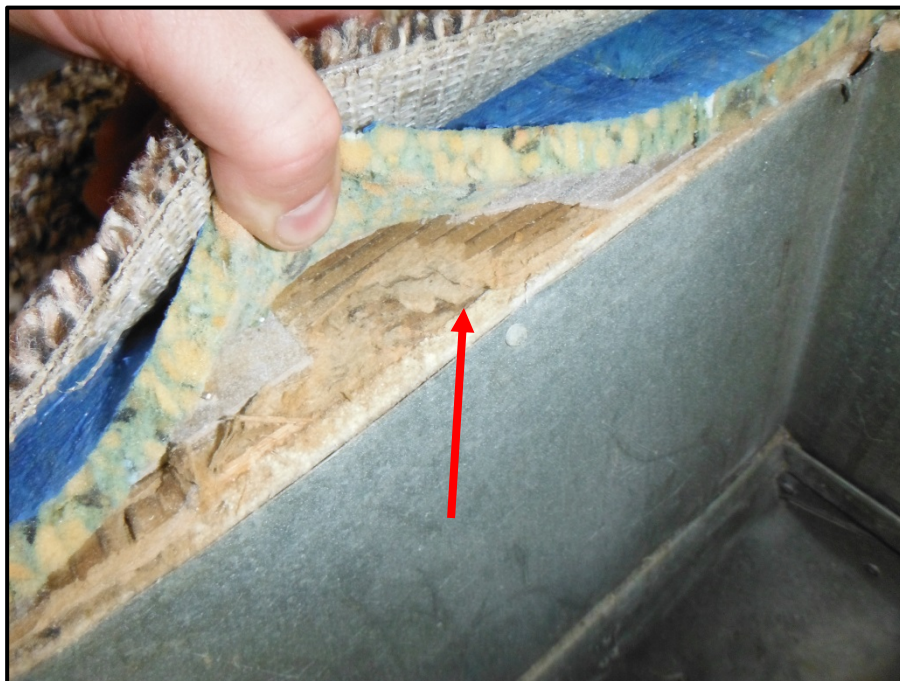
**Photograph 6: Asbestos-Containing Vinyl Floor Tile Beneath Carpet, Lot 20 – Residence**

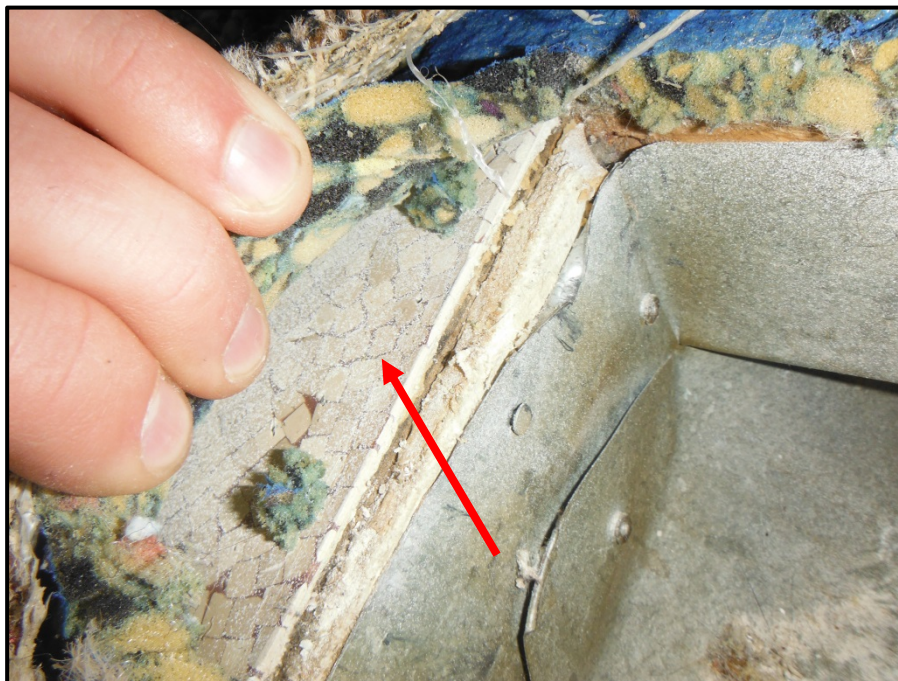
**Photograph 7: Asbestos-Containing Mosaic Sheet Flooring Beneath Carpet, Lot 20 – Residence**

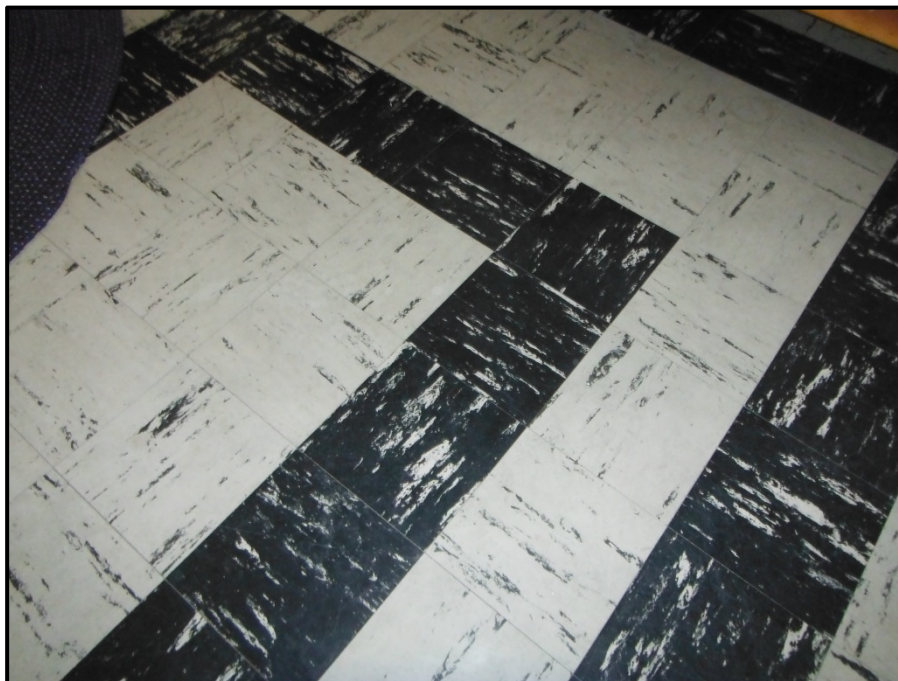
**Photograph 8: Asbestos-Containing 9" x 9" Vinyl Floor Tile, Basement, Lot 20 – Residence**

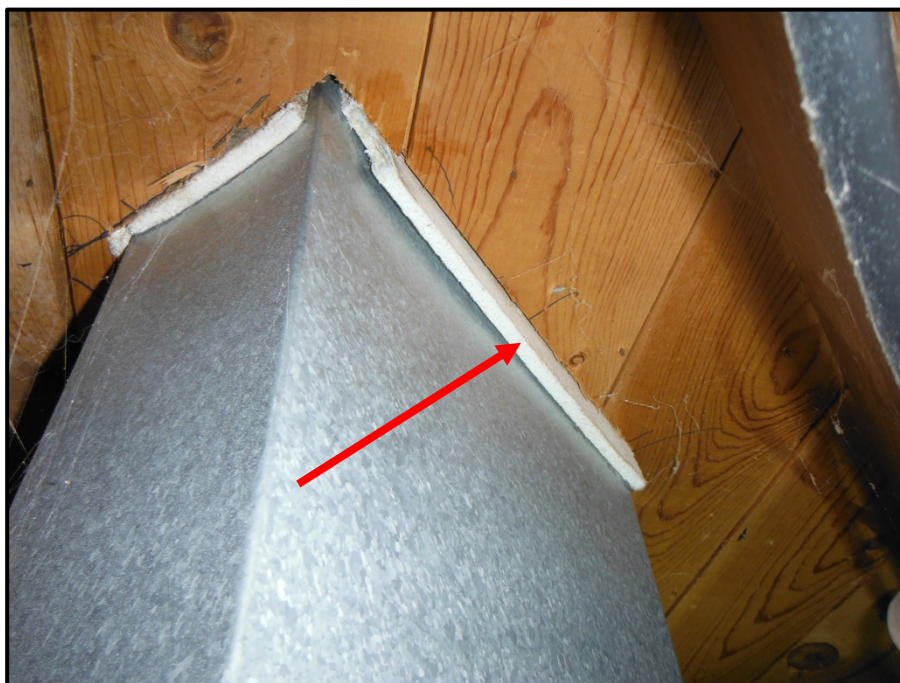
**Photograph 9: Asbestos-Containing White Insulation Board around Floor Vents, Lot 20 – Residence**

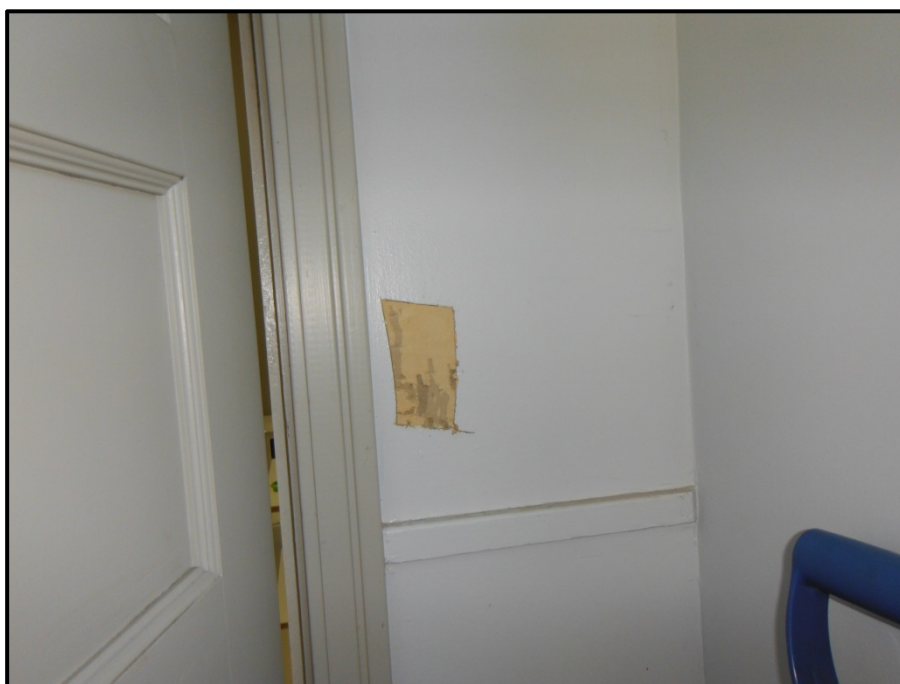
**Photograph 10: Lead-Containing Light Grey Paint on Drywall – Interior, Lot 20 – Post Office**

Lead-containing surfaces with any amounts of lead that will be impacted through maintenance, renovation, or demolition activities in a manner likely to cause some level of airborne lead-containing dust or fumes, (i.e., welding, torch cutting, grinding, sanding or sandblasting) should be controlled through the development and implementation of an Exposure Control Plan. The exposure control plan should include safe work procedures to address the lead exposure hazard during the maintenance, renovation, or demolition activities. The safe work procedures should include procedures to minimize dust during construction and demolition, procedures for proper containment, collection, clean-up and disposal of debris to prevent contamination in other areas, the use of proper cleaning tools, selection and use of proper personal protective equipment, and other applicable procedures.

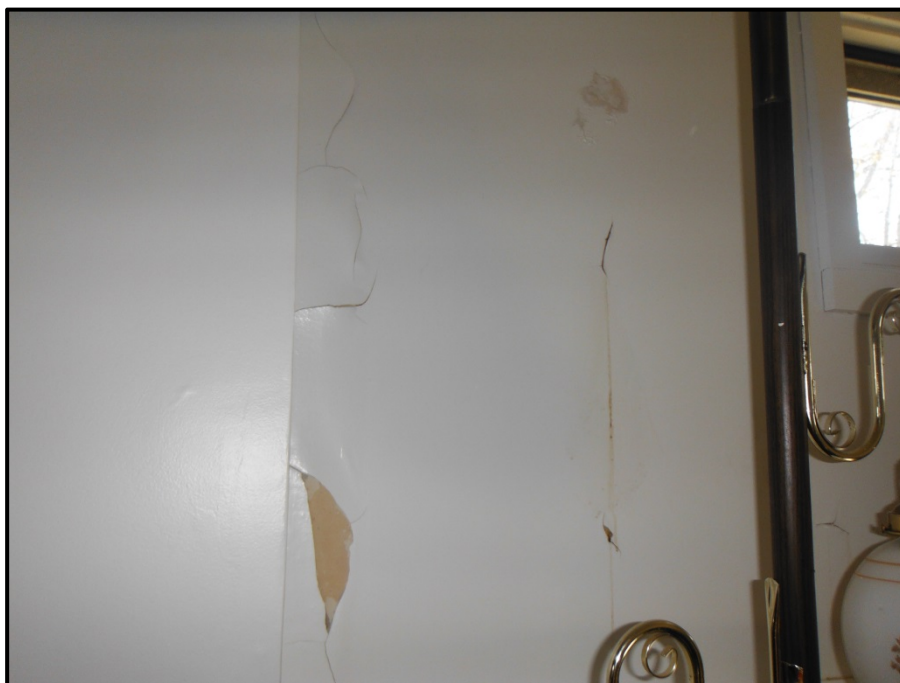
- Light Grey Paint on Drywall – Post Office (good condition);
- White Paint on Drywall – Residence, Basement, South Wall (poor condition); and
- Grey Paint on Concrete Floor – Residence Side (good condition).

**Photograph 11: Lead-Containing White Paint on Drywall – Interior, Lot 20 – Residence**

Lead-containing paint in poor condition should be abated prior to demolition. The lead containing paint that is flaking or loose (poor condition) should be abated following methods and requirements outlined in the Alberta OHS *Lead at the Work Site Bulletin*. The lead-containing paint waste should be analyzed for lead leachability by toxicity characteristic leaching procedure (TCLP) prior to transportation and disposal. The transportation and disposal of lead-containing waste materials must be conducted in accordance with the requirements of AEP and the Federal Transportation of Dangerous Goods Act and Regulations, current to the date of the work. The AEP Waste Control Regulation prescribes the disposal pathways for lead-containing waste.

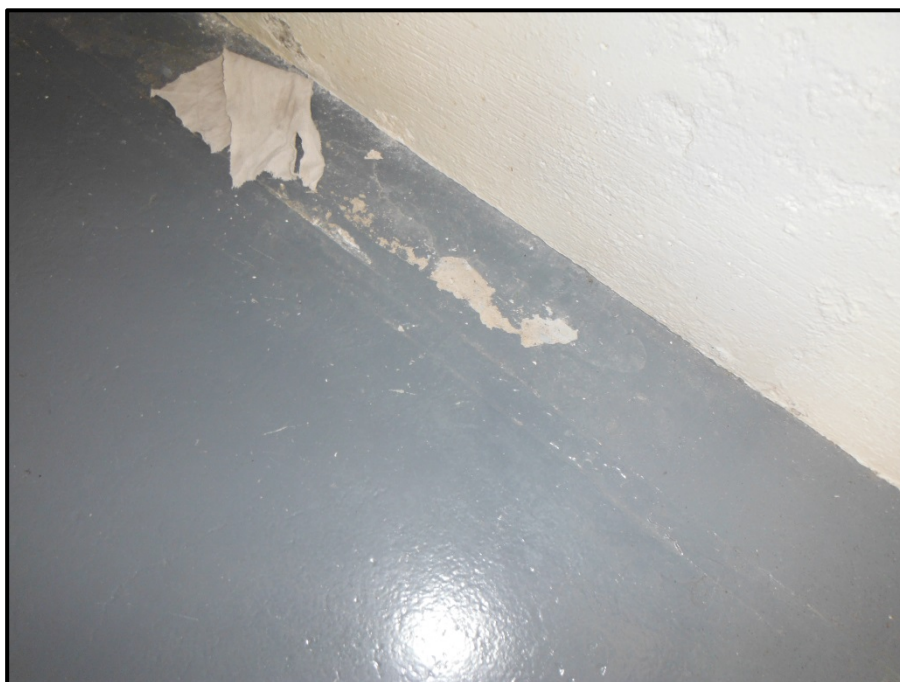
**Photograph 12: Lead-Containing Grey Paint on Concrete Floor – Interior, Lot 20 – Residence**

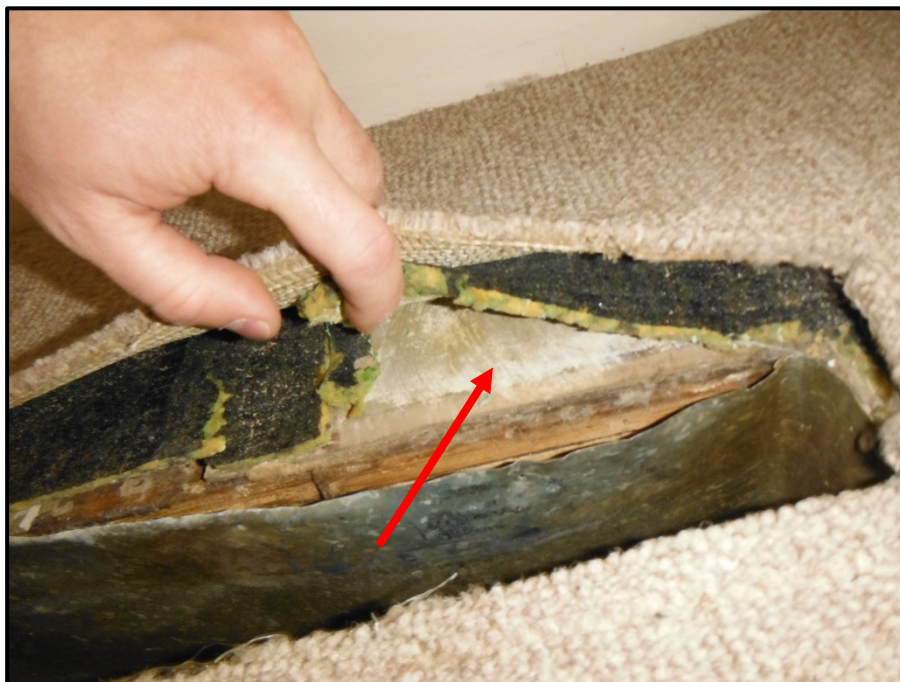
**Photograph 2: Asbestos-Containing Brown Vinyl Floor Tile (Sub Floor), Lot 21**

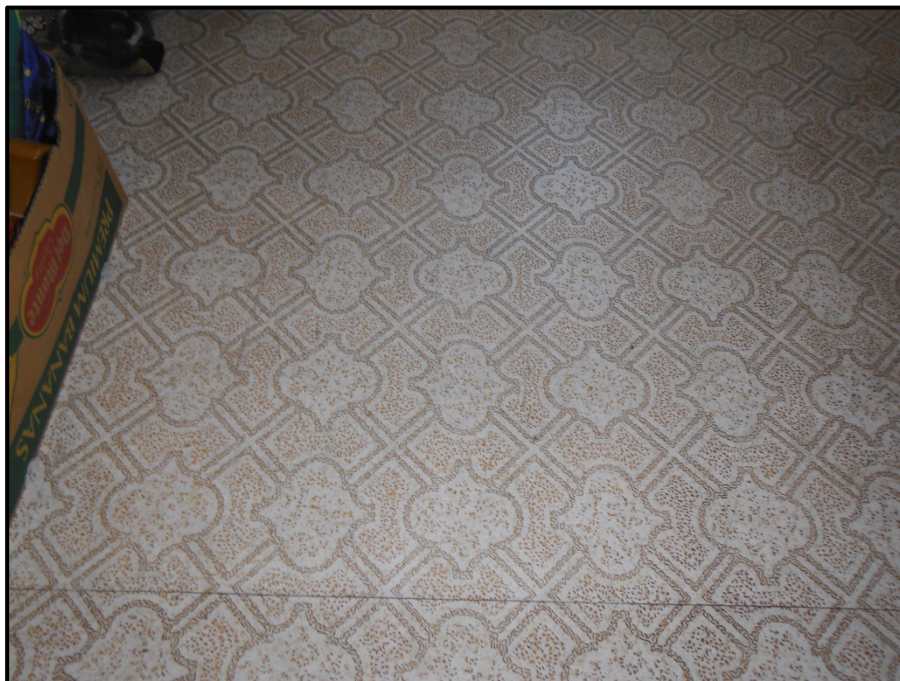
**Photograph 3: Asbestos-Containing Beige Patterned Sheet Flooring, Lot 21**

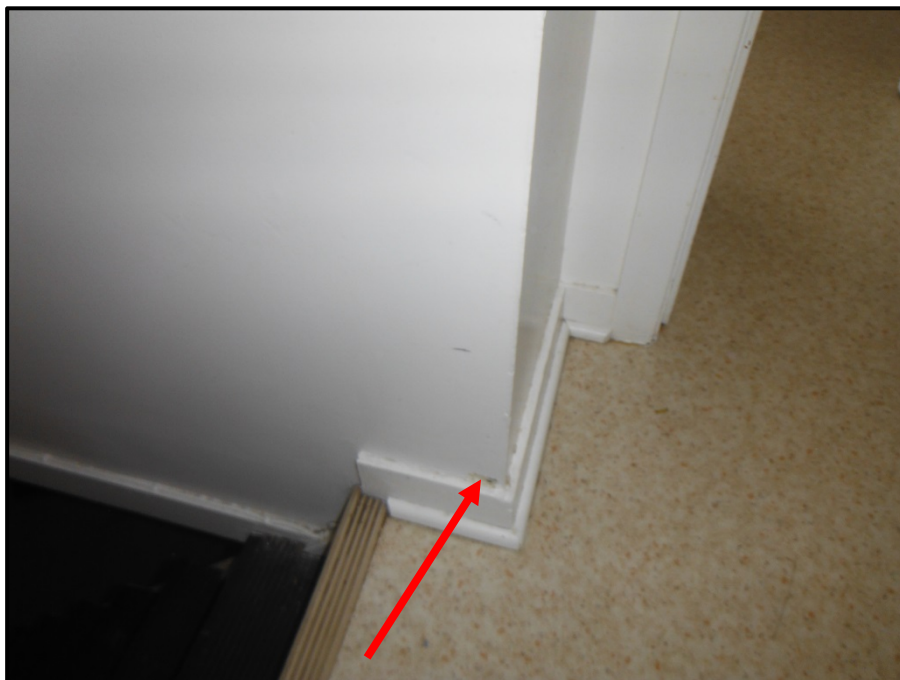
**Photograph 4: Asbestos-Containing Drywall Joint Compound, Lot 21**

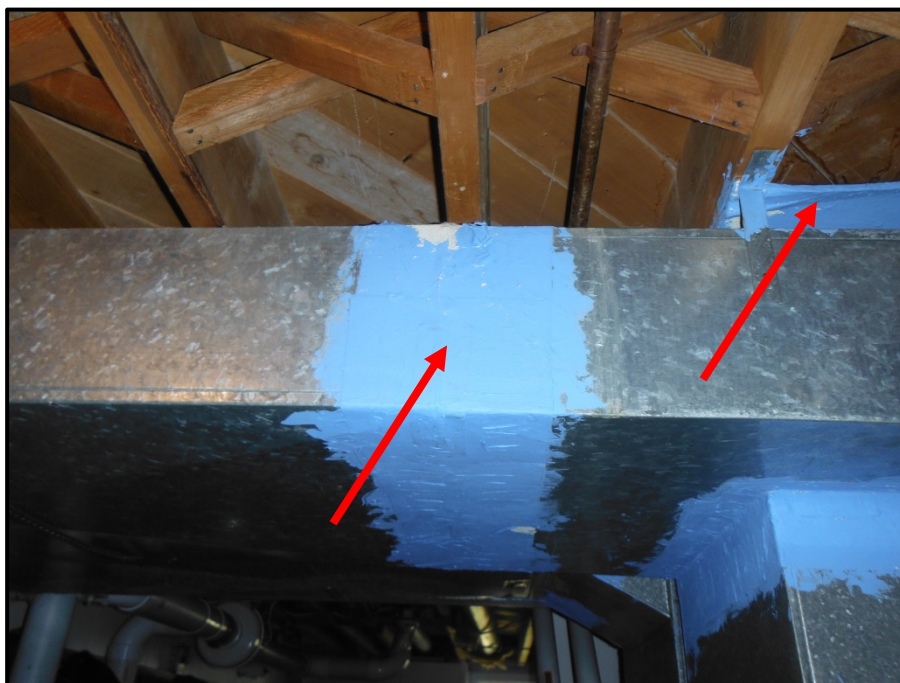
**Photograph 5: Asbestos-Containing Grey Paper Duct Wrap and Grey Board above Furnace, Lot 21**

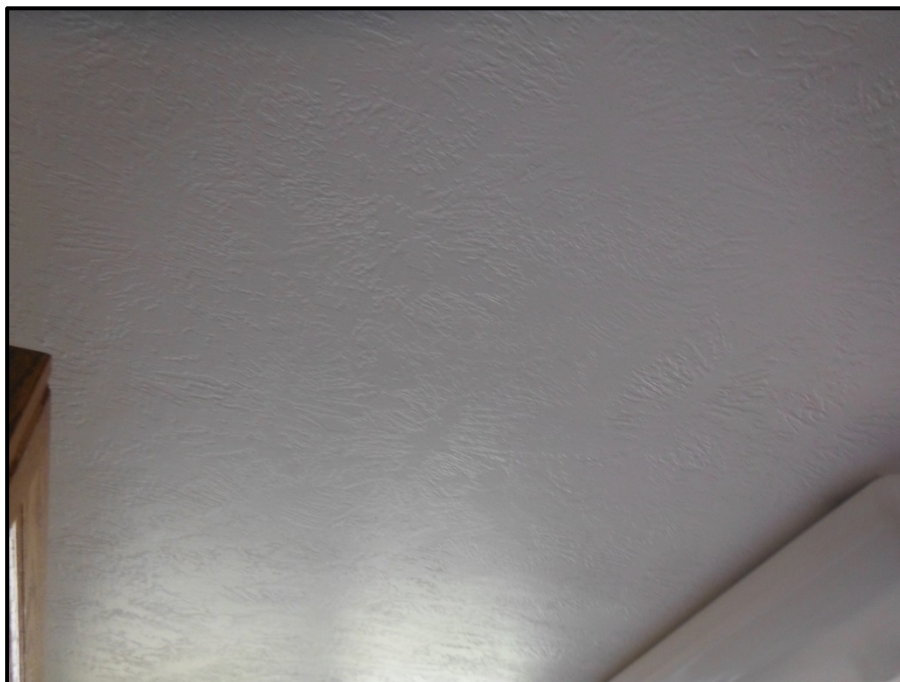
**Photograph 6: Asbestos-Containing Ceiling Texture Coat (Mud), Lot 21**

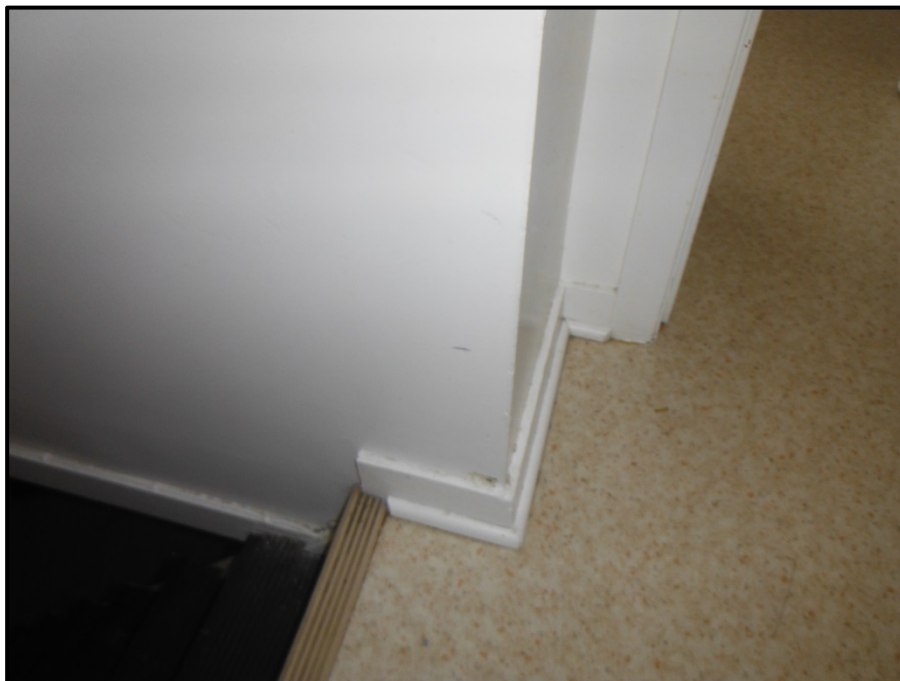
**Photograph 7: Lead-Containing Beige Paint on Drywall and Wood Trim – Interior, Lot 21**

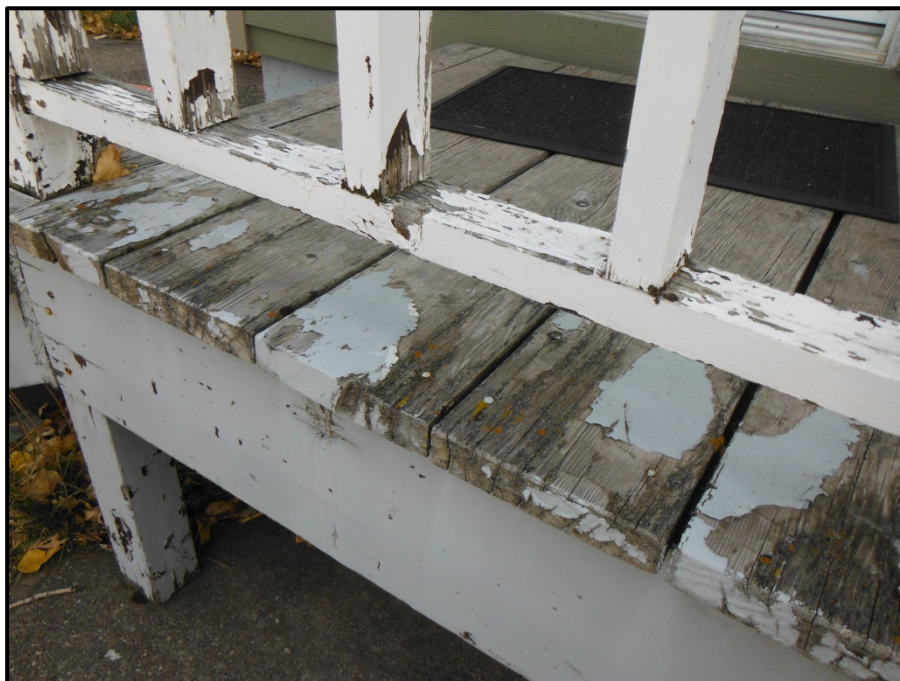
**Photograph 8: Lead-Containing White and Grey Paint on Wood Deck – Interior, Lot 21**

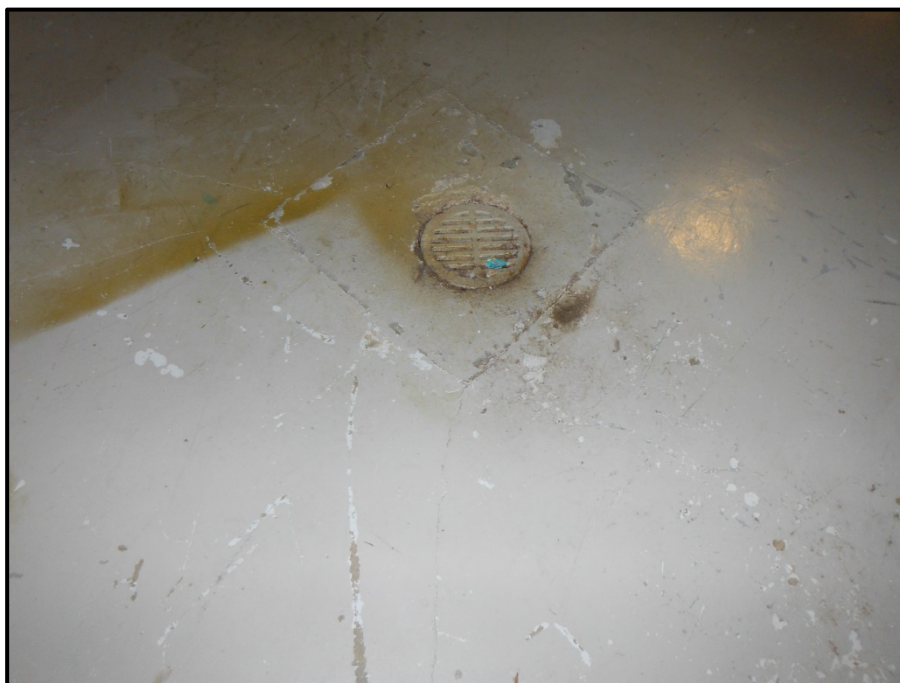
**Photograph 9: Lead-Containing Grey Paint on Concrete Floor – Basement, Lot 21**
