Repulse Bay RCMP Detachment

Lot L94-95, PO Box 31, Repulse Bay. Nunavut

Appendix B – RCMP/SNC Concentric Tank Inspection (2014)

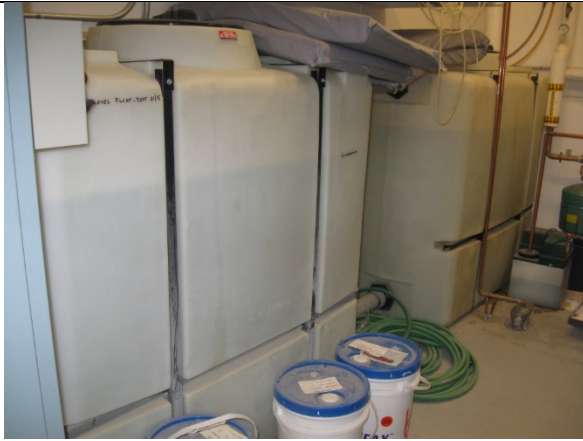
Water tanks at detachment (2 x 325 gal)

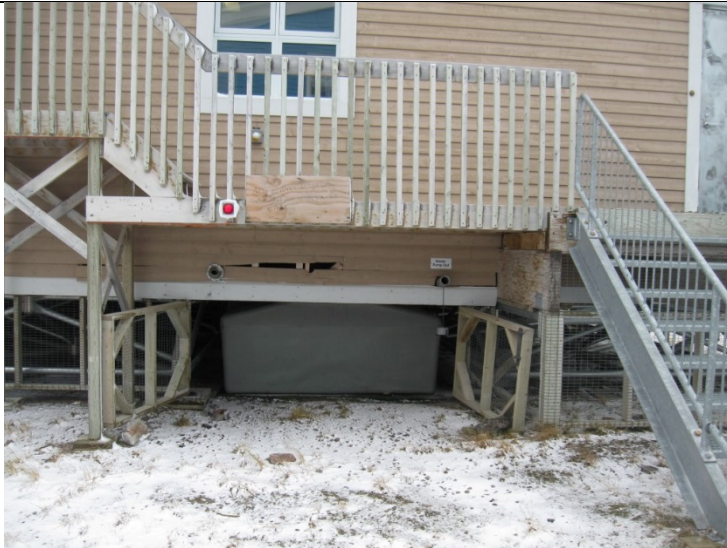
Existing sewage tank is damaged and leaking on three corners. Sewer pipes are freezing, as hydronic heat trace does not extend through piping chase from boiler to sewage tank. There is no light/signal/alarm to indicate heat trace is on.

Sewer tank at detachment, between triodetic foundations

- Remove and replace existing sewage/sanitary tank. Replace with insulated fiberglass glycol/hydronic heat-traced sewer holding tank system. New Sewage tank is to be a double-wall, insulated tank e.g. Equinox G1000 EHT. Tank must be close-to existing sewage tank volume (1000 gals/4500 L) and must be sized 1.5x total capacity of water holding tanks estimated 325-360 gals/ea., 1500-1600 L = 3000 L/total.

- Recommendation is for replacement tank to be located where existing sewage tank is but new tank must be installed with additional protection in an insulated box/containment. The existing winds & extreme cold weather are over-taxing the ability for fluids inside tank to remain thawed, even with heat trace.

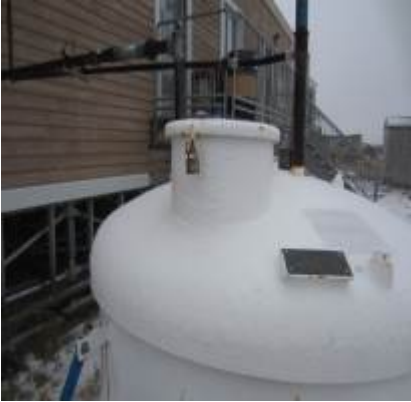
Code Issues	
<p>CSA B139 (09) 7.9.2.3</p>	<p>Issue: The overflow pipe should be at least twice the cross-sectional area of the supply line and not less than 2", and should be installed without sags or traps. Recommendation: Replace existing overflow pipe with properly sized pipe with no sags present.</p>

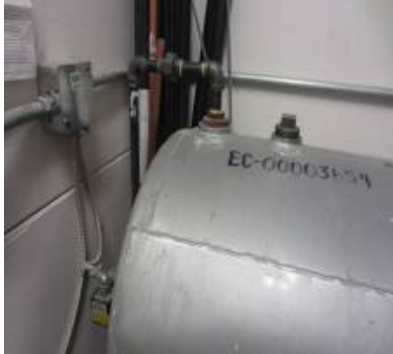
<p>CSA B139 (09) 7.10.2</p>	<p>Issue: Tanks installed inside must be provided with a gauge to determine liquid level. Recommendation: Install code approved gauge on tank.</p>

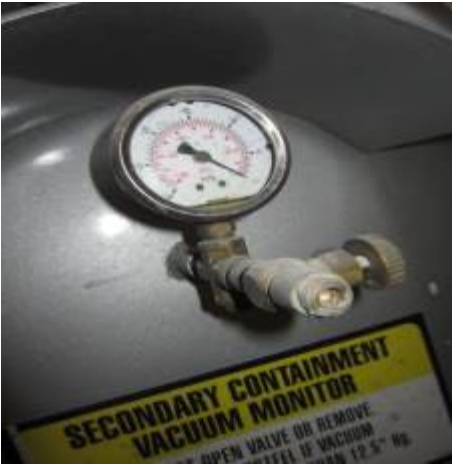
<p>Observation</p>	<p>The vacuum on the tank has been lost. This could be an indication of tank failure. The vacuum should be redrawn, and if it does not hold, the tank should be replaced.</p>

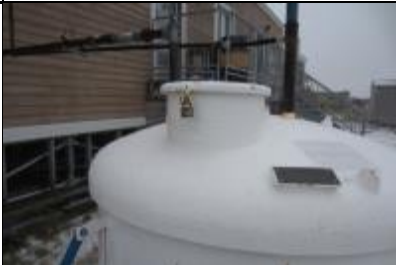
Code Issues	
<p>CSA B139 (09) 9.3.1.5</p>	<p>Issue: Piping shall be supported and protected against physical damage such as foot traffic, vehicles, and snow and ice damage. Recommendation: Protective covering over piping is recommended to prevent falling ice and snow from damaging piping.</p>
<p>CSA B139 (09) 9.4.1</p>

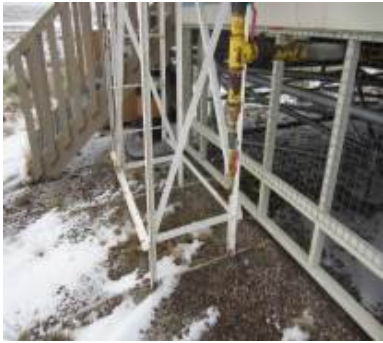
Code Issues	
Code violations are listed below. The overall recommendation for this site since the tank is single wall is to replace the system with new.	
CSA B139 (09) 7.3.8	<p>Issue: A tank shall be installed on rigid, non-combustible supports constructed of materials having a fire-resistance rating of not less than 2h. New tank should be installed with concrete pad, or pressure treated wood flush with grade.</p>

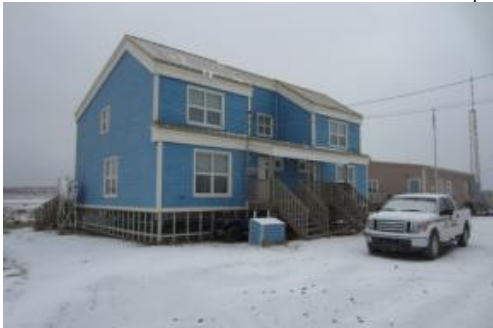
CSA B139 (09) 7.5.5	<p>Issue: Outdoor tanks need secondary containment, or need to be double walled/bottom with interstitial monitoring. Existing tank is single wall and needs to be replaced.</p>
CSA B139 (09) 7.5.6	<p>Issue: Tanks installed in an area not separated by vehicles needs to be protected by good engineering practices. Protective bollards to be installed for new tank to prevent accidental vehicle collision.</p>

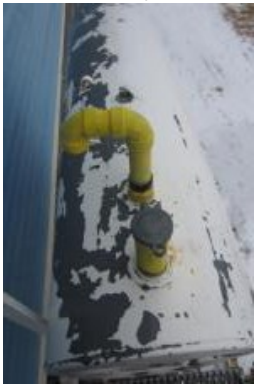
CSA B139 (09) 7.8.2	<p>Issue: Each fill opening and each entry to a fill pipe shall be provided with a weather tight cover designed to prevent tampering. New tank to be provided with code approved, weather tight cover.</p>

<p>CSA B139 (09) 7.8.4</p>	<p>Issue: A fill opening shall be designed to avoid spillage. (see photo above) New tank should be installed with certified spill containment box.</p>
<p>CSA B139 (09) 7.9.1.7</p>	<p>Issue: Vent must terminate a minimum of 6" above fill. (see photo above) New vent to extend a minimum of 6" above fill.</p>
<p>CSA B139 (09) 7.9.1.7</p>	<p>Issue: Vent must be c/w a weatherproof hood. The vent hood or cap shall prevent ingress of objects. (see photo above) New tank vent to terminate in code approved hood.</p>
<p>CSA B139 (09) 9.3.1.5</p>	<p>Issue: Piping shall be supported and protected against physical damage such as foot traffic, vehicles, and snow and ice damage. Protective covering over new piping recommended to prevent falling ice and snow from damaging piping.</p>
