Designated Substance Survey

Maintenance Compound

**100 Laird Avenue
Amherstburg, Ontario**

November 23, 2016

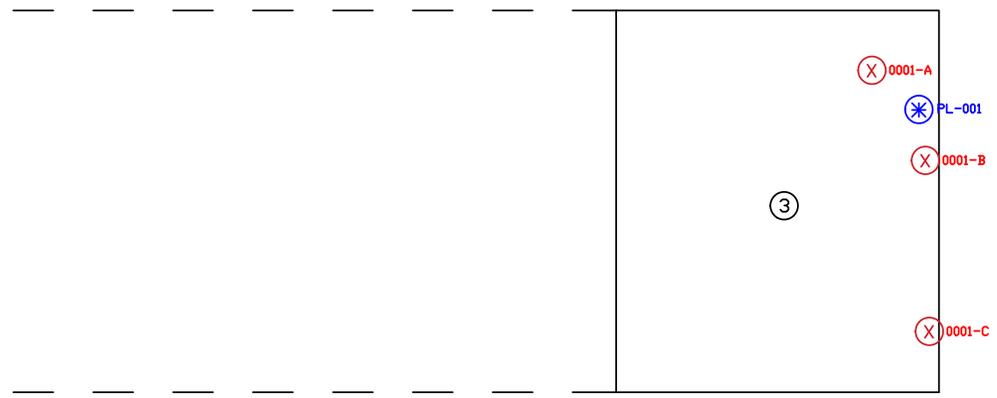
Drawings referencing survey and sample locations are presented in Attachment 3.

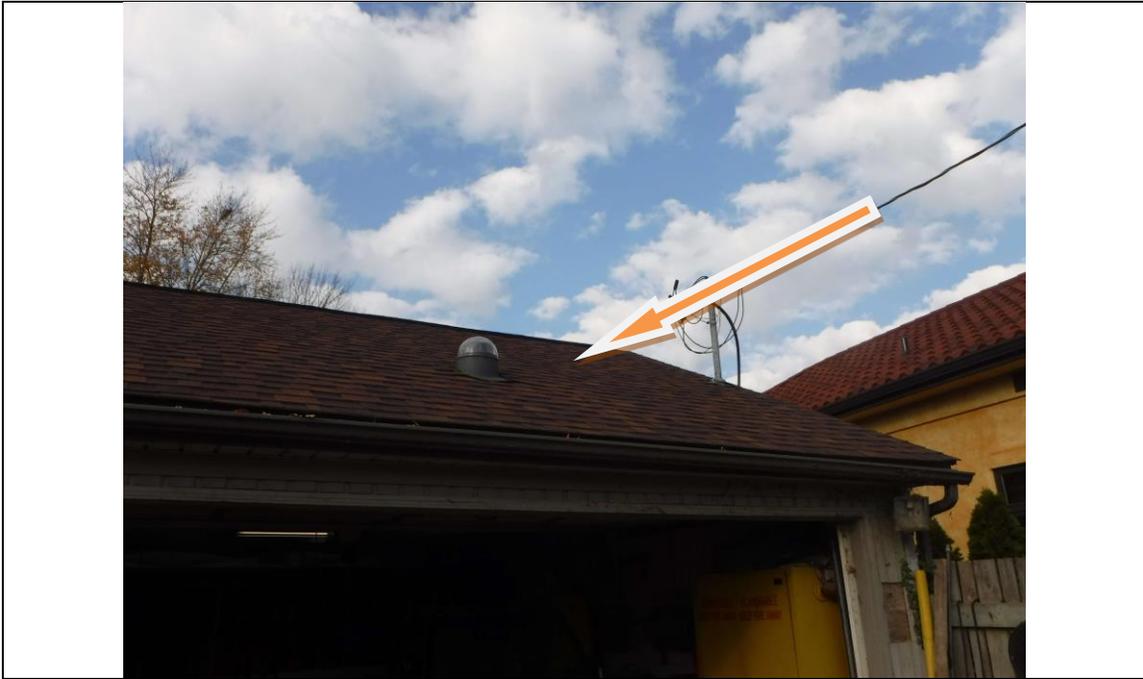
Roofing materials were not sampled as IES was advised the roofing materials were installed within the last decade.

Photo 1 – Non-asbestos roofing materials.

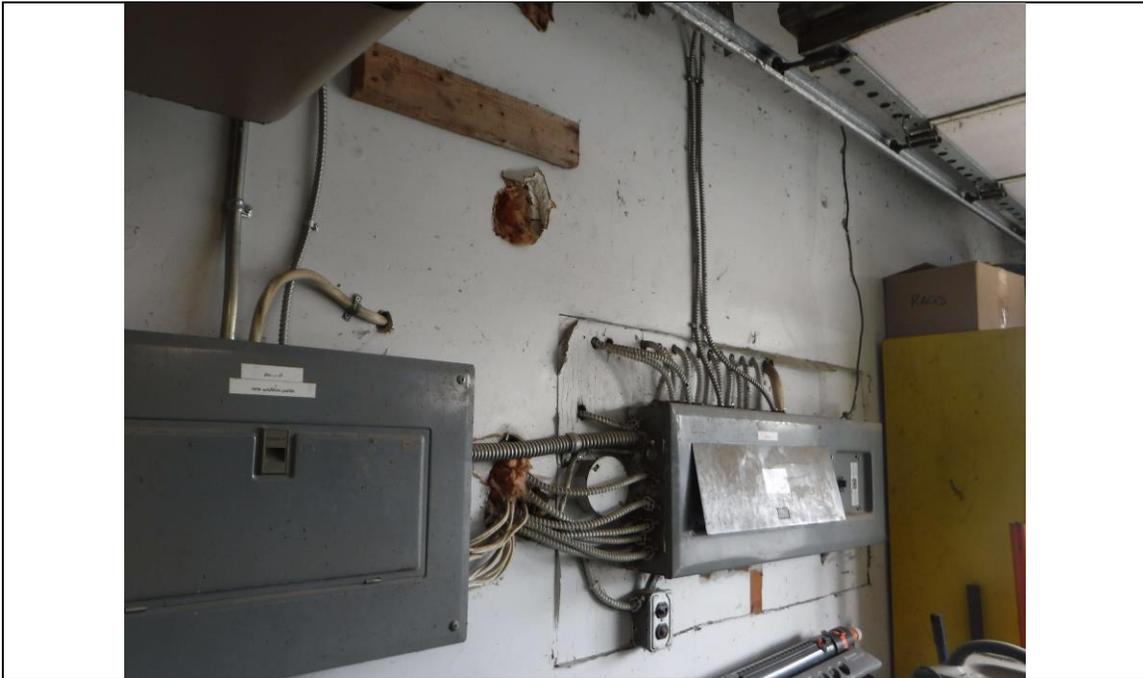
Three (3) samples of drywall joint compound present on drywall finishes throughout the assessed areas of the facility were collected and analyzed for asbestos content (samples 0001 A-C). The drywall joint compound has been analytically determined to be non-asbestos.

Photo 2 – Non-asbestos drywall joint compound.
