Title - Sujet Roof Replacements	
Solicitation No. - N° de l'invitation EZ899-172611/A	Amendment No. - N° modif. 001
Client Reference No. - N° de référence du client	Date 2017-02-09
GETS Reference No. - N° de référence de SEAG PW-\$PWY-026-7985	
File No. - N° de dossier PWY-6-39309 (026)	CCC No./N° CCC - FMS No./N° VME
Solicitation Closes - L'invitation prend fin at - à 02:00 PM on - le 2017-02-24	Time Zone Fuseau horaire Pacific Standard Time PST
F.O.B. - F.A.B. Plant-Usine: <input type="checkbox"/> Destination: <input checked="" type="checkbox"/> Other-Autre: <input type="checkbox"/>	
Address Enquiries to: - Adresser toutes questions à: Yi (PWY), Patty	Buyer Id - Id de l'acheteur pwy026
Telephone No. - N° de téléphone (778) 919-2578 ()	FAX No. - N° de FAX (604) 775-6633
Destination - of Goods, Services, and Construction: Destination - des biens, services et construction: CSC - Mountain Institution - Agassiz, BC

Hazardous Building Materials Assessment

Power House Roof Replacement at Mountain Medium Institution,
Agassiz, BC

January 18, 2017

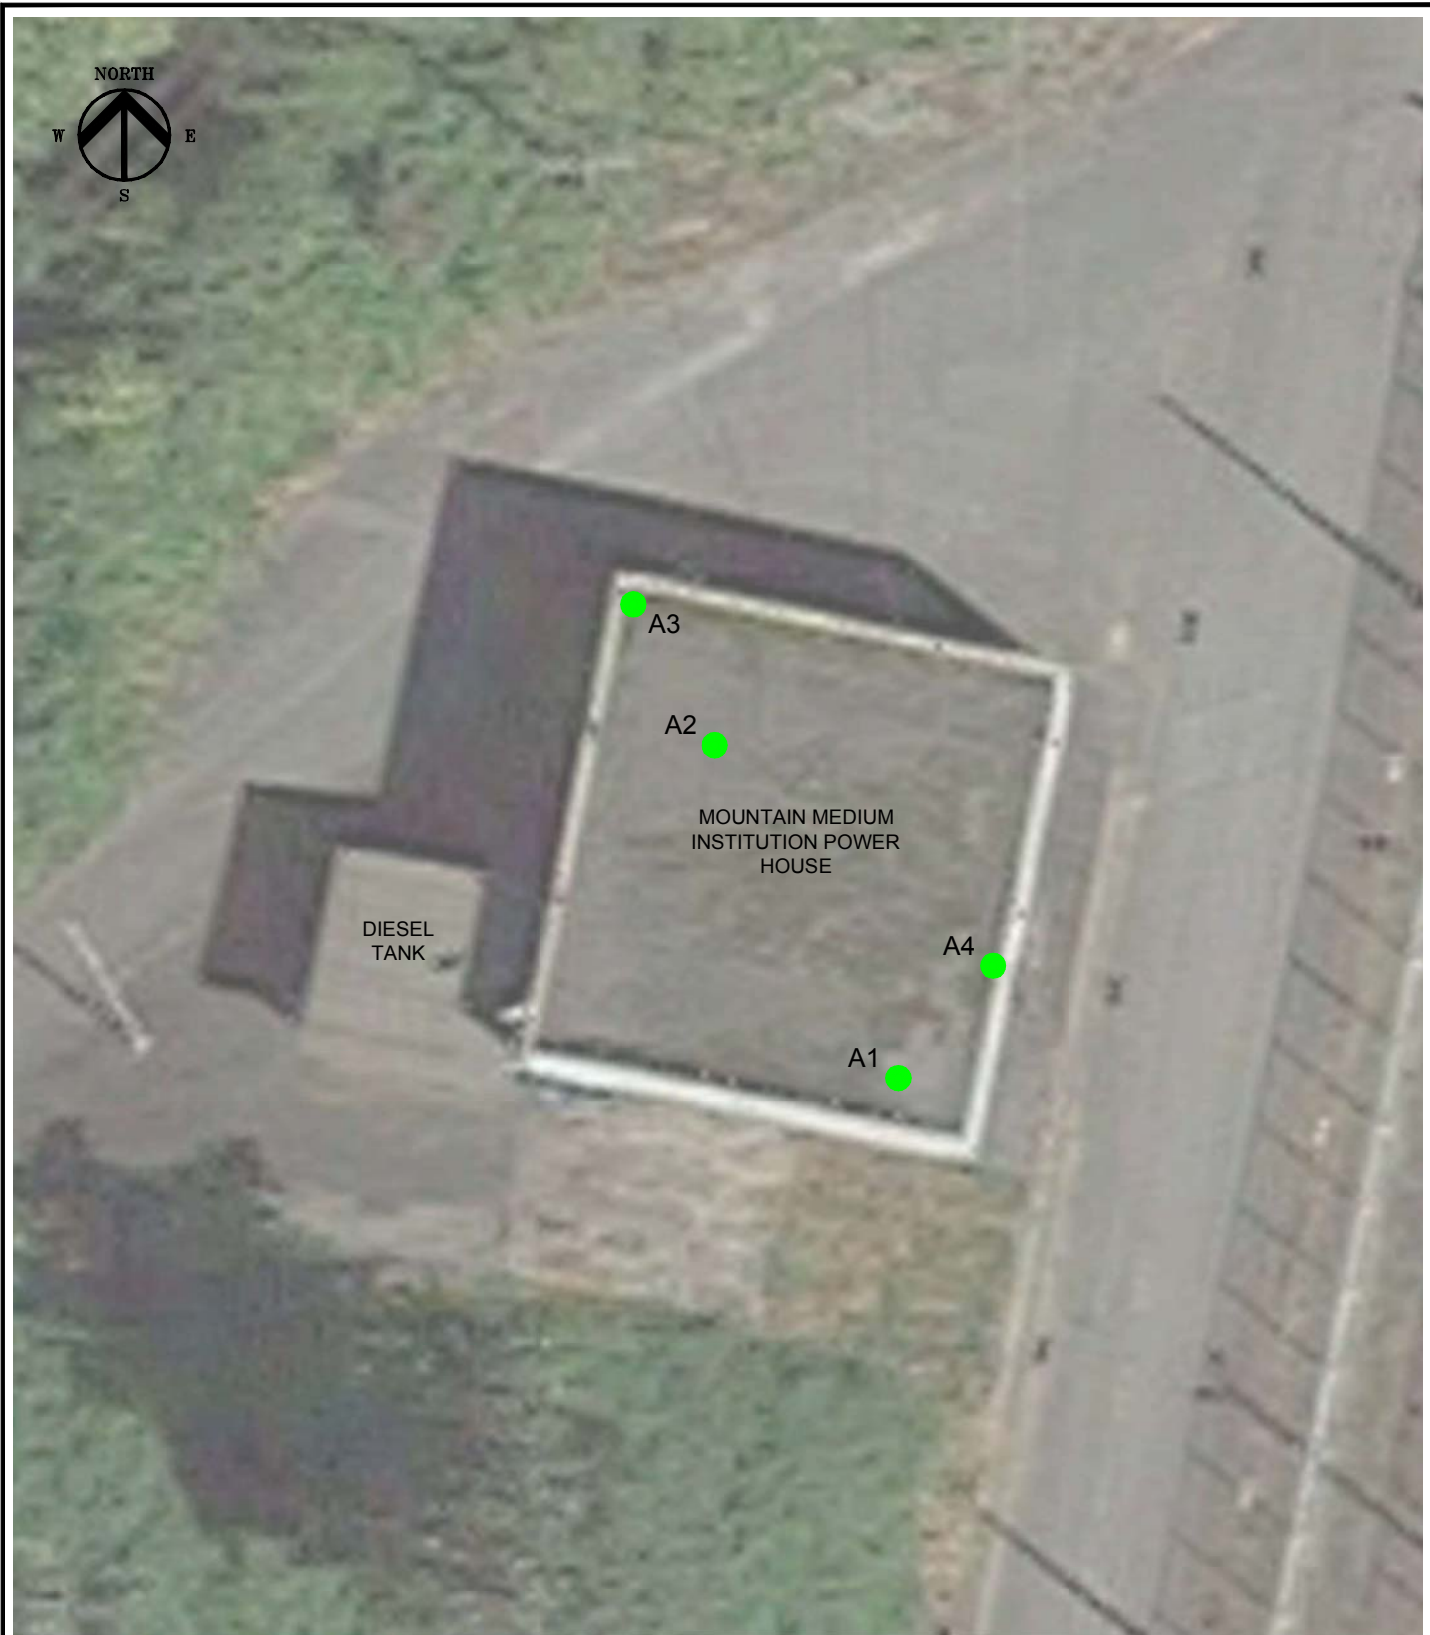
◀ 633545-BM1 – Building Material Survey – Mountain Medium Institution Power House Roof (A20)

A1 ASBESTOS SAMPLE WITH
CONCENTRATION LESS THAN 0.5%

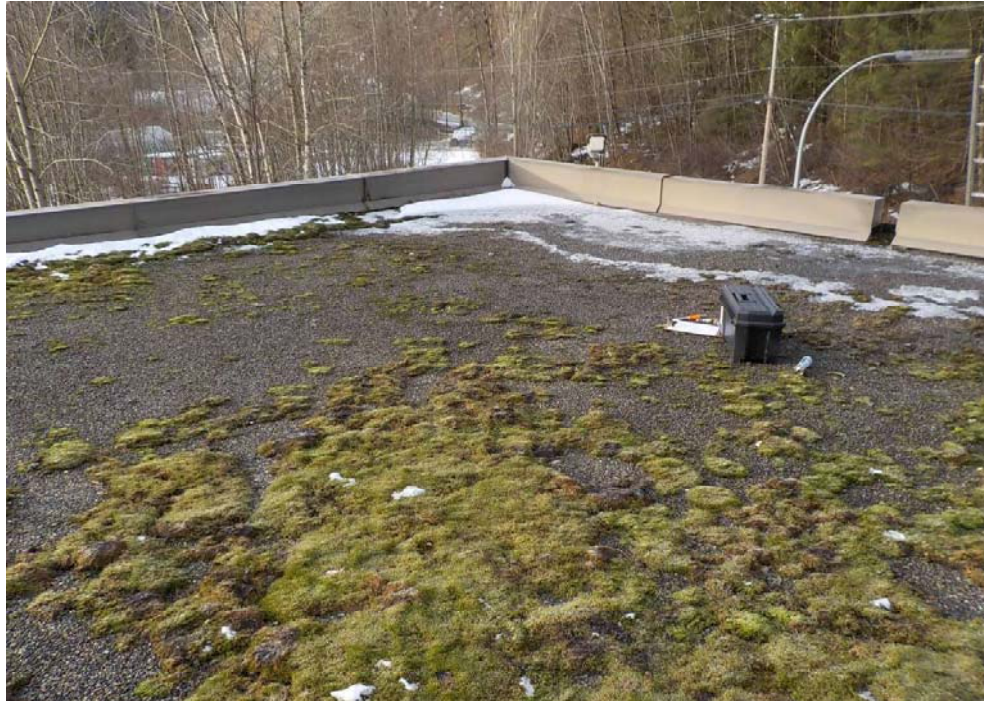
Photograph 1: Power House roof looking southwest from the northeast corner.

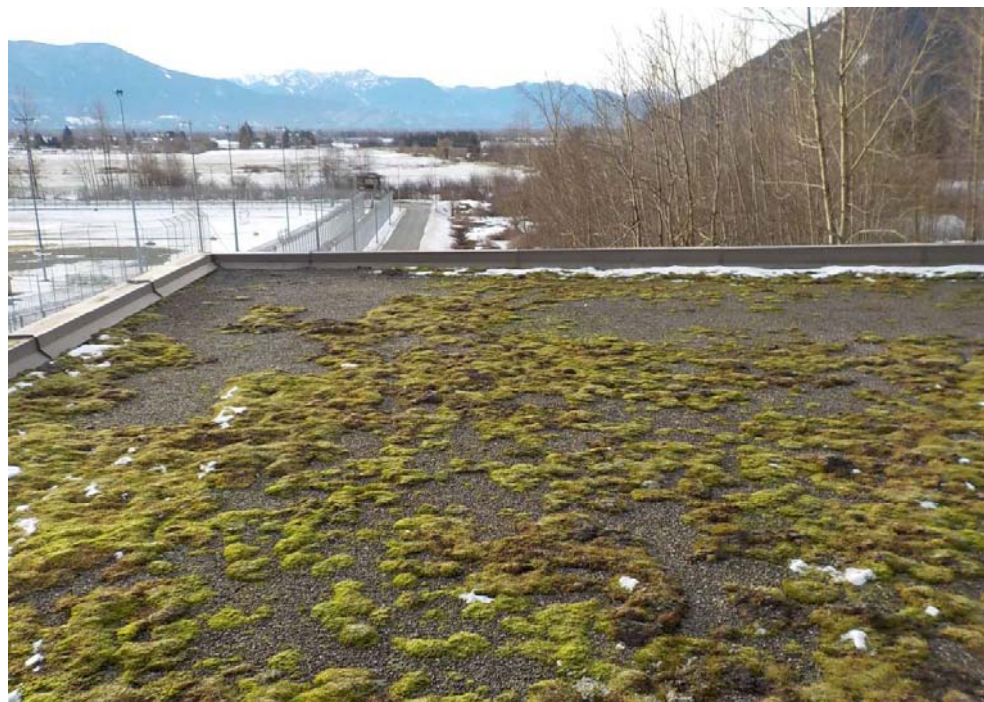
Photograph 2: Power House roof looking south from the northeast corner.

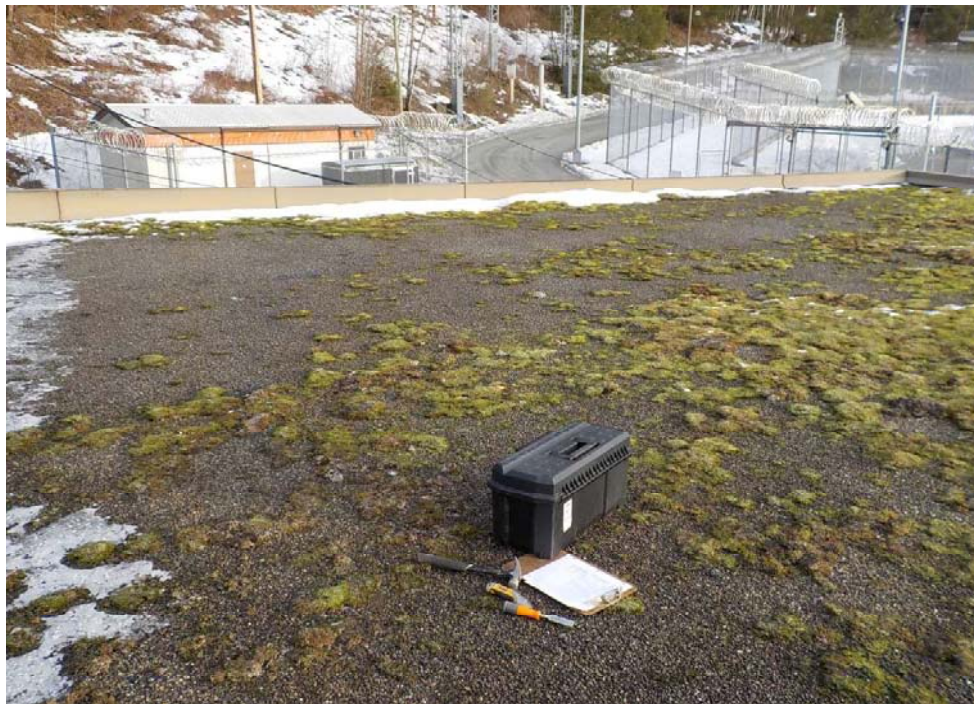
Photograph 3: Power House roof looking northeast from the southwest corner.

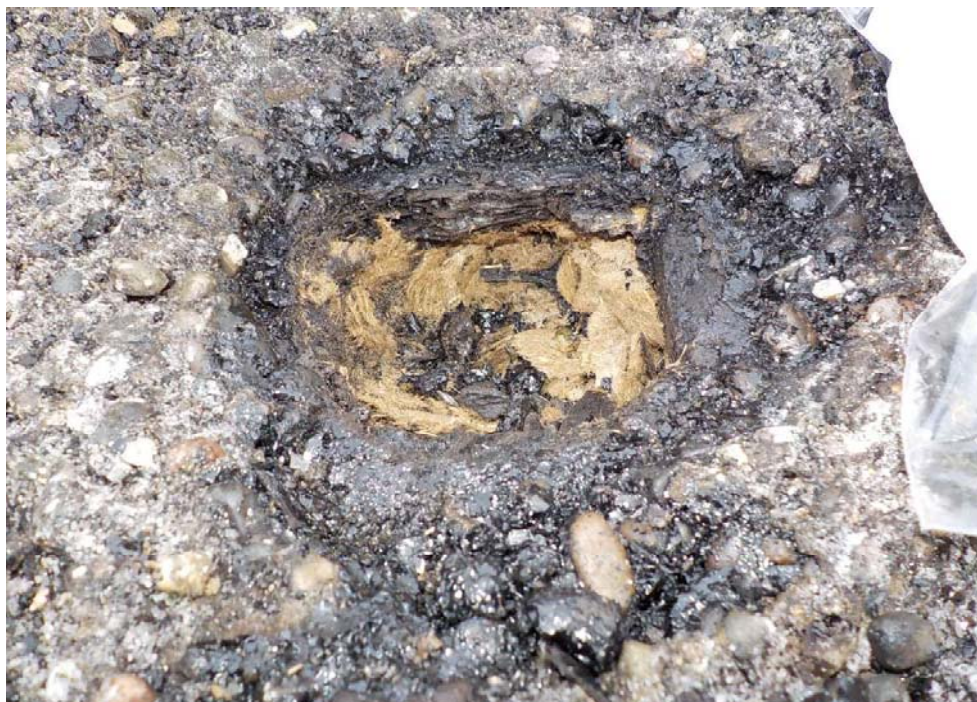
Photograph 4: Roof layers at sample location A2.

Sample QJ1520 [MTN-A2] : 2 layers - black tar mix, brown fibrous mix

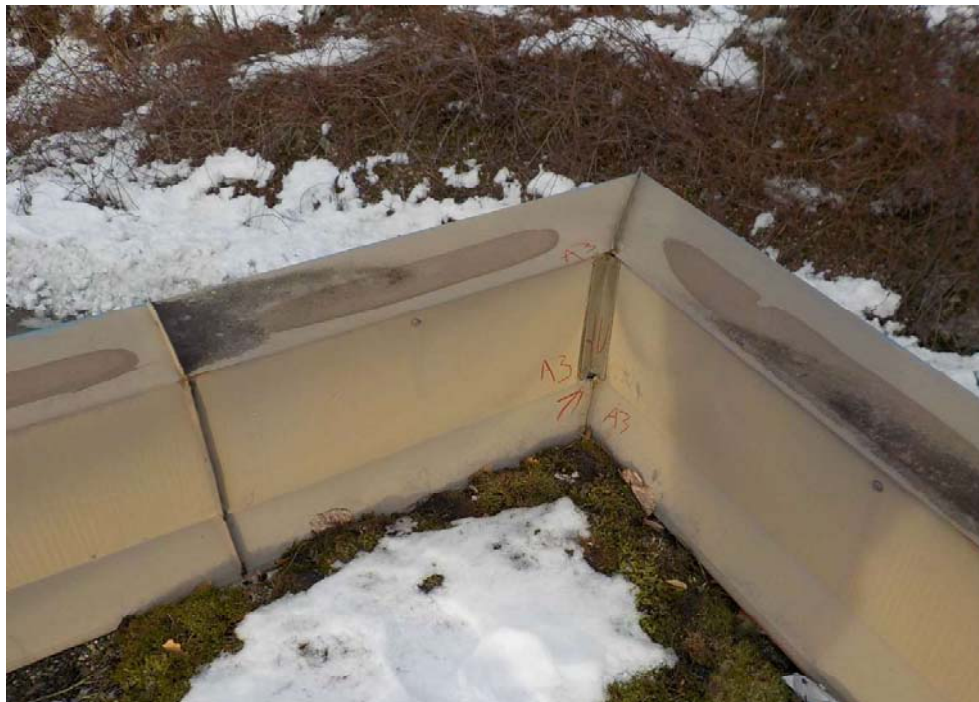
No lead paint samples were collected due to the nature of the paint application method (factory painted) and the substrate (metal flashing). The paint on the flashing may contain lead; however, due to the extremely thin coating applied during factory finishing, sampling was not possible. Based on the thinly applied factory finish, cutting, grinding or torching would not likely release enough airborne lead to exceed the allowable exposure limit if lead based paint was present. However, in order to be safe, removal of the flashing material should be completed by manually un-bolting and removing in sections or alternatively using equipment that will not cut, grind or heat the paint as work procedures should not include those that could potentially release lead fumes or dust.

Photograph 5: Factory painted flashing and A3 (mastic) sample location.

Sample QJ1518 [MTN-A3] : 2 layers - yellow glue, black mix

The roof flashing has been factory painted, the potential airborne lead concentrations during cutting or grinding would not be expected to exceed the airborne lead exposure limit. However, in order to ensure workers are not potentially exposed to lead above the occupational exposure limit, it is recommended that the flashing be removed by manually un-bolting and removing it in sections or alternatively using equipment that will not cut, grind or heat the paint and potentially create lead dust or fumes.

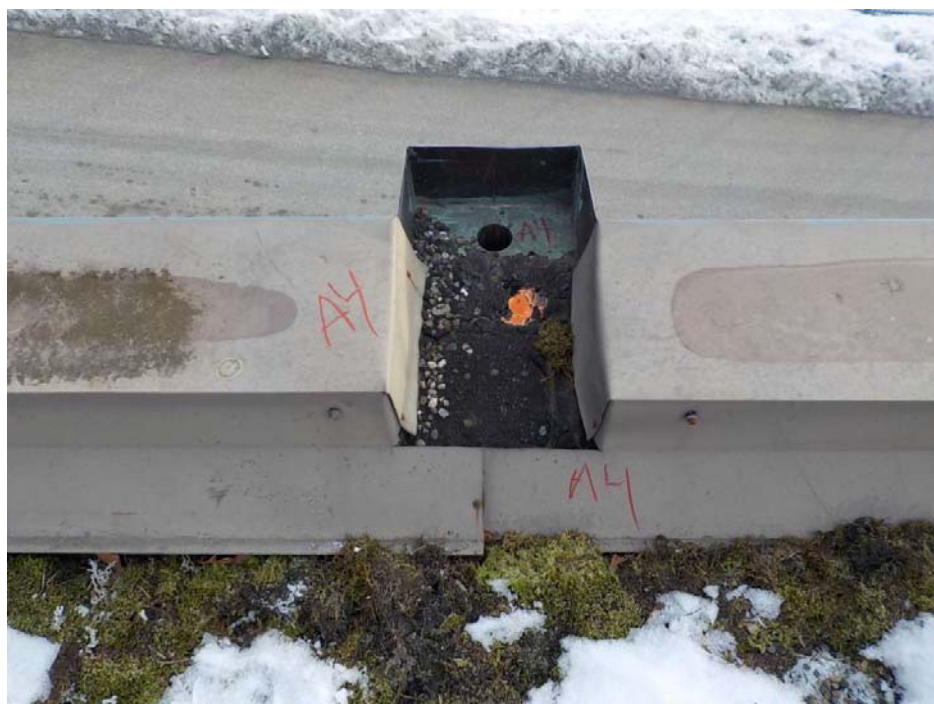
Photograph 6: A4 (roof tar) sample location.

Sample QJ1519 [MTN-A4] : 1 layer - black tar mix
