REPORT N° 151-63666-00 (P30 SP 30D)

PRE-RENOVATIONS HAZARDOUS MATERIALS SURVEY - PUBLIC MARKET, GRANVILLE ISLAND, VANCOUVER, BC

CANADA MORTGAGE AND HOUSING
CORPORATION

AUGUST 23, 2016

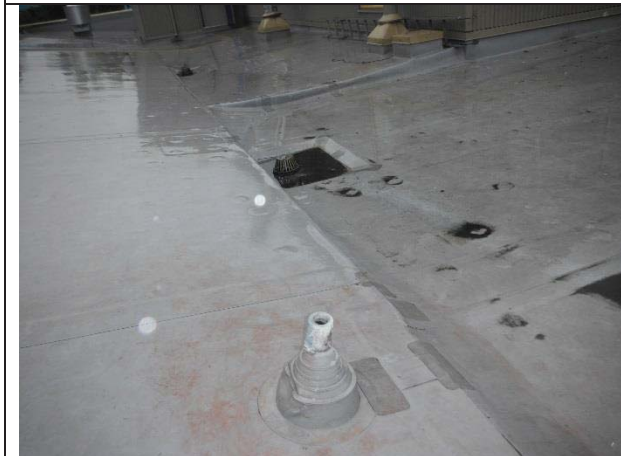
At the time of the onsite building review, lead containing bathroom exhaust vent boots were noted at the roof.

Photo 3: View of lead containing the washroom exhaust boot, present at the roof of the building.

- If the lead roof vents are replaced during renovations, they should be recycled at a licensed facility.
- If mould materials or animal wastes (rodent droppings) are found during renovation, safe work procedures should be followed when removing mould-contaminated materials and animal waste.

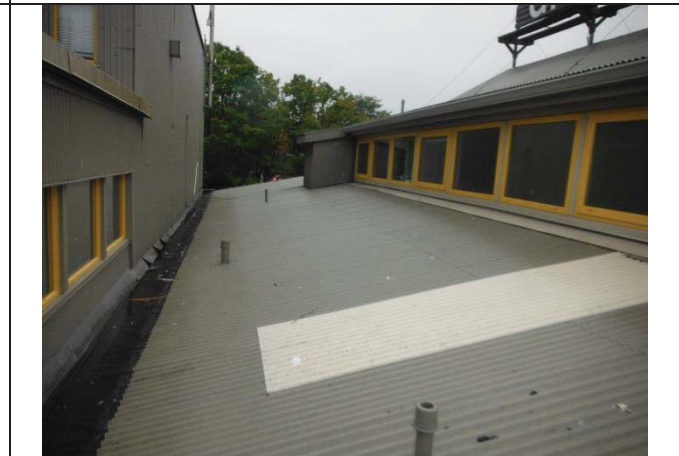
Photo 4: View of lead containing the wash room exhaust boots, present at the roof of the building.

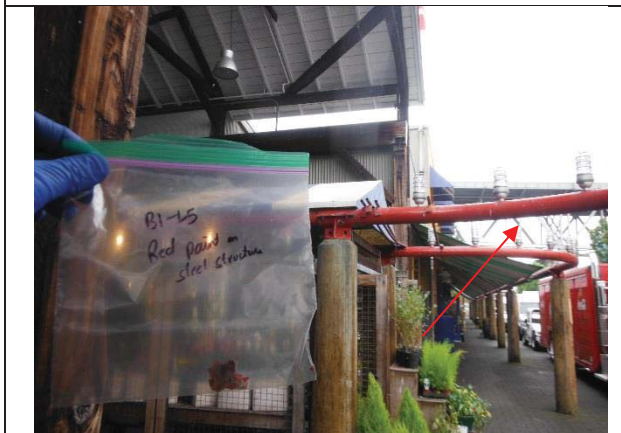
Photo 5: View of the red paint applied on the steel structure present at the exteriors. The paint sample is found to contain greater than 0.06% lead.

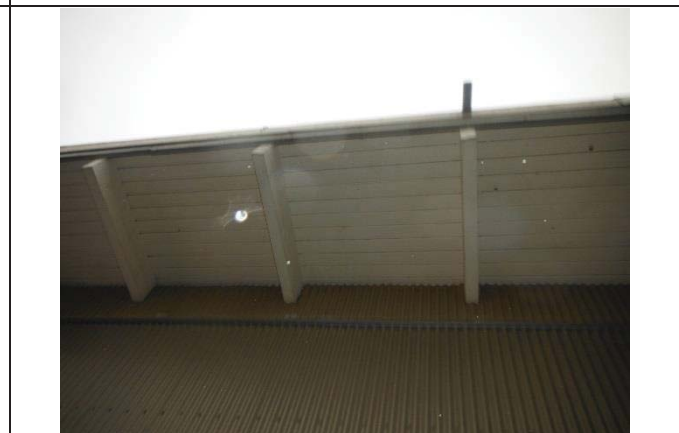
Photo 6: View of the white paint applied on the ceiling of the building structure. The paint sample is found to contain greater than 0.06% lead.

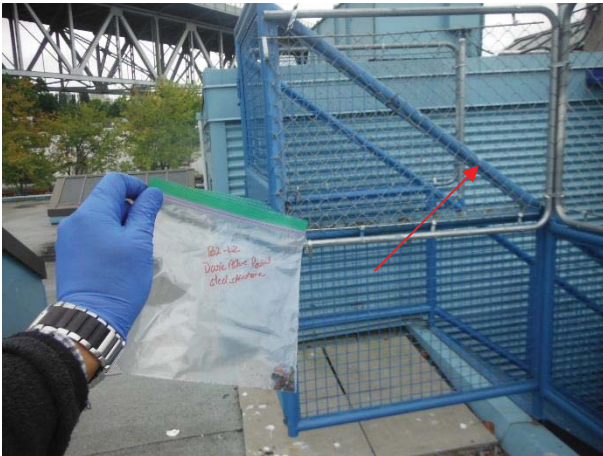
Photo 3: View of paint sample location B2-L2 of dark blue paint sample applied on the steel structure. The paint is found to contain more than 0.06% of lead.

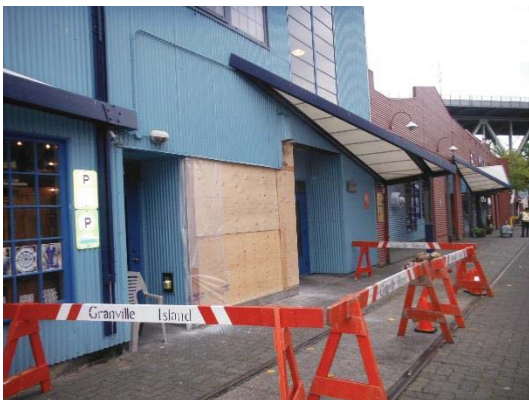
Photo 5: View of the south portion of the building that was damaged in the vehicle accident.

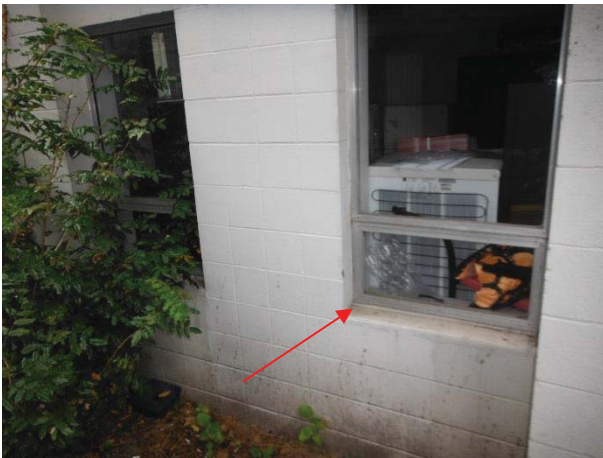
Photo 3: The sample B4-S7g of grey caulking material (10% Chrysotile) present at the northwest portion of the building.

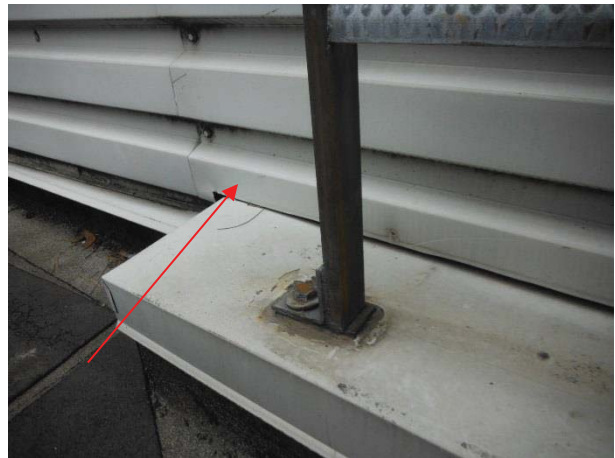
Photo 4: View of the white paint coat applied over the metal flashing. The paint is found to contain lead greater than 0.06%.

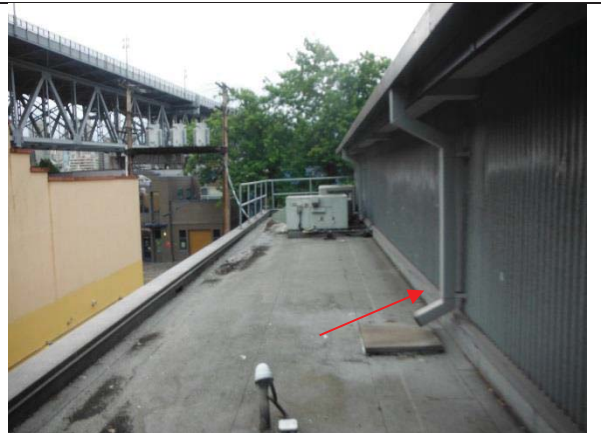
Photo 2: View of the theatre roof (west side). The caulking material present at the walls is found to be asbestos containing (0.25% Chrysotile).

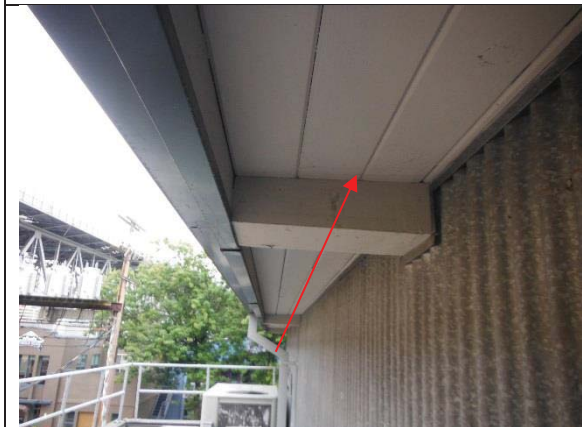
Photo 3: Sample B3-L4 of white paint present at the wooden panels (Roof). The paint contains more than 0.06% lead.

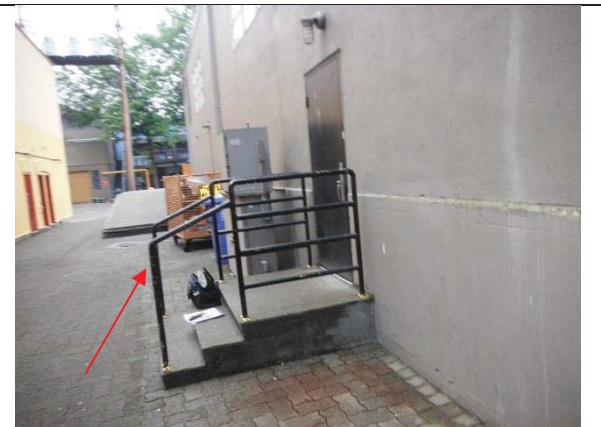
Photo 4: View of west portion of the building. Sample B3-L5 of black on yellow paint present at the steel railings. The paint contains more than 0.06% lead.

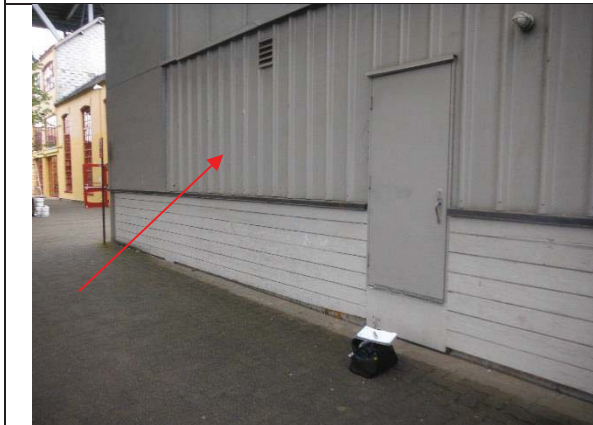
Photo 5: View of the rear portion of the building. The corrugated cement panels present on the exterior walls were assumed to be asbestos containing. The white paint contains more than 0.06% lead.

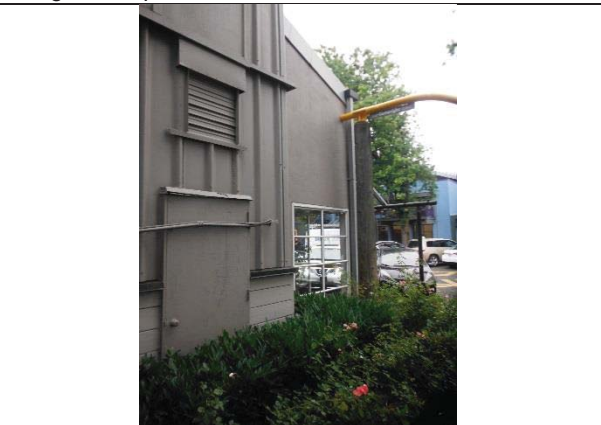
Photo 6: Sample B3-S15 of caulking material present at the exterior wall (northeast portion) was found to be asbestos containing.
