Geotechnical Investigation Sinclair Canyon Site Rehabilitation

Prepared for:
Public Works and Government
Services Canada
Kootenay Park, British Columbia

Prepared by:
Stantec Consulting Ltd.
Calgary, Alberta

GEOTECHNICAL REPORT

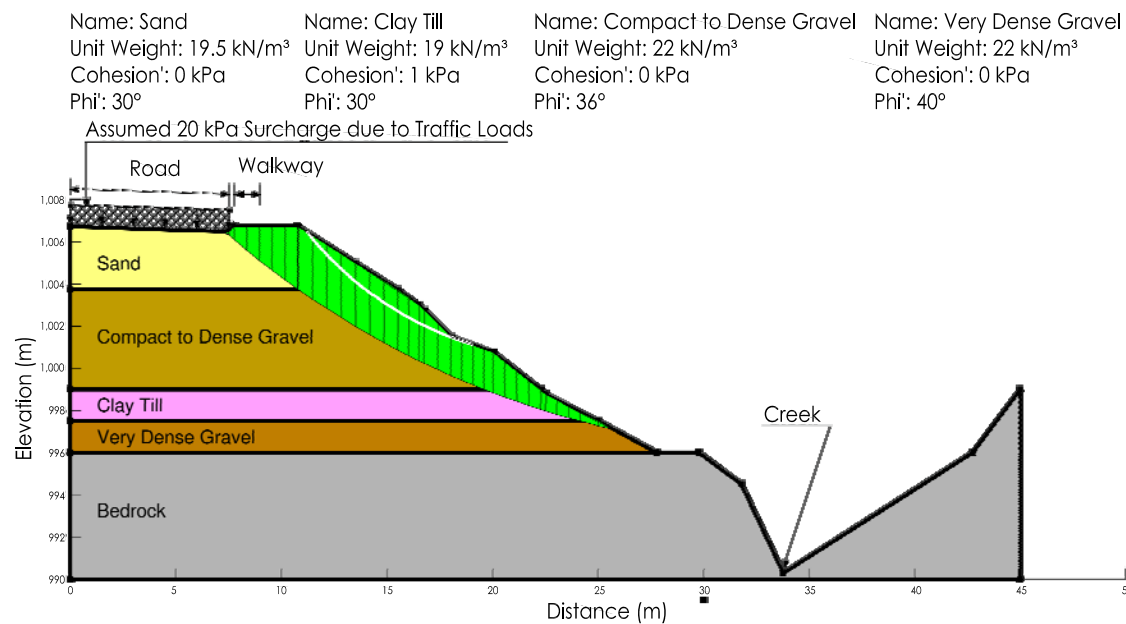
Station 1+650
Section A: Existing Conditions

The calculated FOS values correspond to potential slip surfaces that may extend into the existing highway. Results of our analyses indicate that the current slope is a global stability issue, and that potential slip surfaces may be deep-seated (i.e., 3 m or greater in depth) and may extend to encompass an area which could affect the current road in the event of a failure.

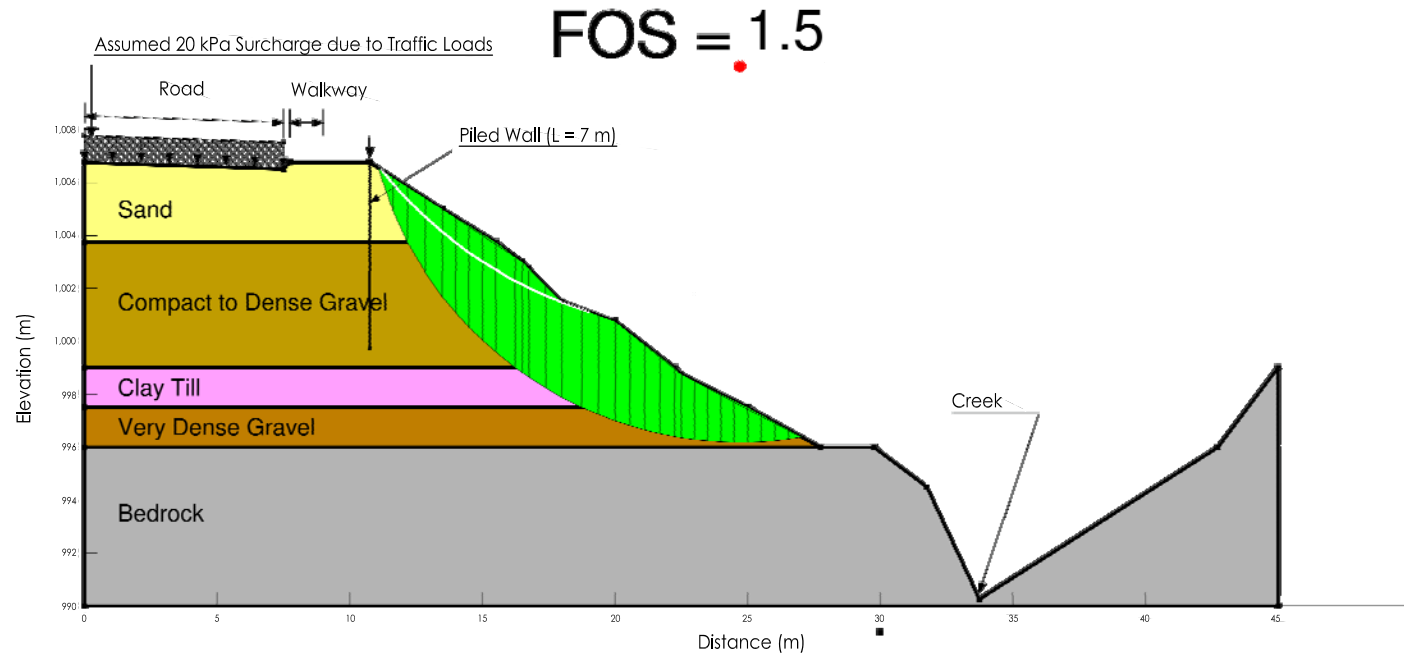
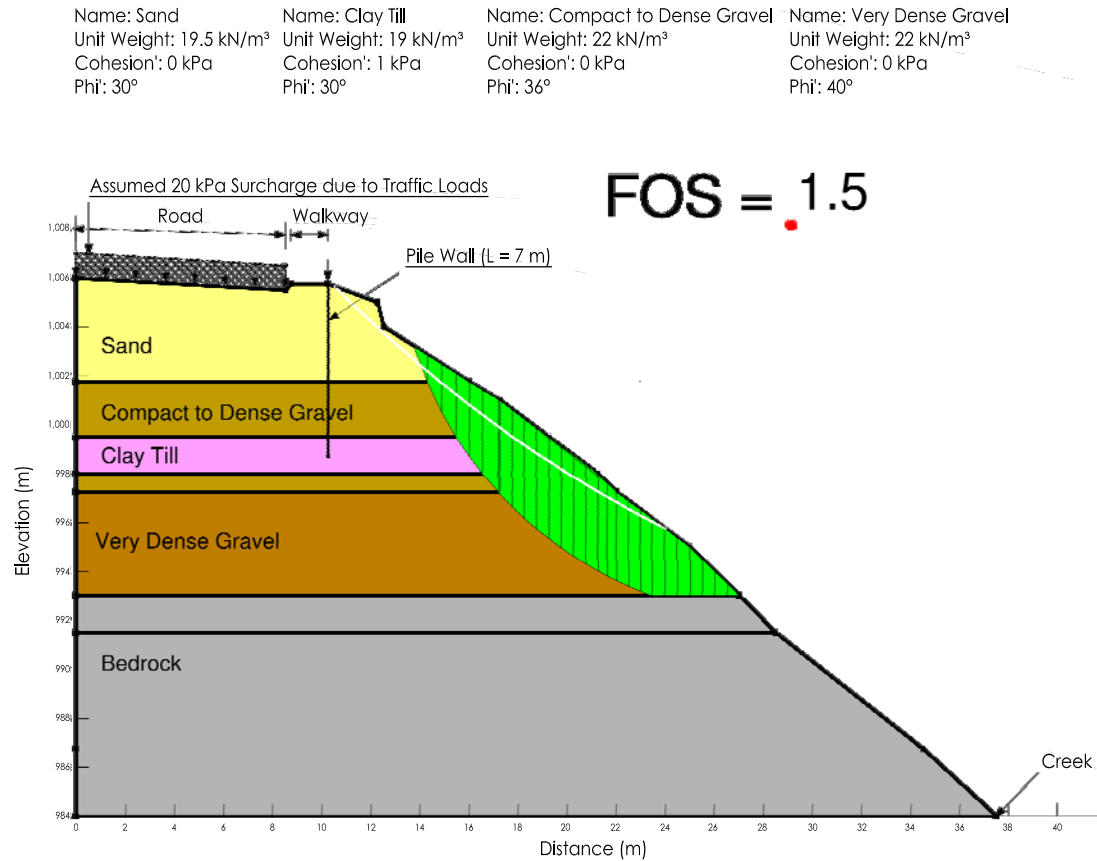
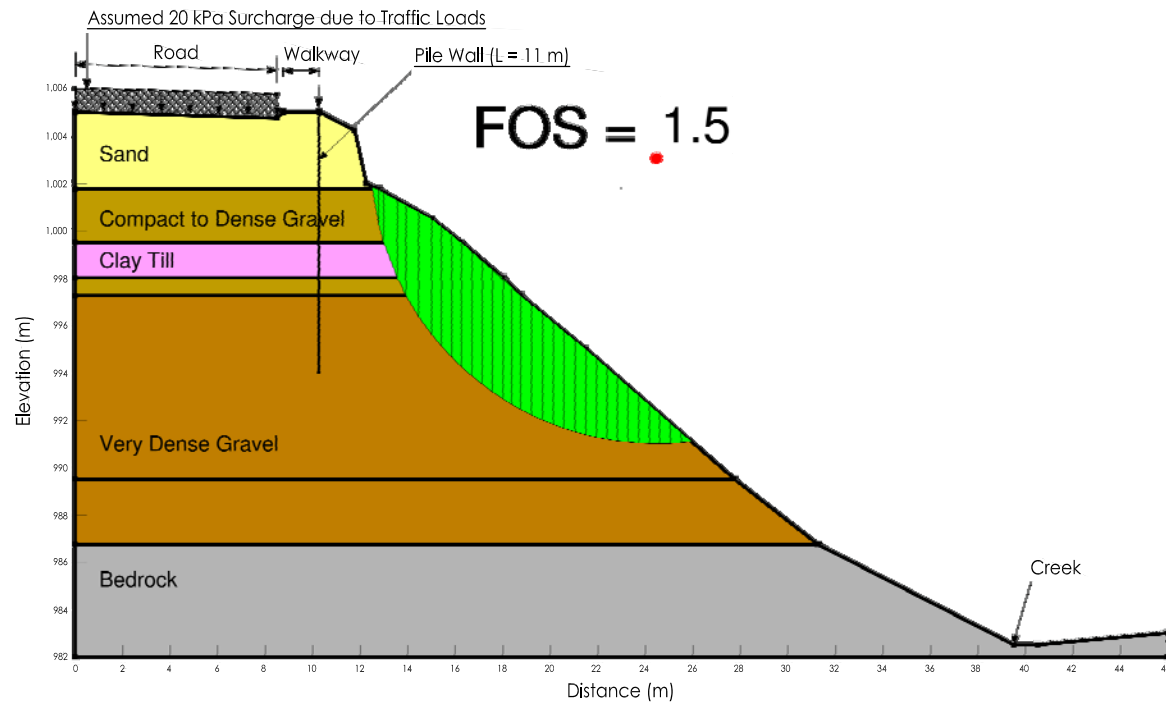
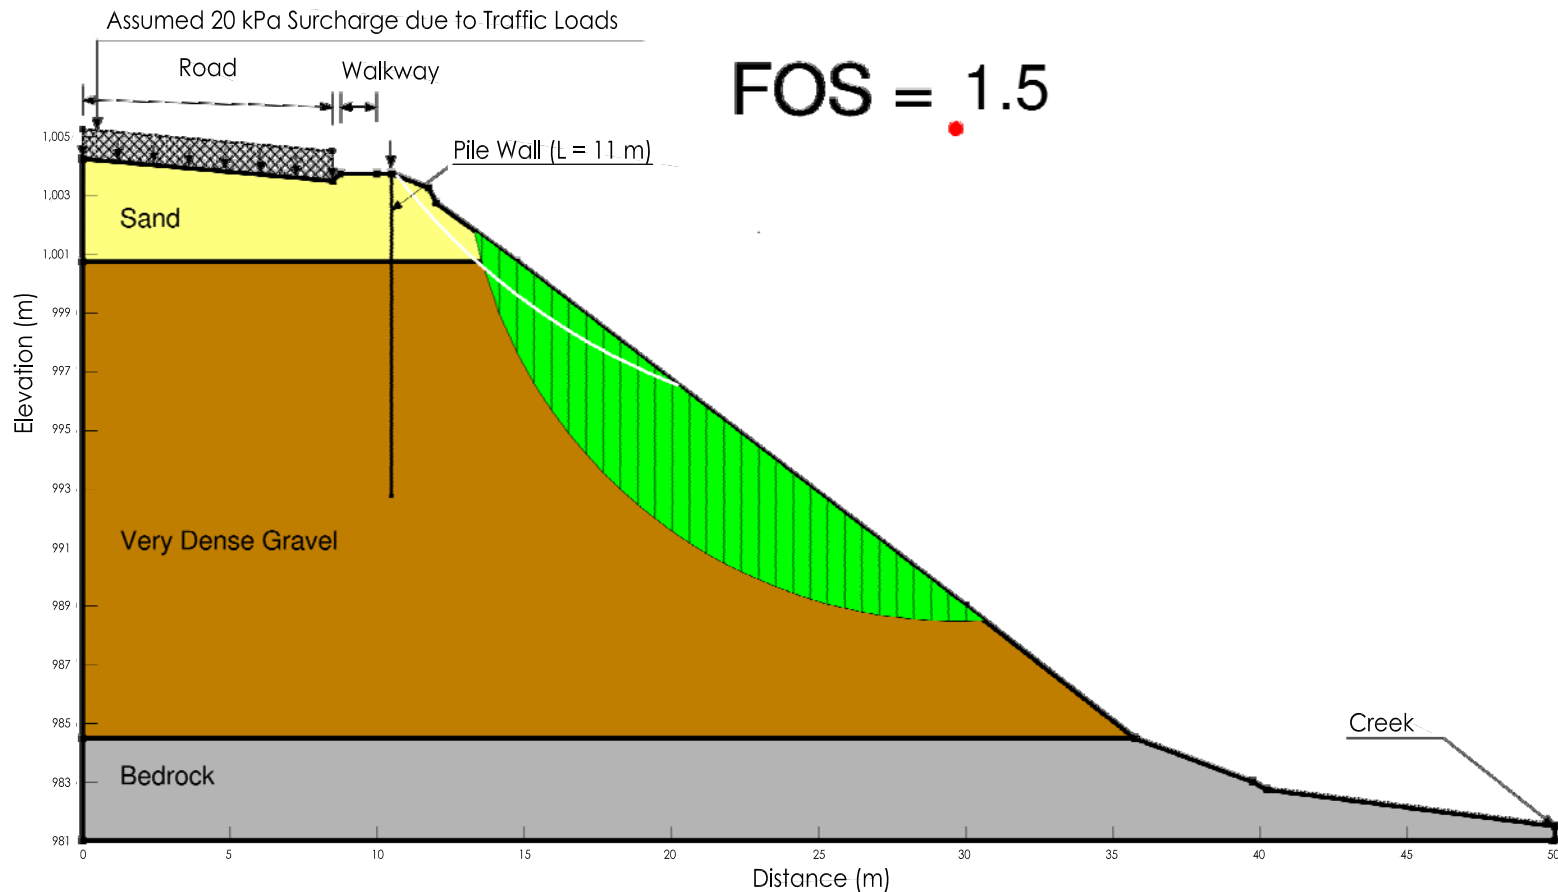
Preliminary slope stability analyses were completed at four (4) cross sections with a proposed pile wall in order to confirm the feasibility of this option. Results of our stability analyses are shown on Figures 7.0 to 10.0, and indicate global FOS values in excess of 1.5 for potential slip surfaces that may affect the existing highway. It should be noted that potential slip surfaces below an FOS of 1.5 were calculated in front of the pile wall which may result in some movements at the slope in front of the wall; however these potential movements will not affect the overall stability of the road and surrounding infrastructure.

Based on the current limitations and subsurface conditions, Stantec is of the opinion that the most feasible retaining wall option will consist of a system of piles founded within the very dense gravel or bedrock in order to intersect the potential slip surfaces. The pile system will retain the roadway and surrounding infrastructure from any potential deep-seated movements at the slope. This system will also be less disruptive to traffic, as large excavations are not expected to be required, reducing construction footprint.

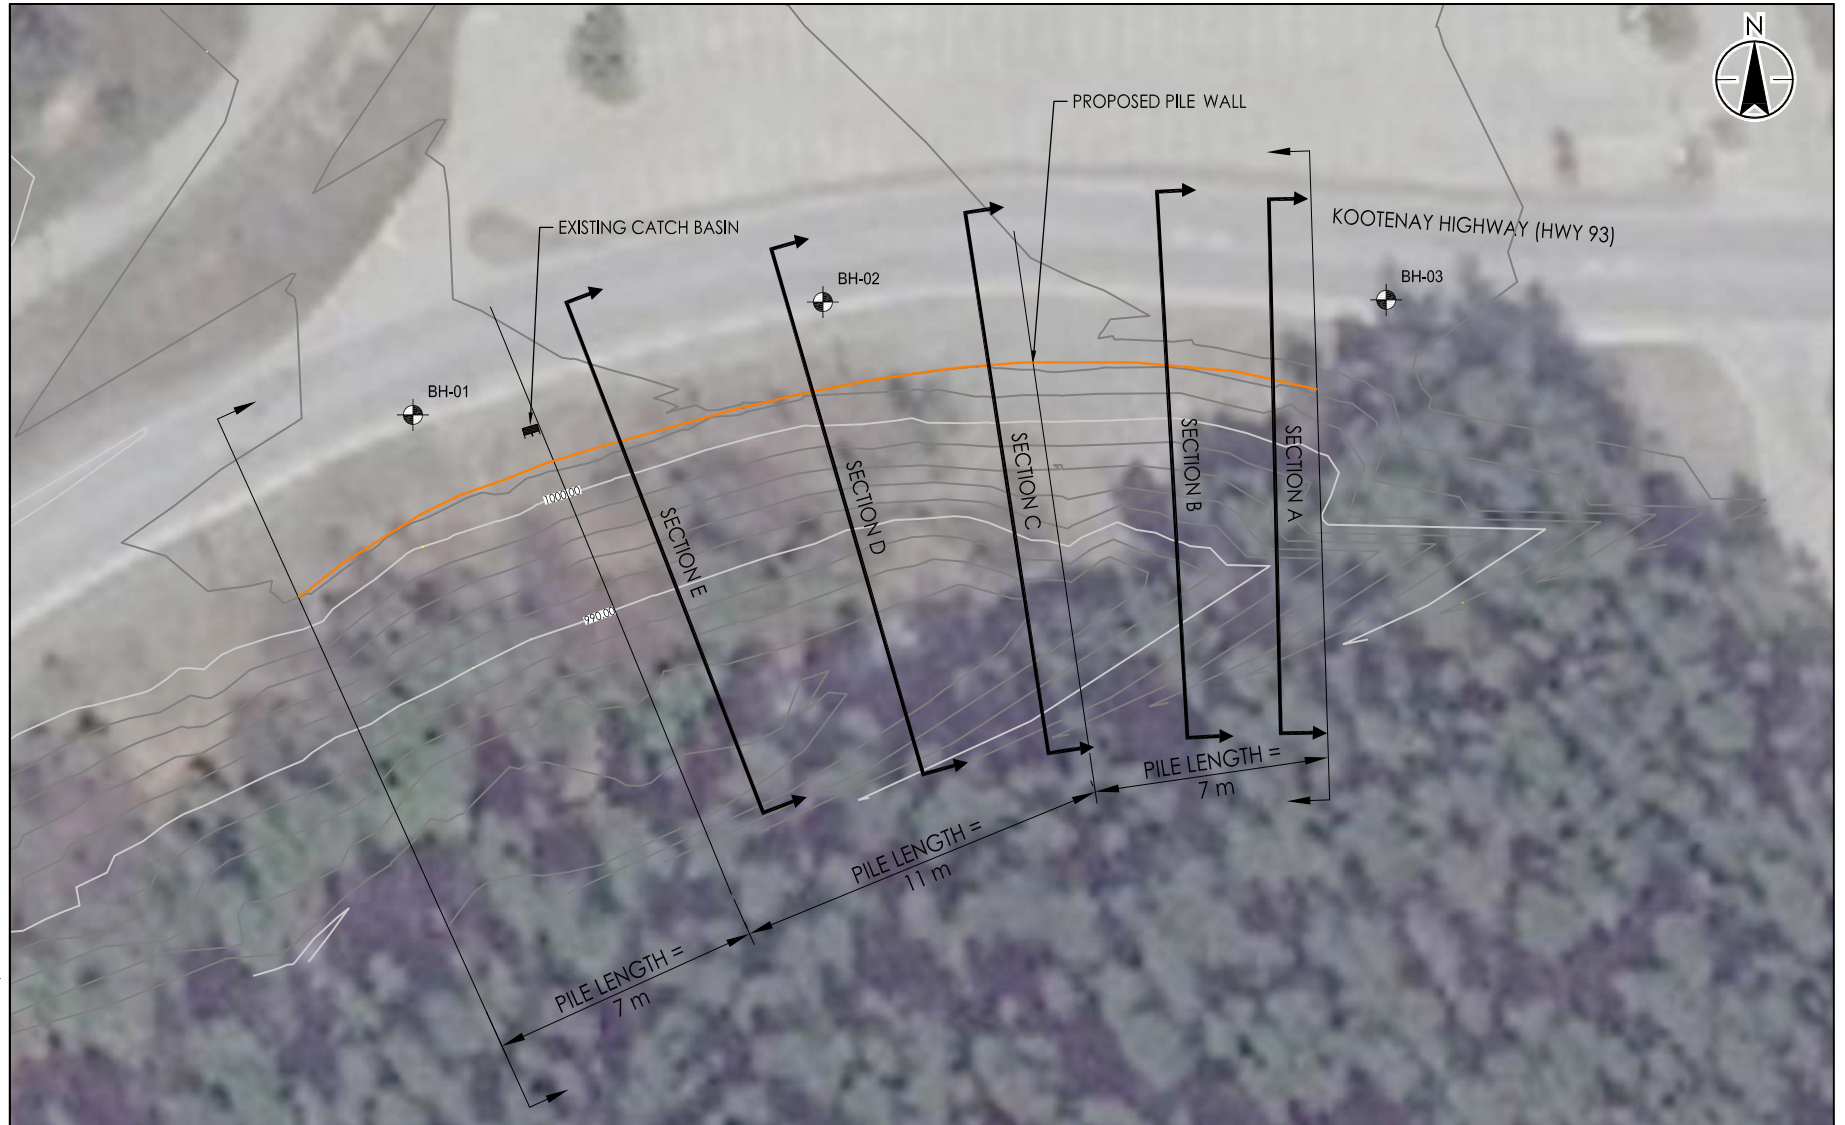
Tie-back anchors may be required to provide additional lateral support for potential loss of ground that may occur due to shallow slope movements. Based on the findings of the investigation, the use of driven piles is not advised due to the presence of cobbles and boulders that may damage the pile and/or lead to early refusal. Drilled cast-in-place concrete piles are considered to be more suitable. Due to the presence of cobbles and boulders a minimum pile diameter of 900 mm is recommended. Difficulties during installation should be anticipated, and casing or other means to control sloughing conditions may be required. The piles should be founded within the very dense gravel or bedrock stratum. Based on the results of our current analyses, minimum pile lengths range between 7 m to 11 m below existing grade as summarized in **Table 4-3** below and shown on Figure 11.0 in **Appendix B**.

Installation of the piles is anticipated to require preparation of a level working surface within the partially closed off road. The pile walls should be installed by contractors experienced with similar soil conditions. Note that actual pile lengths may vary depending on site conditions encountered during construction. In order to confirm design assumptions and ensure the piles will satisfy design requirements, full time quality assurance and quality control (QA/QC) will be required during construction.
