Photograph 2: Overall view of Polaris building Roof Area 1.1 looking south towards Halifax. This is a 2 ply modified bitumen roof that is approximately 12 years old

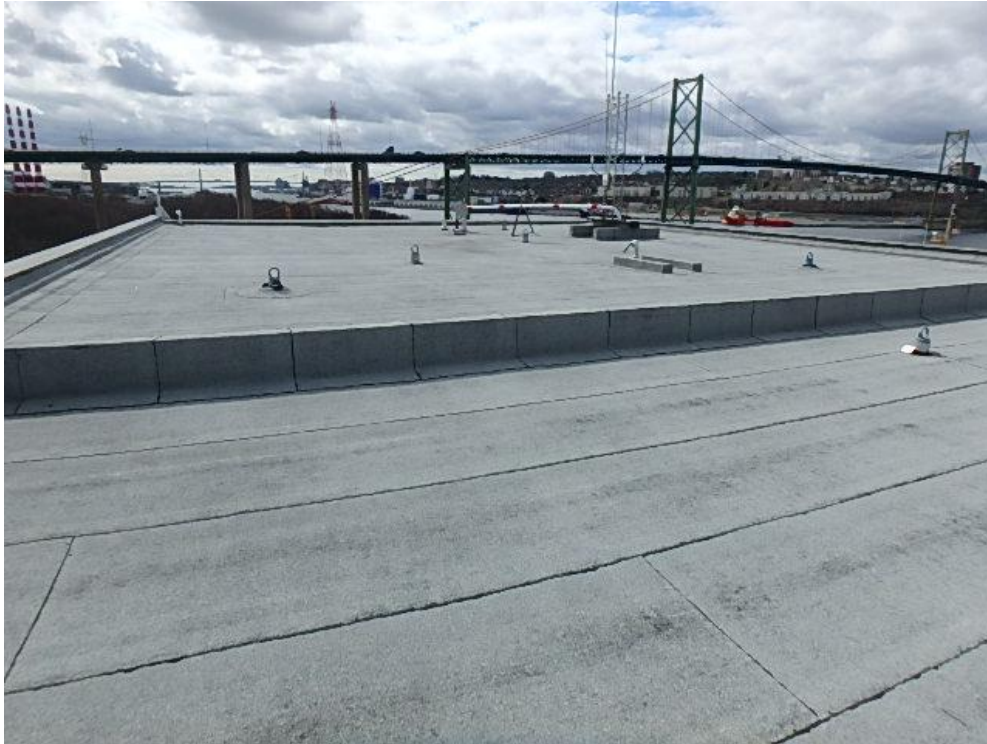
Photograph 1: Overall view of the eastern portion of roof area 1.1 facing east.

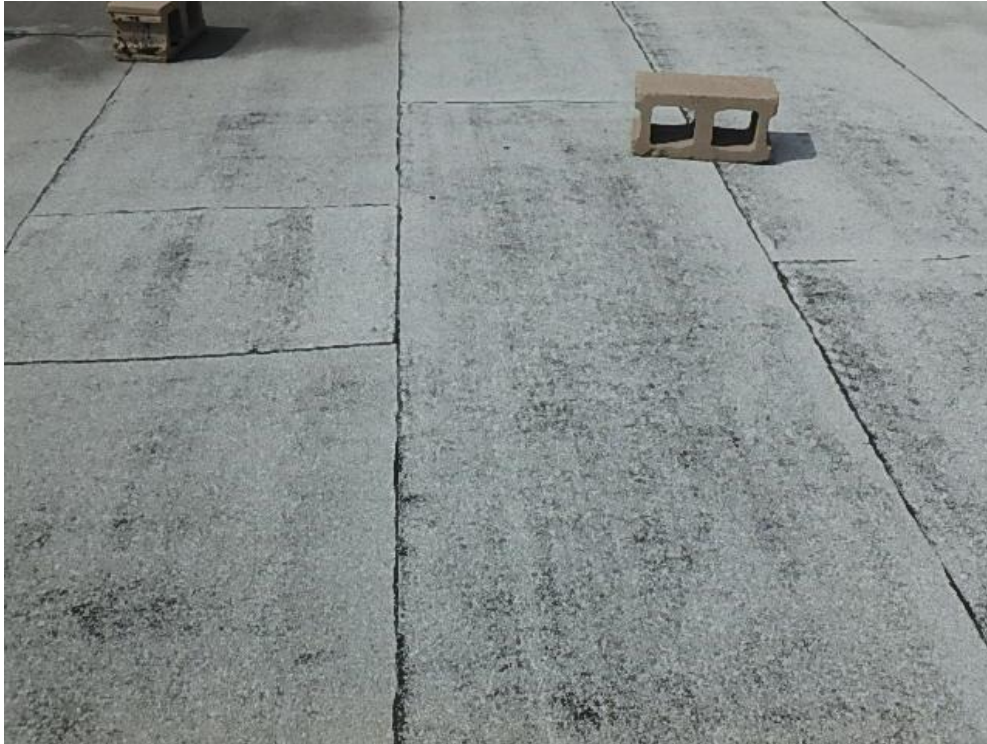
Photograph 3: Roof Area 1.1 – showing debris and membrane wear

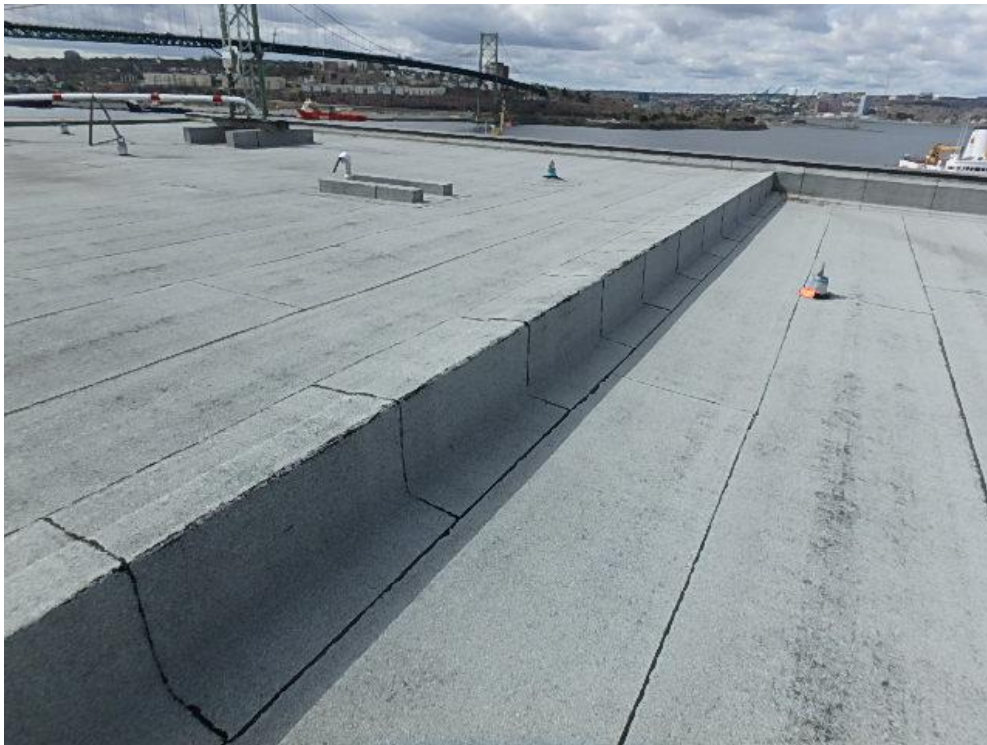
Photograph 4: Roof Area 1.1 – roof divider between two parts of 1.1 that is not protected by metal flashing. Also shows roof anchors that are not in use and should be removed.

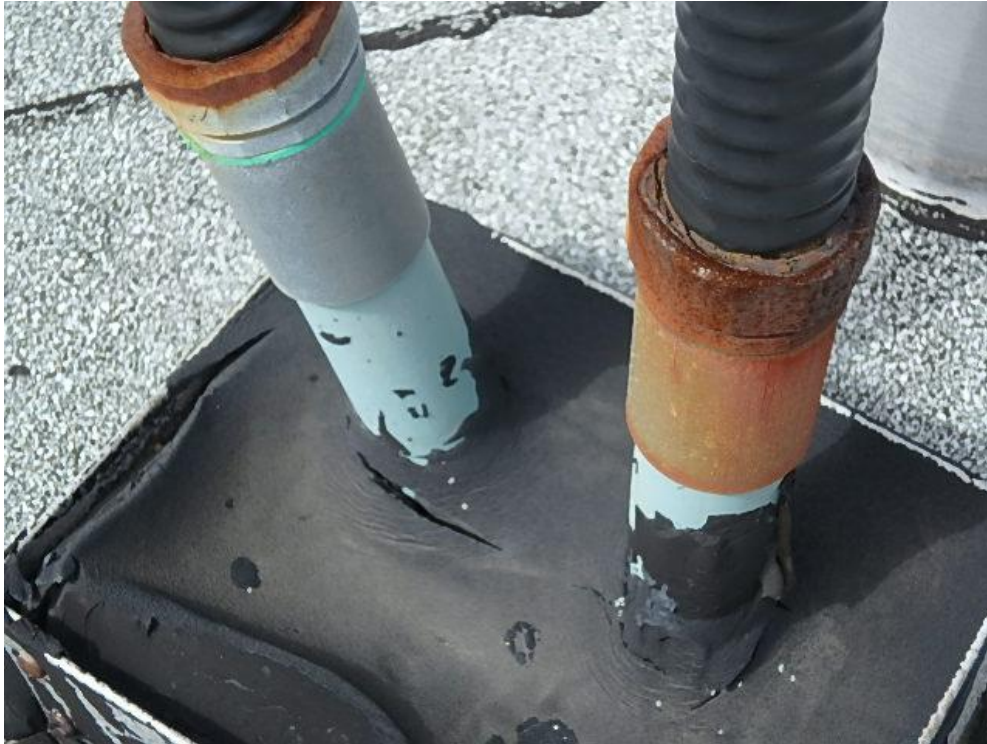
Photograph 5: Roof Area 1.1 – Improperly sealed and cracked pitch pan with improperly sealed conduit penetrations.

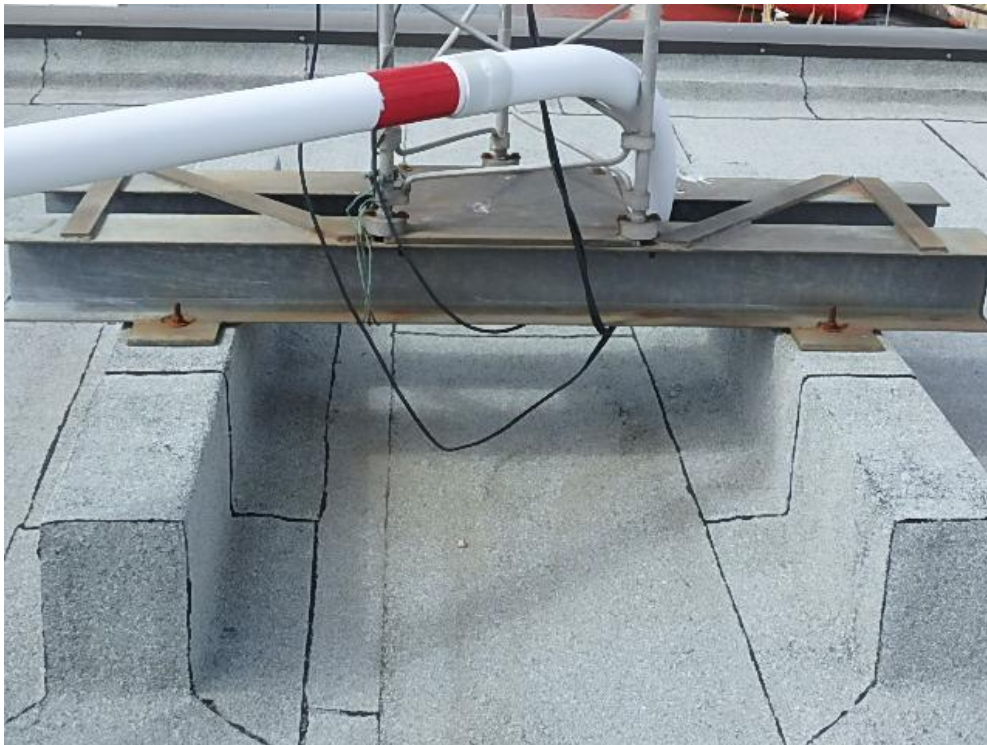
Photograph 6: Roof Area 1.1 – Sleepers supporting steel beam antenna base along with conduit pipe.

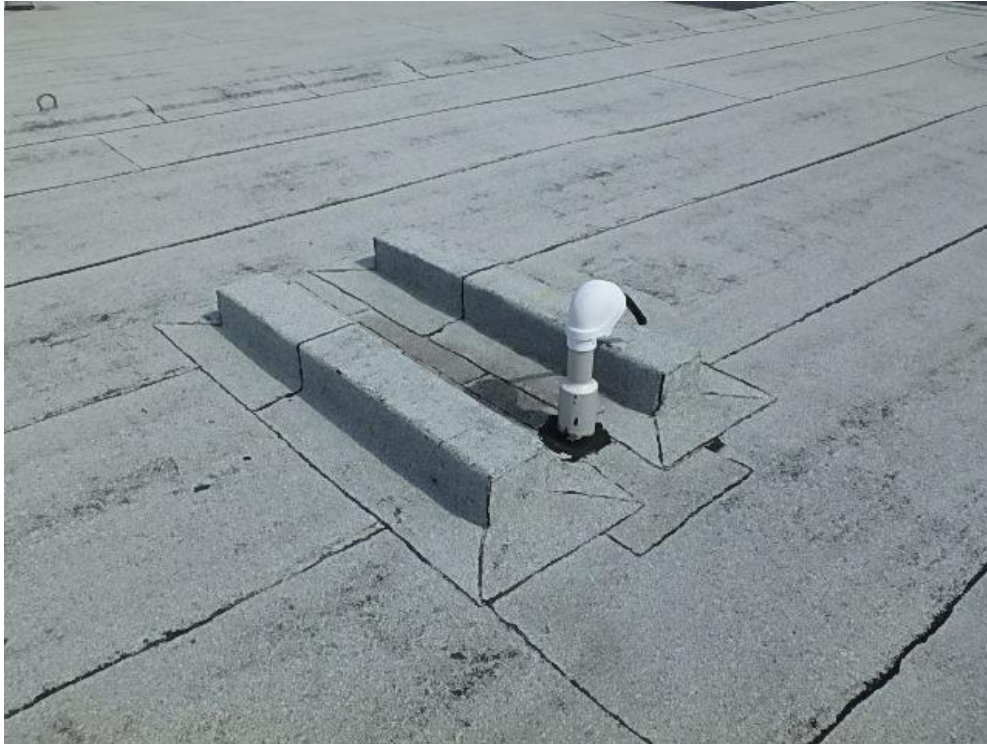
Photograph 7: Roof Area 1.1 – unused sleepers and unused conduit gooseneck with worn out sealant around its base.

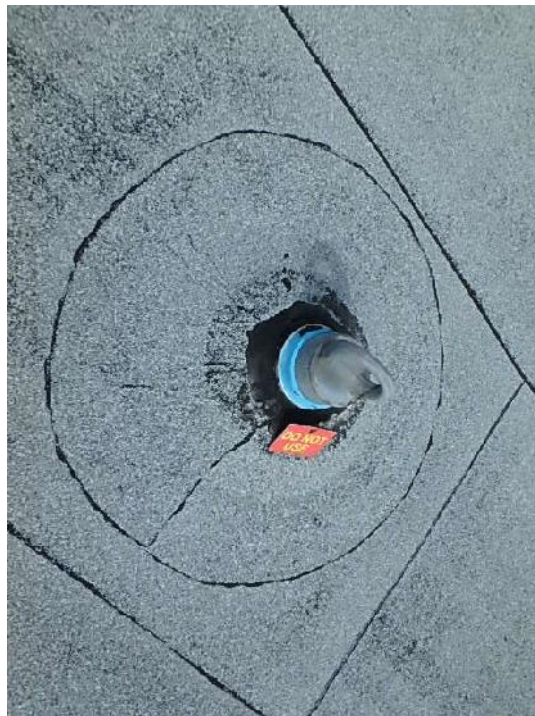
Photograph 8: Roof Area 1.1 – Existing roof anchor that is not in use and should be removed.

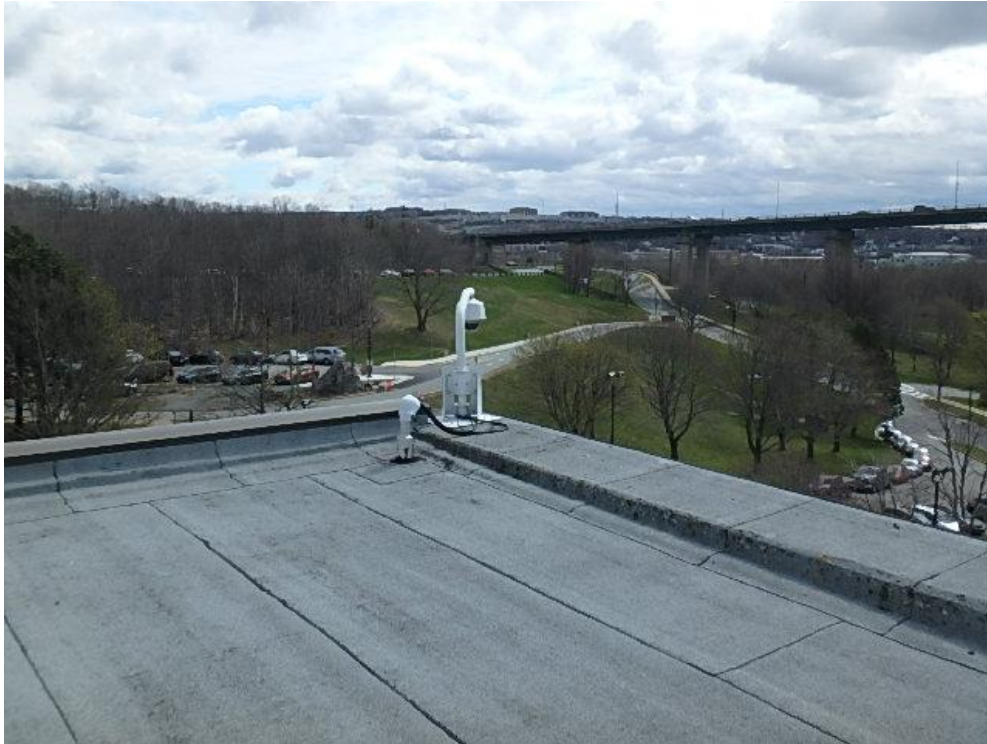
Photograph 9: Roof Area 1.1 – View of the east corner showing two different parapet conditions along with security camera and conduit gooseneck penetration with worn sealant.

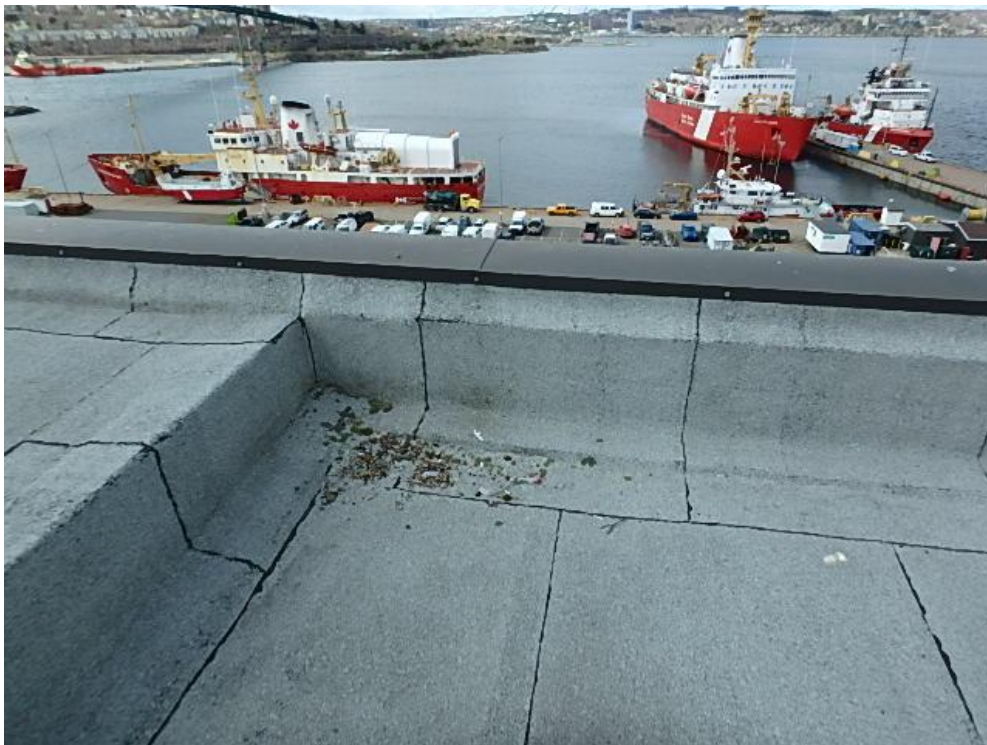
Photograph 10: Roof Area 1.1 – Roof divider condition at perimeter showing minor debris build up. Majority of perimeters are not protected by metal flashing.

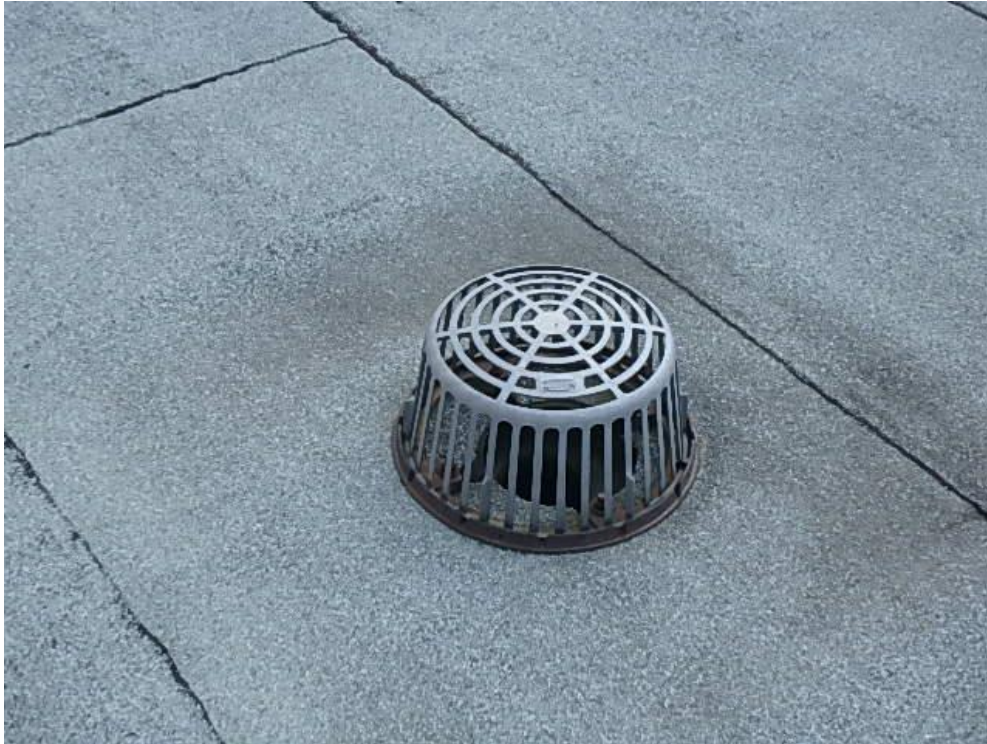
Photograph 11: Roof Area 1.1 – Typical roof drain installation with improper cap sheet detail.

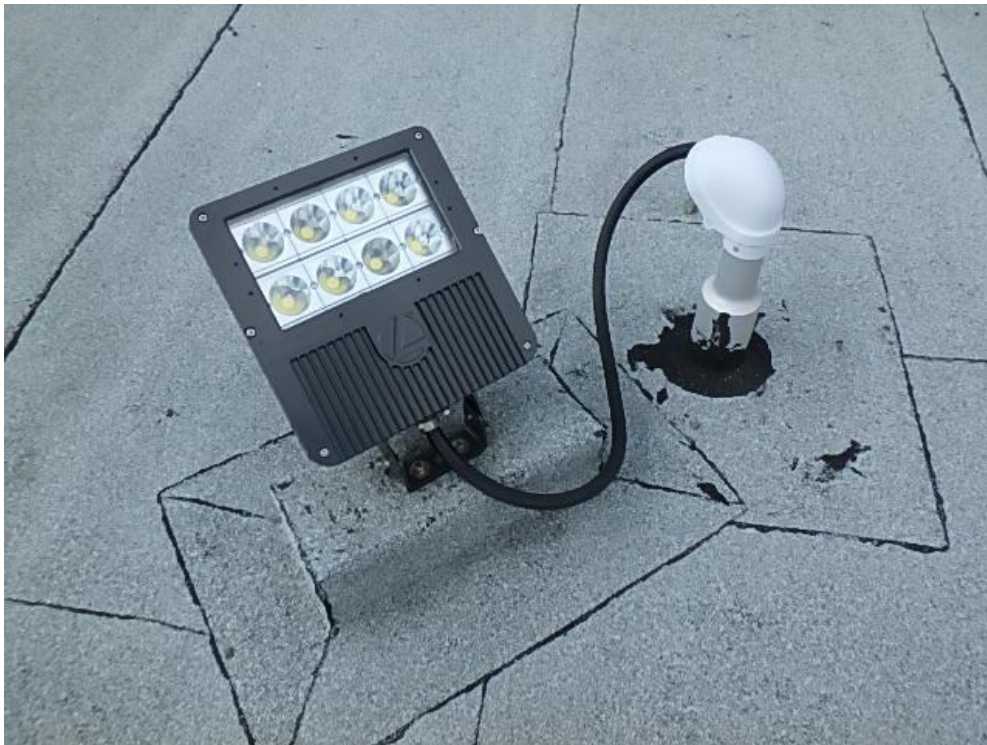
Photograph 12: Roof Area 1.1 – Typical light and conduit gooseneck detail.

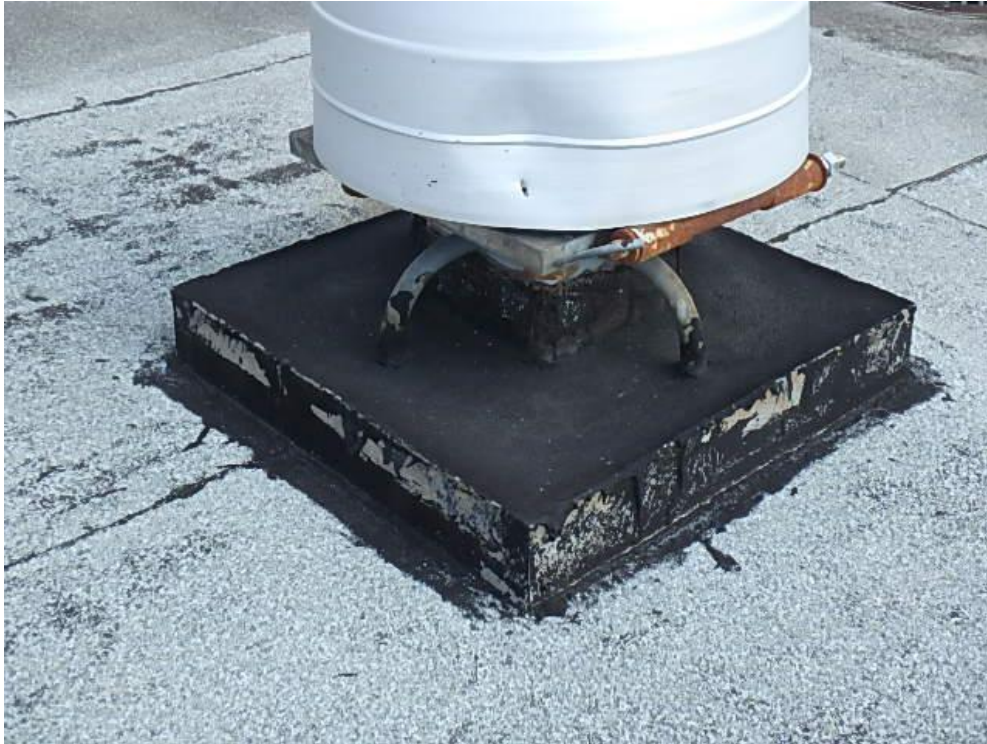
Photograph 13: Roof Area 1.1 – Exhaust fan penetration with improperly sealed conduit and fan penetrations and worn out sealant around base pan.

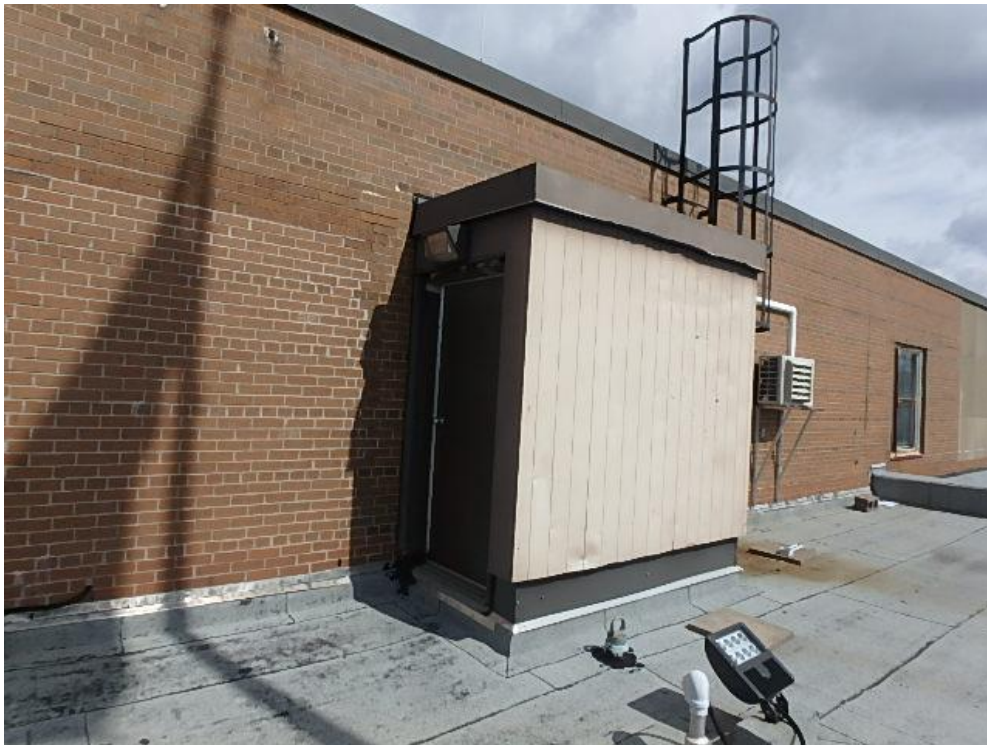
Photograph 14: Roof Area 2.1 – Door to roof area 1.1 with worn membrane due to lack of membrane protection outside of doorway.

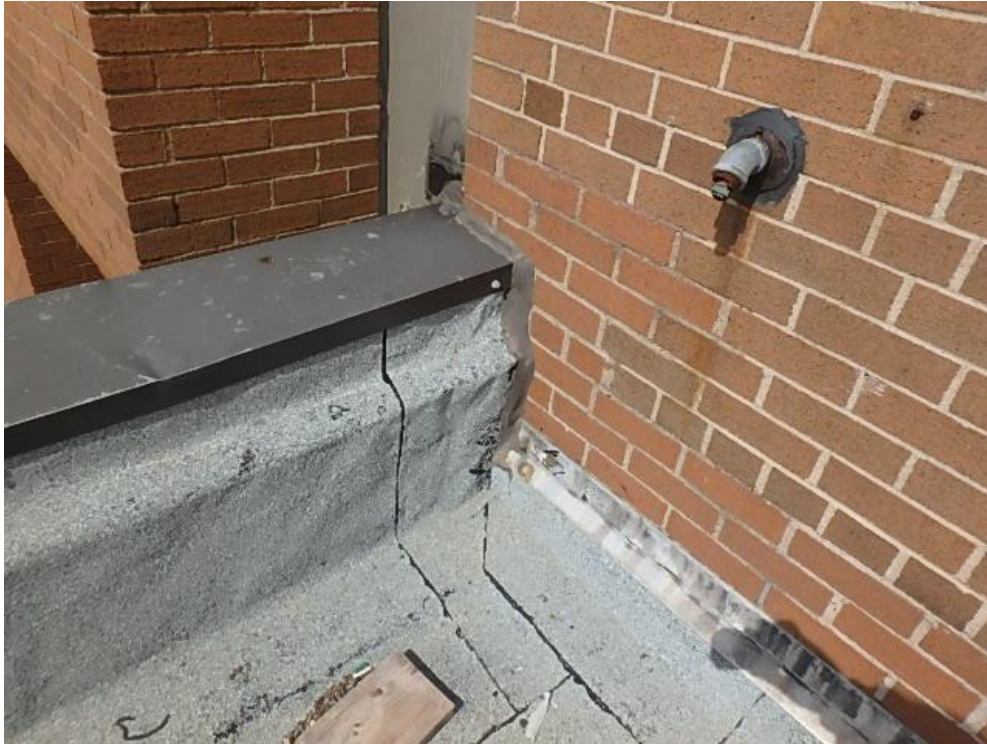
Photograph 15: Roof Area 1.1. Corner of roof area at adjacent wall showing worn, and tented flashing, sealant between parapet and wall, and reglet detail at wall. Both wall transitions are poorly sealed.

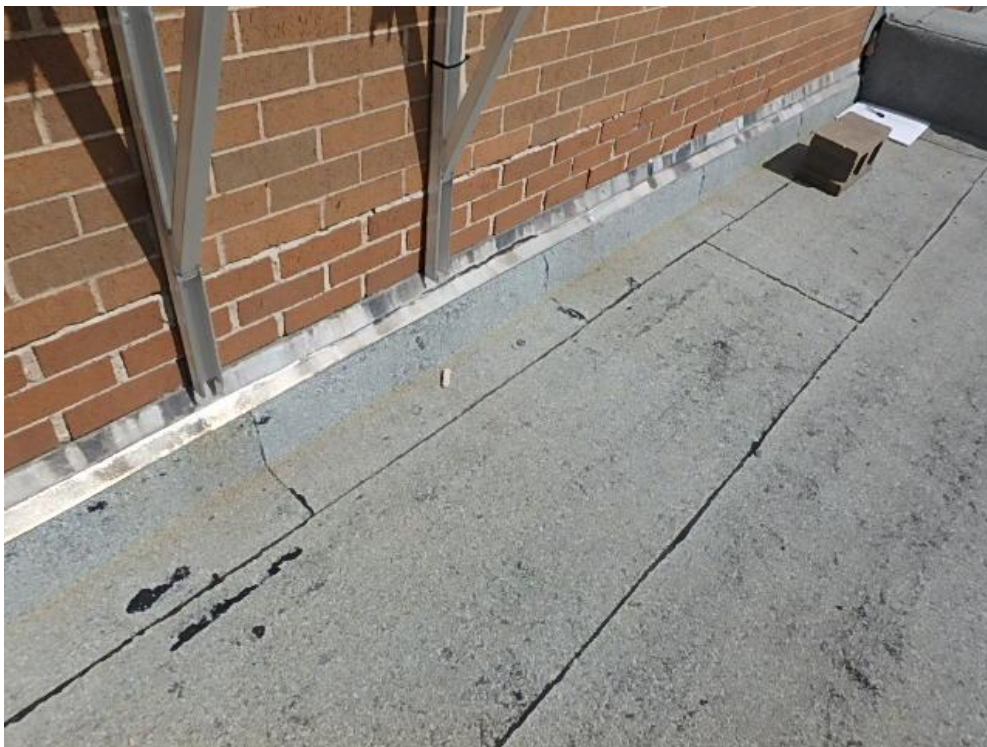
Photograph 16: Roof Area 1.1 – Ladder to roof area 3.1 showing no membrane protection at bottom, bleed out at seams, and wearing of membrane.

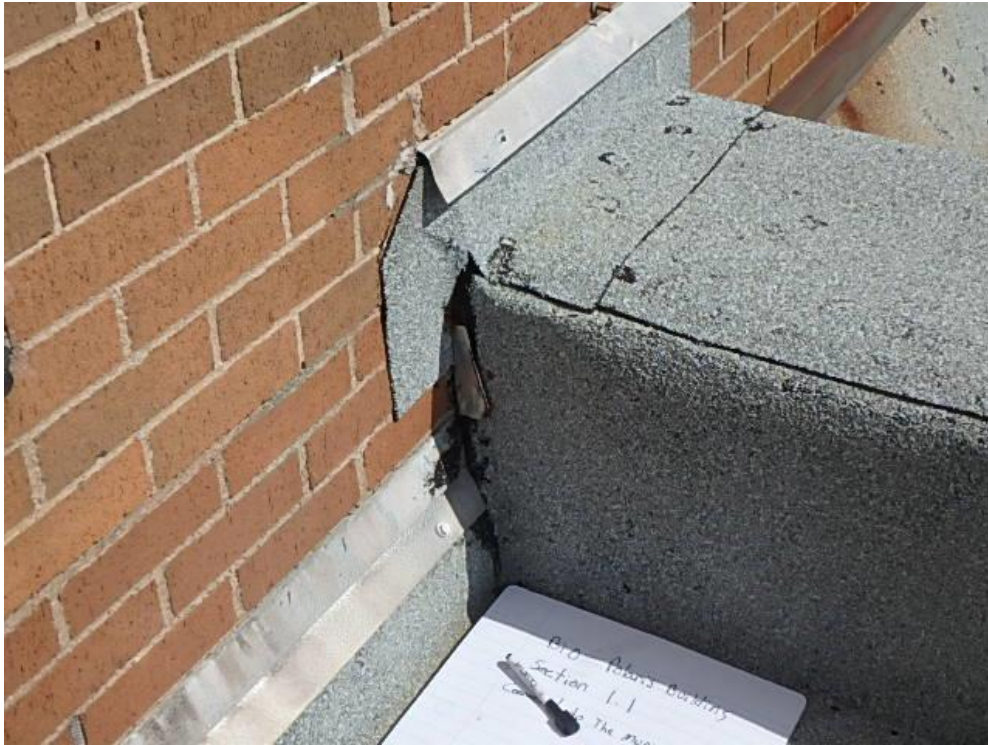
Photograph 17: Roof Area 1.1 – roof divider between Polaris and Murray building with improper reglet detail at intersection of divider and wall.

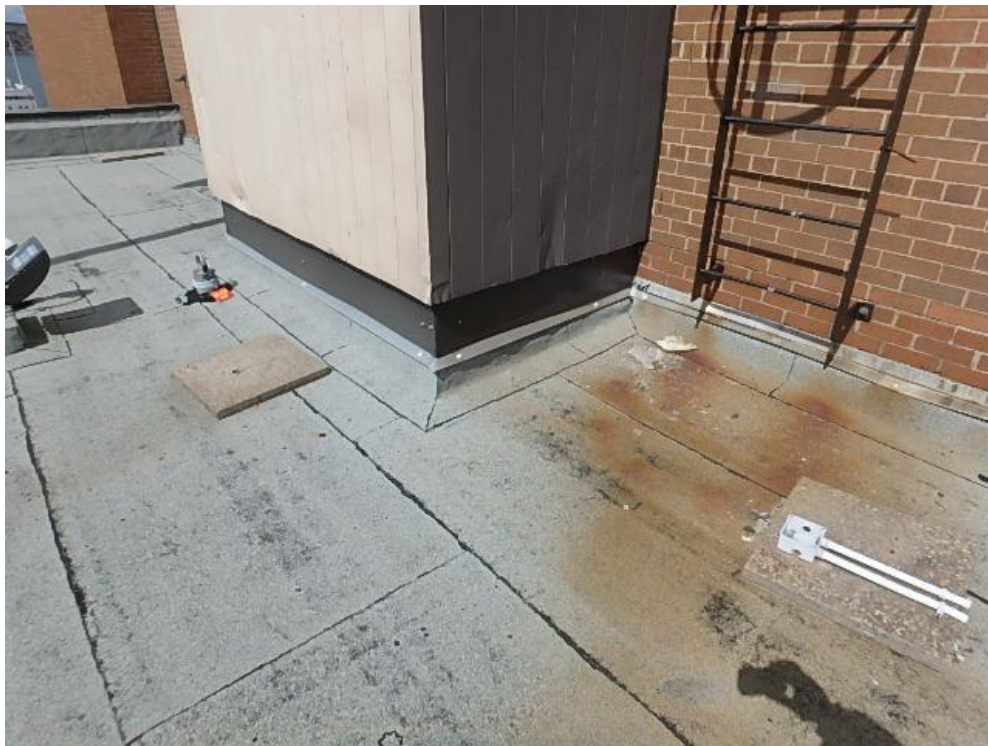
Photograph 18: Roof Area 2.1 – Debris and worn membrane at bottom of ladder along with unused roof anchor.

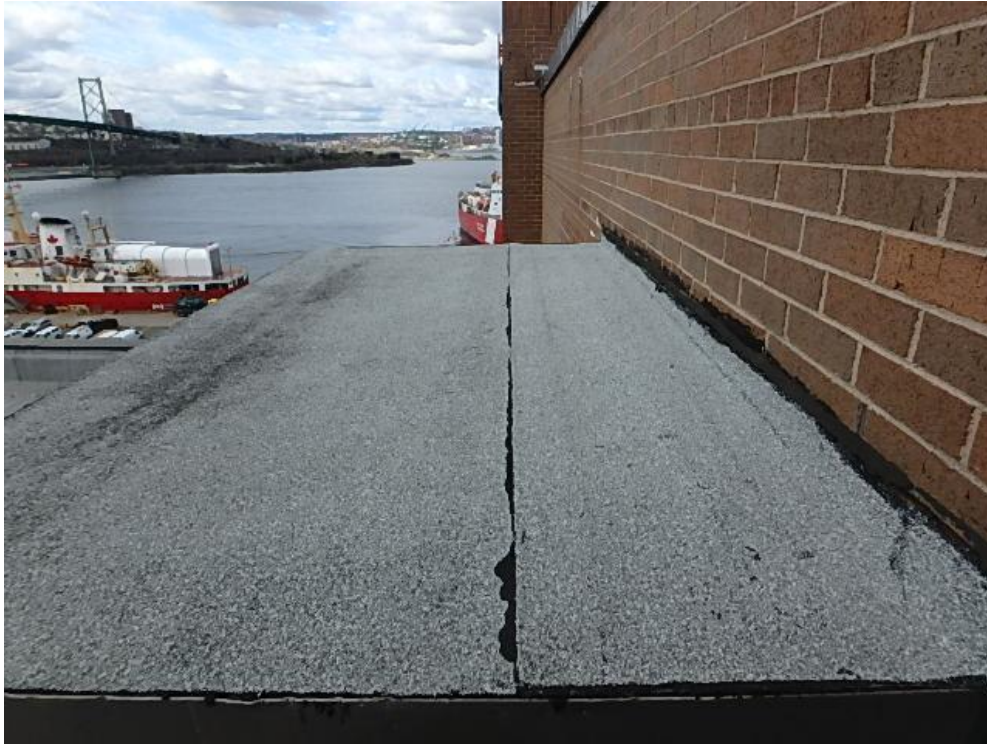
Photograph 19: Roof Area 2.1 – Overall view of roof area 2.1 over doorway to roof area 2.1 with improper drip edge, and reglet detail with poor seal to adjacent wall.

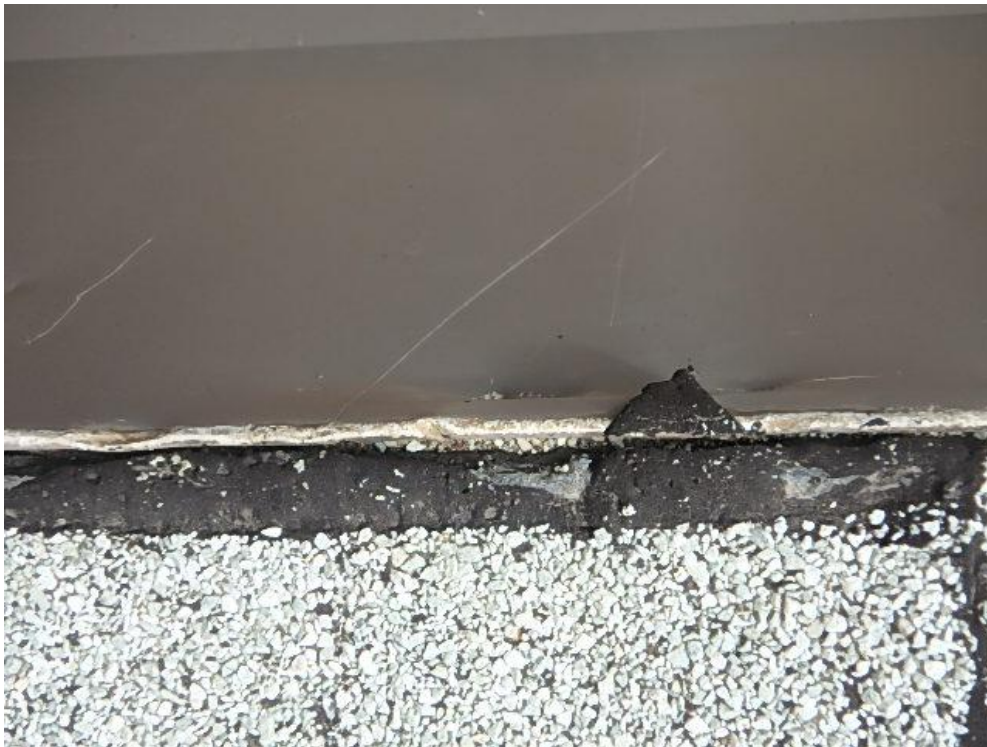
Photograph 20: Roof Area 2.1 – improper and poorly sealed roof edge detail at fascia.

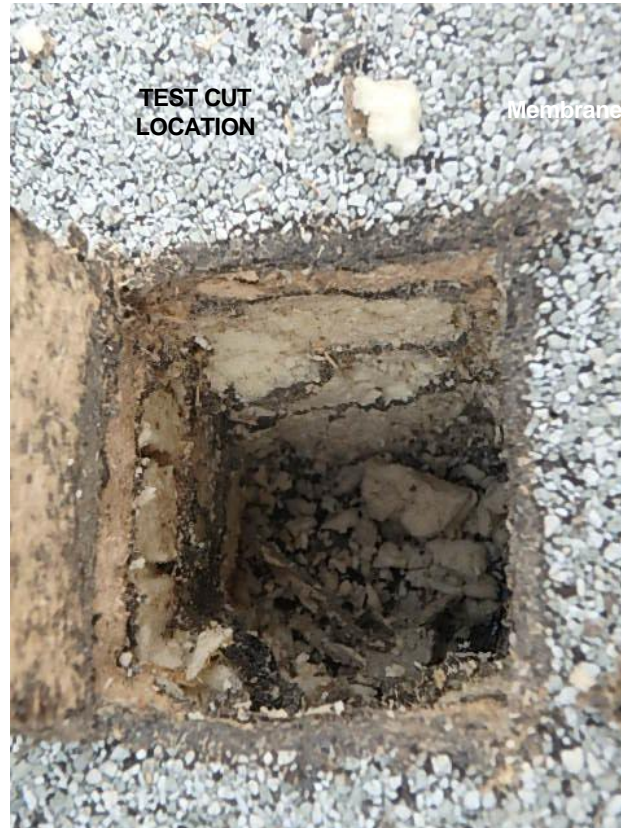
Photograph 21: Roof Area 1.1 - A core test of the roof system was conducted at a central portion of the roof.

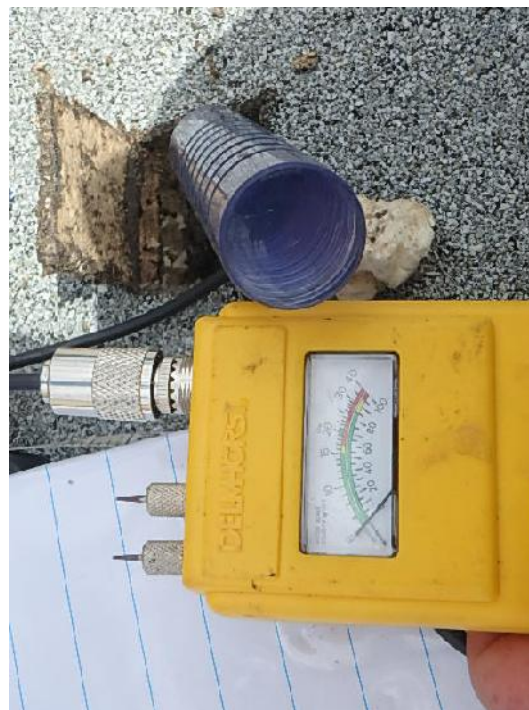
Photograph 22: Roof Area 1.1 – moisture test at core cut location.

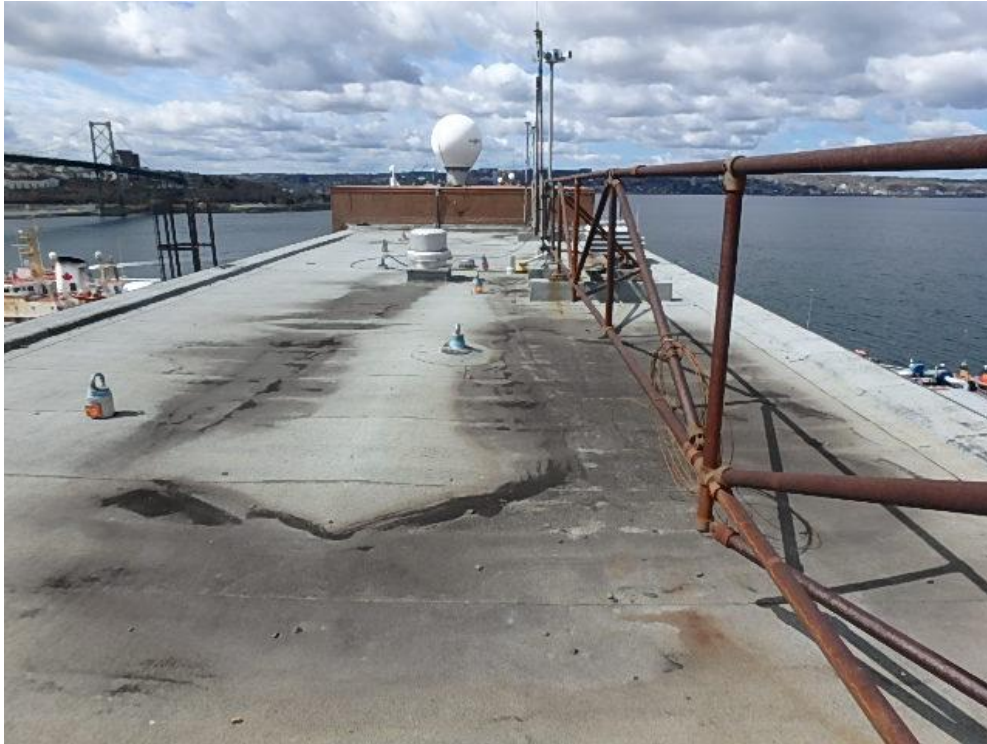
Photograph 23: Roof Area 3.1 – Overall view of roof area facing south west. Also shows metal truss supporting antennae.

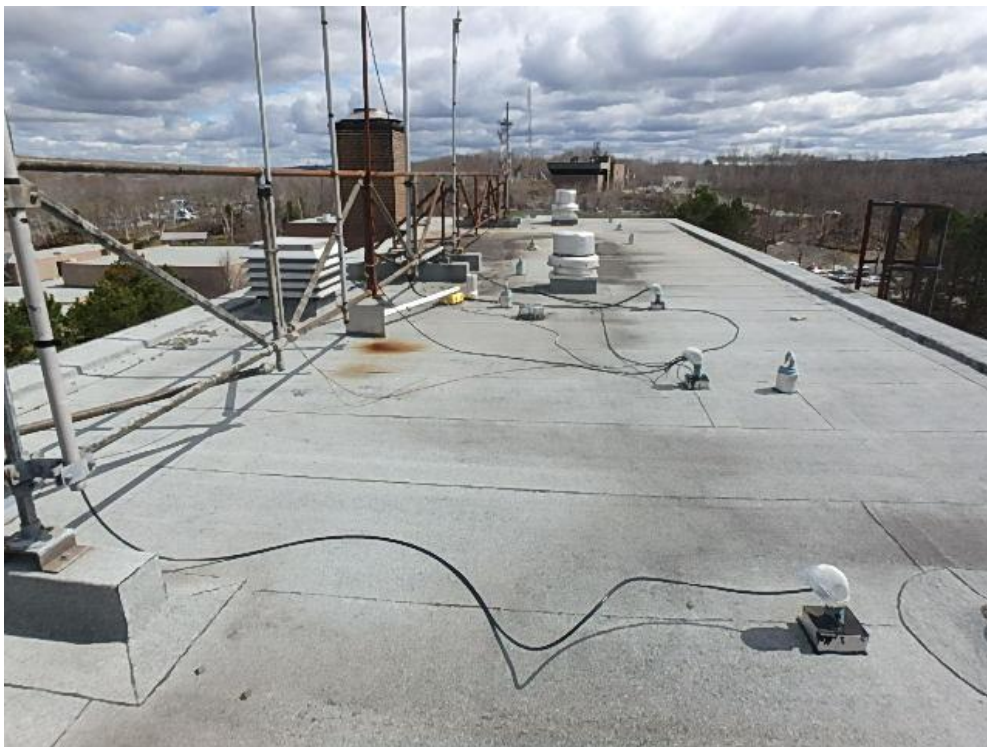
Photograph 24: Roof Area 3.1 – Overall view of roof area facing north east. Also showing metal truss supporting antennae, sleeper truss supports, and conduit goosenecks along with exhaust fans, drains, and roof anchors.

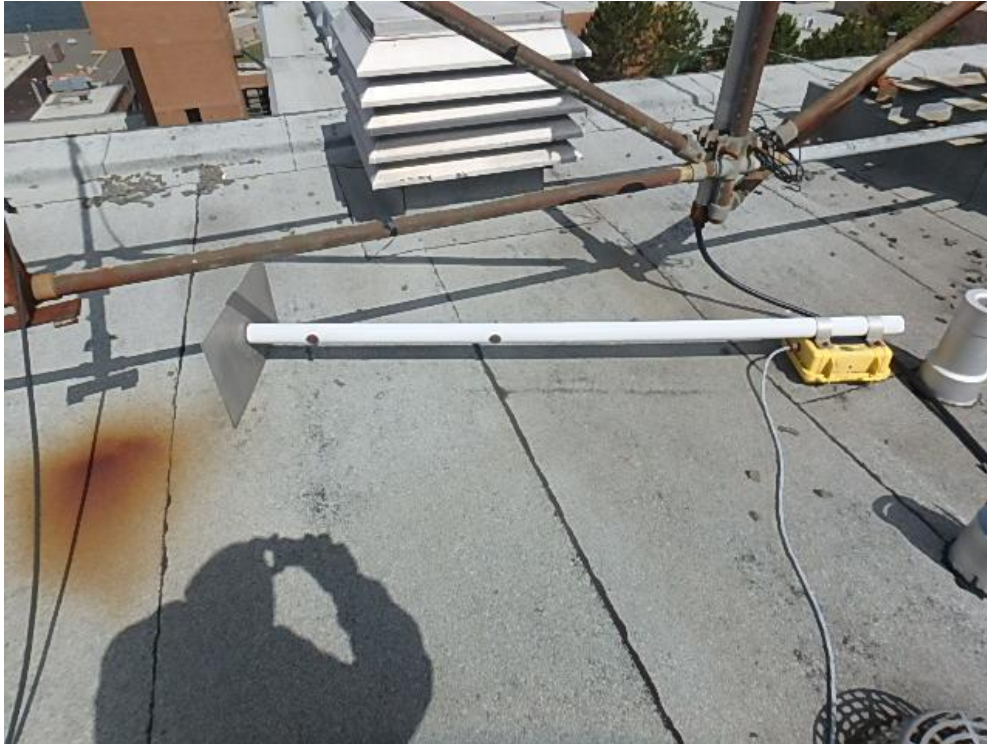
Photograph 25: Roof Area 3.1 – unprotected conduit support and minor debris and membrane rust staining.

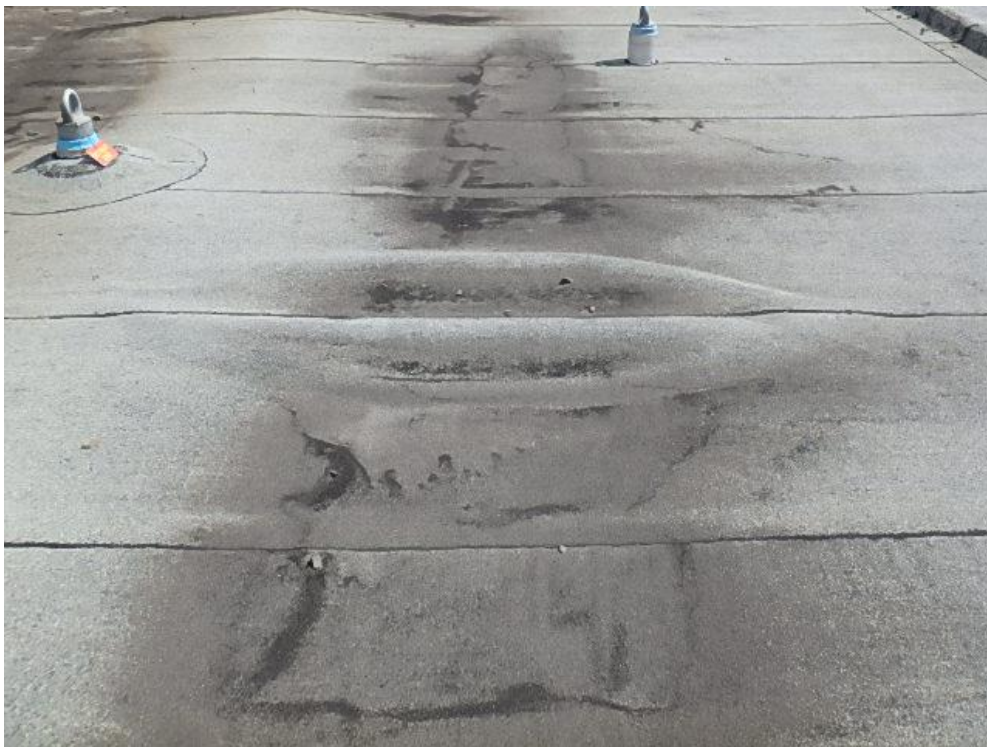
Photograph 26: Roof Area 3.1 – ridging, tenting and evidence of water ponding on membrane. Also shows unused roof anchor to be removed.

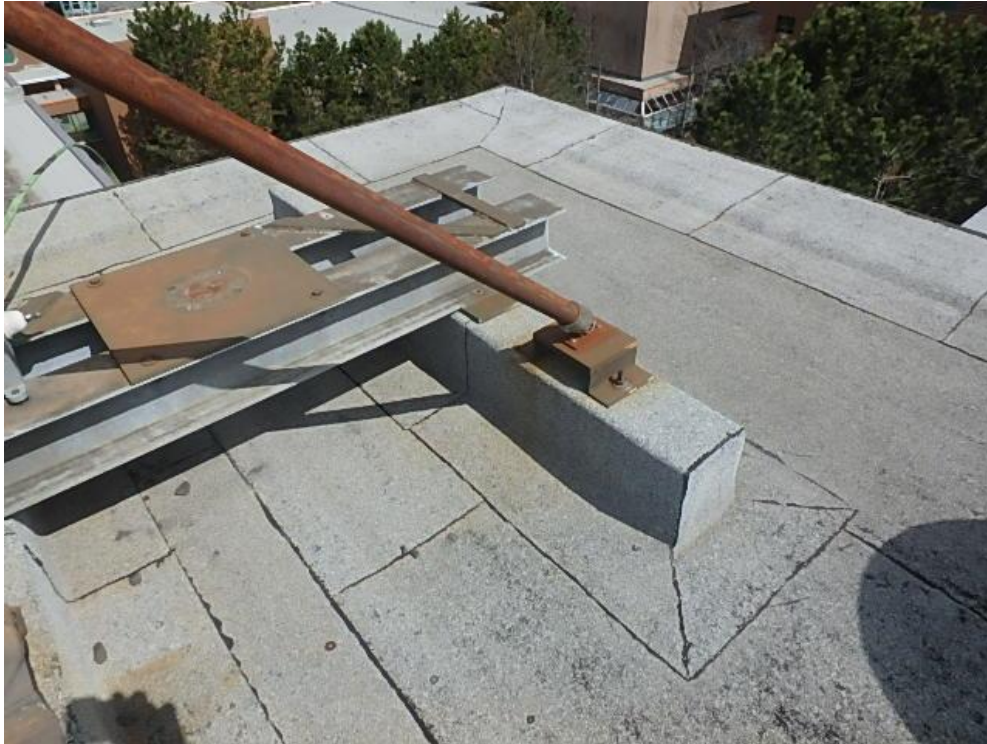
Photograph 27: Roof Area 3.1 –Truss support sleeper with connector screwed directly through membrane (improperly sealed), and typical roof edge detail.

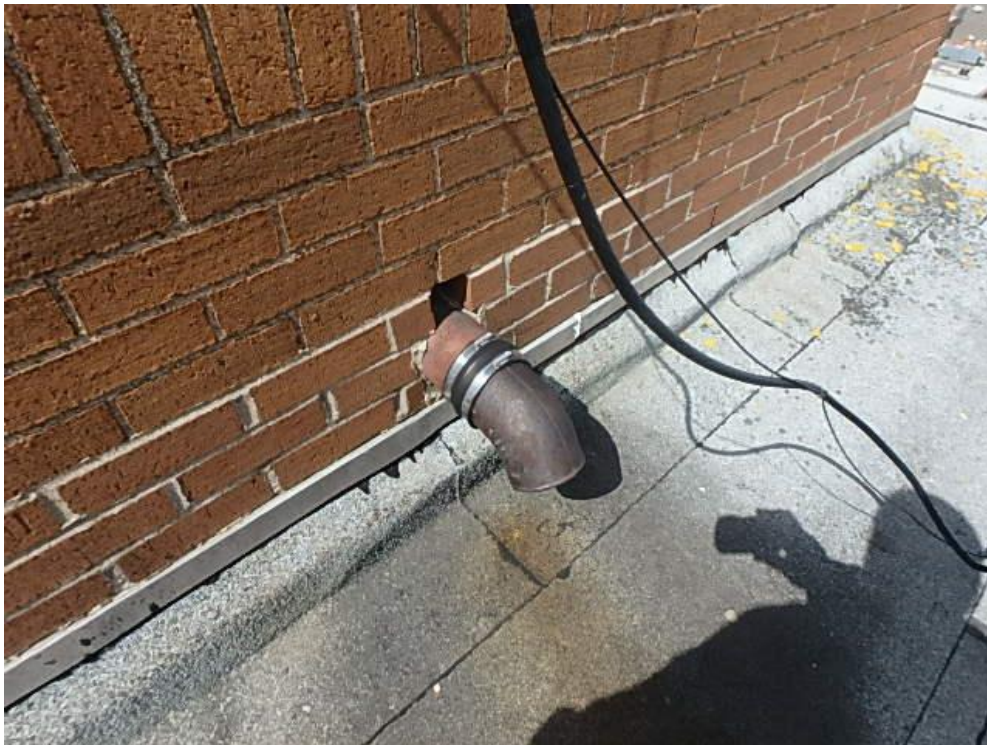
Photograph 28: Roof Area 3.1 – improperly sealed wall penetration and no membrane protection under pipe.

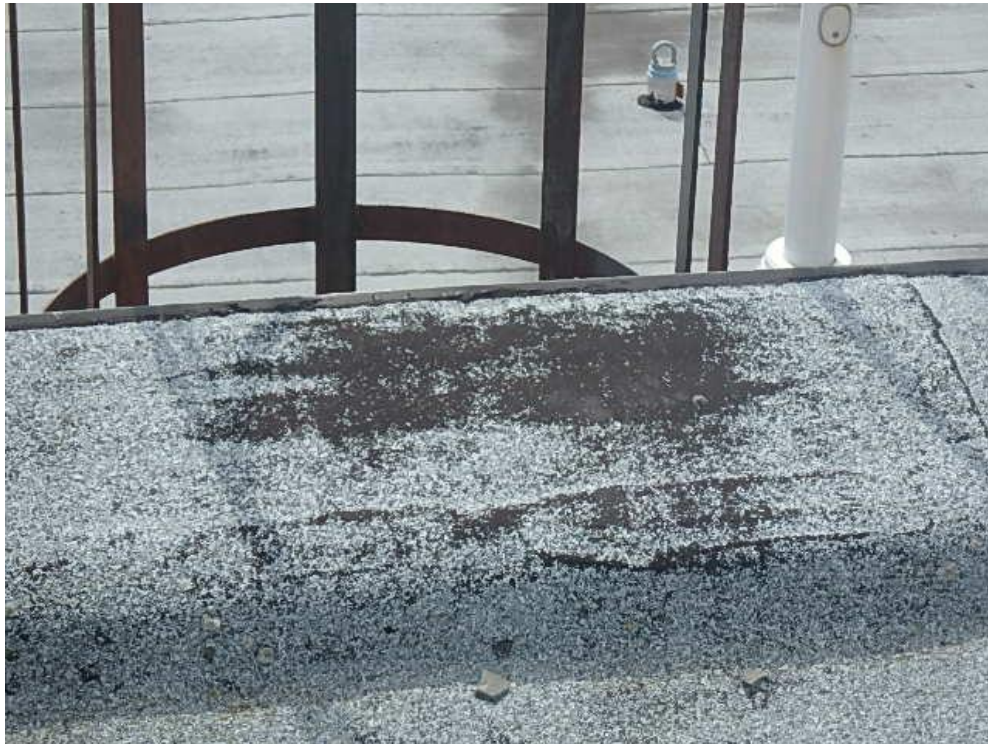
Photograph 29: Roof Area 3.1 – damaged membrane due to lack of protection at top of ladder.

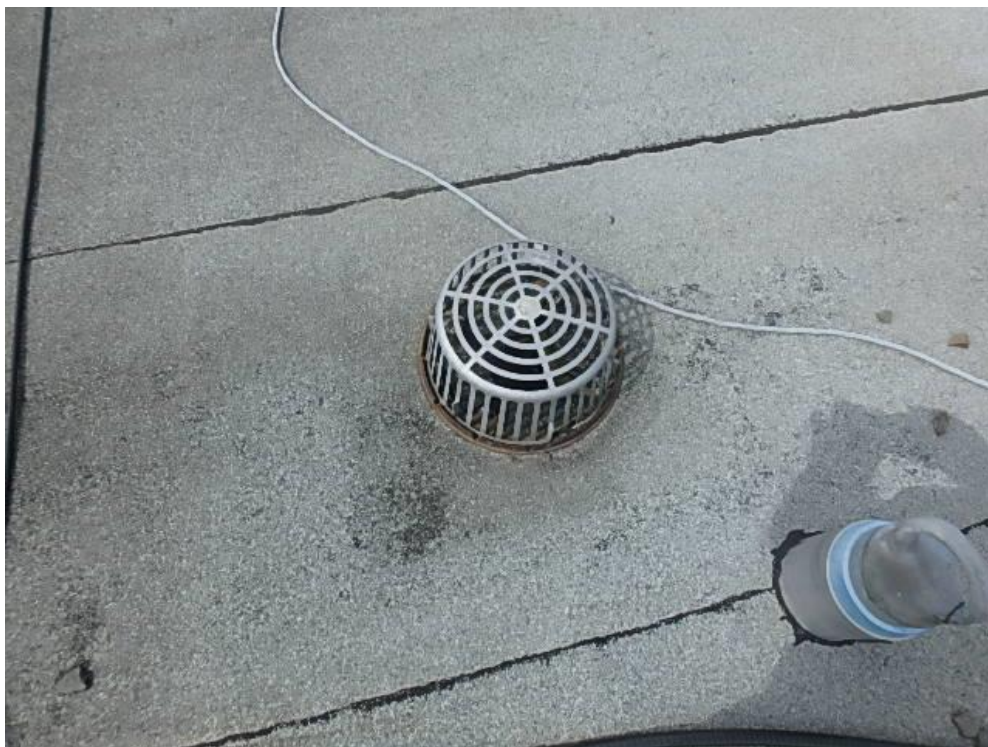
Photograph 30: Roof Area 3.1 – Typical roof drain installation with improper cap sheet detail.
