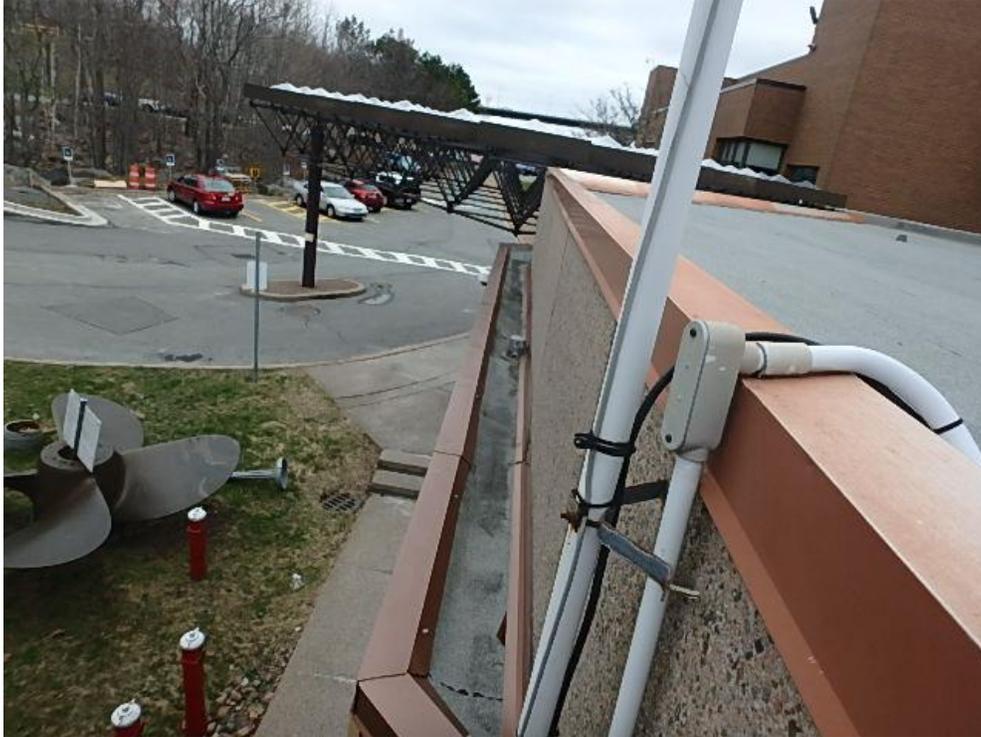
Photograph 1: Overall view of Holland Building Roof Area 1.1 facing east. Ridging exists throughout roof area.

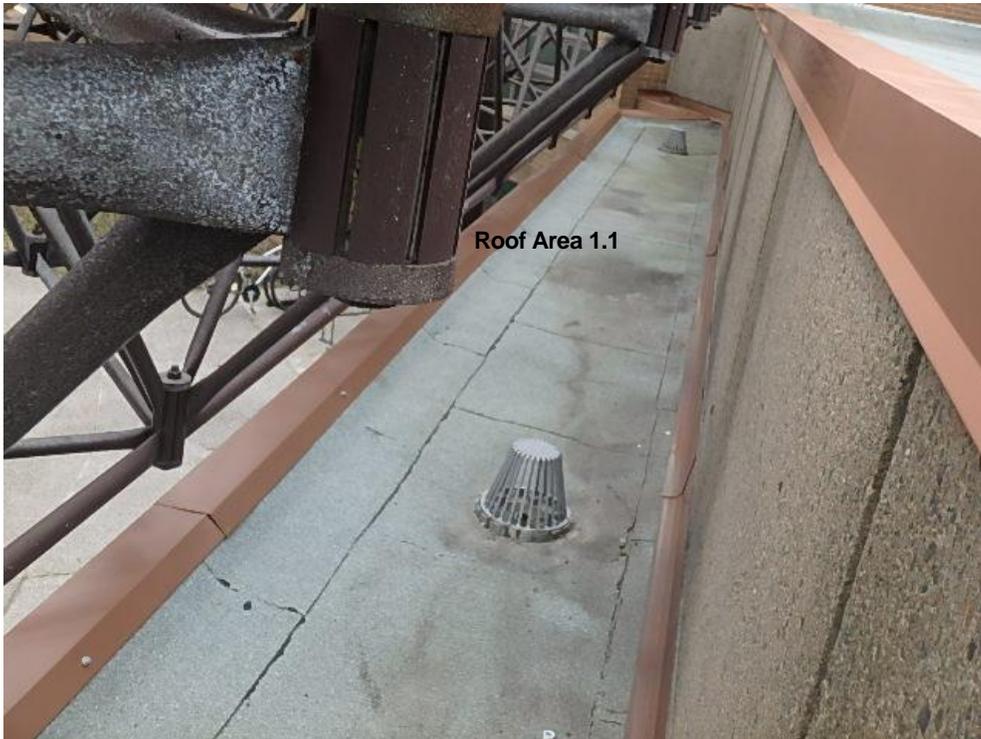
Photograph 2: Holland Building Roof Area 1.1 Ridging in membrane throughout roof area, and typical roof drains.

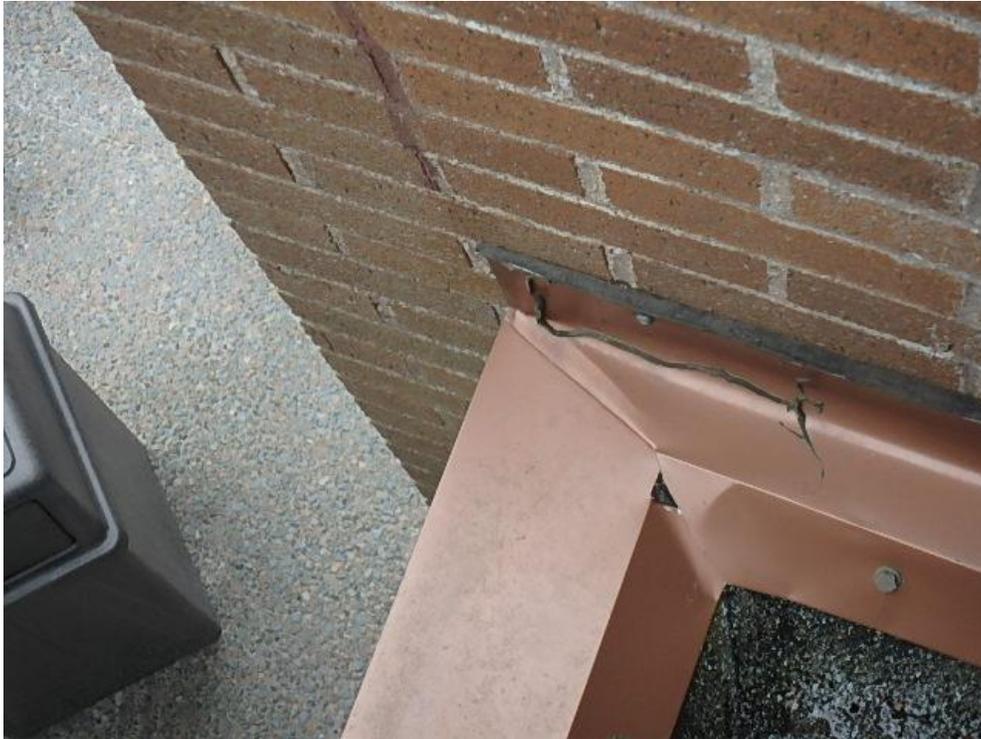
Photograph 3: Roof Area 1.2 – Damaged flashing at reglet.

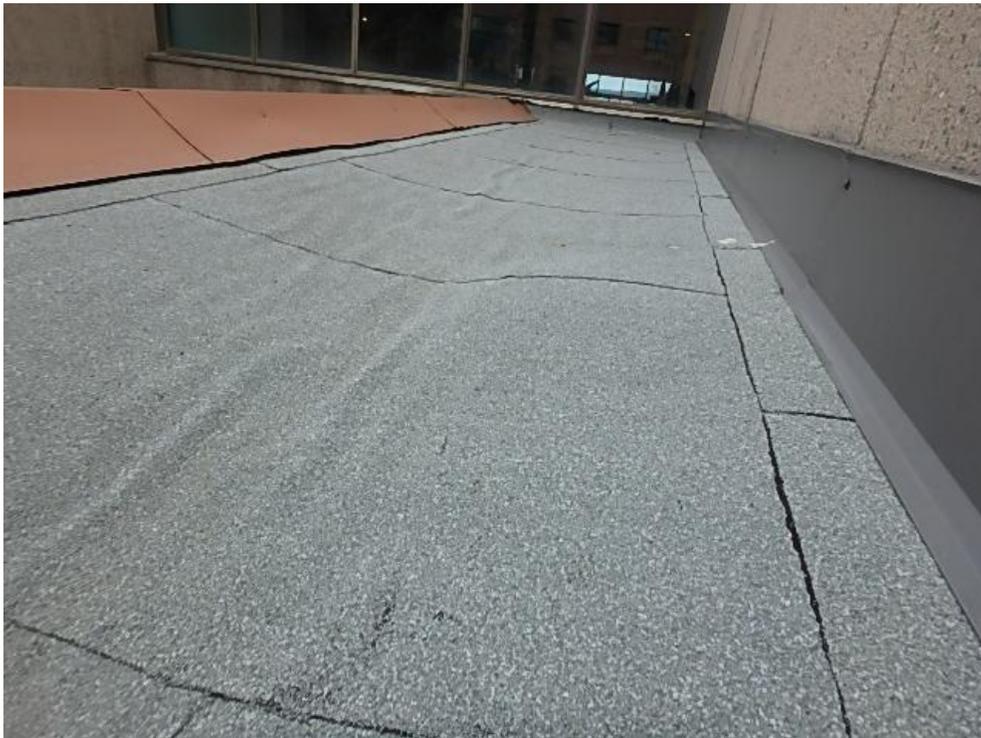
Photograph 4: Holland Building Roof Area 1.2 substantial ridging in membrane throughout roof area.

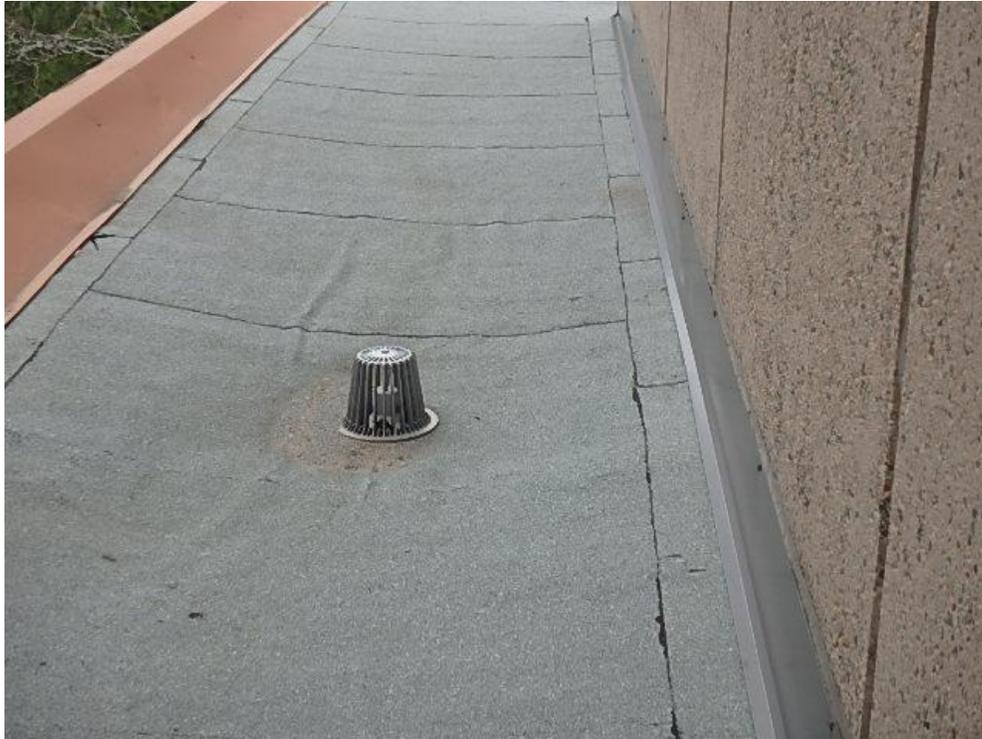
Photograph 5: Roof Area 1.2 – substantial ridging in membrane and typical roof drain

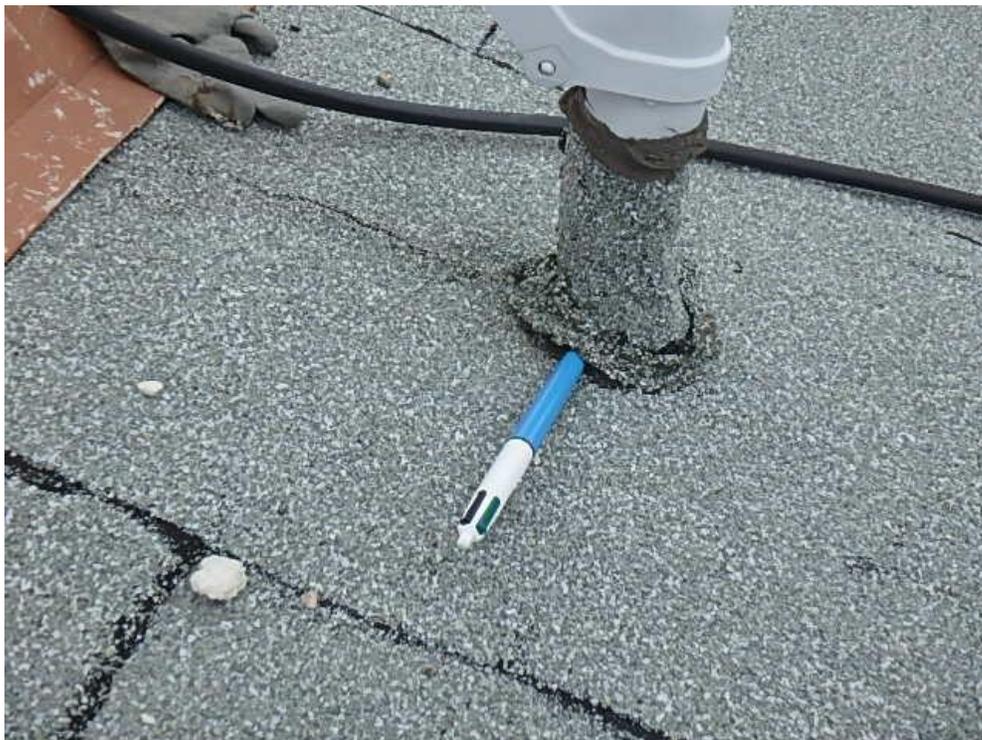
Photograph 6: Roof Area 2.1 – flashing poorly sealed and debonded at conduit gooseneck.

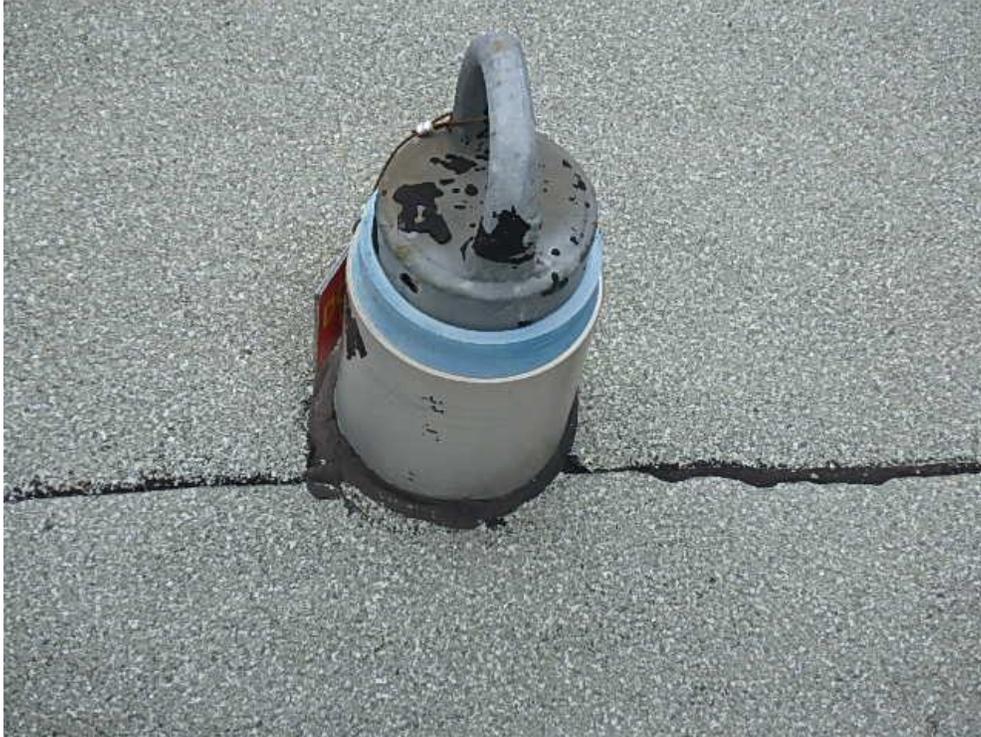
Photograph 7: Roof Area 2.1 – flashing problem at roof anchor that is not being used and should be removed.

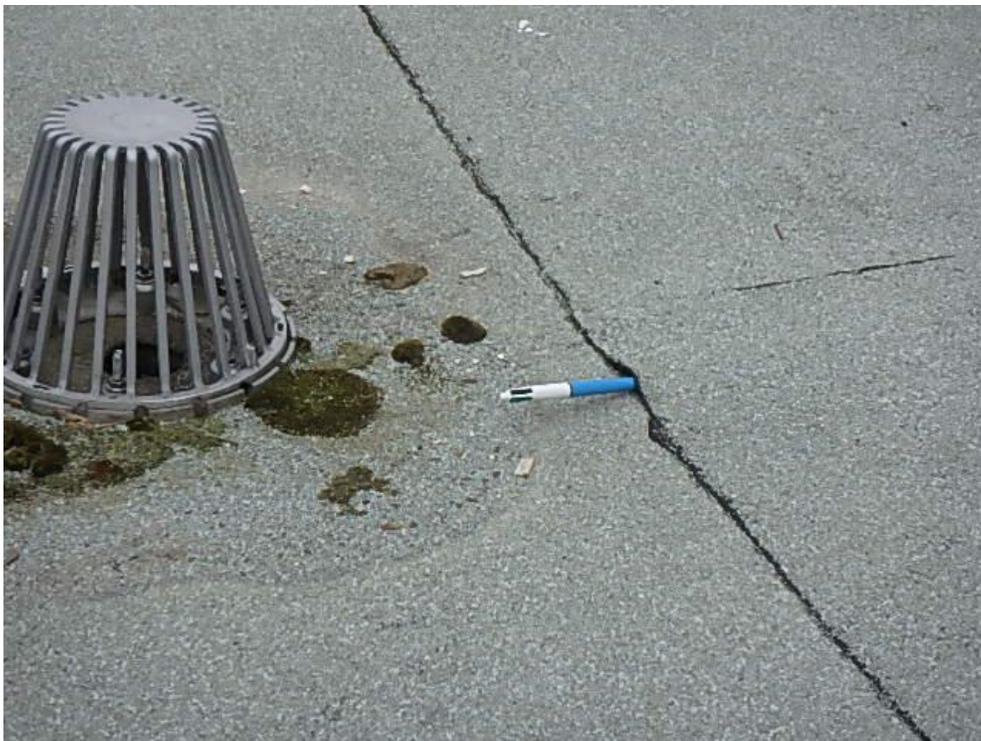
Photograph 8: Roof Area 2.1 – Roof drain without proper membrane cap flashing (typical throughout roof area) and vegetation growth. Also shows debonding of cap sheet membrane.

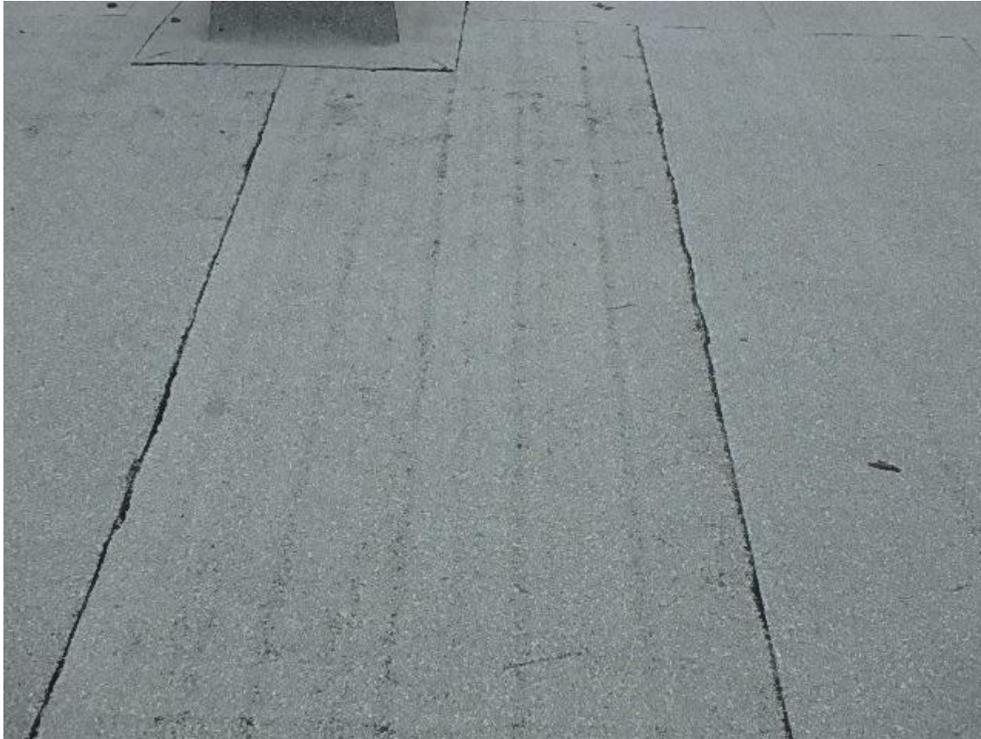
Photograph 9: Roof Area 2.1 – Ridging in membrane

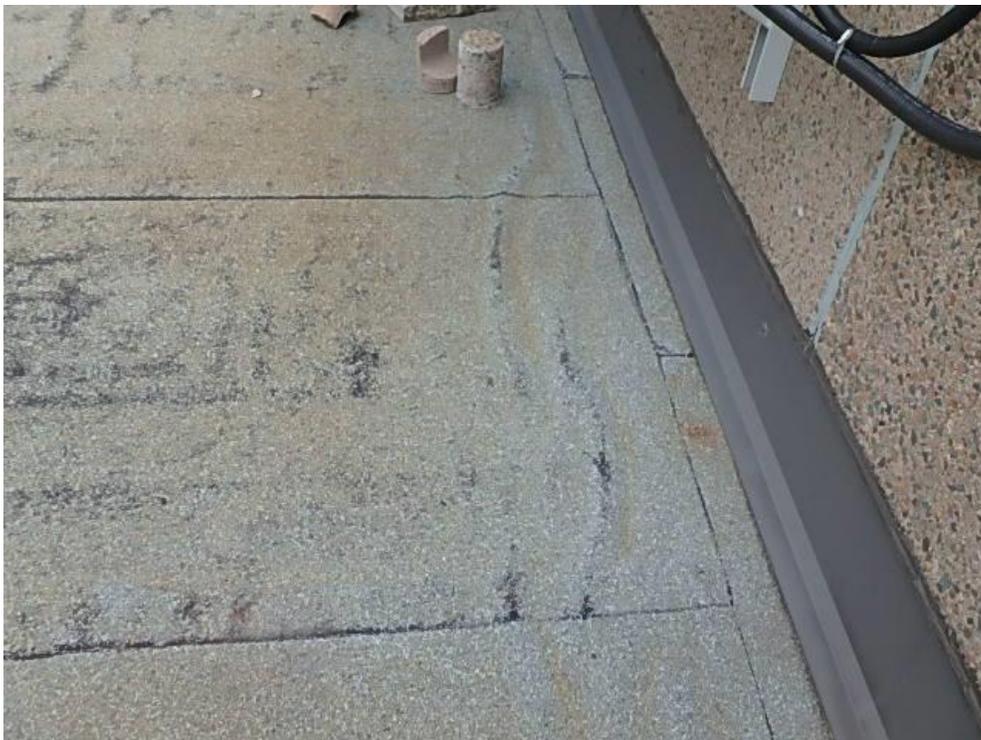
Photograph 10: Roof Area 2.1 – ridging in membrane between roof areas 3.1 and 3.2.

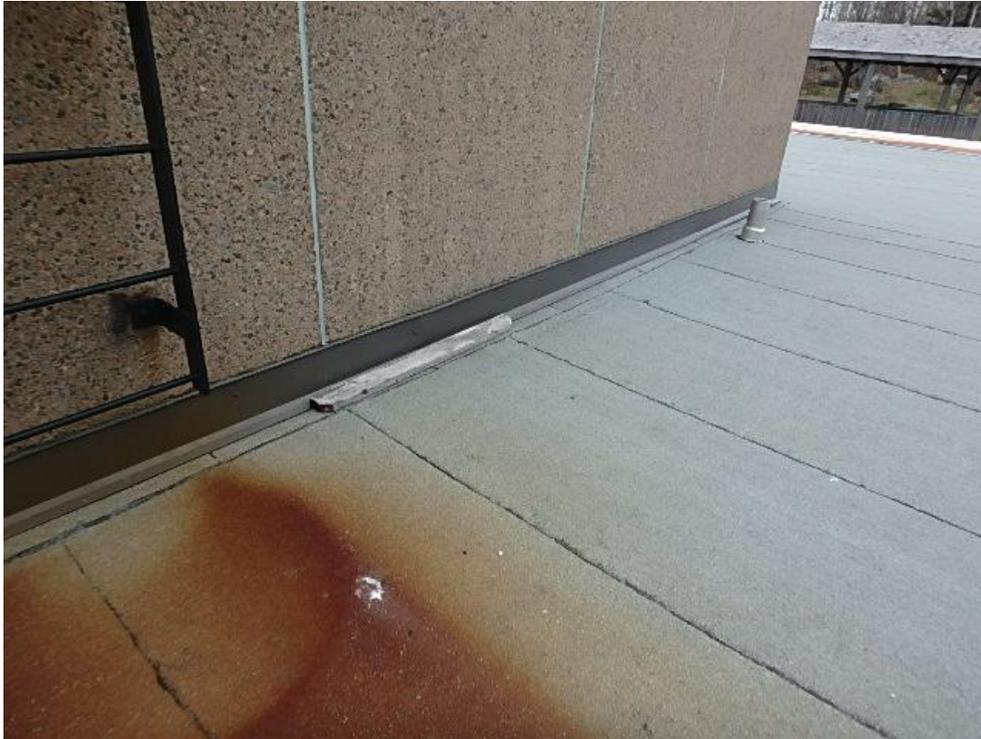
Photograph 11: Roof Area 2.1 – Rust staining of membrane from ladder and membrane protection missing under ladder.

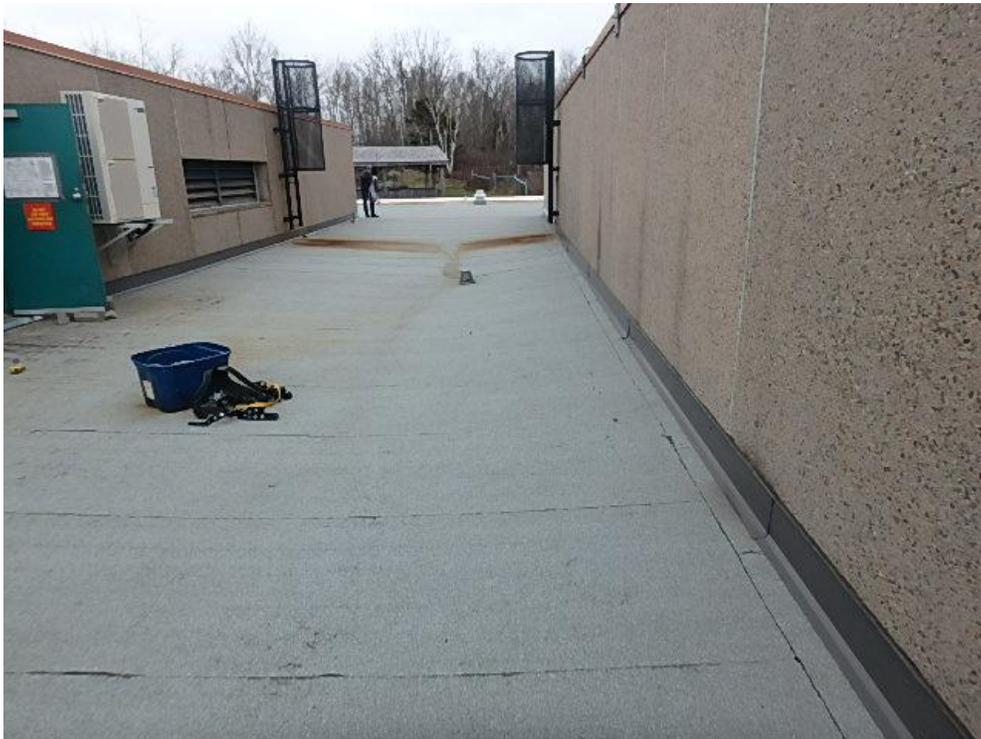
Photograph 12: Roof Area 2.1 – Overall view of roof area 2.1 between 3.1 and 3.2.

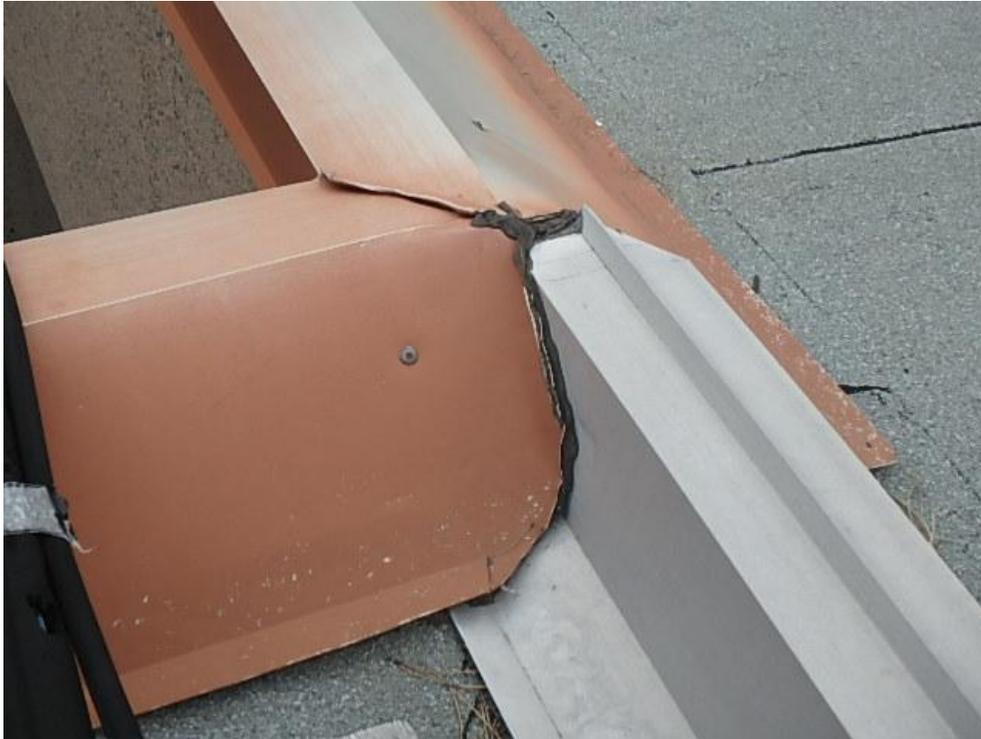
Photograph 13: Roof Area 2.1 – poor adhesion of flashings at intersection of parapet and expansion joint.

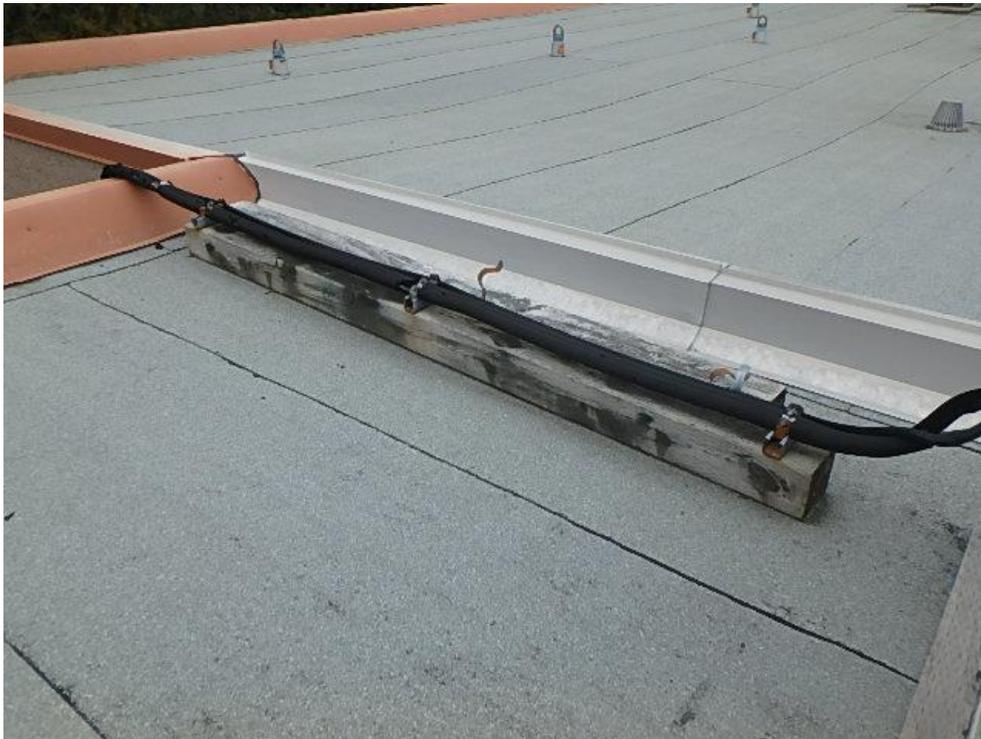
Photograph 14: Roof Area 2.1 – Conduit over parapet and wood sleeper without proper membrane protection.

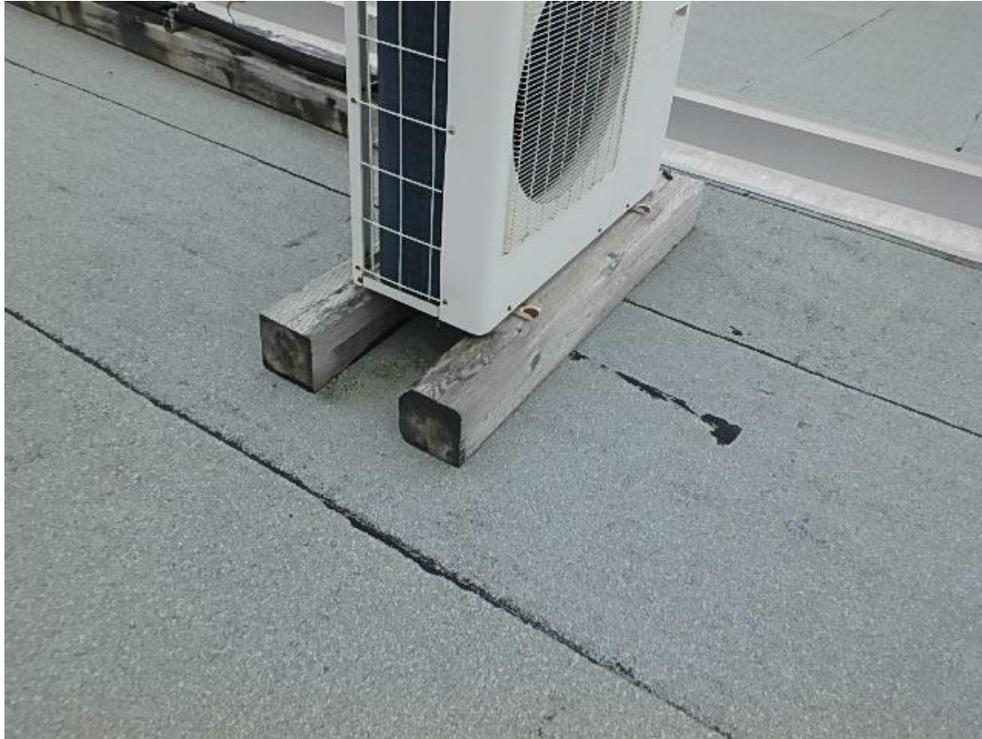
Photograph 15: Roof Area 2.1. Small HVAC unit on wood sleepers without proper membrane protection.

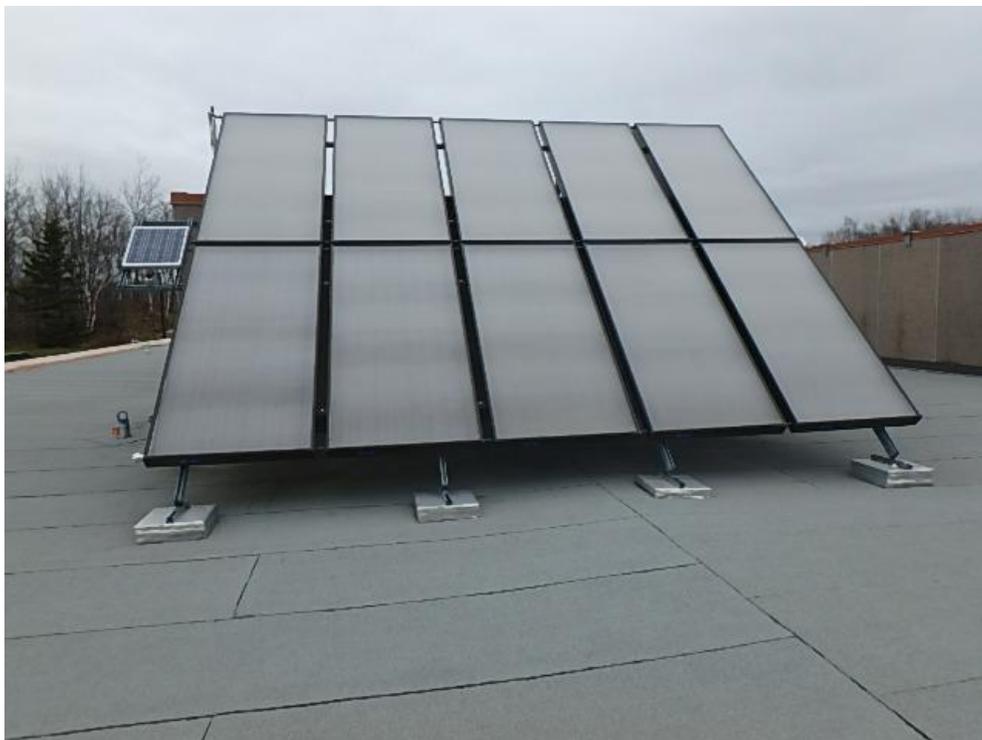
Photograph 16: Roof Area 2.1 – Solar panels on evenly spaced structural supports that are improperly flashed to cap sheet membrane.

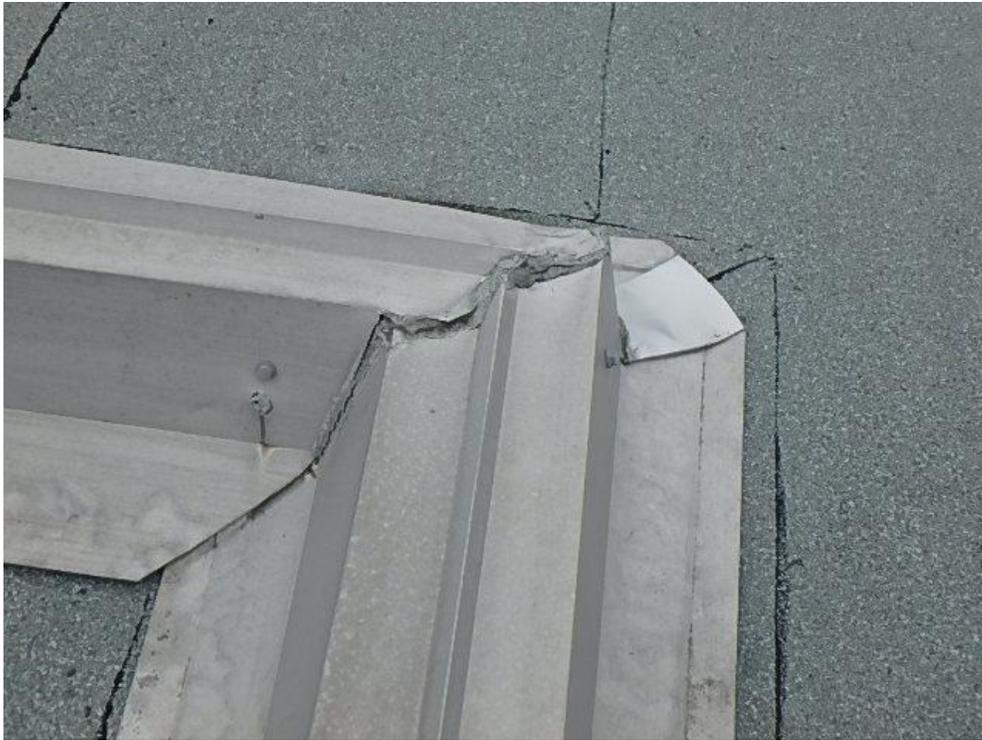
Photograph 17: Roof Area 2.1 – poor sealant adhesion at intersection in expansion joint

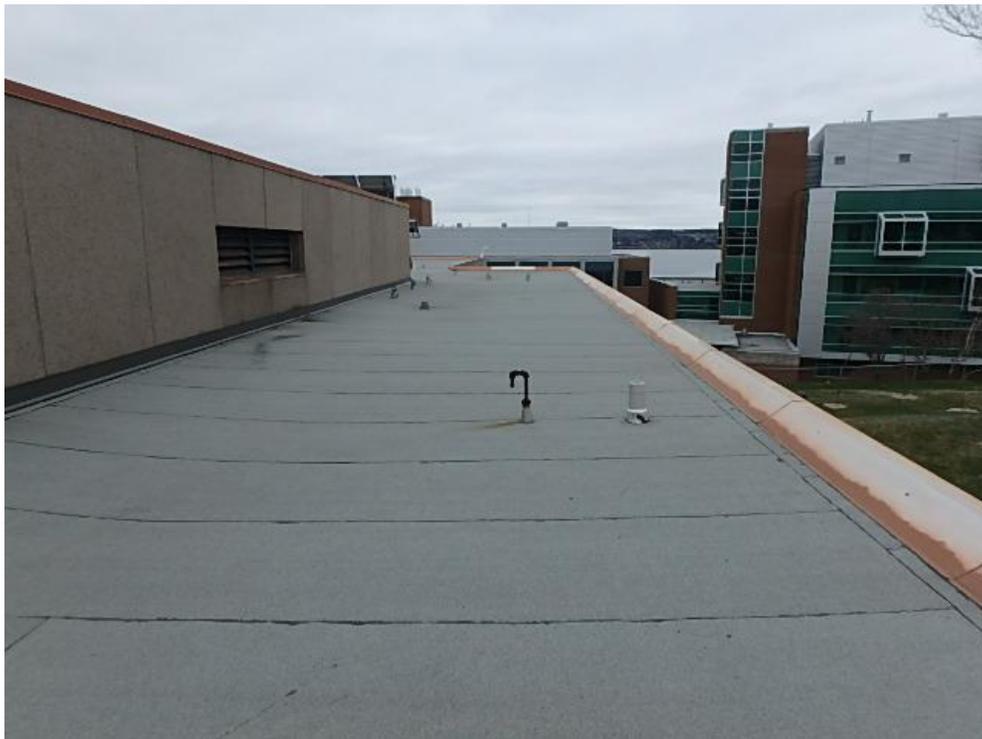
Photograph 18: Roof Area 2.1 – Overall view of west side of roof area facing south.

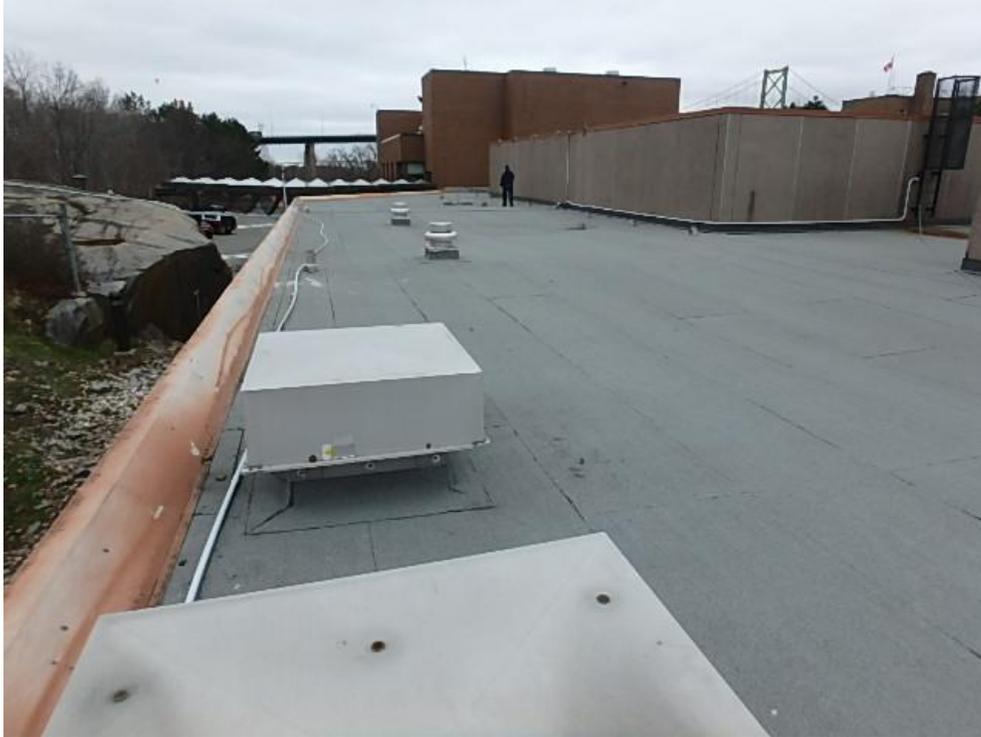
Photograph 19: Roof Area 2.1 – Overall view of roof area 2.1 on north side facing east showing unused roof curbs, conduit, exhaust fans and typical parapet flashing.

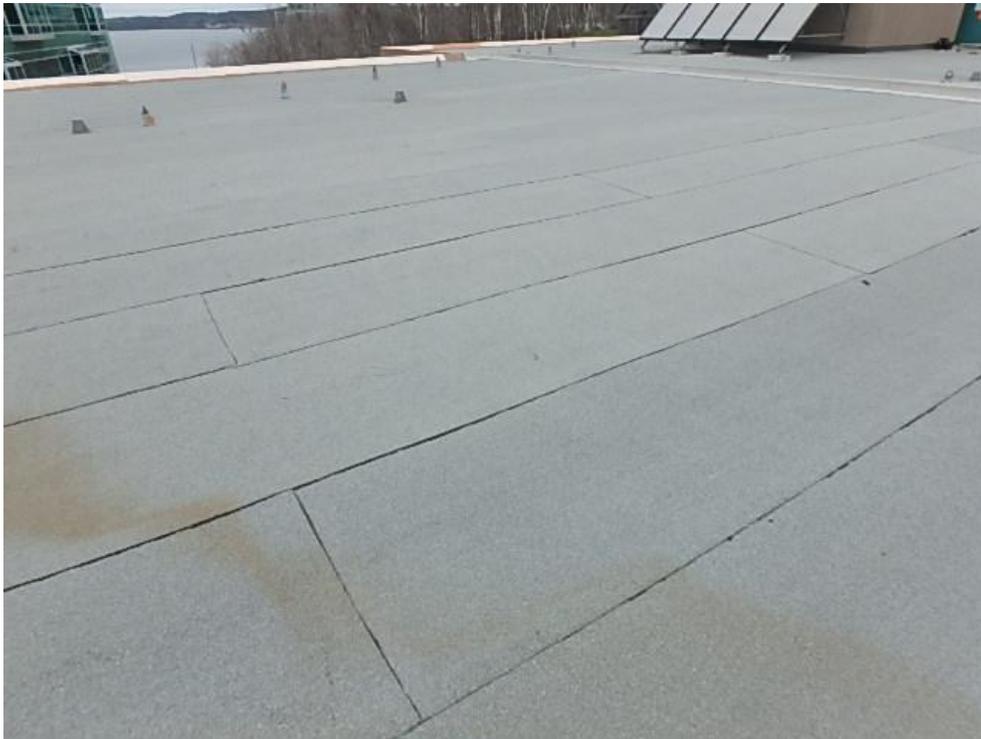
Photograph 20: Roof Area 2.2 – Overall view of roof area 2.2 facing north west.

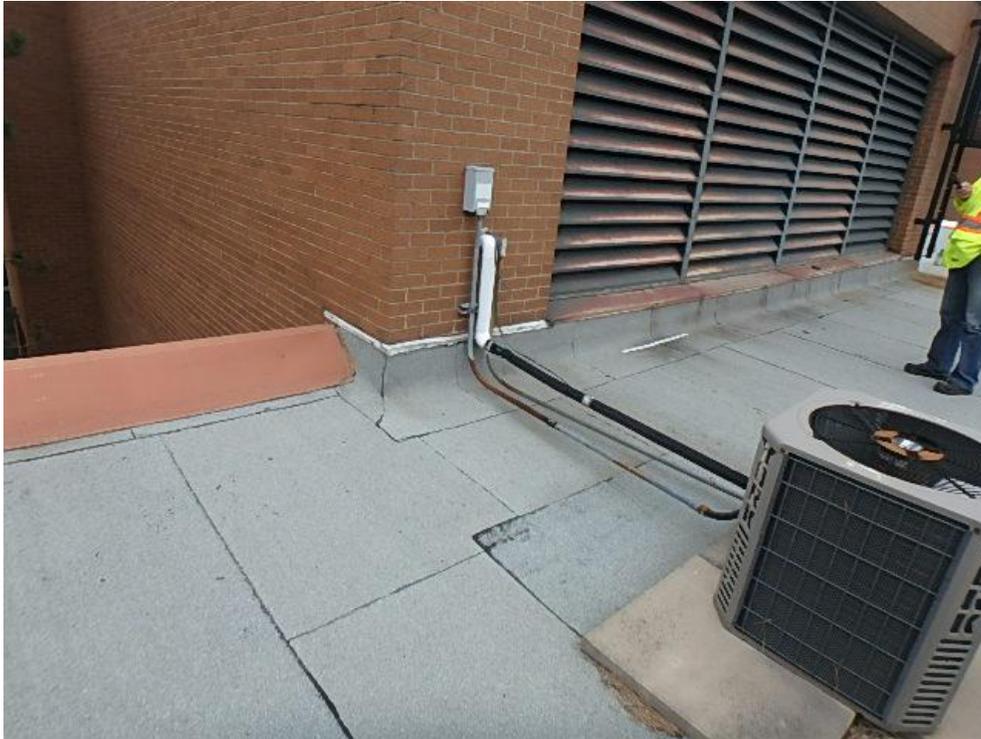
Photograph 21: Roof Area 2.2 – Showing conduit penetration into wall, wall louvre with water staining on membrane and air conditioner on pavers with cap sheet as membrane protection.

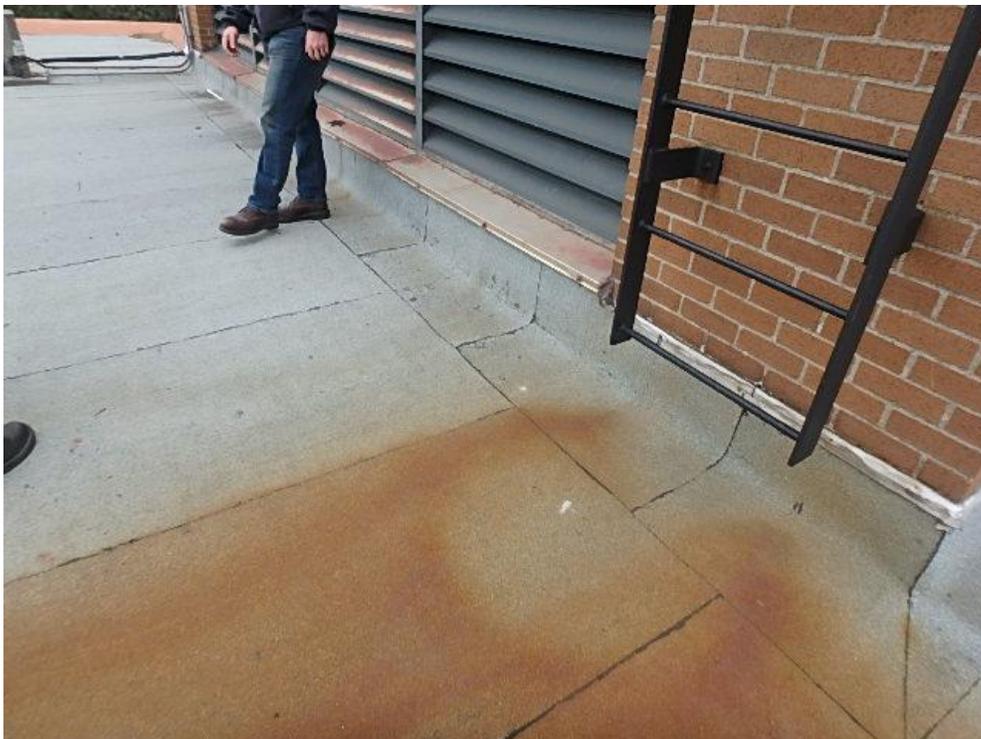
Photograph 22: Roof Area 2.2 – Rust staining on membrane and missing membrane protection under ladder.

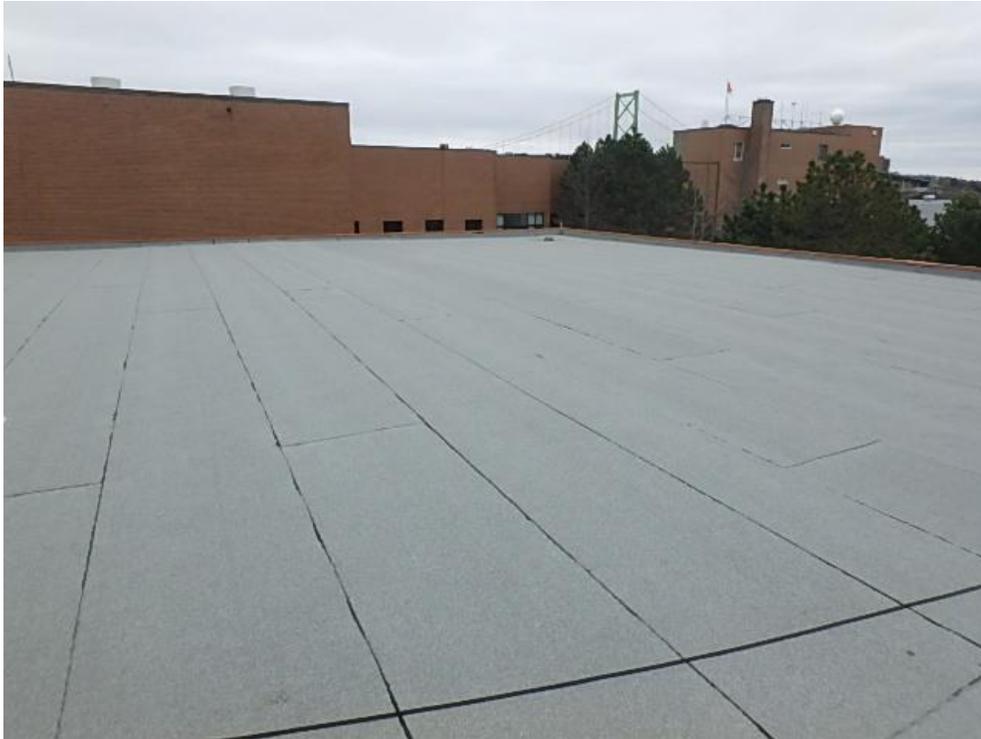
Photograph 23: Roof Area 3.1 – Overall view of roof area facing south west.

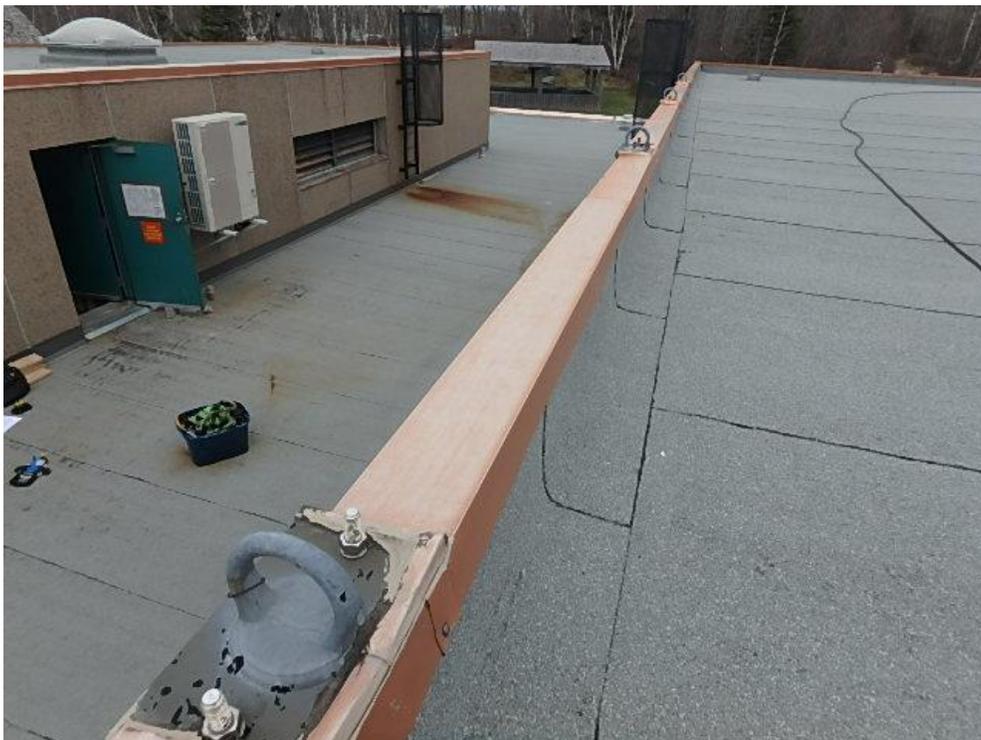
Photograph 24: Roof Area 3.1 – Poor sealant failure around base plate of roof anchor and parapet. Also shows typical parapet condition.

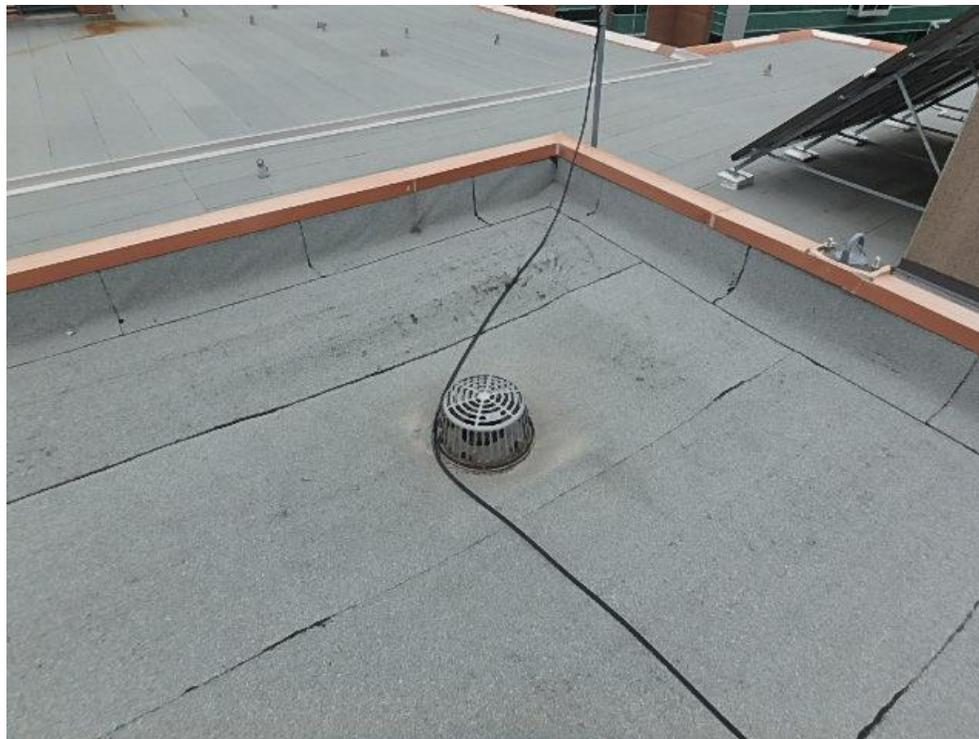
Photograph 25: Roof Area 3.1 – Membrane tenting around parapet, ridging in cap sheet membrane, conduit across roof area and improper cap sheet at roof drain.

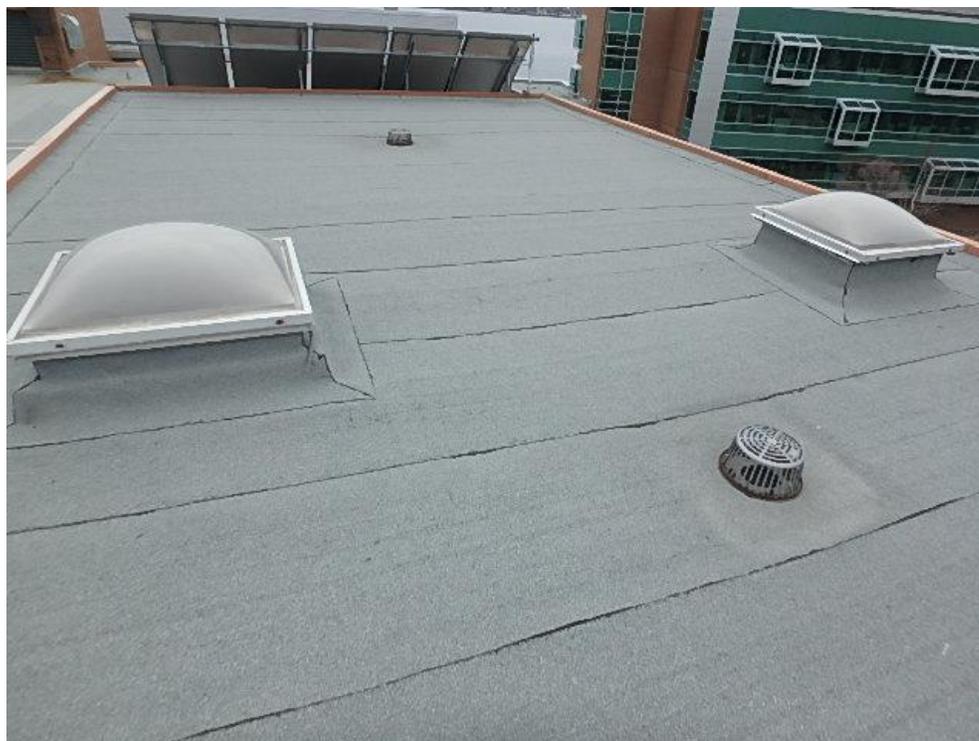
Photograph 26: Roof Area 3.2 – Overall view of roof area 3.2 facing south. Shows drains with improper cap sheet flashing, skylights, adjacent solar panels, and typical parapet. Roof is generally in good condition.

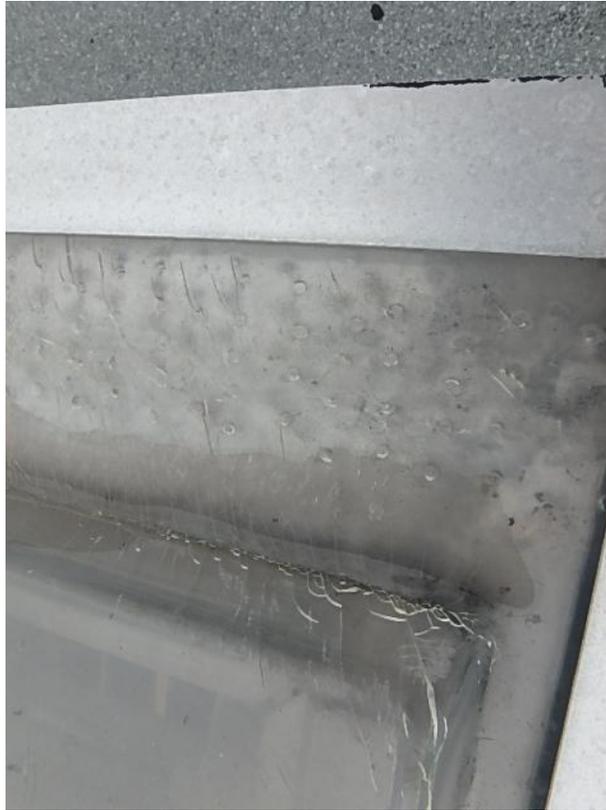
Photograph 27: Roof Area 3.2 –Damaged skylight.

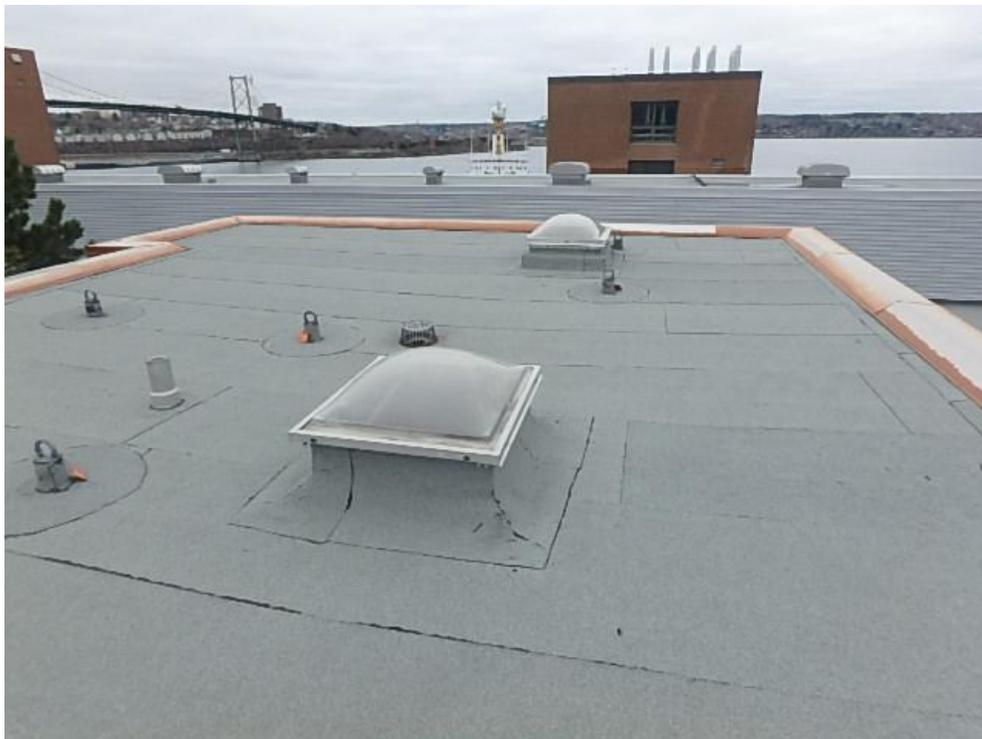
Photograph 28: Roof Area 3.3 –Overall view of roof area 3.3 facing south.

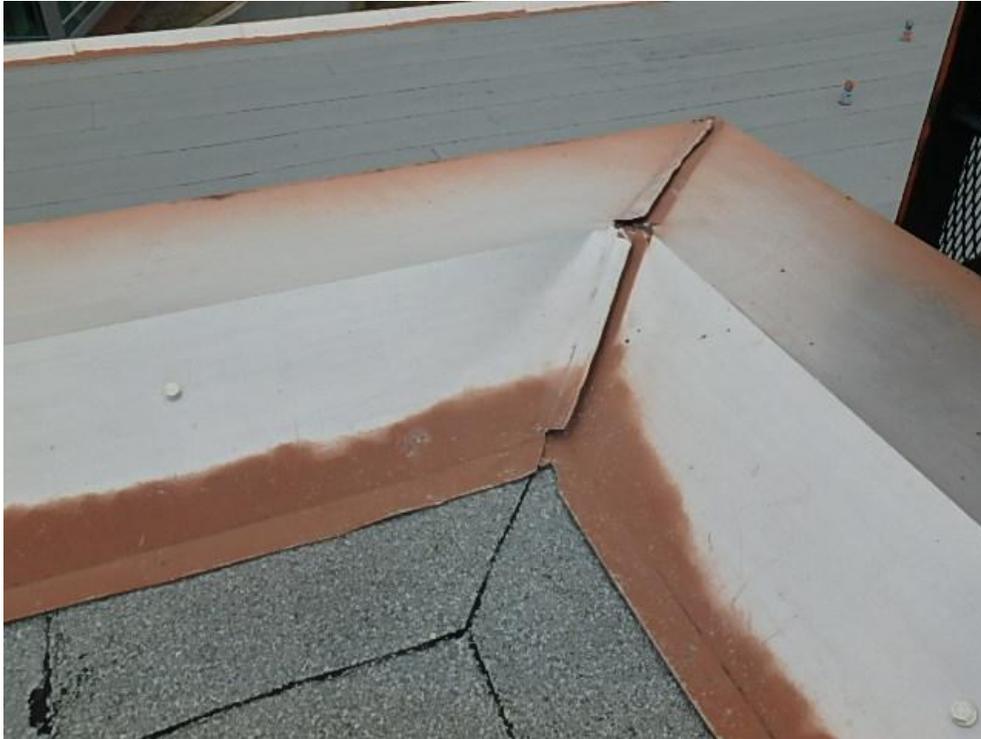
Photograph 29: Roof Area 3.3 – Corner of parapet flashing in poor condition and sealant is missing.

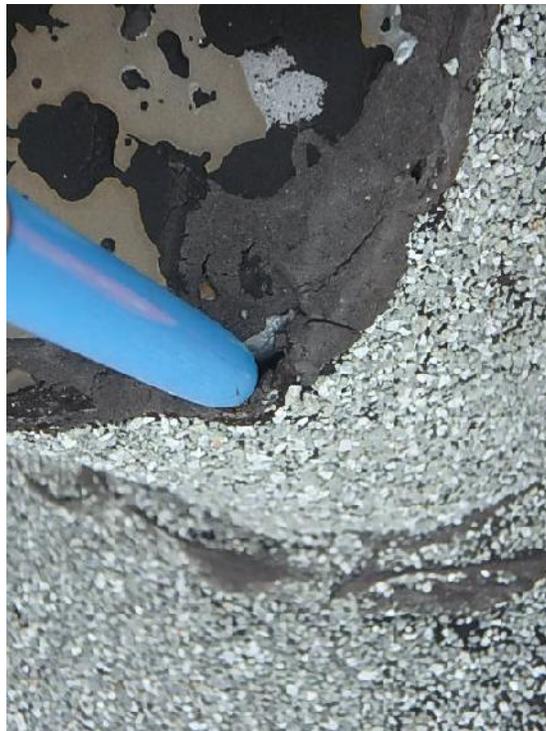
Photograph 30: Roof Area 3.3 – Blistered and poorly sealed membrane flashing around base of roof anchor.

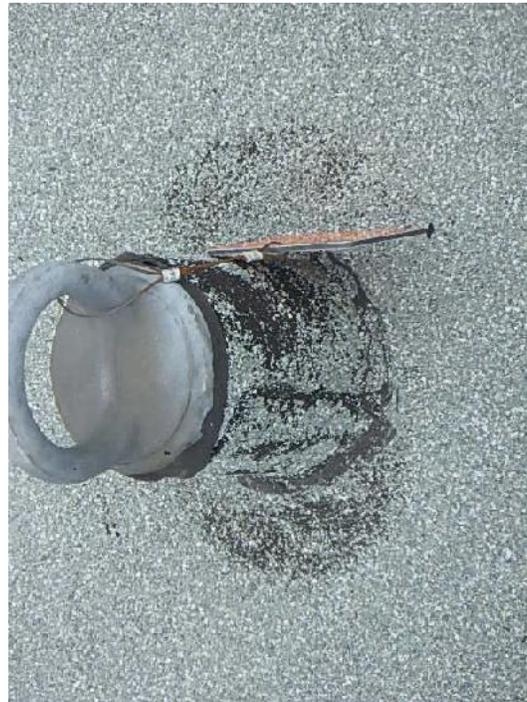
Photograph 31: Roof Area 3.3 – Full view of membrane flashing that is in poor condition around roof anchor.

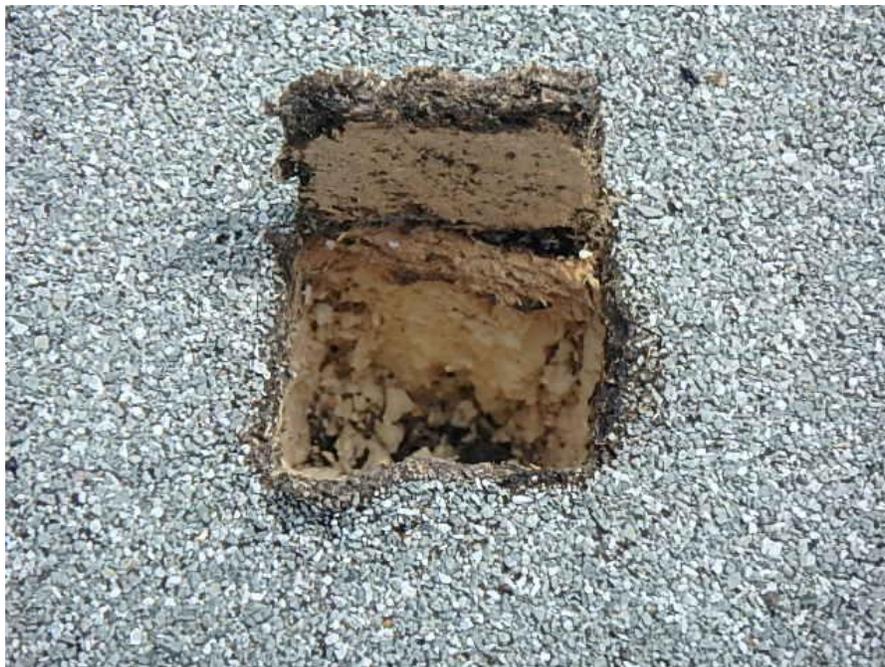
Photograph 32: Typical roof area core cut on Holland Building.
