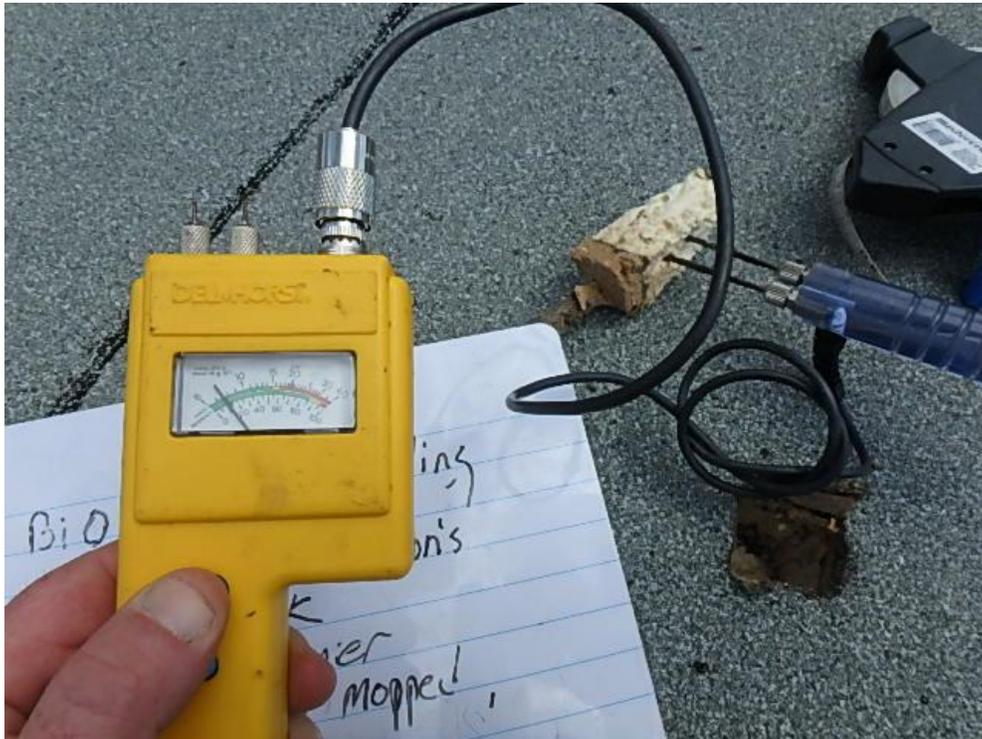
Photograph 33: Moisture testing showing a low level of moisture present in roof system.
