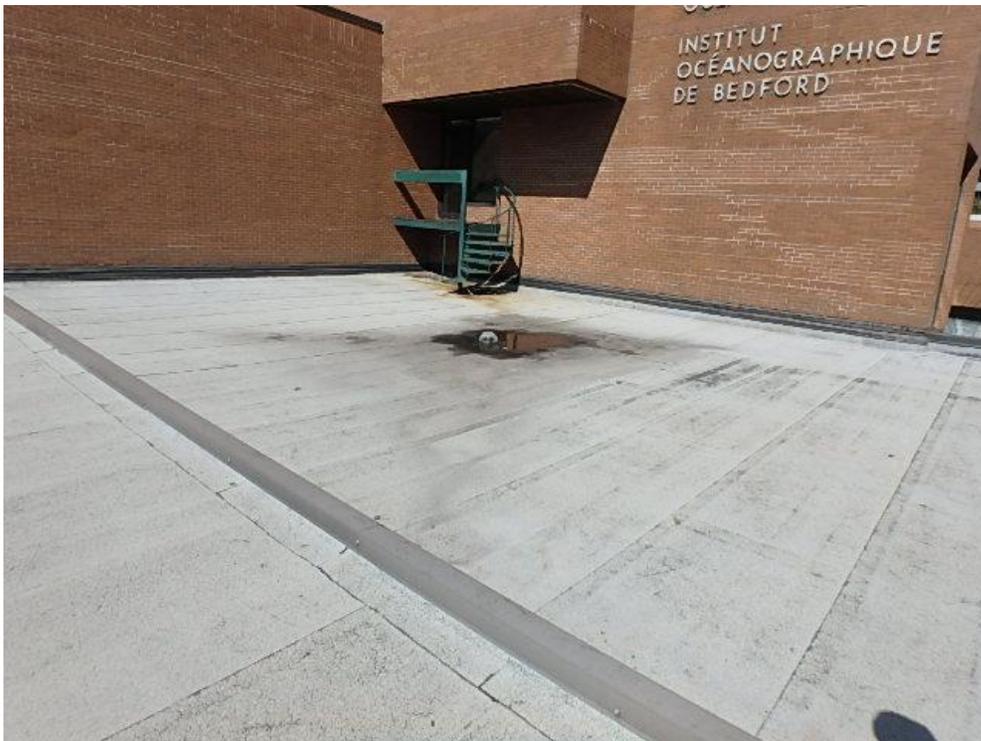
**Photograph 1:** Overall view of Murray building Roof Area 1.1 looking south towards Halifax. This is a 2 ply modified bitumen roof that is approximately 15 years old

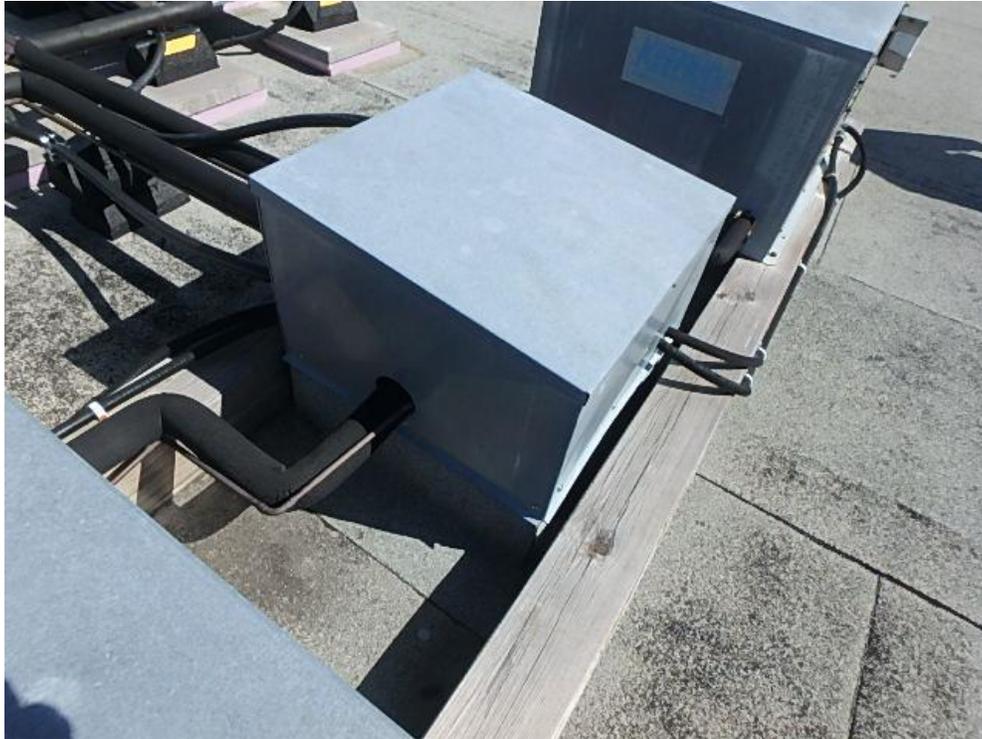
**Photograph 10:** Roof Area 1.1 – HVAC units on pavers with insulation membrane protection and conduits running to adjacent doghouse penetration.

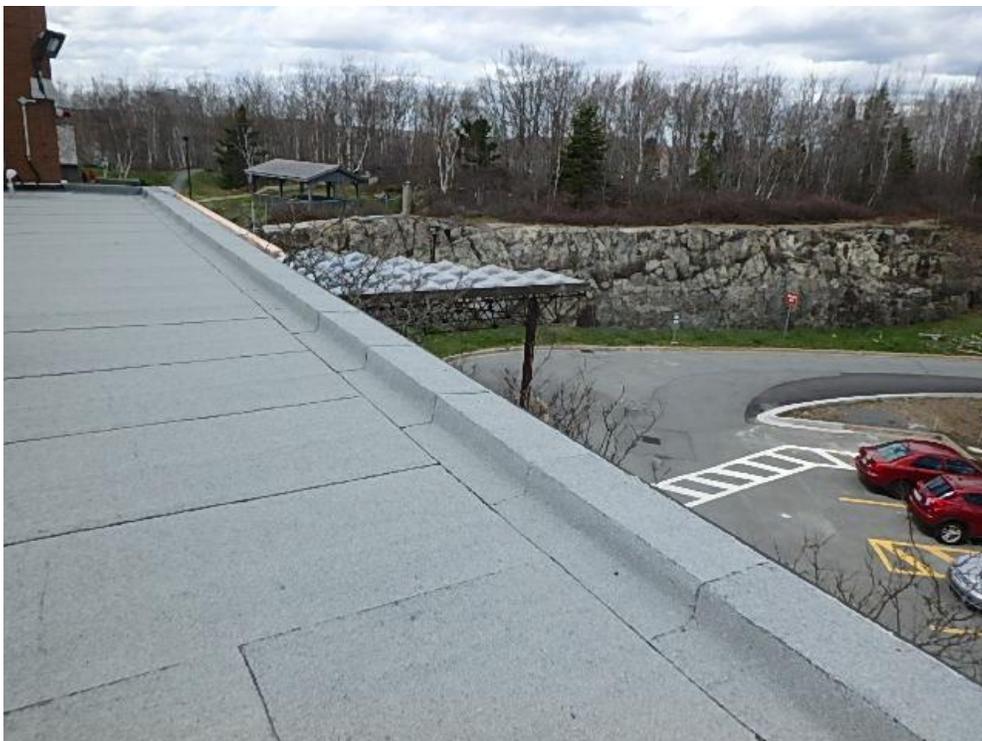
**Photograph 35:** Roof Area 2.2 – Membrane delamination along seam.

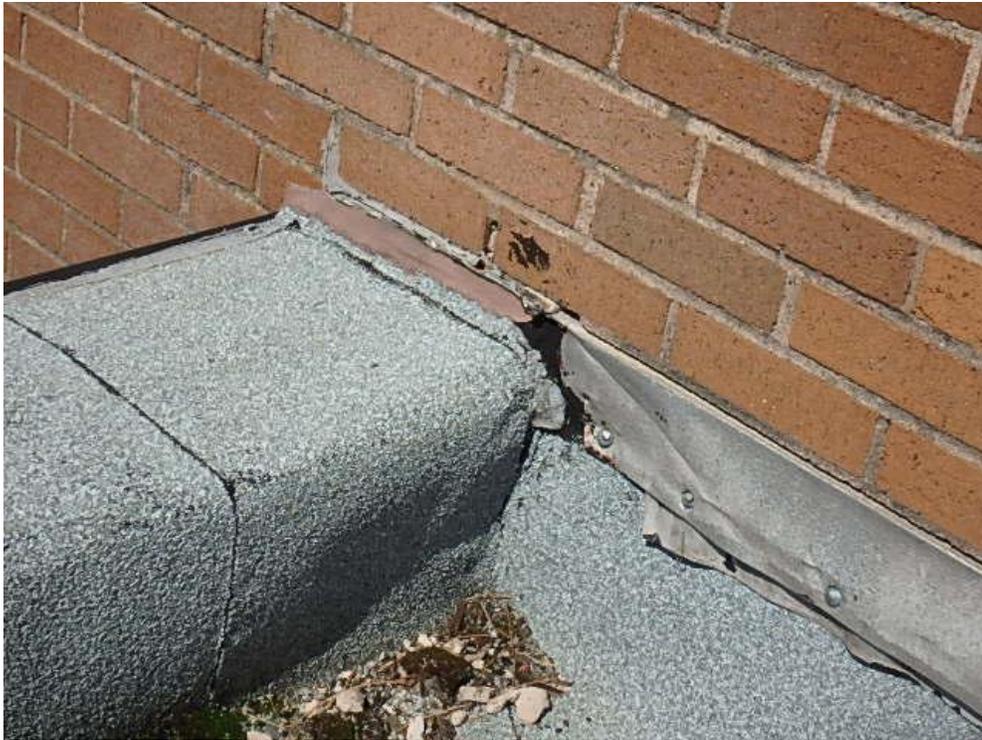
**Photograph 40:** Roof Area 2.3 – Parapet with membrane tenting and vegetation growth.

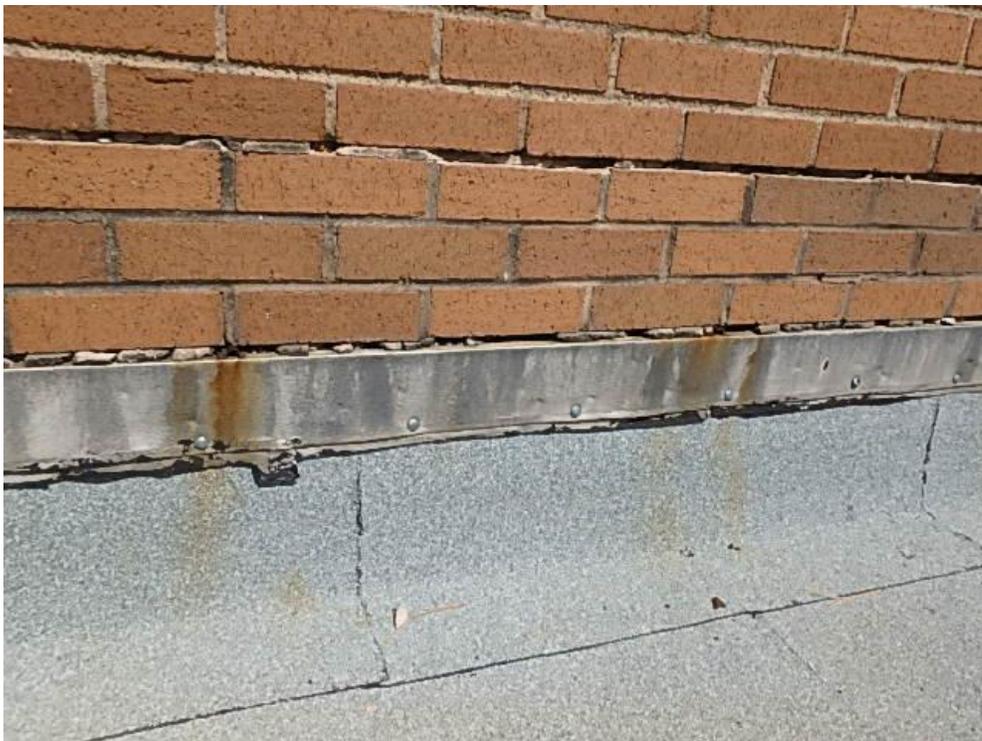
**Photograph 41:** Roof Area 2.3 – Parapet intersection at wall and reglet detail. Improperly sealed reglet over parapet.

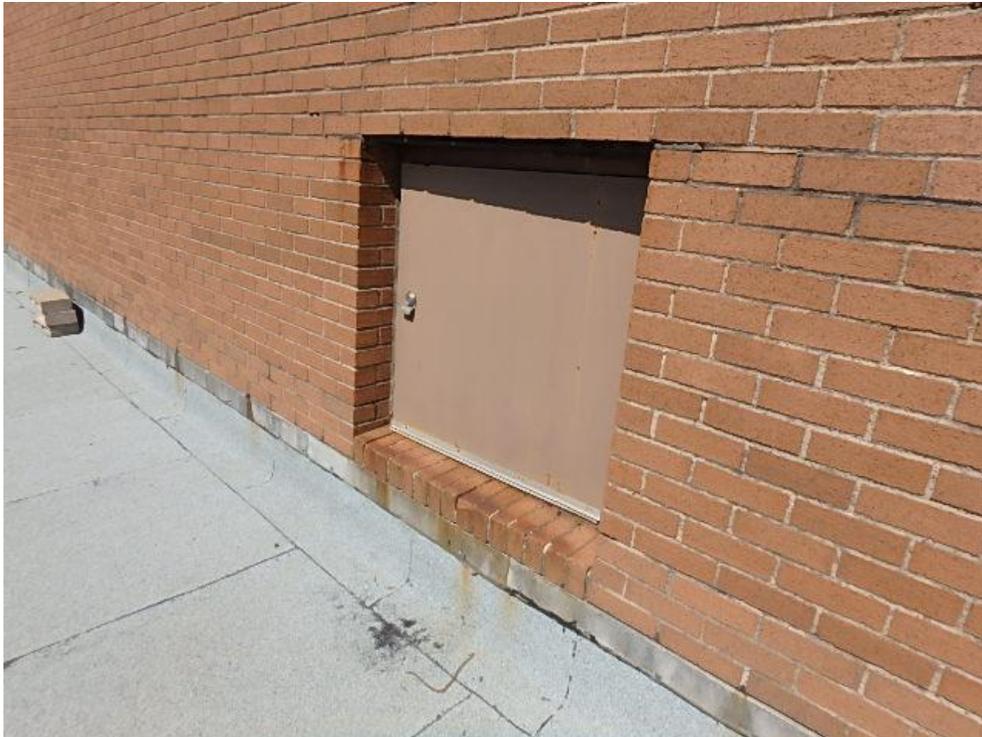
**Photograph 42:** Roof Area 2.3 – sealant missing at reglet and improperly sealed between flashing and membrane.

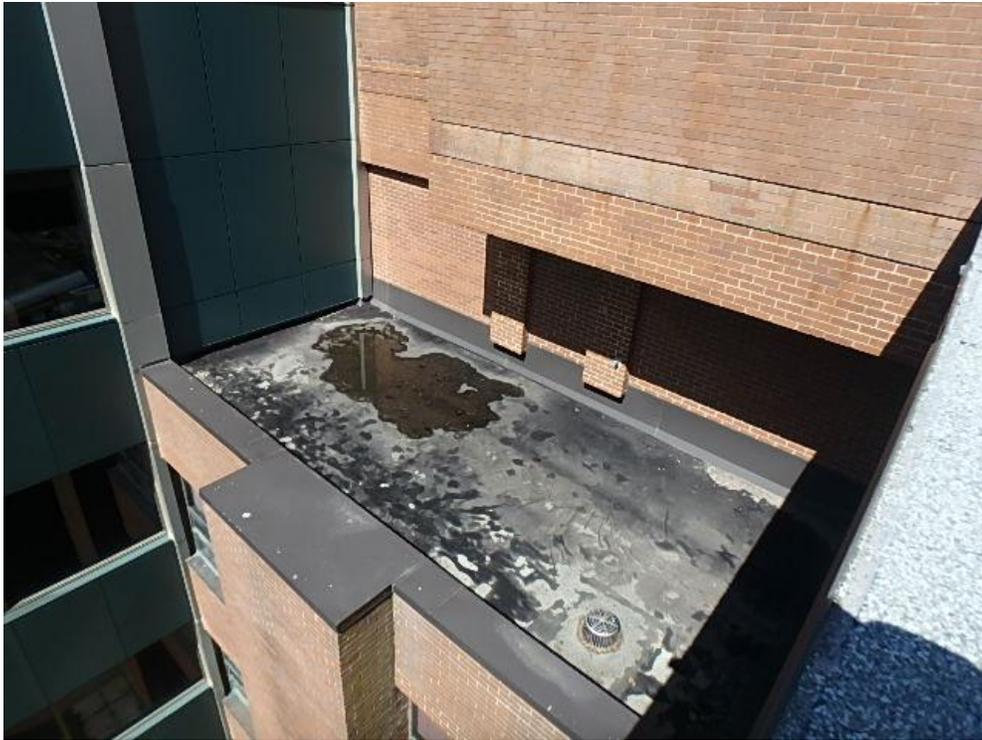
**Photograph 44:** Roof Area 2.3 – Improper sealant/flashing along reglet.

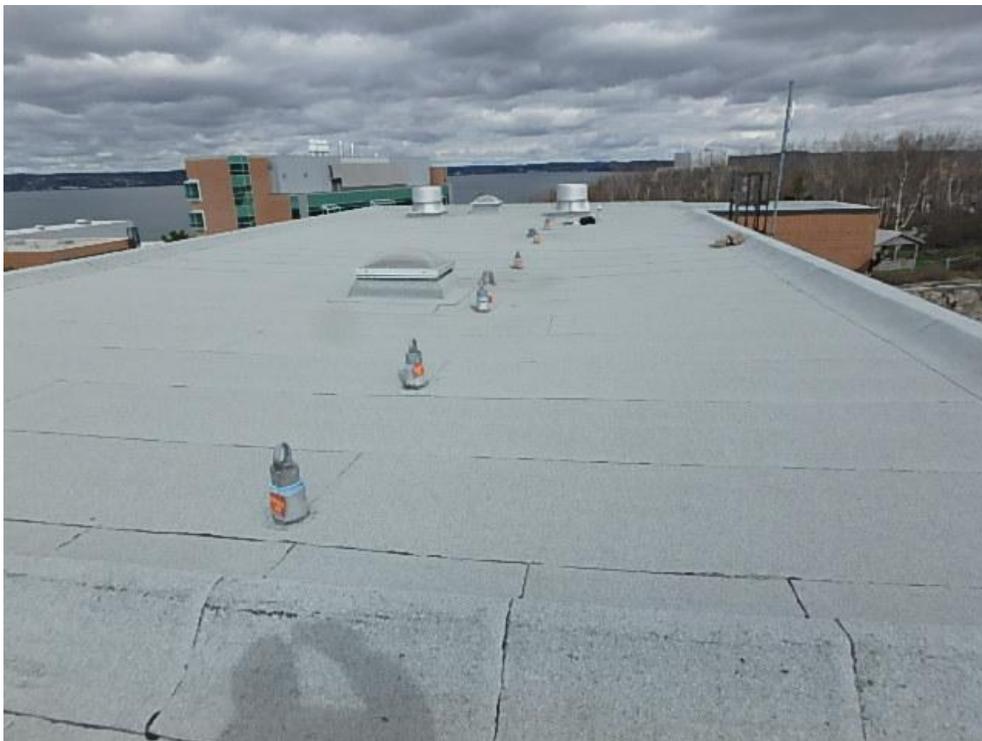
**Photograph 45:** Roof Area 2.4 – Roof area above entrance with no access from building or by ladder. There is evidence of ponding and membrane cracking in multiple locations.

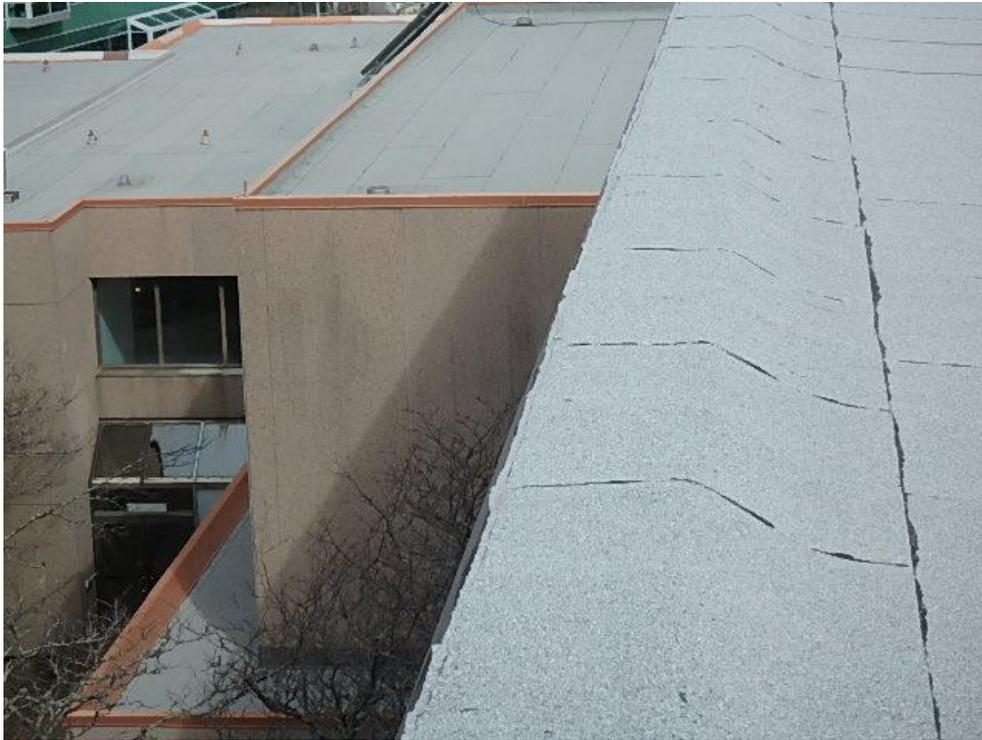
**Photograph 46:** Roof Area 3.1 – Overall view of roof area facing north west. The modified bitumen roof is approximately 12 years old.

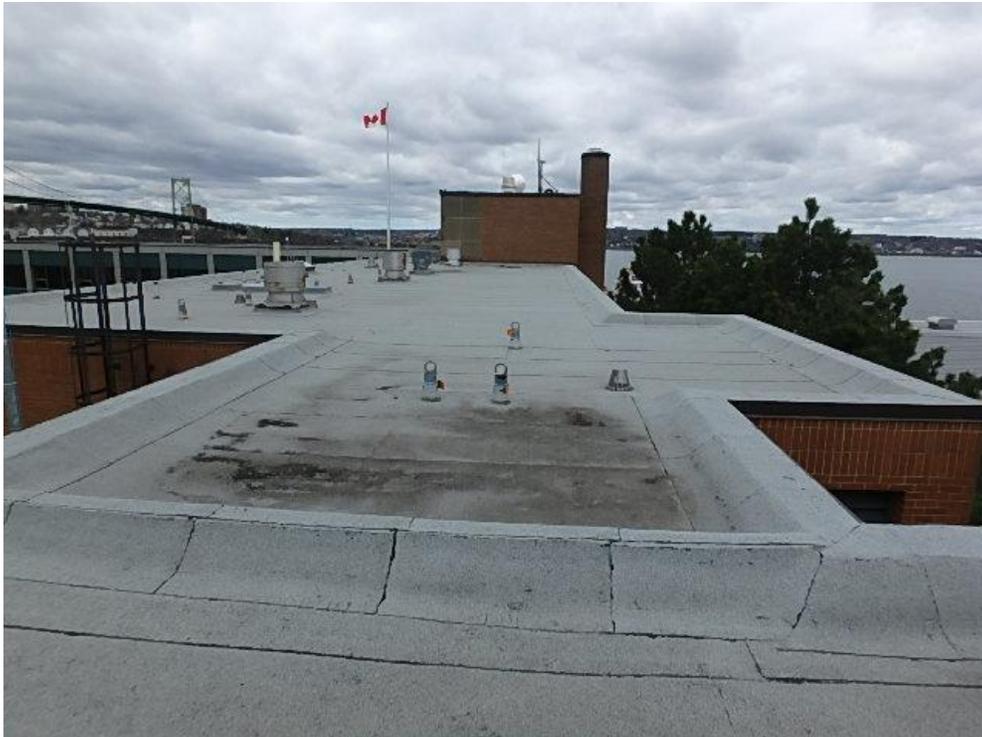
**Photograph 58:** Roof Area 3.2 – Blistering on membrane around roof edge and improper corner flashing detail.

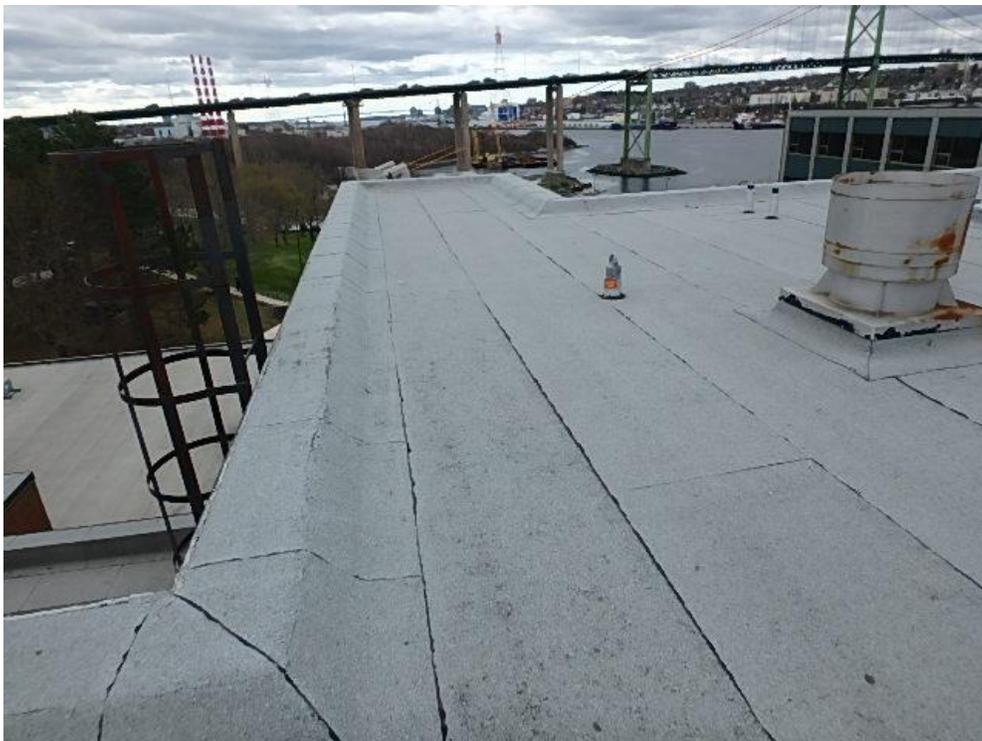
**Photograph 59:** Roof Area 3.3 – Overall view of roof area 3.3 with evidence of ponding along with ridging and blistering of membrane.

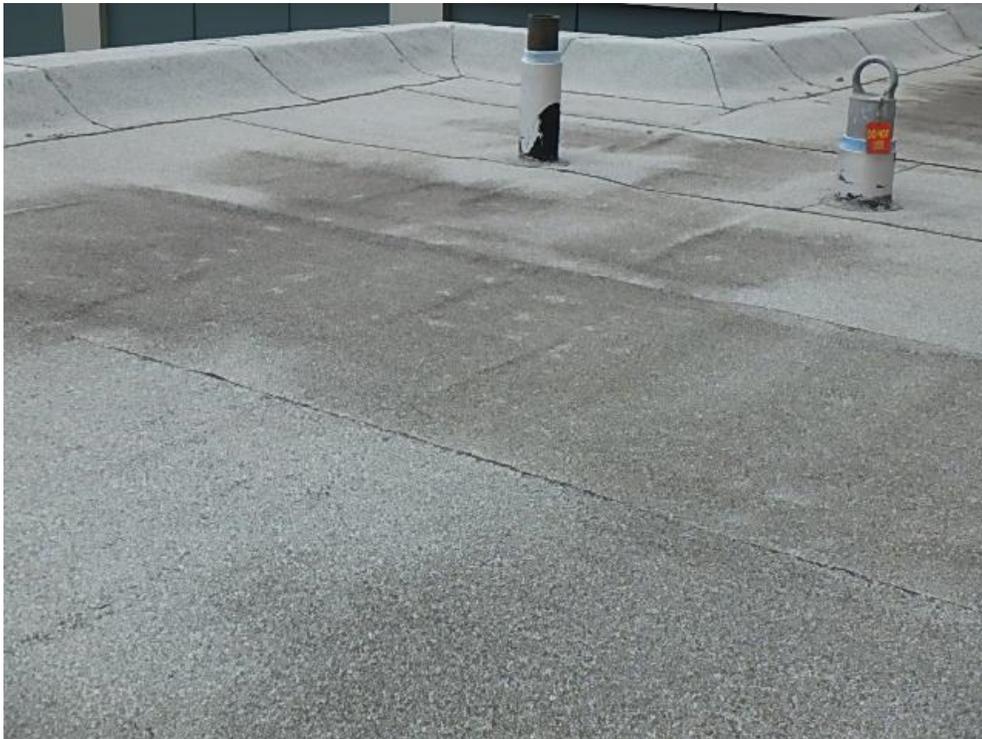
**Photograph 63:** Roof Area 3.3 – Blistering on membrane along with minor debris.

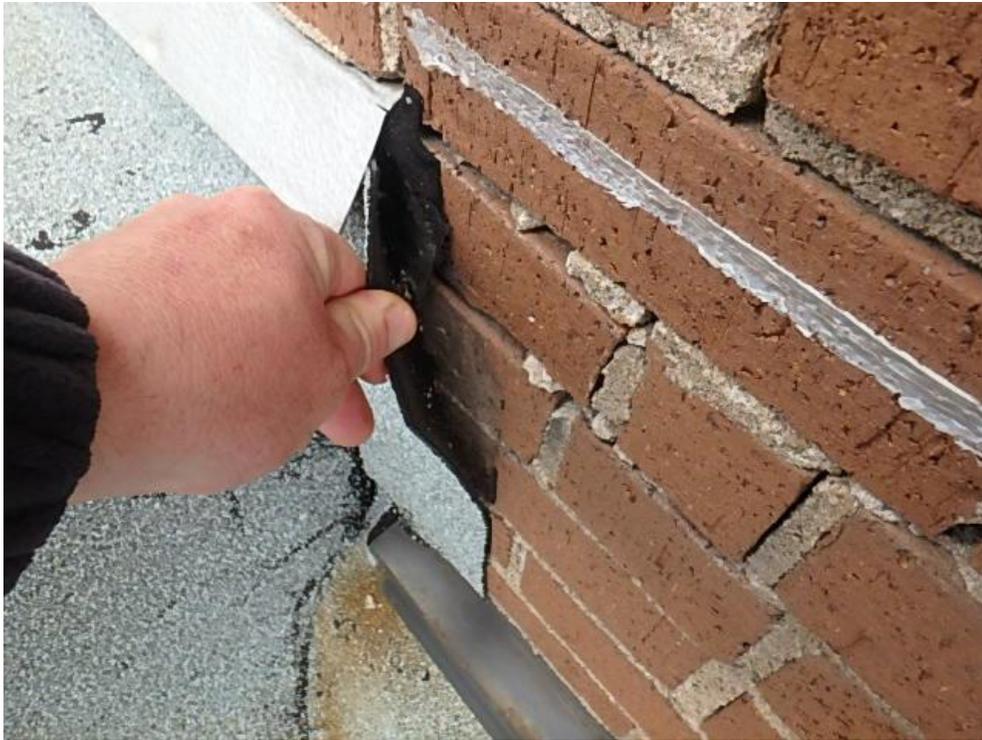
**Photograph 64:** Roof Area 3.3 – Evidence of ponding, ridging and blistering, and flashing problems around penetrations.

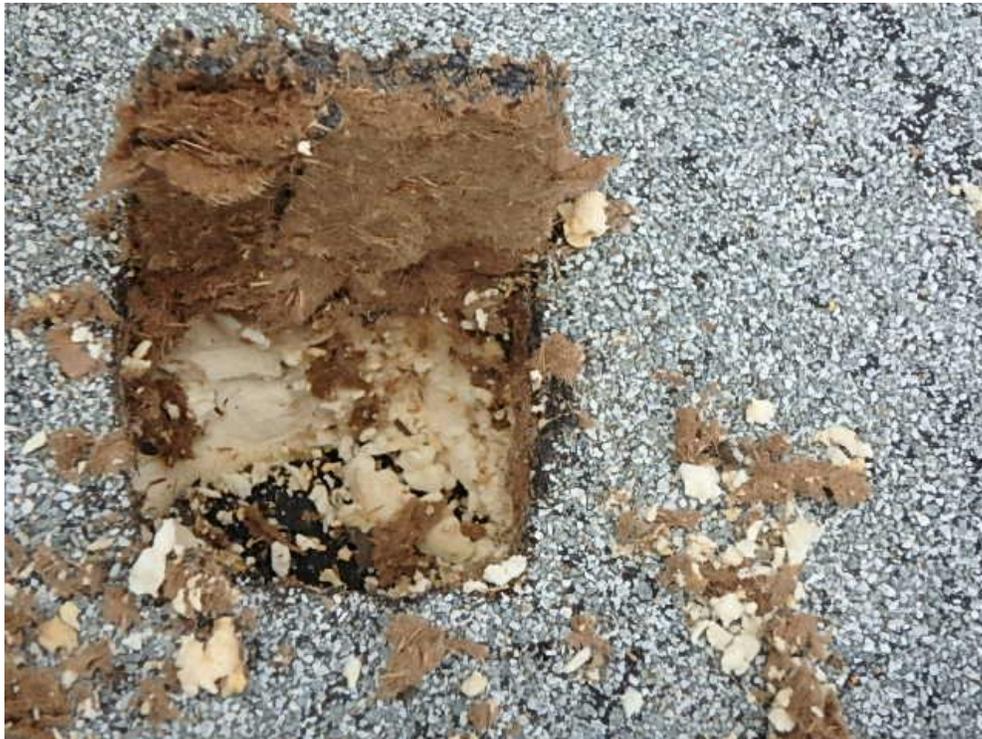
**Photograph 68:** Roof Area 1.1 – Roof insulation moisture test showing low levels of moisture.

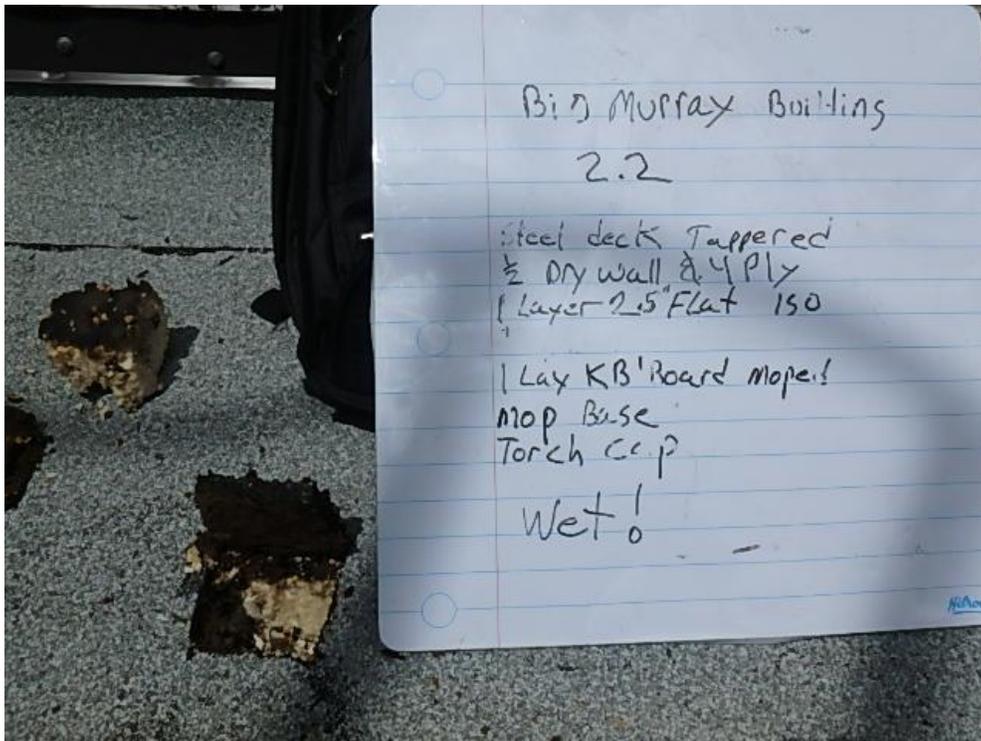
**Photograph 70:** Roof Area 2.1 – Roof insulation moisture test showing high levels of moisture.

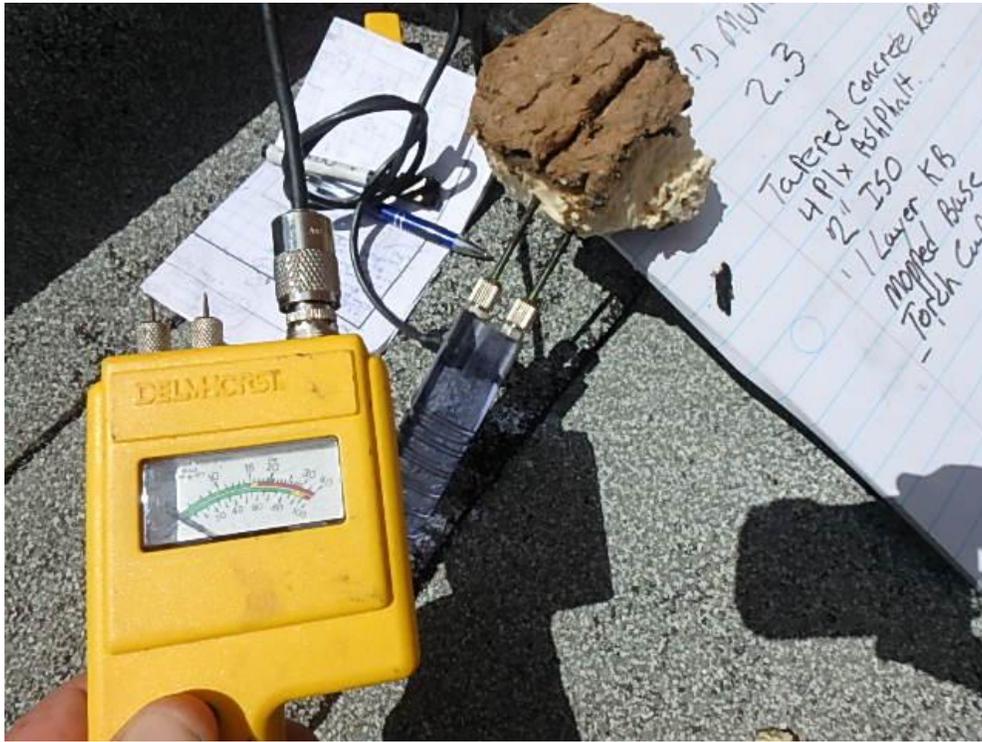
Photograph 72: Roof Area 2.2 –.Roof insulation moisture test showing a completely saturated roofing system.

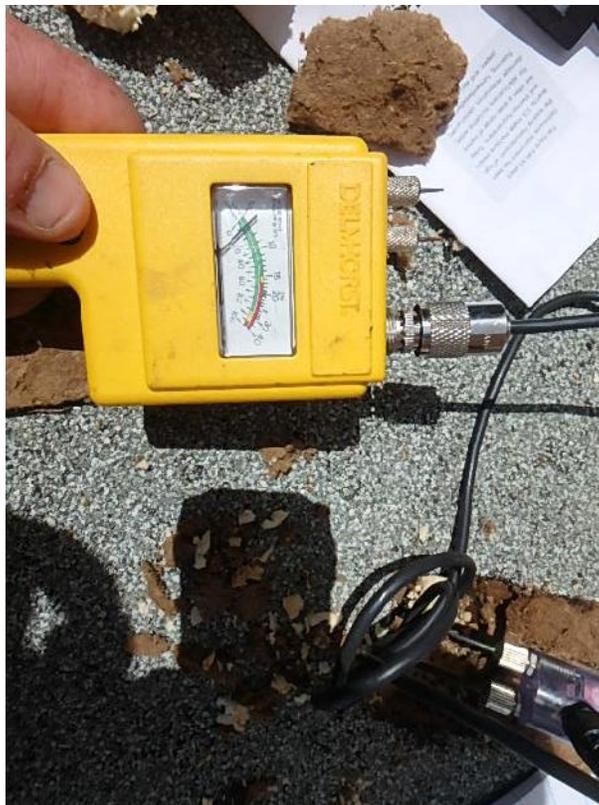
**Photograph 73:** Murray Building roof area 2.3 Core cut & moisture test showing dry insulation

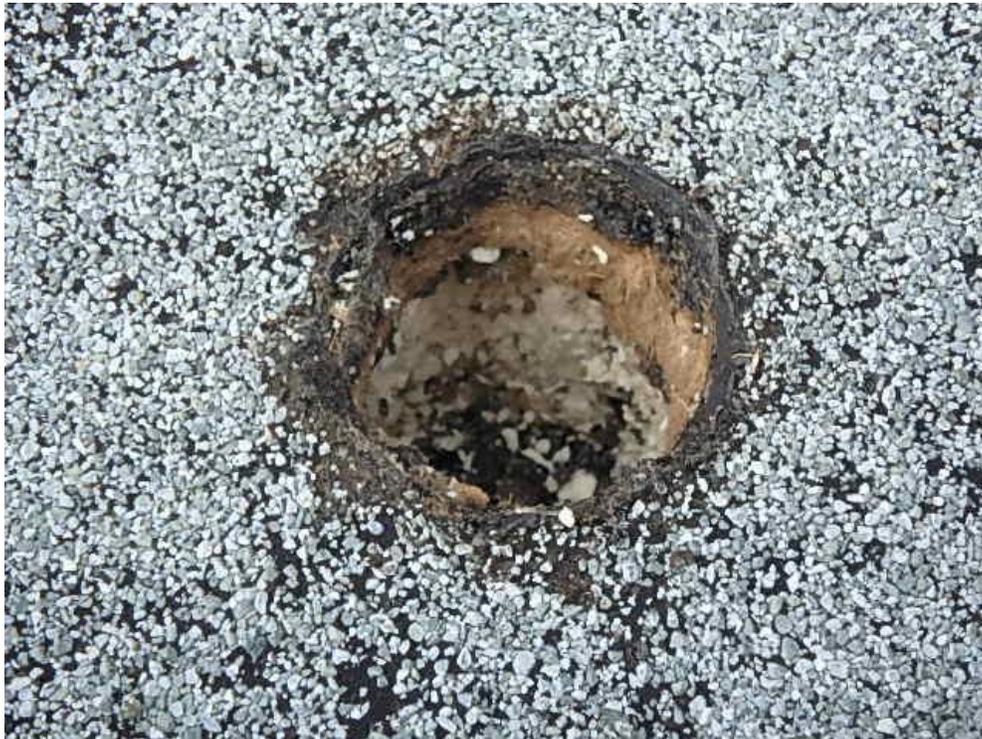
Photograph 76: Roof Area 3.1 –Roof insulation moisture test showing low levels of moisture.
