**APPENDIX A**  
GEOTECHNICAL REPORT

November 17, 2015

**Re: Geotechnical Investigation – Proposed French Mountain Culvert Rehabilitation  
Cape Breton, NS**

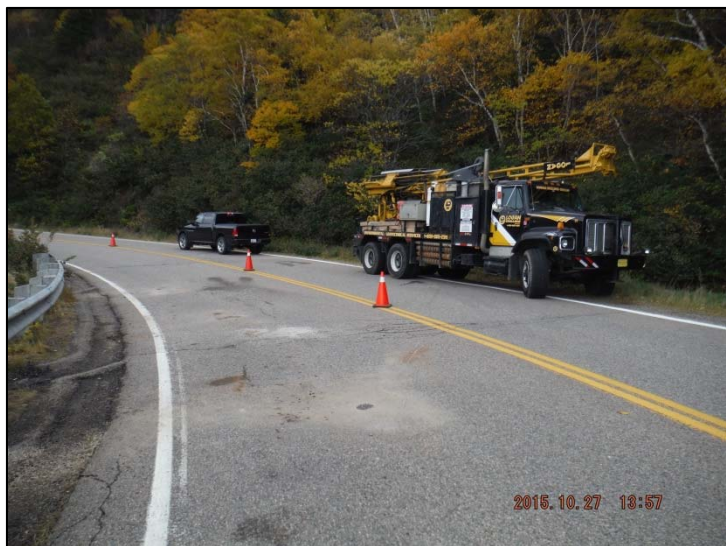
**Photograph A: View of the site looking north.**

The proposed culvert rehabilitation is located at French Mountain along the Cabot Trail in the Cape Breton Highlands National Park, NS. The existing culvert is located under the two-lane Cabot Trail and is approximately 20 km north of Cheticamp. The site is currently a paved roadway on a turn, with high mountains on the east and down slope to the west. The upslope of the mountain is tree covered.

Photograph A shows a view of the site looking north along the Cabot Trail.
