12 November 2014

VANCOUVER DRYDOCK COMPANY LTD.

CCGS JOHN P. TULLY – SHELL THICKNESS TESTING AND WATER BALLAST TANK CONDITION SURVEY

PROJECT NO. : 14-39

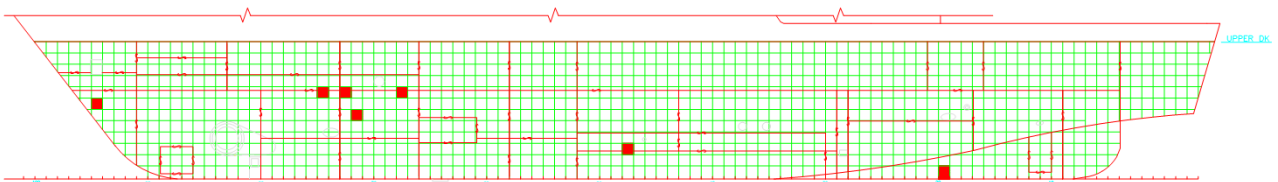
Figure 1. Port Profile

The readings confirm the hull shell scantlings are in good condition.

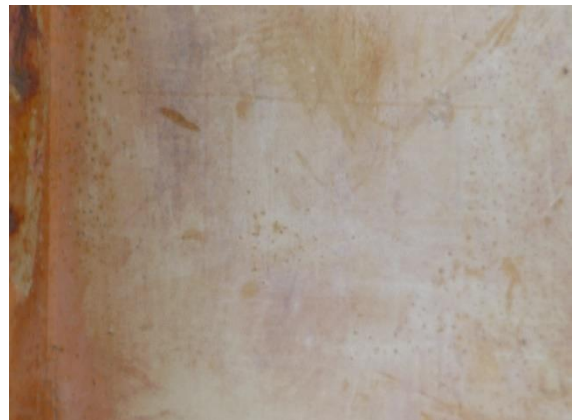
2. Typical bulkhead condition..

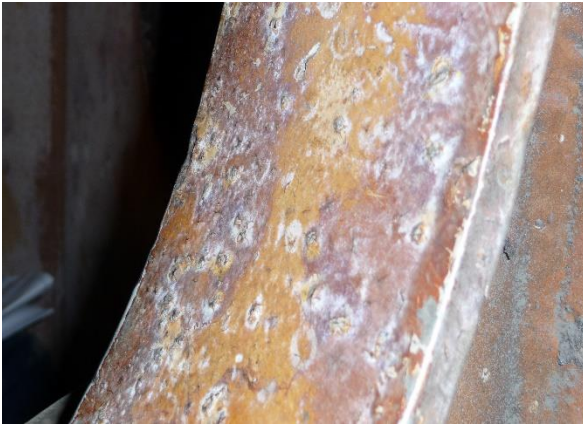
3. Corrosion in way of access coamings (typical)

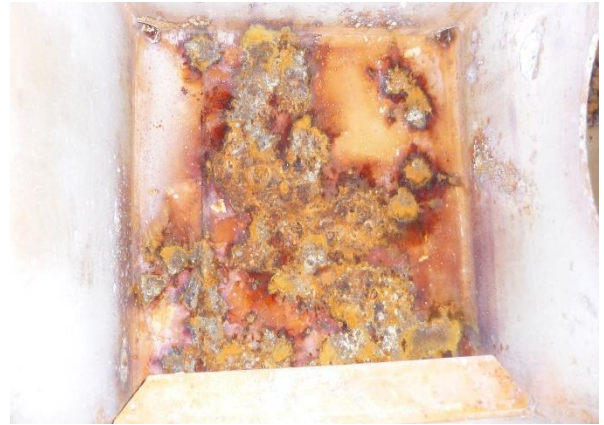
The tank top coatings were flaking in many locations and rust and scaling was evidenced throughout the tank. The tank top was in a satisfactory condition.

4. Typical tank top corrosion.

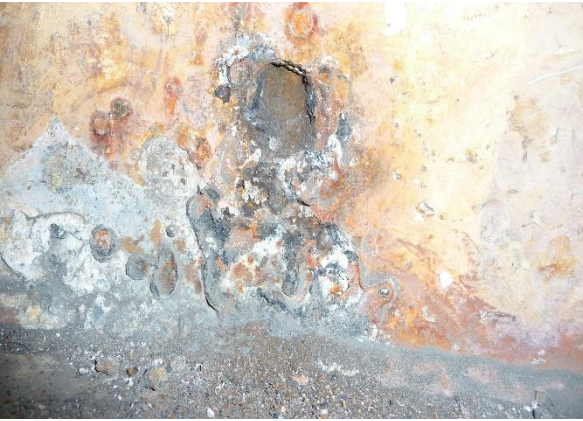
The girders and floors had areas where the paint was compromised. Although not common throughout the tank, there were a few locations where severe local corrosion had occurred. In some cases, the steel had deep pits up to 75% of the thickness of the structure. This was localized, the corrosion occurring in the corners in way of the floor and girder intersections. Waterways were located in the floors and girders although some were poorly constructed. The tank was clean at the time of survey and there was no evidence of mud, however, it is reasonable to assume mud or silt may have been present prior to cleaning the tank. The pitting evidenced may be a result of microbial corrosion as the corrosion took the form of a deep thumbprint type of pit. Although the local corrosion is severe, the overall structural condition of the floors and girders was good. The girders and floors are in a serviceable condition.

5. Severe pitting in port aft floor

The shipyard was in the process of blasting the No 6 tank at the time of the survey and it is recommended the tank be checked periodically to ensure the local corrosion has been ameliorated by the new paint. It is also recommended not to leave partial water in the tanks especially if they have a high content of mud. The tanks should be flushed with fresh water when the vessel is docked for periods of time.

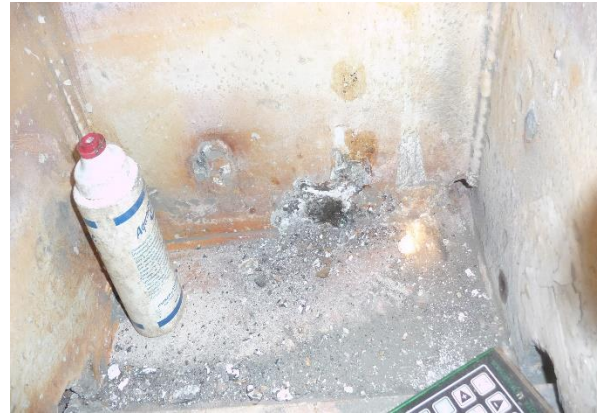
6. Severe pitting in port side girder.

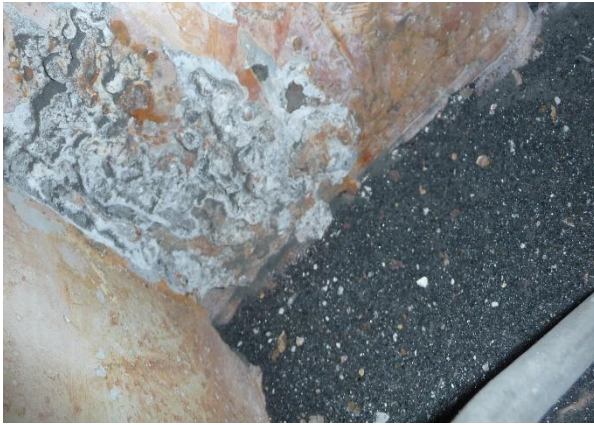
7. Typical paint deterioration in way of pitting.

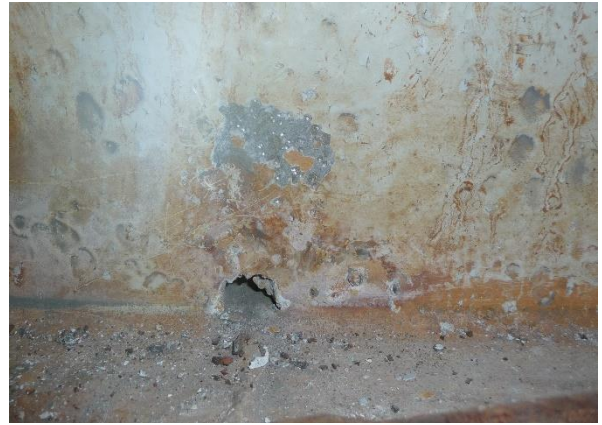
8. Example of pitting and poor quality water way.

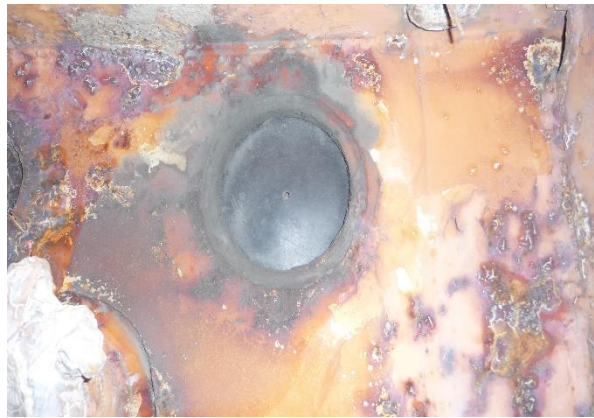
9. Bottom tank fwd port in way of pipe and transducer penetration.

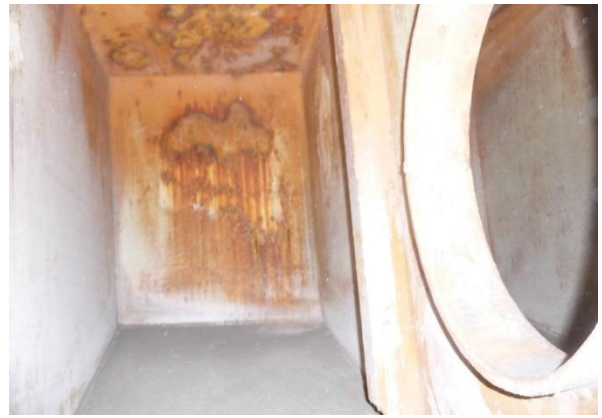
10. Typical corrosion in center tank (looking to stb'd)

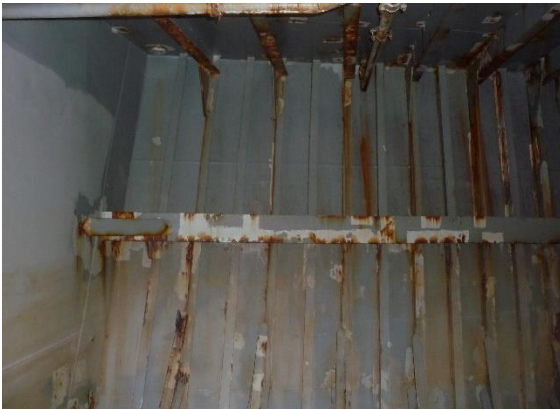
11 No 2 Stb'd WB tank shell and framing.

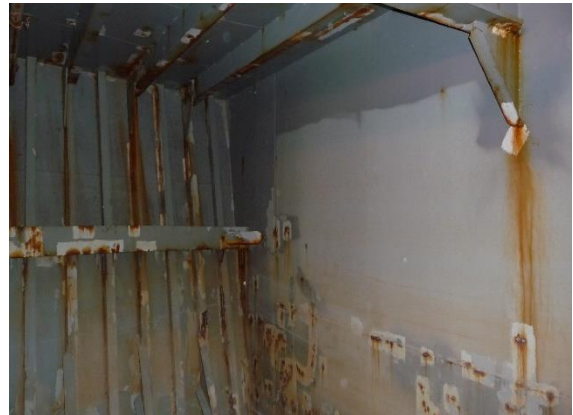
2. Typical bulkhead condition.

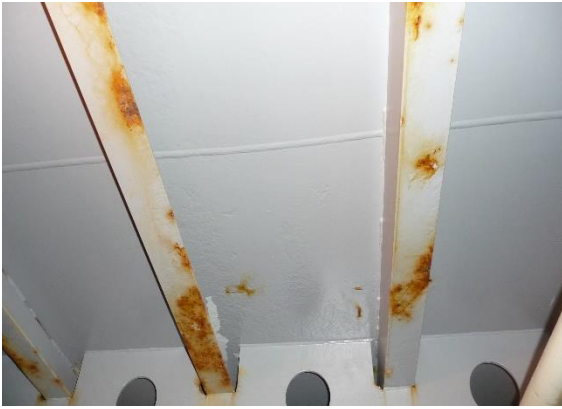
The deck head paint was in good condition with some local deterioration of the paint and associated scaling and rusting on the deck beams. The deck head plate and framing was in a satisfactory condition.

3. Deck head corrosion (typical)

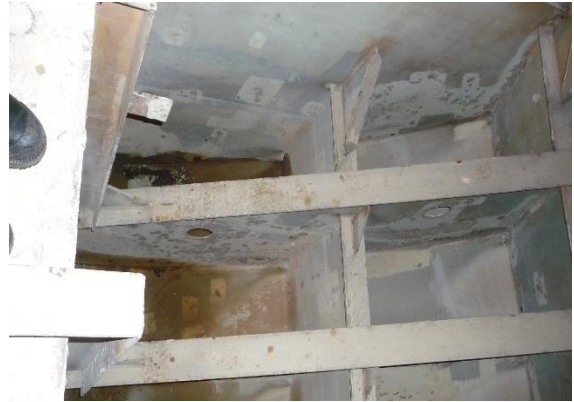
12. Typical tank bottom corrosion.

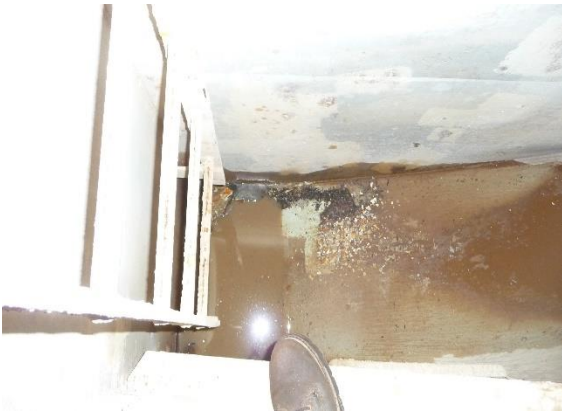
13 Example of standing water in the tank.

It is recommended the tank be checked periodically to monitor the local corrosion. Overall the tank is in a good condition. The face flats are prone to corrosion on the underside and edges and these are areas where future corrosion should be mitigated. This can be achieved by removing all the rust and applying a protective coating. It is also recommended not to leave partial water in the tanks especially if they have a high content of mud. All free standing water should be pumped out if possible. In case this is impractical, monitoring of the areas should occur at regular intervals and any further corrosion should be inhibited by protective coatings.

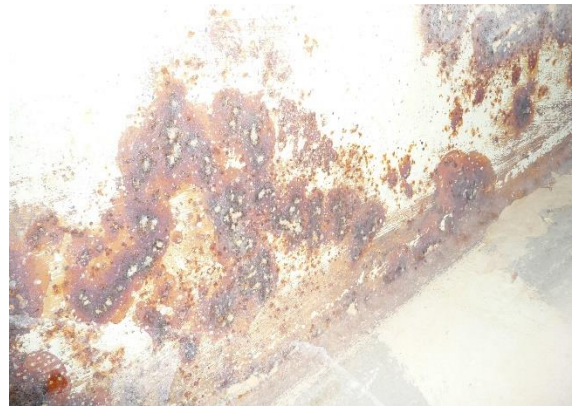
The girders and floors had areas where the paint was compromised. Although not common throughout the tank, there were a few locations where some moderate local corrosion had occurred particularly on the webs and on the underside of the face flats of the floors and girders. The girders and floors are in a satisfactory condition.

6. Corrosion at bottom half of Web of floors

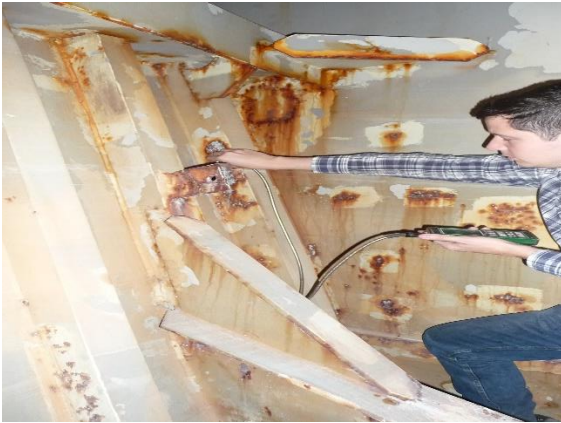
14 Typical paint deterioration and associated corrosion in way of frames.

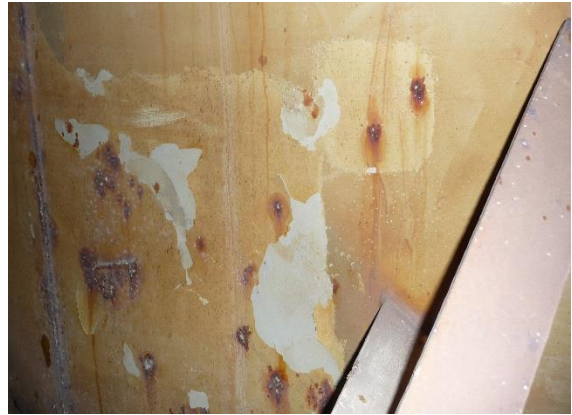
8. Example of spalling of paint.

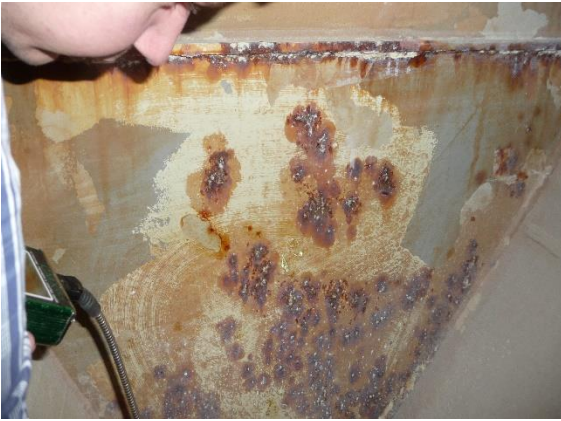
9. Example of web and face flat corrosion

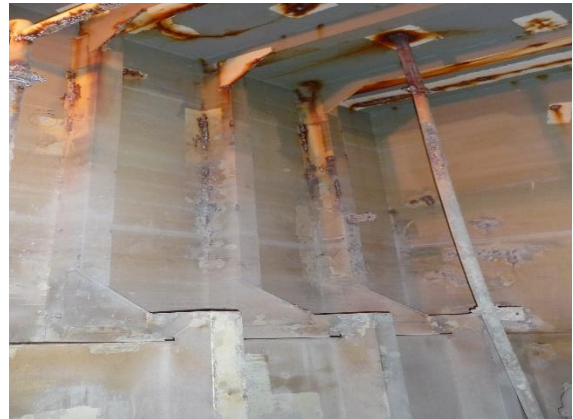
15 Stringer flat and bulkhead stiffeners..

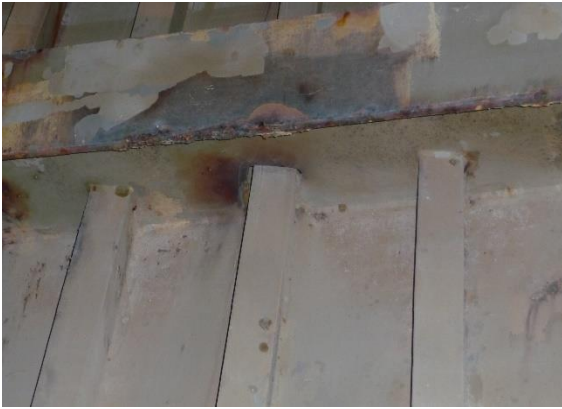
3. Framing corrosion (typical)

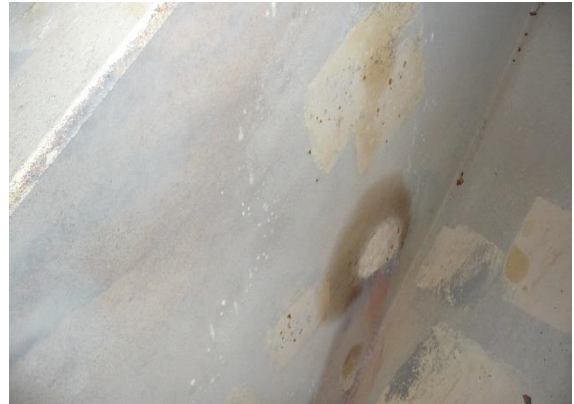
16. Web blister corrosion.

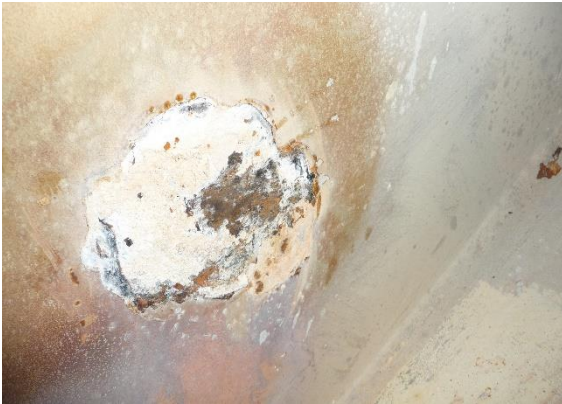
5. Photo 4 with blister removed..

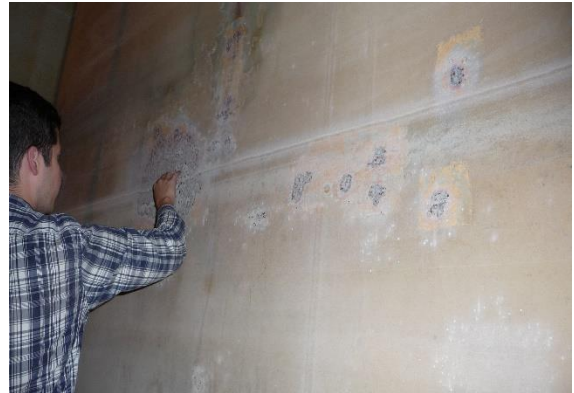
6. Typical bulkhead condition

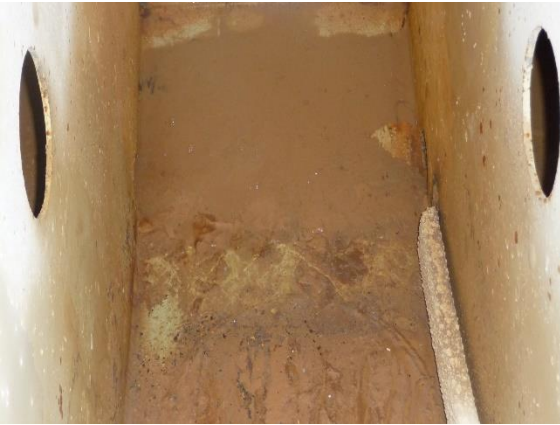
17 Example of standing water in tank..

It is recommended the tank be checked periodically to monitor the local corrosion. Overall the tank is in a good condition although the face flats are an area where future corrosion should be mitigated. It is also recommended not to leave partial water in the tanks especially if they have a high content of mud. All free standing water should be pumped out if possible. In case this is impractical, monitoring of the areas should occur at regular intervals and any further corrosion should be inhibited by the application of a protective coating.

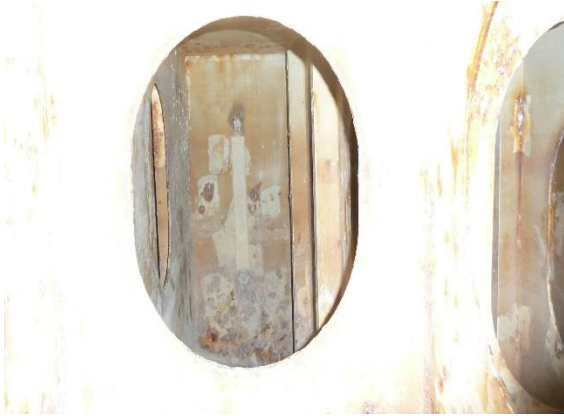
1. No 7 Stb'd WB tank typical condition

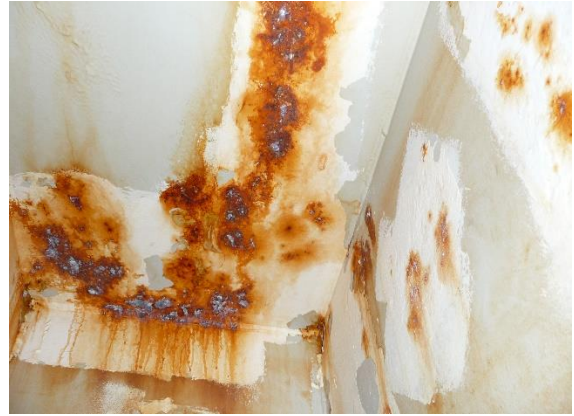
2. Typical tank top paint deterioration..

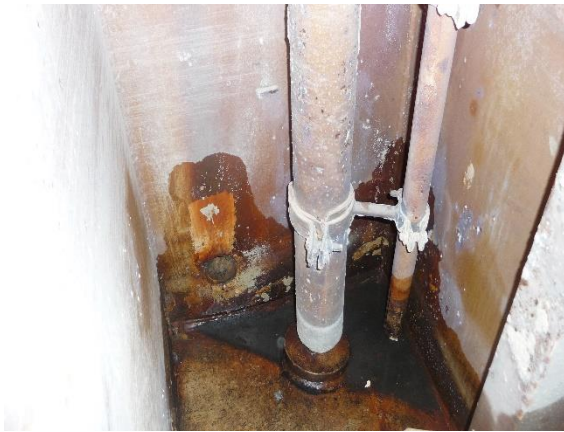
3. Example of standing water in tank..

It is recommended the tank be checked periodically to monitor the local corrosion. Overall the tank is in a good condition. It is also recommended not to leave partial water in the tanks especially if they have a high content of mud. All free standing water should be pumped out if possible. In case this is impractical, monitoring of the areas should occur at regular intervals and any further corrosion should be inhibited by the re - application of a protective coating.

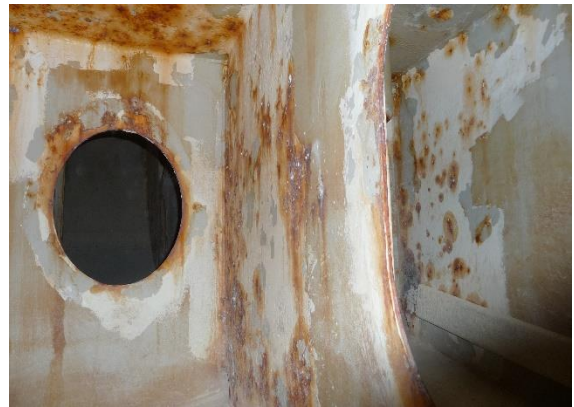
The girders and floors had areas where the paint was compromised and surface rust had erupted. Photo 4 illustrates the general condition of the floors and girders. The floors and girders were found to be in a satisfactory condition.

4. Typical Girder- Floor corrosion.

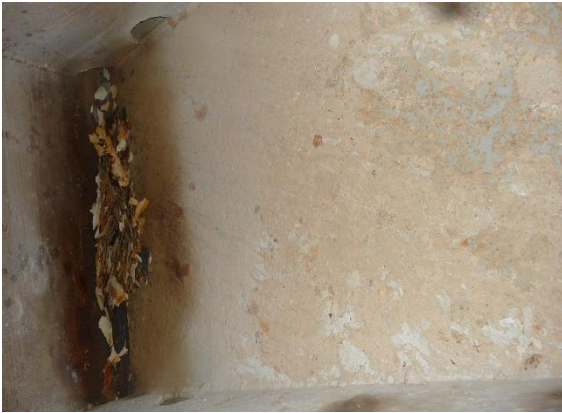
5. Paint flakes trapped in way of drainage point.

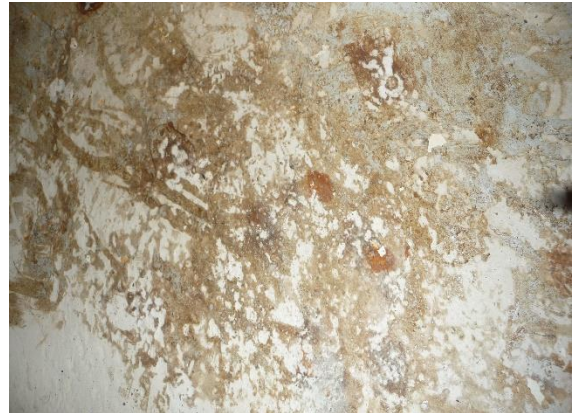
6. Typical bottom shell condition showing minor pitting.

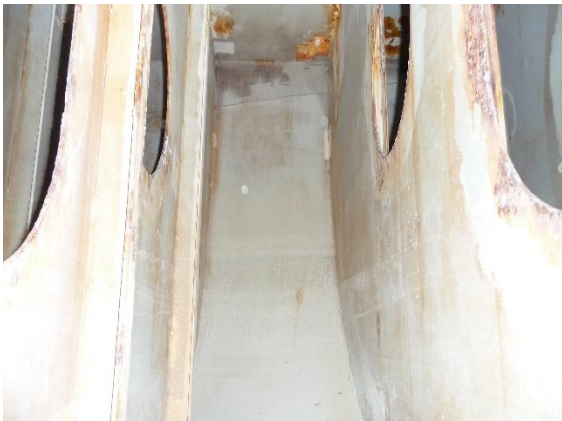
No 7 WB tanks are typical double bottom tanks with floors intercostal to the girders. At the time of the survey on November 3rd 2014 at 9:30am, the space was dry with a slight sheen of mud on the bottom shell. Although the tank was painted, the paint was showing deterioration in various places throughout the tank. The structure of the tank was found to be in satisfactory condition. The bottom shell indicated minor pitting in locations throughout the tank, however the paint was in good condition which has inhibited further corrosion from occurring. The paint on the bottom shell of the tank was found to be in satisfactory condition. Corrosion was limited to the lower areas of the tank. The bottom shell towards the turn of the bilge was in good condition as illustrated in photo No. 7.

7. Typical condition in way of side shell.

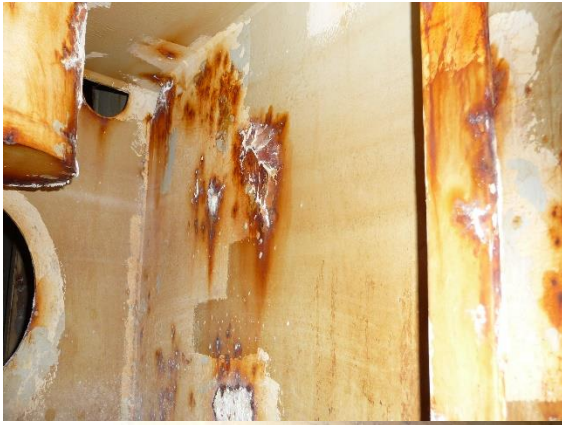
7. Blistering on web of Floor.

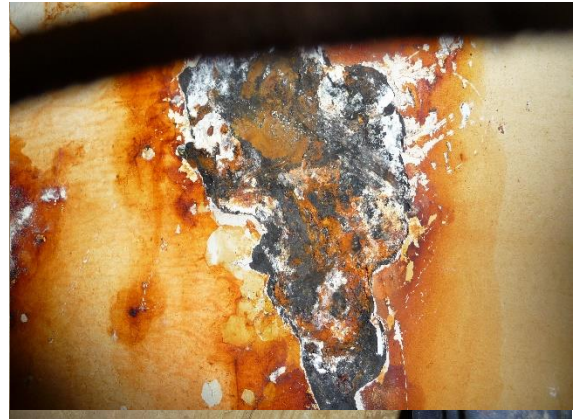
8. Blister removed showing typical corrosion on web of Floor.

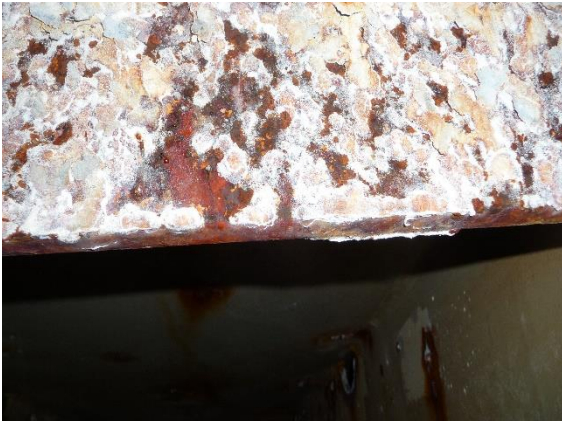
The deck head paint was in poor condition with local deterioration of the paint and associated scaling and rusting throughout. The deck head plate and framing was in a serviceable condition. There was one area where a tank top carling was badly corroded, as shown in Photo No 5. Although this is a tertiary structural member, it would be prudent to clean the carling of all surface rust and apply a coating or rust inhibitor to limit further deterioration.

5. Badly corroded carling at tank top.

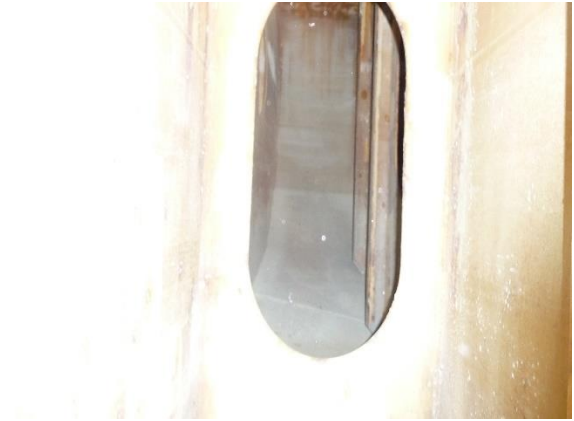
No 7 WB tanks are typical double bottom tanks with floors intercostal to the girders. At the time of the survey on November 3rd 2014 at 10:30am, the space was dry with a slight sheen of mud on the bottom shell. Although the tank was painted, the paint was showing deterioration in various places throughout the tank. The structure of the tank was found to be in satisfactory condition. The bottom shell paint was in satisfactory condition. Photo No 4 illustrates blistering, which was observed on the bottom of the shell in a couple of places. The bottom shell towards the turn of the bilge was in good condition as illustrated in photo No. 6.

6. Typical condition in way of side shell.

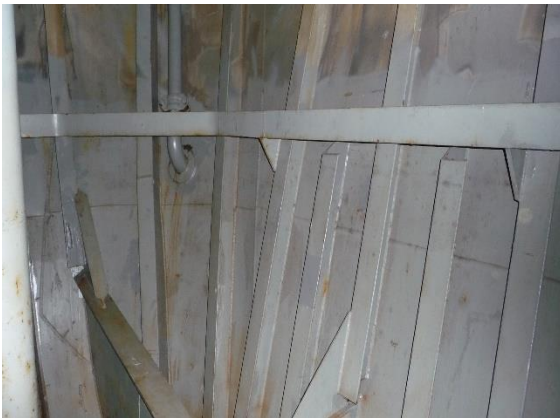
1. No 10 Stb'd WB tank shell and framing

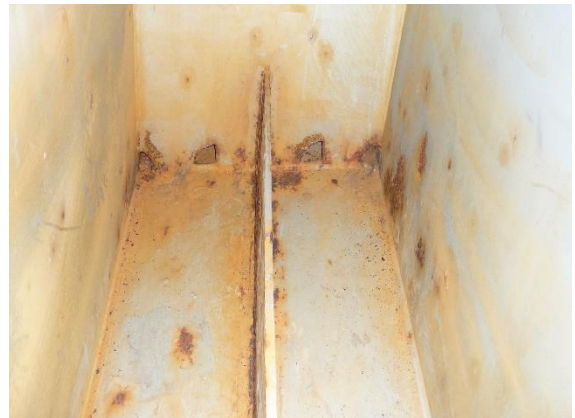
2. Typical tank bottom condition..

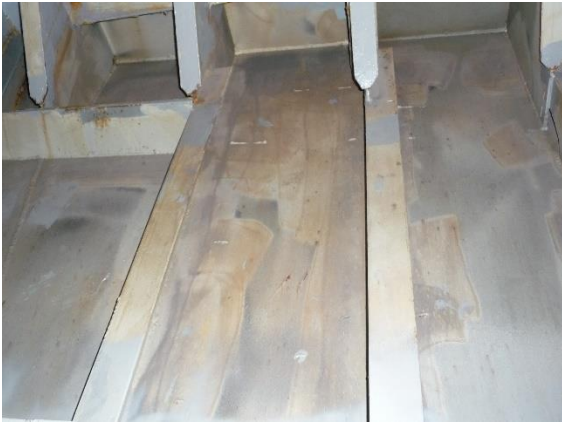
3. Side shell corrosion (typical)

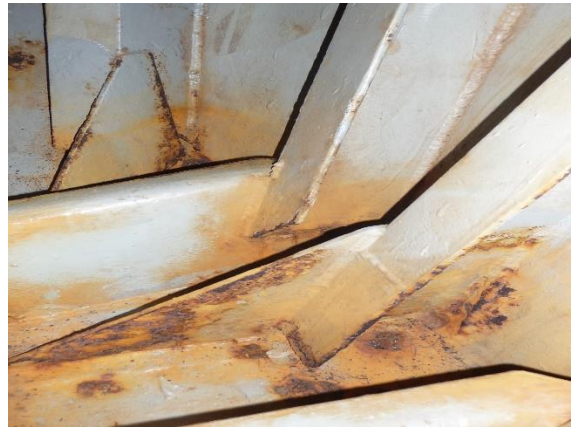
18. Bottom brackets corrosion (typical).

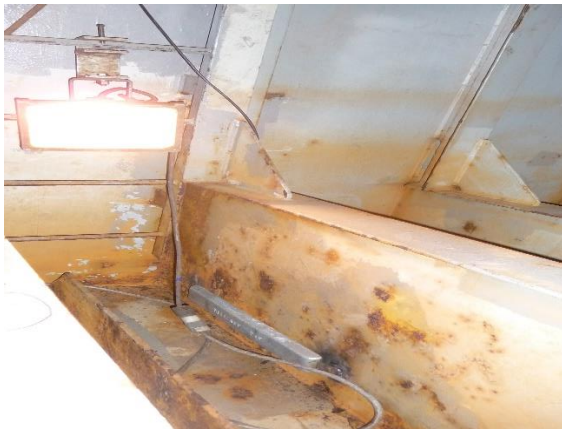
5. Typical Floor corrosion and new anode.

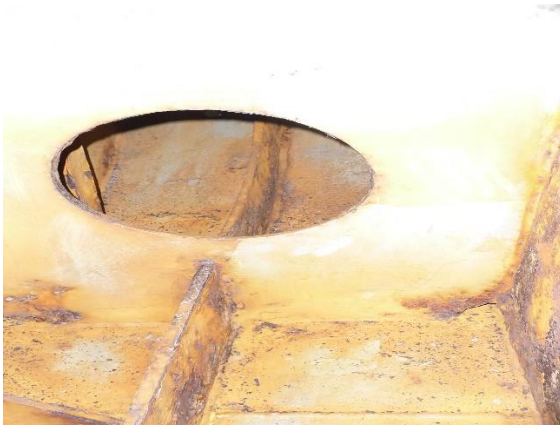
19 Corrosion under crane pedestal.

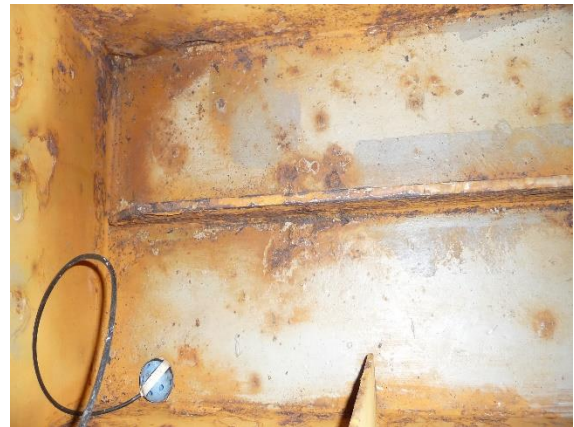
8. Typical corrosion of bottom shell and intermediate bottom transverse.

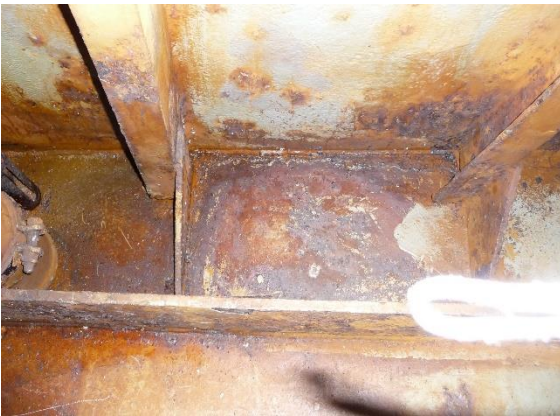
9. Corrosion in way of bulkhead.

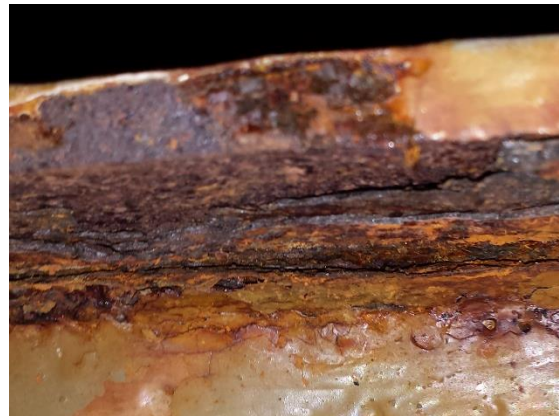
10. Face Flat corrosion.

It is recommended the tank be checked periodically to monitor the local corrosion. Overall the tank is in a good condition although the face flats are an area where future corrosion should be mitigated. It is also recommended not to leave partial water in the tanks especially if they have a high content of mud. All free standing water should be pumped out if possible. In case this is impractical, monitoring of the areas should occur at regular intervals and any further corrosion should be inhibited by protective coatings.

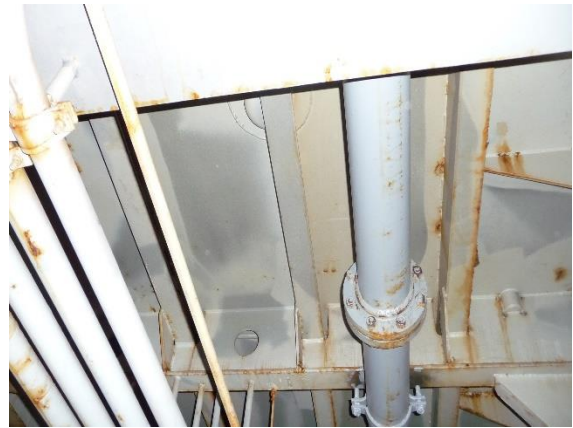
The deck head paint was in good condition with some local deterioration of the paint and associated scaling and rusting on the deck beams particularly along the edges of the face flats as indicated on photo No 2. The deck head plate and framing was in a satisfactory condition.

2. Typical Deck head condition..

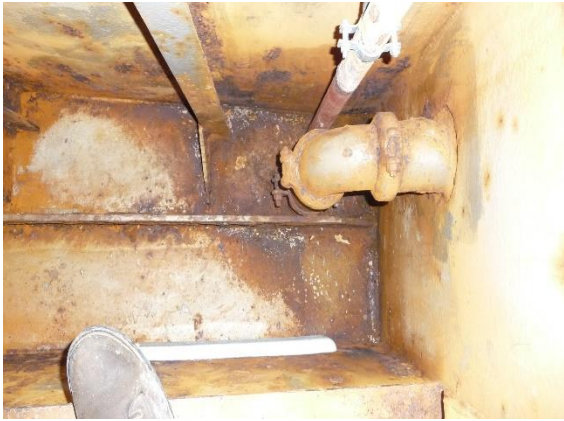
3. Bottom shell corrosion (typical)

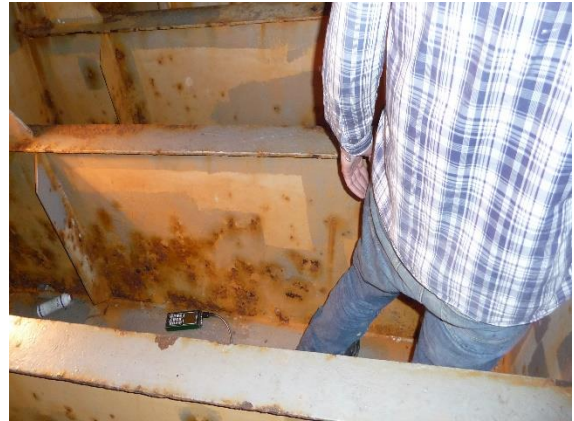
20. Webs of Floor corrosion (typical).

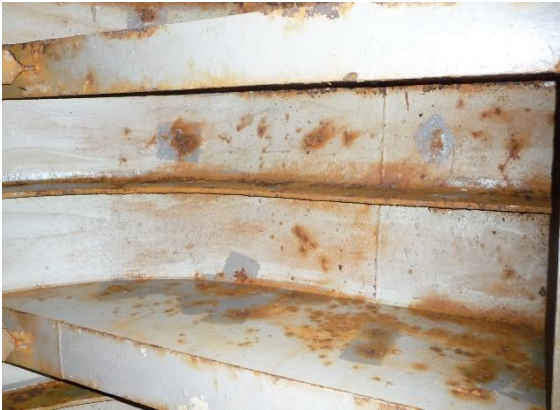
5. Typical Bottom Shell corrosion

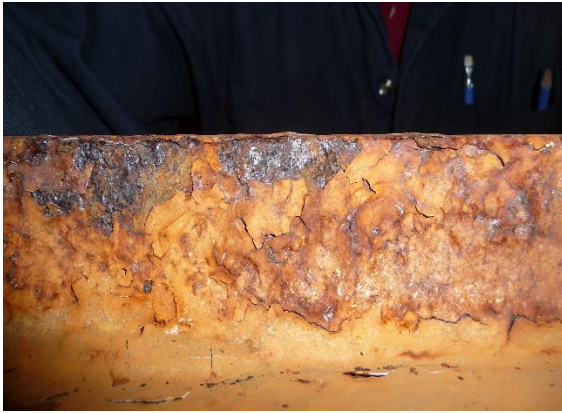
22 Corrosion under Face flat.

It is recommended the tank be checked periodically to monitor the local corrosion. Overall the tank is in a good condition although the face flats are an area where future corrosion should be mitigated. It is also recommended not to leave partial water in the tanks especially if they have a high content of mud. All free standing water should be pumped out if possible. In case this is impractical, monitoring of the areas should occur at regular intervals and any further corrosion should be inhibited by protective coatings.

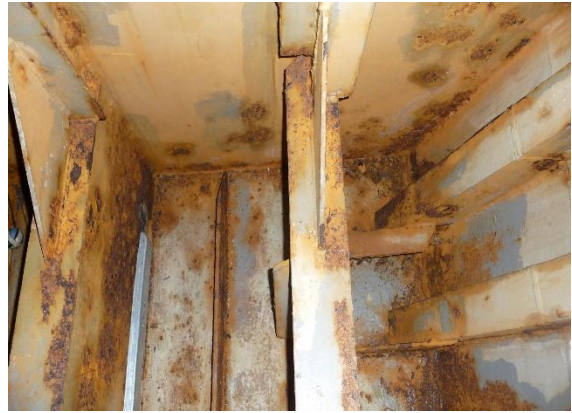
8. Typical corrosion of bottom shell and Floors.

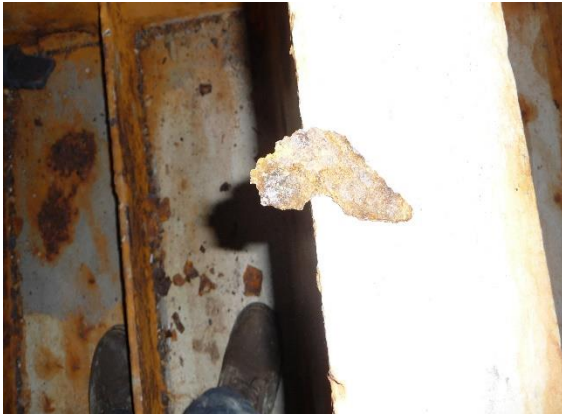
9. Typical scaling on webs and face flats.

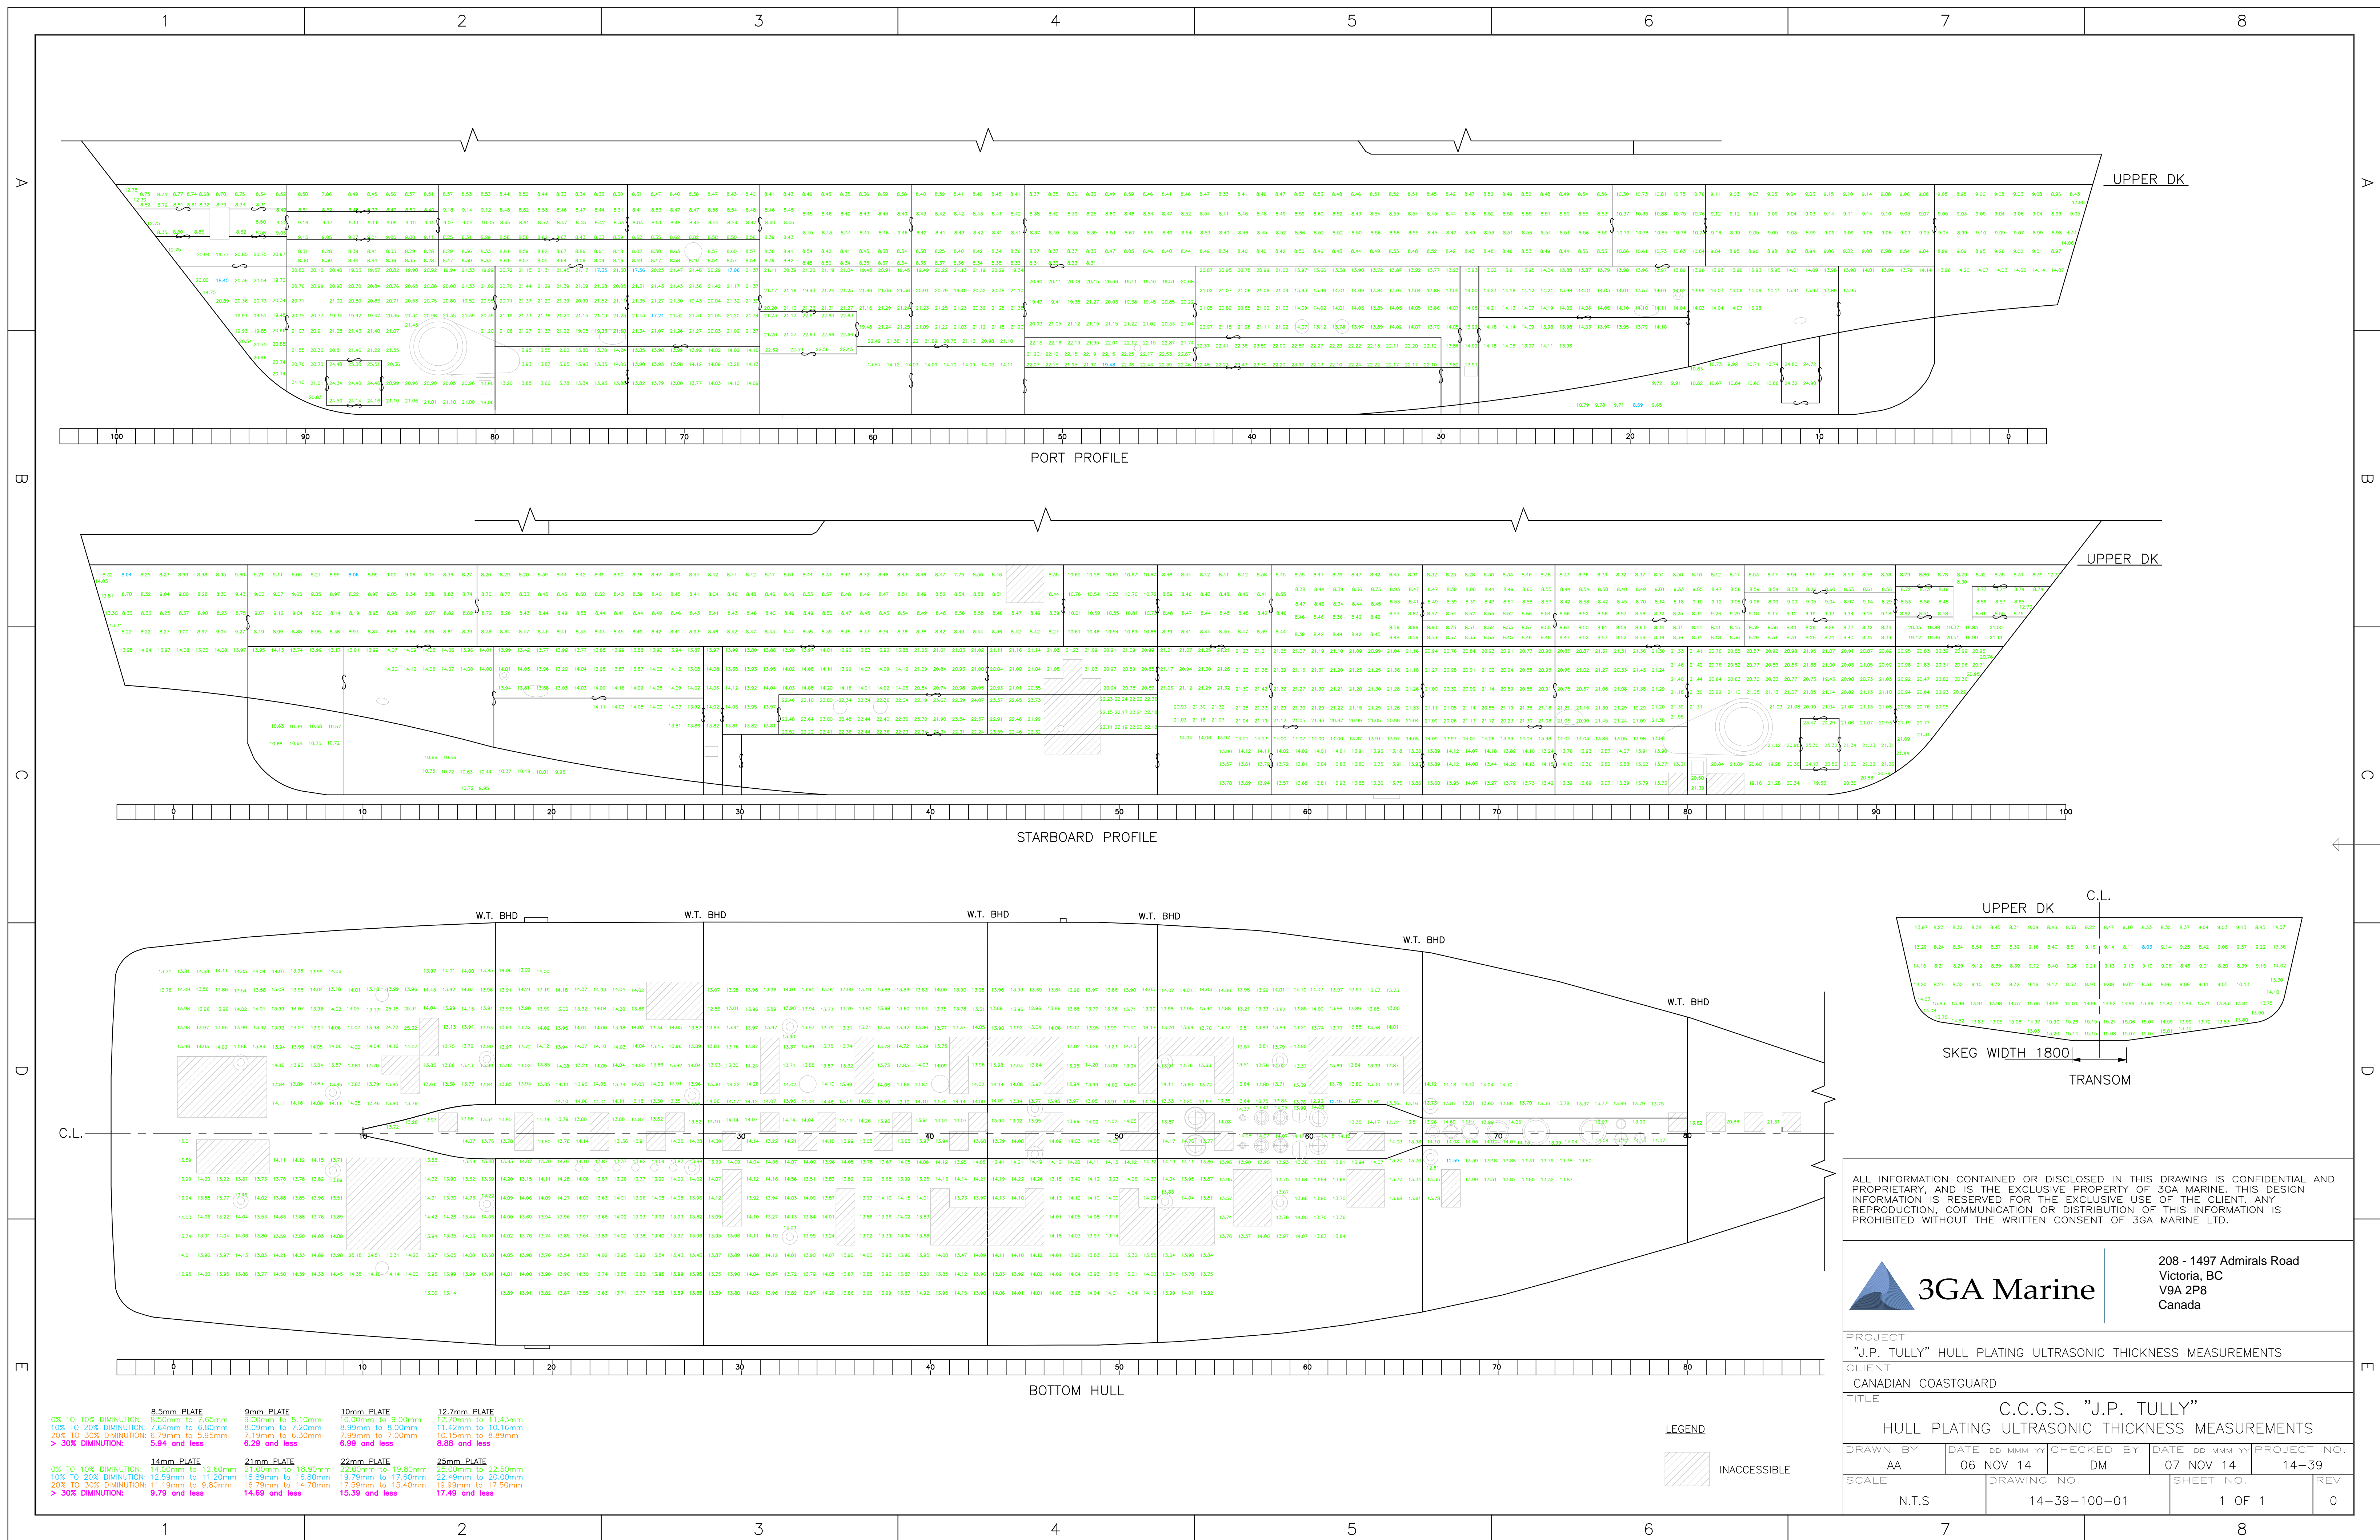
Appendix "A"
Plate Thickness Testing

Appendix A is a summary of all the thickness measurement results. The results were compared against the values shown in the shell expansion plan in Appendix A. The results indicate out of 3,148 measurements taken, 3,136 indicated less than 10% diminution (99.6%). The remaining 0.4% of the readings indicated a diminution between 10% and 20%, all 12 readings trended towards the 10% value. The 12 readings were scattered over the hull as shown in Figures 1 through 3. The readings above the 10% diminution are shown as red squares. It should be noted, one reading is located on the transom. The transom is not included in Figures 1 to 3.
