Appendix C – Building Capability Report EC + DFO – Co-Location at FWI

For:
Environment Canada & Department of Oceans and Fisheries
Fresh Water Institute (FWI)
Winnipeg, Manitoba
Project No. R.075255

Prepared by:
Coupland Kraemer Architecture + Interior Design Inc.

February 13, 2017

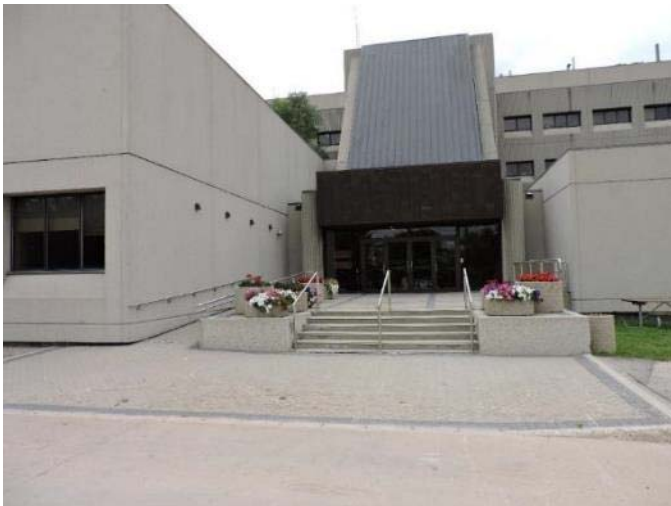
Figure 1 Barrier free main entrance. Architectural elements appear to be in good condition.

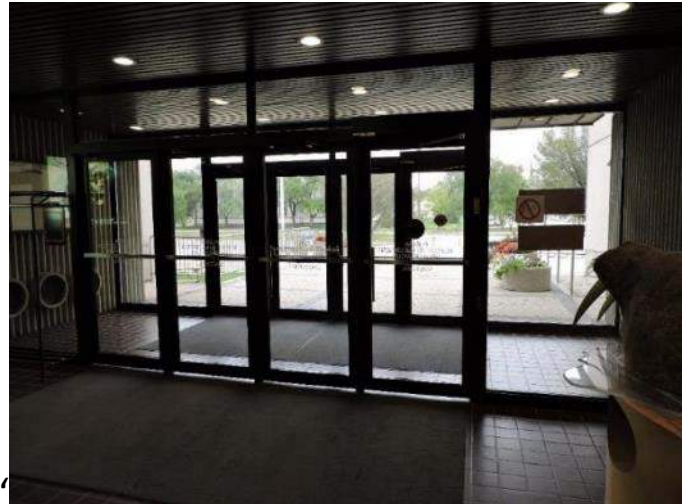
Figure 2 Aluminum entrance doors are dark bronze anodized and provide barrier free accessibility.

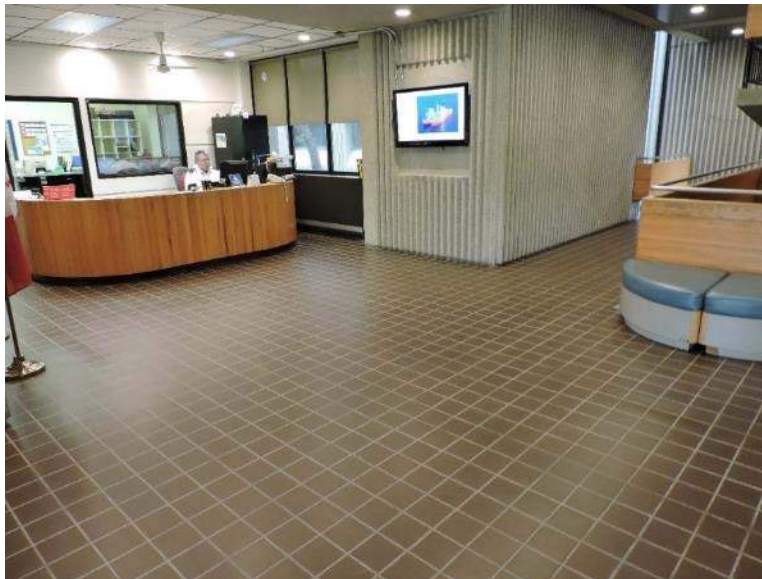
Figure 3 Quarry tile and main building security desk.

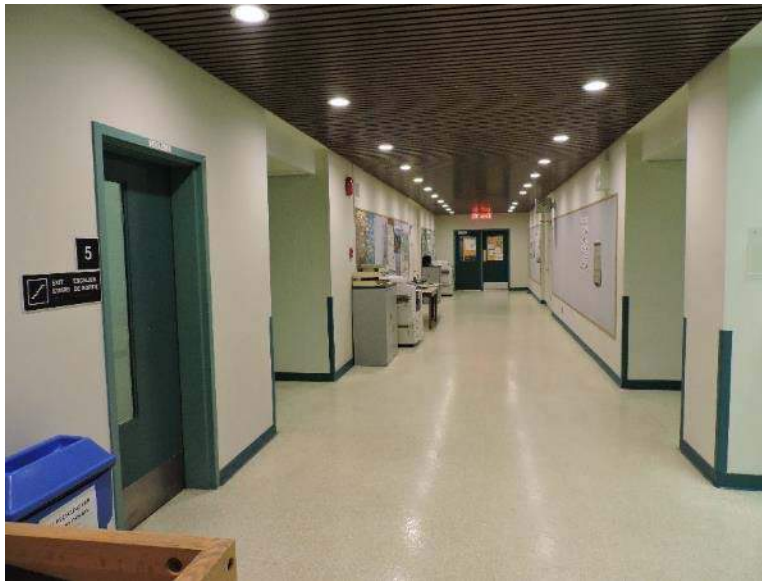
Figure 5 Elevator Lobby in Lab Block is in good condition.

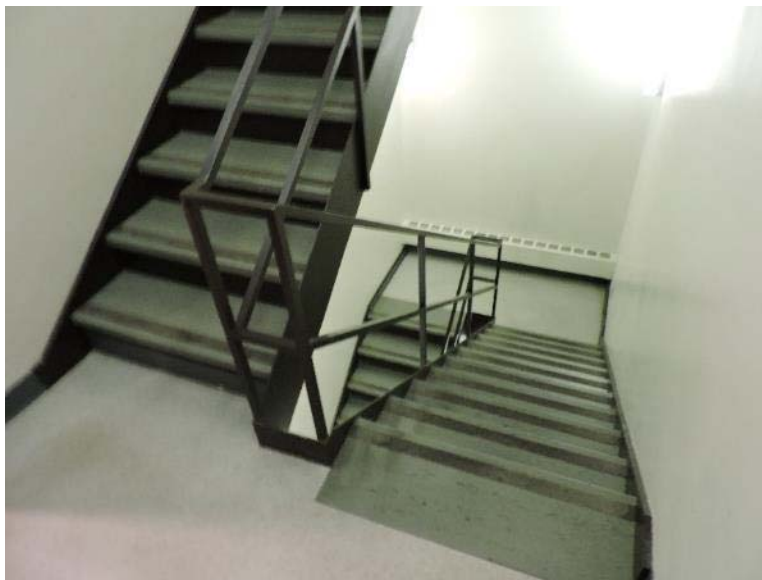
- .1 The Lab Block Main Corridor appears to be in good condition and can support the Co-Location project. However, the guardrails in the exit stairs do not conform to current building code requirements and should be upgraded as discussed below.
- .2 Located in the central part of the Lab Block, the floors are serviced by 2 elevators and 2 exit stairwells (Stair 2 and Stair 4).

Figure 6 Figure 6 Stairs do not have code compliant guardrails.

- The exits have guardrails that do not conform to current building code requirements – however, they most likely conformed to the code when the building was built. Upgrading the guardrails is recommended. This is typical for ALL stairs in the building.
- Upgrade the wall and floor finishes in the corridor to provide a uniform appearance and replace original materials that are at the end of their lifecycle
- Upgrade the elevator cabs to conform with current Barrier Free requirements

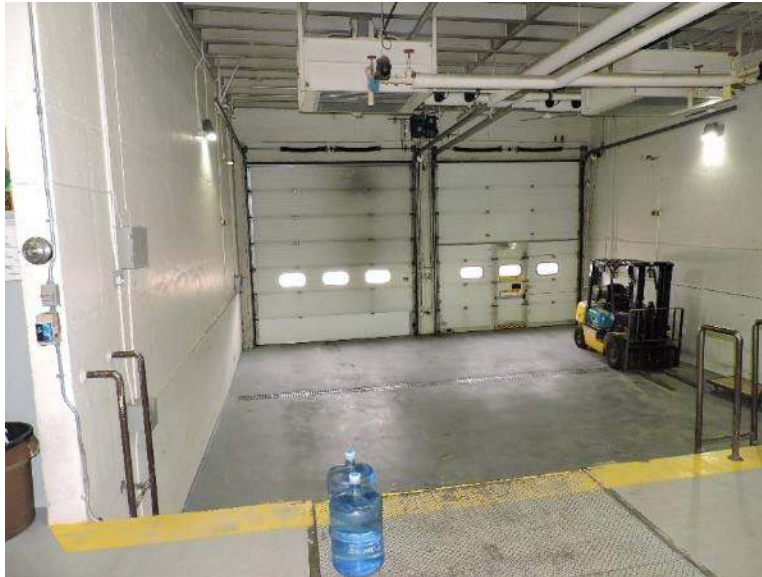
Figure 8 Loading area is sufficient in size and function. Overhead doors may require replacement in the future.

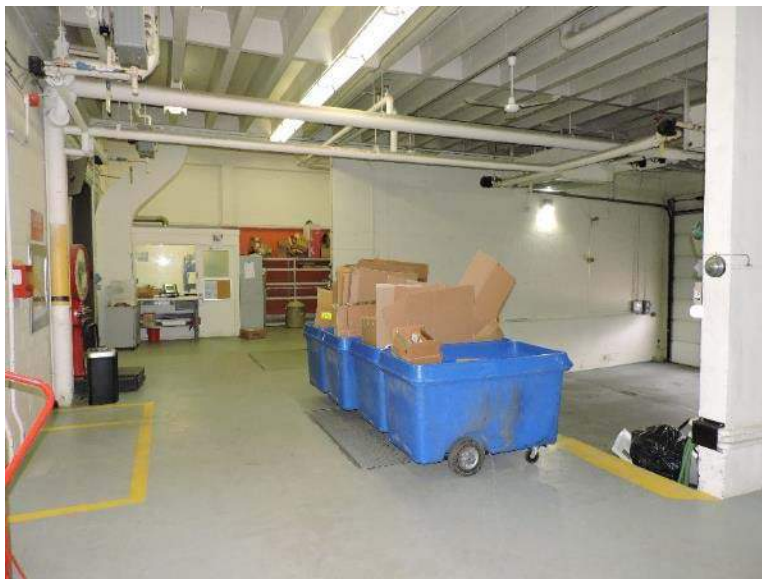
Figure 9 Loading area is sufficient in size and function. 2013 BCR report indicated a floor slab report is to be conducted.

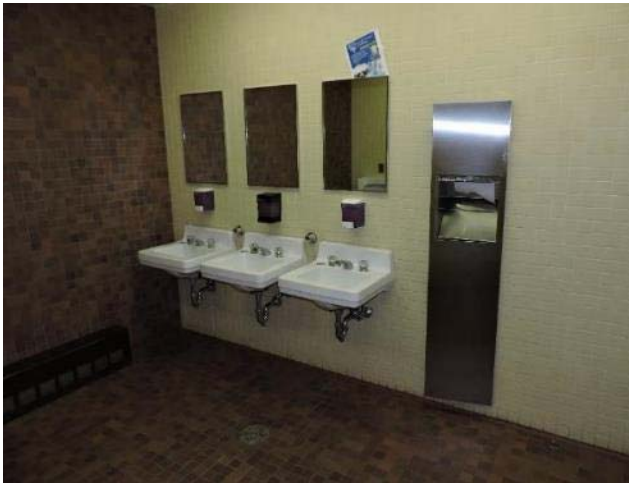
- .1 The Washrooms will need to be addressed by the Co-Location project as discussed below:
 - .1 Minimum number for each sex
 - .2 Minimum number barrier free
- .2 Washroom facilities are provided throughout the Lab Block. Upgrading these facilities to include barrier free provisions is recommended as they do not meet current building code requirements. Finishes in the washrooms are durable and robust. However, they are dated and may need to be updated to achieve a uniform aesthetic on all floors to accommodate this project. Also, washrooms will need to be upgraded on each floor to accommodate current Barrier Free requirements.
- .3 The Admin Block has limited washroom facilities. Based upon the final design, adding washrooms in this area is recommended.

Figure 12 Washrooms in the Admin & Lab Block require upgrades.

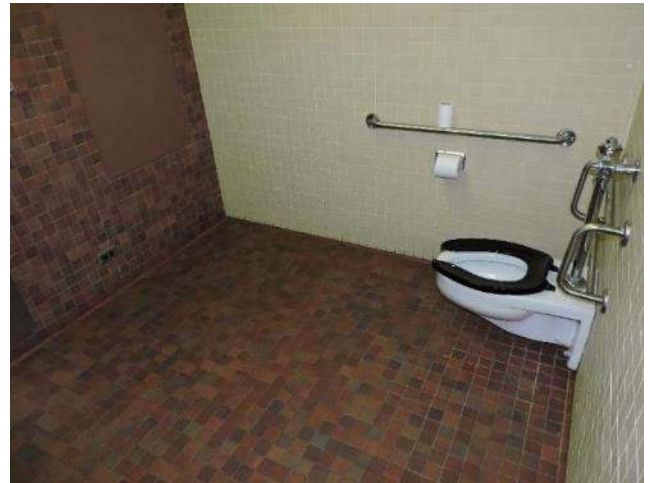
Figure 13 Washrooms on each Level require upgrades for barrier free compliance.

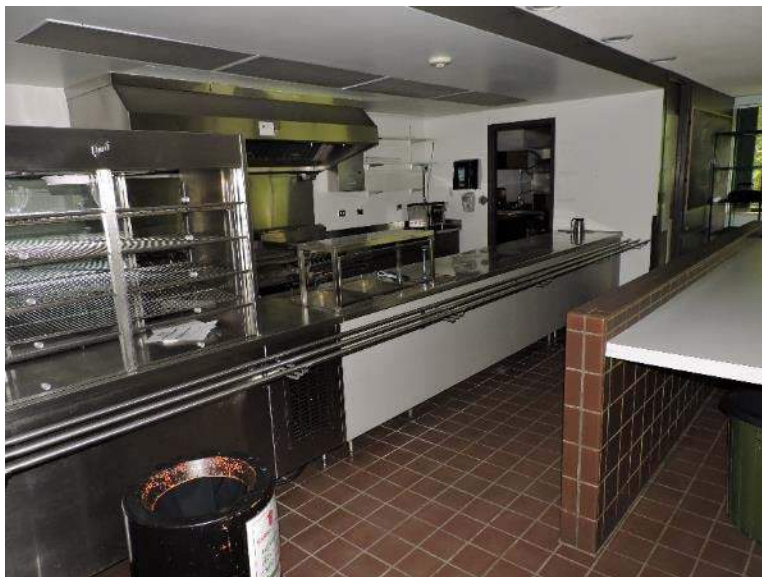
Figure 16 Existing cafeteria kitchen is currently not in use.

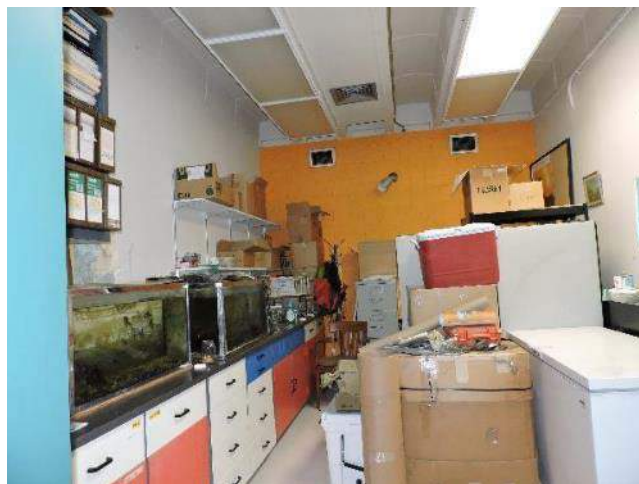
Figure 20 Typical under-utilized Lab.

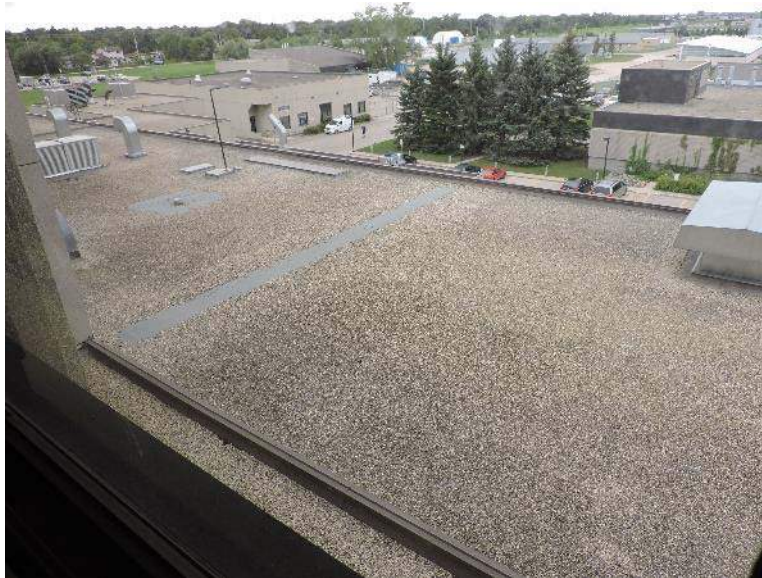
- .1 The Roof appears to be in poor condition and should be replaced. At this time, the roof covering is most likely not capable of supporting the Co-Location project due the risk of potential leaks and subsequent damage in the future.
- .2 The existing roof on the Admin and Lab block is a 4 ply built-up roof that was installed in 1998.

Figure 22 BUR roofing.

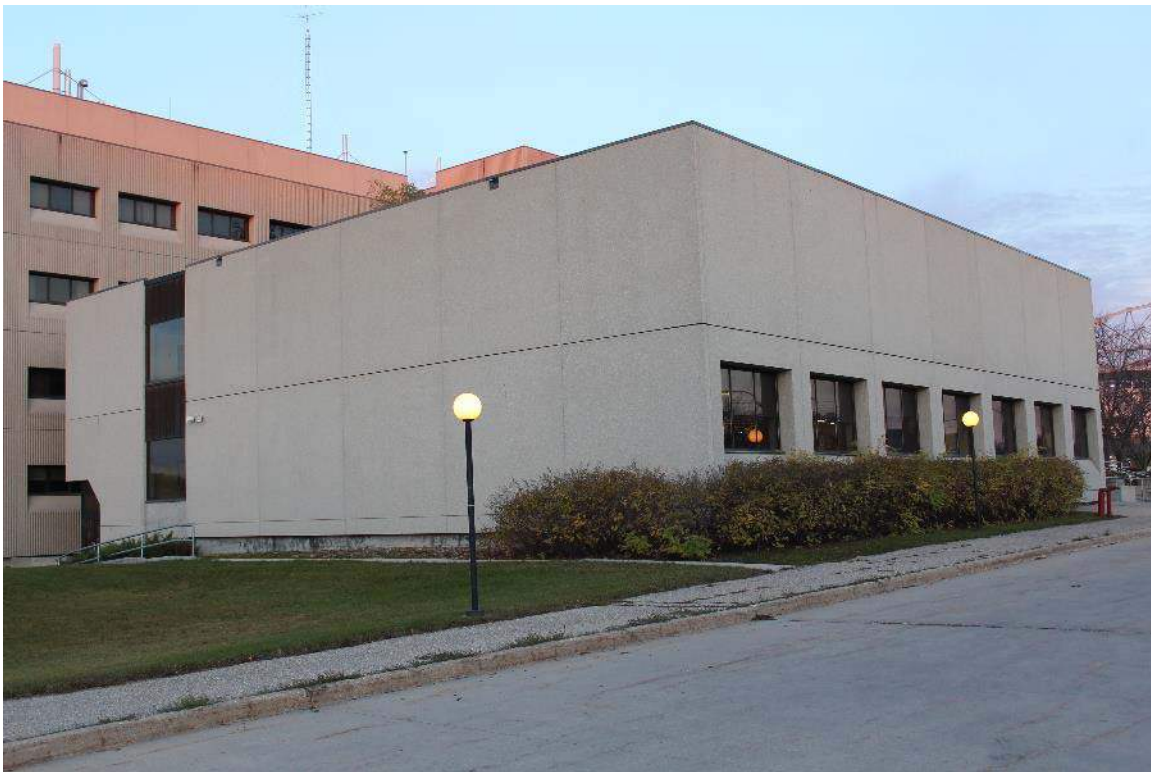
Figure 23 Existing Admin block - new windows may be provided on Level 3

- All new openings (Admin windows, 2nd floor exit) in the existing envelope will need to be assessed during design.

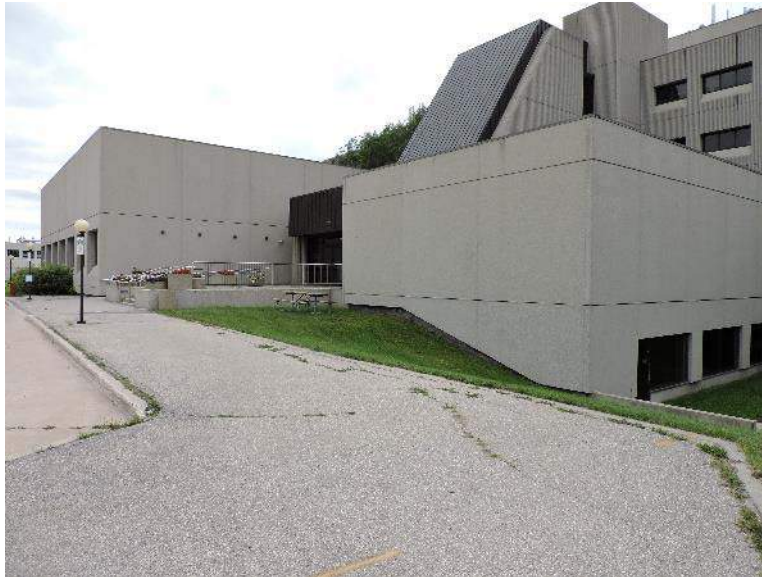
- .1 The exterior envelope of the building appears to be in good condition and can support the Co-Location project.
- .2 The envelope is primarily characterized with 10mm precast concrete panels over an airspace, 50mm rigid insulation, air barrier and 200mm concrete (block).
- .3 The envelope also features a large sloping copper roof/wall extending from the roof of the main entry to the roof parapet.

Figure 24 Exterior envelop - precast panels & sloped copper siding

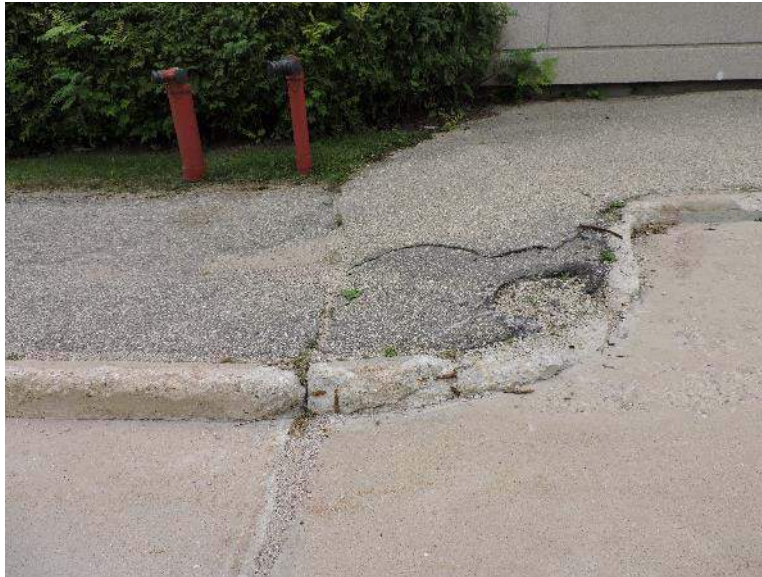
Figure 46 Sidewalks, curbs and roads are showing signs of deterioration and should be repaired.

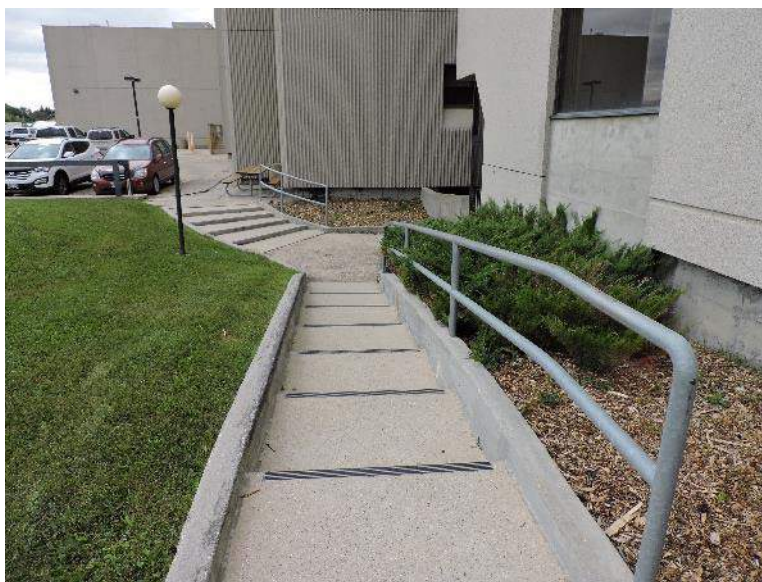
Figure 47 Sidewalks, steps and handrails appear to be sufficient for the Co-Location project.

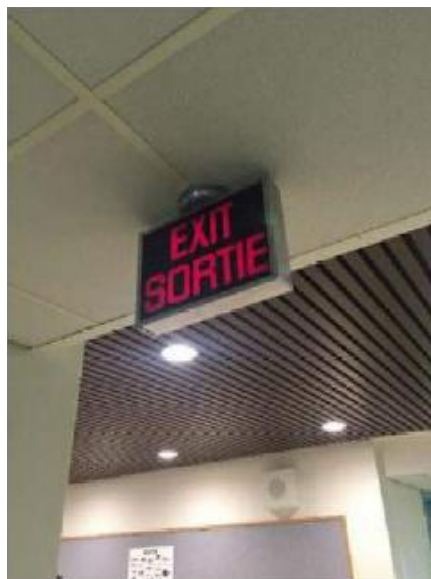
Figure 10 Exit sign from original 1972 installation, not conforming to current code.

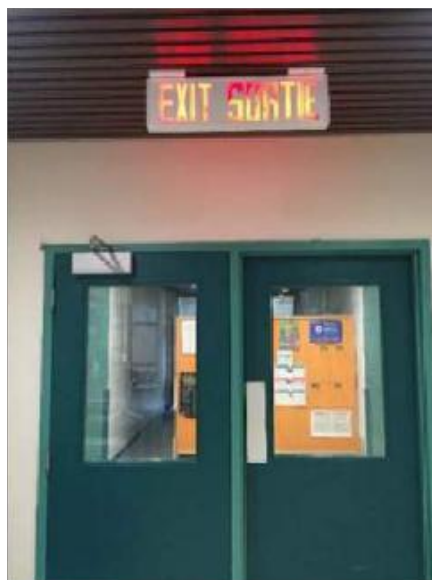
Figure 12 Exit sign upgraded from original installation.

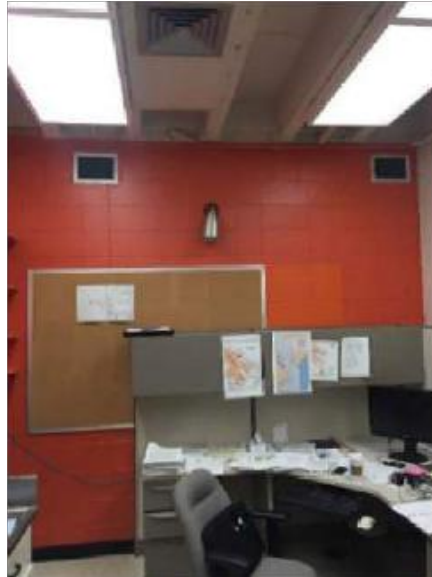
Figure 22 Lab area with single lamps emergency lighting head.
