Asset Performance Report

DFO-FWI - Main Lab-Administration Building

September 2013

PWGSC – A&E CoE
Winnipeg, Manitoba
Edmonton, Alberta
Project - R.060627.001

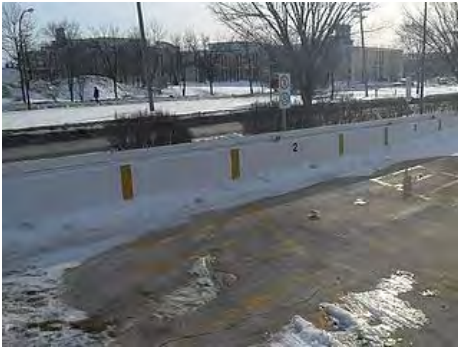
Event delay may see concrete wall deterioration.

Concrete wall in parking lot.

Replace Concrete Wall

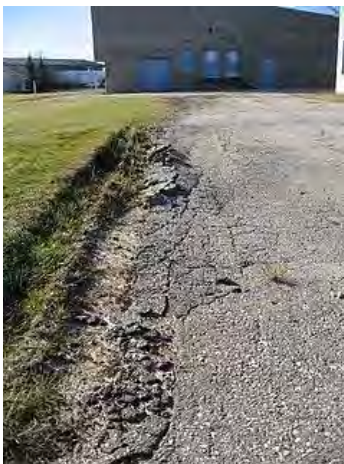
Deteriorated pavement - access road approaching solar warehouse.

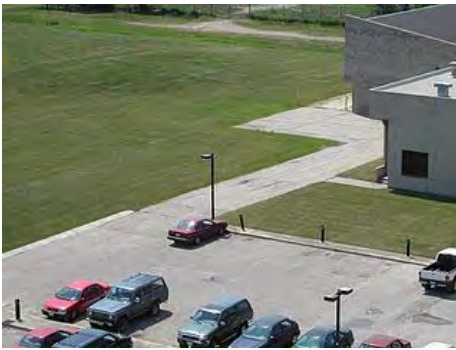
South Parking Area. Faded pavement markings.

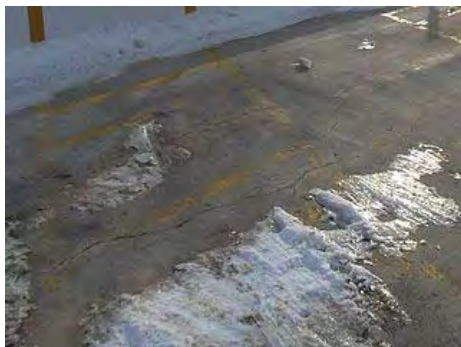
Event delay would promote poor parking assignments and improper parking for all.

Faded and worn parking stall markings in parking lot - typical.

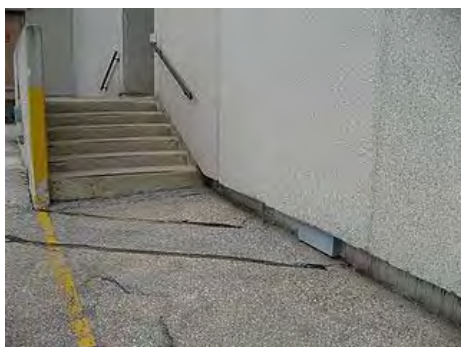
Lab Block, South Exit Exterior Landing and Stair. Concrete repairs and nosings required. First tread exceeds allowable height.

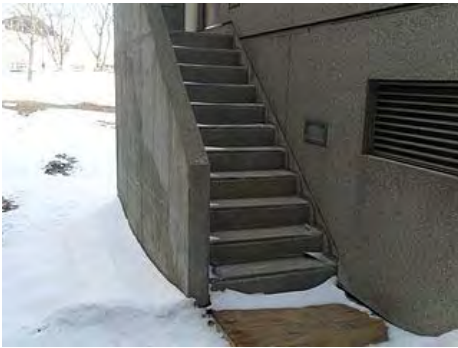
Exterior stair at south exit stair from Lab block. Deteriorated concrete and handrails non-compliant with NBC.

Missing handrail. Provide proper landing at base of stair.

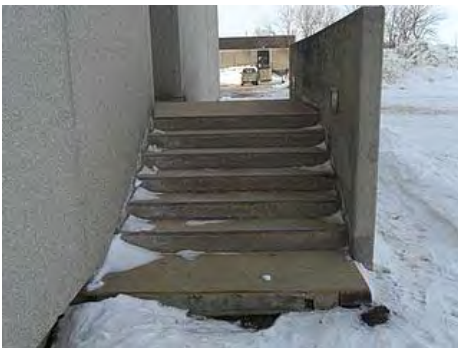
Exterior stair at north exit. Missing handrails. Makeshift wood landing at base of stairs.

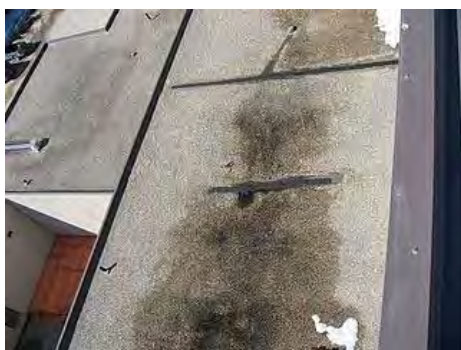
Built-up roofing (at Service Block) showing roof repairs and residual water pooling.

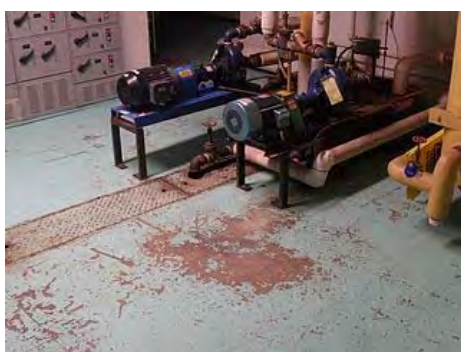
Deteriorated Paint on concrete floor (typical) - electrical / mechanical room.

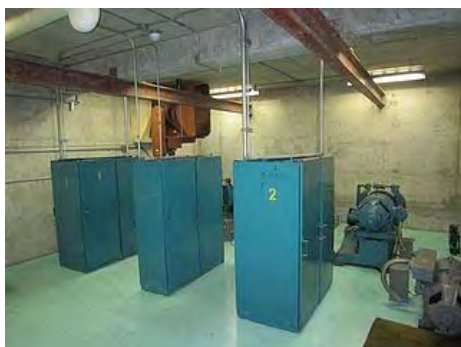
Elevators appears to be in average condition but based on their age, have been given a fair rating in this BCR. There is no history of extensive problems and regular service is provided by a long standing elevator contractor. The mechanical-electrical controls are quite dated but appear to be functioning well. An upgrade to electronic controls may be considered and budgeted for at the time of the next BCR in 2017. The mechanical drive system is also near its projected life expectancy but no reported immediate concerns.

Original electrical-mechanical controls in Elevator Machine Room

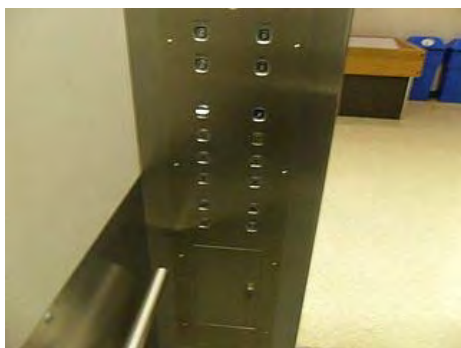
Event delay will infringe on accessibility standard compliance.

Elevator controls - do not conform with current accessibility standard.

Note - elevator control panels do not meet accessibility standard. Panels should be replaced in 2014.

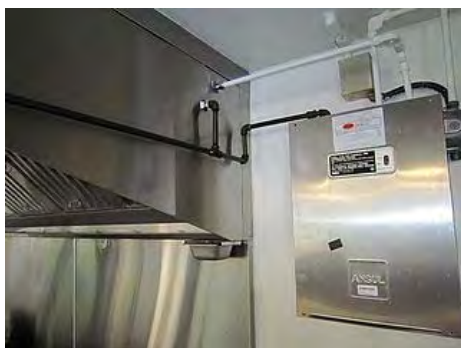
Kitchen fire suppression, no longer in use and to be decommissioned

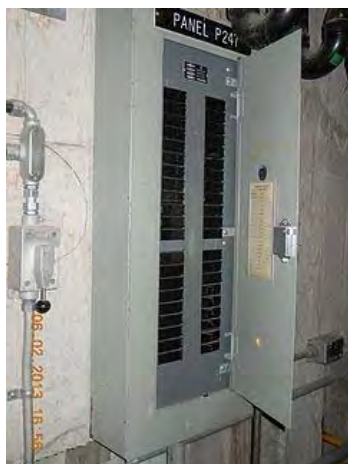
Typical access restriction of panel. Typical of 3 panels in service space.

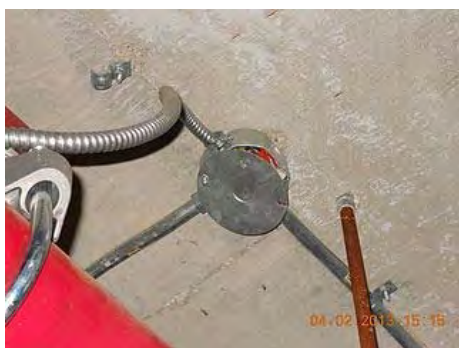
EMT conduit, AC90, wiring and coveplate loose.

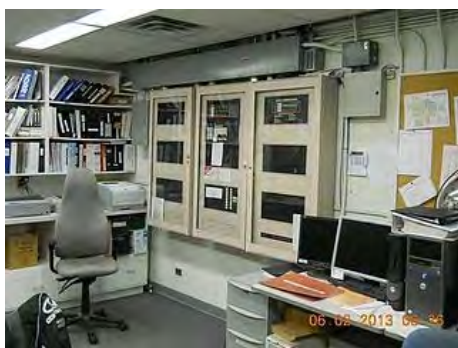
The fire alarm system appears to have been upgraded last in about 1998, and is missing any visual signal devices. This would make the system in fair condition overall. Although operational and stable, the fire alarm should be scheduled for replaced by 2018. If replacement is going to be delayed until then, visual devices should be considered in 2014.

Fire alarm cabinet in operators office.

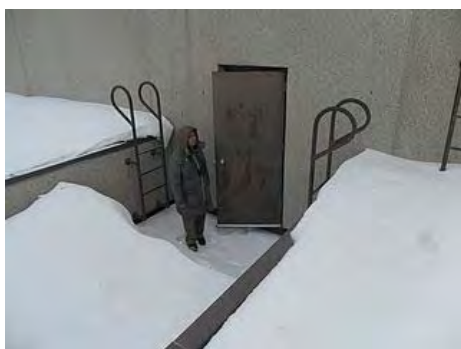
Current roof access is poor during winter conditions. Implement inspection/report in 2013 to find a solution.

Snow buildup frequently prevents door from opening.

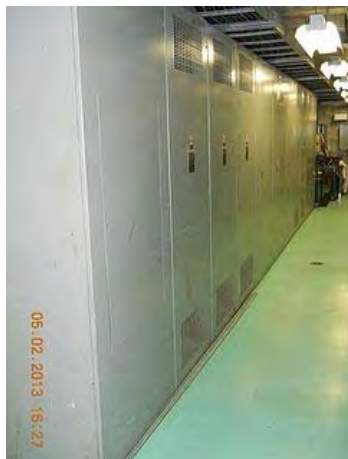
The equipment is identified as average condition as the majority of the equipment has had little preventive maintenance over the years. Cleaning and torquing should be done every 5 years and start in 2013.

Distribution EE. Typical for several.

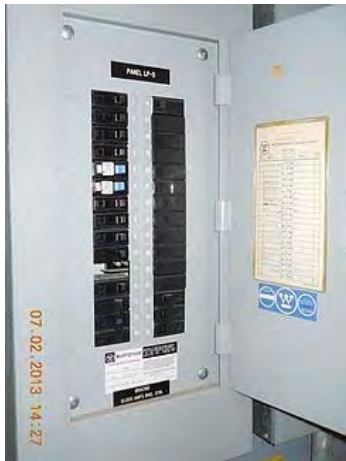
Filler plate missing.

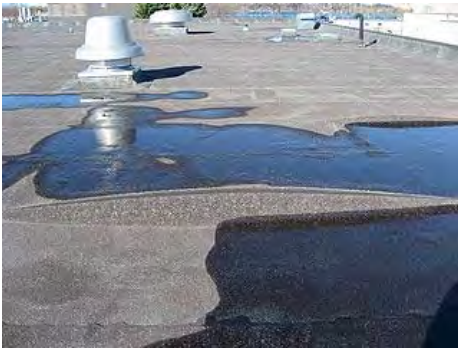
Currently, the visual and thermal conditions are rated as average with numerous roof corners having granule accumulations. The next thermal/visual inspections are scheduled for 2013.

Roof area with deteriorated SBS roof membrane.

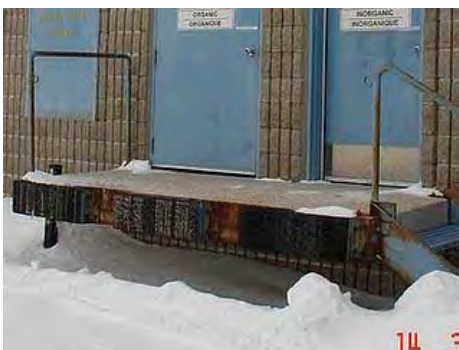
Exterior concrete loading dock with rusted steel framing and worn rubber bumpers.

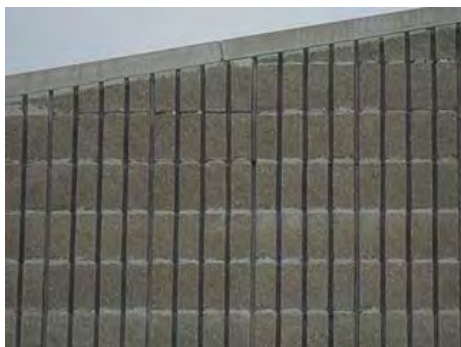
Event delay may lead to inner wall degradation and mold issues.

Deteriorated horizontal mortar joints near top of wall (typical).

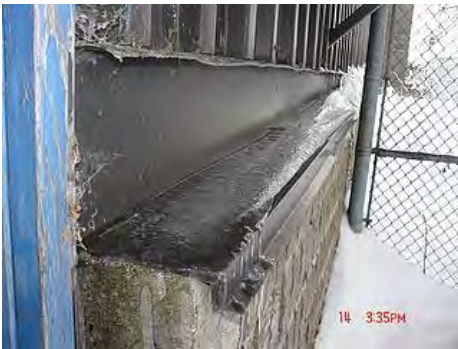
Delaying the sill flashing redesign may lead to further inner wall damages.

Lack of drainage at sill flashing causing water / ice buildup.

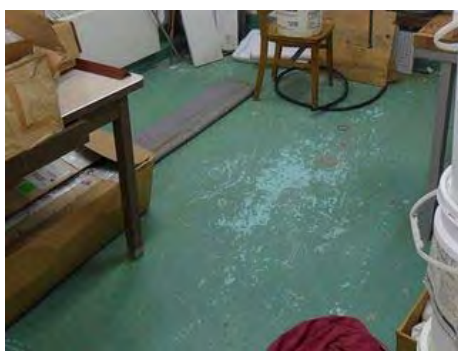
Slab on grade with painted wearing surface - worn.

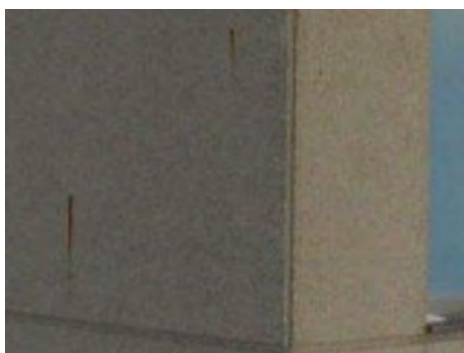
Event deferral may lead to enhanced panel decay from continued spalling and rusting. Appearance and panel anchorage would be issues.

Iron spotting on west wall near southwest corner.

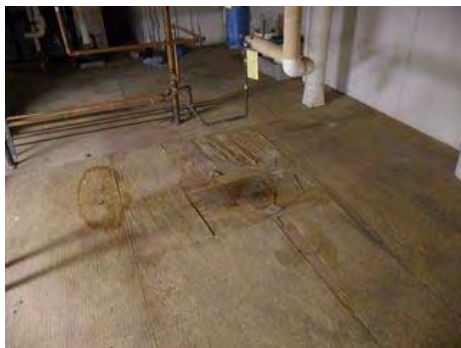
Event delay would inhibit proper footing for service personnel.

Mezzanine flooring with deteriorated plywood finish.

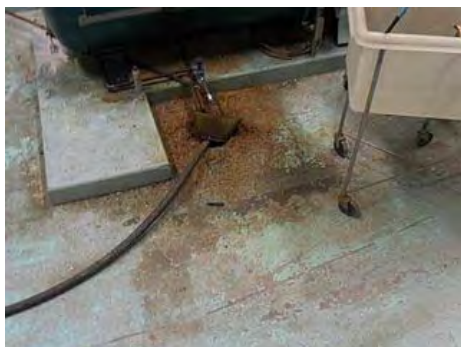
Paint finish at floor drain damaged and worn.

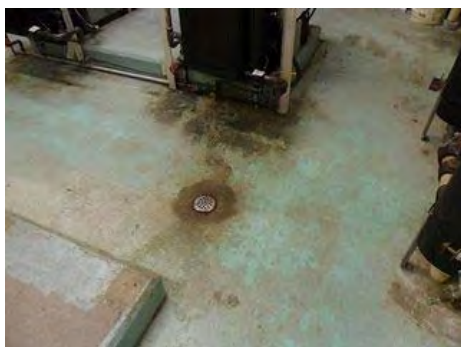
Event delay would have low risks. Appearance factor would be poor.

Worn and chipped paint finish on concrete floor.

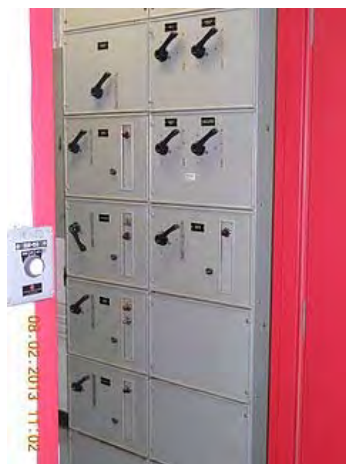
Confusing labeling.

Motor Control Centre.

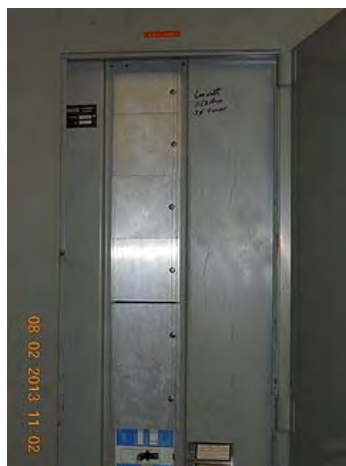
The equipment is in poor condition from its usage and operation with the corrosive product in the vicinity. Arc flash identification, evaluation and labeling should be done in 2013.

Main service CDP.

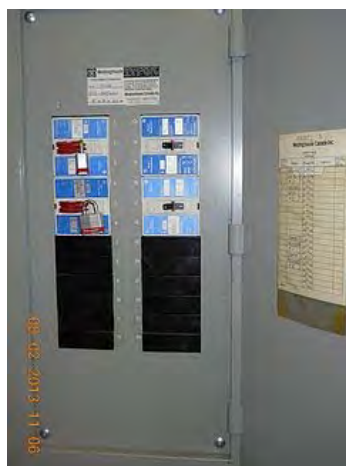
The equipment is in average condition but has not been cleaned and retorqued, and should be done every 5 years starting in 2013.

One of two CDP's.

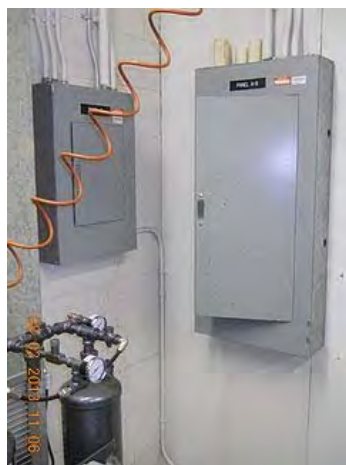
Currently, the electrical components are in average condition. Since thermal scanning has never been implemented, the initial scan should be completed in 2013.

Panels in Ozone Generation Room.
