# SPECIFICATION FOR THE RENOVATION OF COMPARTMENTS FLOORS & WALLS ON UPPER DECK

C.C.G.S. MARTHA L. BLACK | TYPE-1100 NAVAIDS TENDER

CANADIAN COAST GUARD

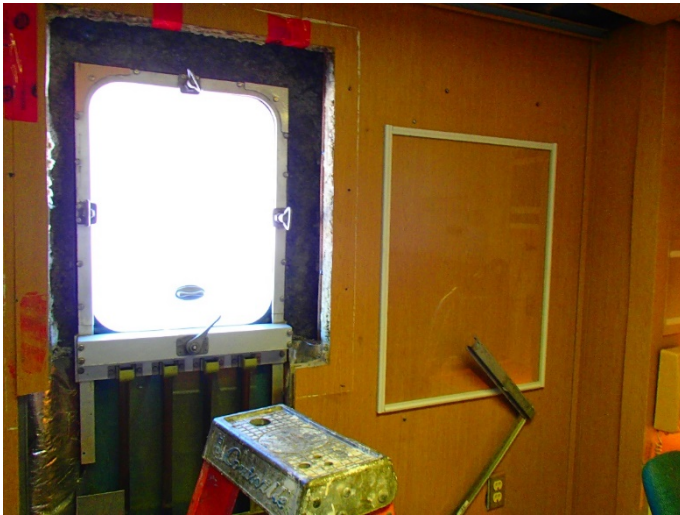
A few lining wall panels on Upper deck cabins were taken down so as to permit us to see firsthand the extent of the damage caused by the ice melt that had formed during winter, principally around the sliding pane window and frame in cabin no.245, Upper deck (see figure no.1).

*Figure 1: cabin 245 + typical sliding window*

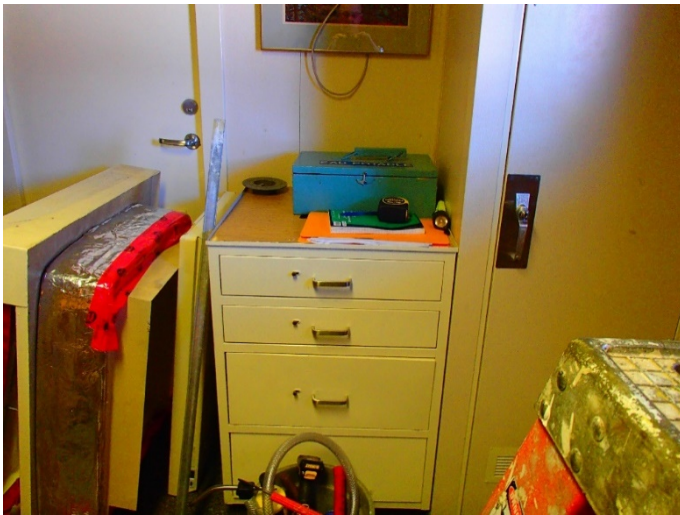
Figure 12: Sliding window frame + 4-drawer dresser cabin 245

This frame will be reinstalled and the end of the prescribed work. See figure 12.

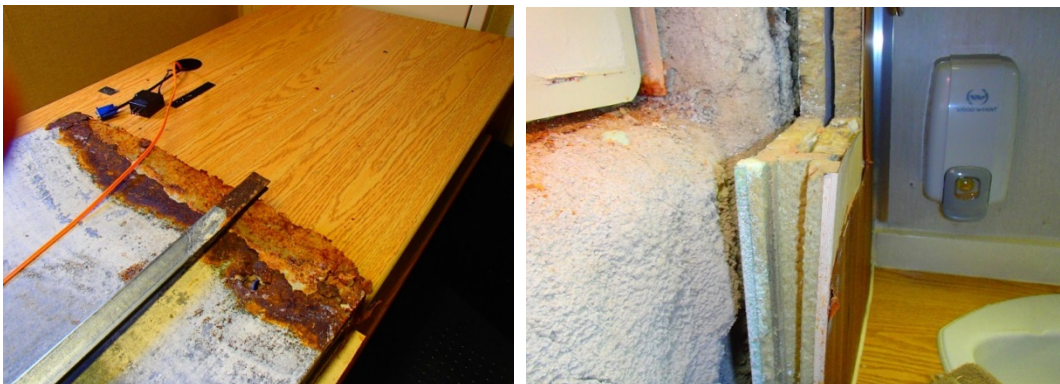
There are approximately 19 meters of wall lining panels, Joiner B-15, 50mm X 600mm X 2250mm, in outside walls, plus 9 meters of paneling in inside transversal wall. The actual panels are deteriorated by corrosion on the lower end, as well as the positioning channels. These will be replaced by new paneling and tracks of the same type and color. Refer to sketch 1, walls dimensions are shown with circle readings in inches. See figures 13 & 14.

Figure 13: Corroded lower part of Joiner panel

Figure 14: Typical 50mm (2") Joiner panel

- a. The old lining panels previously dismantled will be replaced by new Joiner B-15 panels, 50mm X 600mm X 2250mm. These new panels will be installed using all new tracks (lower & upper), inside and outside corners, and end caps.

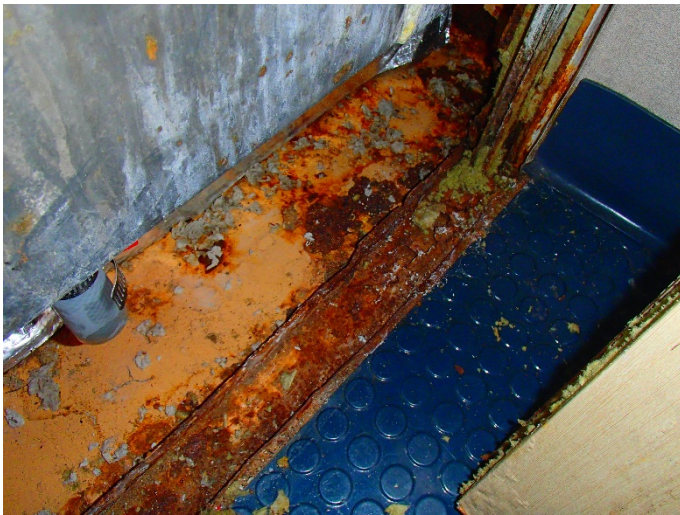
- a. Once all the insulation has been removed, Contractor will mechanically grind off all rust on exterior wall, ceiling and floor plating.
- b. Special attention will be exercised on the deck beneath the porthole, as water and humidity were particularly aggressive in that area. Also the lower lining track will be removed, as it is badly corroded. See figure 16. Under the entrance inside step of # 204 and 207, and on an additional length of 4 ' forward on each side, therefore on an area of 1 foot high from the deck x 8 feet long we will do 20 measurements of thickness on each side, thus 40 measurements of total thickness of the bulkhead. Give a report of the reading with % steel degradation.

*Figure 16: Corroded tracking & floor below sliding window*

- c. Grinding to be performed all around sliding window (frame), if necessary.
- d. Rusty surface to be grind and painted, 25% overall surface (350 ft<sup>2</sup> total to be grind), mostly 2 feet above deck, and around the sliding windows, applied on coat of marine enamel primer and two finishing coat.

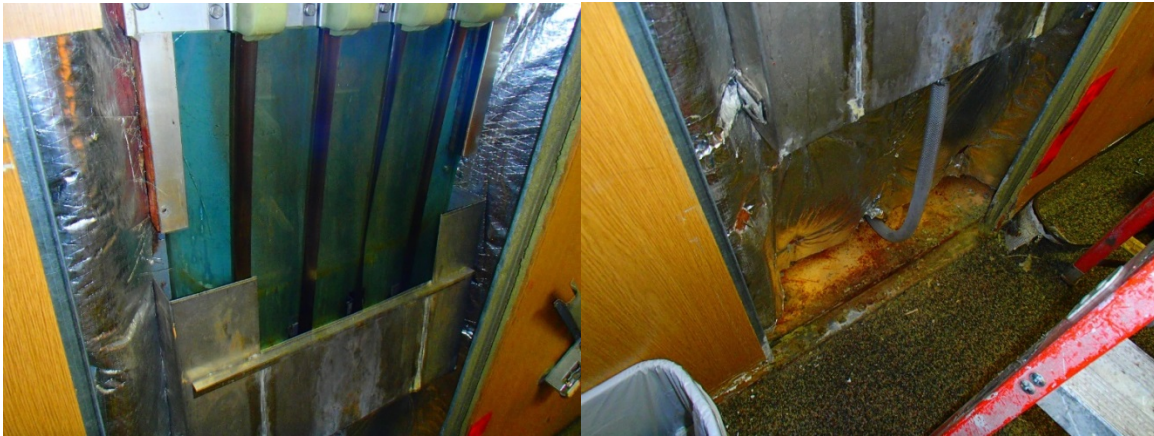
The sliding windows were installed with a stainless steel retention reservoir. This reservoir is too small (not high enough) and cannot prevent accidental overflowing of rain water or sea spray that can drip down to the reservoir when window is partially open or not well sealed. Contractor must proceed with the following modification on all 7 sliding windows:

- a. The actual tank measures approximately 35cm high X 50cm wide. See figure 9.

*Figure 17: Retention reservoir cabin 245*

*Figure18: Flexible hose connection under reservoir*

- b. A new reservoir approximately 70cm high X 50cm wide will need to be fabricated and installed, as this new tank will allow rain water and sea spray to be more readily captured. The bottom of tank to be designed to permit water being channelled towards drain connection.
- c. This new reservoir will be built using stainless steel 316 material.
- d. The actual reservoir is fitted with a drain connection under, permitting rain water and sea spray to be drained on deck. The new arrangement will need to be fitted with a similar arrangement, c/w flexible drain hose. Make sure drainage connection in wall is free flowing. See figure 18.
- e. A leak tightness test to be performed before boxing up panels.
